An Analysis of Tsunami Impacts to Lifelines

N.A. Horspool S. Fraser

GNS Science Report 2016/22
May 2016

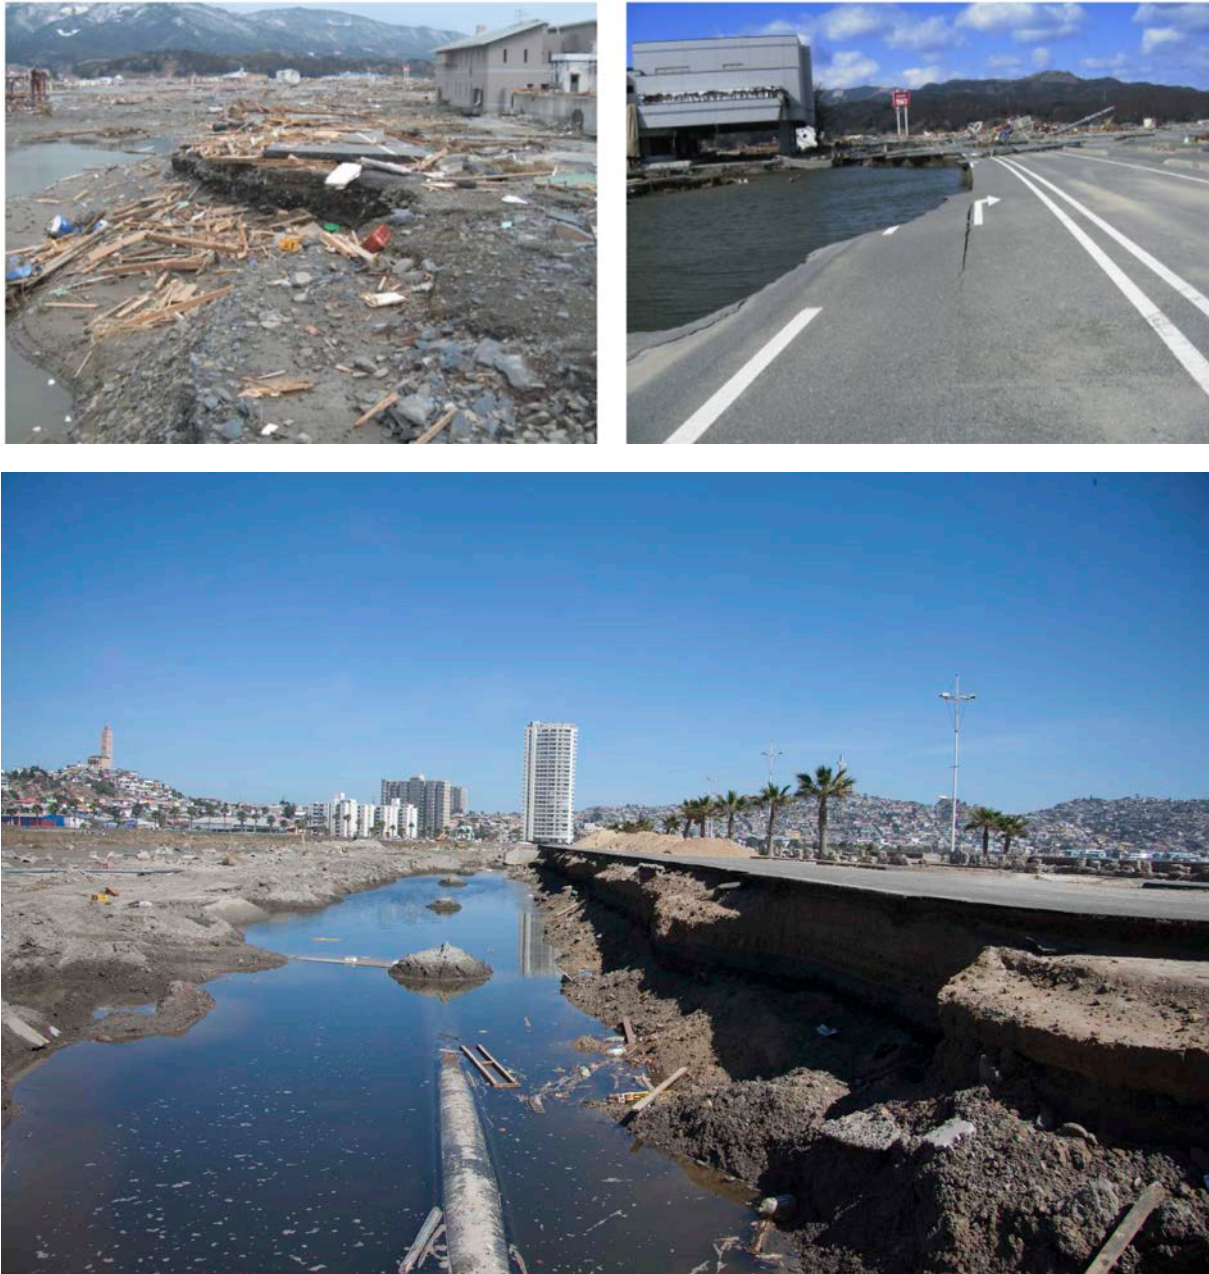
Figure 4 Upper Left: Peeling off of road surface in Iwate Prefecture (Unjoh, 2012), Upper Right: Scouring of road in Iwate Prefecture (Unjoh, 2012). Lower: Scouring of a raised coastal road and scour pit on the landward side of the road caused by the receding wave. (Horspool et al, 2016).

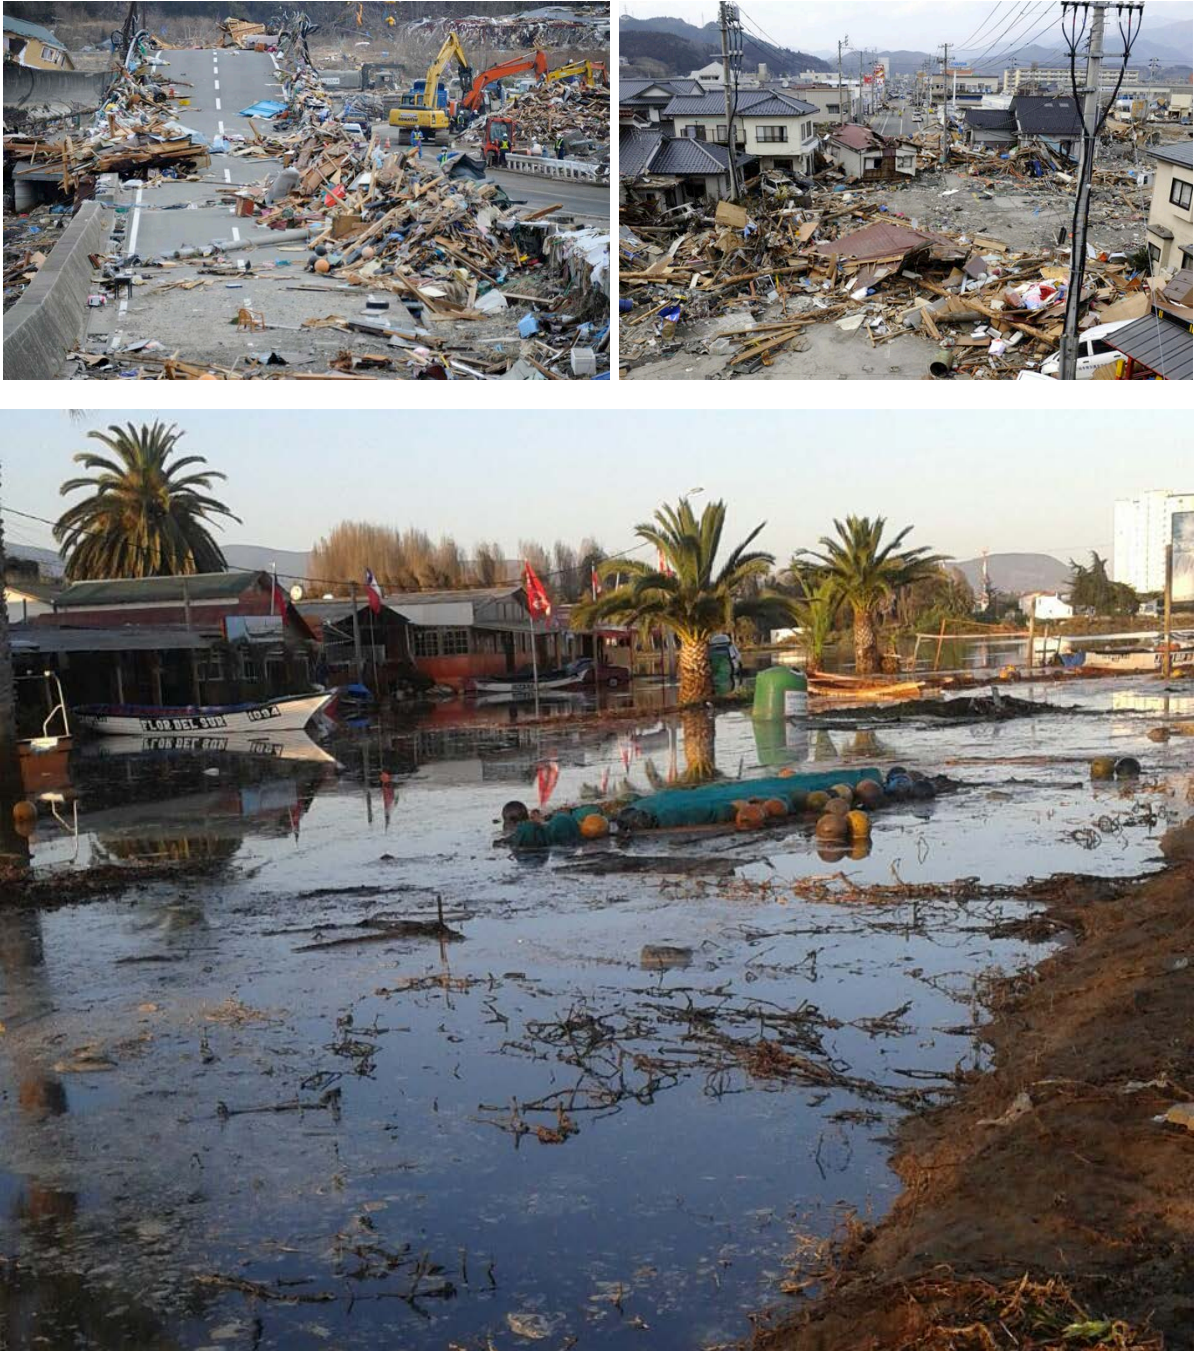
The second type of damage to roads from tsunami is from debris. Tsunami are very high energy waves and have the ability to suspend large loads and then deposit these many kilometres from the shoreline (Shoji, 2012). This is evident from some striking photos from recent tsunami events (Figure 6). In most cases damage to roads from debris is superficial, with debris being deposited on the road surface and requiring clean up. This size of debris that can be deposited is related to the flow depth (Evans, 2011) and Table 2 describes the debris type and size that can be expected as a function of tsunami flow depth. Generally, flow depths of greater than 2 m can suspend most objects. At flow depths over 2 m, damage to most types of building increases significantly (Suppers, et al. 2013a; MLIT, 2012), increasing the amount of debris that is being mobilised and deposited, and creating a snowball effect by then causing more damage to other buildings. It was noted in Japan, that in areas of severe inundation (i.e., >2 m), roads often have coincident scouring and disposition (Shoji, 2012). In addition to debris, some areas that are low lying and poorly drained may have ponding of water that can remain for days following a tsunami (Horspool et al., 2016).

Figure 6 Photos of debris on roads in Iwate Prefecture, Japan. Excavators clearing a road (top left), example of debris from destroyed timber frame buildings blocking a main road (top right) (Source: theatlantic.com) and example of ponded water in Coquimbo during that remained for a few days following the 2015 Chile Tsunami (Horspool et al, 2016).

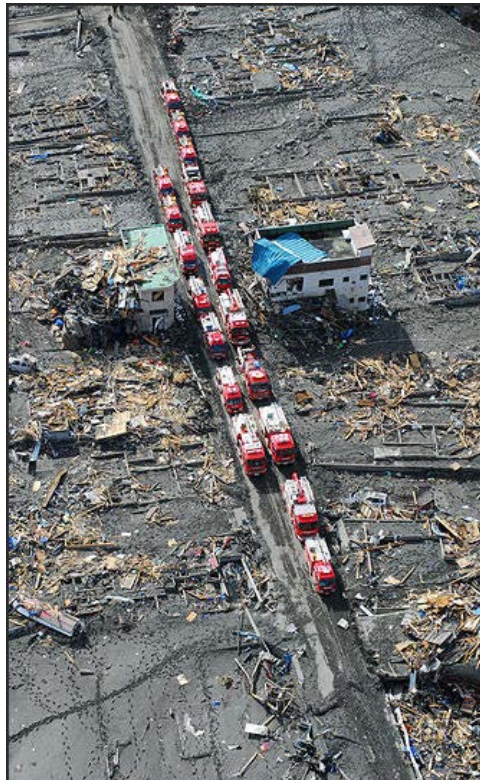
Figure 7 First responders blocked by debris on roads. Source: telegraph.co.uk

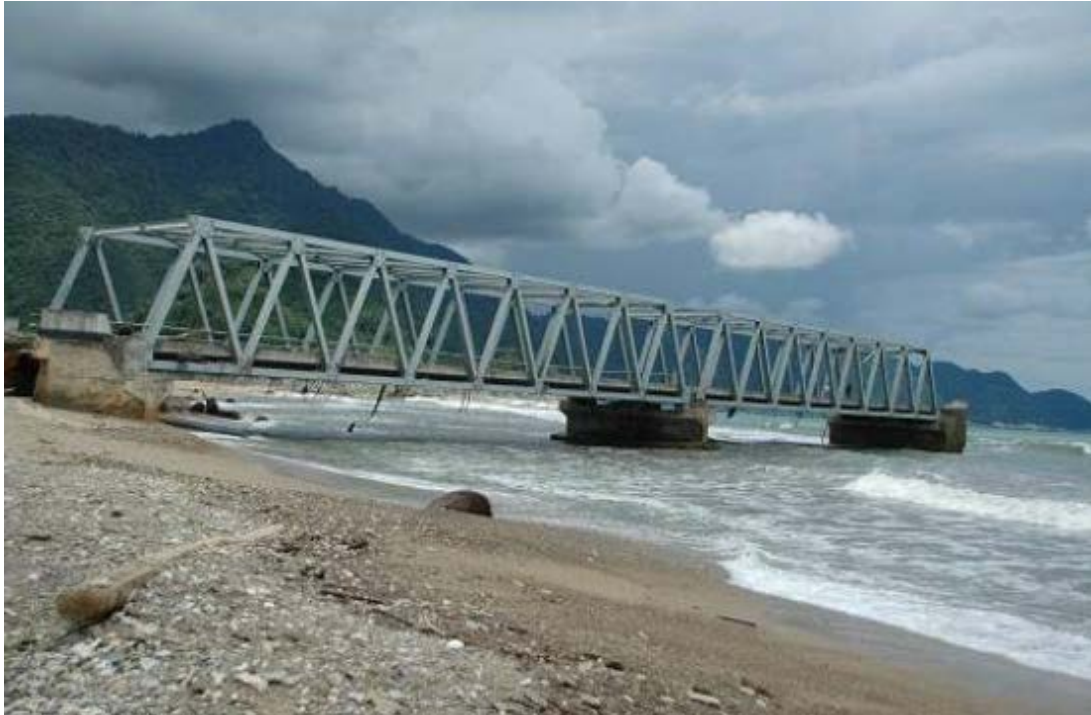
Figure 8 Bridge in Sumatra, Indonesia located on a river entrance, with complete scouring of one riverbank (right side of photo). Source: Francis, 2006.

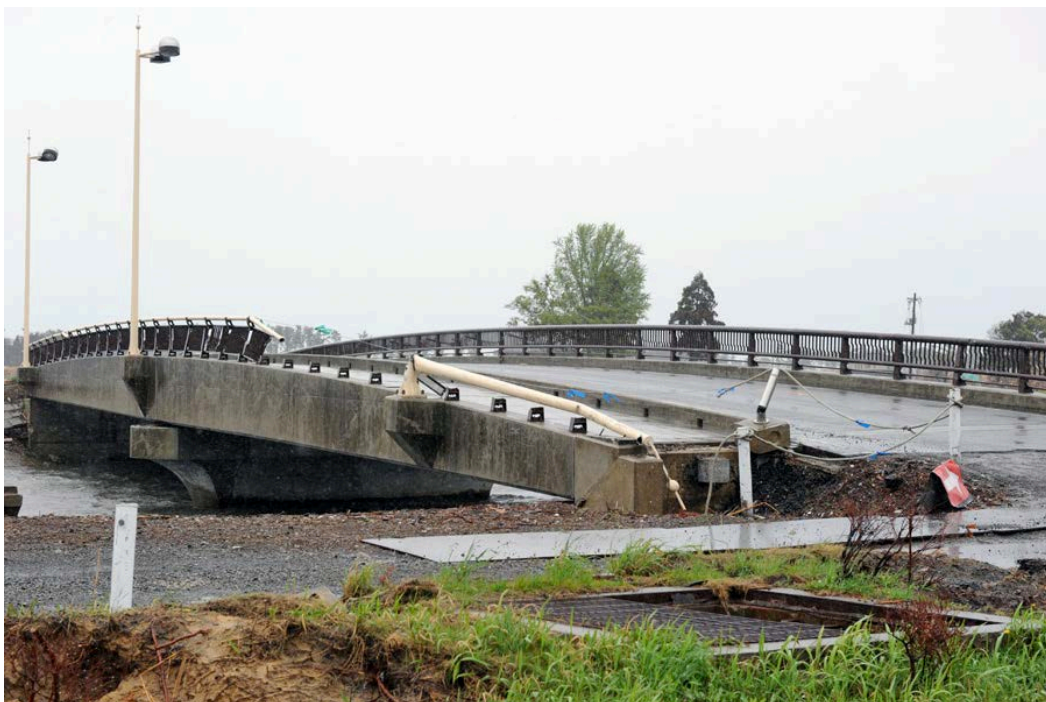
Figure 9 Bridge in Japan with minor-moderate damage of the superstructure and some minor scouring in the foreground. Source: Structural Engineers Association of Washington.

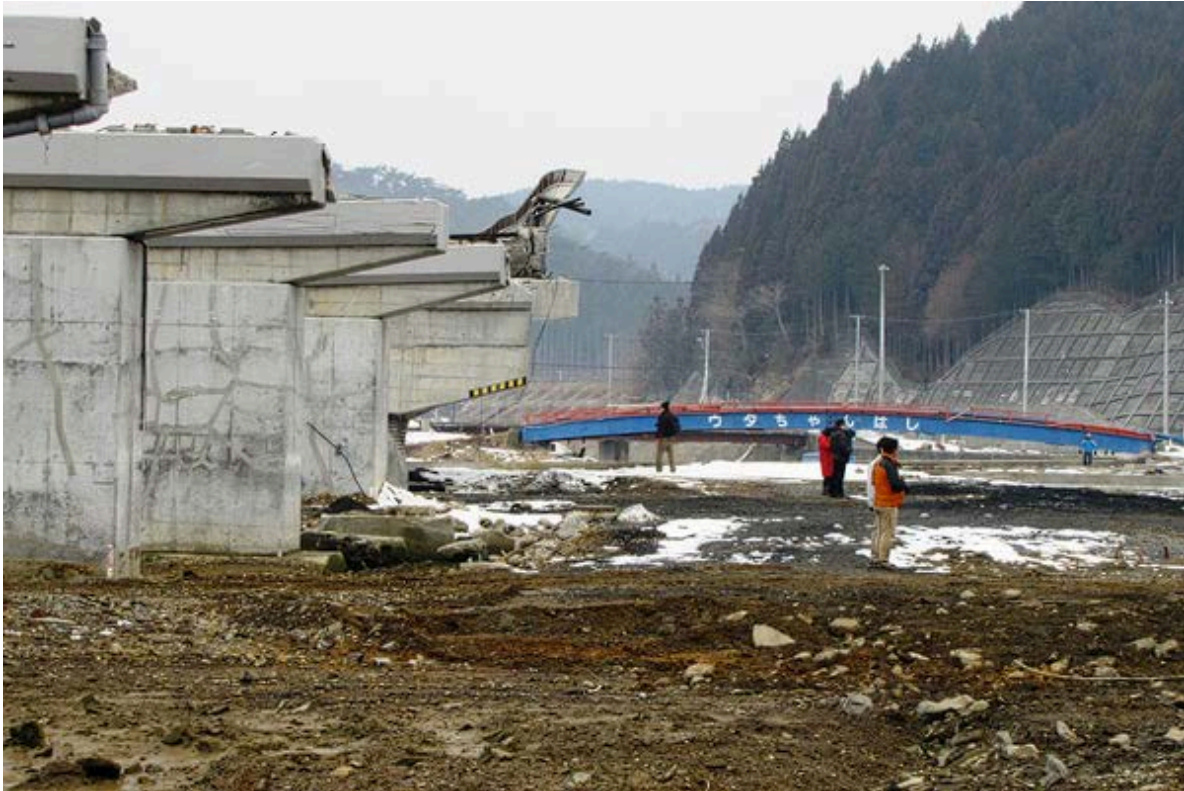
Figure 10 Bridge in Japan with complete wash out of the superstructure with only the piers remaining. Source: Structural Engineers Association of Washington.

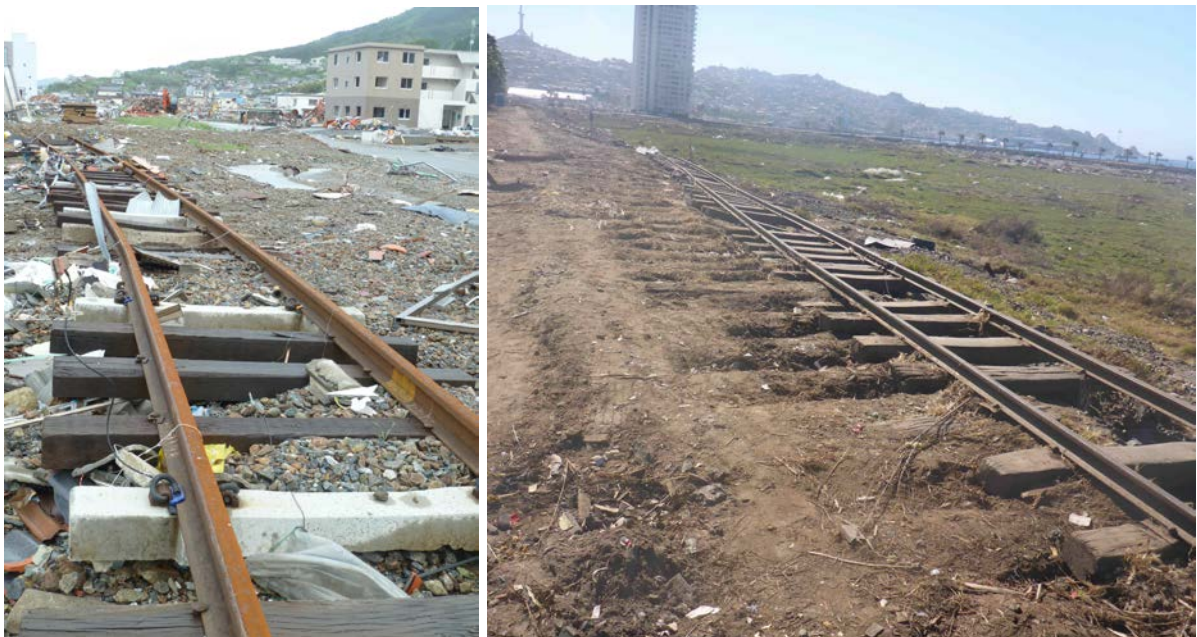
Figure 13 Scouring of rail ballast in Ofunato City, Japan, 2011 (Source: S. Fraser), and lateral movement and washout of a track in Coquimbo, Chile during the 2015 Tsunami (Horspool et al., 2016).

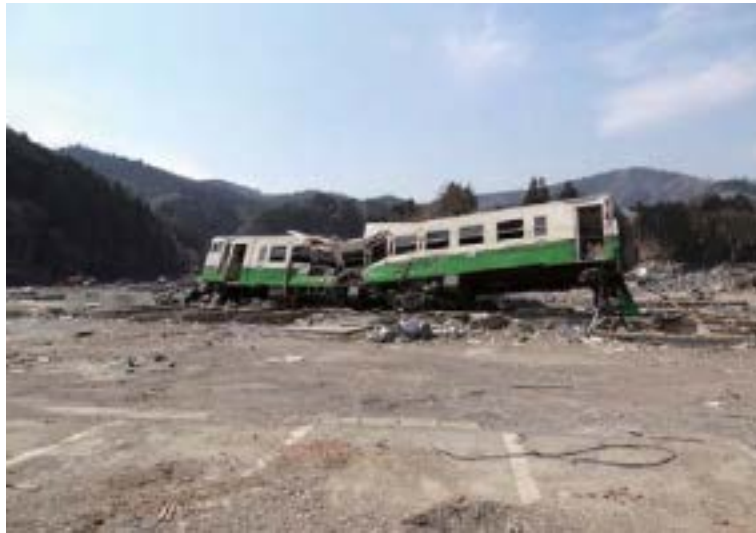
Figure 14 A train that has been suspended and carried ~200 m from its original location at a station in the Great East Japan tsunami (Shimamura, 2012).

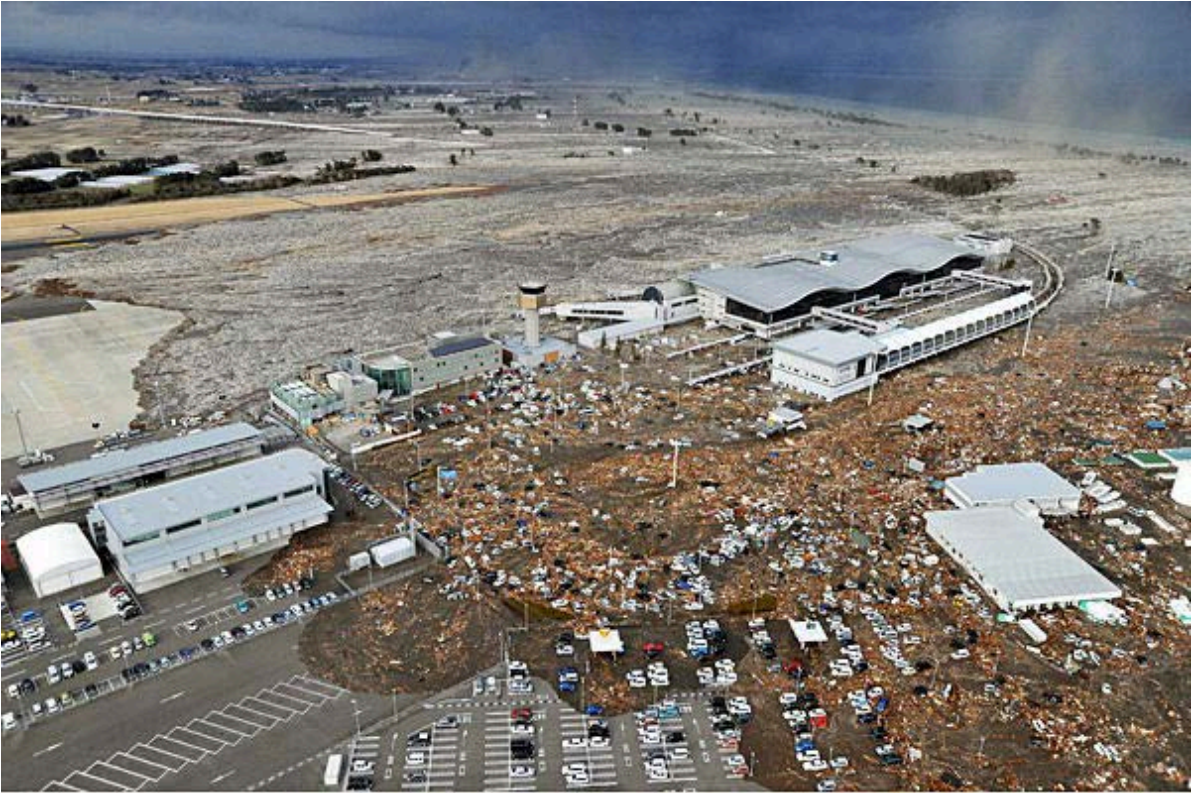
Figure 15 The first wave of the tsunami inundating the Sendai Airport. Note the large amount of debris being carried through the car park. Source: telegraph.co.uk

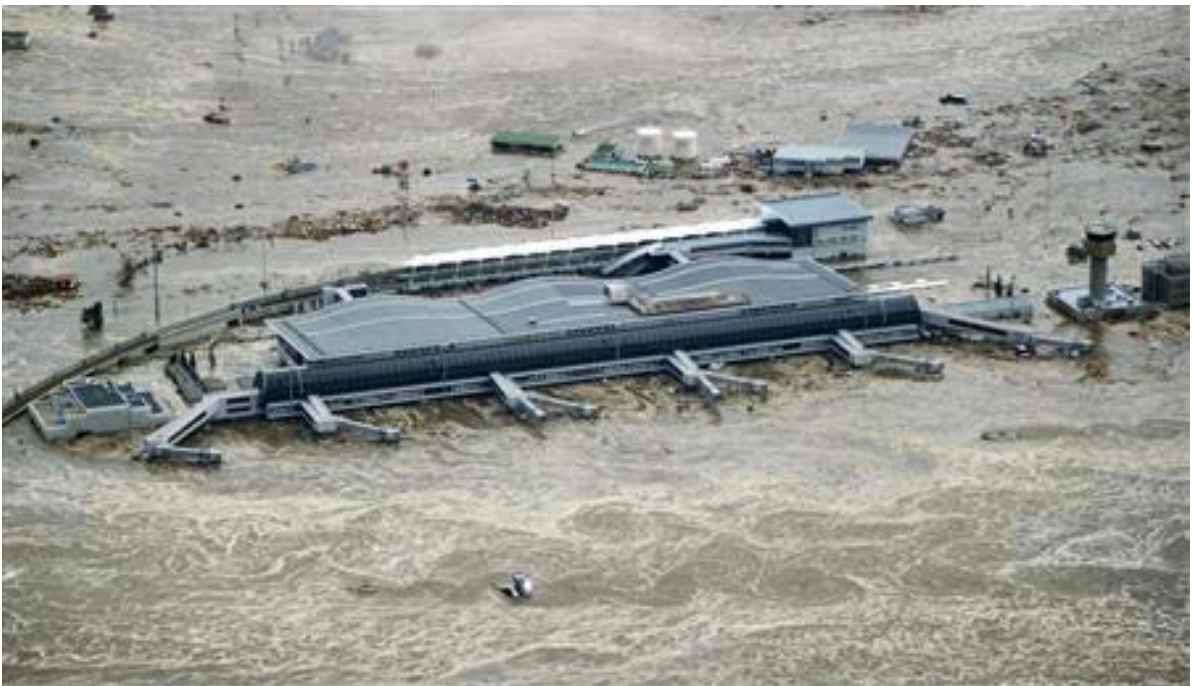
Figure 16 Sendai Airport when inundated by the tsunami. This is taken near the peak tsunami height (4–5 m). Source: Reuters.

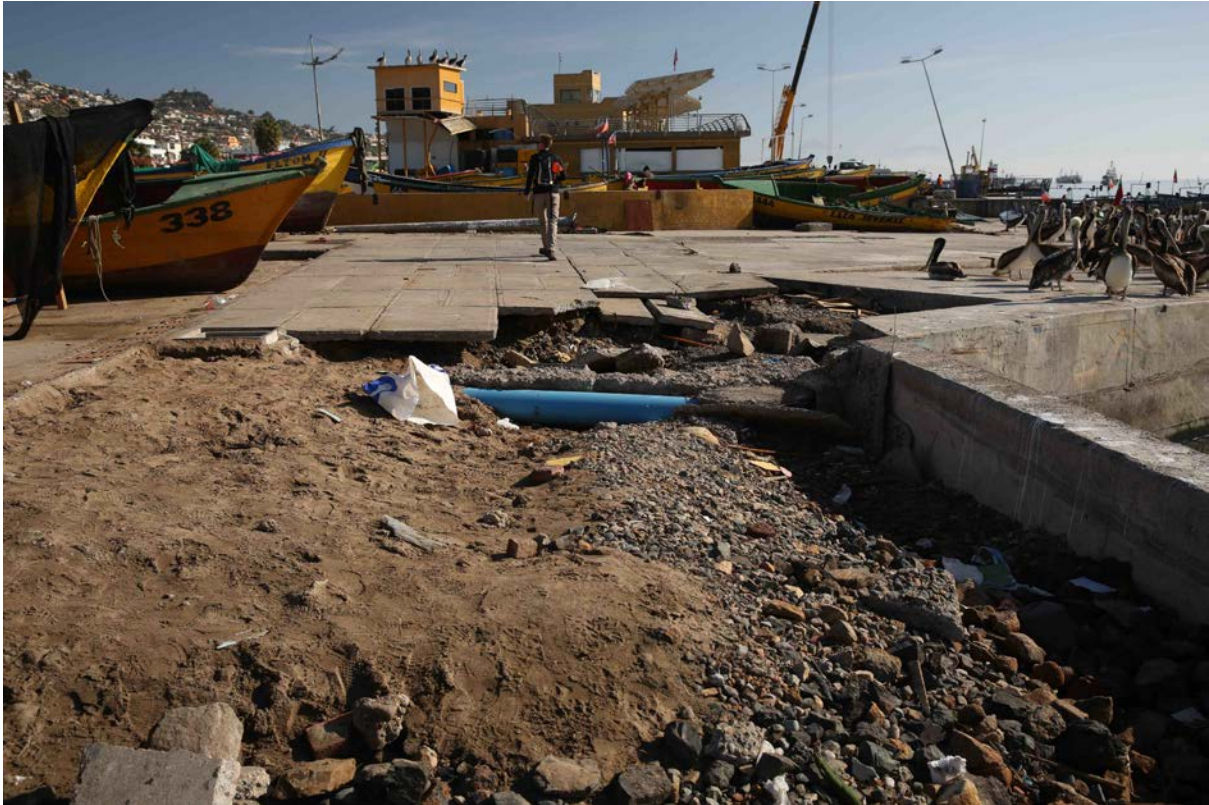
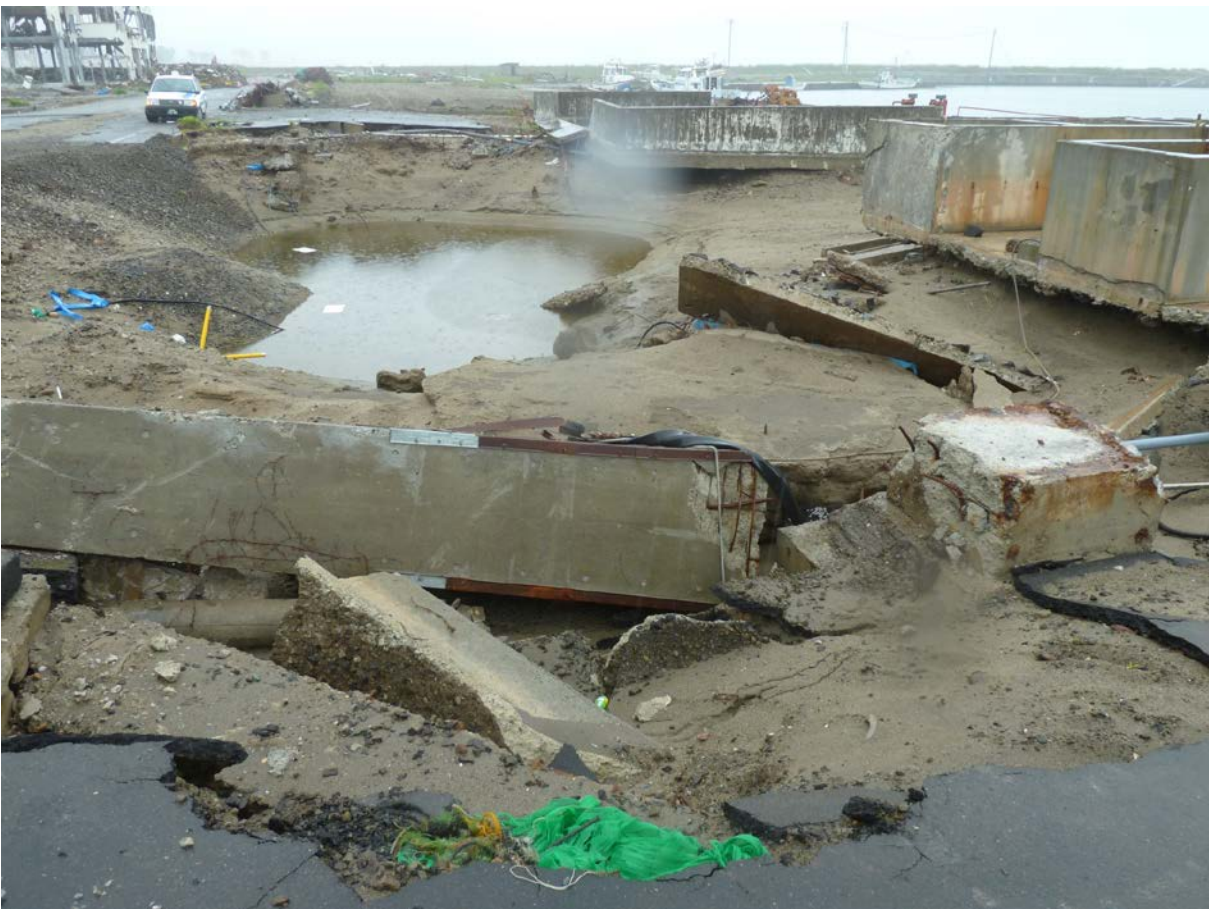
Figure 17 Bottom: scour, and collapsed reinforced concrete columns of the wharf and associated buildings at Yuriage, Miyagi, Japan, in the Great East Japan tsunami. Source: S. Fraser. Top: washout of some untied concrete tiles at Coquimbo wharf in the 2015 Chile tsunami (Horspool, et al., 2016).

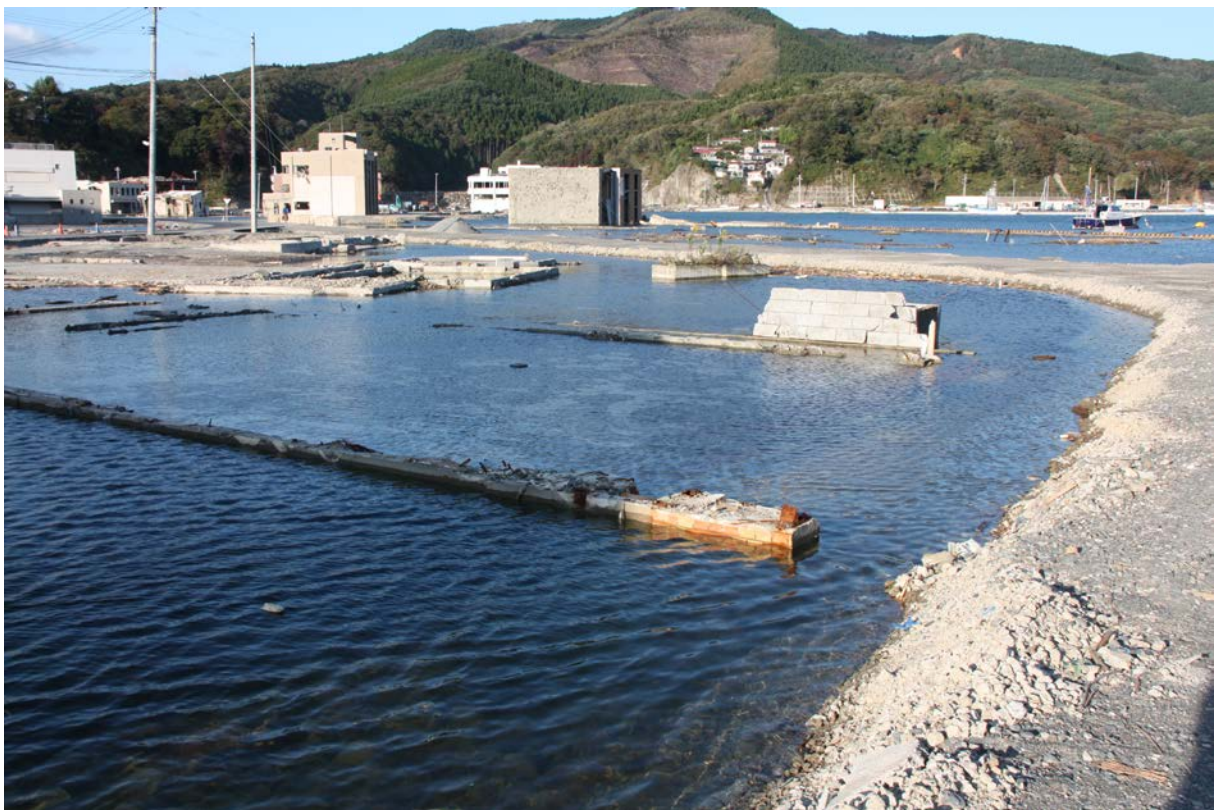
Figure 18 Subsidence reduced ground elevation, resulting flooding land in Onagawa, Japan. Taken six months after the Great East Japan tsunami, new roads have been constructed at a higher elevation. Source: S. Fraser and G.S. Leonard.

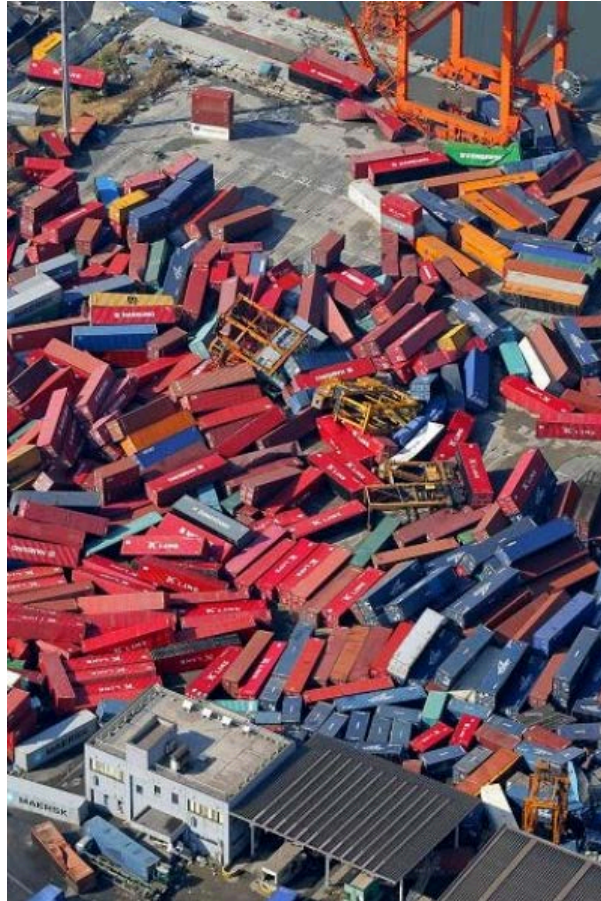
Figure 19 Containers lifted and transported by the tsunami in Japan. Source: PARI, 2012.

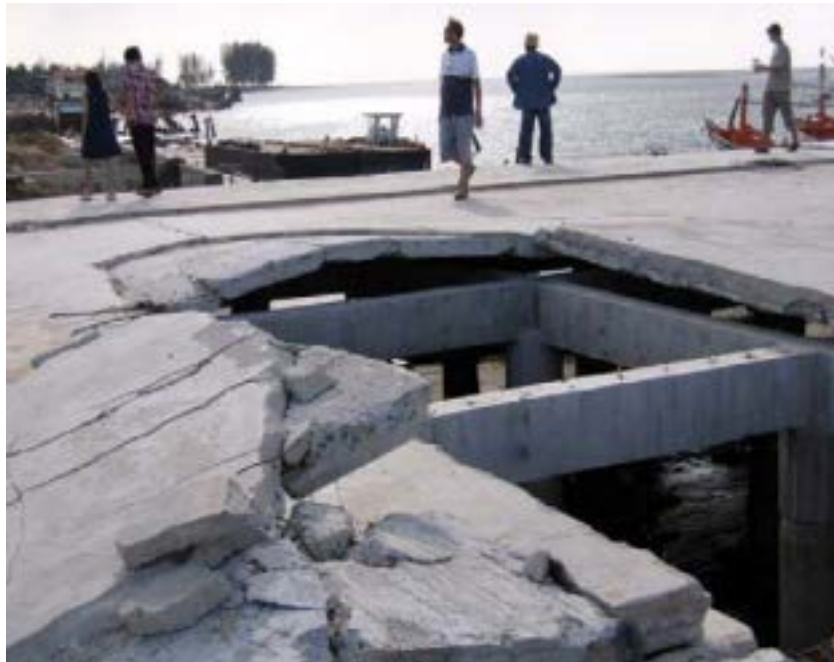
Figure 20 Damage to a wharf deck in Thailand from vertical buoyancy forces. Source: PARI, 2009.

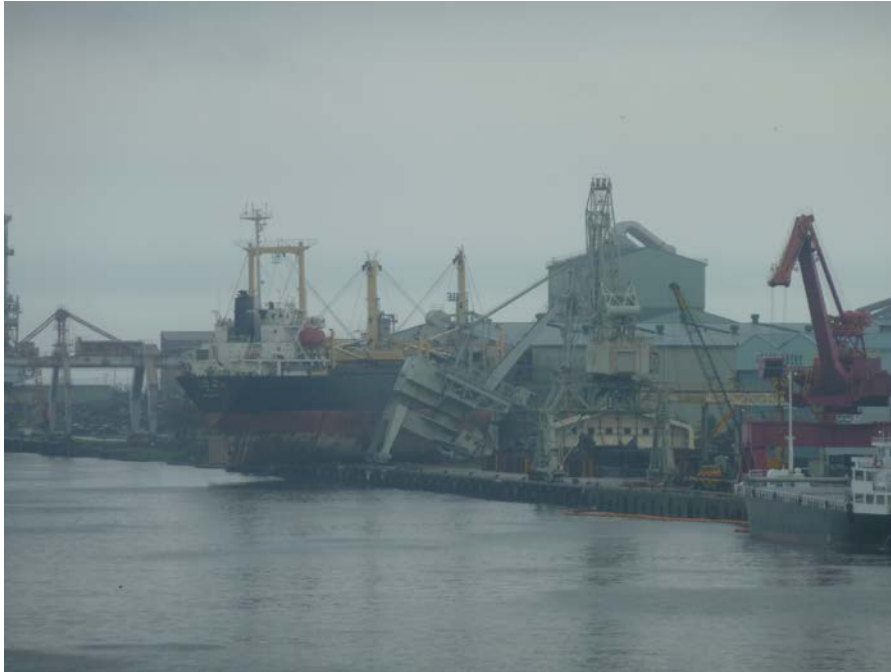
Figure 21 Example of damage to a gantry crane from debris strike by a large ship. Source: S. Fraser, 2011.

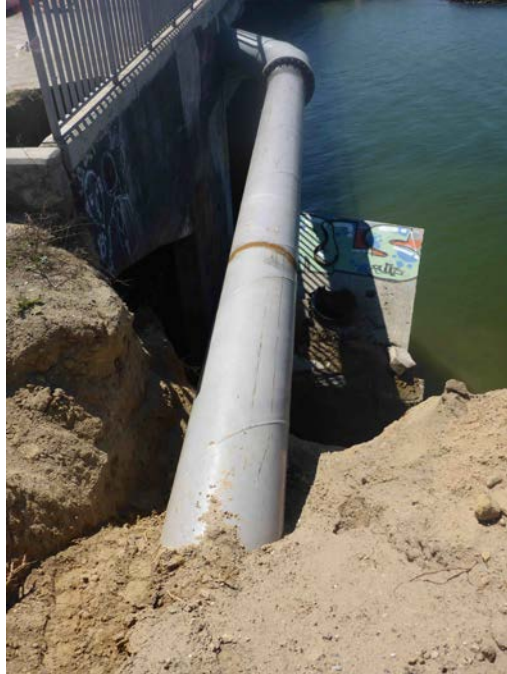
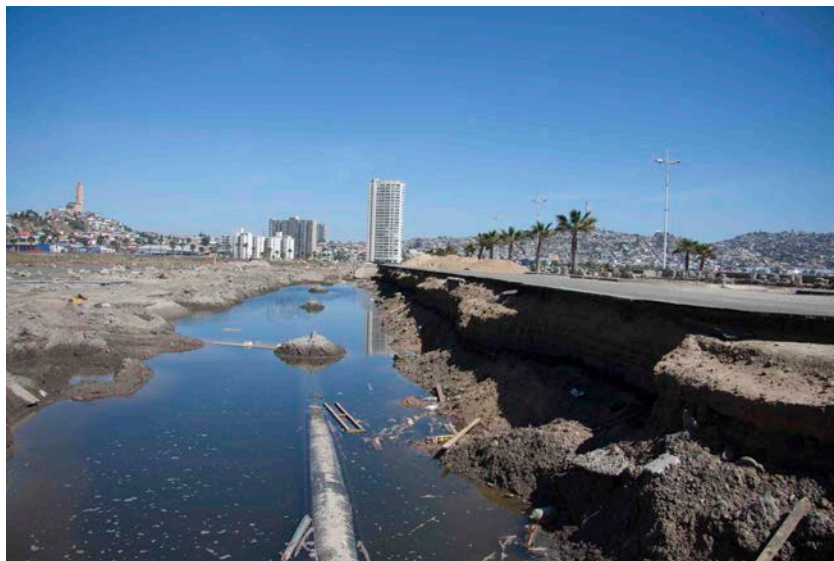
Figure 22 Top: Severed water main where it crosses a bridge in Coquimbo, Chile caused by erosion of the abutment. Bottom: severe scouring that exposed the same water main and caused it to float to the surface. (Horspool et al, 2016).

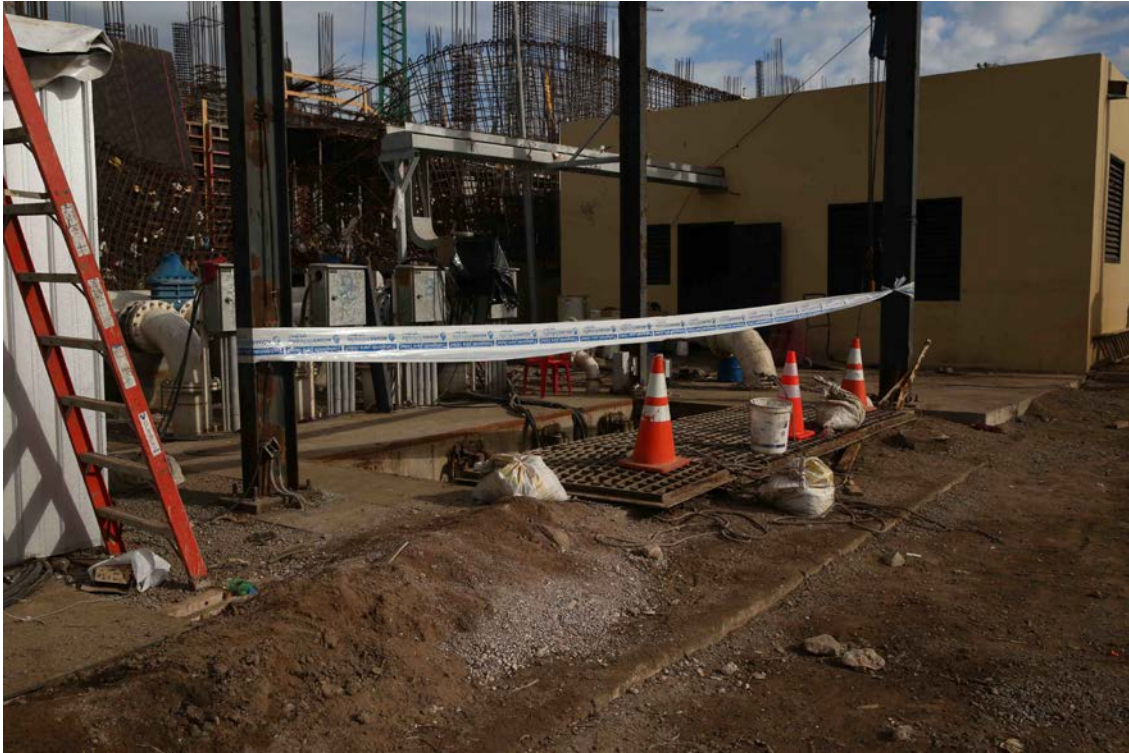
During the 2015 Chile tsunami a pump station located 200 m from the coast was inundated by flow depths of around 3 m and suffered complete damage. The structure housing the pump, all electrical equipment and most mechanical equipment was destroyed. The only remaining mechanical components were some of the in-ground filters (Figure 24). The pump station was reinstated to 80% capacity within 2 weeks, which required new parts to be shipped in and a mobile generator on site (Horspool et al, 2016).

Figure 24 Pump station near Coquimbo port that was inundated by a tsunami with a flow depth of ~3 m. This destroyed most of the pump station with only in-ground filters surviving semi intact (Horspool et al., 2016).

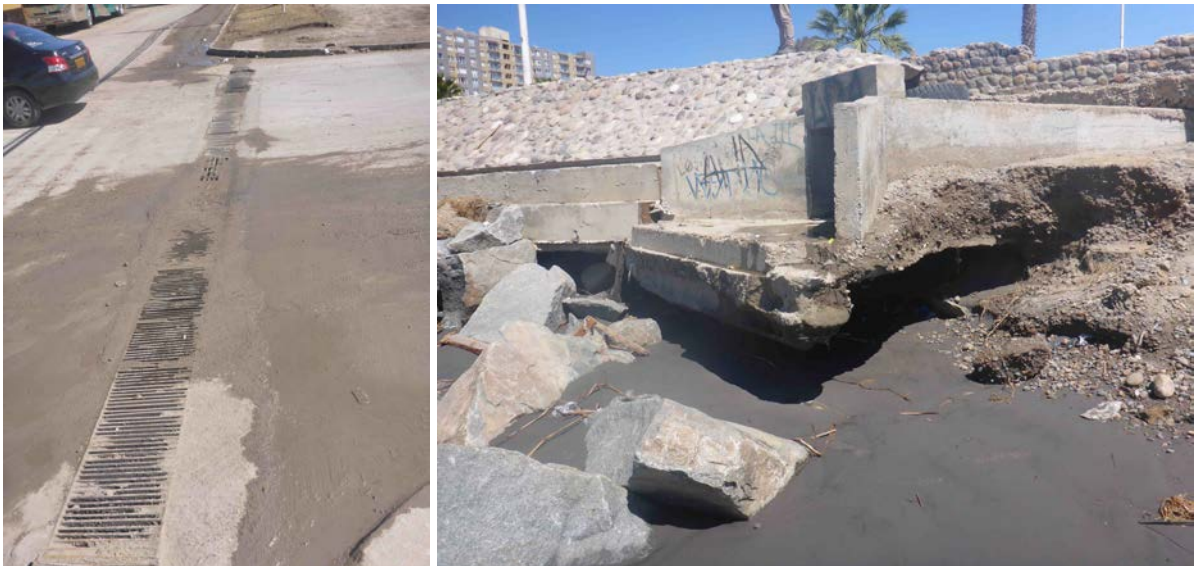
Figure 27 Left: Stormwater drain blocked by silt and sand in Coquimbo, Chile during the 2015 Chile tsunami. Right: Culvert/outfall at the coast in Coquimbo that was eroded during the 2015 Chile tsunami (Horspool et al., 2016).

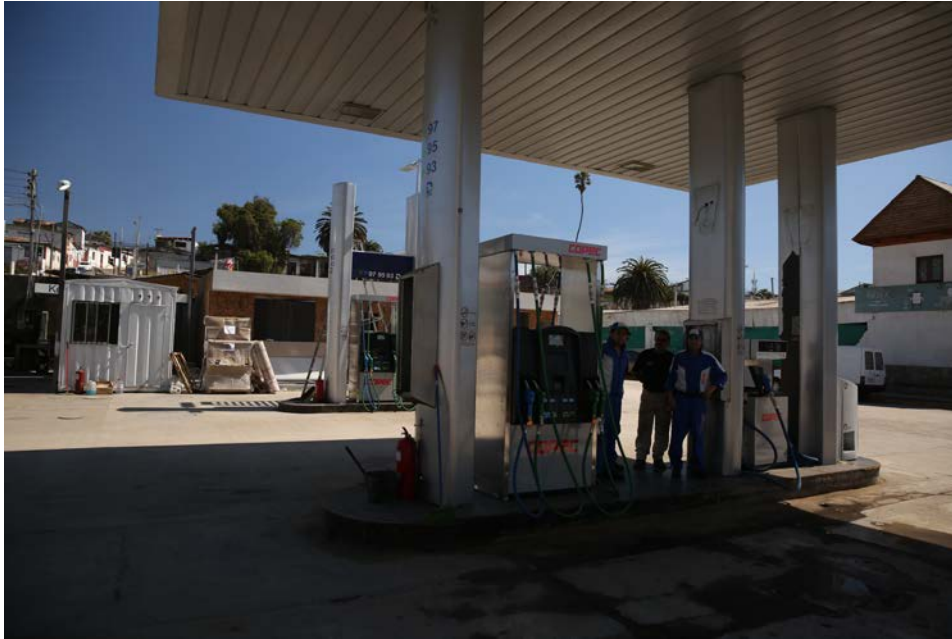
Figure 35 COPEC petrol station in Coquimbo, Chile damaged during the 2015 Chile tsunami. This photo taken 12 days after the tsunami shows the newly installed pumps and temporary retail building under construction (Horspool et al., 2016).

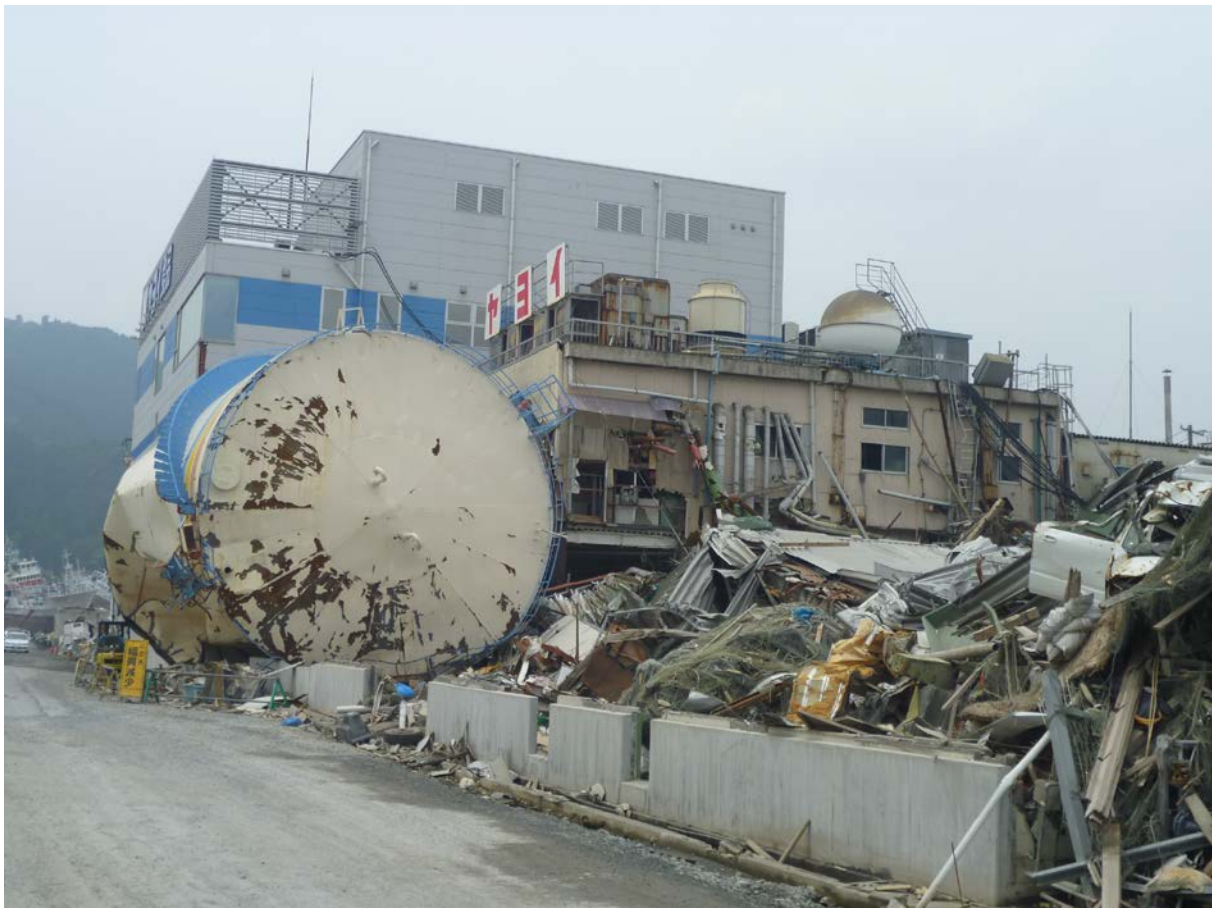
Figure 36 A damaged storage tank that has been deposited away from its original site in Kesennuma during the Great East Japan tsunami. Note the buckling and/or impact damage to the side of the tank nearest the road. Source: S. Fraser.

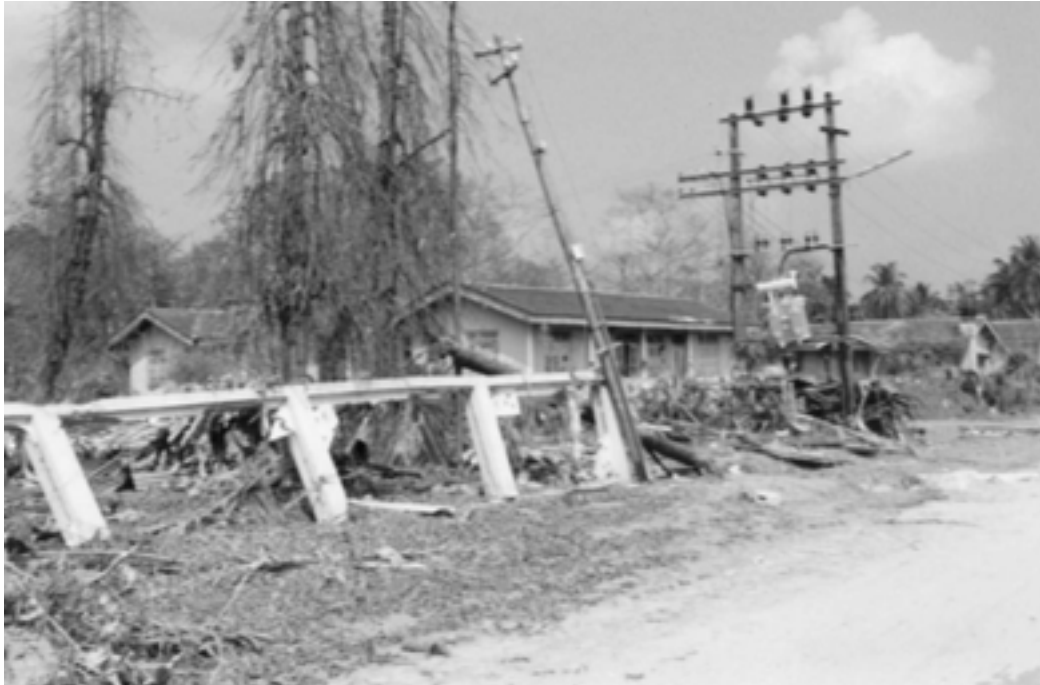
Figure 39 Example of damage to utility poles in Sri Lanka. In this example the poles have been moderately damaged and the tsunami inundated above the height of the pole mounted transformer, which later needed replacement. This would correspond to Damage State 1. (Source: Tang, 2006)

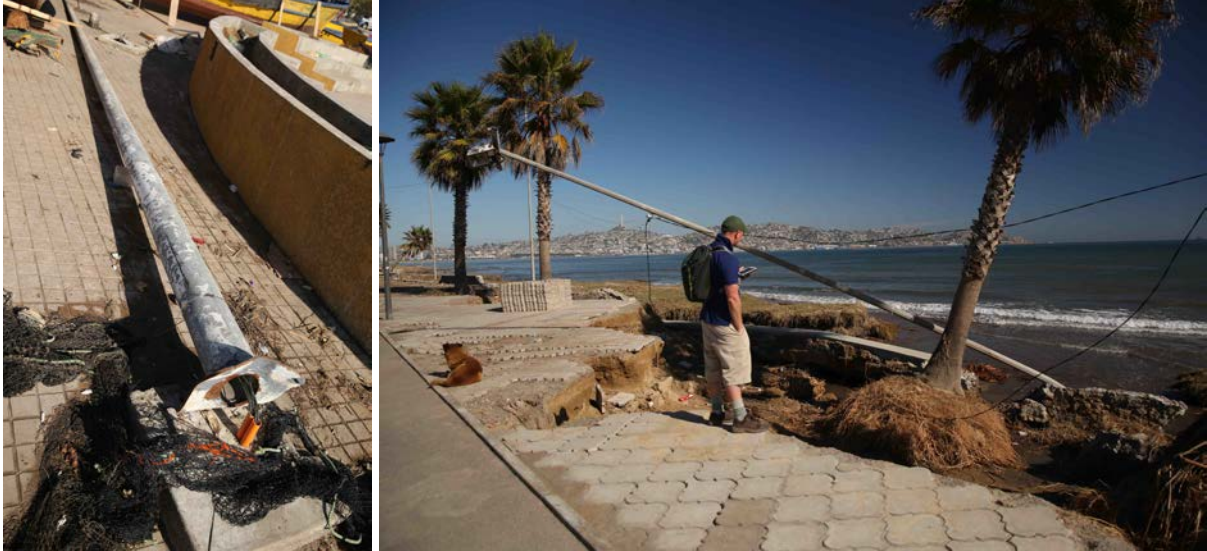
Figure 40 Example of damage to utility poles by shearing due to lateral forces or debris strike (left) and scouring of base (right) in Coquimbo during the 2015 Chile tsunami (Horspool et al., 2016).

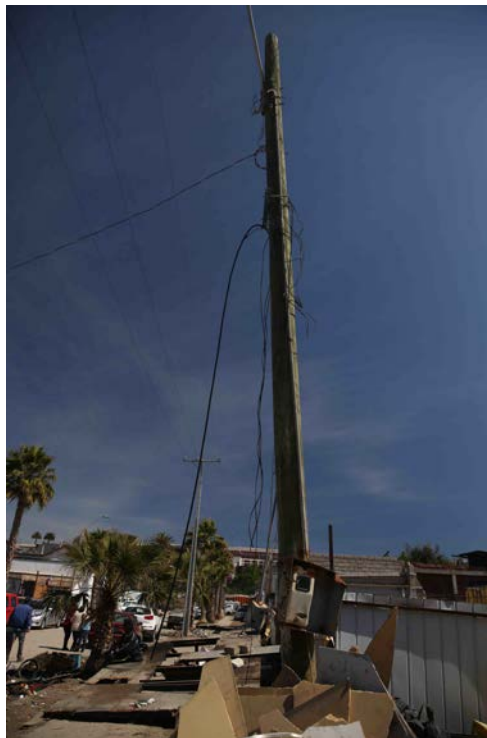
Figure 41 Example of damage to overhead lines in Coquimbo during the 2015 Chile tsunami (Horspool et al., 2016).

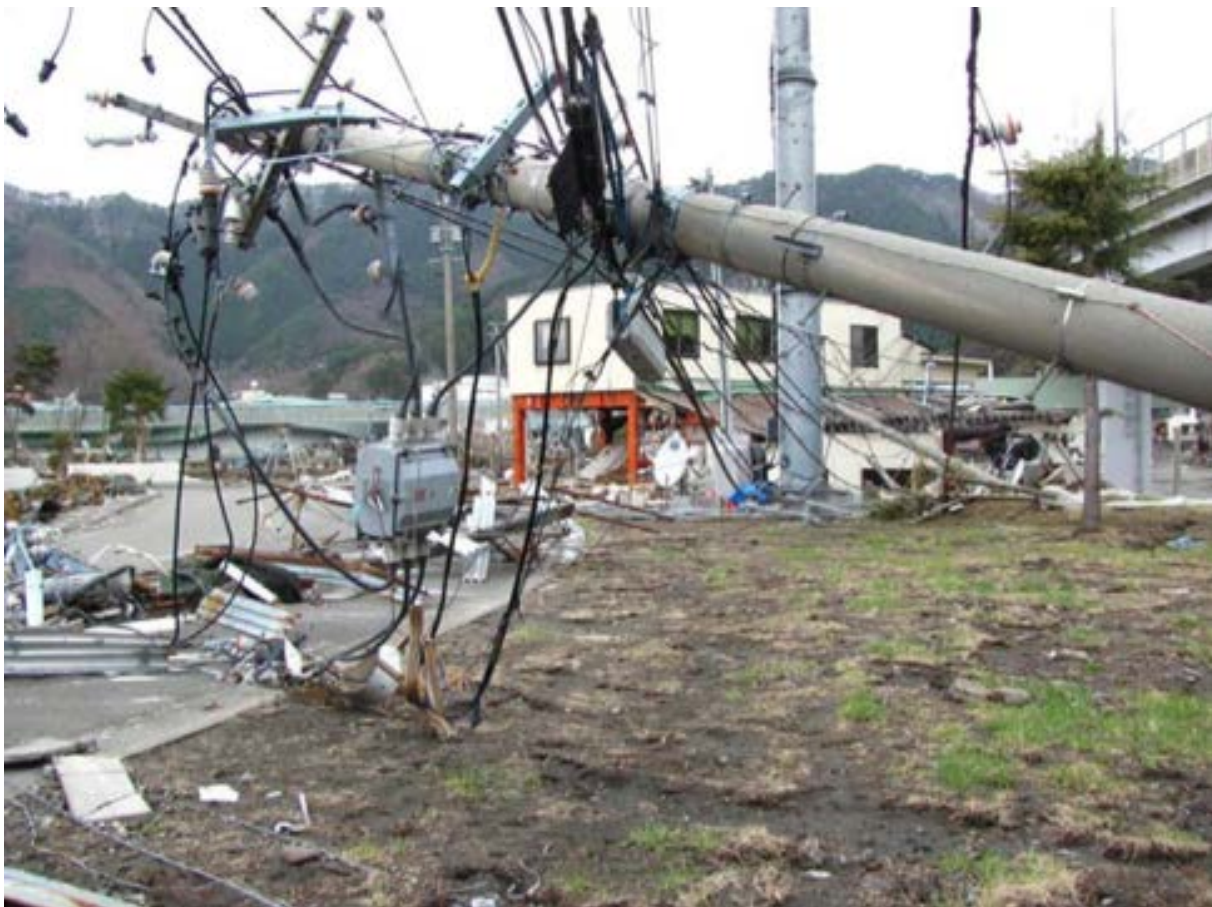
Figure 42 Damage to local electricity transmission lines from the 2011 Japan Tsunami. This would correspond to Damage State 1 in the analysis and Figure 43 below. (Source: TCLEE, 2010).
