An Analysis of Tsunami Impacts to Lifelines

N.A. Horspool S. Fraser

GNS Science Report 2016/22
May 2016

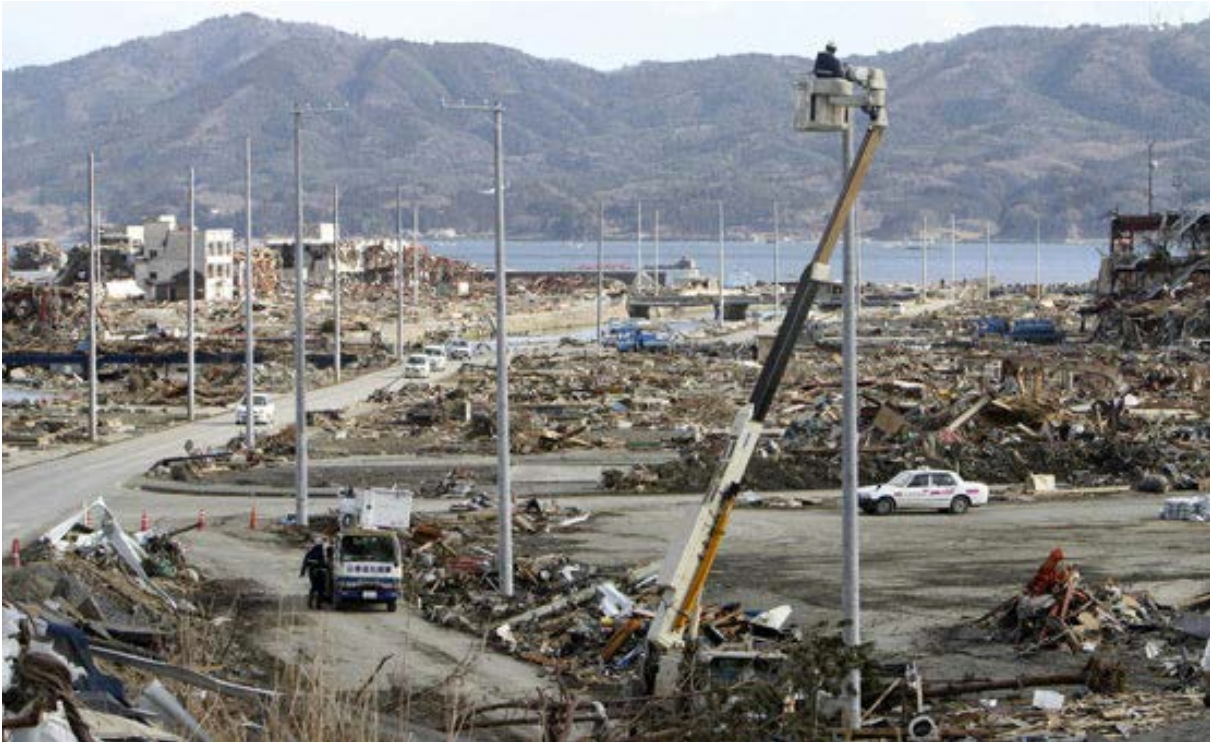
Figure 45 Example of utility poles being erected in the early stages of the recovery process following the 2011 Japan Tsunami. In this coastal location the majority of utility poles were washed away by the tsunami. Source: USA Today.
