SOME IMPACTS OF ROADING AND FLOOD DAMAGE ON SOUNDS ROADS

Part only - Queen Charlotte Drive and Kenepuru Road

Period 1985 - 2010

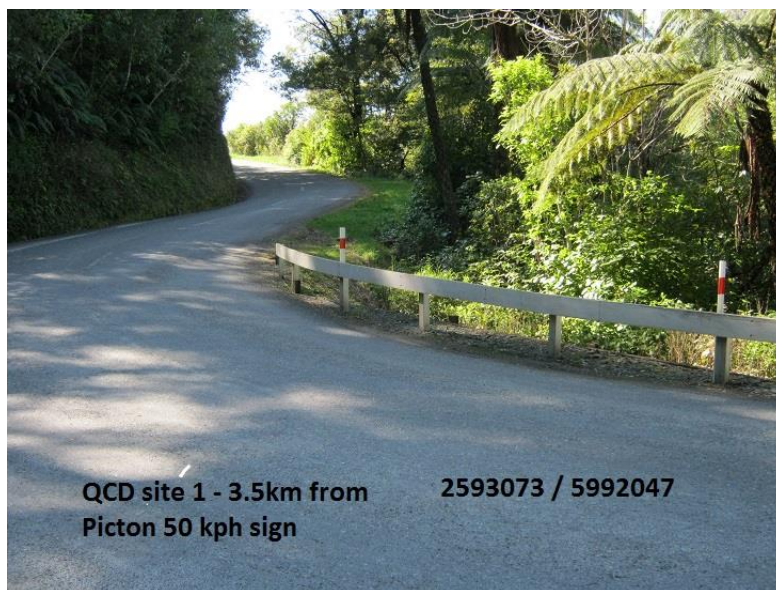
Site 1

Just above and beyond this site evidence of early spoil dump sites are apparent.

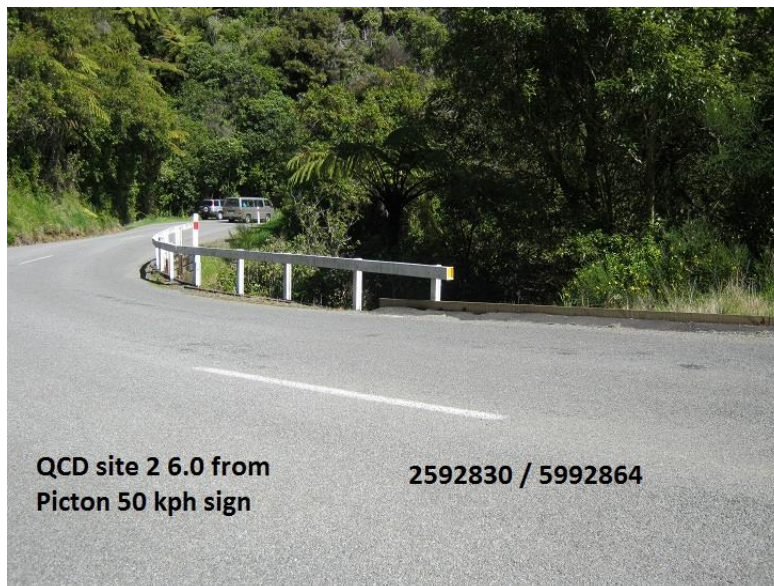
Site 2

I consider the roading related activities (widening) may have been a significant contributor to the damage.

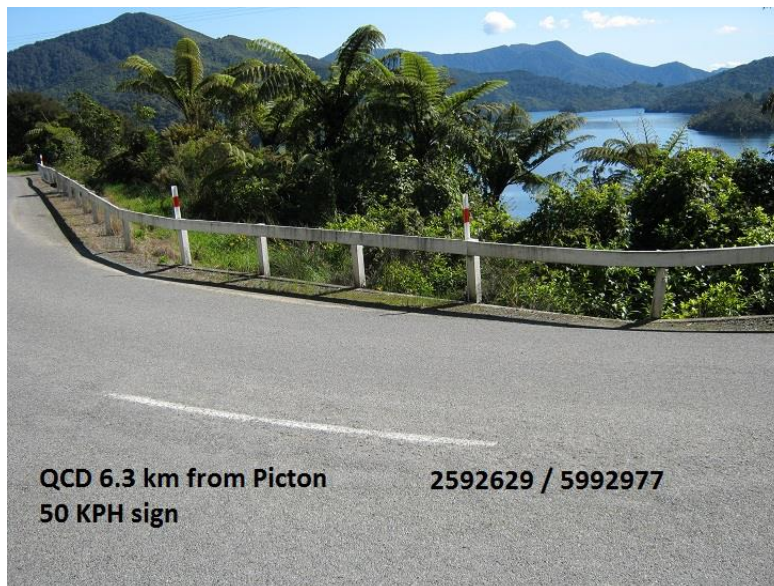
Site 3

There are 2 retaining walls at this site and there was approx., 600m³ to the coast.

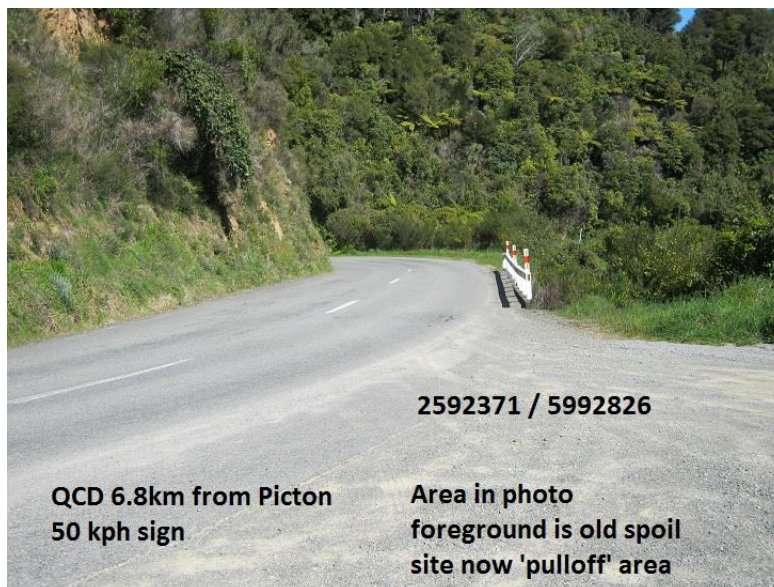
Site 4

There is an obvious spoil site which is now a vehicle 'turnoff' /passing area ; there are a considerable number of these and virtually every outer corner has had some quantity of material placed (many are now used as parking / passing areas) ; I noted that at the time of inspection there was still some material recently stockpiled near this site (this may be a temporary storage area allowing the carriageway to be opened.

I consider widening works may have contributed to the instability and collapse of the face / faces above the road , most of the old slip faces are still visible in this area.

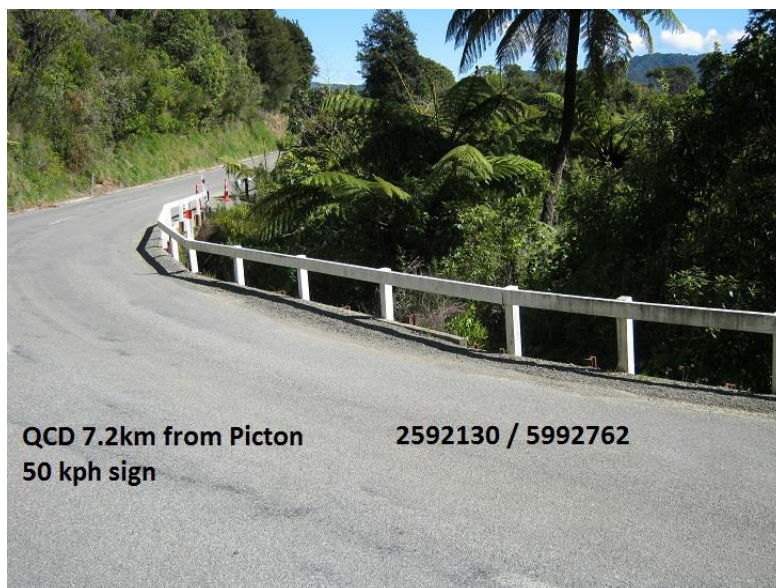
Site 5

Many of the slips above the road are still unstable and further damage is likely although the risk of material overtopping the retaining walls is considered slight.

I consider the event may have been significantly influenced by road widening works.

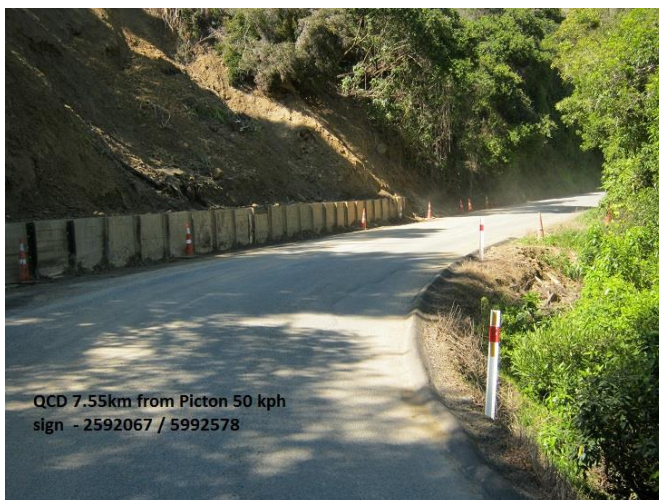
Site 6

Date : The approx. date of the first event was 2000 – note also current at this site at time of report (see photo) ; this bare face is typical of previous sites that are now revegetated.

I would consider widening works precipitated the damage.

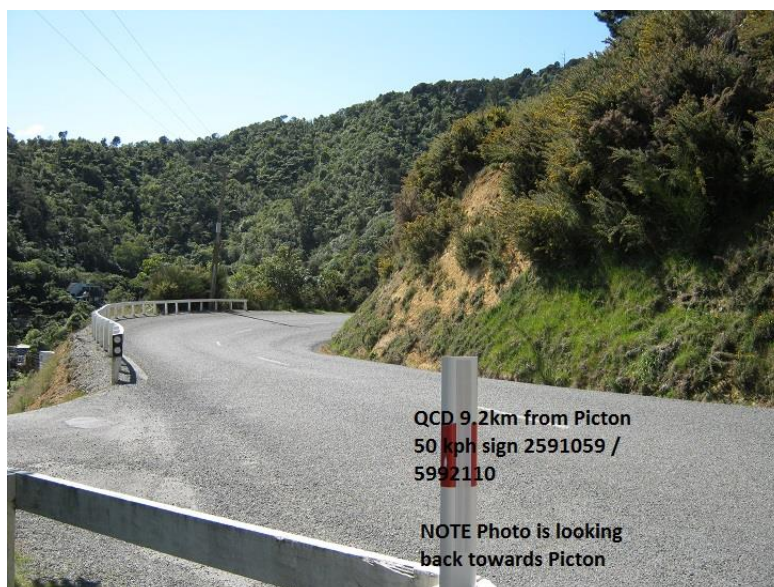
Site 7

NOTE the photo is taken looking back towards Picton.

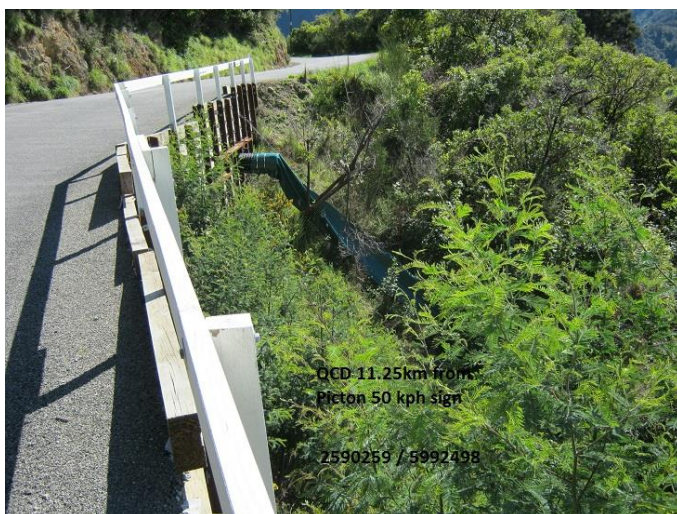
Site 8

The fill especially at the southern end spilt after the wall suffered some damage by rotation and collapse of backfill and has recently been repaired and the road reinstated.

I could not see any evidence of the material at the coast line (water was clear at the time of inspection – this does not mean there is no evidence , simply I could’nt see it from the road into clear water 10/2015)

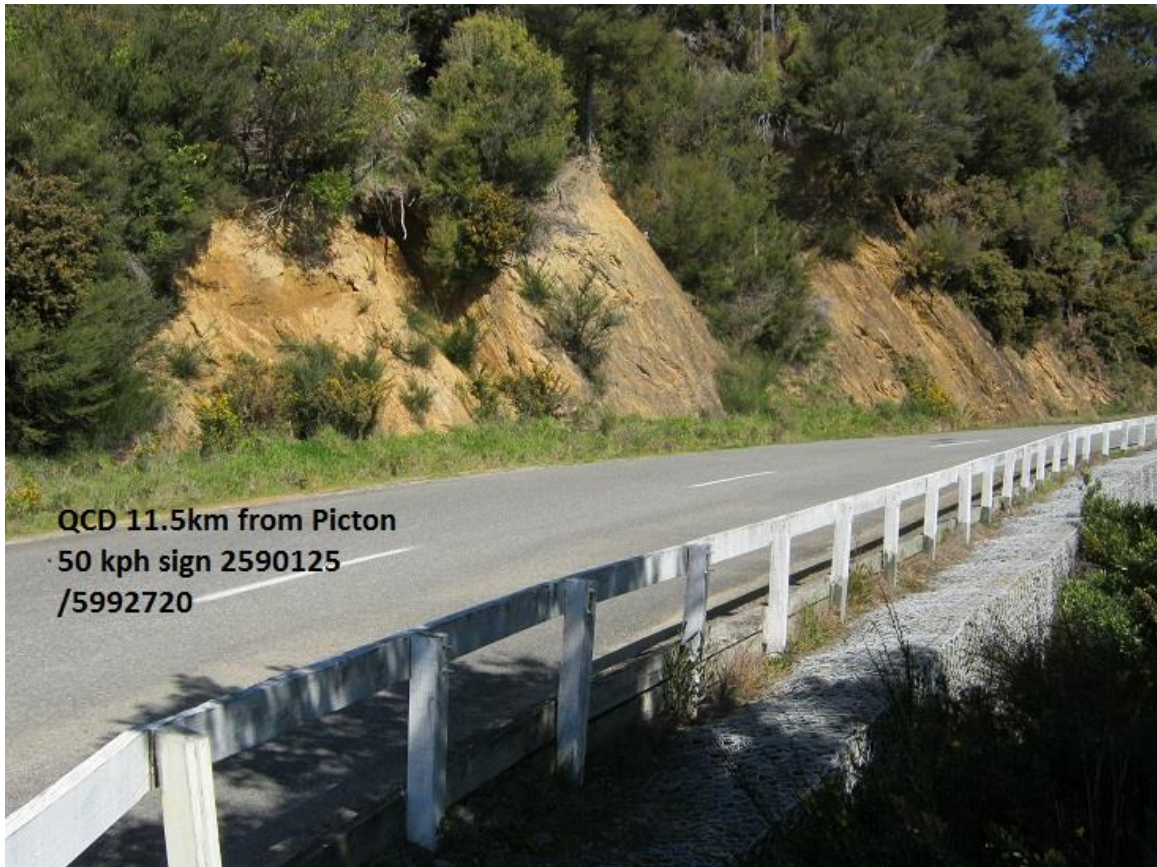
Site 9 photo (see sketch, following page)

This site was the scene of significant damage to the road and private property.

The damage consisted of the total collapse of the road over a length of some 36metres to the sea and app. 3000 m3 of slip material.

It damaged beyond repair an 'A ' Frame house located below the site which shifted on its foundations (it did NOT fall into the sea)

Subsequent survey and research showed that the section of road had been considerably elevated above an earlier vertical alignment by about 2-3 metres and this was further evidenced by the remains of a section of old culvert that had been left below the road when the later section was constructed. It was considered , and still is , that this was a significant contributor to the damage as it was still discharging water post event (subsequently blocked off)

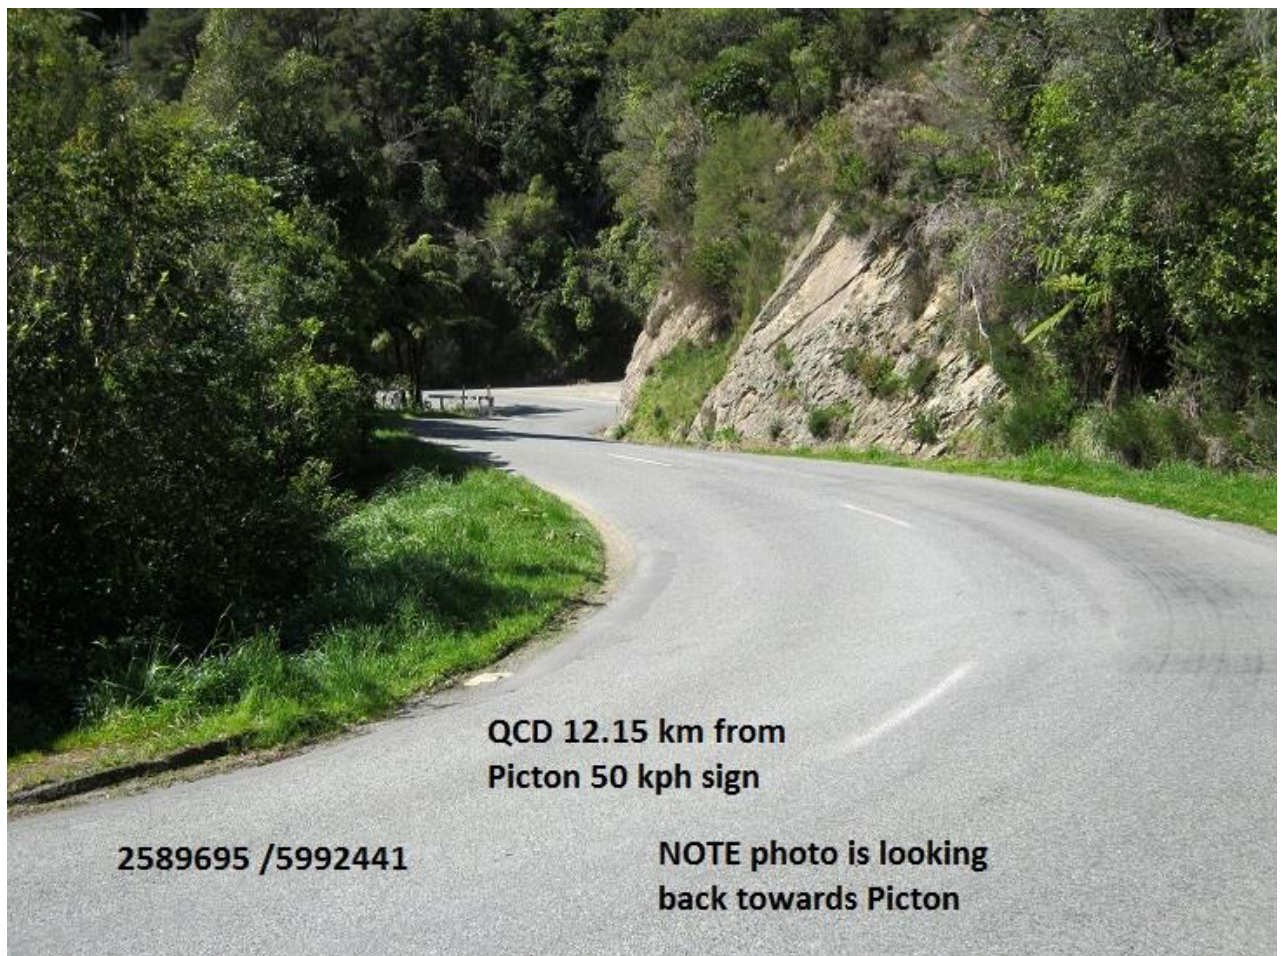
Site 10

This site was the subject of extensive damage when slips emanating from 2 watercourses (each distinct and apparent on site) crossed the road carrying away the outer edge at 2 locations to a width of approx. 4 metres and blocking both culvert installations with the result significant quantities of material estimated at over 1200 m³ discharged down the watercourse below the road and into the sea.

Although the slips “heads’ are well above the road and would indicate it was a natural event it is possible that the watercourse had been steepened during road construction and may have contributed to the damage. I would consider

Note the photo is looking back towards Picton with the Blythel Bay drive and photo left / distant.

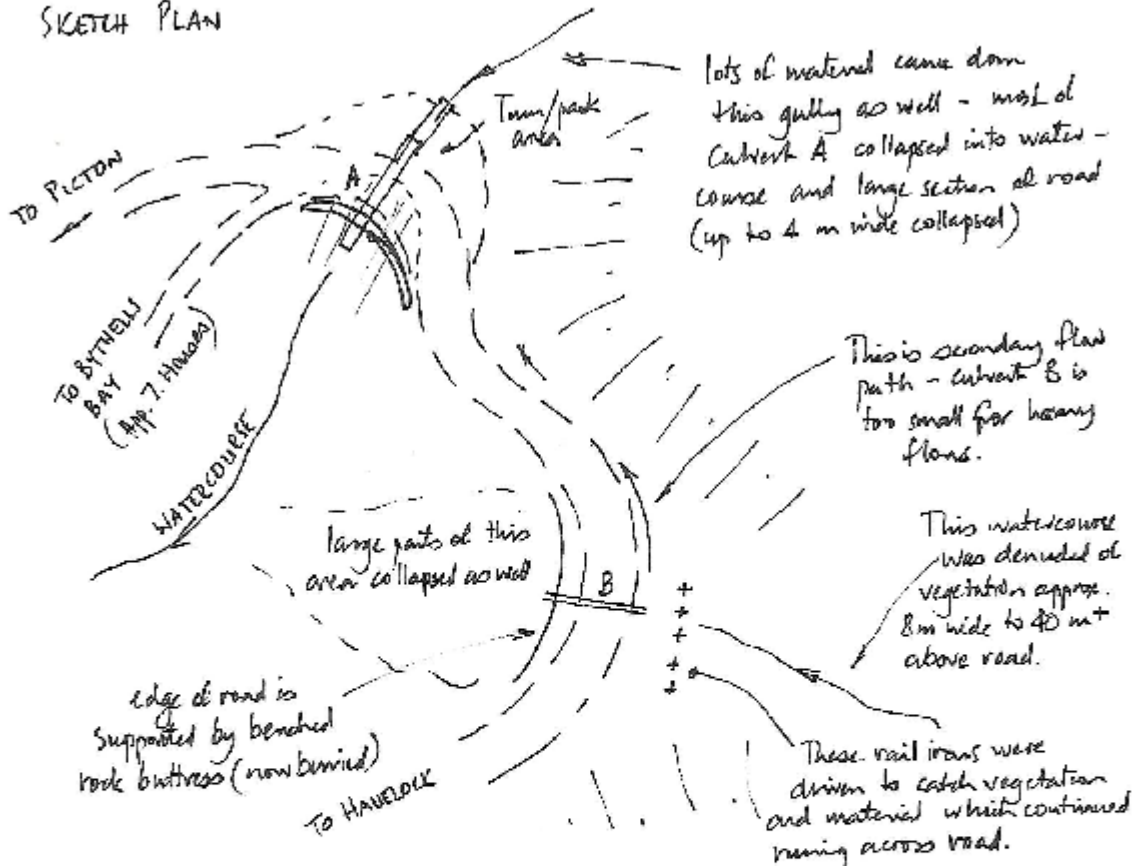
SITE 10

(Note the bed has aggraded by about 1.5-2.0 metres and rails are barely visible now)

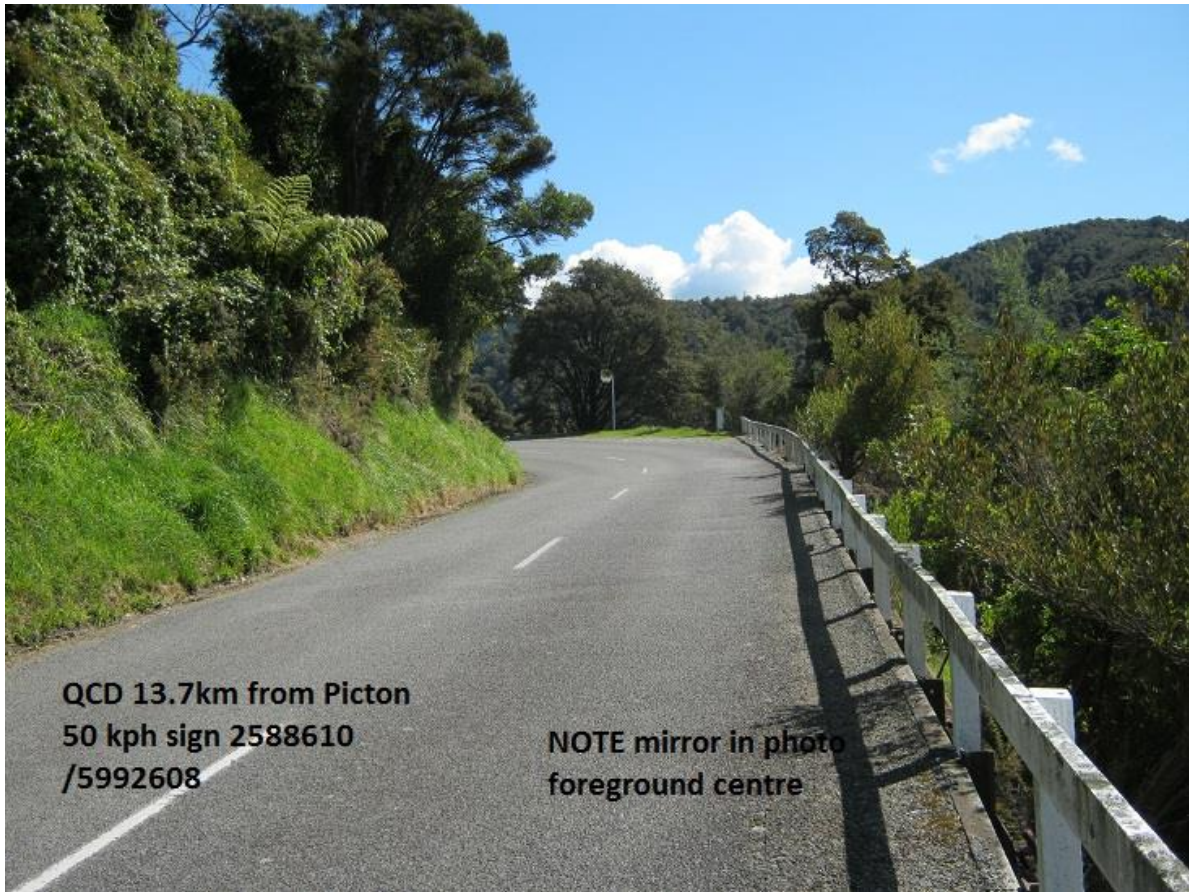
QCD 13.7km from Picton
50 kph sign 2588610
/5992608

This was a significant event where approx. 4 metres plus of the road edge collapsed , accompanied by , or caused by a slip on the LHS above the road.

The extent of the damage is apparent on both sides of the road and below the 60metre long retaining wall , although some second growth vegetation now covers much of the area.

I consider the collapse may have been caused by an instability of the old sidling fill on the outer edge exacerbated by the slip and water running over the road from the LHS – this LHS face would have been excavated during widening works.

NOTE mirror in photo
foreground centre

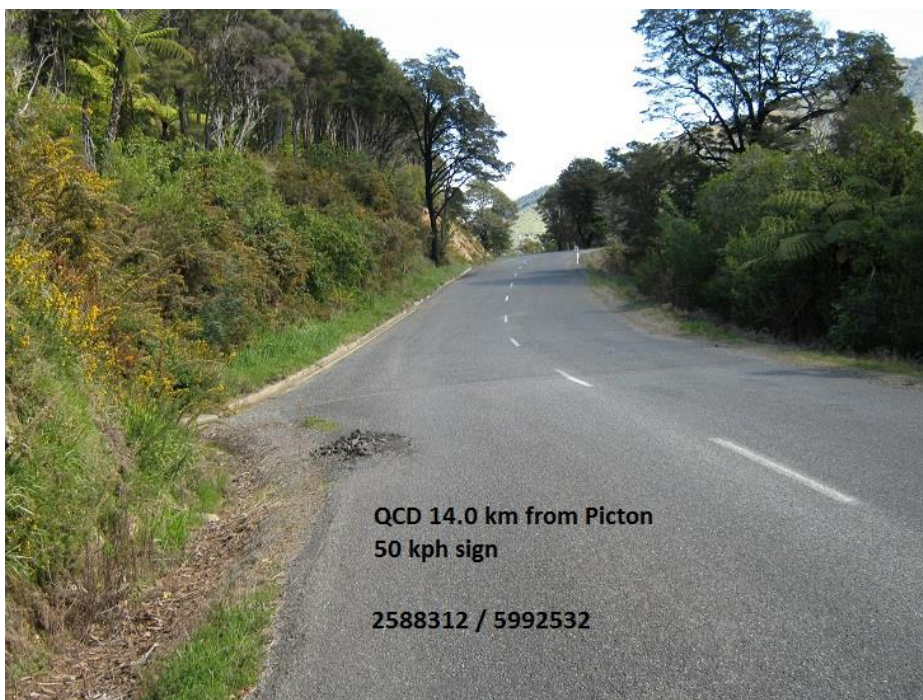
Within the test pit there were several wide (up to 100mm) cracks , some extending forward and back along the road ; we were unable to define a bottom to them and in at least one we could hear subterranean water running in a significant flow well below the base of the test pit.

Note the pavement has again been resurfaced over the area, indicating there has been a further event since 2004, and I noted the outer edge of the pavement appears to be slowly subsiding again.

I consider the damage is the result of a natural slip and that the road simply sits within that slip plane (see sketches -2 pages)

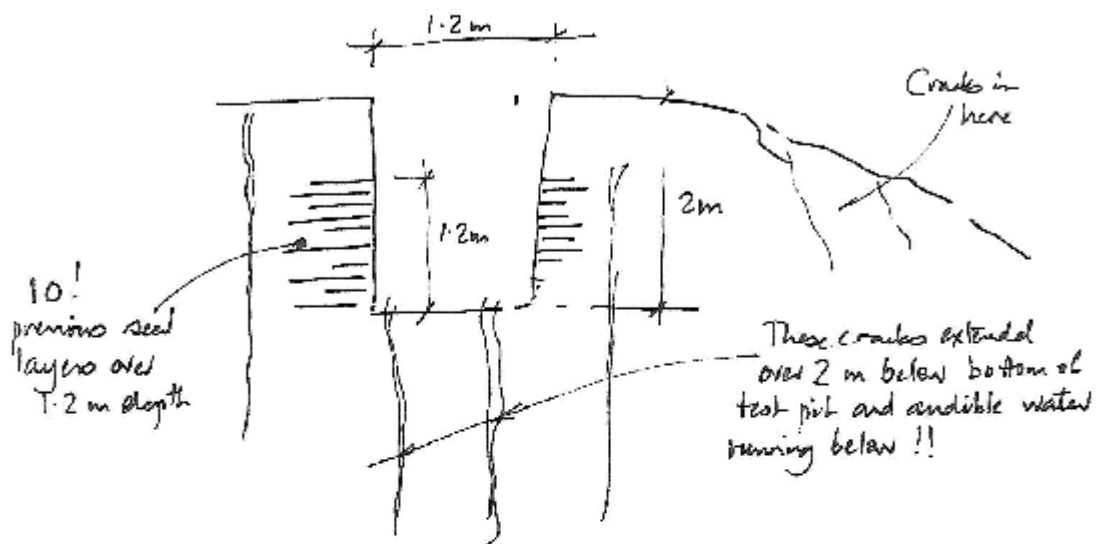
SKETCH OF TEST PIT (N.B. located near GPS reference)

First identified by a small hole appearing in road surfacing - on pushing down a 'crowbar' was > 2 m deep!! Test pit was then excavated.

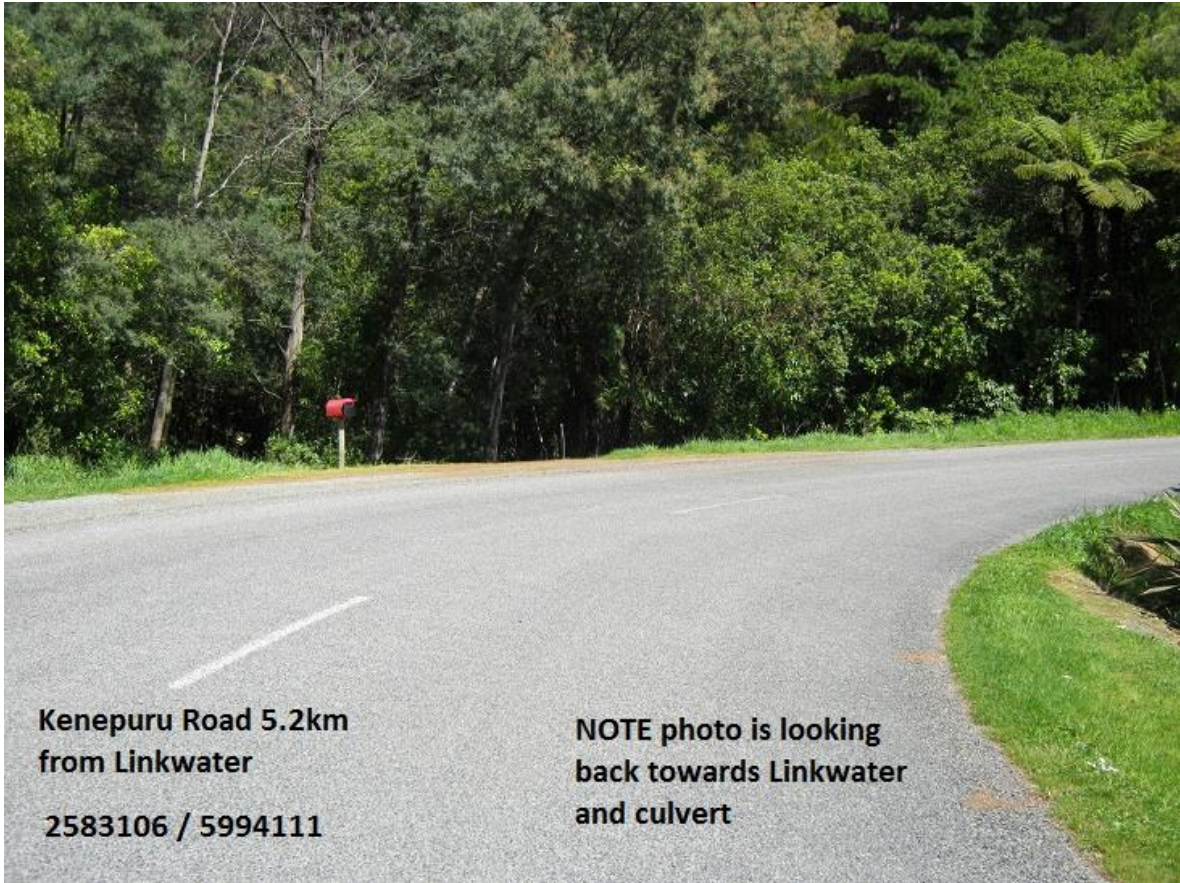
**Kenepuru Road 5.2km
from Linkwater
2583106 / 5994111**

**NOTE photo is looking
back towards Linkwater
and culvert**

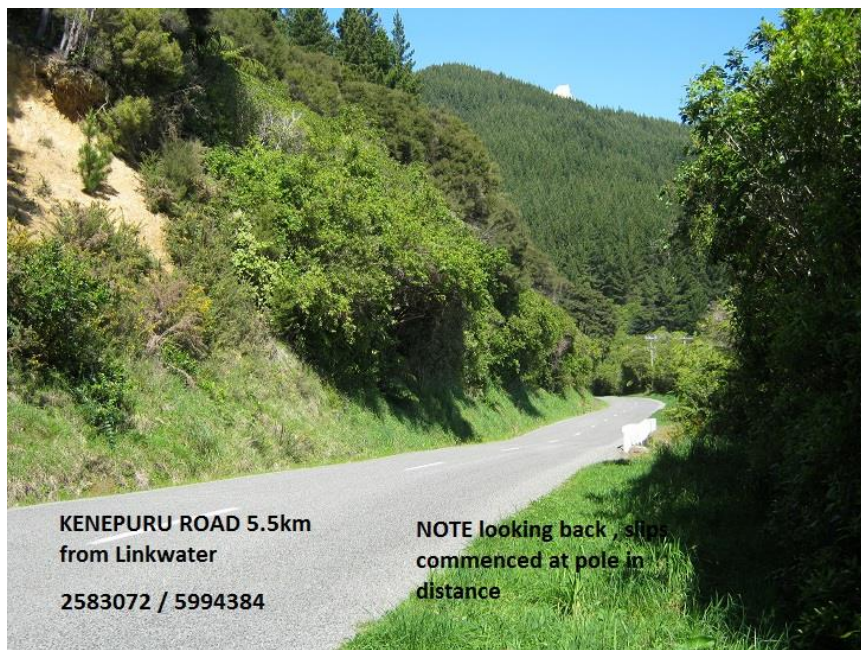
I consider the increased runoff from the cleared area may have been a significant contributor to the damage.

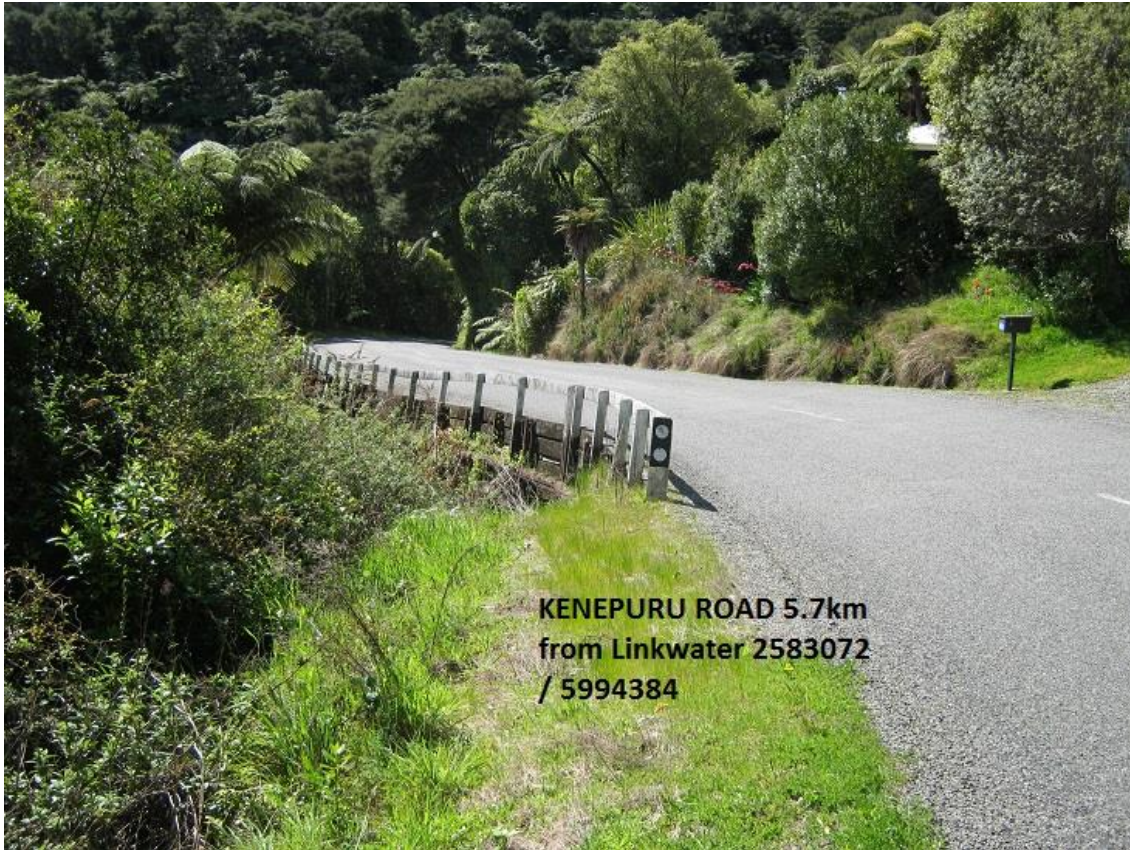
Site 3A (see sketch on following page)

This site has evidenced movement for a number of years and first repairs were undertaken in approx.. 1988 , since then there have been several recurring settlements of a major nature .

It was observed by me in about 1988 that the coast line has moved forward perceptibly by about 4-5 metres (I do not know if any further movement is apparent)

I consider the slip is a natural event .

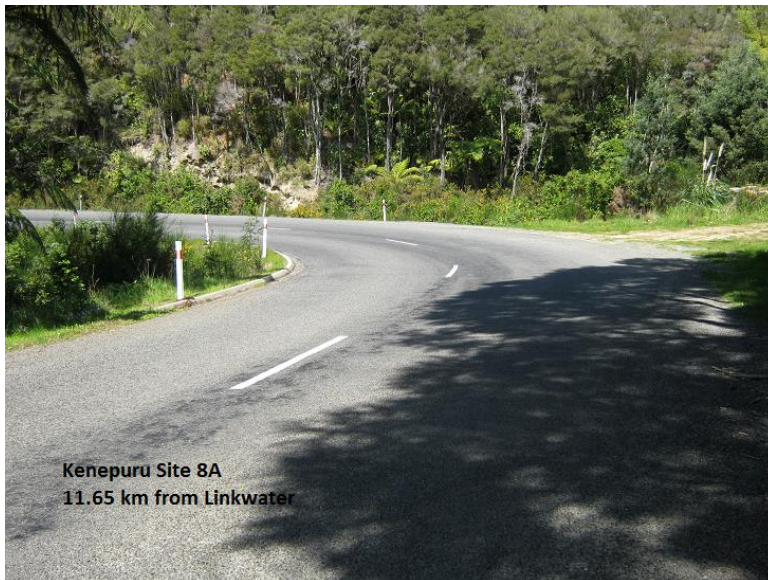
KENEPURU ROAD
SITE 8 A

The event followed clearfelling of forestry above the road and the slips referred to above contributed to the damage caused.(probably the sole contributor to the event)

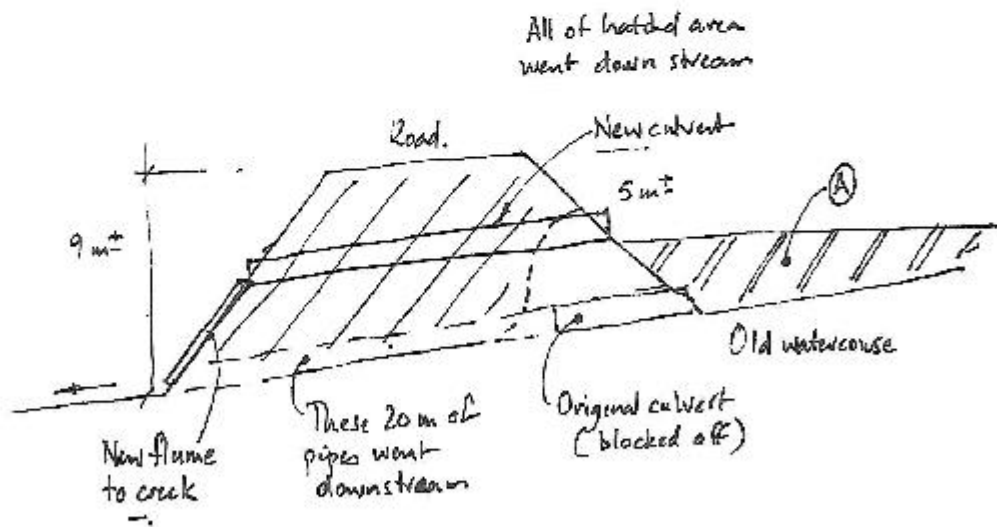
SKETCH SECTION AT SITE N. T. S

(A) All of this creek invert was raised with a combination of slash, slip material and hand rock sheathing - 80 m long x app. 15 m wide

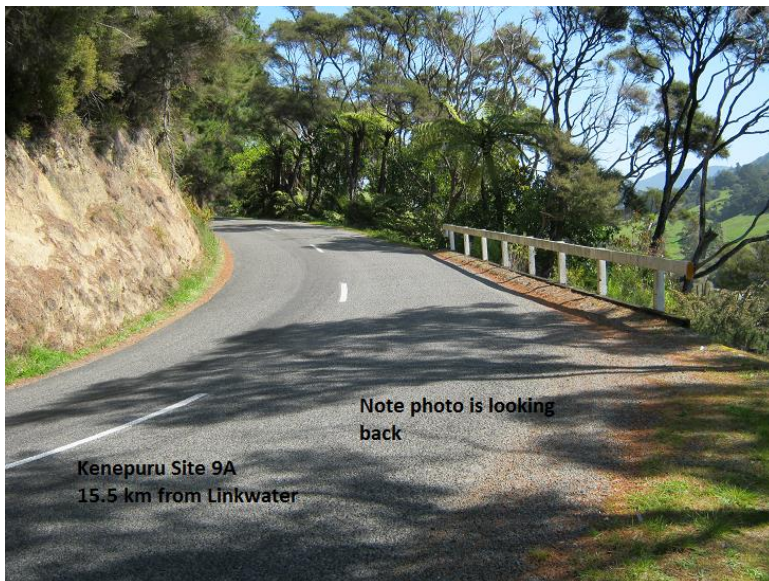
Approx. 500 m³ of material collapsed to the sea and I consider the cause was roading related (an old sidling fill ?)

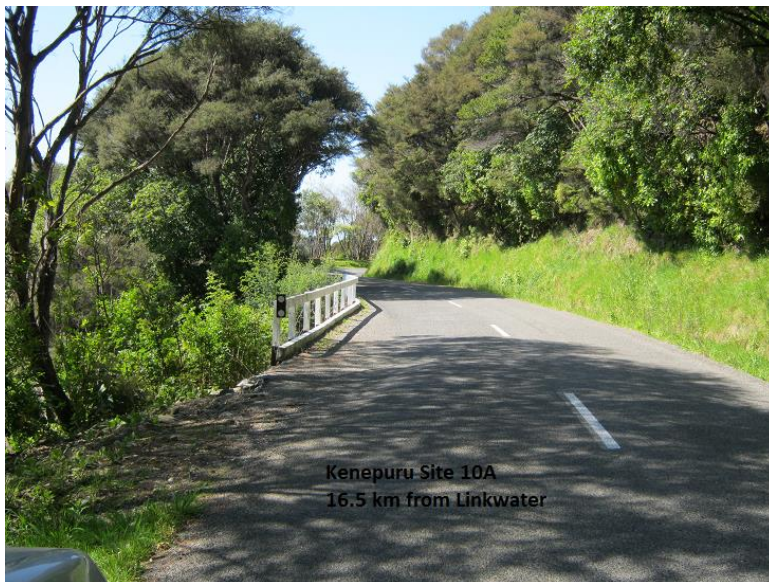
Site 10A

I consider it was caused by a collapse of the road (probably part was an old sidling fill)

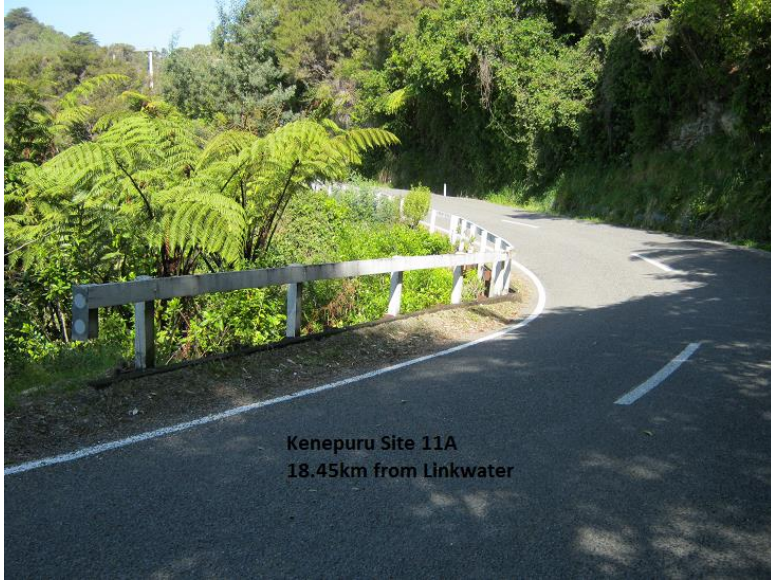
Kenepuru Site 11A
18.45km from Linkwater

I believe the event was caused by instability of the formed road.

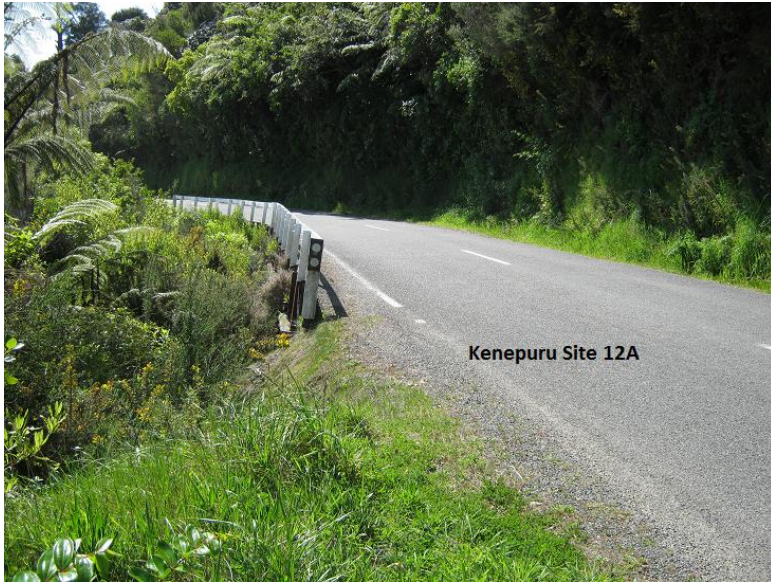
Site 12 A

The scene of a dramatic event and major damage to a downhill property.

The estimated quantity was near 5-6000 m³

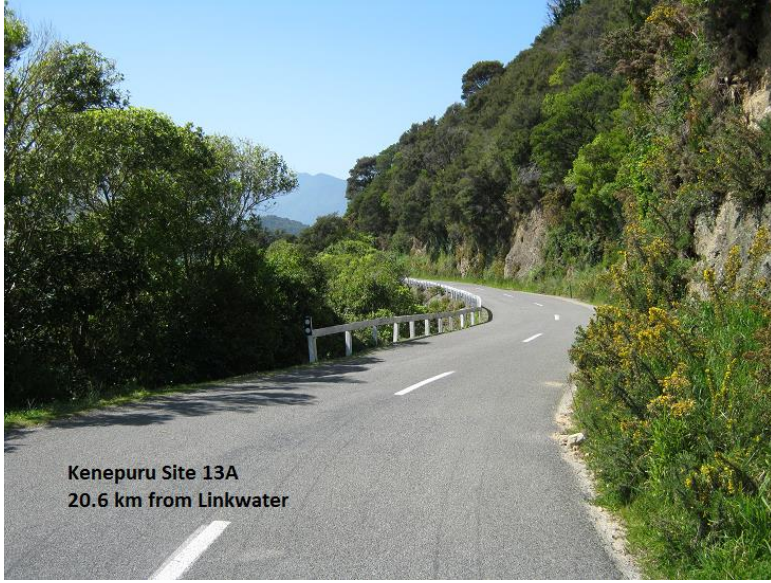
Kenepuru Site 13A
20.6 km from Linkwater

It has obviously stayed in position and retained the road , however ,it has rotated since construction as evidenced by the rails which have been straightened and replaced several times. (aesthetically it would have to be considered pretty poor)

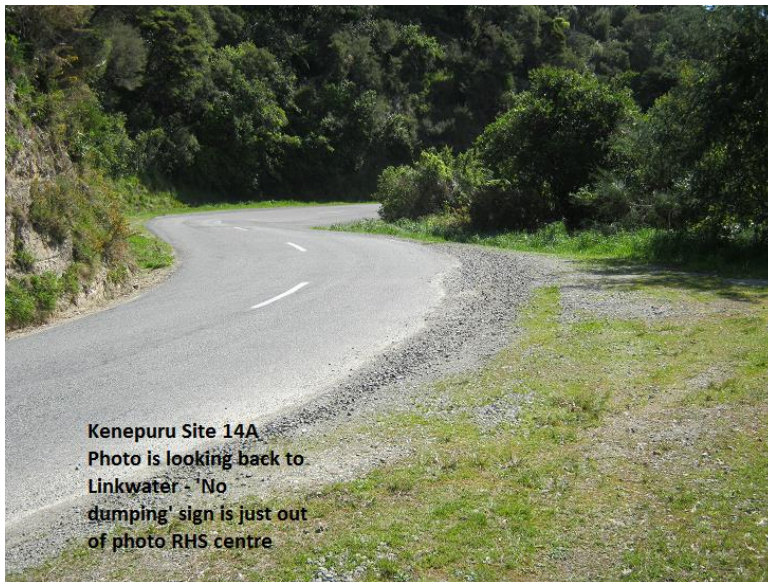
The spoil site was retired after the first use and a 'no dumping' sign erected (there is still a sign at this location) , however , local contractors / builders / residents etc. continued to dump material at the top ; this blocked drainage systems which diverted water to the culvert South side and may have precipitated the damage ; in any event it was roading related.

The repair of the site involved trimming and compacting the new face and installing contour drains diverting water to the south ; this appears to have been successful and no further damage has occurred .

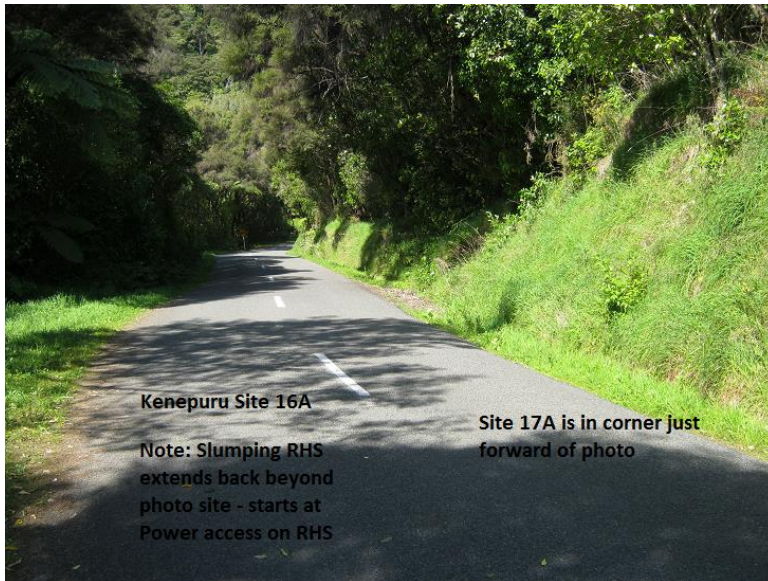
Site 16 a – Site 17A – Site 18A

The flow went under the corner of the house causing some damage and app. 600m³ of material flowed into the Bay.

I consider this was exacerbated by the widening works however the area above the road up to and through the Power pole access track is all cracked and fractured ; for this reason this section has not been widened again.

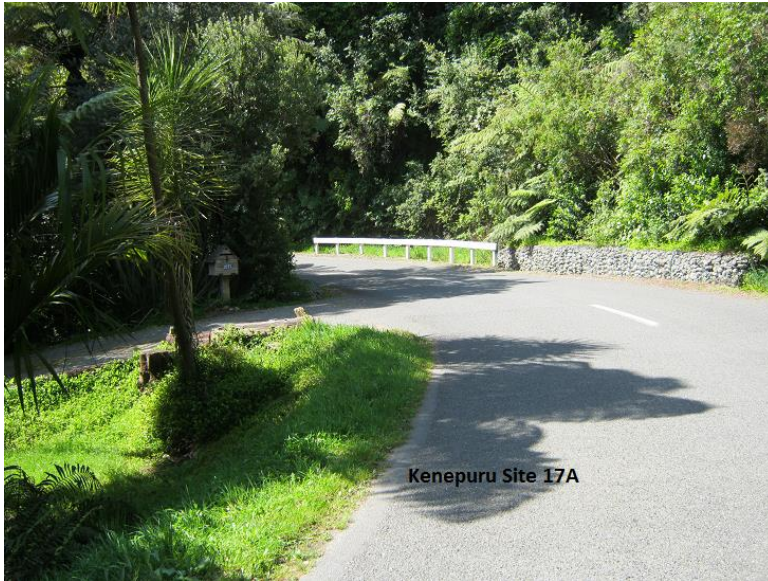
Site 17 A

At least 2 major slips occurred in the bush clad area upstream of the significant culvert .

At this second event there was only about 500 m³ of material to the coast.

A smaller event occurred in about 2000 , at this time culvert repairs were again undertaken and the stone baskets installed to protect the access in the event of future floods . A second 1.2 m dia culvert was added at this time doubling the waterway.

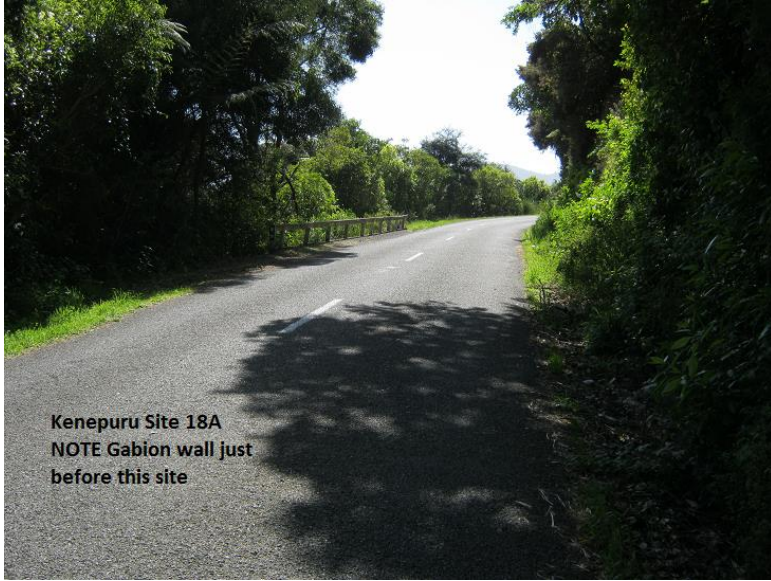
Kenepuru Site 18A
NOTE Gabion wall just
before this site

There are 2 areas here where the excavated banks above the road collapsed (still visible in places) collapsed onto and over the road and down to the creek and out to the sea.

I consider events 16A and 18A were the result of land disturbance as a result of road widening ; events 17A were natural erosion well away from the road proper.

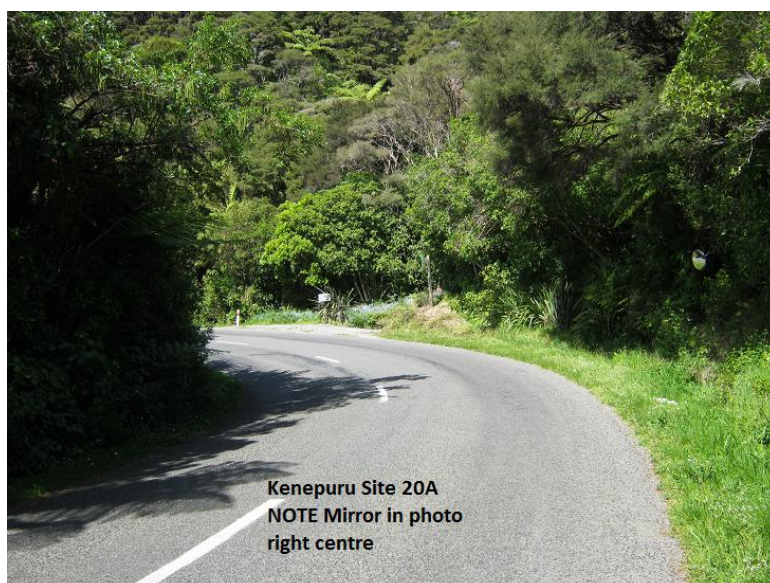
Site 20 A

No damage occurred to the adjacent house and only minimal material on the drive.

The culvert was a large 'Armco' steel pile which was destroyed ; remnants of it are visible in the creek below . it was replaced with a 1.5m concrete pipe.

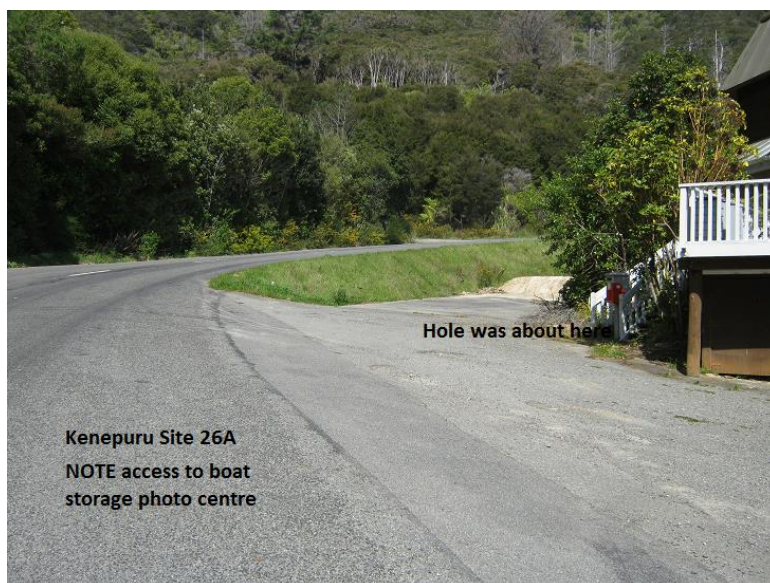
Site 26A

- 1 Most of the Armco pipe had rusted and collapsed
- 2 There was a 'tomo' of about or larger waterway than the pipe (450mm dia ?) generally along or below the line of the pipe to the outlet.
- 3 about 500m³ of material went to the sea at this event

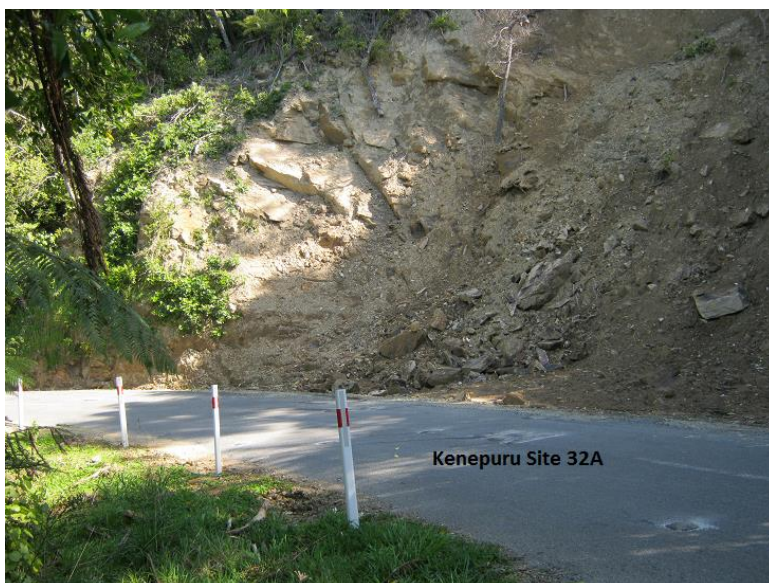
Site 32 A

The cause is probably roading related.

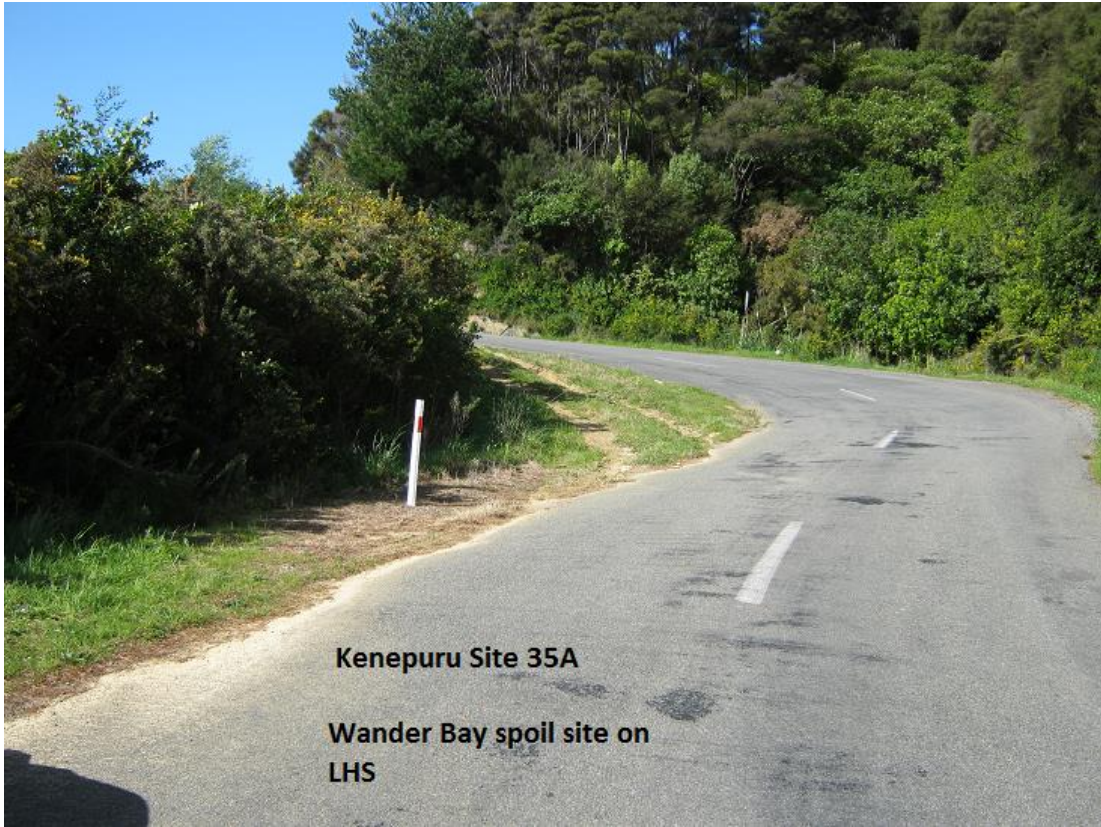
Kenepuru Site 35A

**Wander Bay spoil site on
LHS**

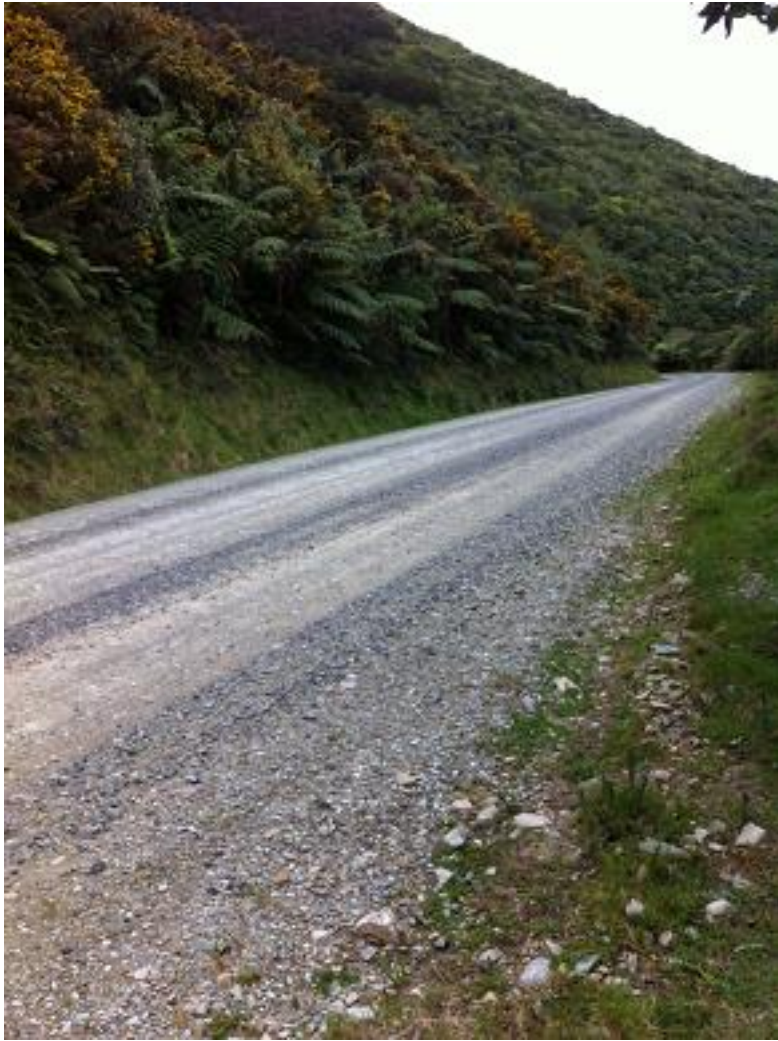
Site 3 B

It is difficult to believe the scale and scope of this event with the growth of Gorse and Broom etc. covering virtually all evidence of the damage.

Although not evidenced in the photo , this section is quite steep uphill from photo distance.

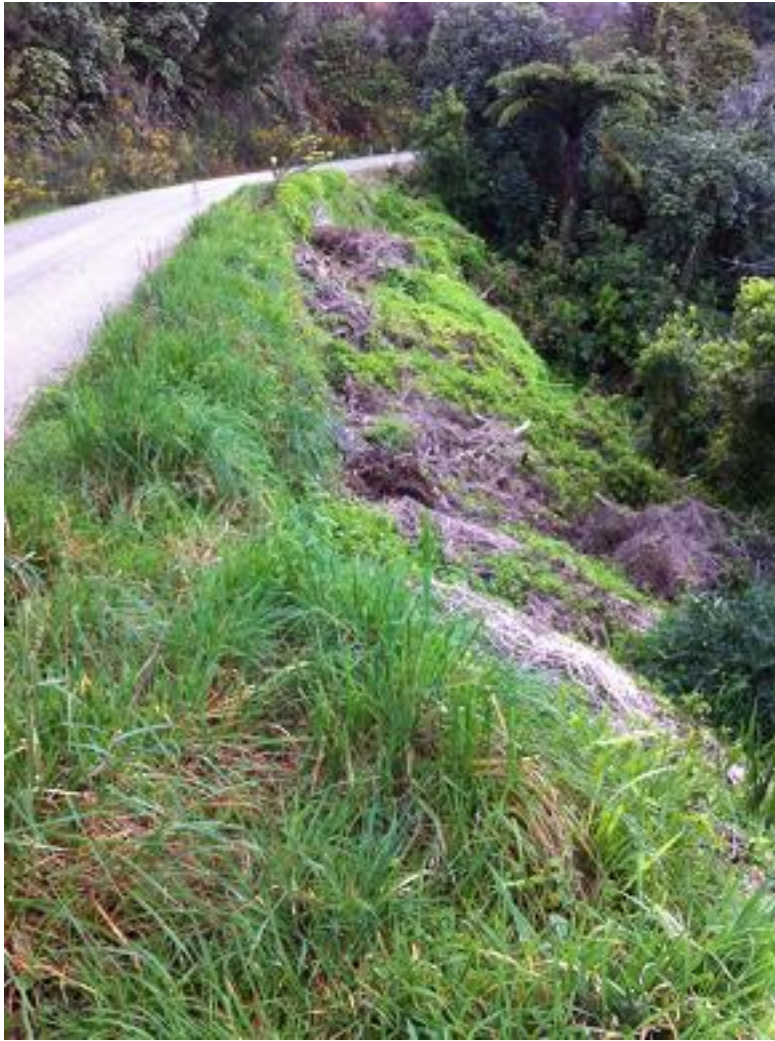
Kenepuru site 5 B

I consider this event was probably caused by the excavation above the road steepening the cut batter face.
