## Appendix 1

Some Observations of Erosion as a Result of the 28 December 2010 Storm Event

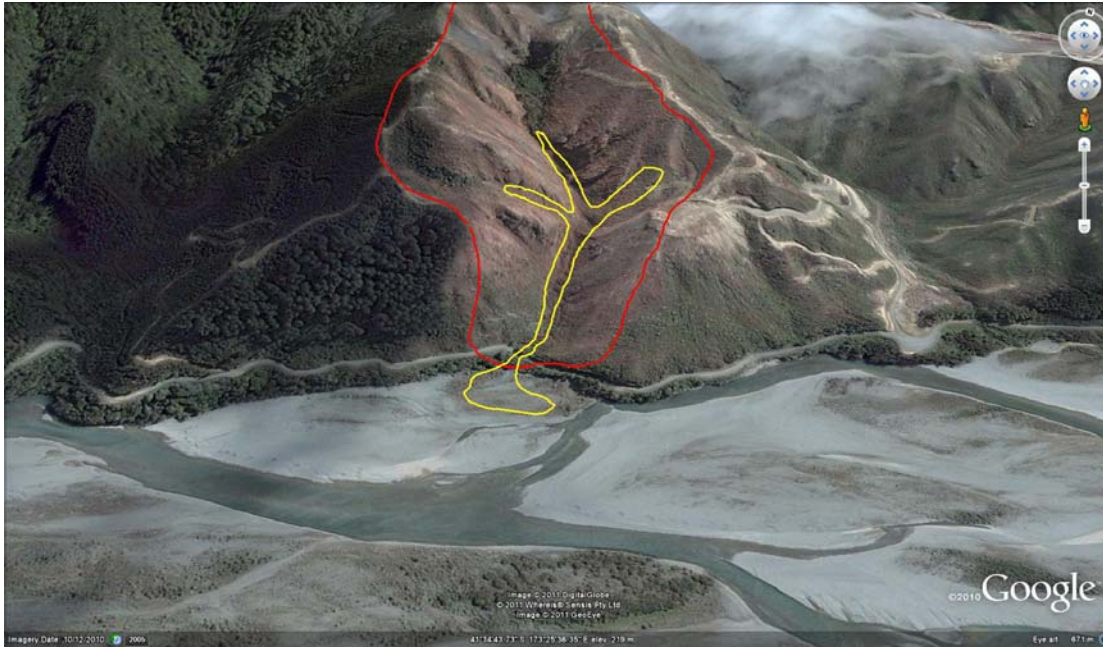
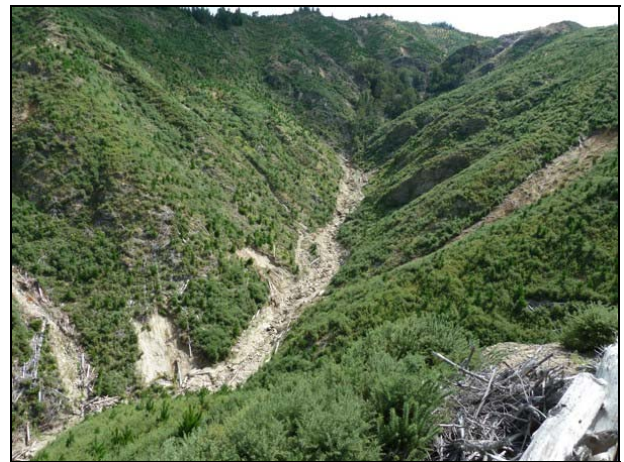
Site	Site 1
GPS	1635584 5397071
Land cover	Pines < 10 years
Type of erosion	2Da 3Df
LUC Class	7e12
Infrastructure damage	Public road closure

Figure A1 Site 1 erosion in pines <10 years

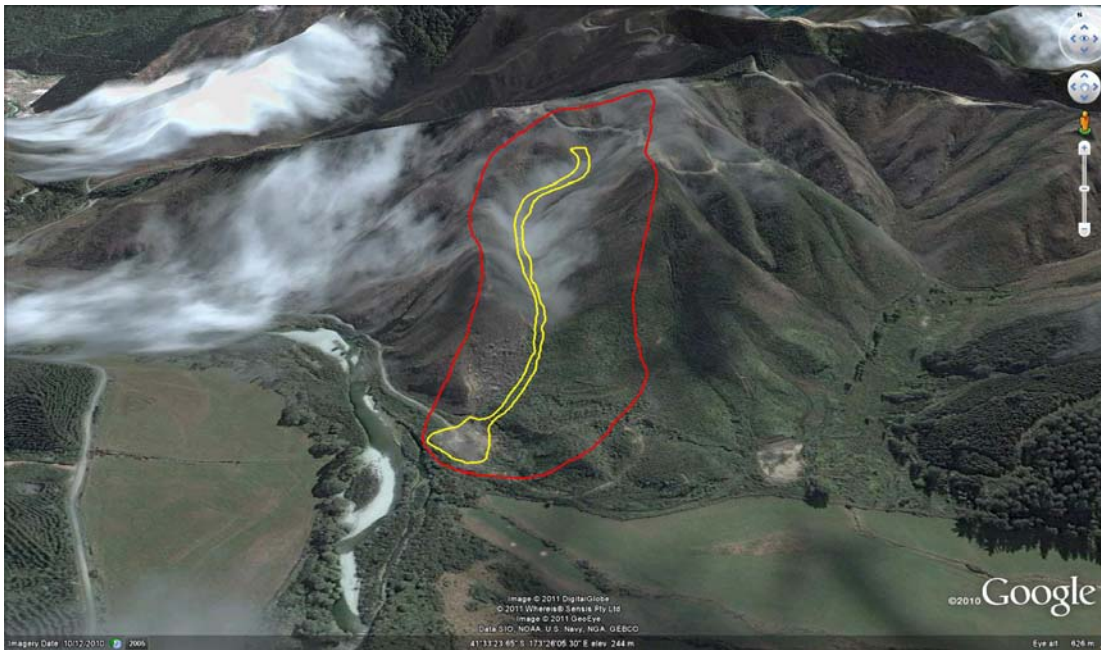
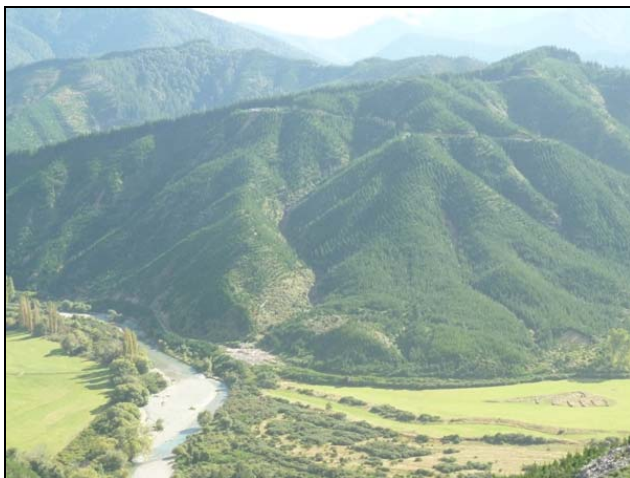
Site	Site 2
GPS	1636418 5399309
Land cover	Pines < 10 years
Type of erosion	2Da 3Df
LUC Class	7e9
Infrastructure damage	None noted

Figure A2 Site 2 erosion in pines <10 years

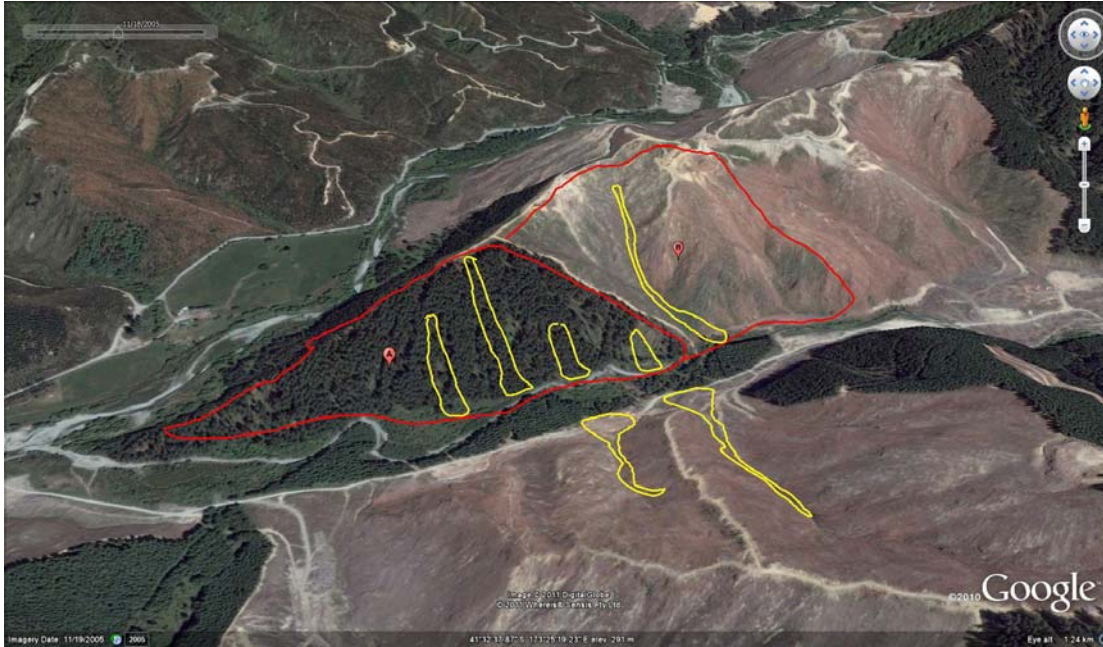
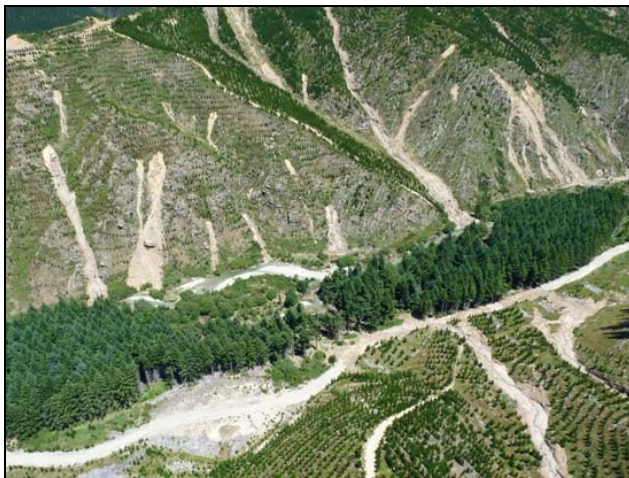
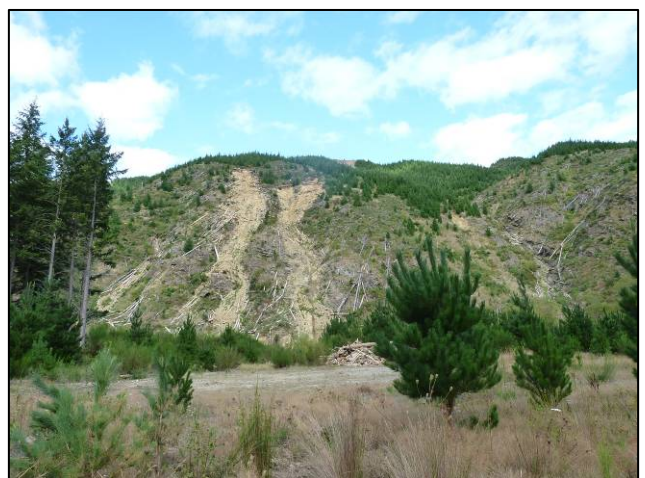
Site	Site 3
GPS	1635339 5399545
Land cover	Pines < 10 years
Type of erosion	3Da 3Df 3Ss
LUC Class	7e12
Infrastructure damage	Road closure

Figure A3 Site 3 erosion in pines <10 years

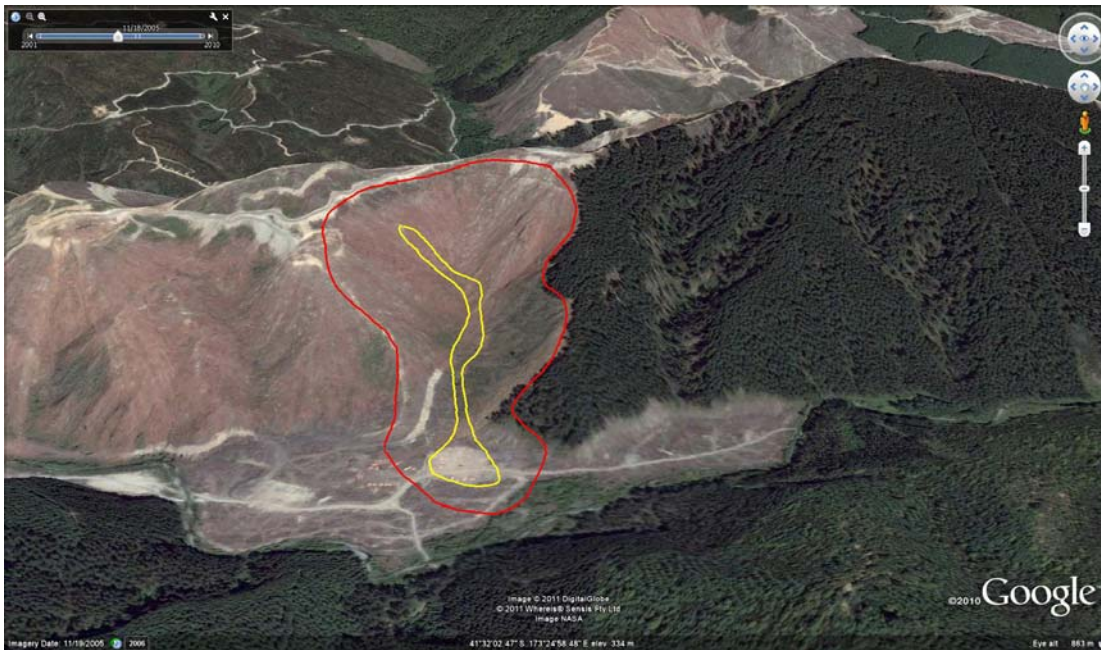
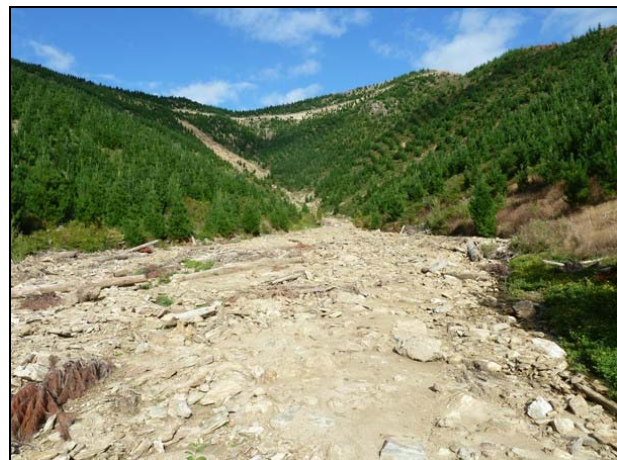
Site	Site 4
GPS	1634676 5401704
Land cover	Pines < 10 years
Type of erosion	3Da 4Df 2Ss
LUC Class	7e12
Infrastructure damage	Processing site damage

Figure A4 Site 4 erosion in pines <10 years

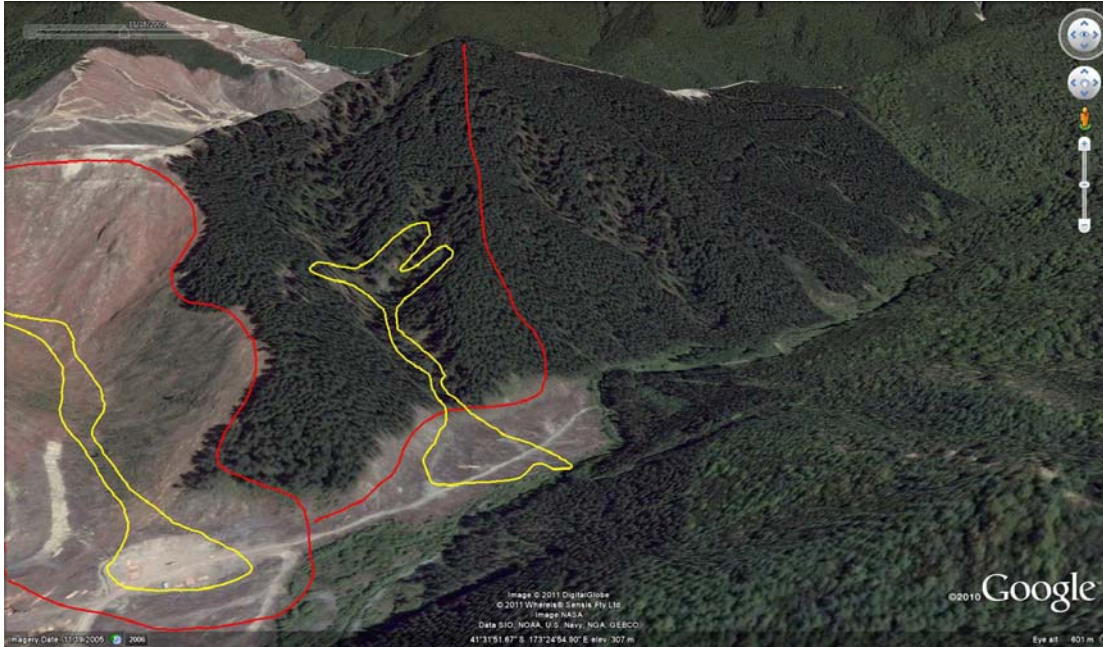
Site	Site 5
GPS	1634676 5402032
Land cover	Recently harvested
Type of erosion	2Da 2Df 2Ss
LUC Class	7e12
Infrastructure damage	Forestry road closure

Figure A5 Site 5 erosion in recently harvested pines

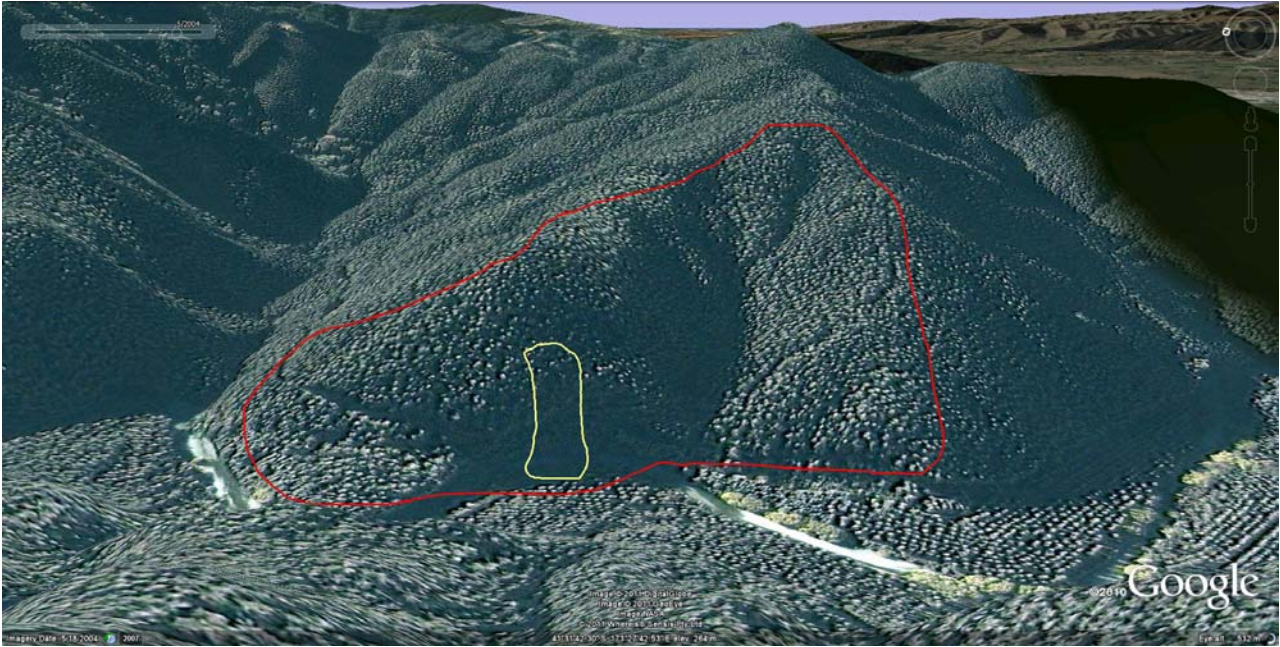
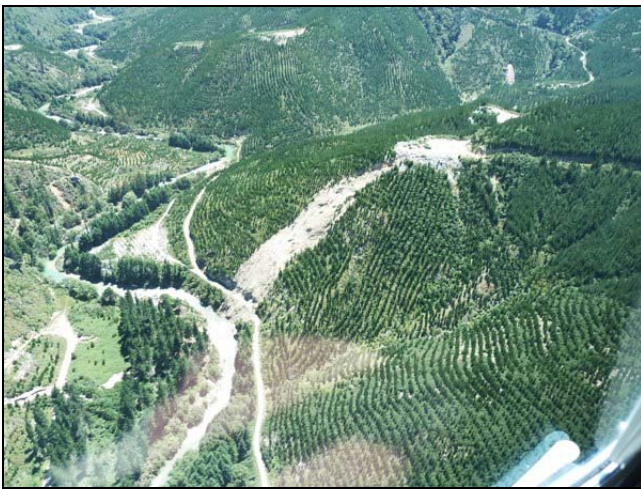
Site	Site 6
GPS	1638551 5402530
Land cover	Pines < 10 years
Type of erosion	3Da 1Ss
LUC Class	7e12
Infrastructure damage	Forestry road closure

Figure A6 Site 6 erosion in pines <10 years

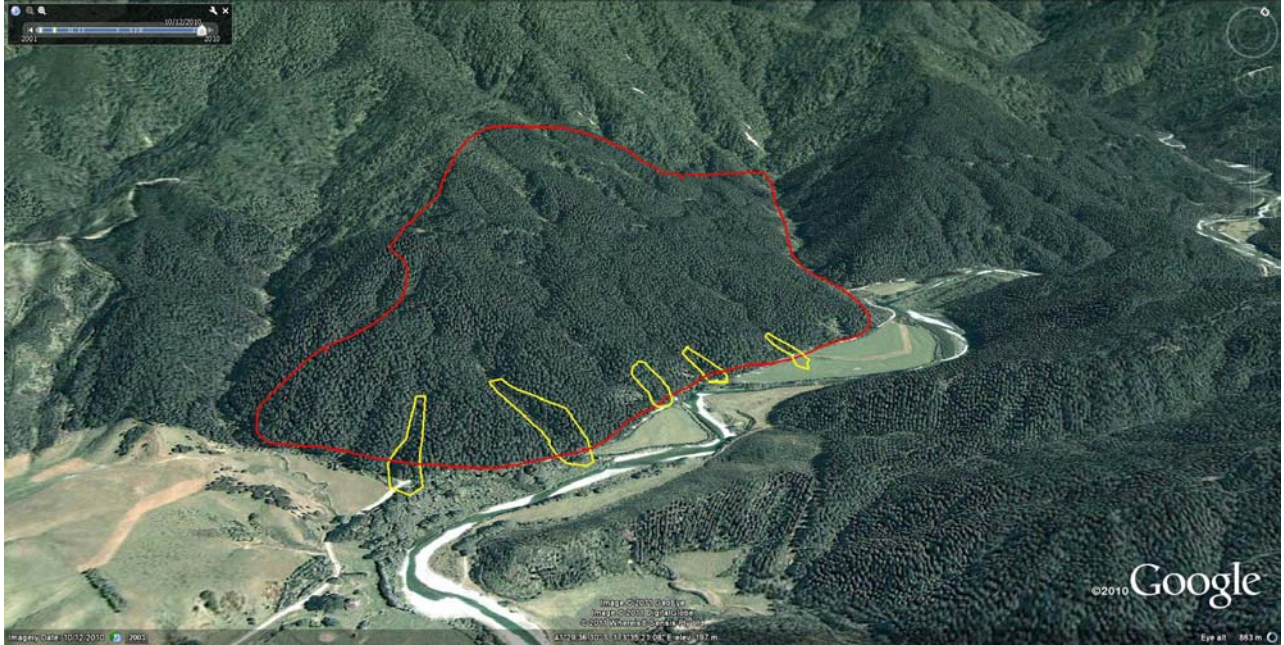
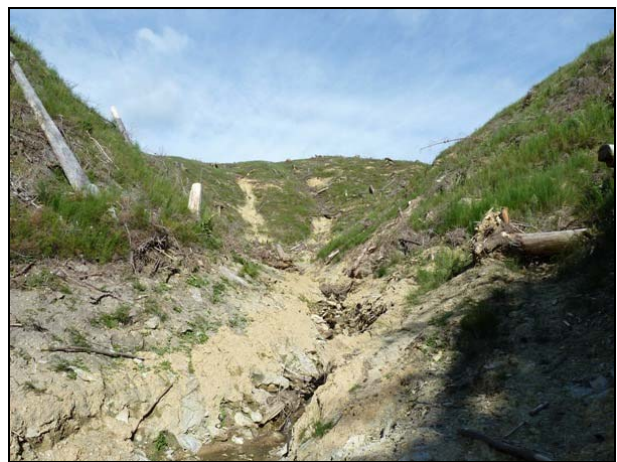
Site	Site 7
GPS	1649583 5407315
Land cover	Recently harvested
Type of erosion	2Ss 2Da 2Df
LUC Class	7e12
Infrastructure damage	Public road closure

Figure A7 Site 7 erosion in recently harvested pines

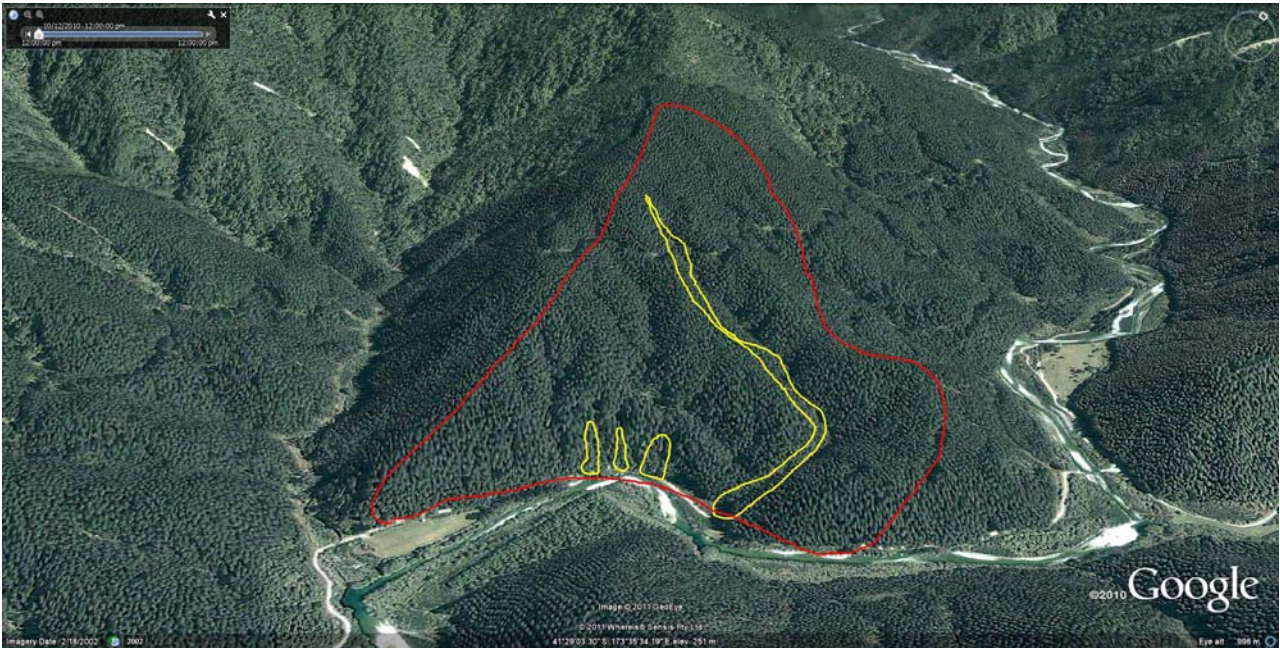
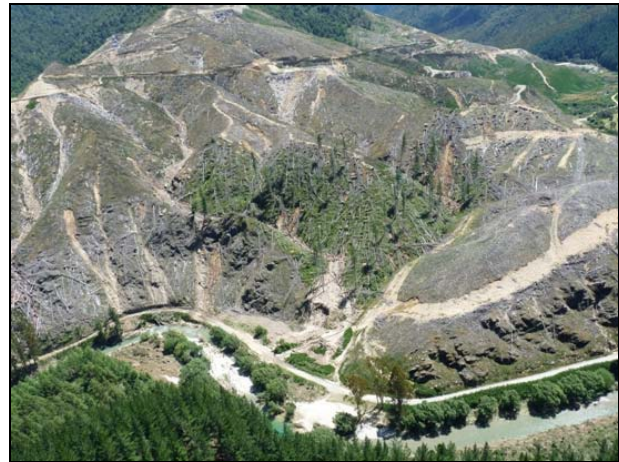
Site	Site 8
GPS	1649622 5407225
Land cover	Recently harvested
Type of erosion	3Ss 3Da 2Df
LUC Class	7e12
Infrastructure damage	Public road closure

Figure A8 Site 8 erosion in recently harvested pines

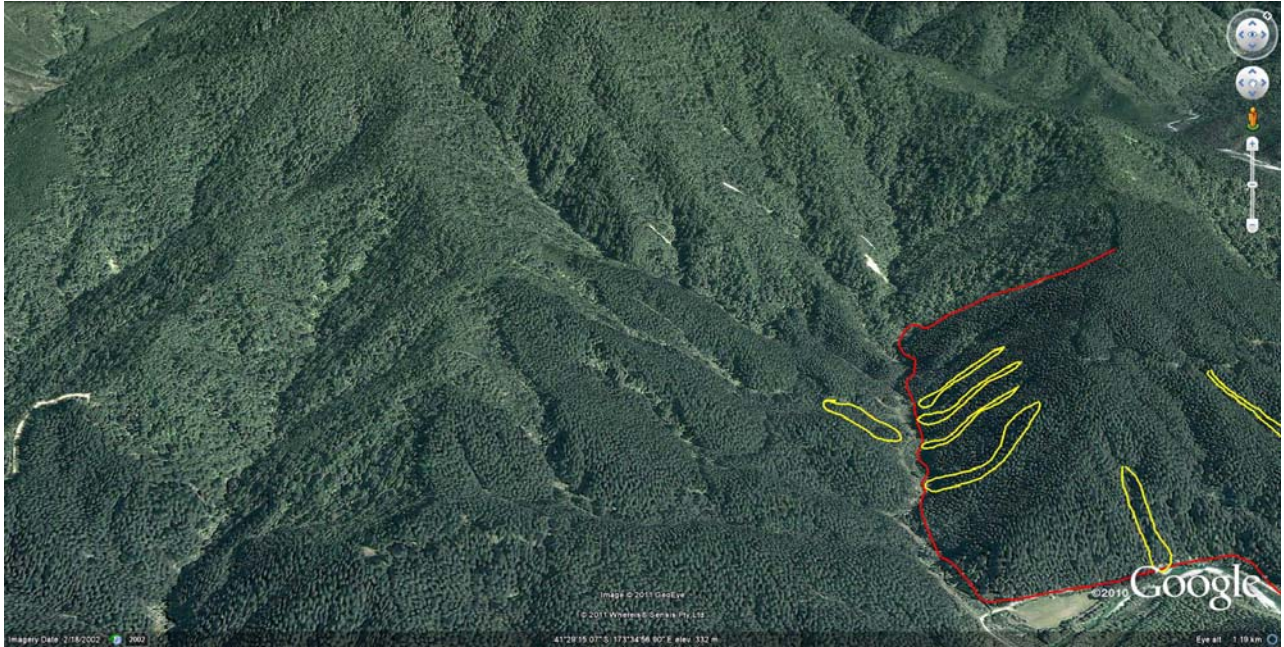
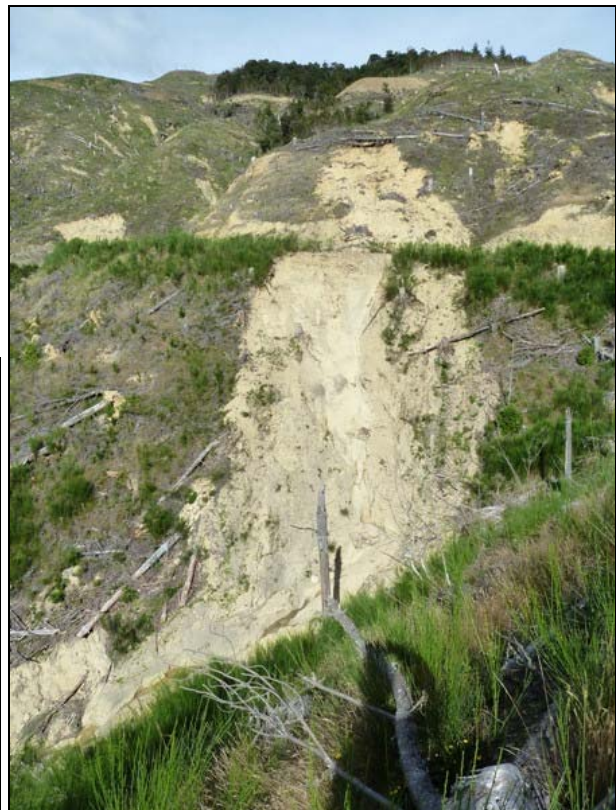
Site	Site 9
GPS	1649251 5407244
Land cover	Recently harvested
Type of erosion	2Ss 4Da
LUC Class	7e12
Infrastructure damage	Forestry road closure

Figure A9 Site 9 erosion in recently harvested pines

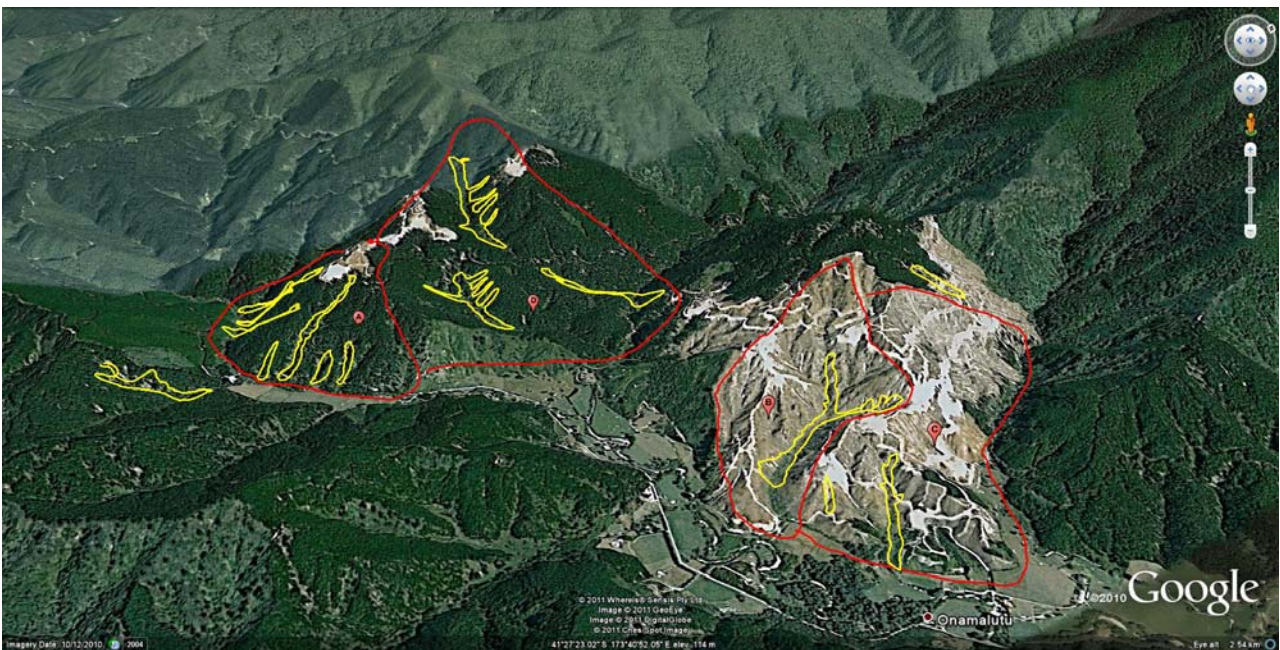
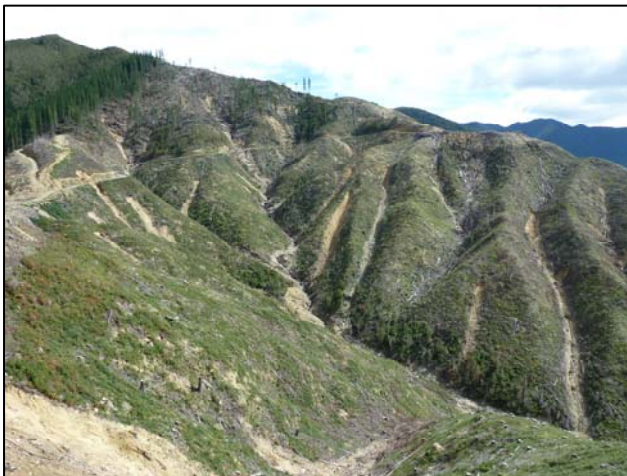
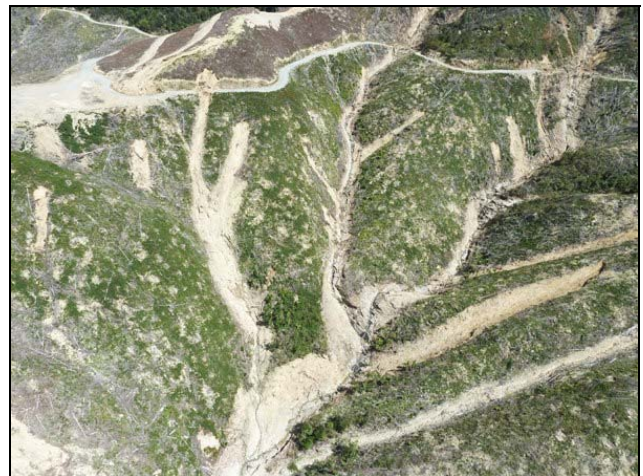
Site	Site 10 a, b, c, d
GPS	1657360 5410863
Land cover - a	Recently harvested
Land cover - b	Recently harvested
Land cover - c	Recently harvested
Land cover - d	Recently harvested
Type of erosion - a	2Ss 3Da 3Df
Type of erosion - b	2Ss 2Da 3Df
Type of erosion - c	3Ss 2Da 3Df
Type of erosion - d	3Ss 4Da 4Df
LUC Class - a	7e12
LUC Class - b	7e12
LUC Class - c	7e12
LUC Class - d	7e12
Infrastructure damage	Public road closure

Figure A10 Site 10 a, b, c, d erosion in recently harvested pines

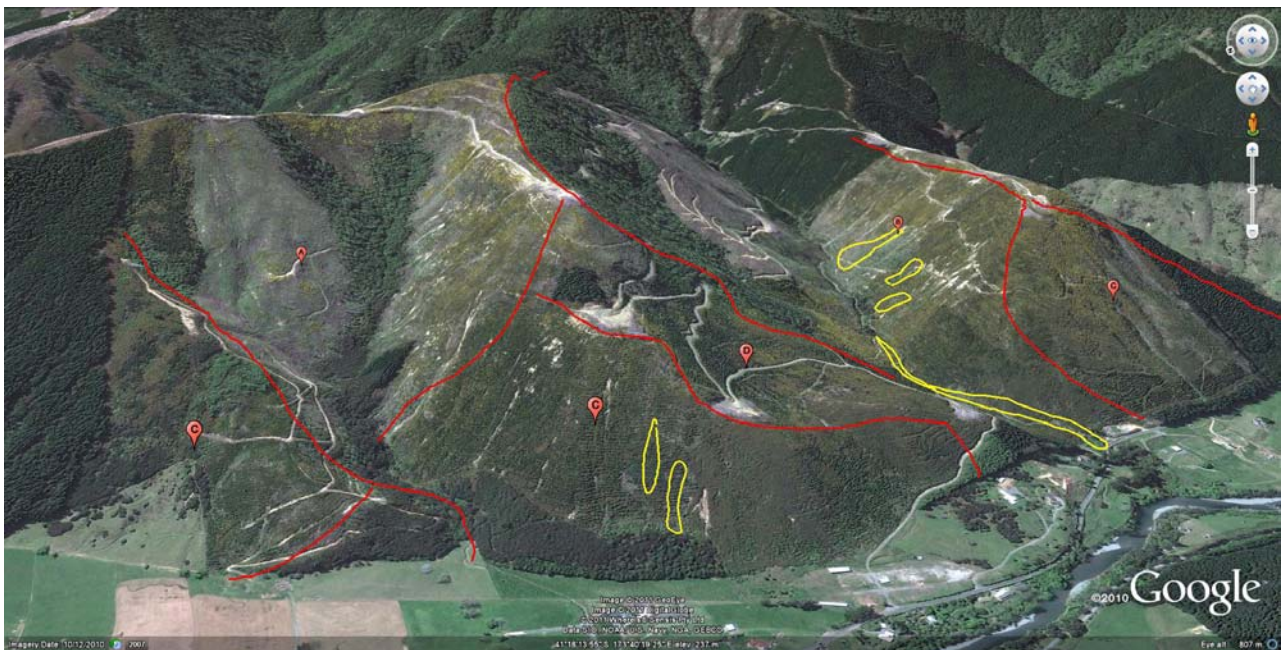
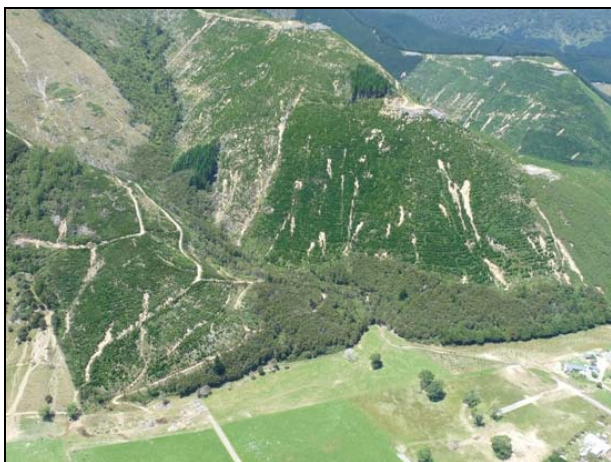
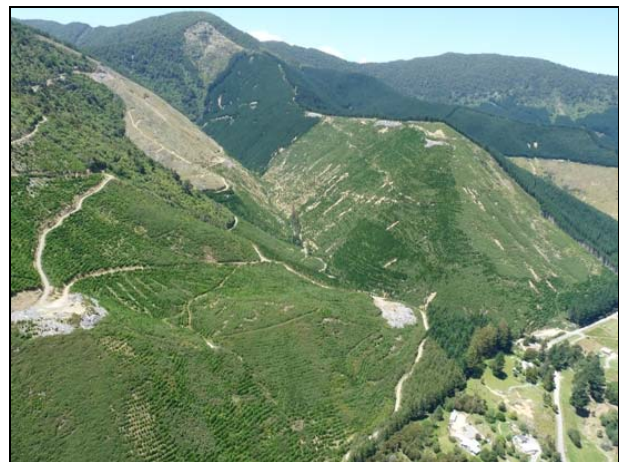
Site	Site 22 a, b, c, d
GPS	1656825 5426409
Land cover - a	Pines less than 10 years
Land cover - b	Pines less than 10 years
Land cover - c	Pines less than 10 years
Land cover - d	Pines less than 10 years
Type of erosion - a	2Ss 2Da
Type of erosion - b	3Ss 3Da 3Df
Type of erosion - c	3Ss 3Da
Type of erosion - d	1Ss 1Da
LUC Class - a	7e9
LUC Class - b	7e9
LUC Class - c	7e9
LUC Class - d	6e11
Infrastructure damage	Public road closure; culvert-bridge damage

Figure A22 Site 22 a, b, c, d erosion in pines >10 years

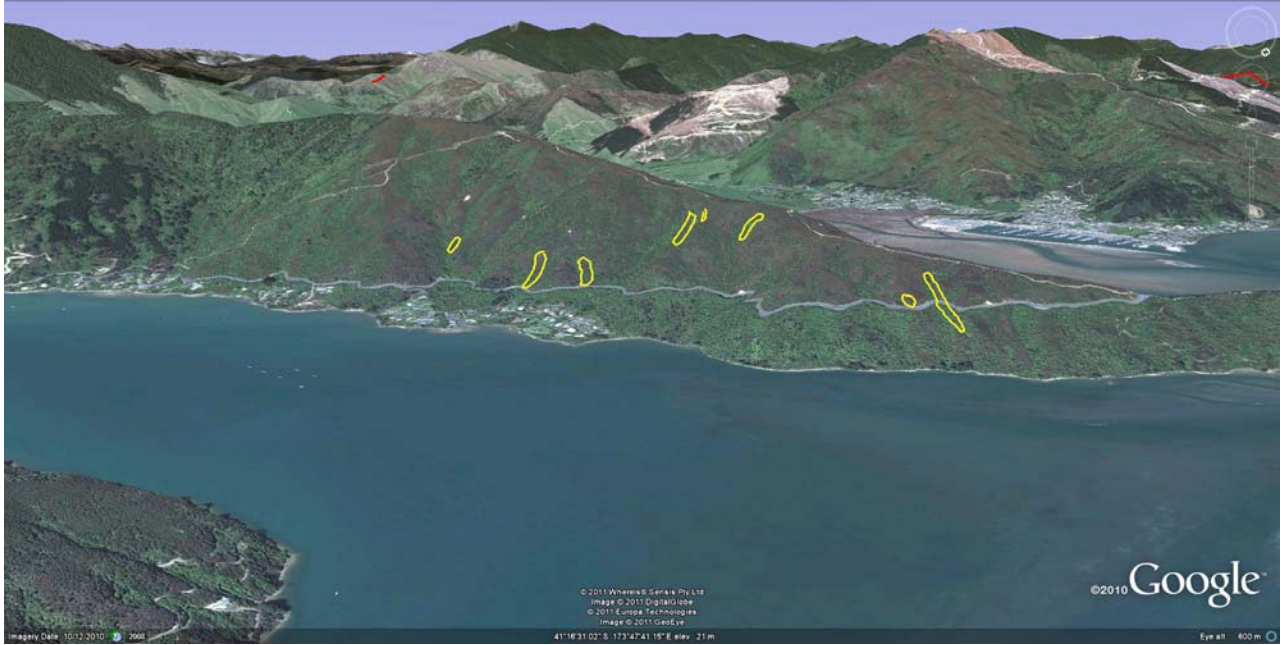
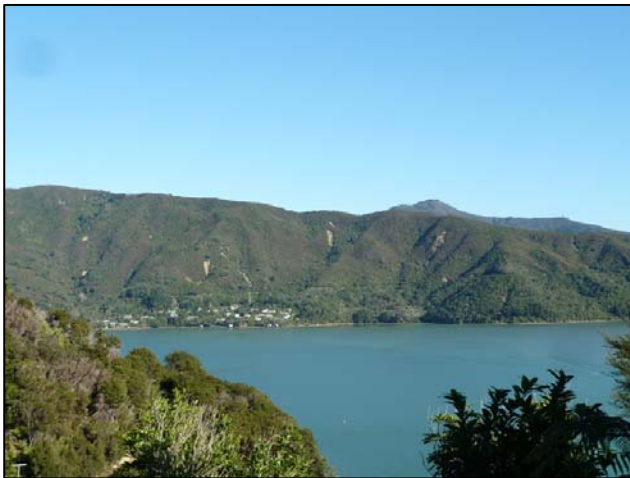
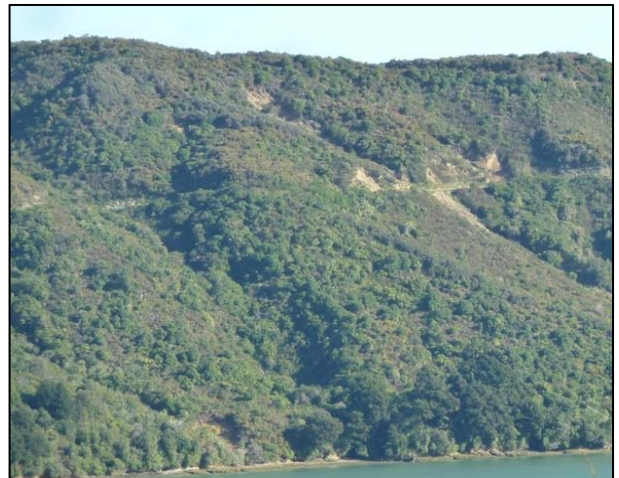
Site	Site 23
GPS	1666178 5430944
Land cover	Scrub
Type of erosion	1Ss
LUC Class	6e11
Infrastructure damage	Public road closure

Figure A23 Site 23 erosion in pines >10 years

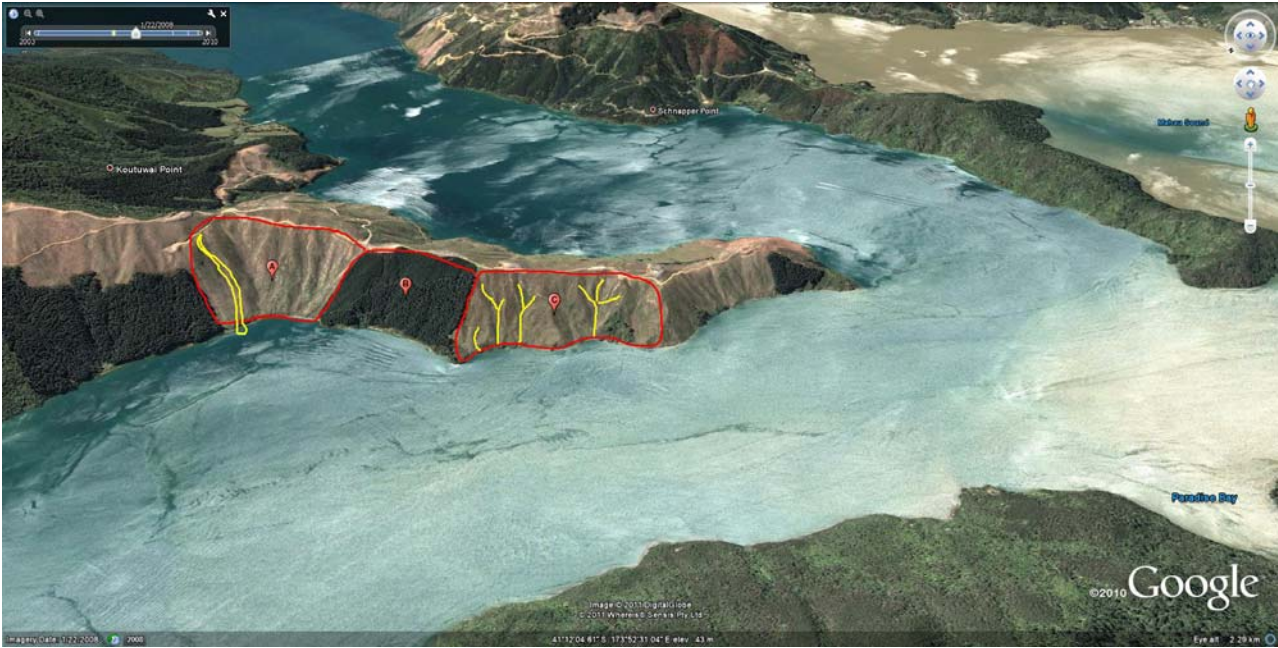
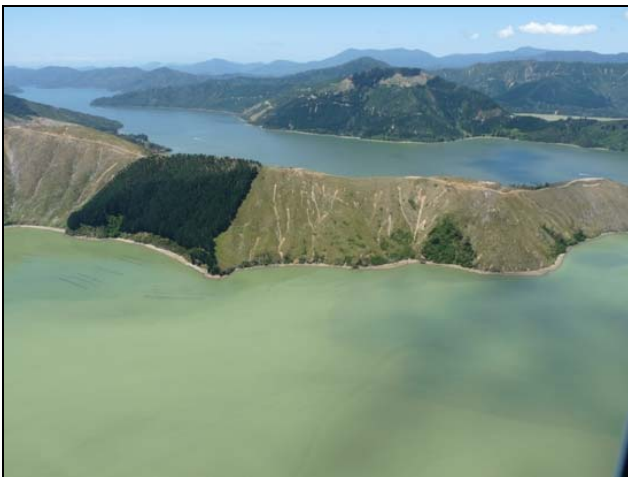
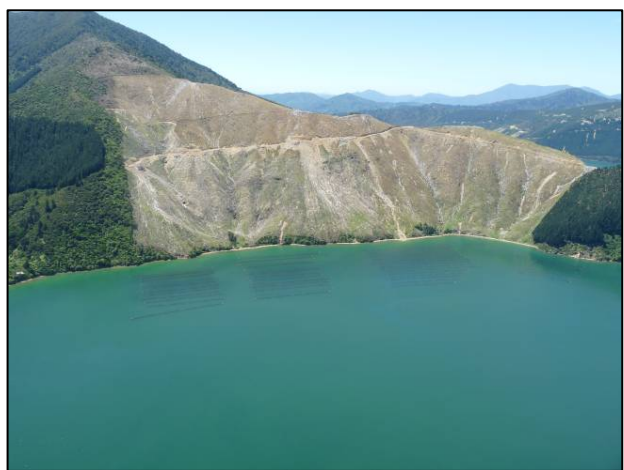
Site	Site 24 a, b, c
GPS	1674091 5439130
Land cover - a	Recently harvested
Land cover - b	Pines > 10 years
Land cover - c	Recently harvested
Type of erosion - a	2Ss 3Da
Type of erosion - b	0Ss 0Da
Type of erosion - c	2Ss 3Da
LUC Class	7e9
Infrastructure damage	None noted – slip into ocean

Figure A24 Site 24 a, b, c erosion in recently harvested and pines >10 years

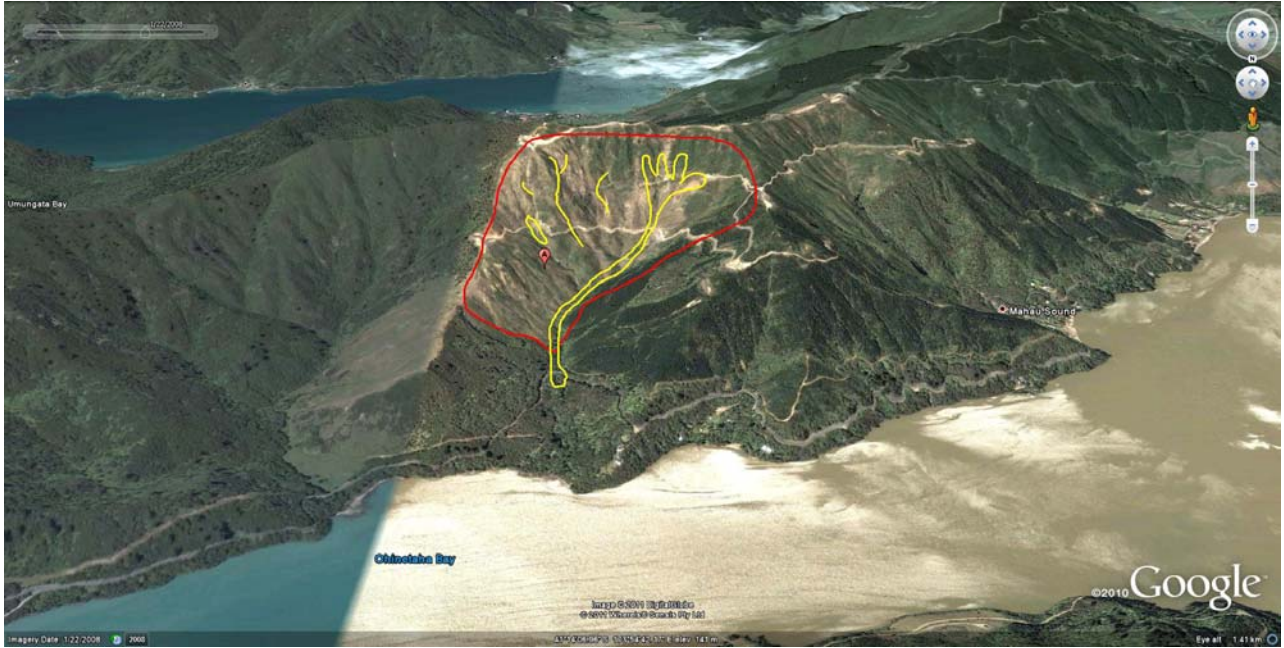
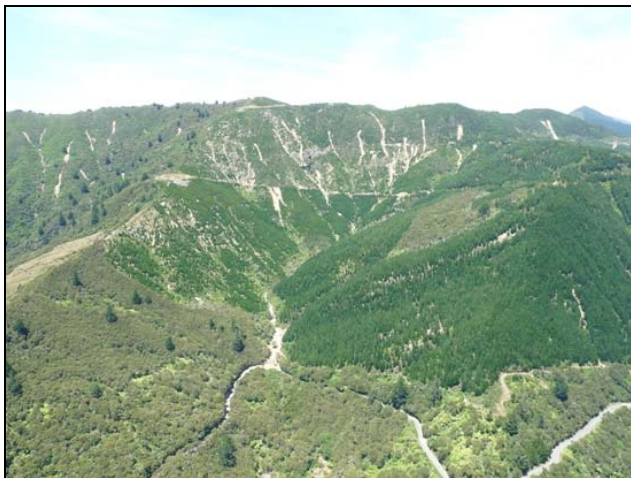
Site	Site 25
GPS	1676553 5434339
Land cover	Pines < 10 years
Type of erosion	2Ss 3Da 3Df
LUC Class	7e9
Infrastructure damage	Public road closure; culvert damage

Figure A25 Site 25 erosion in pines <10 years

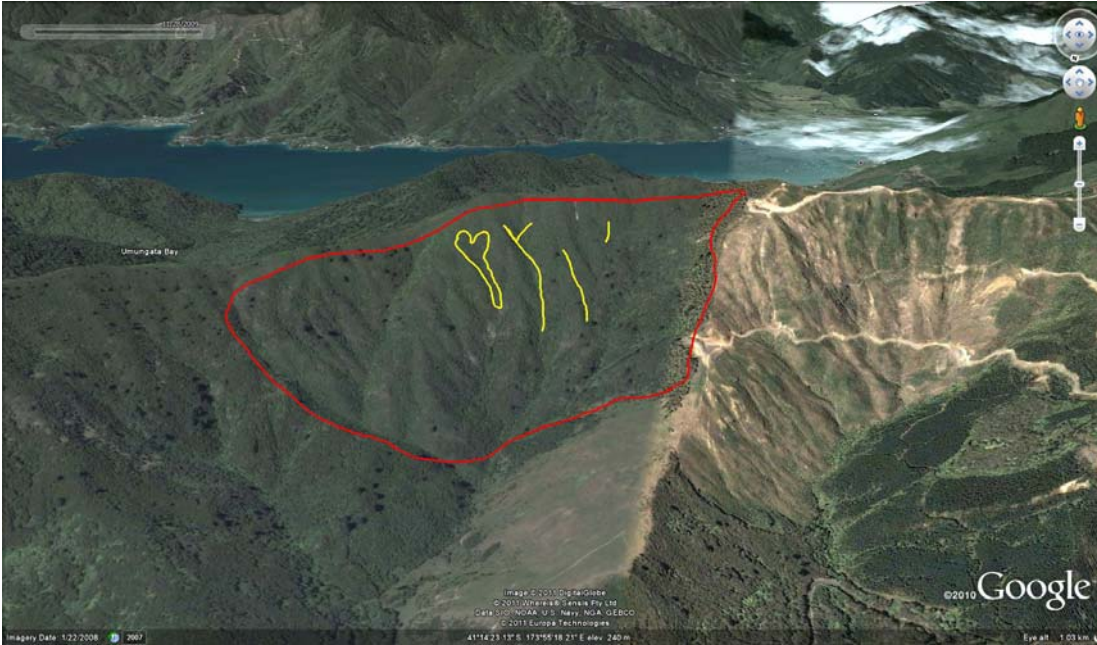
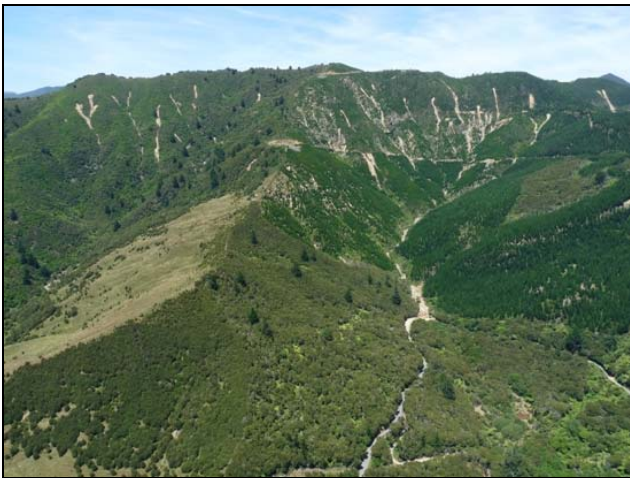
Site	Site 26
GPS	1677065 5434071
Land cover - a	Scrub
Type of erosion - a	1Ss 2Da
LUC Class	7e9
Infrastructure damage	None noted

Figure A26 Site 26 erosion in scrub

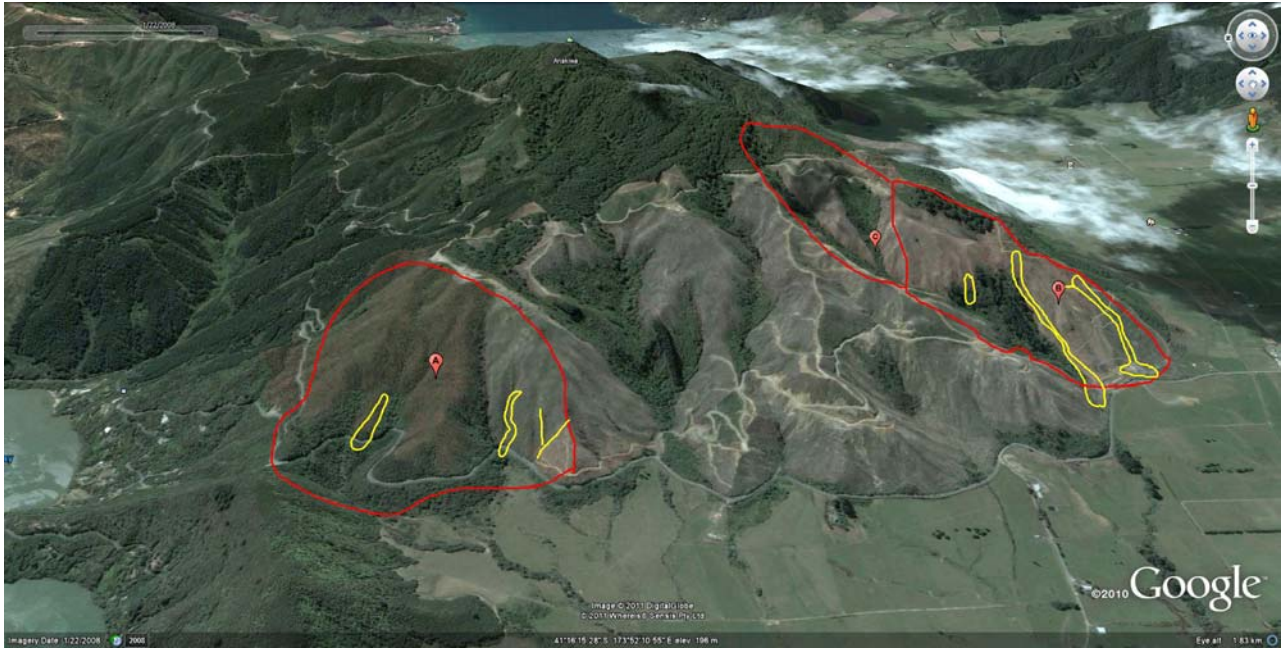
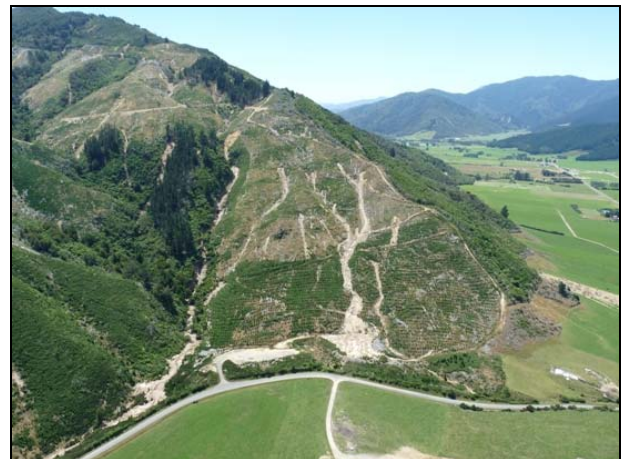
Site	Site 27 a, b, c
GPS	1672856 5429526
Land cover - a	Recently harvested
Land cover - b	Pines < 10 years and recently harvested
Land cover - c	Recently harvested
Type of erosion - a	2Ss 2Da
Type of erosion - b	2Ss 3Da 3Df
Type of erosion - c	1Ss
LUC Class - a	7e9
LUC Class - b	7e9
LUC Class - c	6e11
Infrastructure damage	Public road closure

Figure A27 Site 27 a, b, c erosion in pines <10 years and recently harvested

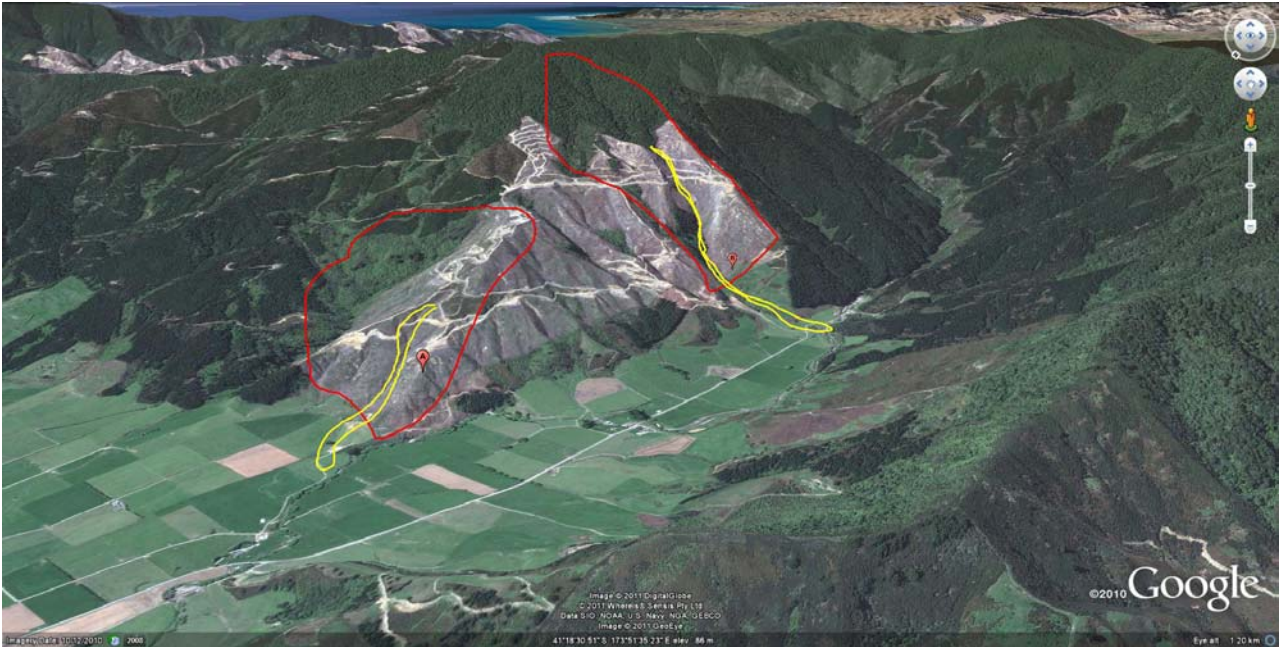
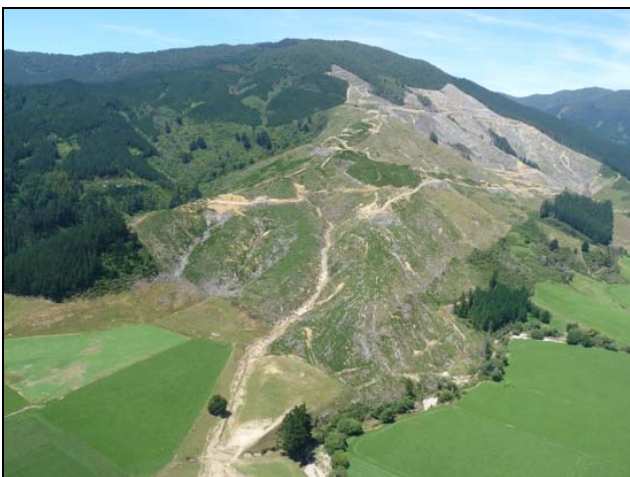
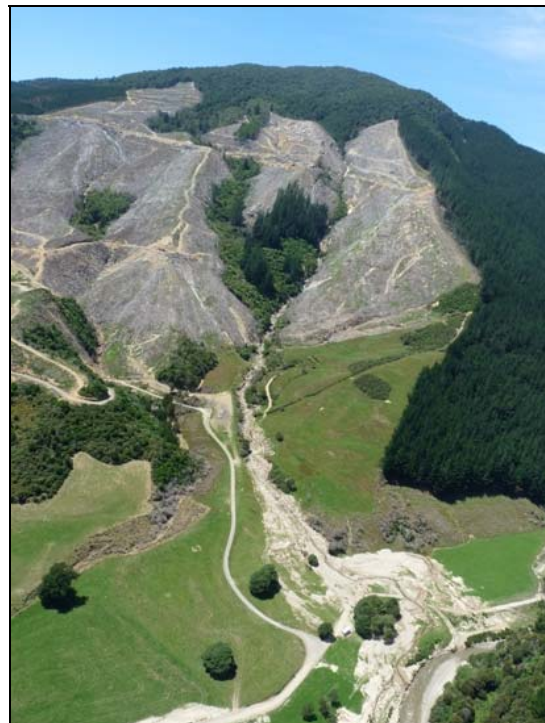
Site	Site 28 a, b
GPS	1672244 5427458
Land cover - a	Recently harvested
Land cover - b	Recently harvested
Type of erosion - a	2Ss 2Da 2Df
Type of erosion - b	2Ss 2Da 4Df
LUC Class - a	6e11
LUC Class - b	7e12
Infrastructure damage	Public road closure

Figure A28 Site 28 a, b erosion recently harvested pines

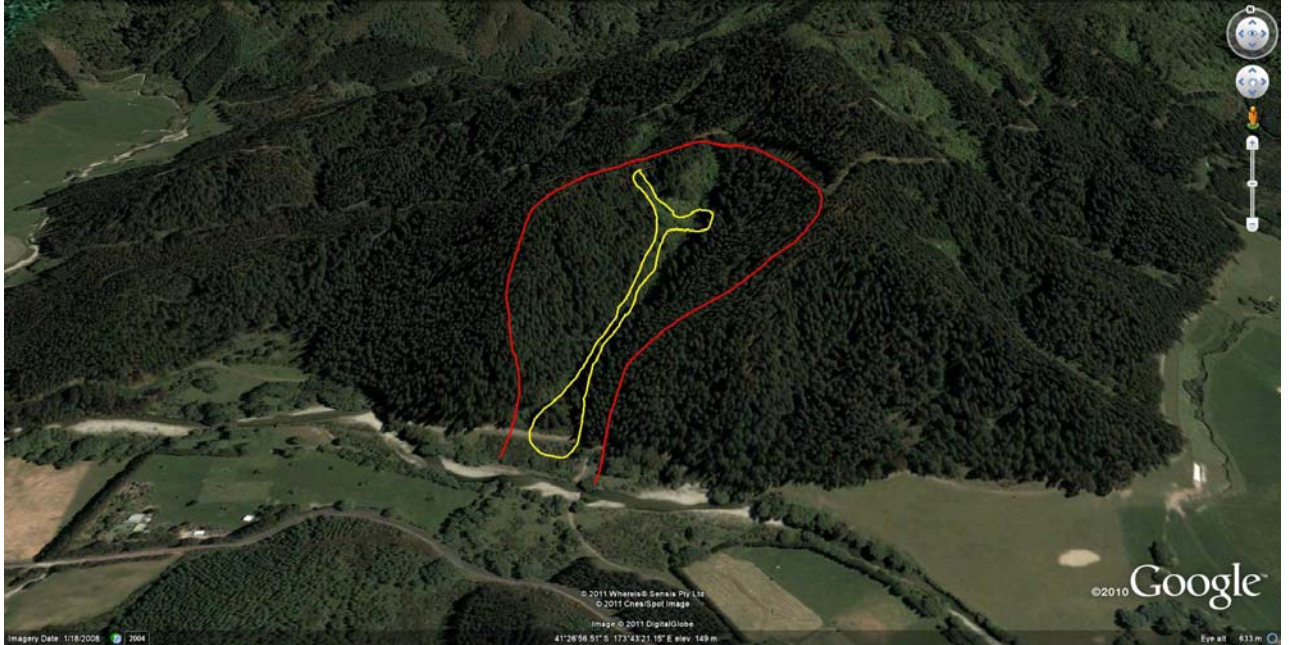
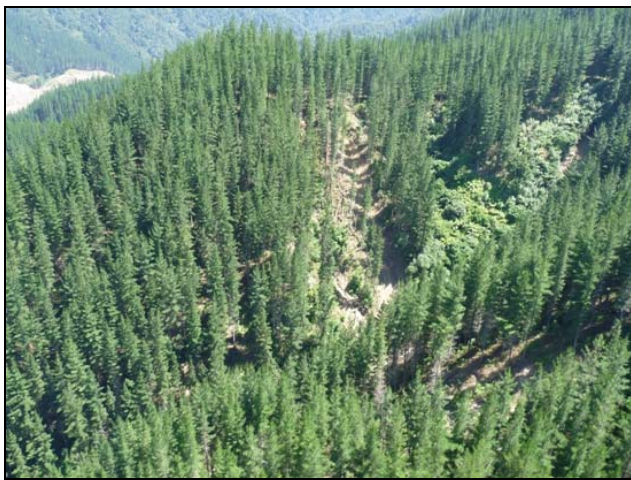
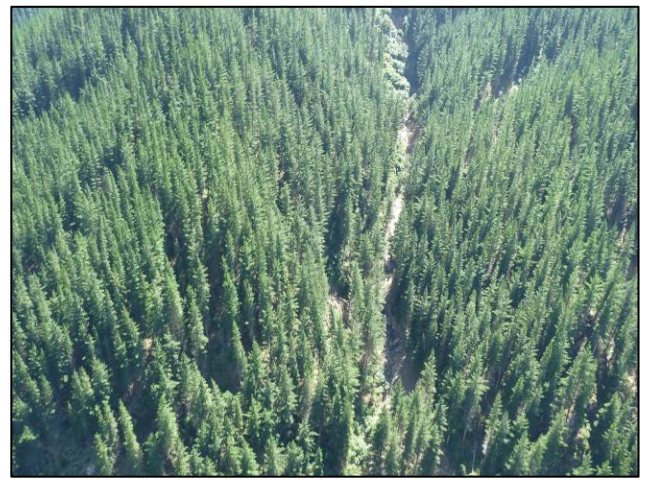
Site	Site 29
GPS	1660326 5411035
Land cover - a	Pines >10 years
Type of erosion - a	2Da 2Df
LUC Class	7e12
Infrastructure damage	Forestry road closure

Figure A29 Site 29 erosion in pines >10 years
