## Appendix 1

Some Observations of Erosion as a Result of the 28 December 2010 Storm Event

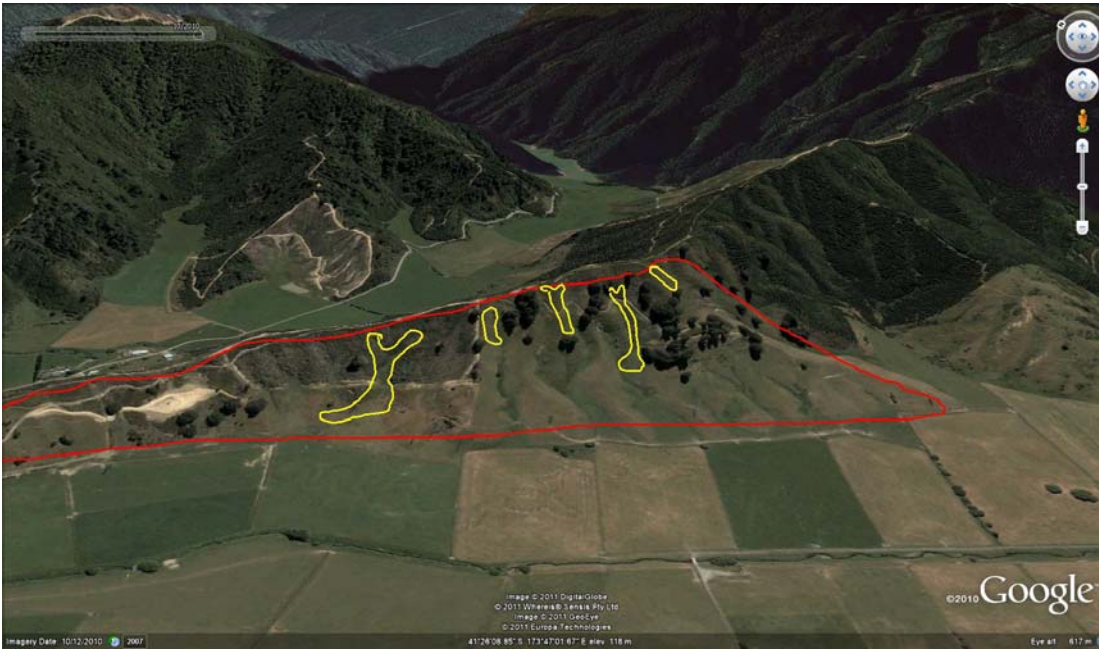
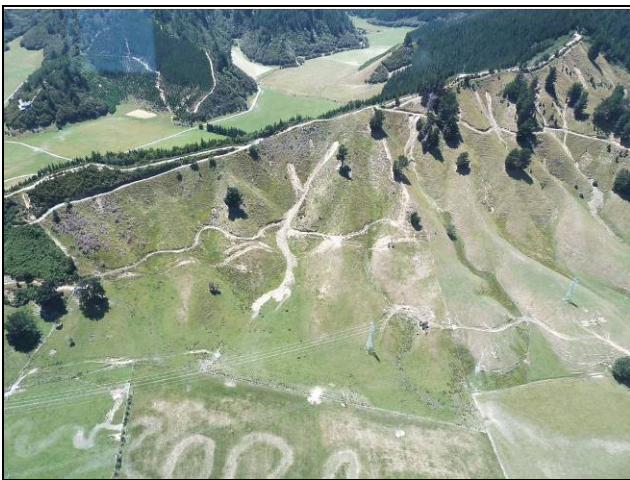
Site	Site 30
GPS	1665207 5412831
Land cover	Exotic pasture
Type of erosion	2Ss 1Da
LUC Class	6e11
Infrastructure damage	None noted

Figure A30 Site 30 erosion in exotic pasture

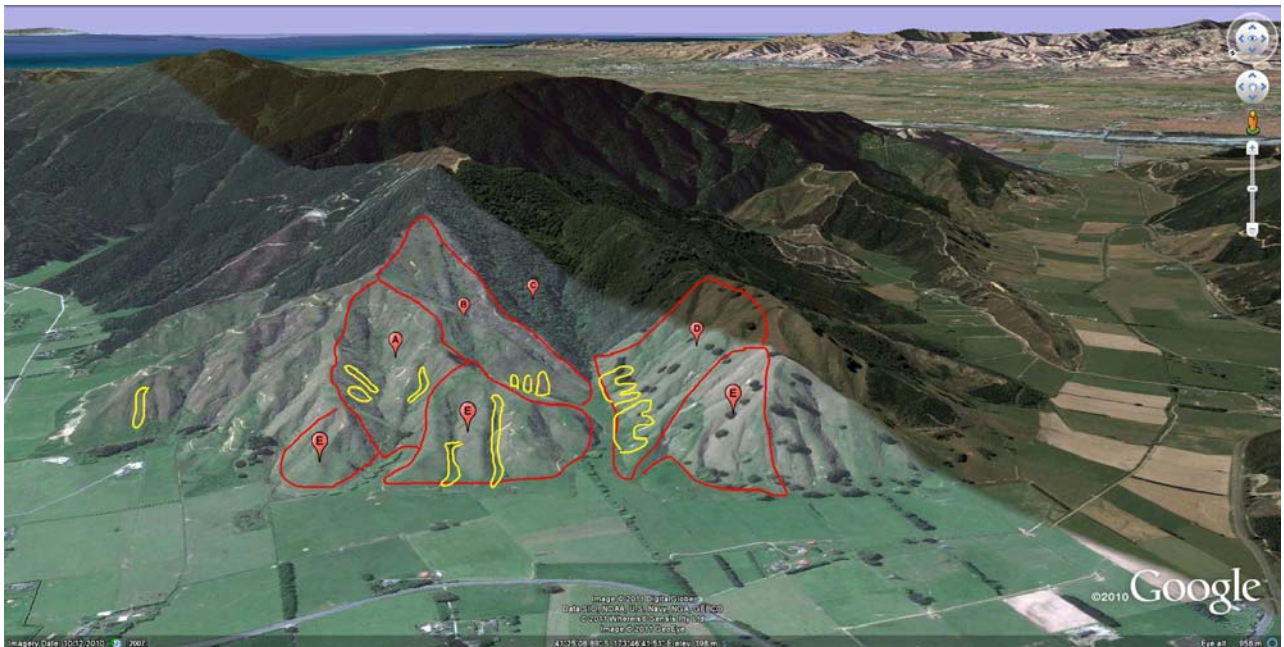
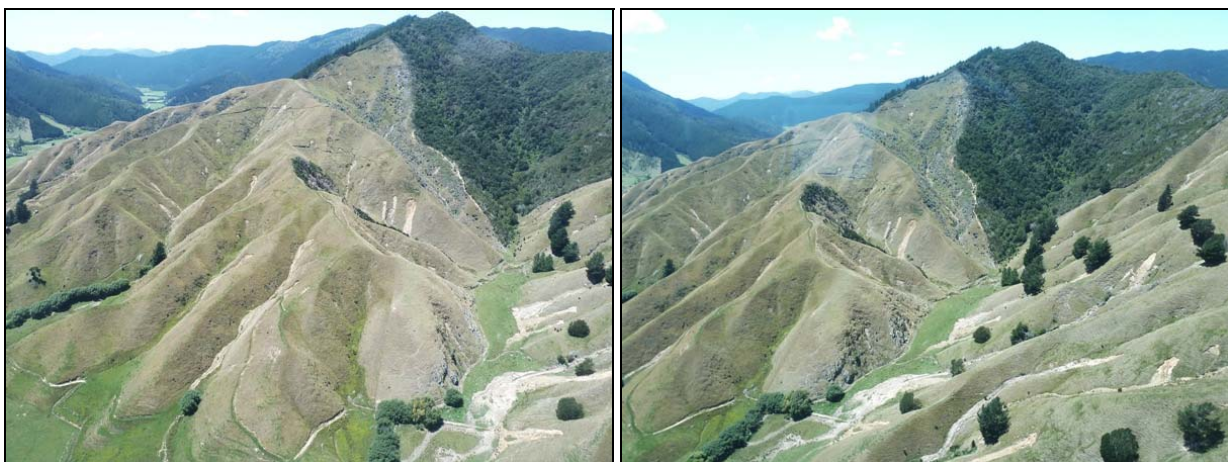
Site	Site 31 a, b, c, d, e
GPS	1664702 5414603
Land cover - a	Exotic pasture
Land cover - b	Exotic pasture
Land cover - c	Scrub
Land cover - d	Exotic pasture
Land cover - e	Exotic pasture
Type of erosion - a	2Ss
Type of erosion - b	2Ss 1Da
Type of erosion - c	0Ss 0Da
Type of erosion - d	2Ss
Type of erosion - e	1Ss
LUC Class - a	7e12
LUC Class - b	7e12
LUC Class - c	7e12
LUC Class - d	6e11
LUC Class - e	6e11
Infrastructure damage	None noted

Figure A31 Site 31 a, b, c, d, e erosion in exotic pasture and scrub

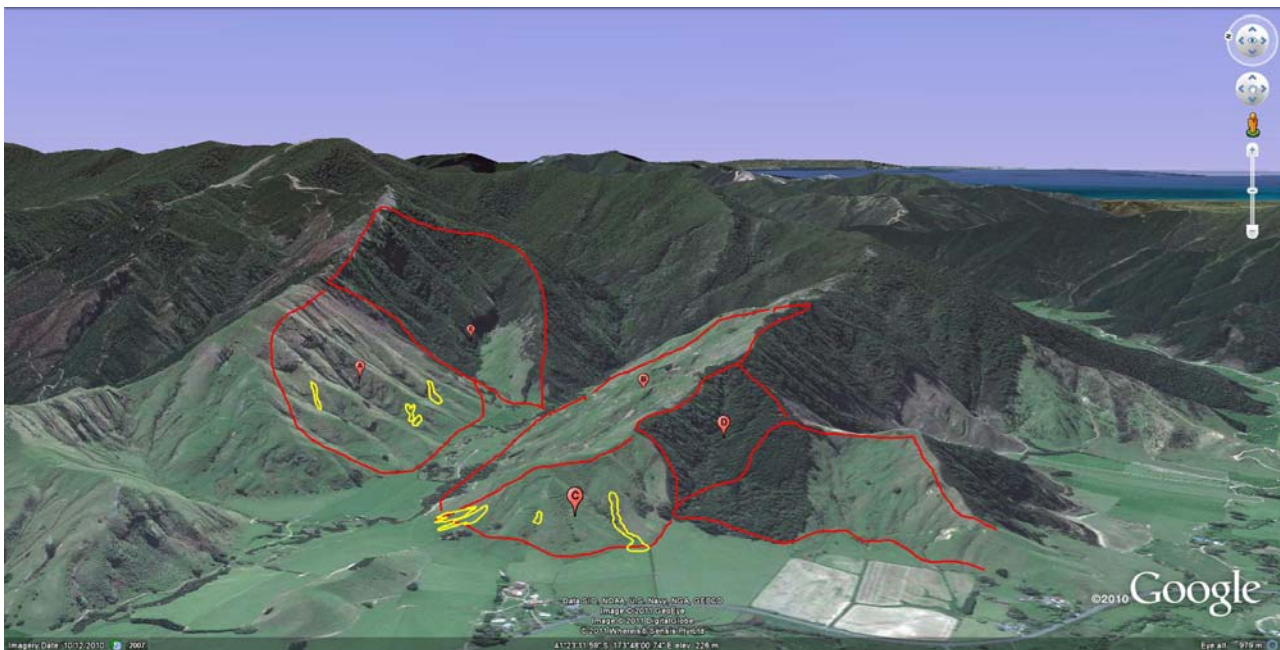
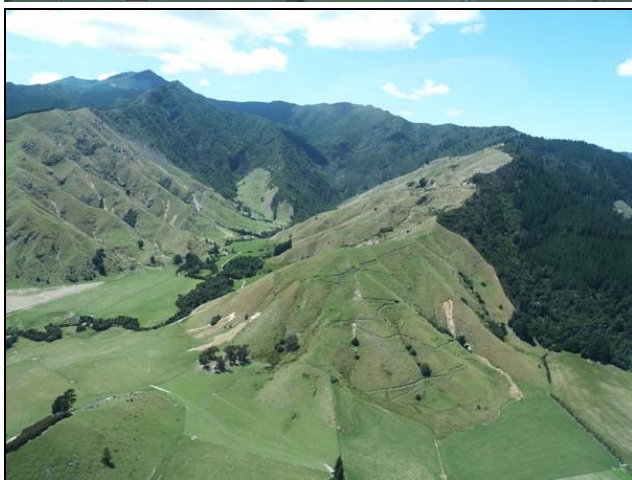
Site	Site 32 a, b, c, d, e
GPS	1664912 5418102
Land cover - a	Exotic pasture
Land cover - b	Exotic pasture
Land cover - c	Exotic pasture
Land cover - d	Scrub/bush
Land cover - e	Scrub
Type of erosion - a	1Ss 1Da
Type of erosion - b	1Ss 2Su
Type of erosion - c	2Ss
Type of erosion - d	0Ss
Type of erosion - e	1Ss 0Da
LUC Class - a	7e9
LUC Class - b	6e11
LUC Class - c	6e11
LUC Class - d	7e9 upper slope; 6e11 lower slope
LUC Class - e	7e9 with patches of 8e2 on bluffs
Infrastructure damage	None noted

Figure A32 Site 32 a, b, c, d, e erosion in exotic pasture and scrub/bush

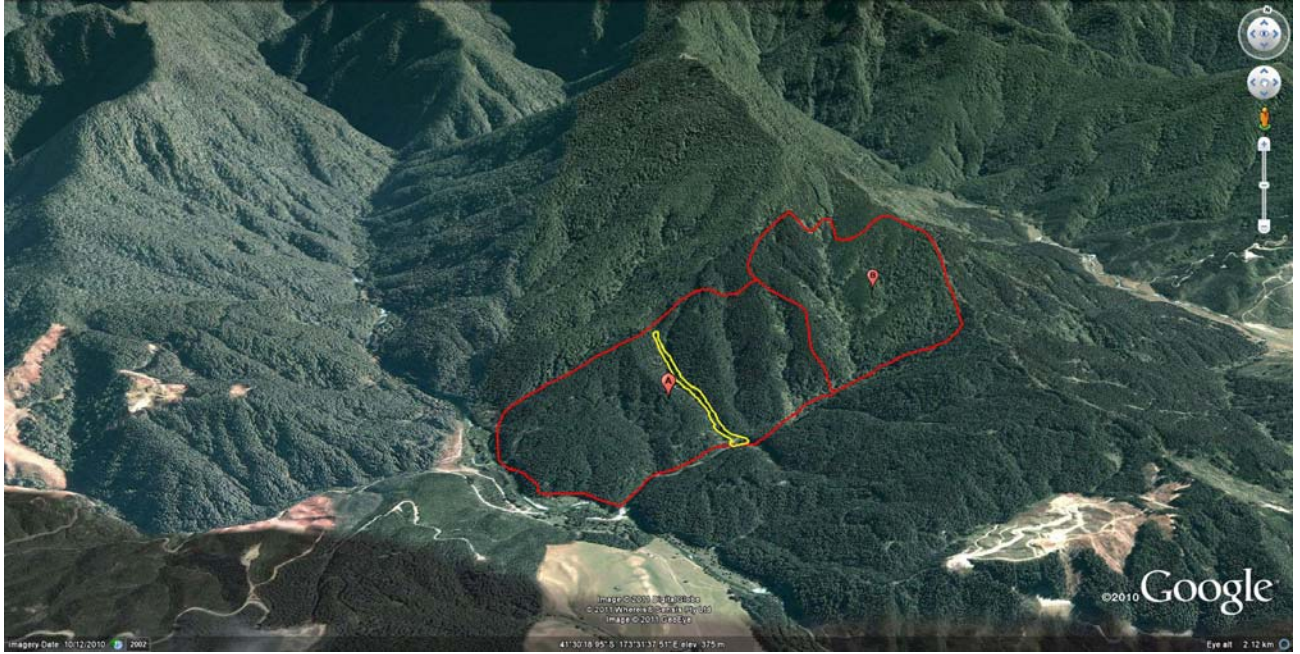
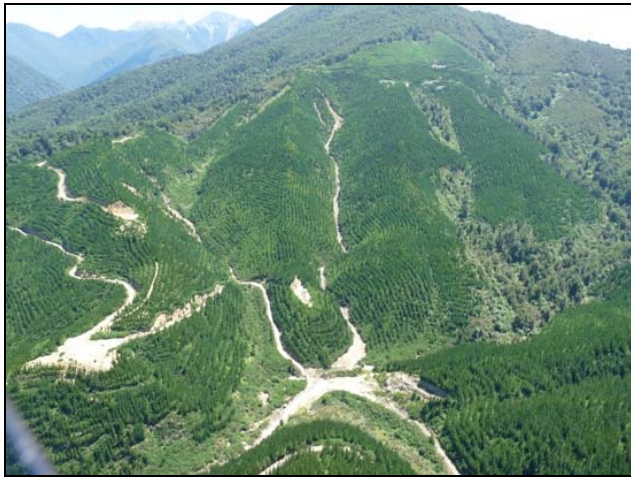
Site	Site 33
GPS	1644355 540605
Land cover	Pines > 10 years
Type of erosion	2Da 4Df 2Ss
LUC Class	7e12
Infrastructure damage	Forestry road damage

Figure A33 Site 33 erosion in pines > 10 years

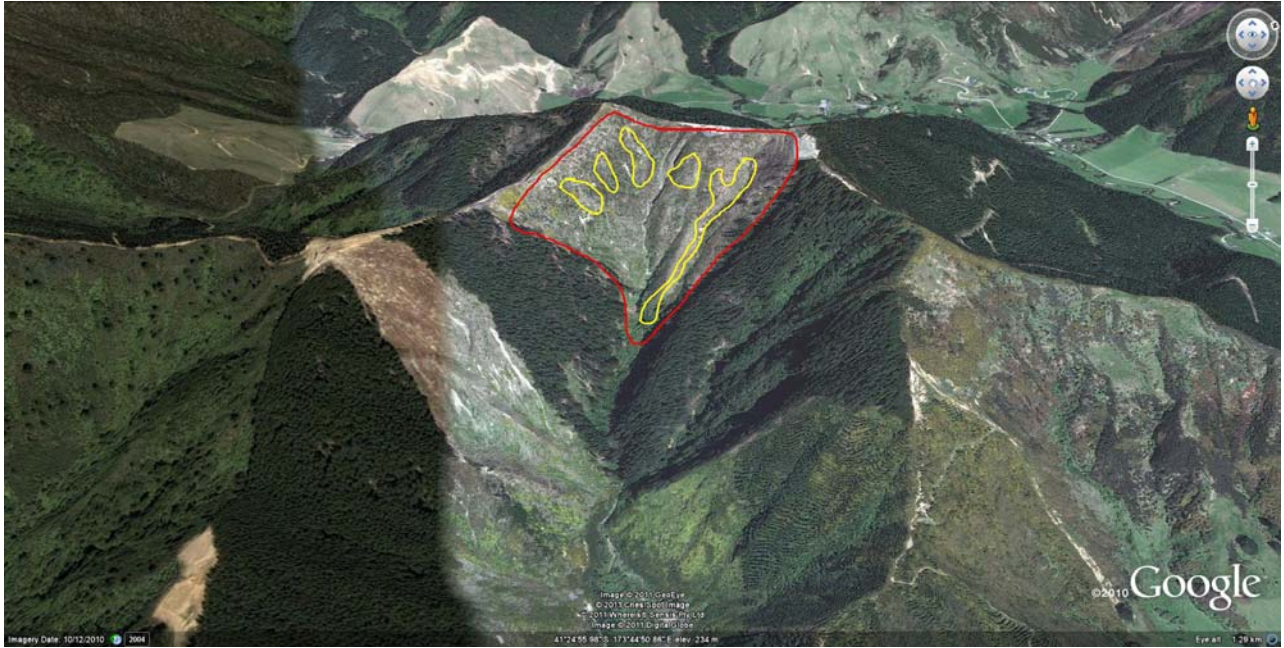
Site	Site 11
GPS	1662324 5414920
Land cover	Pines < 10 years
Type of erosion	3Da 3Df
LUC Class	7e12
Infrastructure damage	None noted

Figure A11 Site 11 erosion in pines <10 years

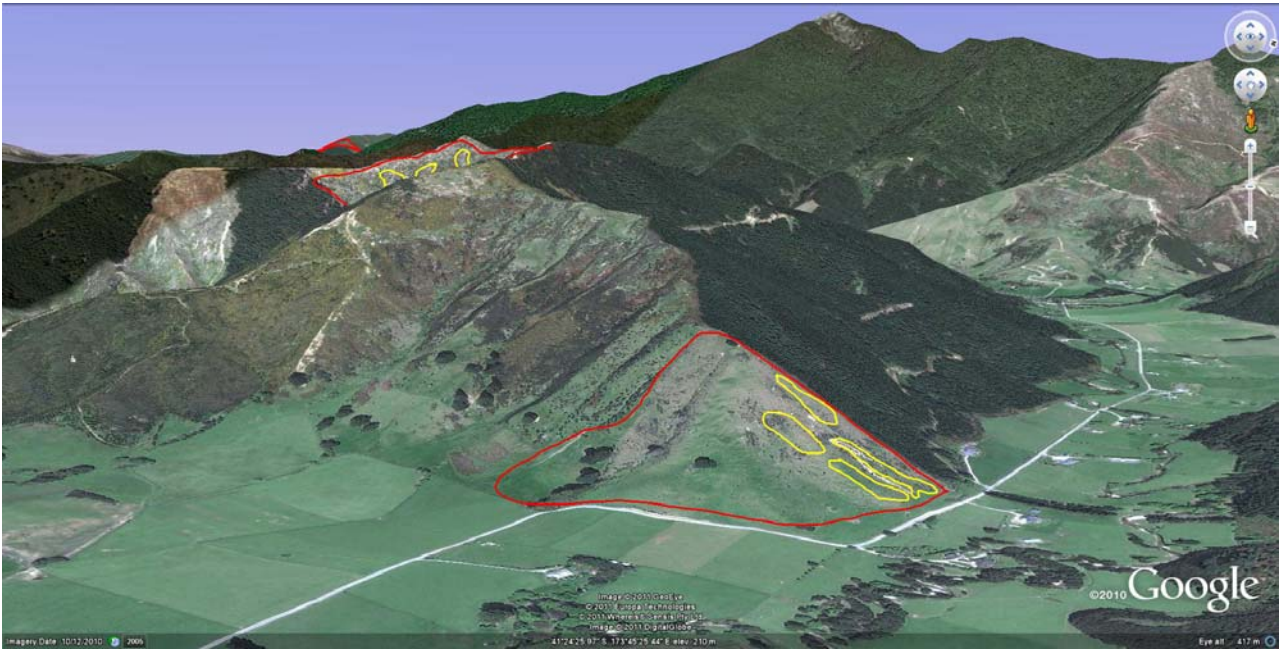
Site	Site 12
GPS	1663456 5416047
Land cover	Exotic pasture
Type of erosion - a	1Ss
LUC Class	6e11
Infrastructure damage	None noted

Figure A12 Site 12 erosion in exotic pasture

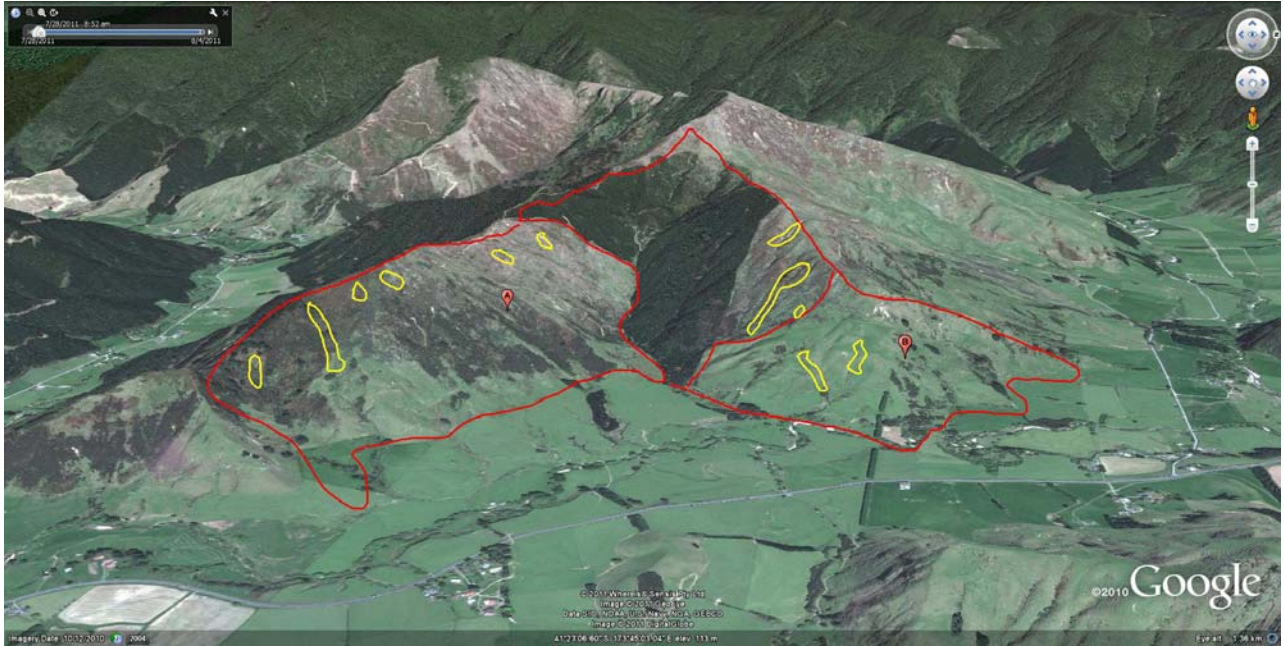
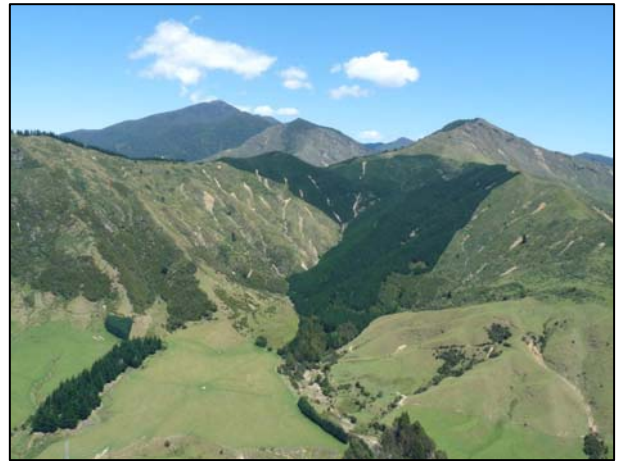
Site	Site 13 a, b
GPS	1663449 5417284
Land cover - a	Scrub
Land cover - b	Exotic pasture
Type of erosion - a	2Ss 2Da
Type of erosion - b	2Ss
LUC Class - a	7e9
LUC Class - b	6e11
Infrastructure damage	None noted

Figure A13 Site 13 a, b erosion in recently harvested pines

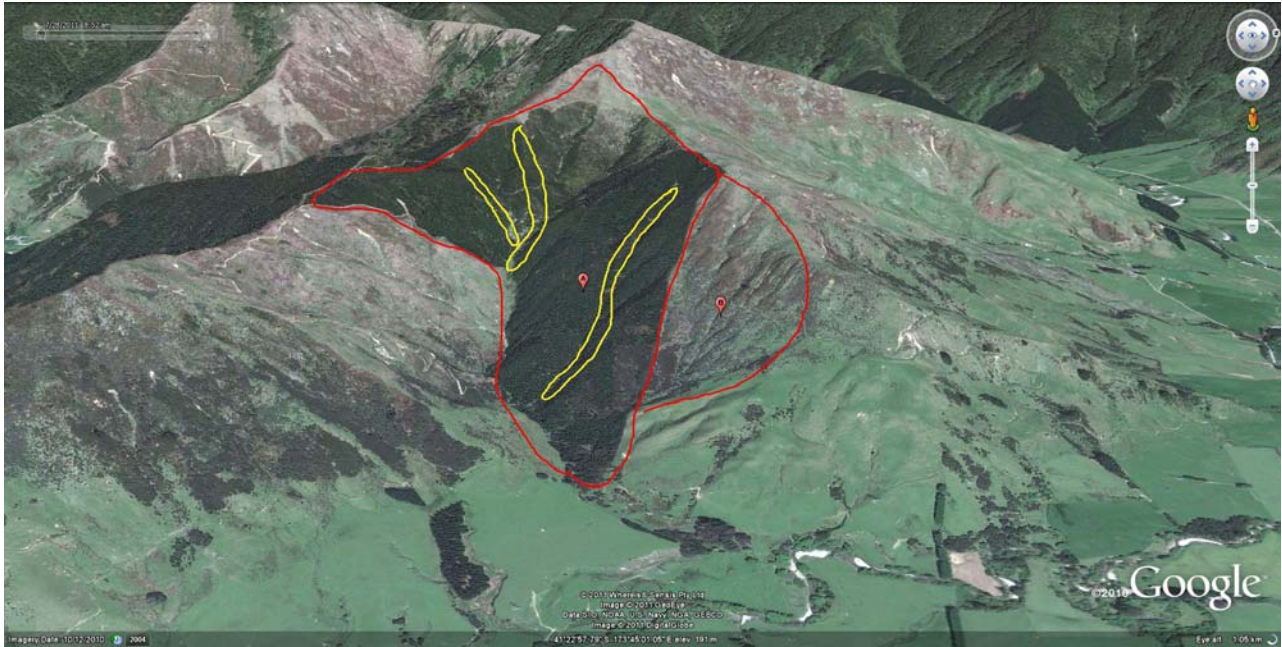
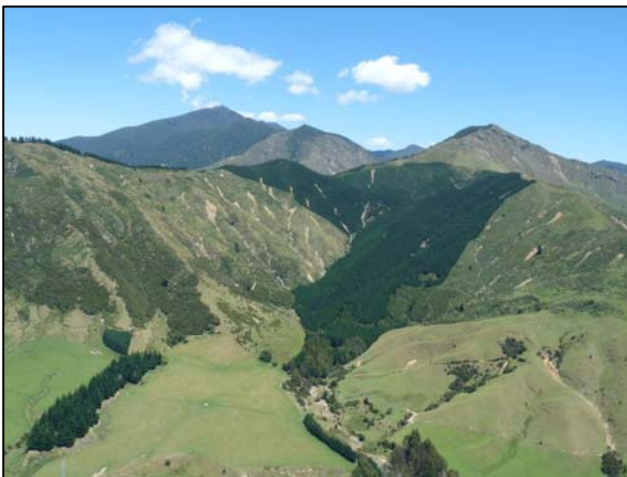
Site	Site 14 a, b
GPS	1661881 5418380
Land cover - a	Pines > 10
Land cover - b	Scrub
Type of erosion - a	2Ss 2Da 2Df
Type of erosion - b	2Ss 2Da
LUC Class - a	7e9
LUC Class - b	7e9
Infrastructure damage	None noted

Figure A14 Site 14 erosion in pines >10 years

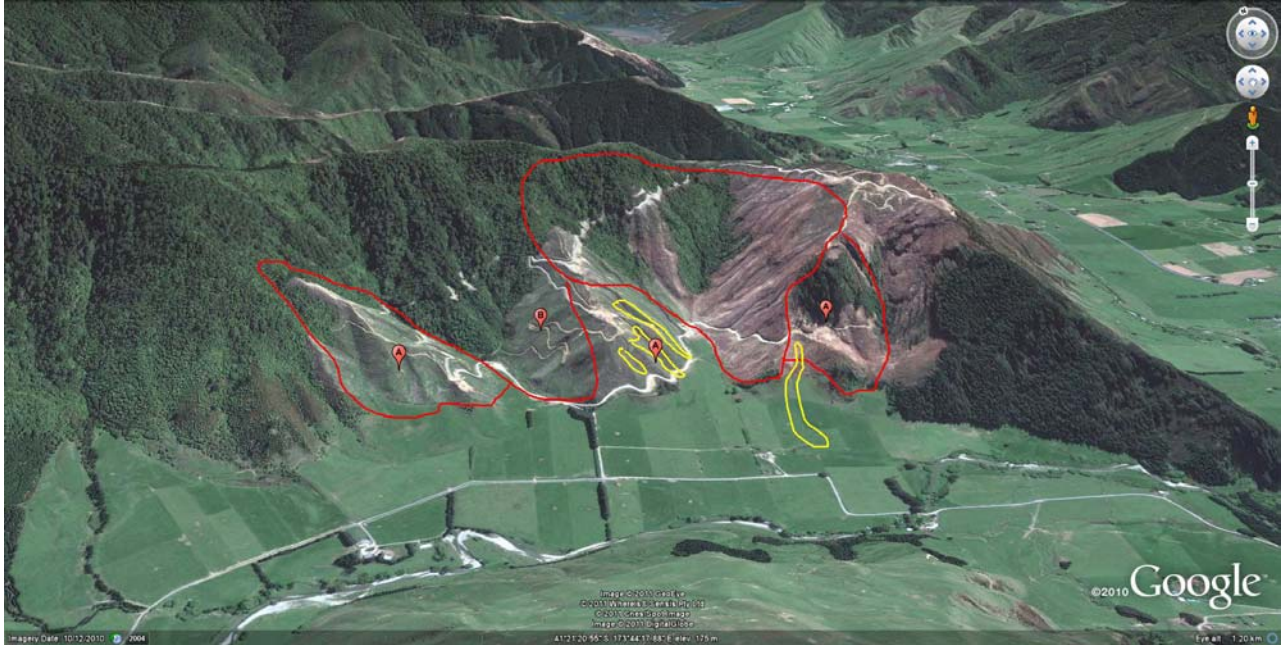
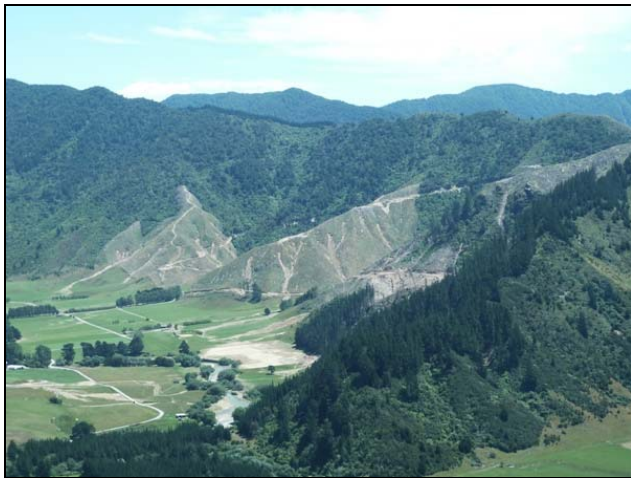
Site	Site 15 a
GPS	1661818 5421444
Land cover - a	Recently harvested
Land cover - b	Recently harvested
Type of erosion - a	2Ss 2Df
LUC Class - a	6e11
Infrastructure damage	Forestry road closure

Figure A15 Site 15 a, erosion in recently harvested pine

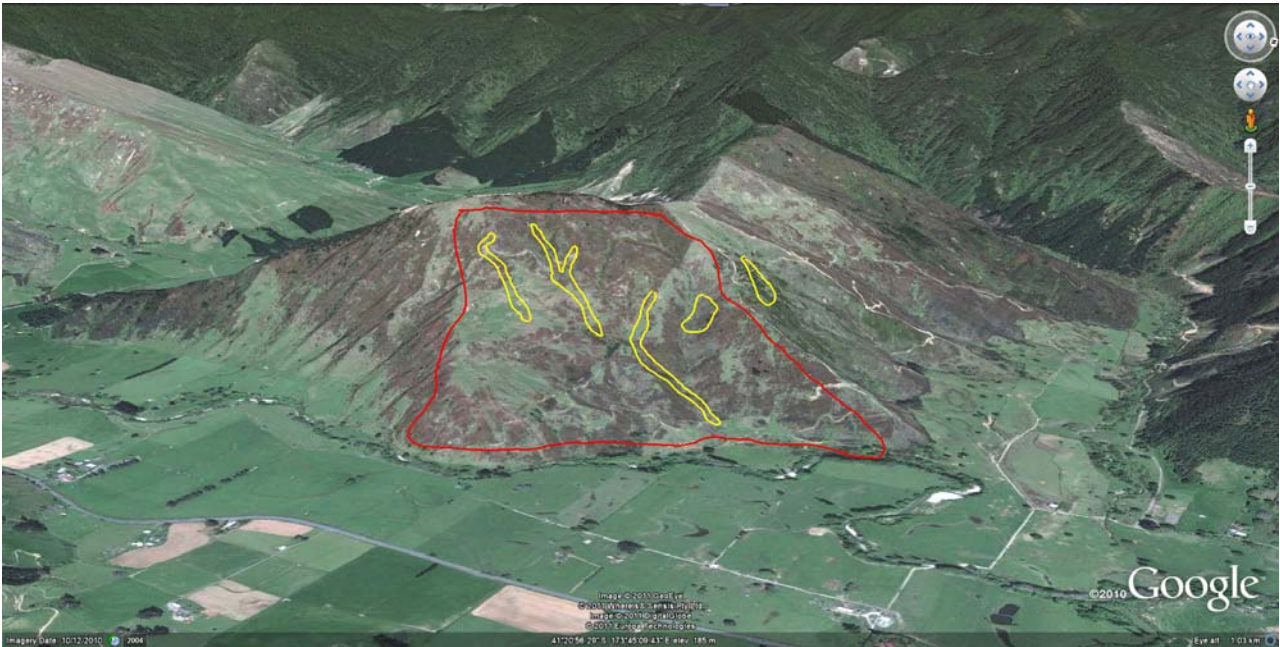
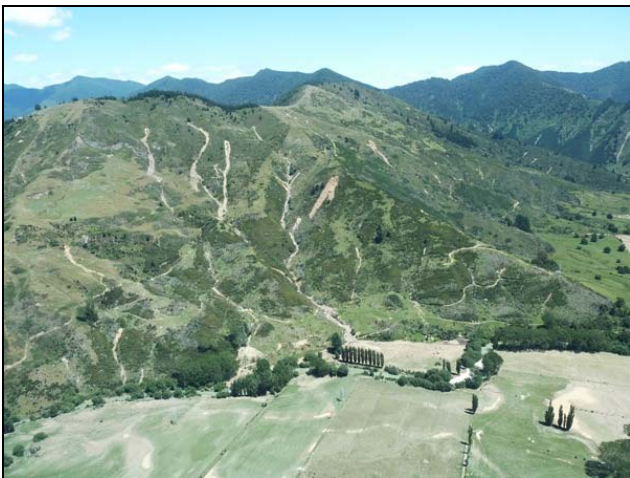
Site	Site 16
GPS	1663038 5422530
Land cover	Scrub
Type of erosion	2Ss 2Da 2Df
LUC Class	Upper part of slope 7e9 and lower part is 6e11
Infrastructure damage	None noted

Figure A16 Site 16 erosion in scrub/bush

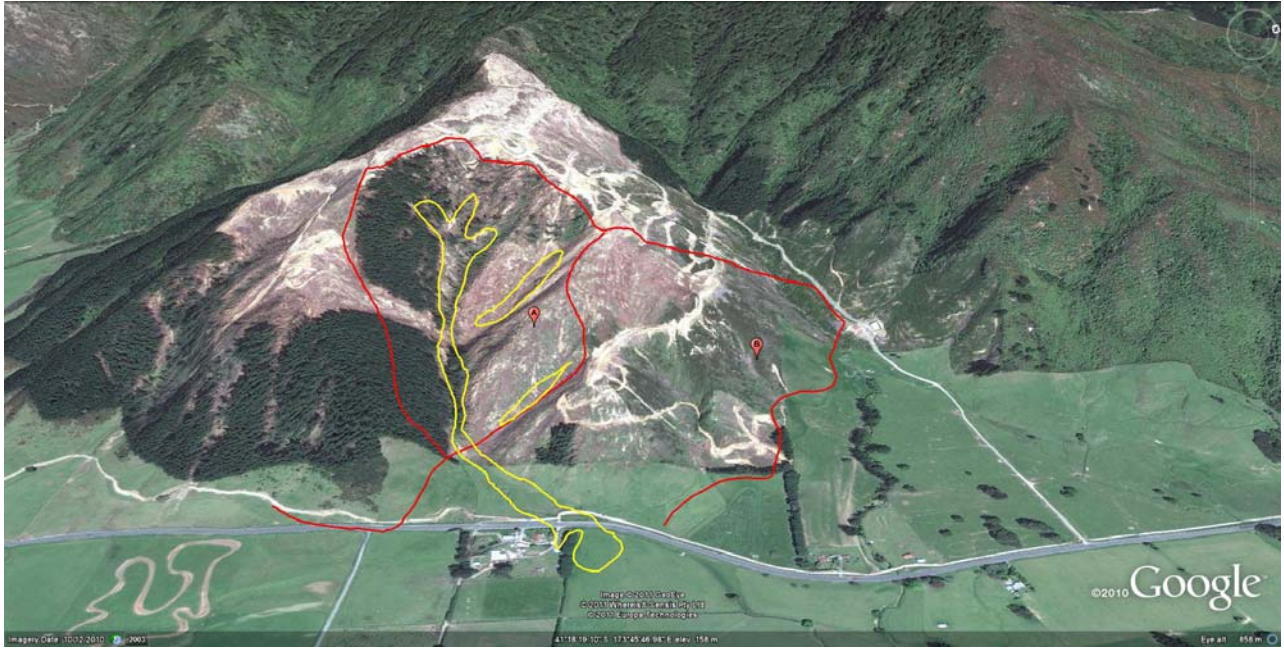
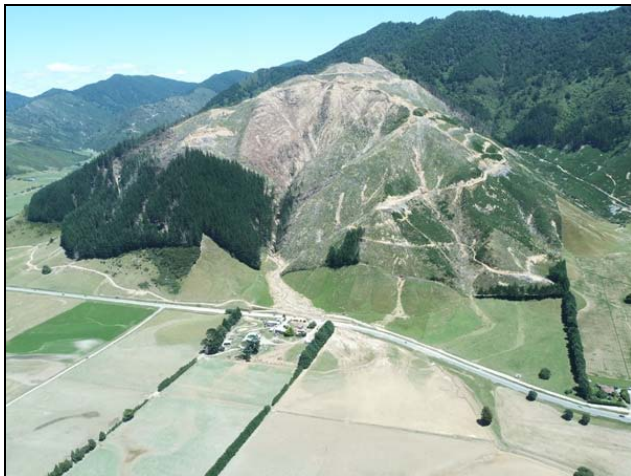
Site	Site 17 a, b
GPS	1663722 5426745
Land cover - a	Recently harvested
Land cover - b	Recently harvested
Type of erosion - a	2Ss 3Da 4Df
Type of erosion - b	2Ss 1Da
LUC Class - a	8e2
LUC Class - b	Upper part of slope 7e9 and 6e11 for lower part
Infrastructure damage	Public road closure; property damage

Figure A17 Site 17 a, b erosion in recently harvested pines

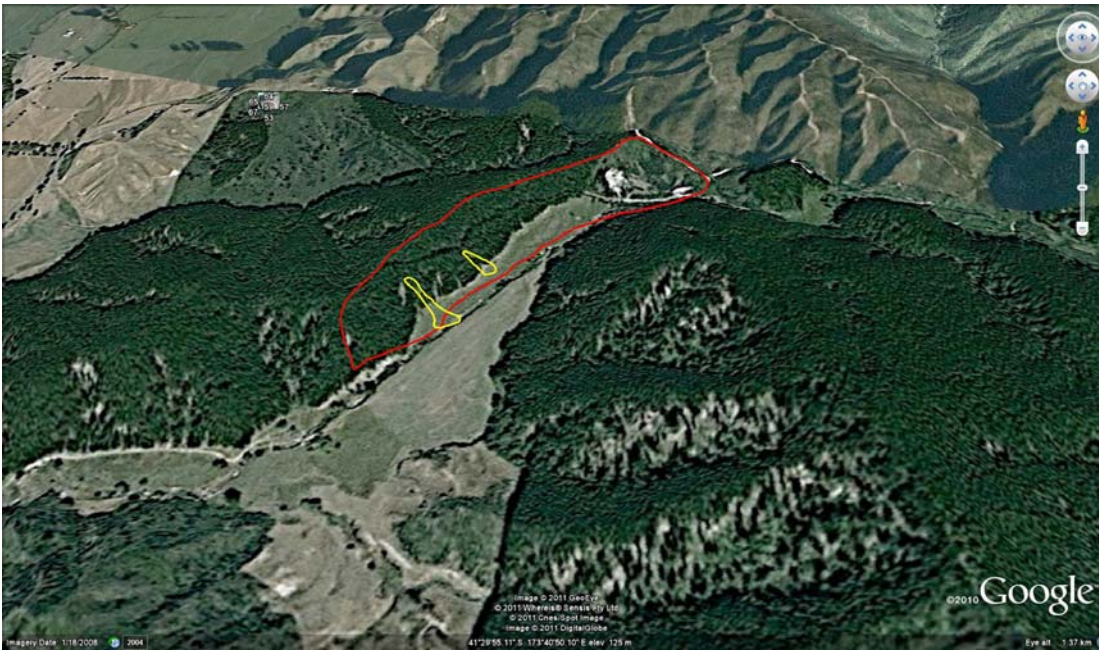
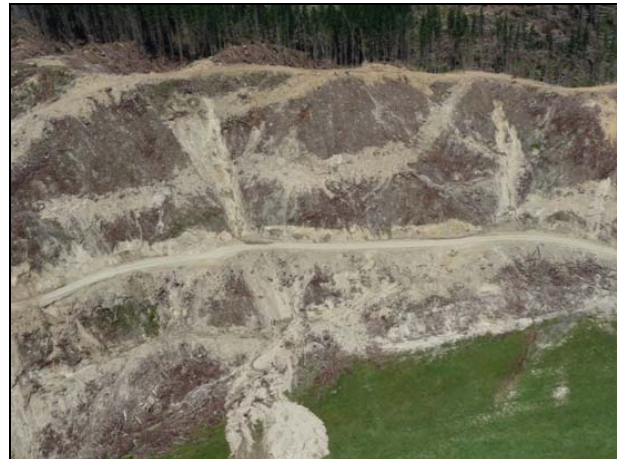
Site	Site 18
GPS	1656715 5426745
Land cover	Recently harvested
Type of erosion	2Ss 3Da 3Df
LUC Class	6e11
Infrastructure damage	None noted

Figure A18 Site 18 erosion in recently harvested pines

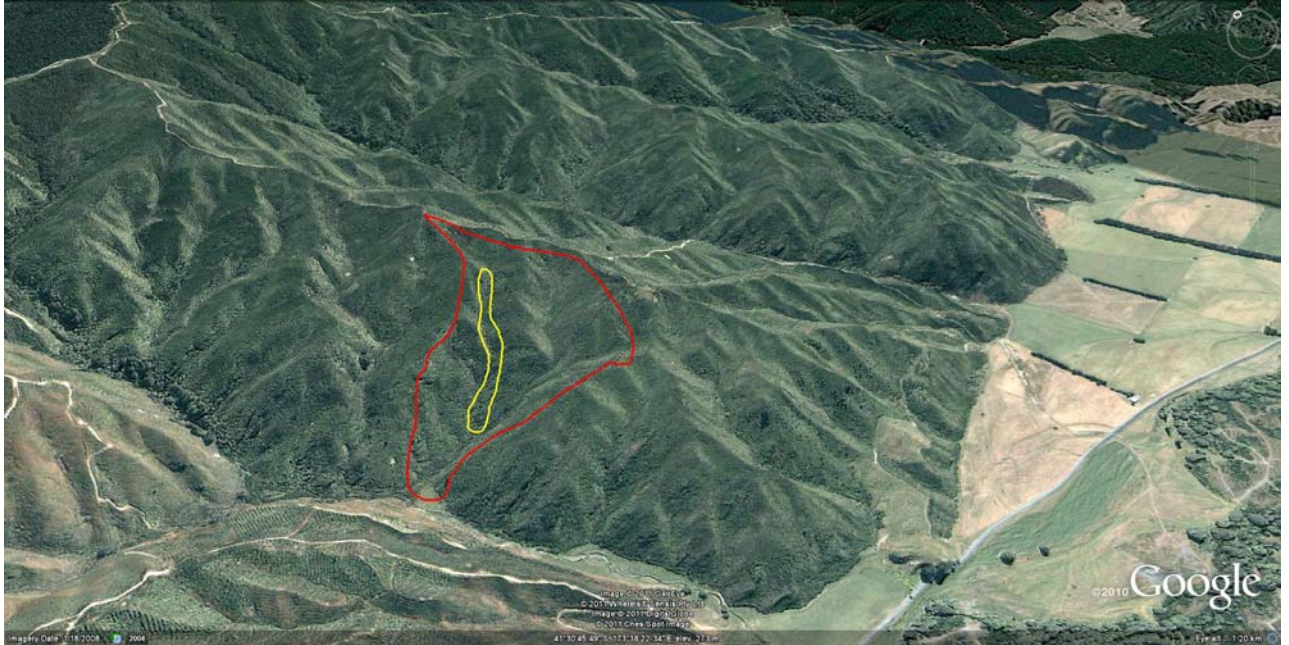
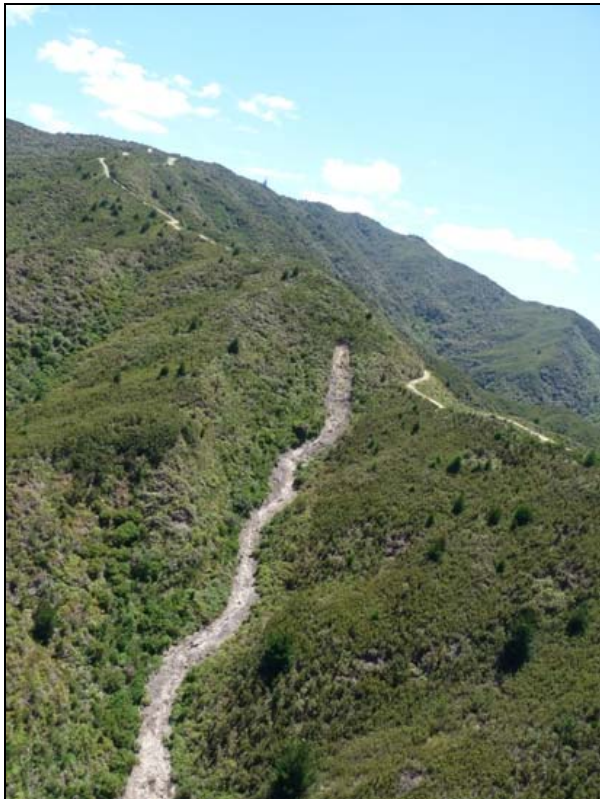
Site	Site 19
GPS	1653036 5404685
Land cover	Scrub
Type of erosion	1Da 1Df
LUC Class	7e9
Infrastructure damage	None noted

Figure A19 Site 19 erosion in scrub/bush

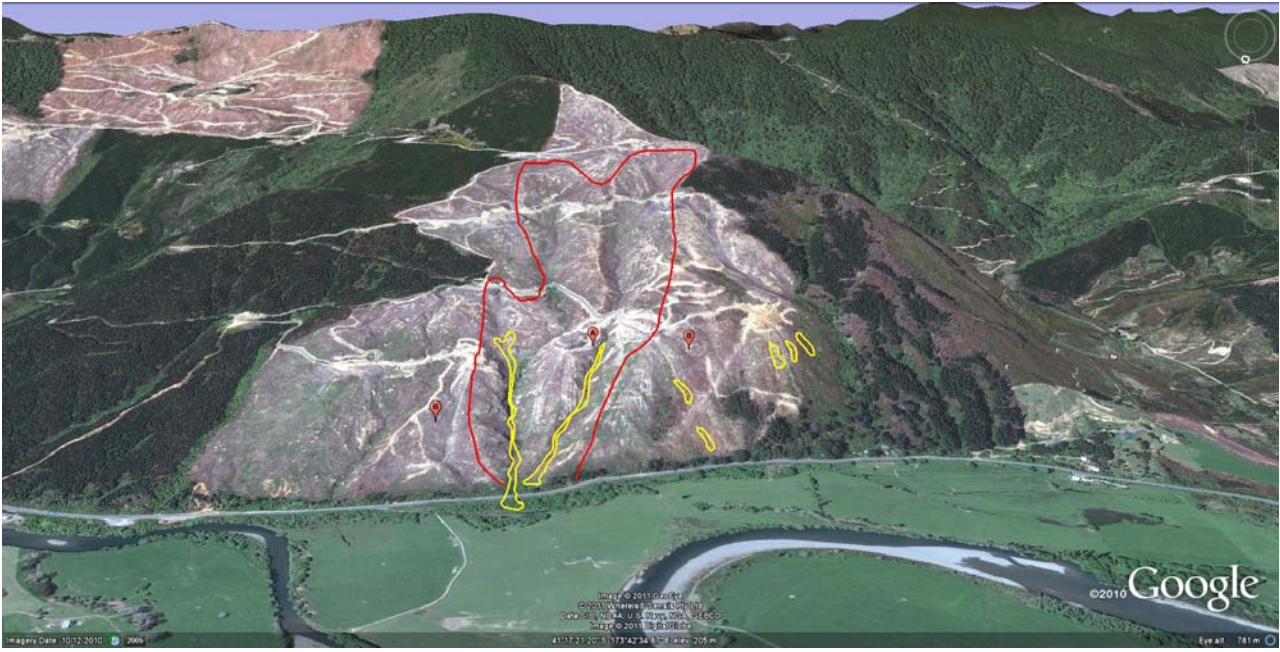
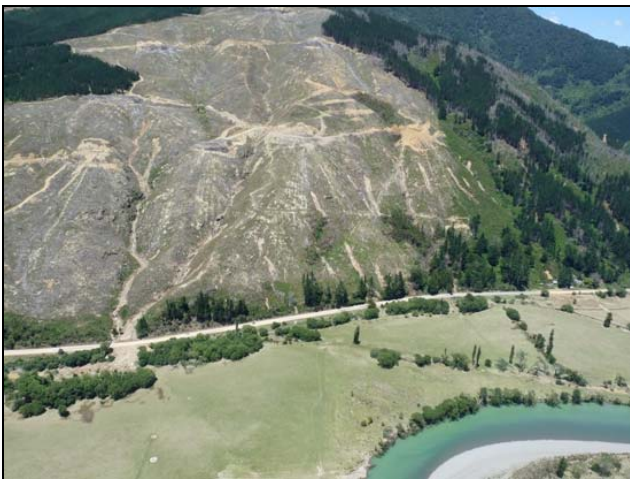
Site	Site 20 a, b
GPS	1659535 5429238
Land cover - a	Recently harvested
Land cover - b	Recently harvested
Type of erosion - a	3Ss 2Da 2Df
Type of erosion - b	2Ss 3Da
LUC Class - a	7e9
LUC Class - b	7e9
Infrastructure damage	Public road closure

Figure A20 Site 20 a, b erosion in recently harvested pines

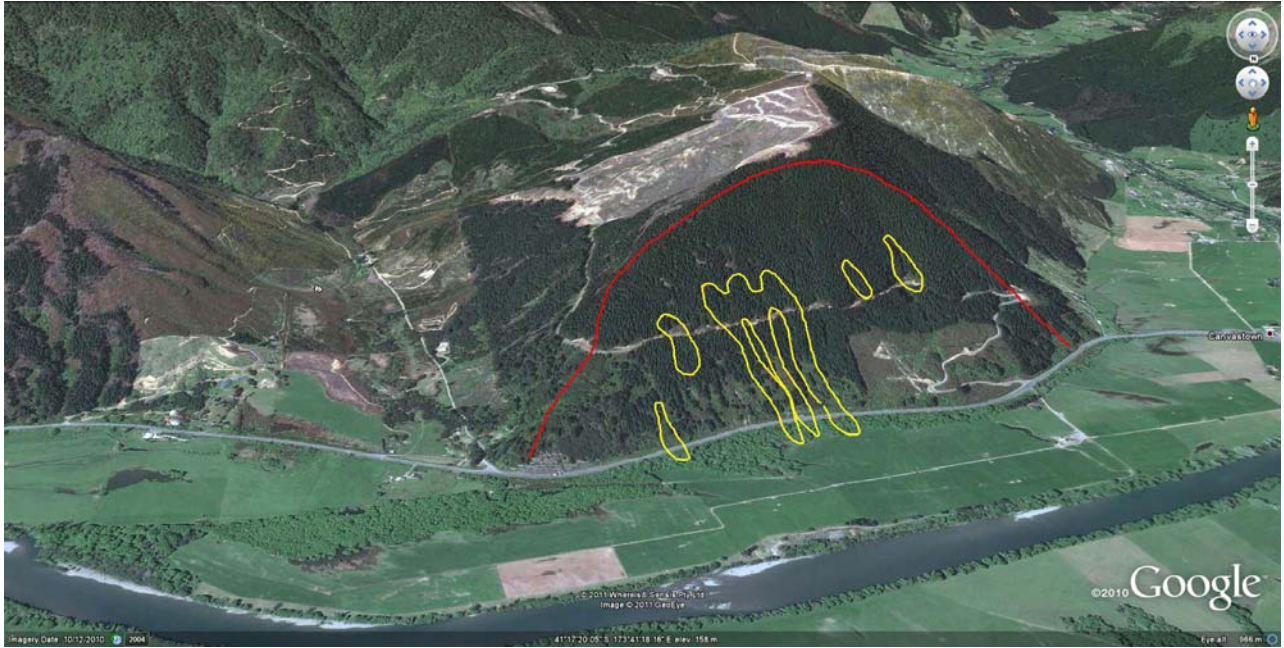
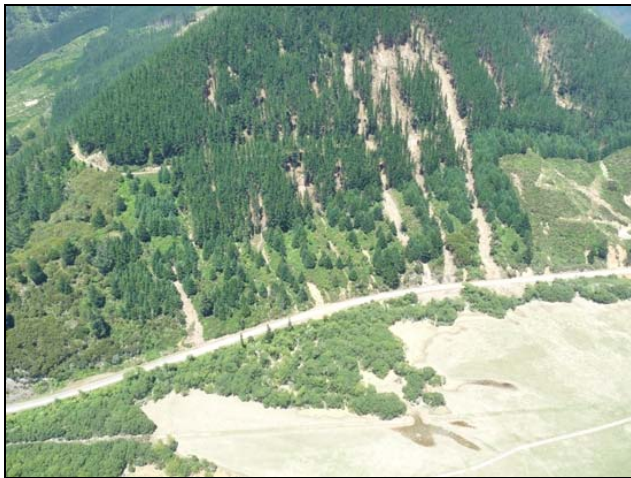
Site	Site 21
GPS	1657366 5428870
Land cover	Pines > 10 years
Type of erosion	3Ss 4Da
LUC Class	8e2 above forestry road but 7e9 below forestry road
Infrastructure damage	Pubic road closure

Figure A21 Site 21 erosion in pines <10 years
