# Some Observations of Erosion as a Result of the 28 December 2010 Storm Event

Technical publication No 11-024

June 2011

**MARLBOROUGH**  
DISTRICT COUNCIL

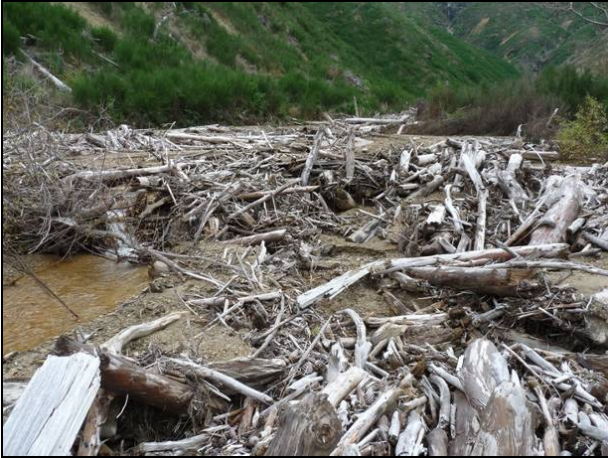
Figure 5 Pine debris and sediment deposited in the stream bed

In places the sediment and logs that had been deposited in the stream bed were in excess of 1.5 metres deep. When the slipping occurred, the sediment and debris that entered the stream would have killed all fish and macroinvertebrate life present at that point in time. Since the deposition event a new stream channel has formed in the surface of the deposited material. The substrate of the stream is now a mixture of fine gravels and silt with very few larger cobbles and boulders (Figure 6).

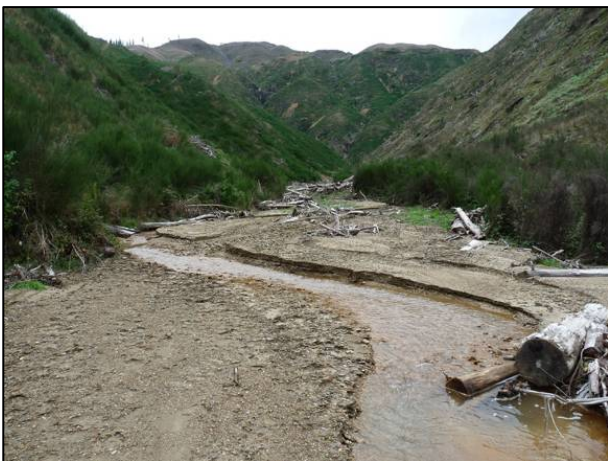
Figure 6 New stream channel has formed in the surface of the deposited material

Iron bacteria smother the bed of the stream below the confluence of the valley where the skid site failure occurred. This has further reduced the habitat availability. The source of the iron that allows the iron bacteria to flourish is unknown. However, it is assumed to be from naturally occurring iron deposits that have been exposed by large boulders from bedrock outcrops which have been dislodged by the movement of logs and debris down the stream.

There is no sign of instream life in the stream below the confluence of the valley where the skid site was sited. However, above the confluence mayfly and caddis fly larvae are present. As the large mass of logs that are in the water and sediments decay they will consume oxygen from the water and it is envisaged that there will be large fluctuations in oxygen concentrations in the stream until the breakdown of the logs is complete.
