Phase II: Remote mapping of landslides triggered by the July 2021 and August 2022 Marlborough storms, and selected field investigations of landslide impact

**GNS Science Report 2023/20
July 2023**

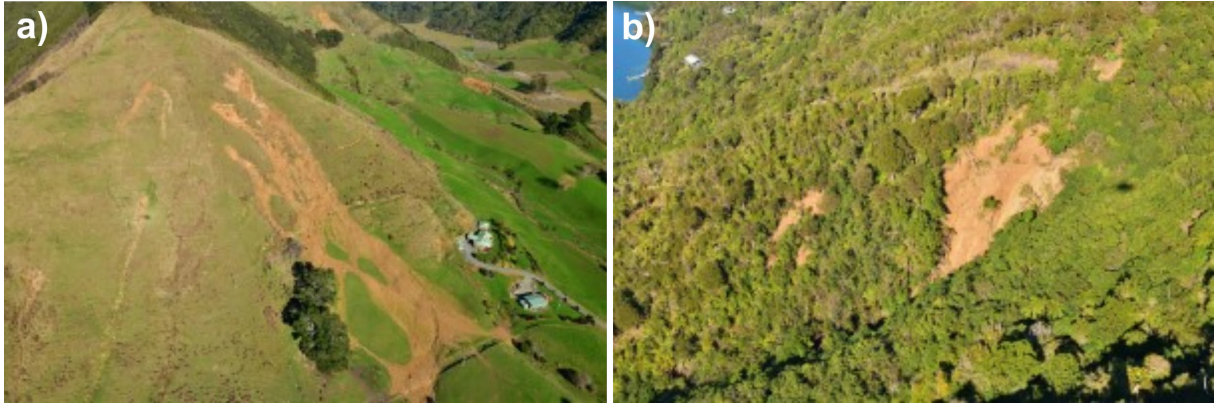
Figure 3.1 Examples of landslides from the reconnaissance flight: (a) shallow soil and debris flows and (b) deeper-seated slide triggered on an existing relict landslide.

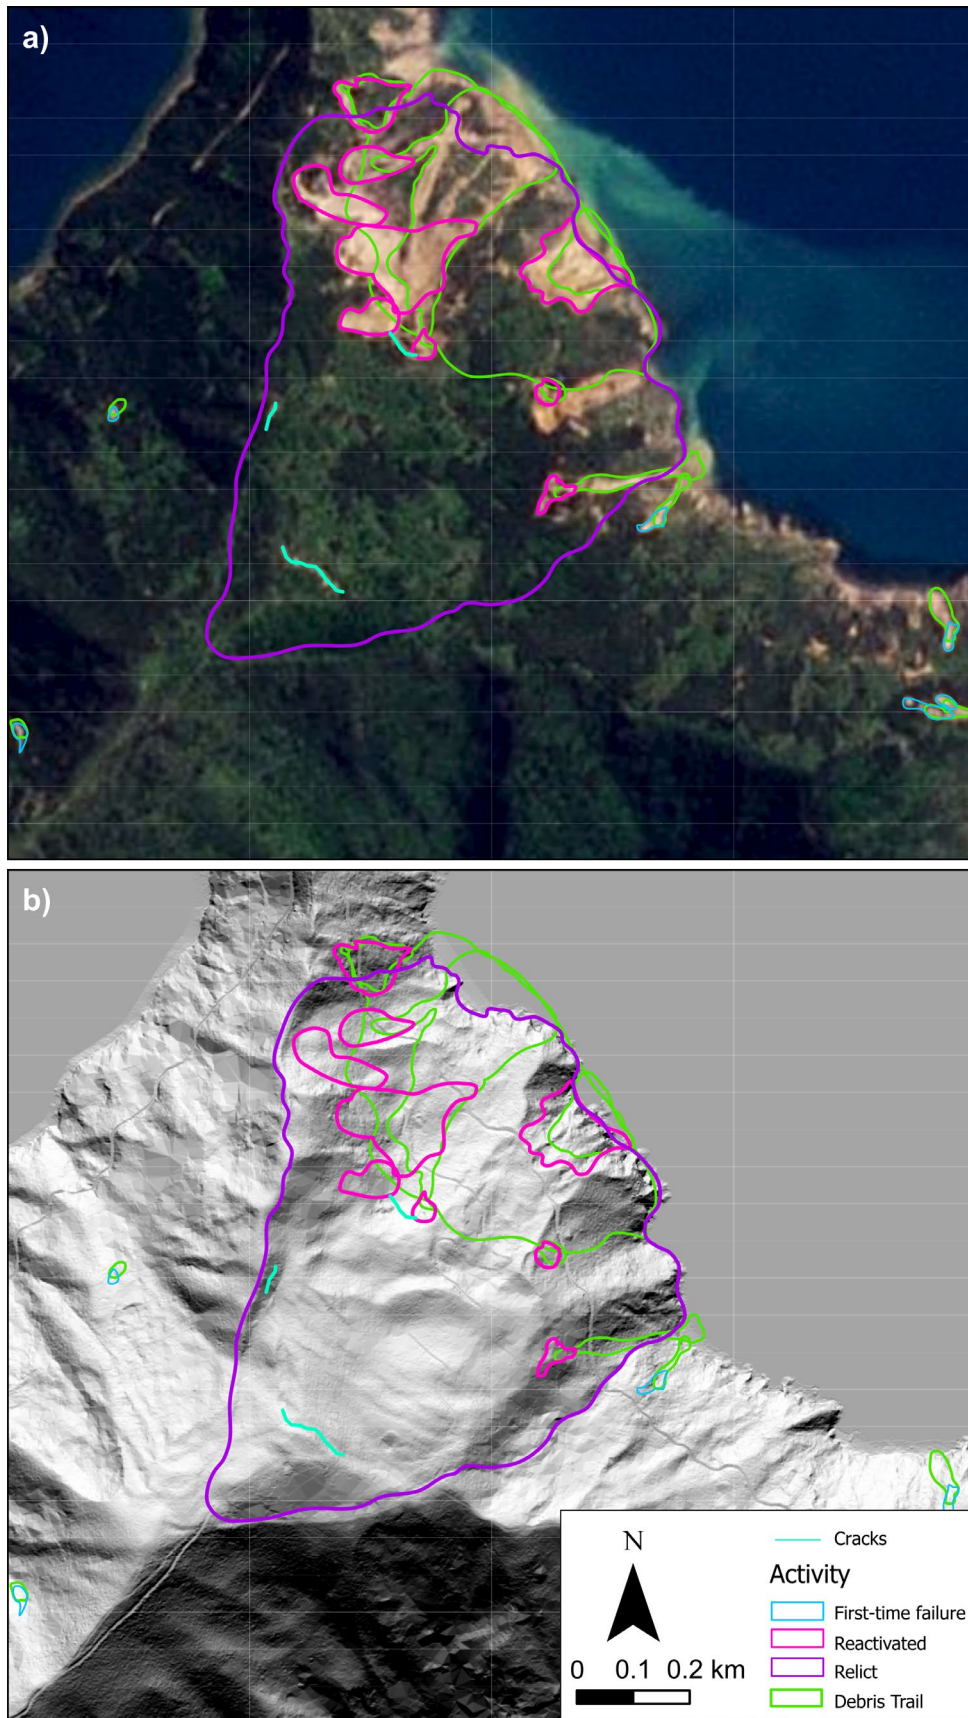
Figure 3.2 Example of a relict landslide on Forsyth Island that re-activated during the August 2022 storm event. (a) Post-storm Planet imagery showing mapped landslide polygons. (b) Landslide polygons from (a) overlaid onto the pre-event LiDAR. Note that the recent landslide debris polygons extend out into the sea compared to the pre-event imagery and LiDAR, indicating that debris has extended the coastline in some places. The area of the relict landslide is $\sim 300,100 \text{ m}^2$, and the area of the re-activated landslides is about $110,000 \text{ m}^2$.

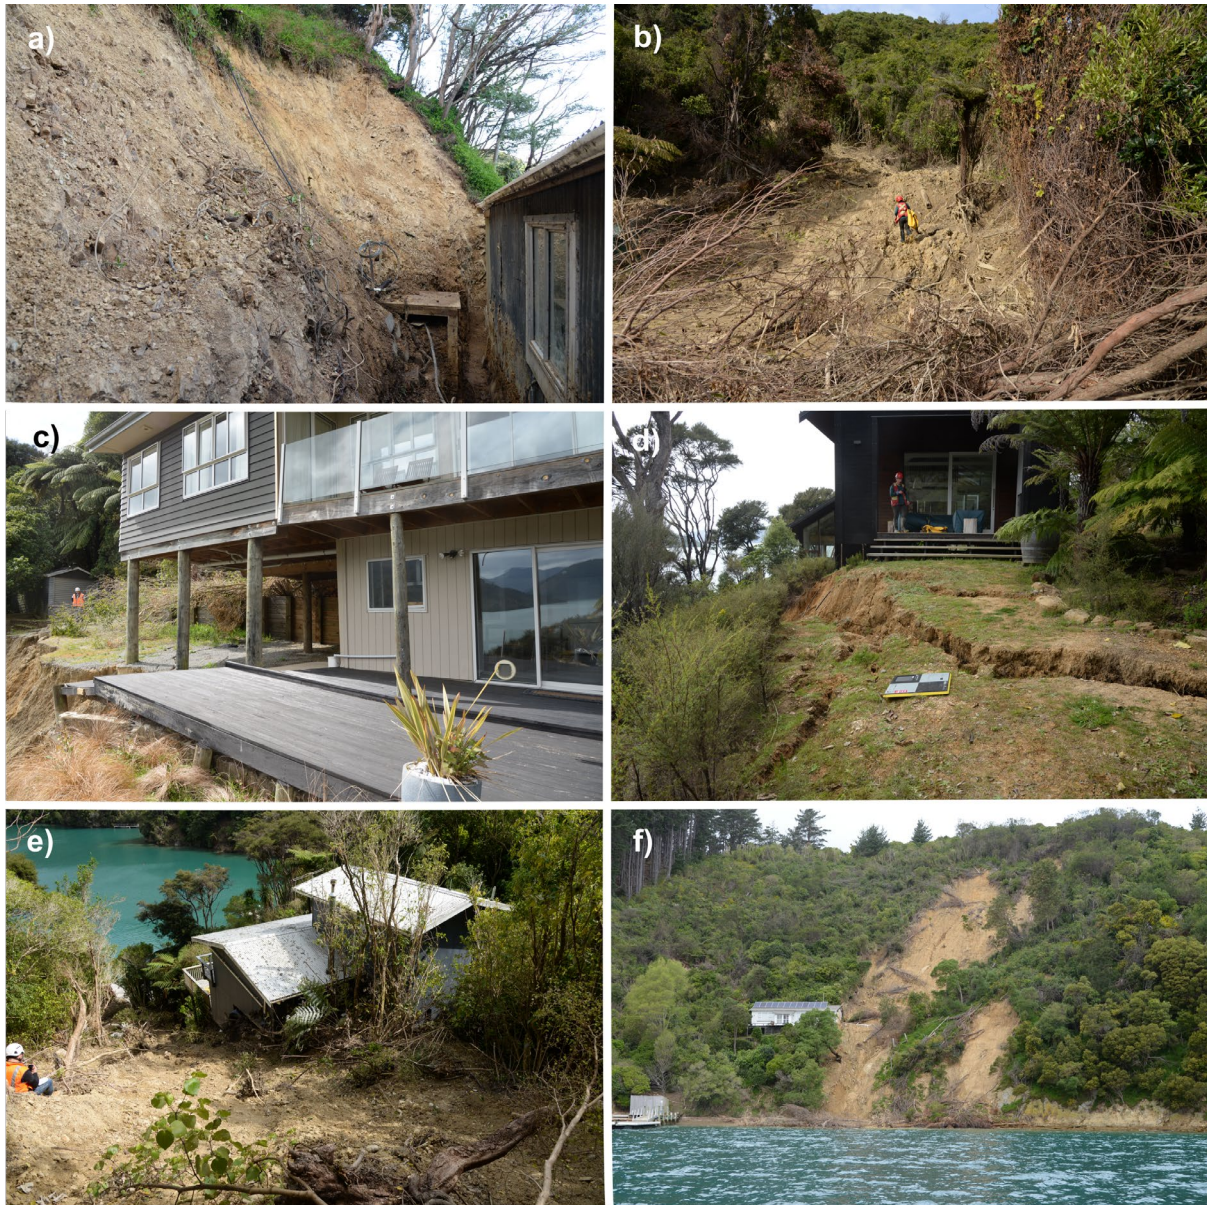
Figure 4.3 Examples of landslides visited during field investigations. (a) A debris spread/flow that impacted the back of a home; debris had been cleared by the time we visited (landslide ID 22-1). (b) The debris trail of a debris flow/flood, looking up towards the source and showing woody debris and the landslide material (22-2). (c) An example of slippage undermining a house (22-3). (d) Ground cracking at the source of a debris slump/slide (22-6). (e) Source area looking down the debris trail of a debris slump/flow (22-8). (f) Debris avalanche on very steep slope (22-9).

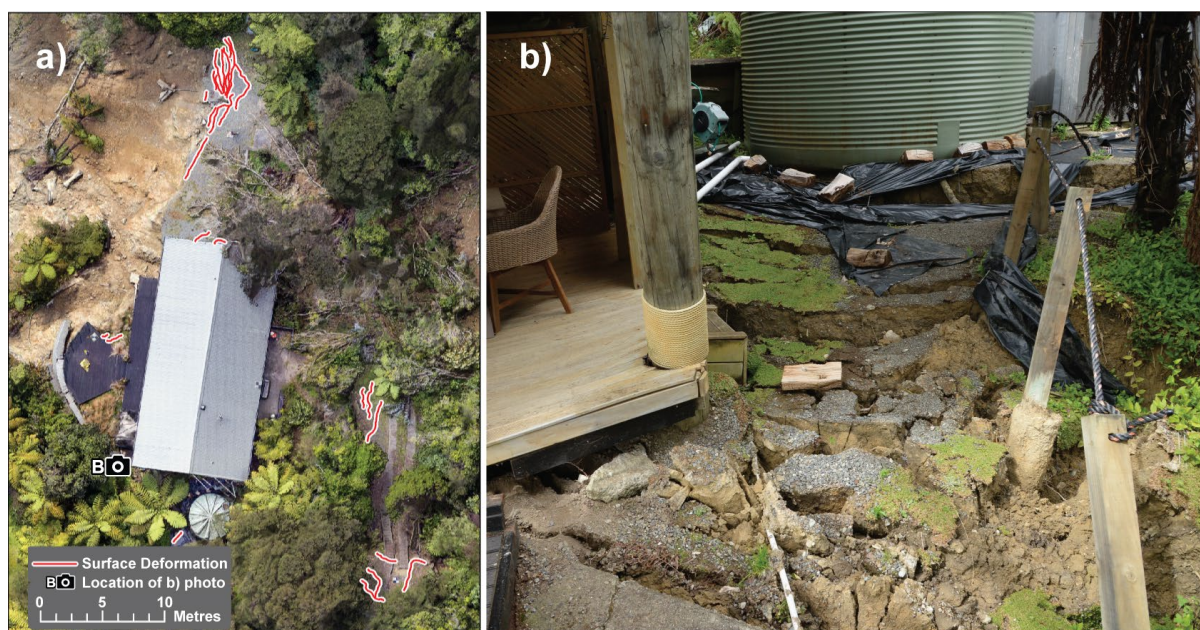
Ground cracking at and above landslide headscarps indicated incipient and ongoing slope instability – more material could mobilise in future. Ground cracks were a maximum of 10 m long and open a maximum of 0.5 m wide. See Figure 4.4 for an example of ground crack (surface deformation) mapping.

Figure 4.4 Example of surface deformation (cracking) at LS 22-3. (a) Location of cracks mapped from orthomosaic photos. (b) Extensive cracking obscured from the orthomosaic by vegetation.

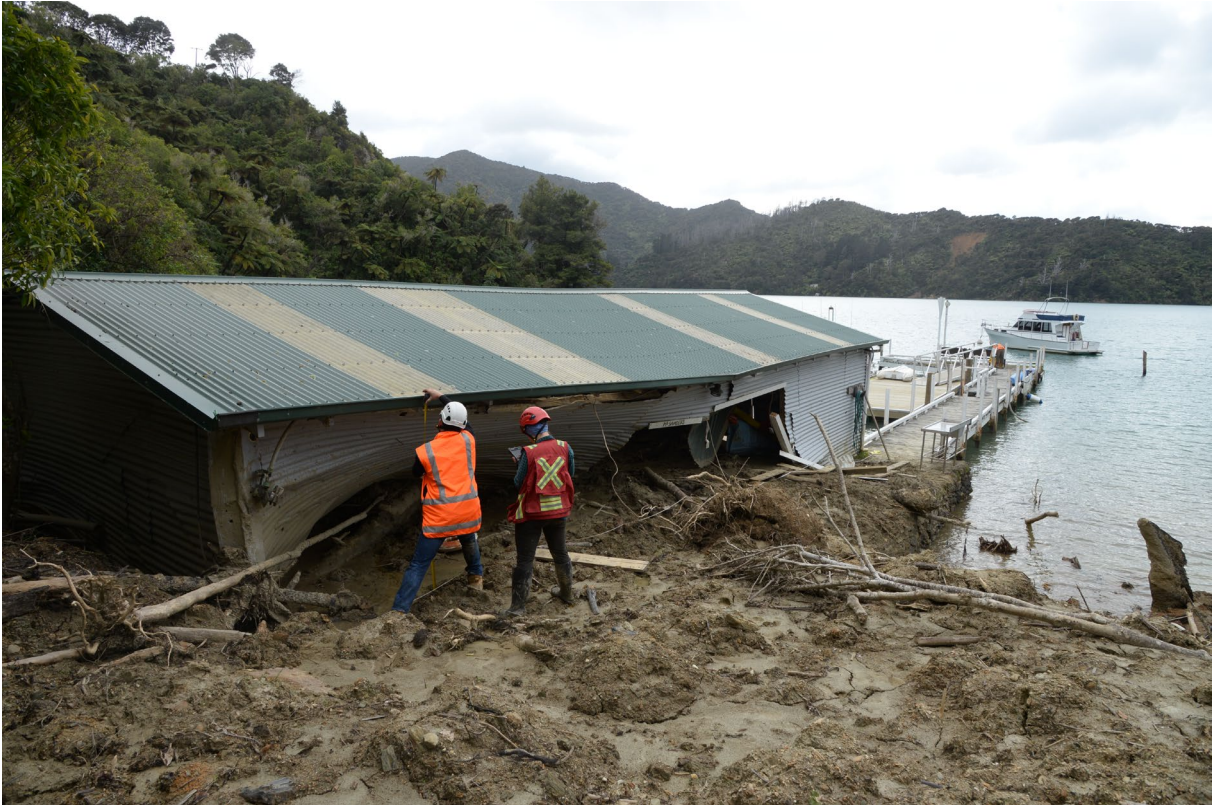
Figure 4.5 Inspecting and assessing structural damage to a boatshed impacted by a debris flow.

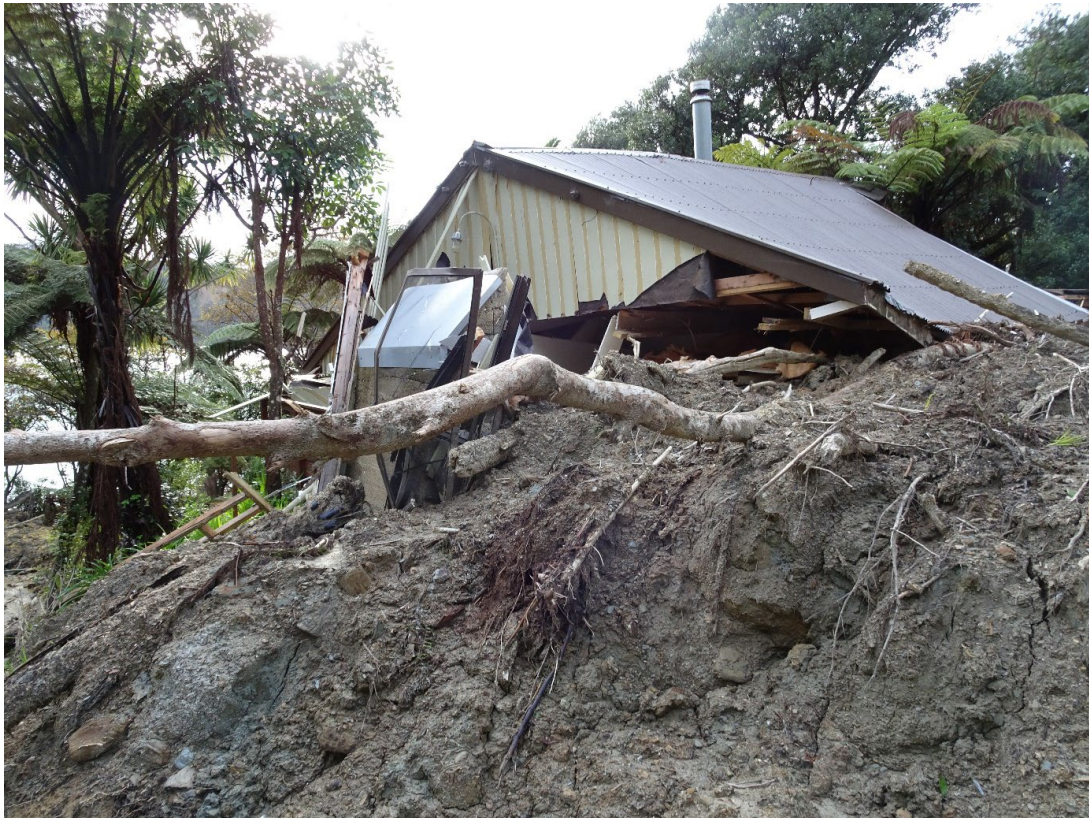
Figure 5.4 Damage to a building from large debris flow.

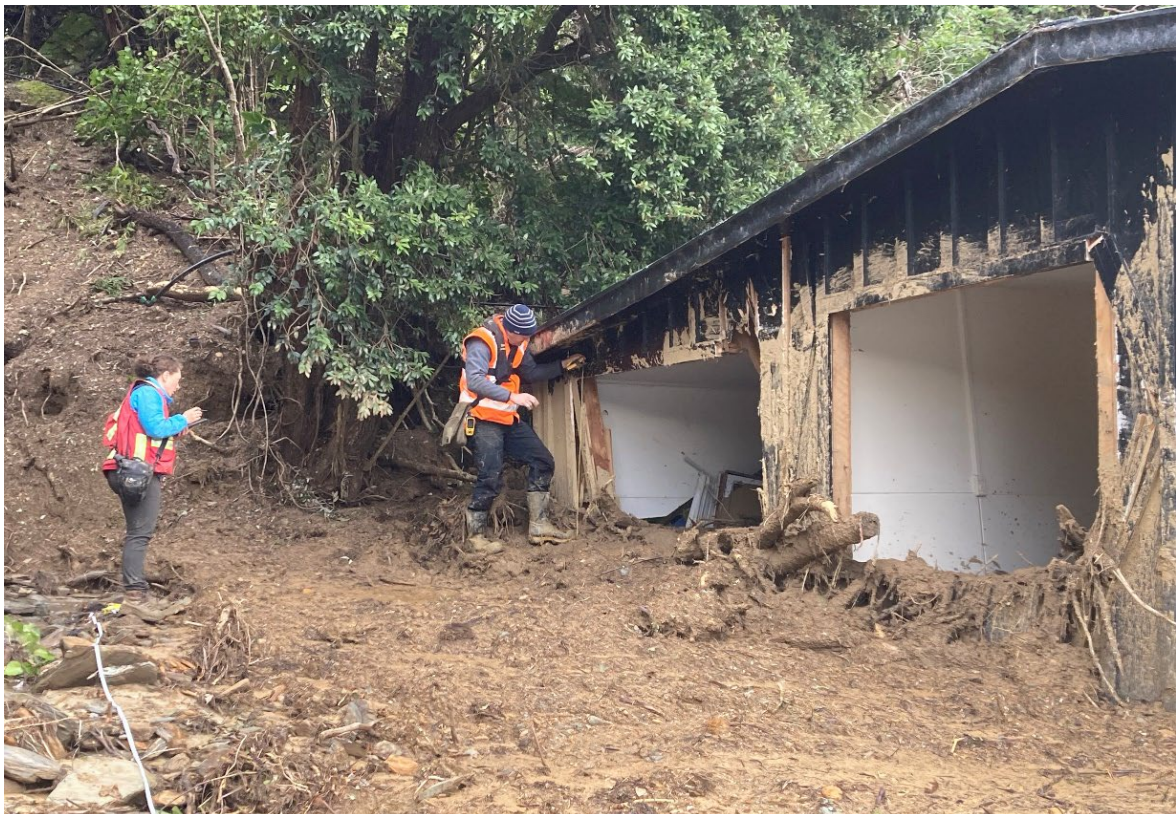
Figure A3.2 Surveying of landslide debris; measuring inundation along building side. We measured maximum run-up signs (here, above the building windows) not the height of the debris at the time of survey (here, at the base of the windows).

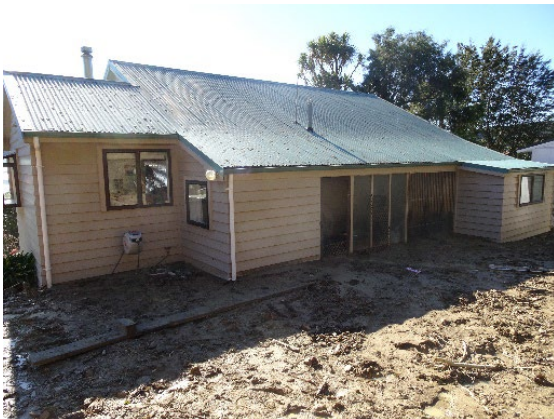
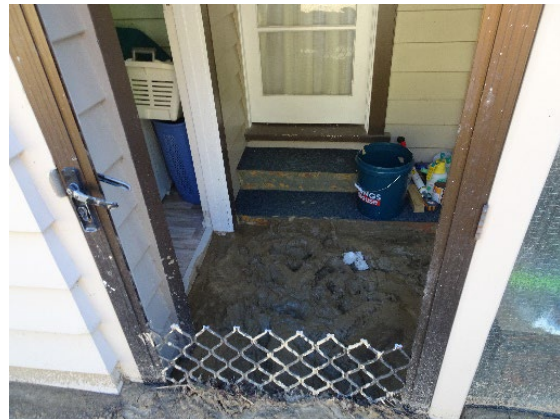
DS1 – Insignificant: Minor non-structural damage

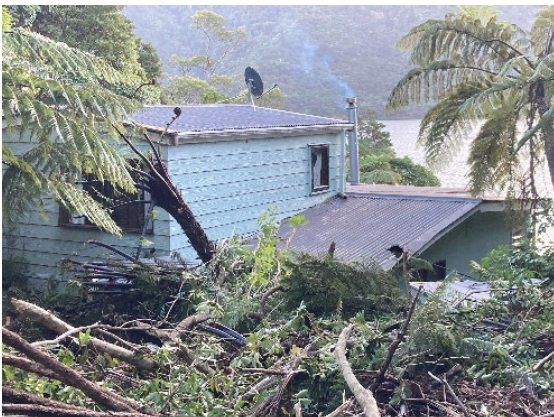
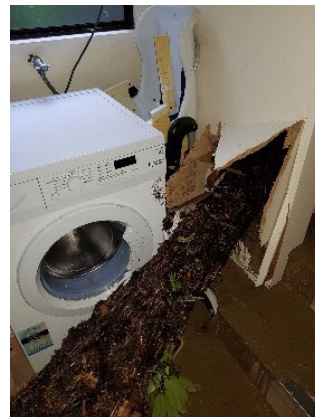
DS2 – Light: Non-structural damage only

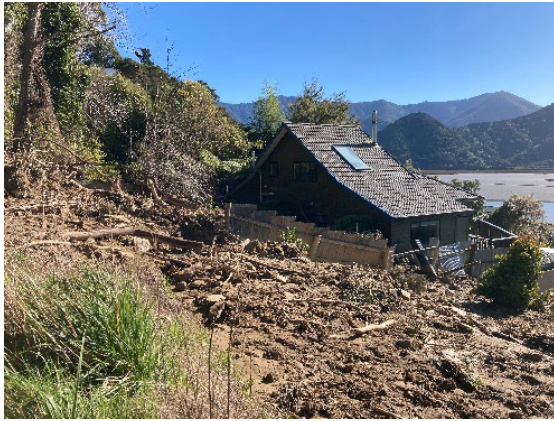
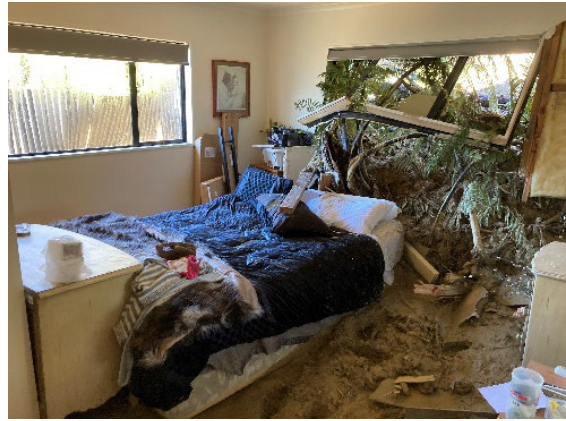
DS3 – Moderate: Repairable structural damage

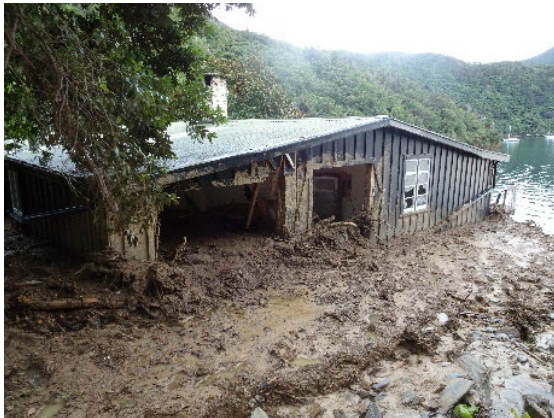
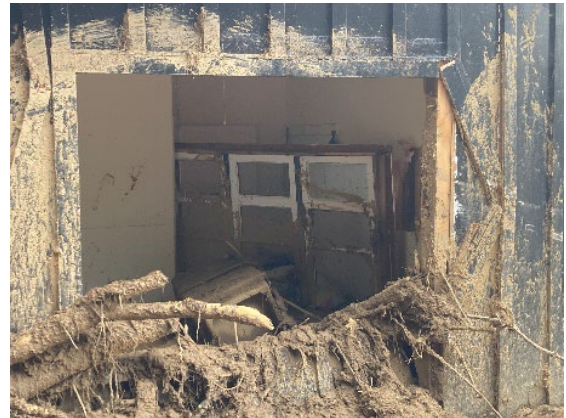
DS4 – Severe: Irreparable structural damage

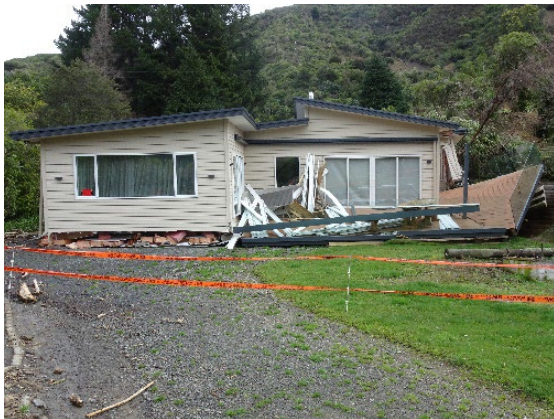
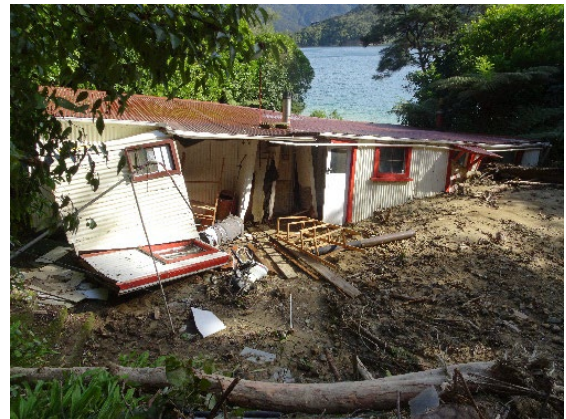
DS5 – Critical: Structural integrity fails

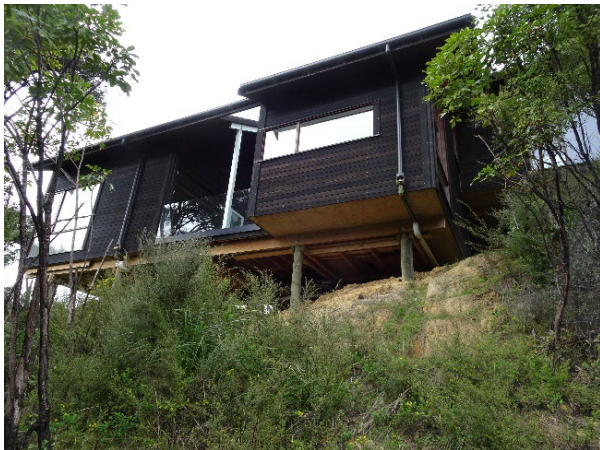
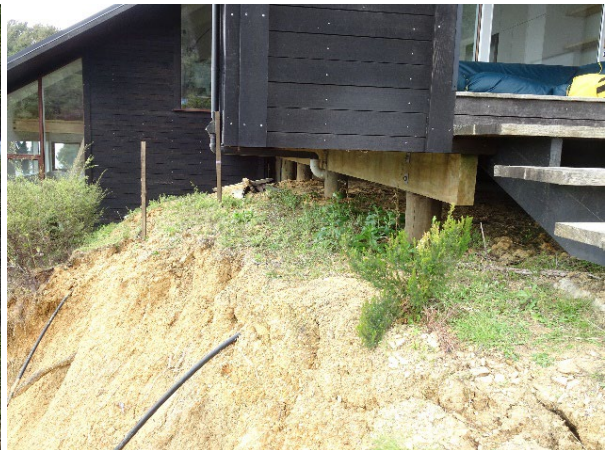
DS0 – None: No damage

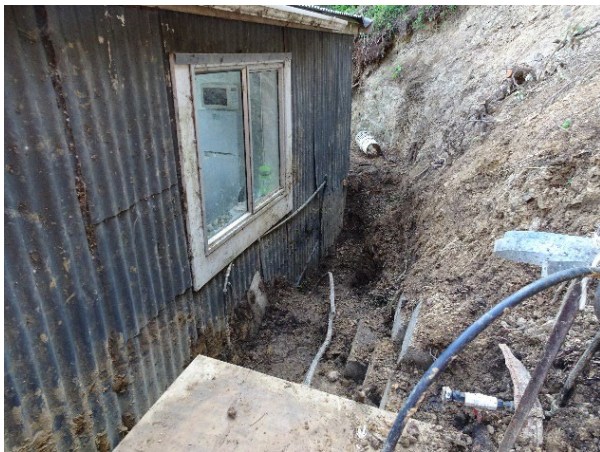
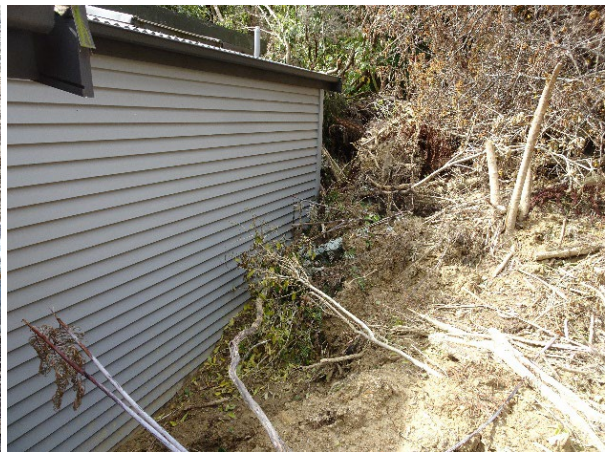
DS1 – Insignificant: Minor non-structural damage

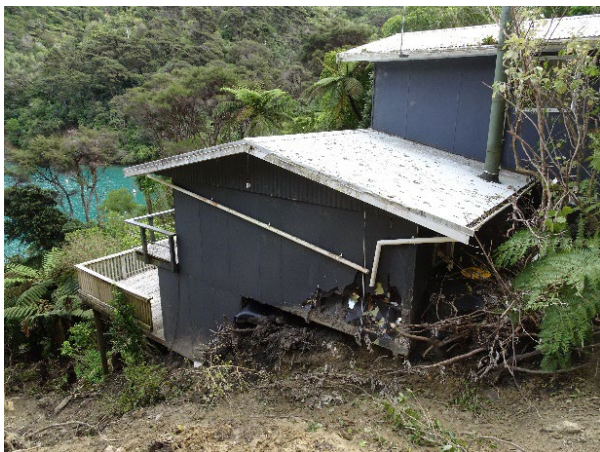
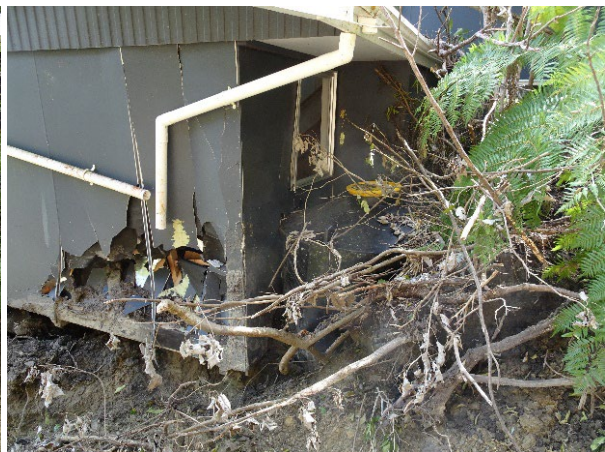
DS2 – Light: Non-structural damage only

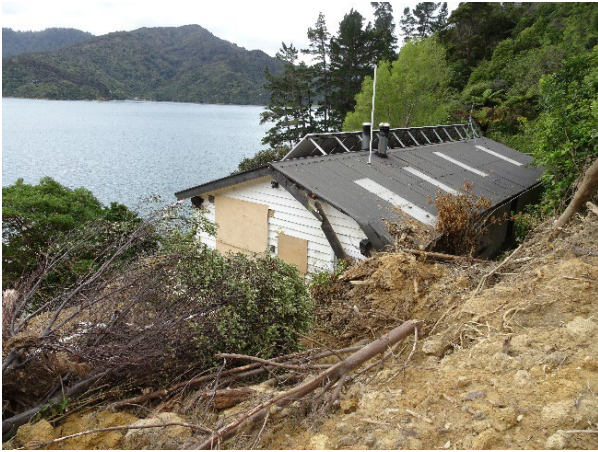
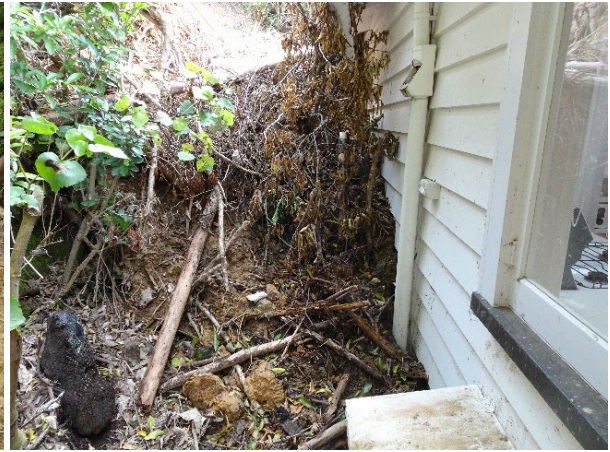
DS3 – Moderate: Reparable structural damage

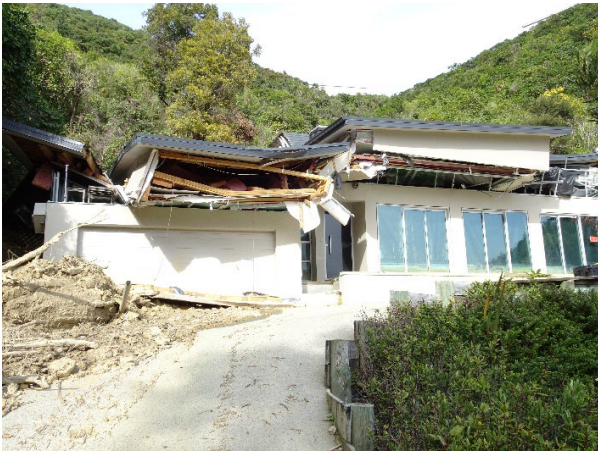
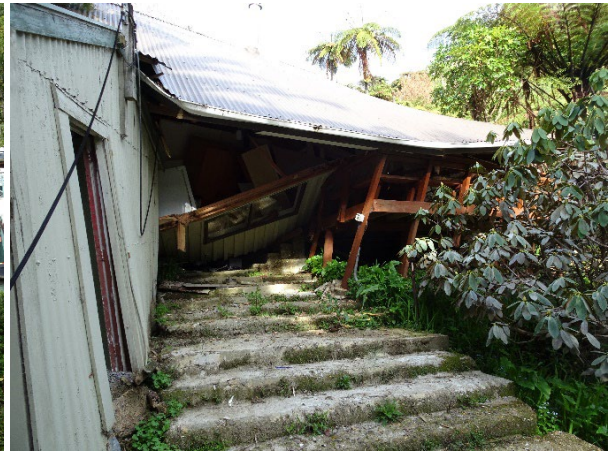
DS5 – Critical: Structural integrity fails
