Storm event

FRIDAY, 29 OCTOBER 2021

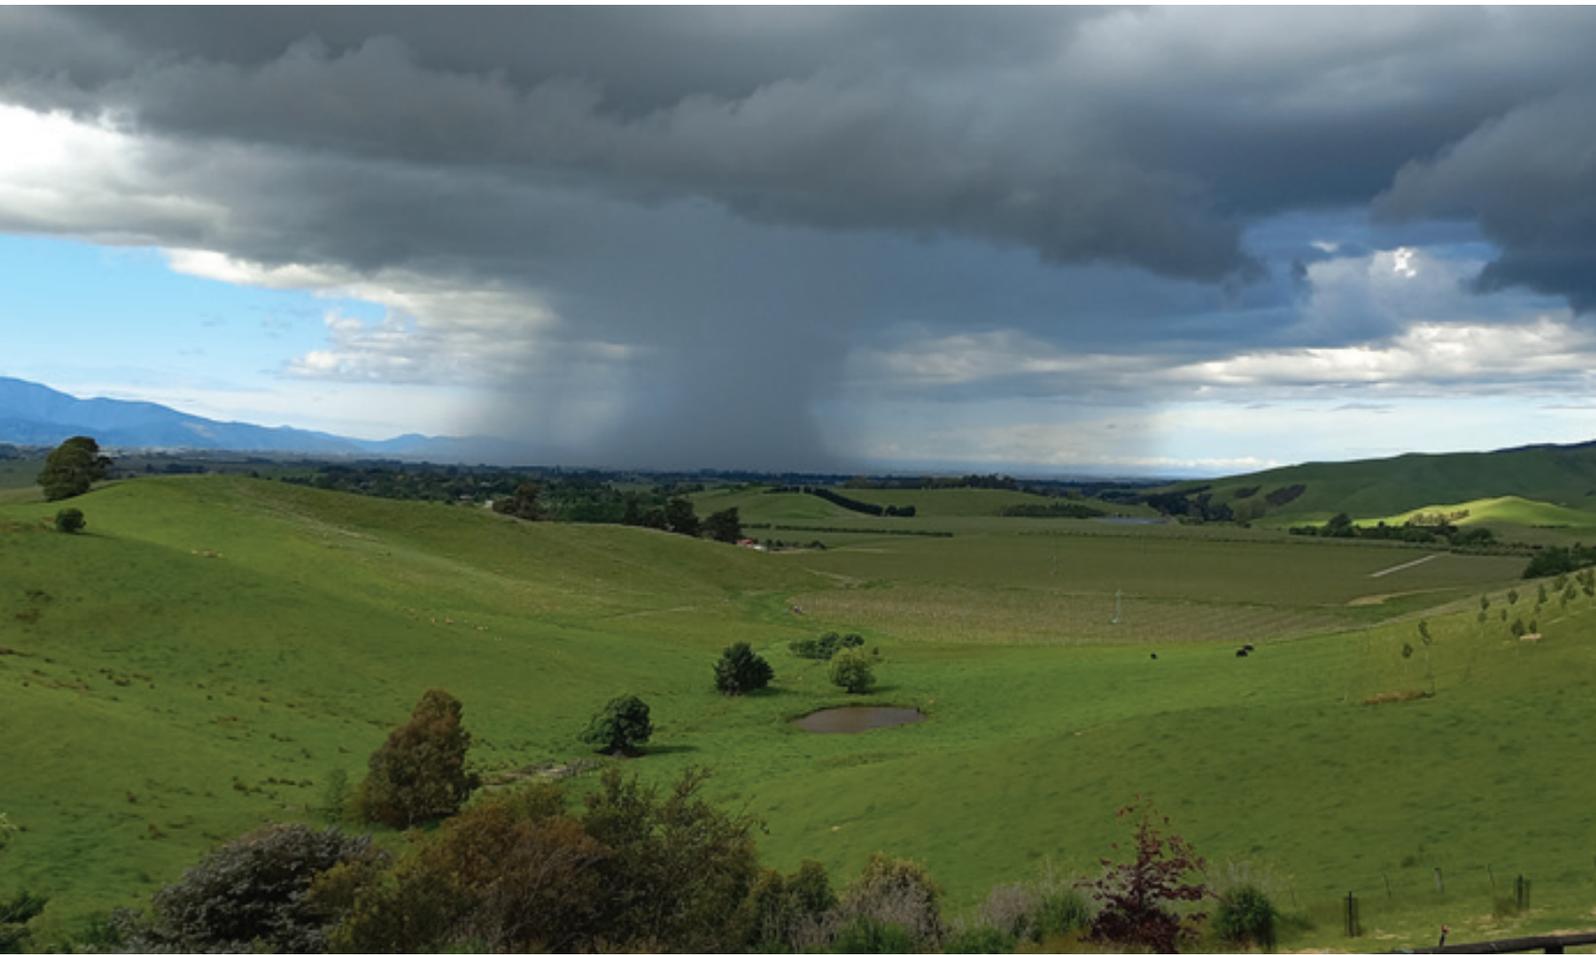
This photo clearly shows the start of the event over central Blenheim

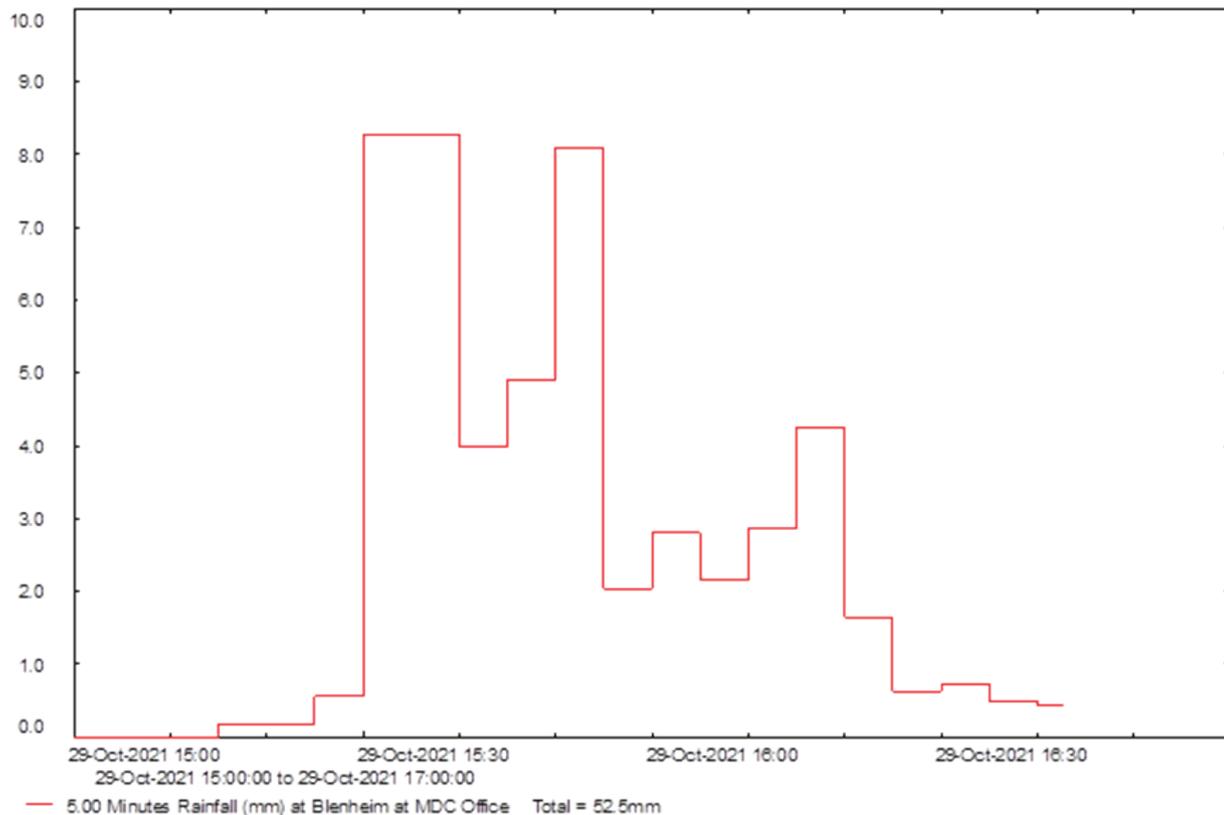
The following graph shows the 5 min intensities for the duration of the event.

Note the time scale is not in daylight saving time so is showing the time as an hour early.

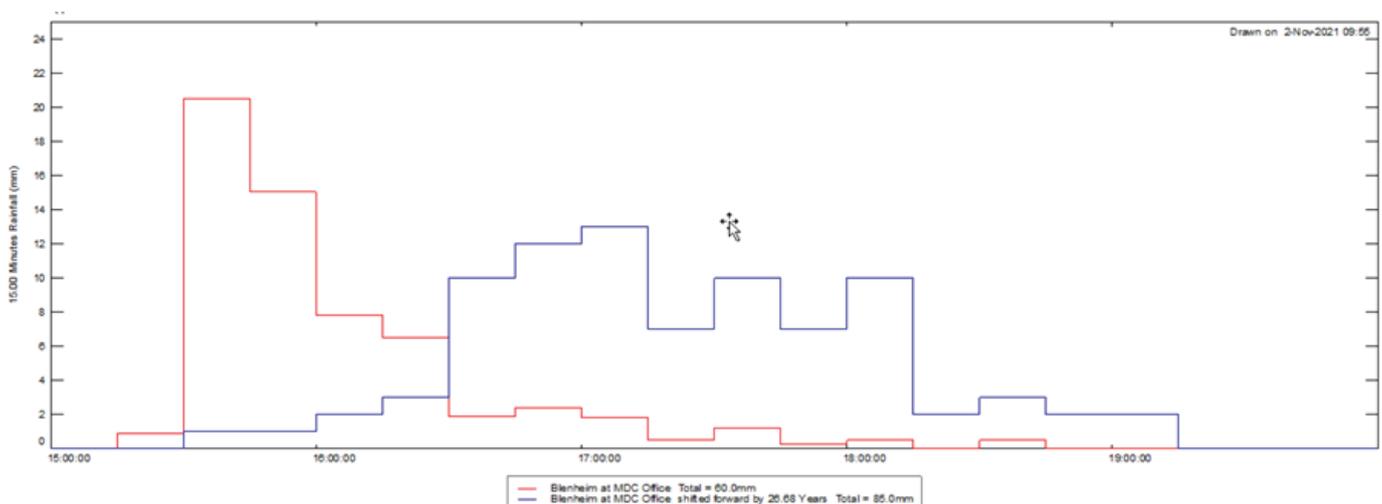
The last event that affected the CBD like this was in February 1995, the following is a comparison of the rainfall for the two events. Red is Oct 21 and blue is Feb 1995. Note this data is in 15 min intervals, not 5 min as in the previous graph.

There was a total of 85 mm in the Feb 1995 event, but with intensities that were “lighter”.
