## **Report to Council's Environment Committee – 16 February 2016**

### **Inventory of slips from Sounds roads into coastal waters**

## **SOME IMPACTS OF ROADING AND FLOOD DAMAGE ON SOUNDS ROADS**

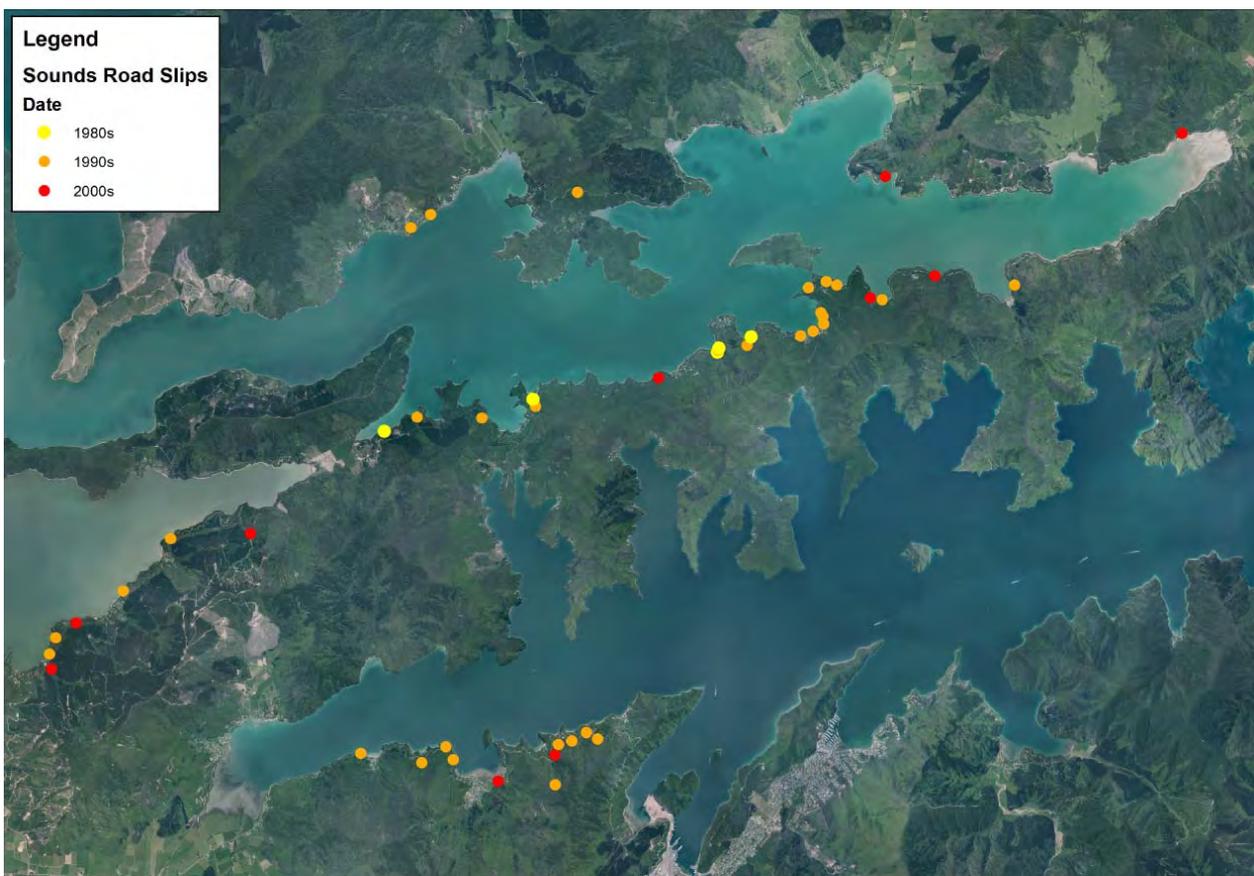
**Figure 1:** Slips that entered coastal waters associated with the transport road network on Queen Charlotte Drive (bottom centre – 12 dots) and the Kenepuru Road. Source Miller 2015.

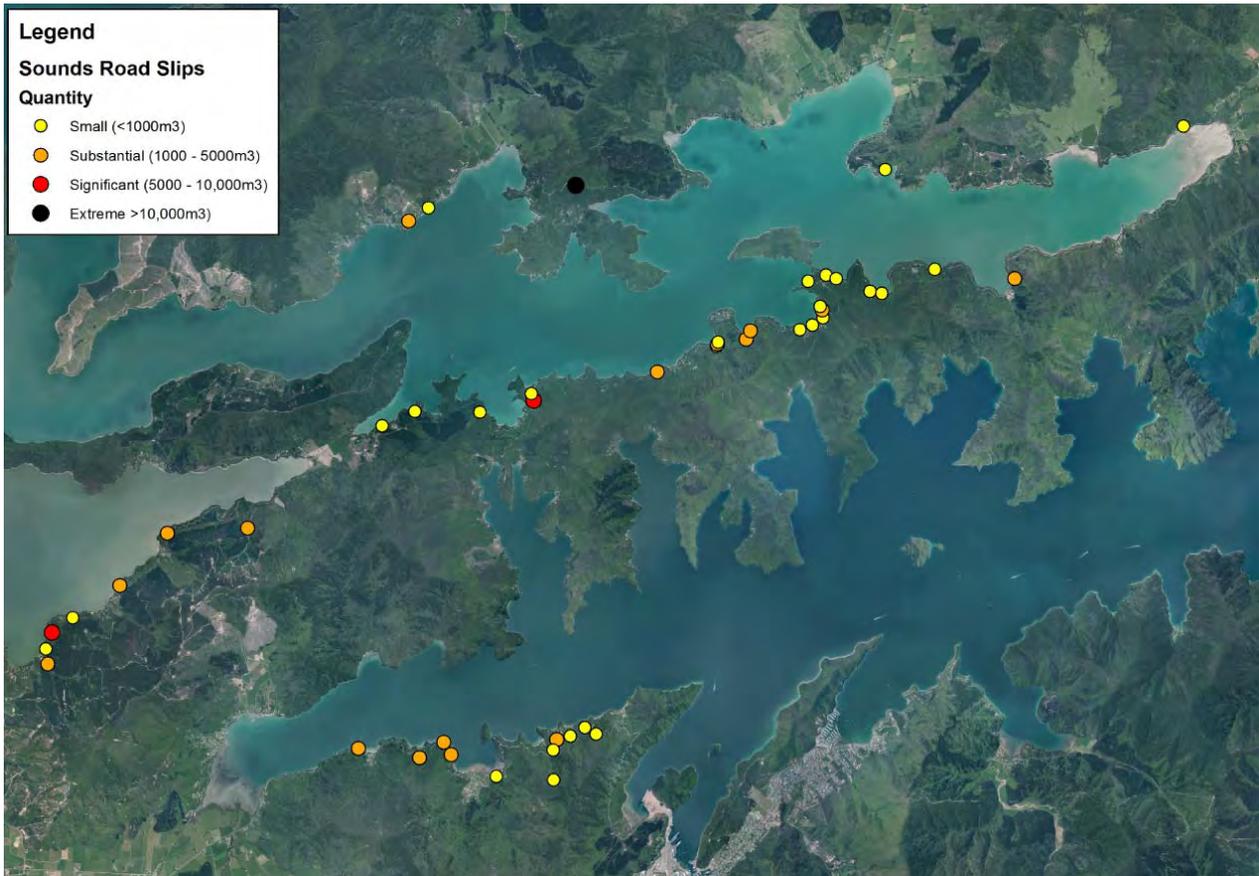
Figure 2: Estimated volume of slip material associated with the slips identified in Figure 1. Source: Miller 2015

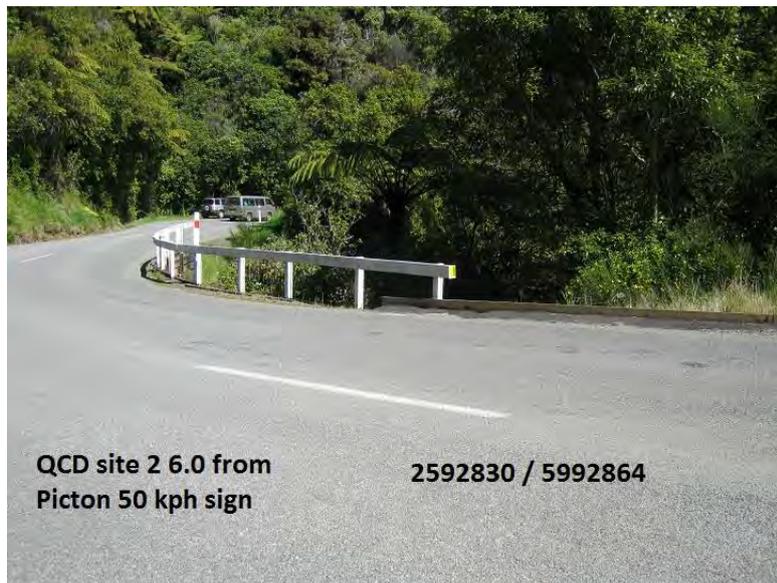
I consider the roading related activities ( widening ) may have been a significant contributor to the damage.

**Approx. Date :** 1990

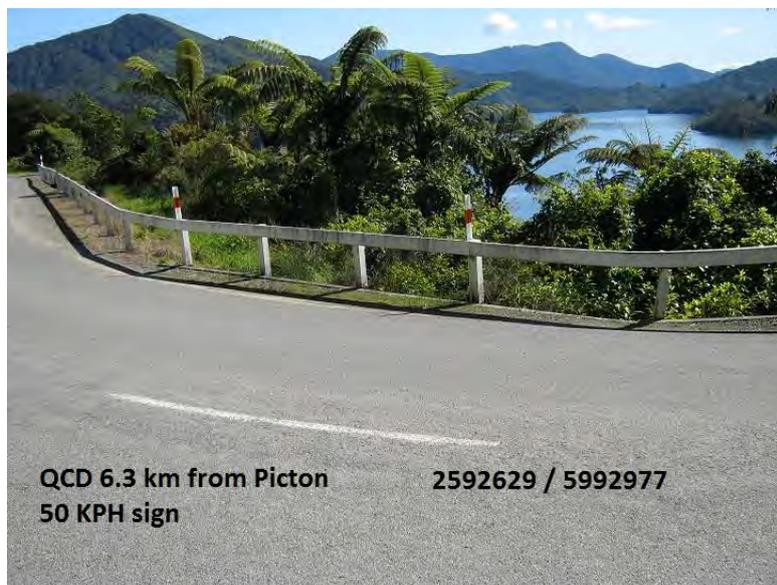
There are 2 retaining walls at this site and there was approx., 600m<sup>3</sup> to the coast.

**Date :** This event occurred approx., 1995.

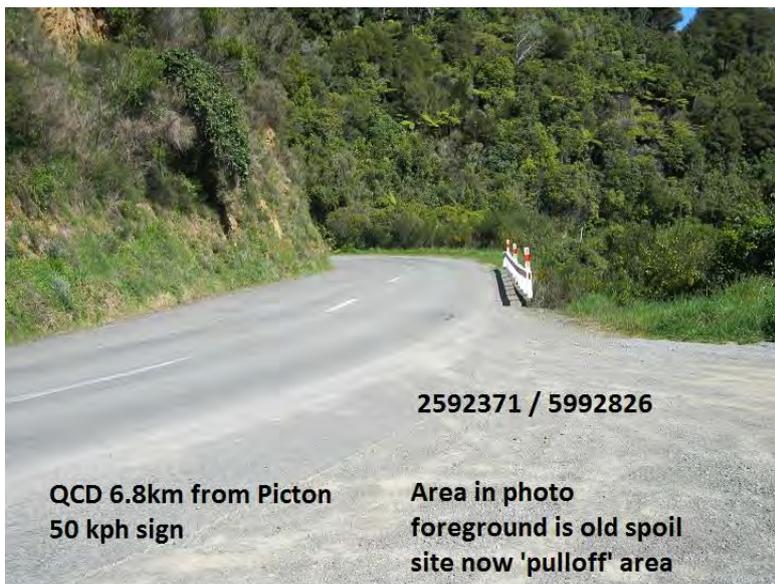
There is an obvious spoil site which is now a vehicle 'turnoff' /passing area ; there are a considerable number of these and virtually every outer corner has had some quantity of material placed ( many are now used as parking / passing areas) ; I noted that at the time of inspection there was still some material recently stockpiled near this site ( this may be a temporary storage area allowing the carriageway to be opened.

I consider widening works may have contributed to the instability and collapse of the face / faces above the road , most of the old slip faces are still visible in this area.

**Date :** This event occurred approx. 1998.

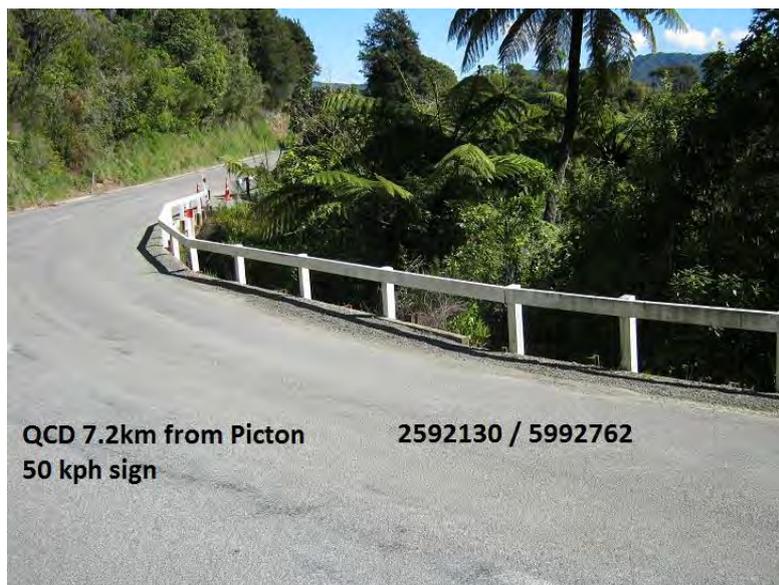
Many of the slips above the road are still unstable and further damage is likely although the risk of material overtopping the retaining walls is considered slight.

**Date :** the approx.. date of the event was 1996

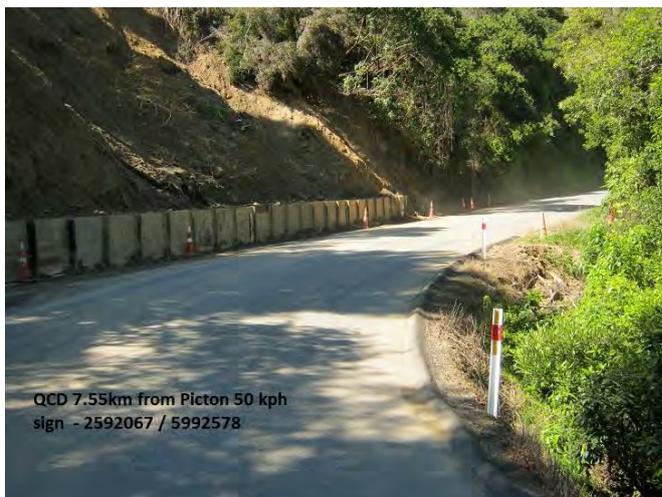
**Date :** The approx. date of the first event was 2000 – note also current at this site at time of report ( see photo ) ; this bare face is typical of previous sites that are now revegetated.

I would consider widening works precipitated the damage.

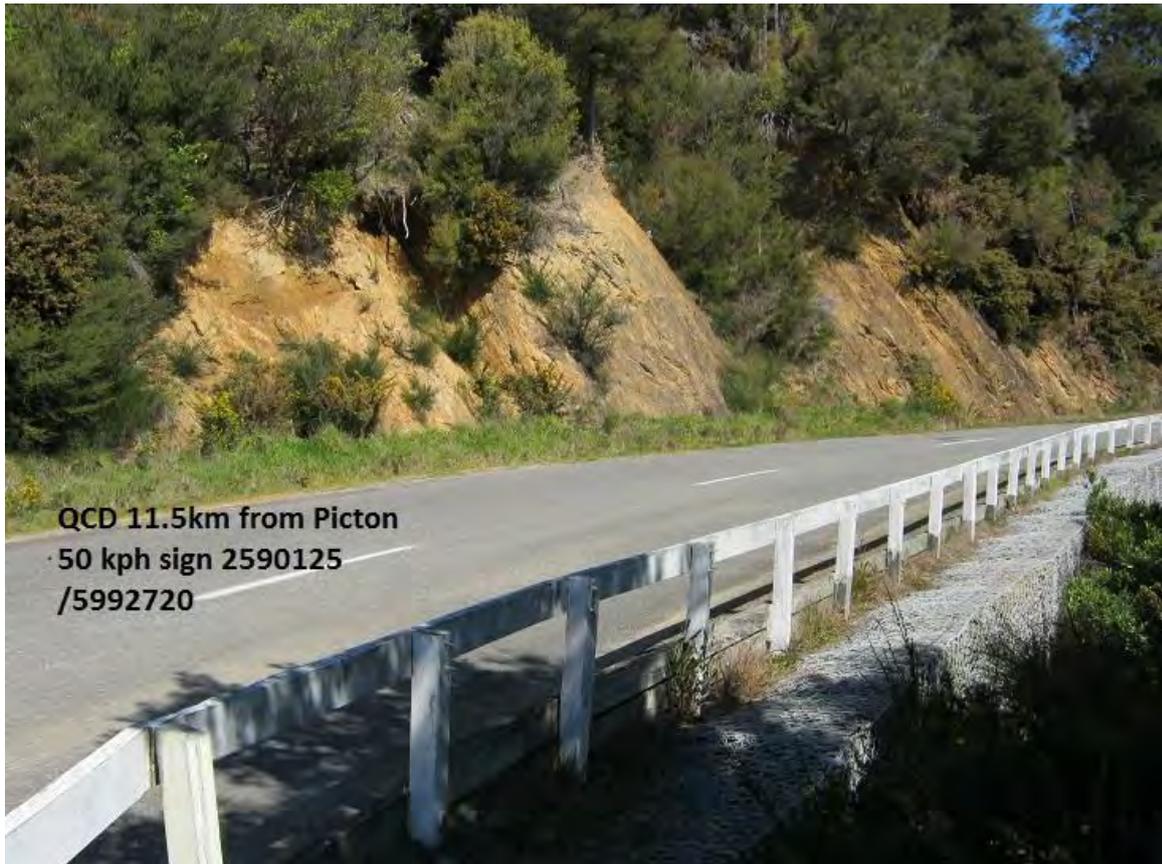
Site 9 photo ( see sketch, following page )

This site was the scene of significant damage to the road and private property.

The damage consisted of the total collapse of the road over a length of some 36metres to the sea and app. 3000 m3 of slip material.

It damaged beyond repair an 'A ' Frame house located below the site which shifted on its foundations ( it did NOT fall into the sea )

Subsequent survey and research showed that the section of road had been considerably elevated above an earlier vertical alignment by about 2-3 metres and this was further evidenced by the remains of a section of old culvert that had been left below the road when the later section was constructed. It was considered , and still is , that this was a significant contributor to the damage as it was still discharging water post event ( subsequently blocked off )

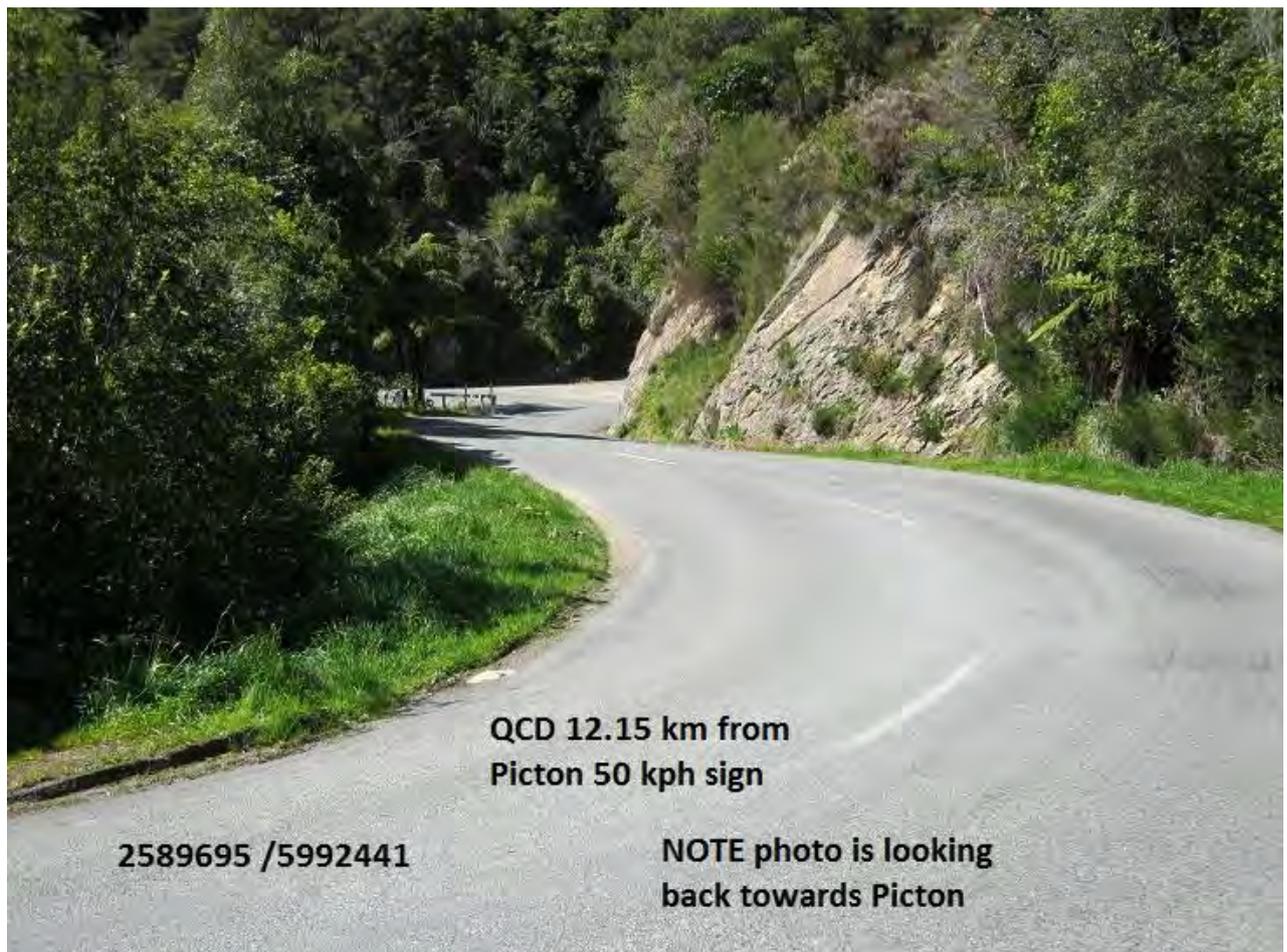
This site was the subject of extensive damage when slips emanating from 2 watercourses ( each distinct and apparent on site ) crossed the road carrying away the outer edge at 2 locations to a width of approx. 4 metres and blocking both culvert installations with the result significant quantities of material estimated at over 1200 m<sup>3</sup> discharged down the watercourse below the road and into the sea.

Although the slips “heads’ are well above the road and would indicate it was a natural event it is possible that the watercourse had been steepened during road construction and may have contributed to the damage. I would consider

**Date** : The date was approx. 1996

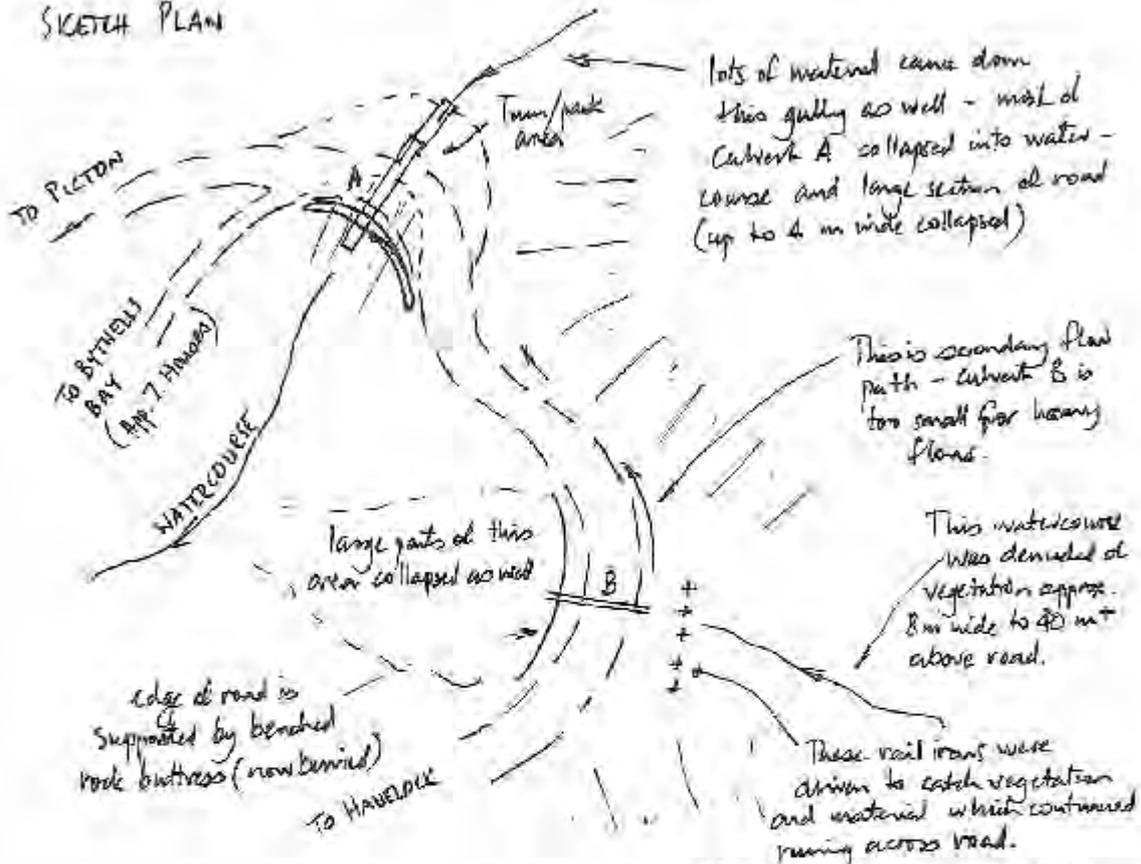
SITE 10

lots of material came down this gully so well - most of Culvert A collapsed into water - course and large section of road (up to 4 m wide collapsed)

This is secondary flow path - culvert B is too small for heavy flows.

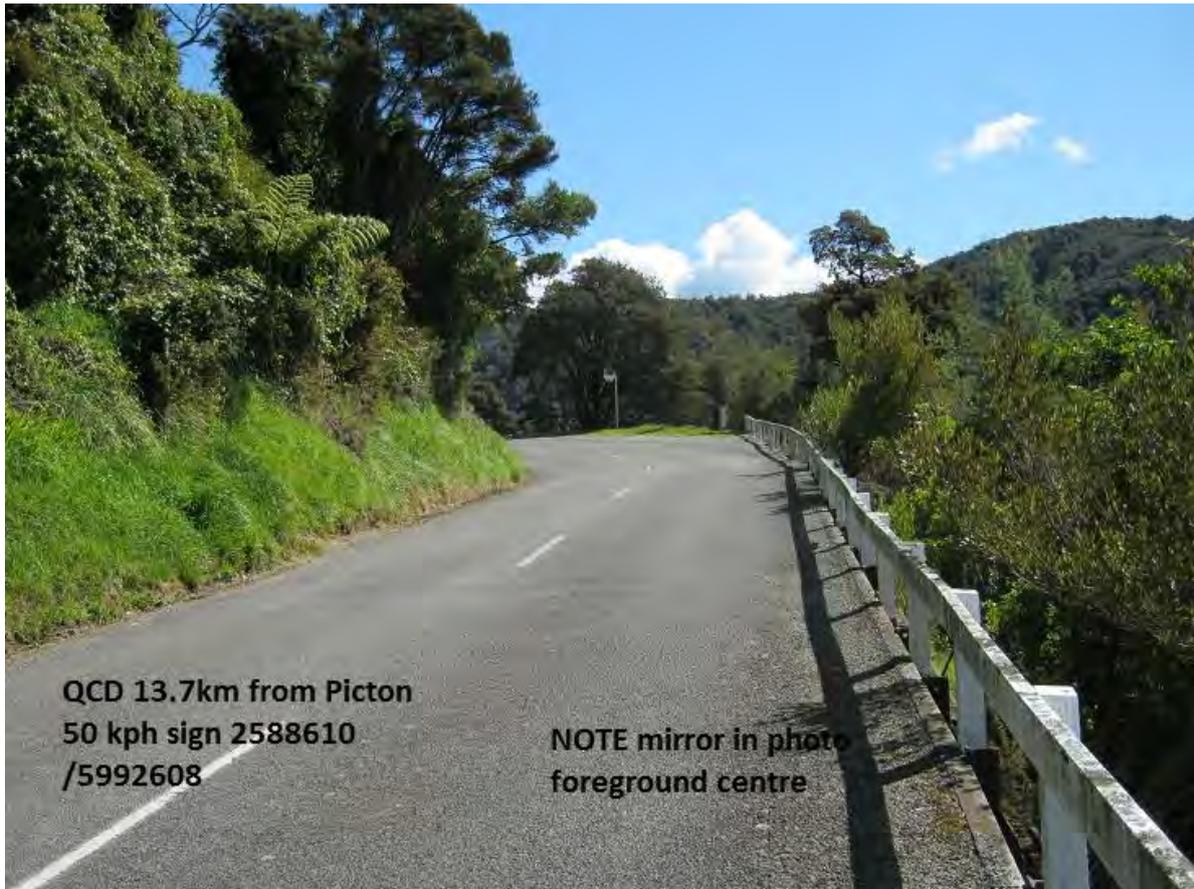
**QCD 13.7km from Picton  
50 kph sign 2588610  
/5992608**

This was a significant event where approx. 4 metres plus of the road edge collapsed , accompanied by , or caused by a slip on the LHS above the road.

The extent of the damage is apparent on both sides of the road and below the 60metre long retaining wall , although some second growth vegetation now covers much of the area.

I consider the collapse may have been caused by an instability of the old sidling fill on the outer edge exacerbated by the slip and water running over the road from the LHS – this LHS face would have been excavated during widening works.

**Date :** The initial damage occurred approx. 1994 ( there have been subsequent repairs to the retaining wall.

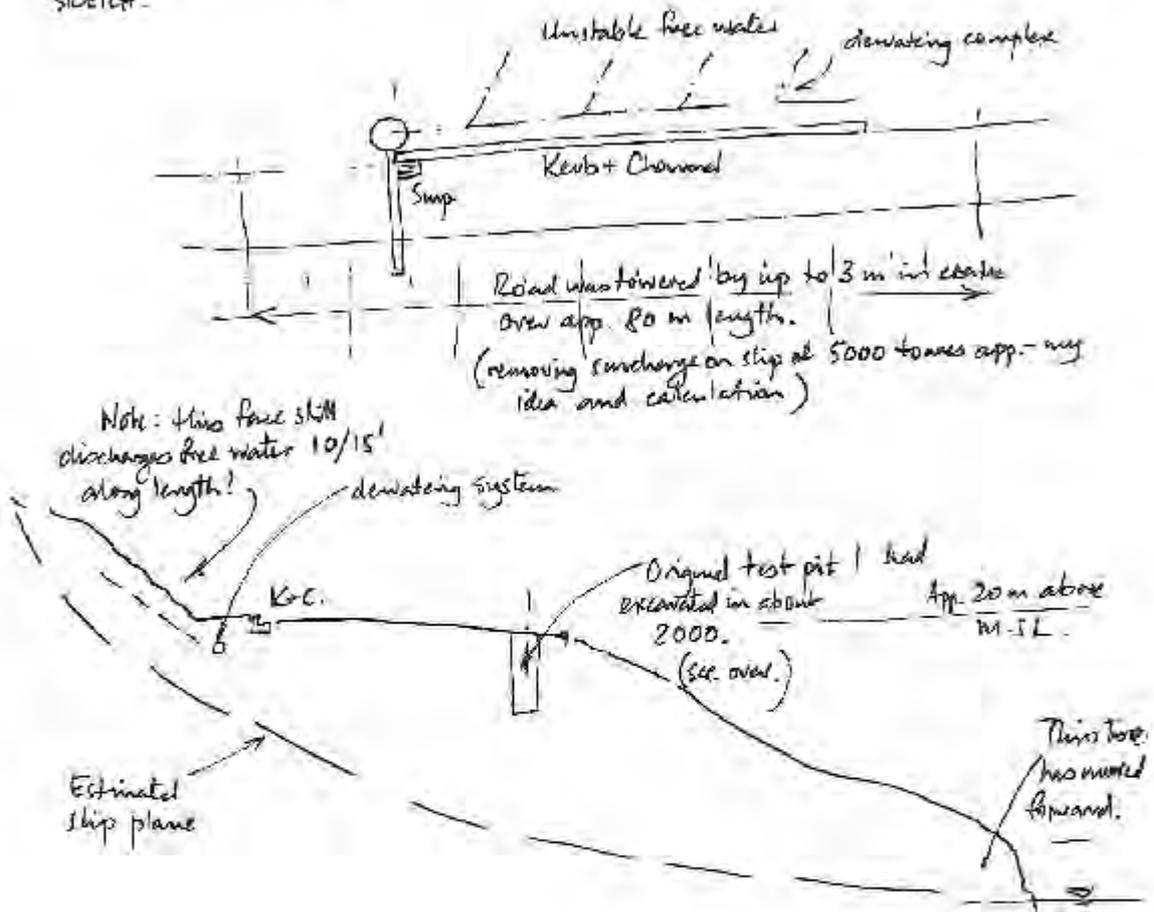
SITE 12  
2588312 / 5992532

Within the test pit there were several wide ( up to 100mm ) cracks , some extending forward and back along the road ; we were unable to define a bottom to them and in at least one we could hear subterranean water running in a significant flow well below the base of the test pit.

Note the pavement has again been resurfaced over the area, indicating there has been a further event since 2004, and I noted the outer edge of the pavement appears to be slowly subsiding again.

I consider the damage is the result of a natural slip and that the road simply sits within that slip plane ( see sketches -2 pages )

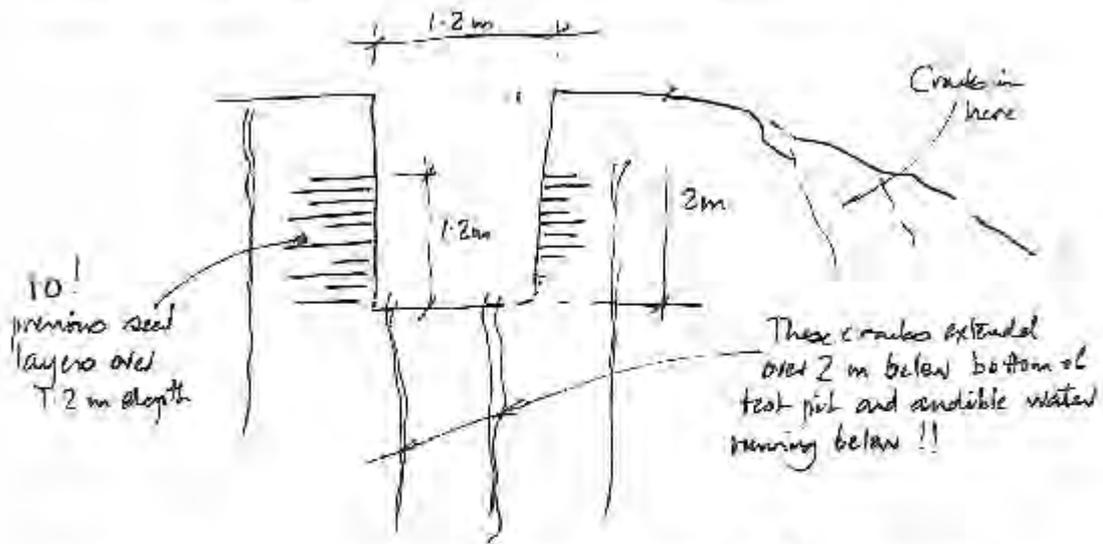
SITE 12

First identified by a small hole appearing in road surfacing - on pushing down a 'crowbar' was > 2 m deep!! Test pit was then excavated.

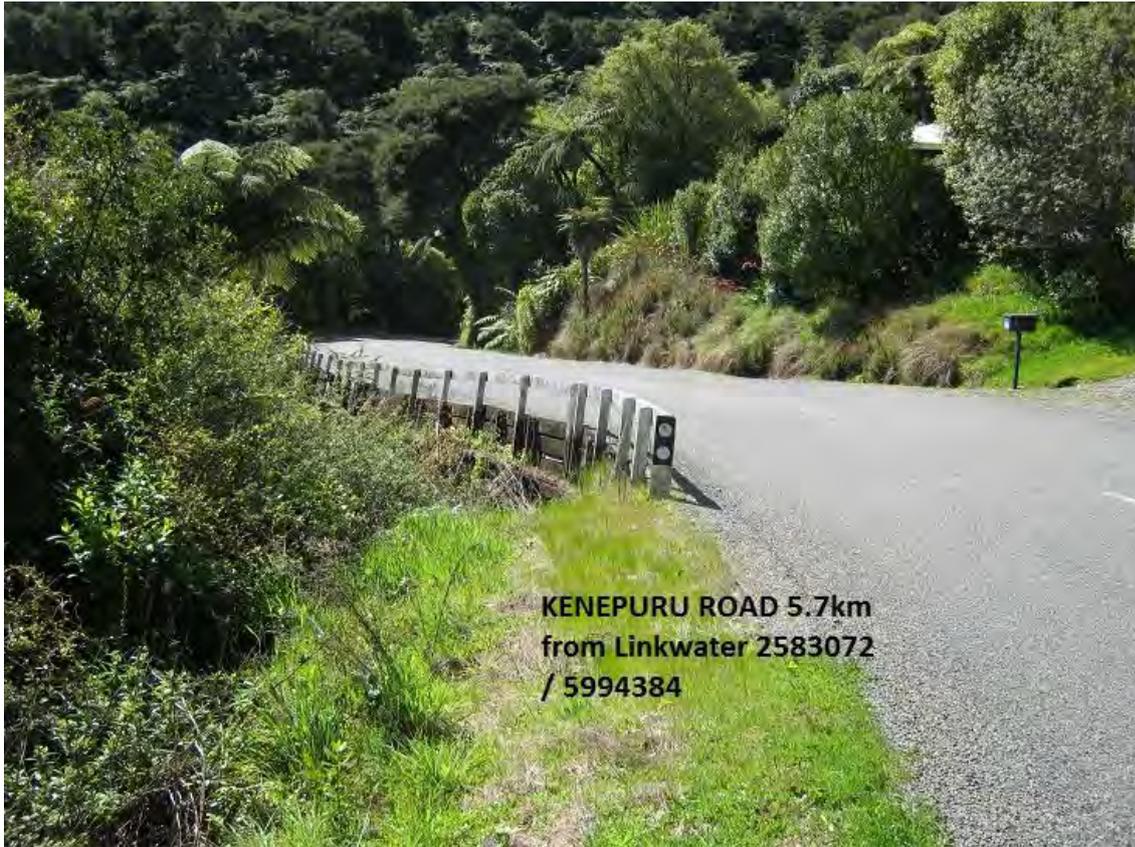
Site 3A ( see sketch on following page )

This site has evidenced movement for a number of years and first repairs were undertaken in approx.. 1988 , since then there have been several recurring settlements of a major nature .

It was observed by me in about 1988 that the coast line has moved forward perceptibly by about 4-5 metres ( I do not know if any further movement is apparent )

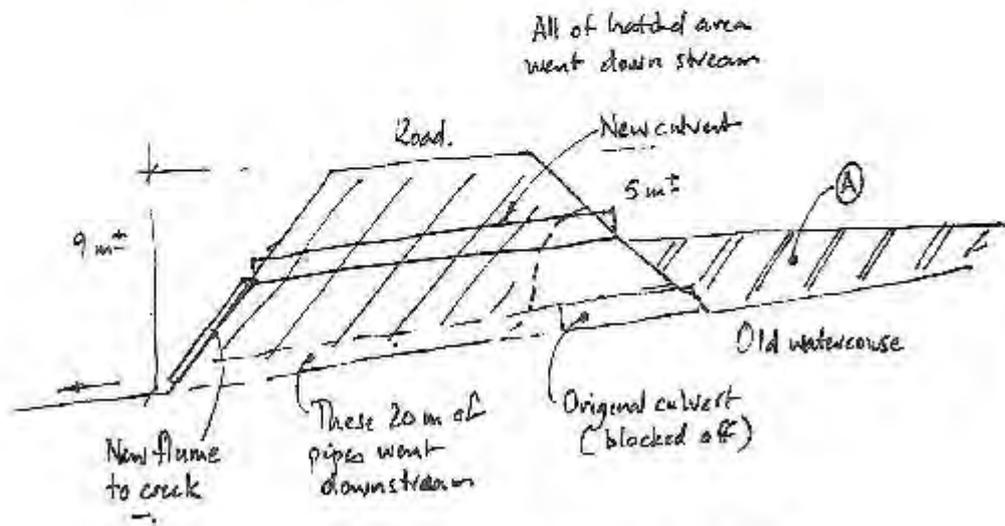
KENEPURU ROAD  
SITE 8 A

The event followed clearfelling of forestry above the road and the slips referred to above contributed to the damage caused.( probably the sole contributor to the event )

(A) All of this creek invert was raised with a combination of slash, slip material and hand rock sheathing - 80 m long x app. 15 m wide

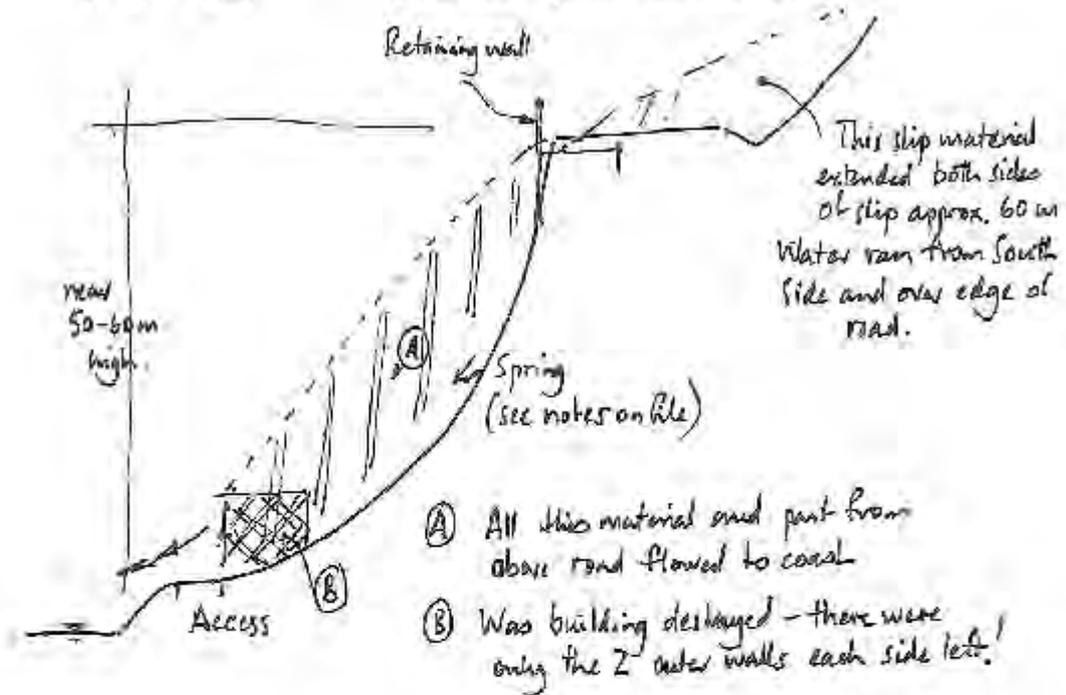
SITE 12A

The scene of a dramatic event and major damage to a downhill property.

- (A) All this material and part from above road flowed to coast
- (B) Was building destroyed - there were only the 2 outer walls each side left!

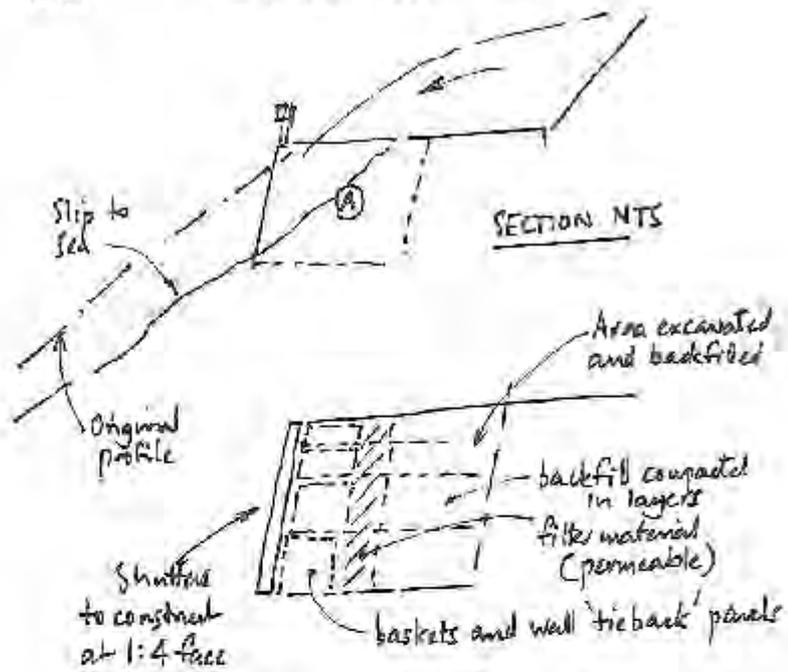
20.6 KM from Linkwater.

It has obviously stayed in position and retained the road , however ,it has rotated since construction as evidenced by the rails which have been straightened and replaced several times. ( aesthetically it would have to be considered pretty poor )

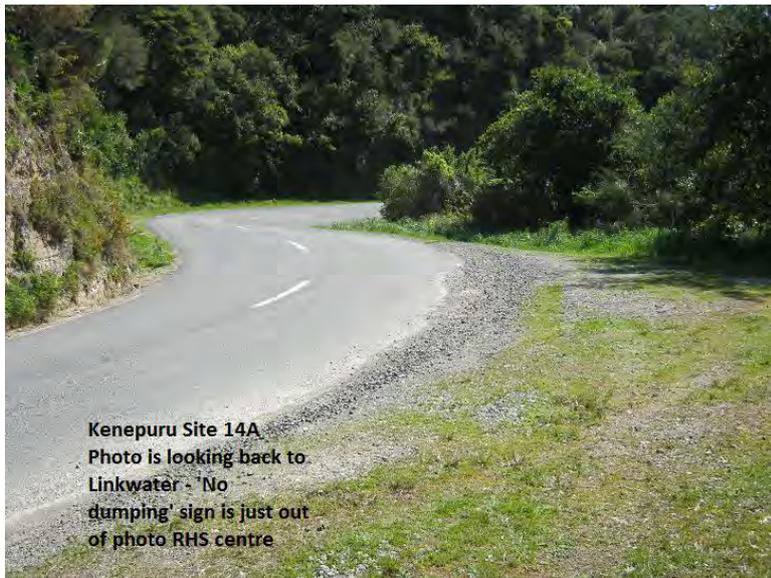
The spoil site was retired after the first use and a 'no dumping' sign erected ( there is still a sign at this location ) , however , local contractors / builders / residents etc. continued to dump material at the top ; this blocked drainage systems which diverted water to the culvert South side and may have precipitated the damage ; in any event it was roading related.

Date : the collapse occurred about 1989

The repair of the site involved trimming and compacting the new face and installing contour drains diverting water to the south ; this appears to have been successful and no further damage has occurred .

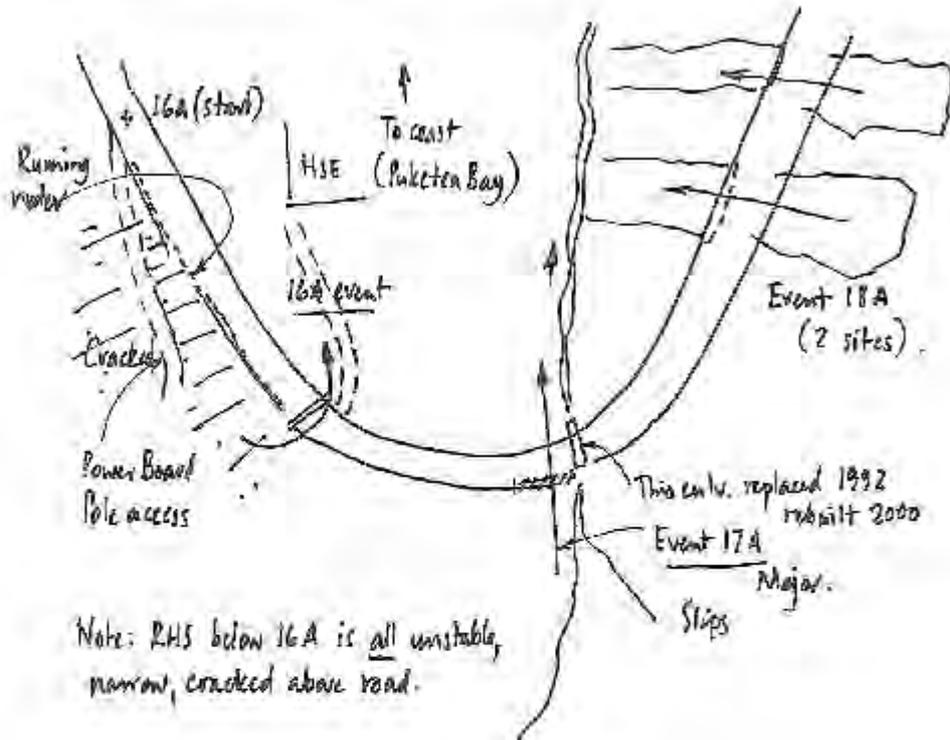
SITE	16A	17A	18A
FROM LINKWATER	25.3*	25.45	25.55 / 25.60

I consider events 16A and 18A were the result of land disturbance as a result of road widening ; events 17A were natural erosion well away from the road proper.

Note: RHS below 16A is all unstable, narrow, cracked above road.

Big slip, was visible from corner near 26 Kus - now overgrown
