Technical Council on Lifeline Earthquake Engineering (TCLEE)
Report of the
4 September 2010 M_w 7.1 Canterbury (Darfield), New Zealand Earthquake
By: John Eidinger, Alex Tang, Thomas O'Rourke

Summary

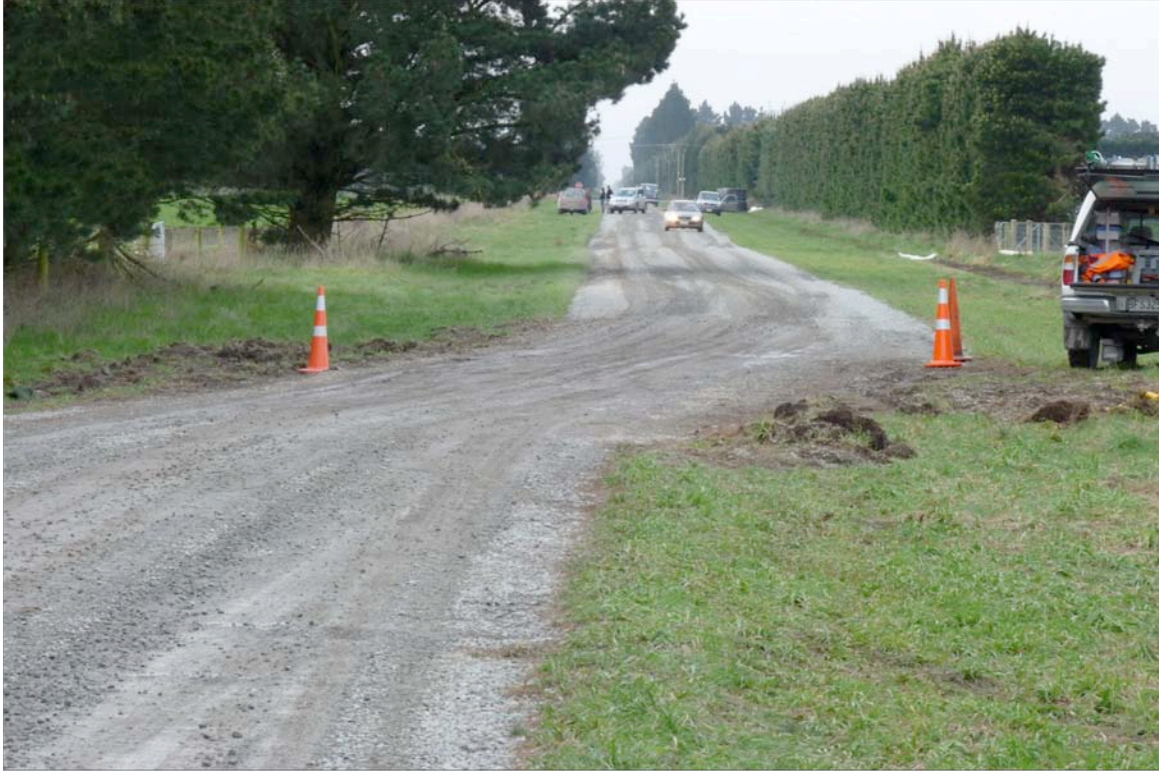
Figure 8 shows the right lateral offset of a country road. The road was straight prior to the earthquake. Figure 9 shows a paved road that crossed the fault; the right lateral offset of the fault appears to have forced the road to shorten, resulting in many pavement buckles.

Figure 8. Fault Offset Through a Road

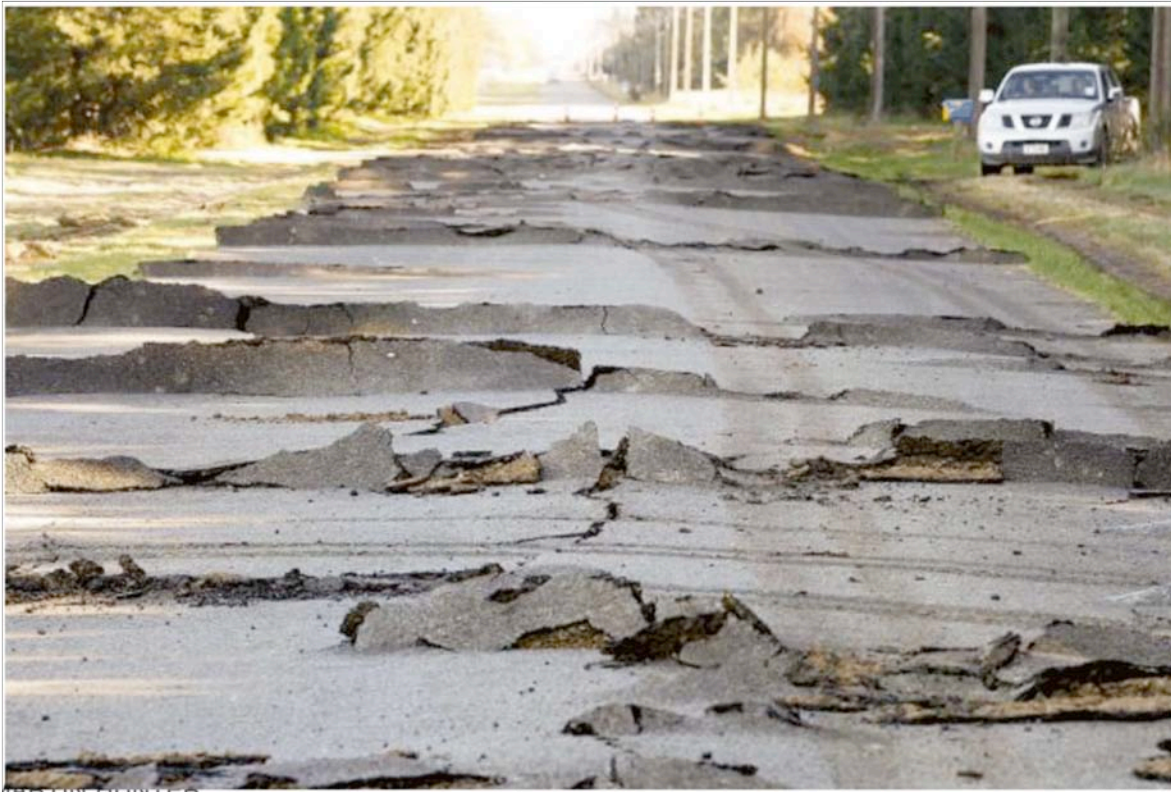
Figure 9. Fault Offset Through a Road

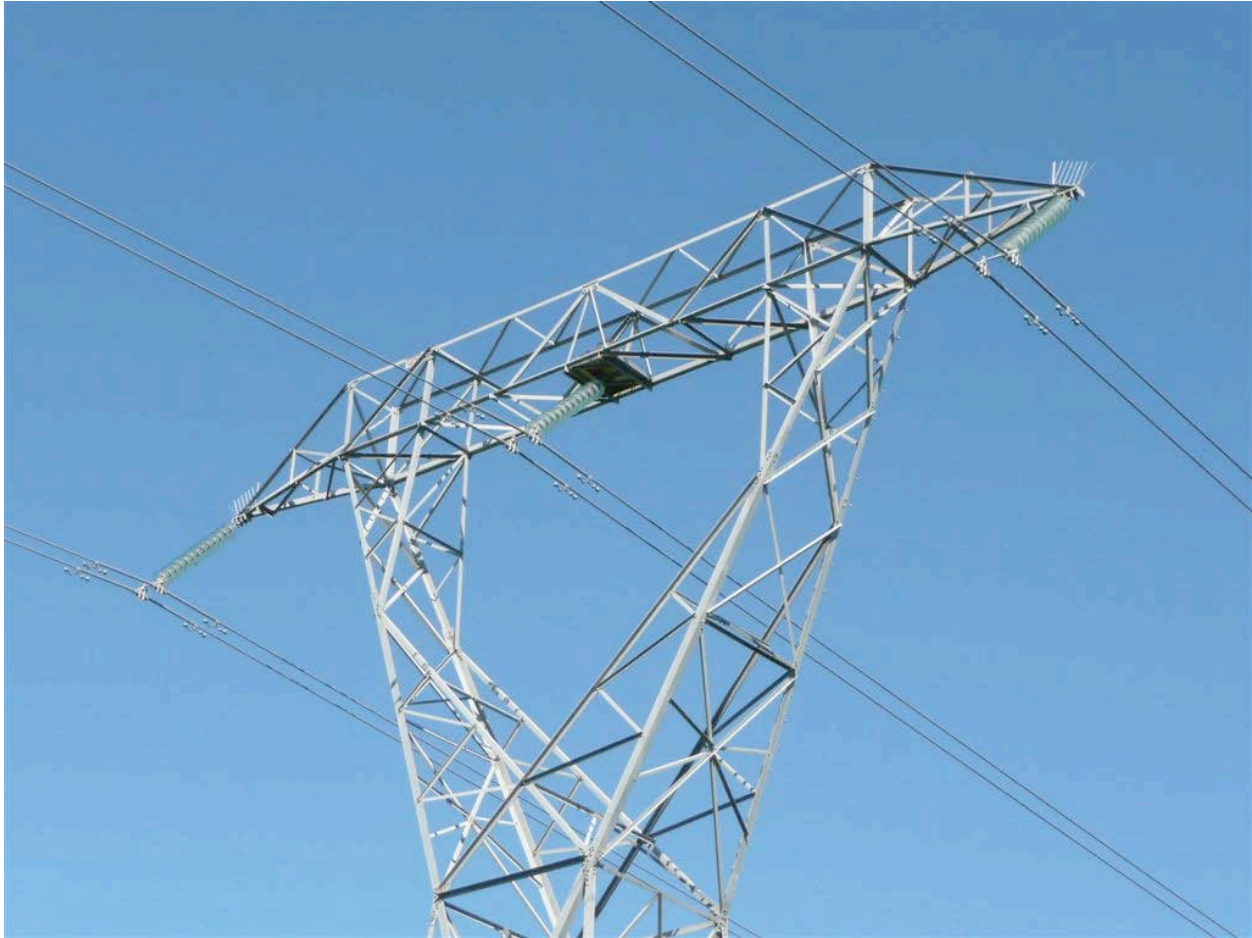
Two single-circuit 220 kV overhead transmission lines crossed the rupture zone. The fault rupture passed nearby the legs of the steel lattice towers, but not through them. There was no observed damage to any towers due to inertial shaking. Due to the fault offset, on the order of 4 meters, the conductor sags on either side of the fault became unbalanced. On the ROX-ISL-A line, the unbalanced sag is indicated by the diagonally-swung insulators (normally they would be straight down) in Figure 15; this sag remains unbalanced 6 weeks after the earthquake; Transpower reported that they would adjust the sag during some future outage. On the Benmore-Islington line, the fault offset resulted in high tension loads in a ground wire, which bent the tower extension that supported the ground wire; again, this did not lead to an outage, but could be repaired during a future outage.

Figure 15. Displaced Insulators on Suspension Tower Adjacent to Fault Offset

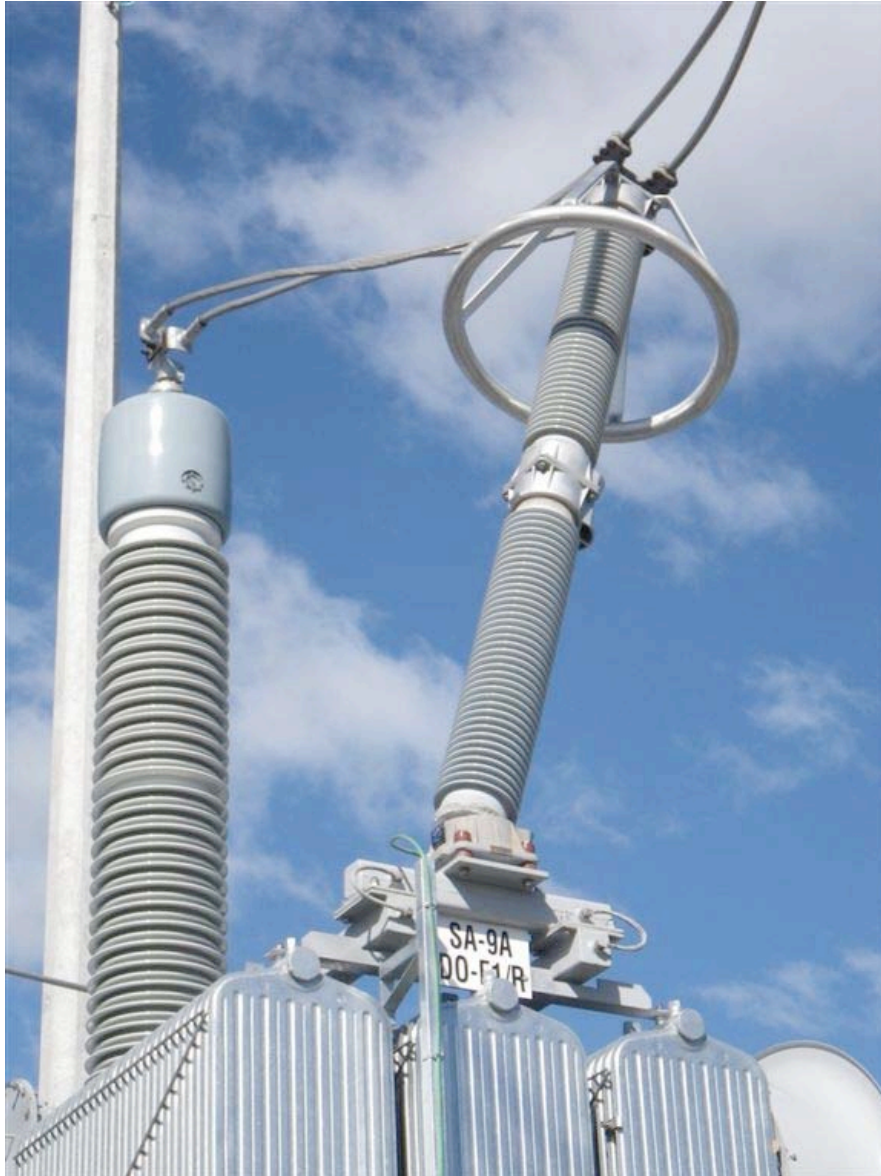
Figure 16. Broken Lightning Arrester

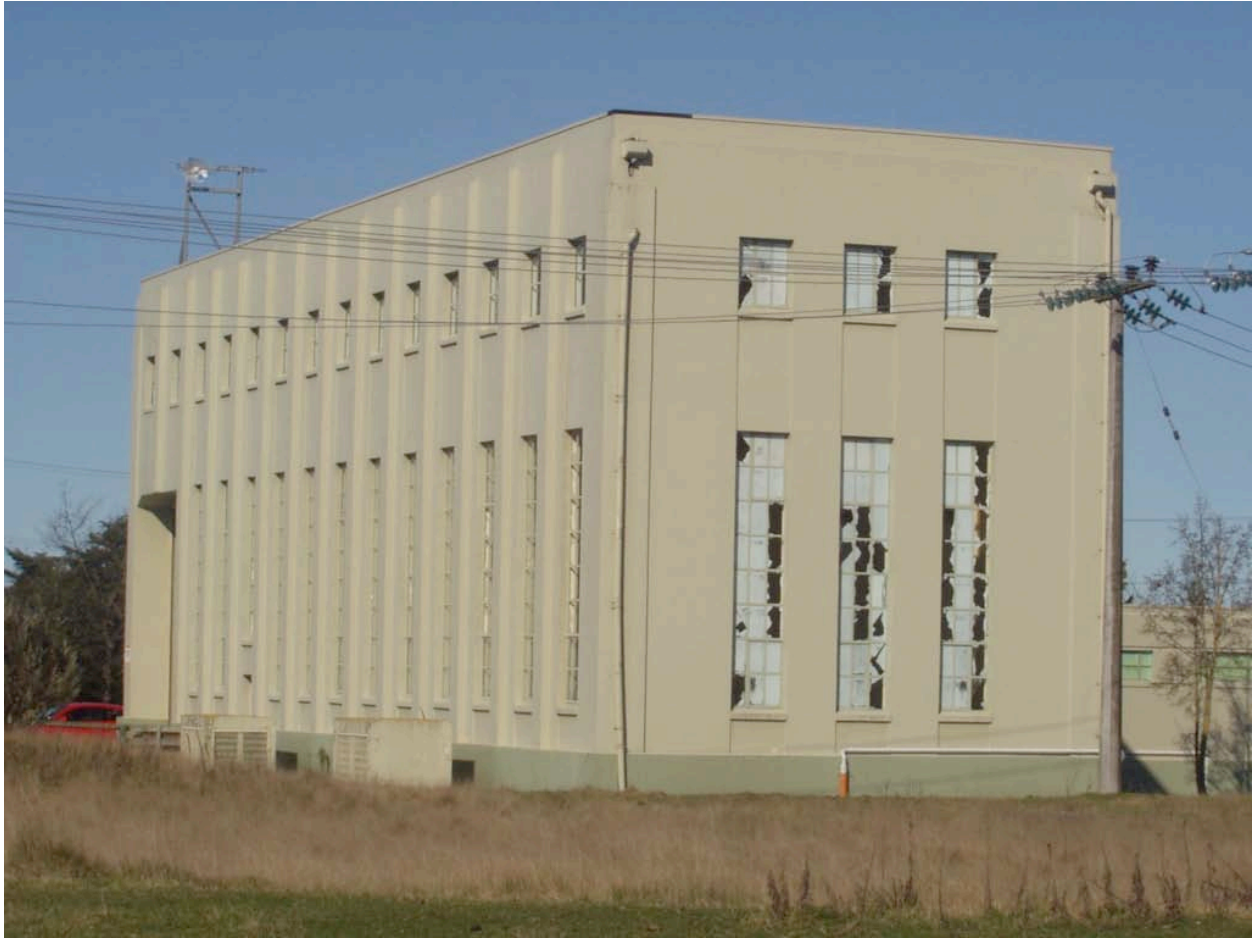
Older style multi-level reinforced concrete building had broken windows (Figure 17). Three spare (unanchored, in process of relocation) current transformers toppled. A desk collapsed. Florescent lights on chains, hanging from the ceiling, became loose; florescent tubes fell out. Some data cable tray tie rods ripped out of the ceiling. Lightning poles swayed and loosened their foundations.

Figure 17. Hororata Control Building

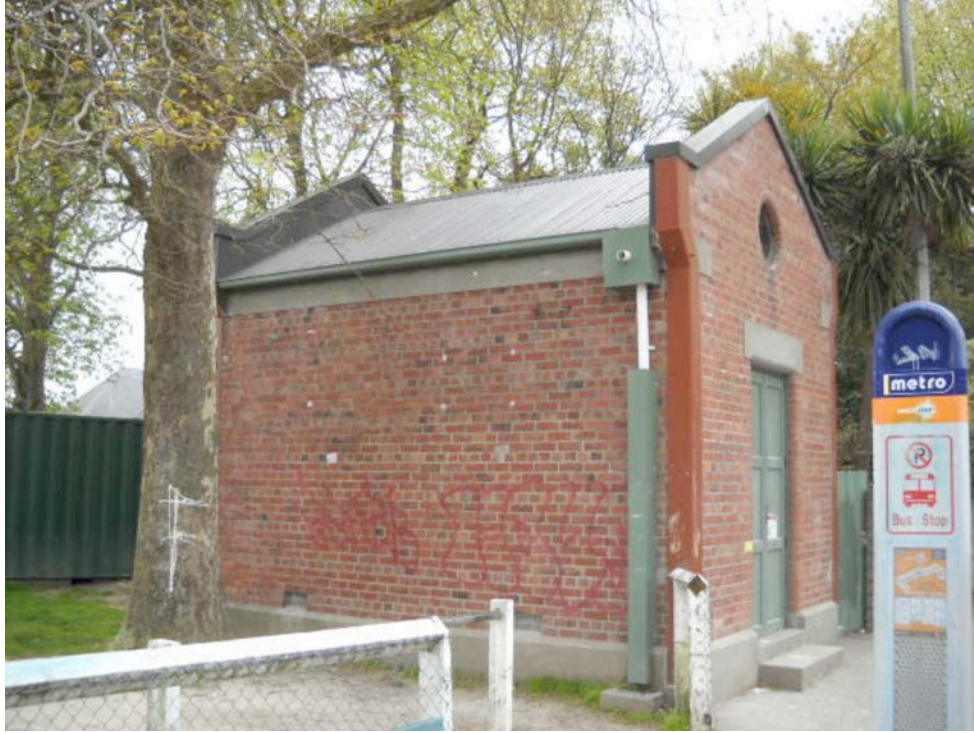
Figure 20 shows one of Orion's seismically upgraded small URM substations. Note the steel supports outside the building, that had been installed as part of the seismic upgrades instituted over the prior years. Figure 21 shows another URM and non-retrofitted building; instead of upgrading this building, Orion abandoned it; the amount of damage observed is common to that observed at other URM buildings in Christchurch.

Figure 20. Orion URM Upgraded Small Substation

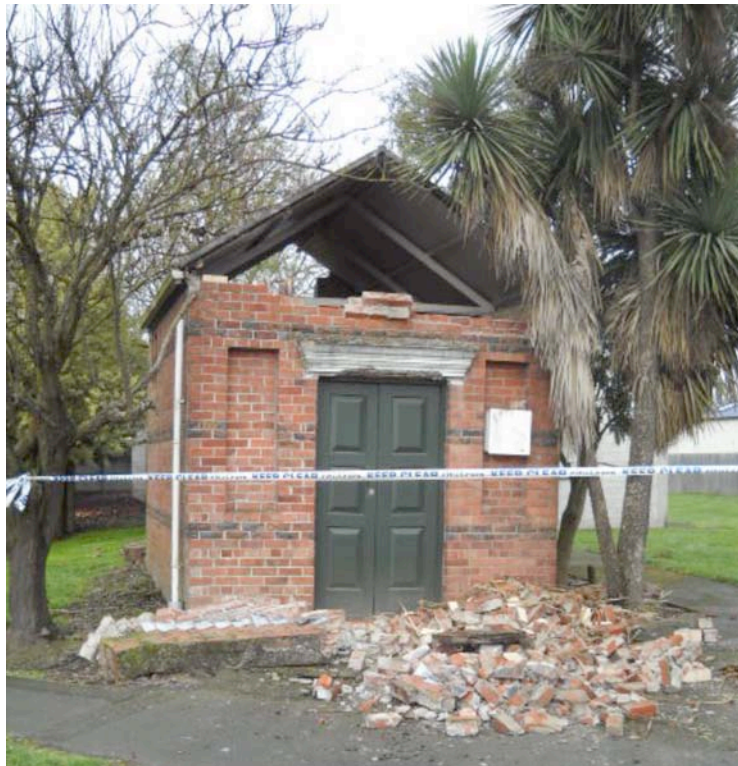
Figure 21. Orion URM Non-Upgraded Former Small Substation

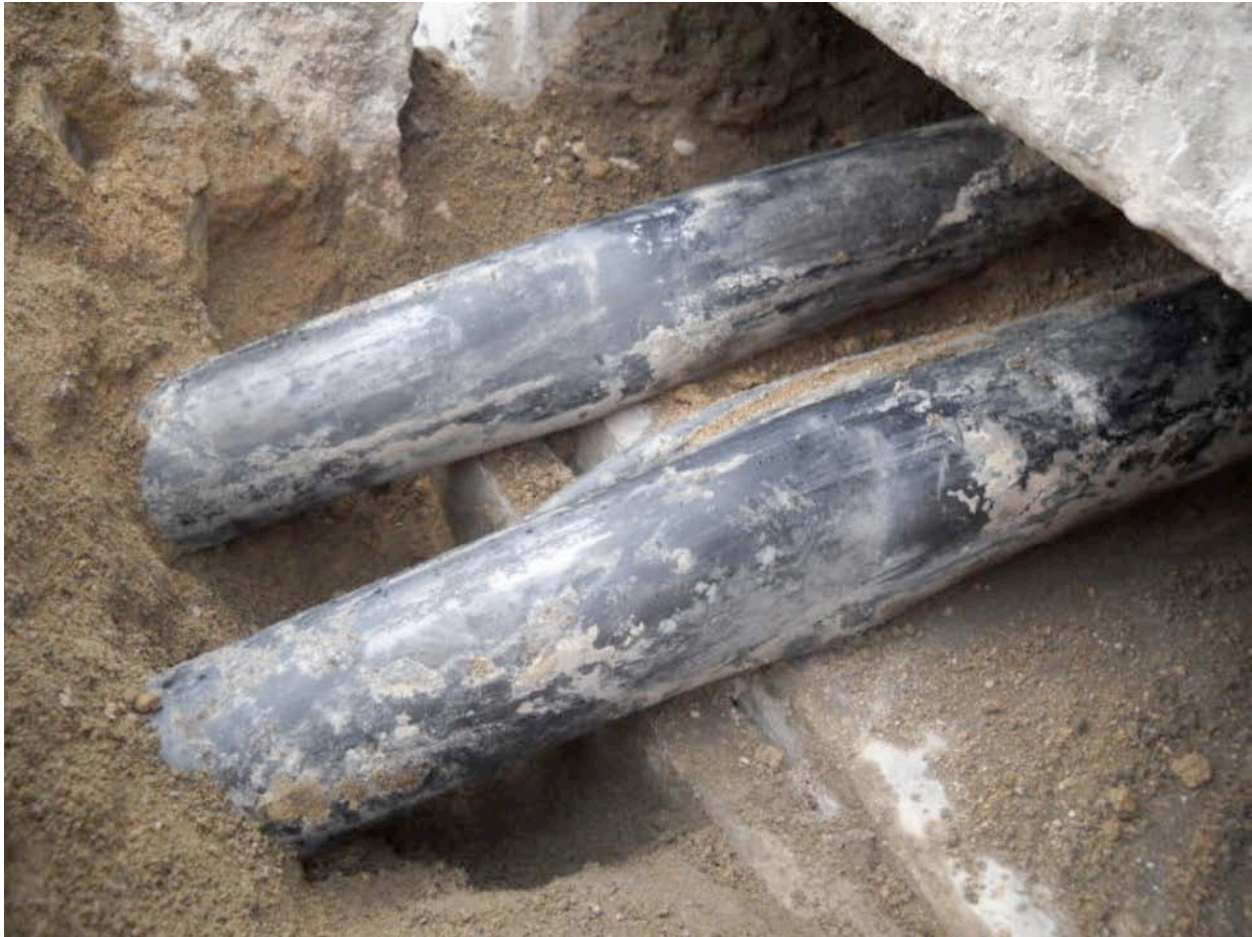
Figure 22 shows two partially crushed 66 kV oil-filled low pressure cables. This occurred where the buried cables transitioned from a buried condition, and went onto a pile-

supported bridge across the Avon river. While the cables remained functional after the earthquake, they will ultimately need to be replaced or otherwise bypassed; as part of a temporary measure after the earthquake, Orion braced the bridge on which the cables are located. There were several other 11 kV buried cables that were completely broken; we believe all of the broken cables were in the areas with lateral spreads and/or settlements.

Figure 22. 66 kV Cables

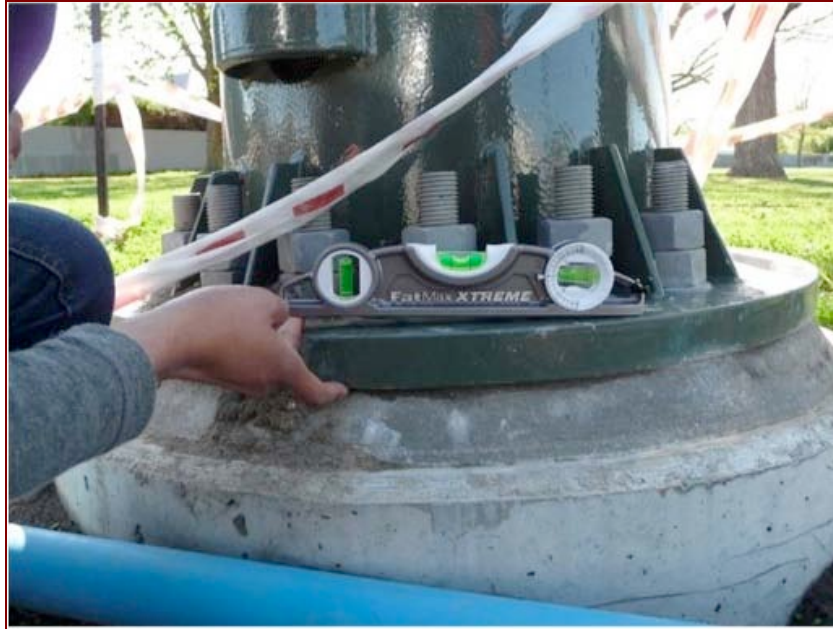
At two cell phone tower sites, liquefaction resulted in rotation of the tower (see Figure 23). The towers were out-of-plumb by 2° to 5°. These rotations did not affect service, and no effort to restore the towers to vertical had been made within the first 6 weeks after the earthquake.

Figure 23. Cellular antenna tower out of plumb due to ground deformation.

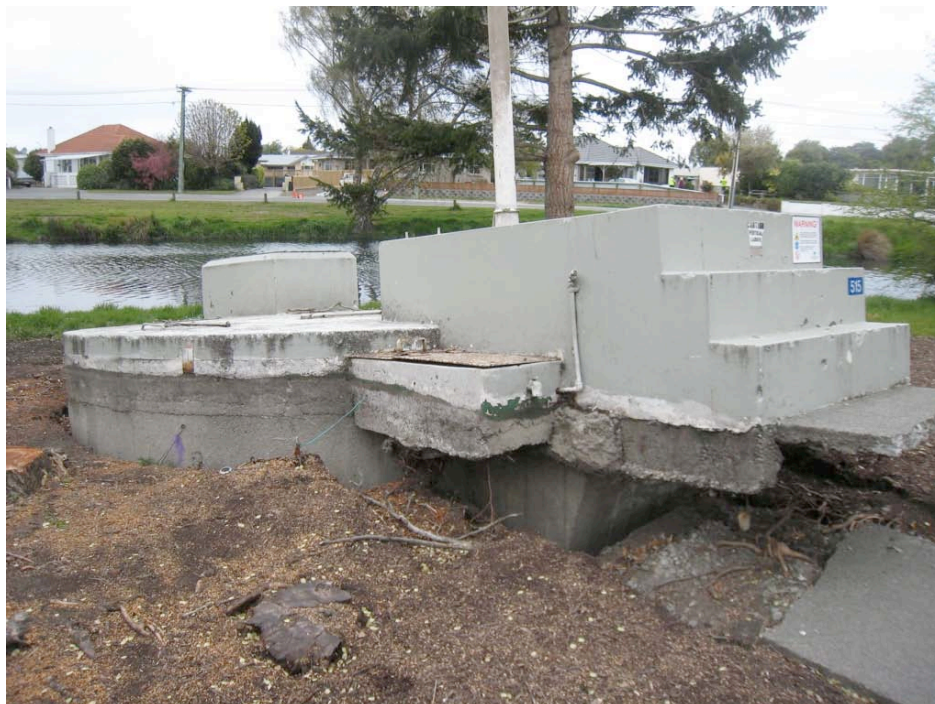
Figure 27. Floated and Tilted Wastewater Life Station 26, Porritt Park, Avonside

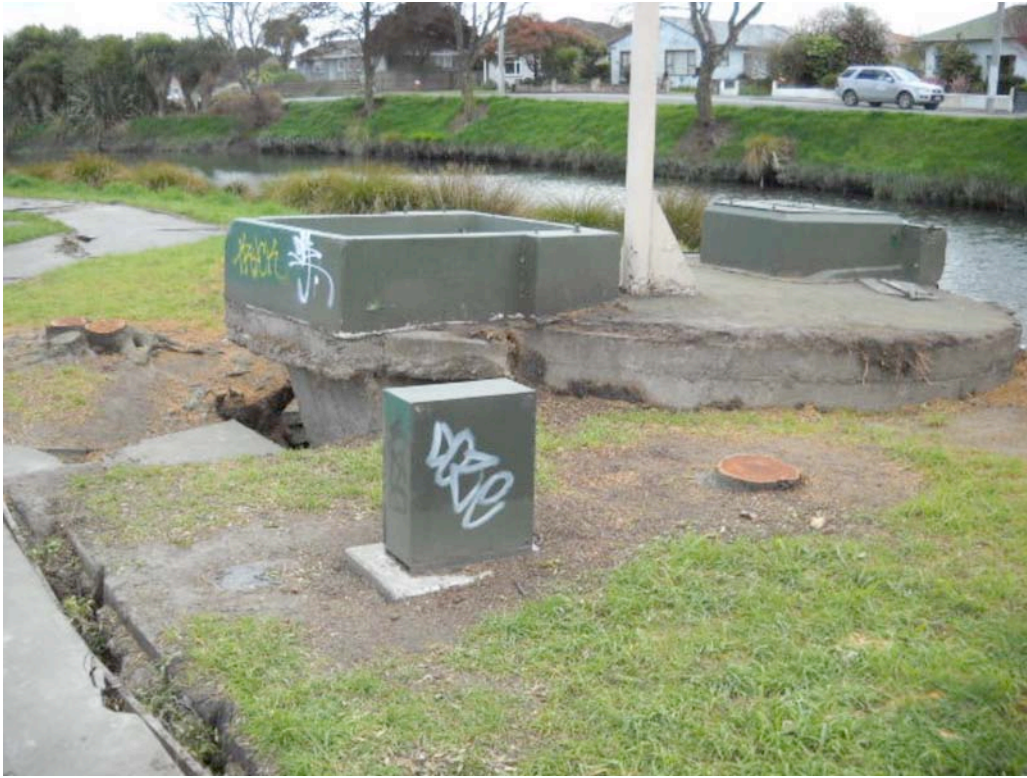
Figure 28. Floated and Tilted Wastewater Life Station 27, Avonside

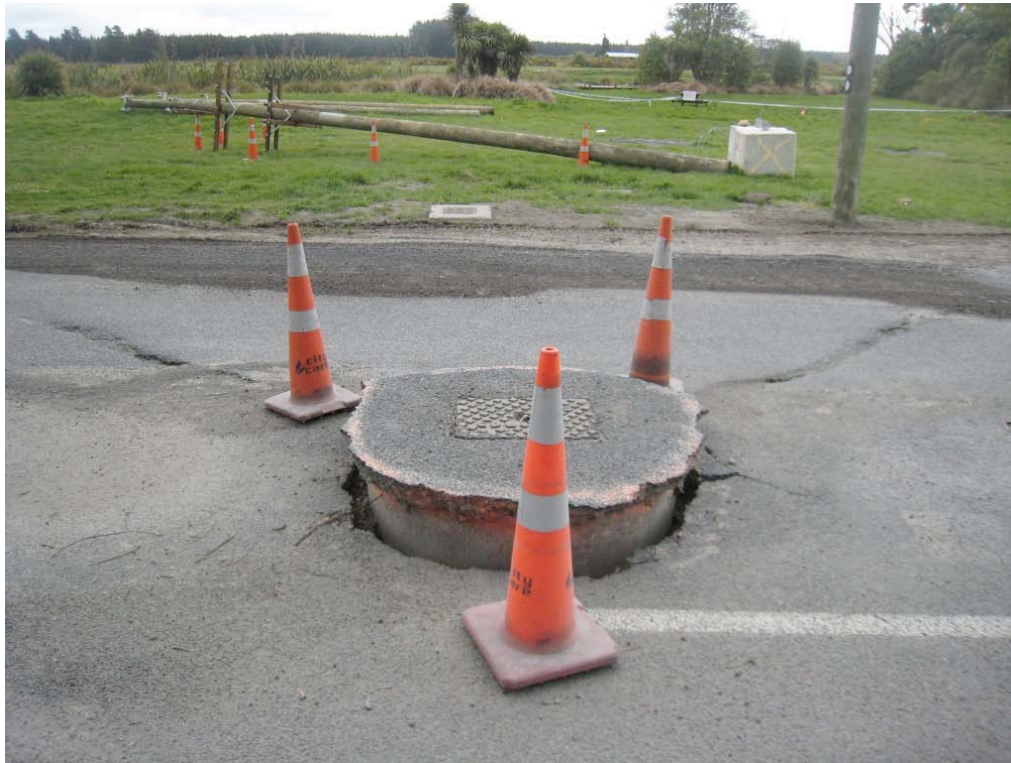
Figure 29. Floated Sewer Manhole, Brooklands (one of fifteen)

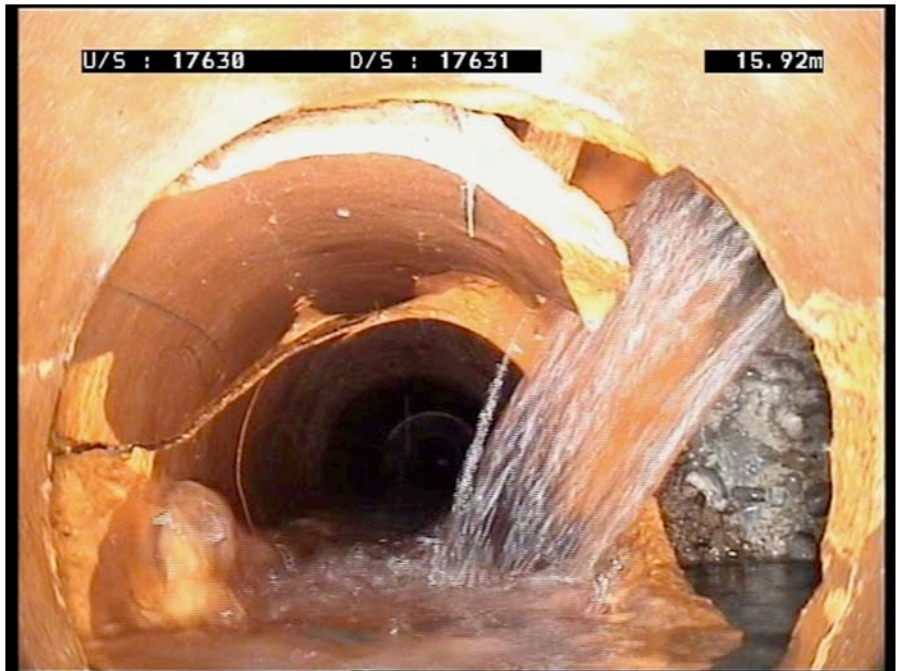
Figure 30. CCTV picture of Broken Sewer, MDC

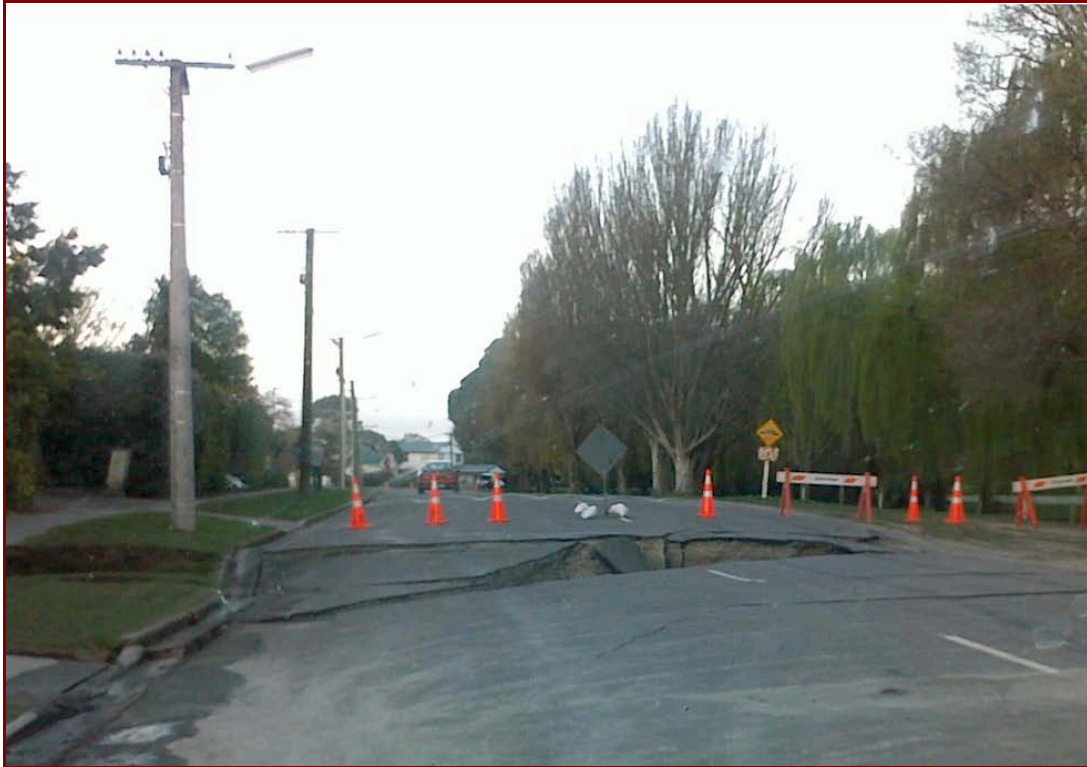
Figure 35. Road surface up heaving due to permanent ground deformation

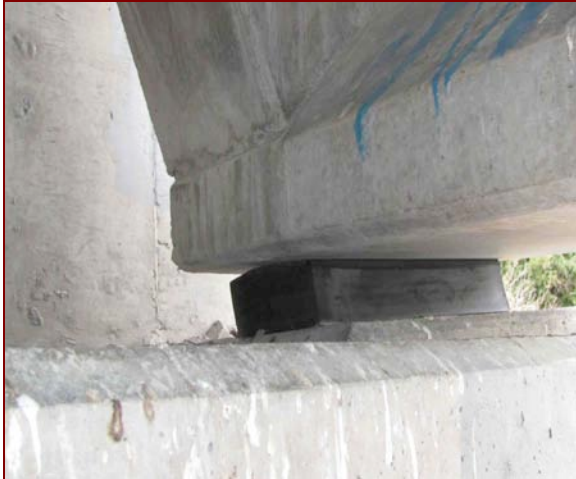
Figure 36. Rubber bearing deformed

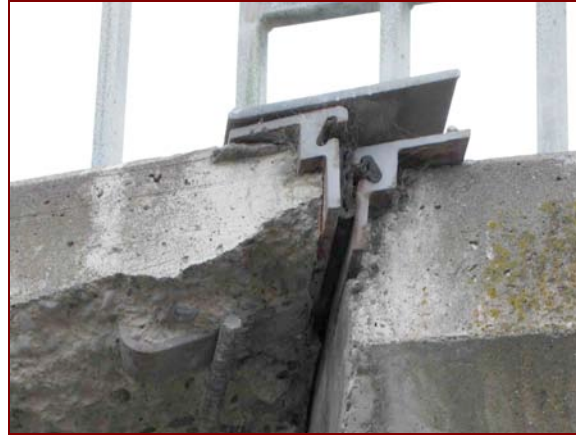
Figure 37. Deck and abutment impact damage

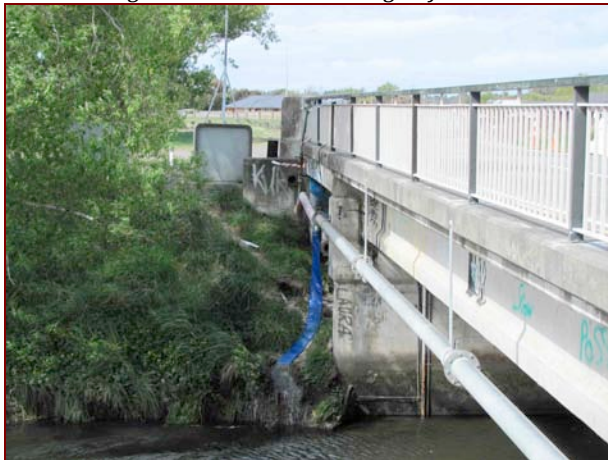
At most of the bridges that we visited that suffered abutment damage, if there were pipes hanging from the bridge, then the pipes were broken. Figures 38 and 39 show a broken sewer pipe crossing a bridge; the broken pipe remained in service and was discharging into the creek below.

Figure 38. Plastic hose connected to broke pipe to discharge wastewater to stream

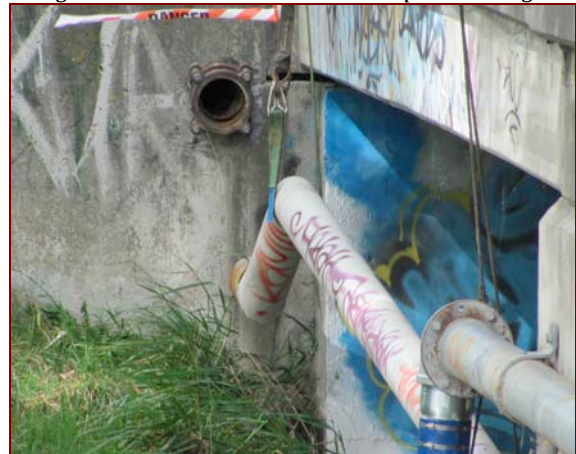
Figure 39. Close up of the damaged wastewater pipe

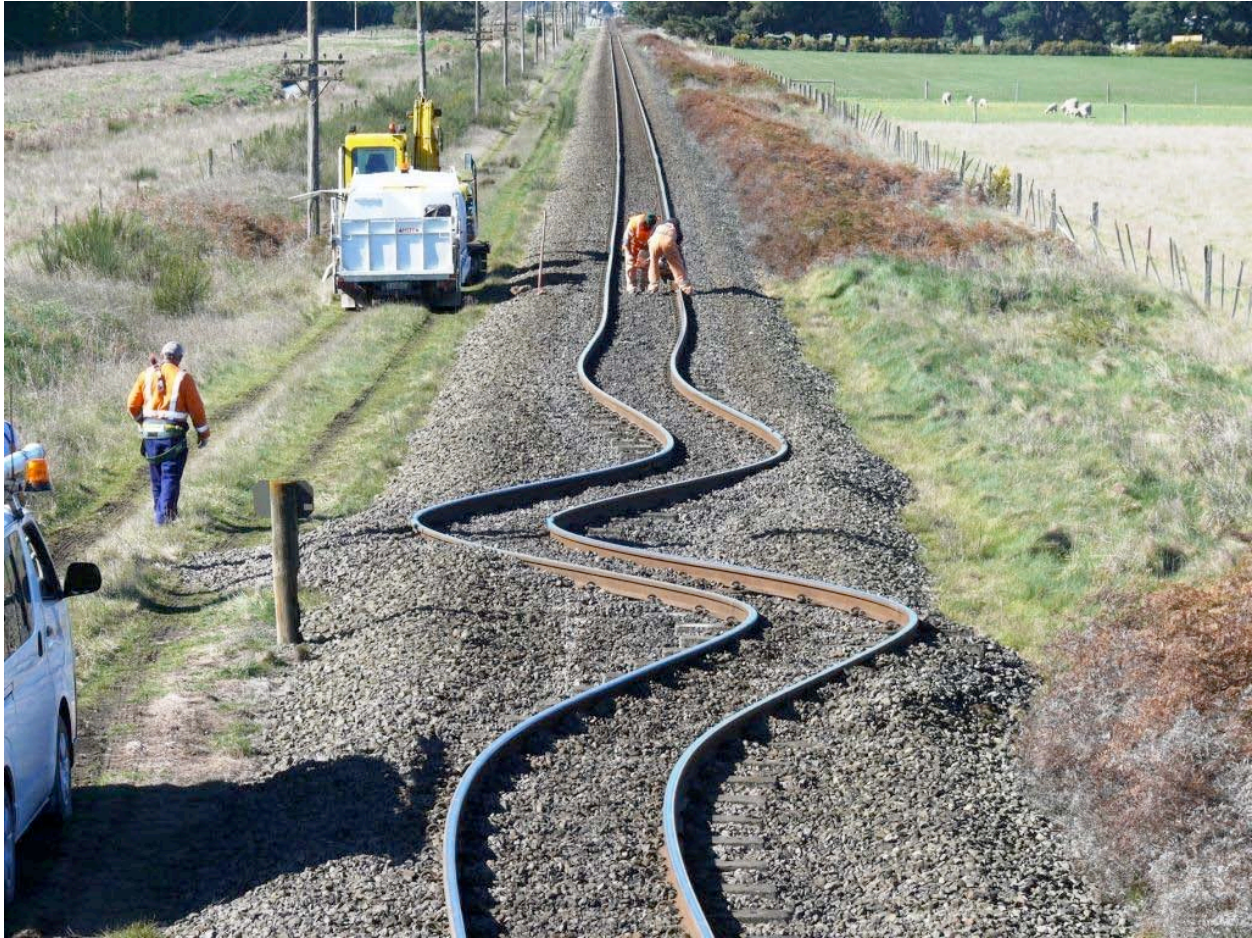
Figure 41. Buckling of Rails at Fault Offset Location

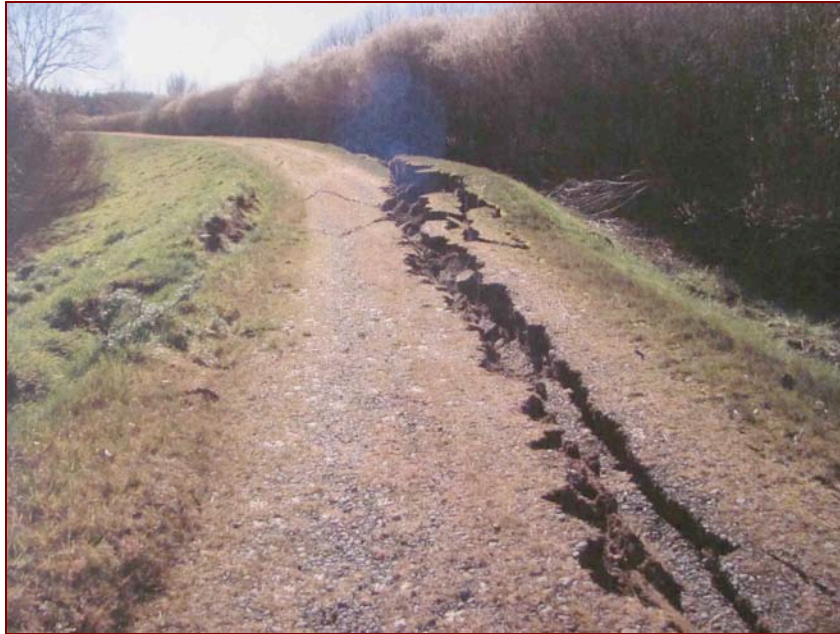
A survey reported by Riley Consultants indicated the following damage to stopbanks: 10 severe, 4 major, 11 moderate, and 14 minor damage: see Figures 45 to 47.

Figure 45. Severe Damage – Stopbank

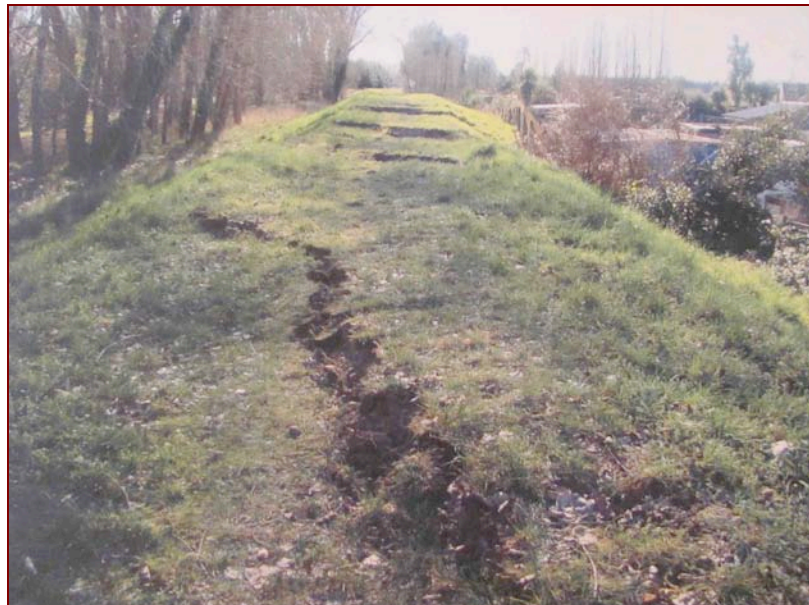
Figure 46. Major Damage – Stopbank

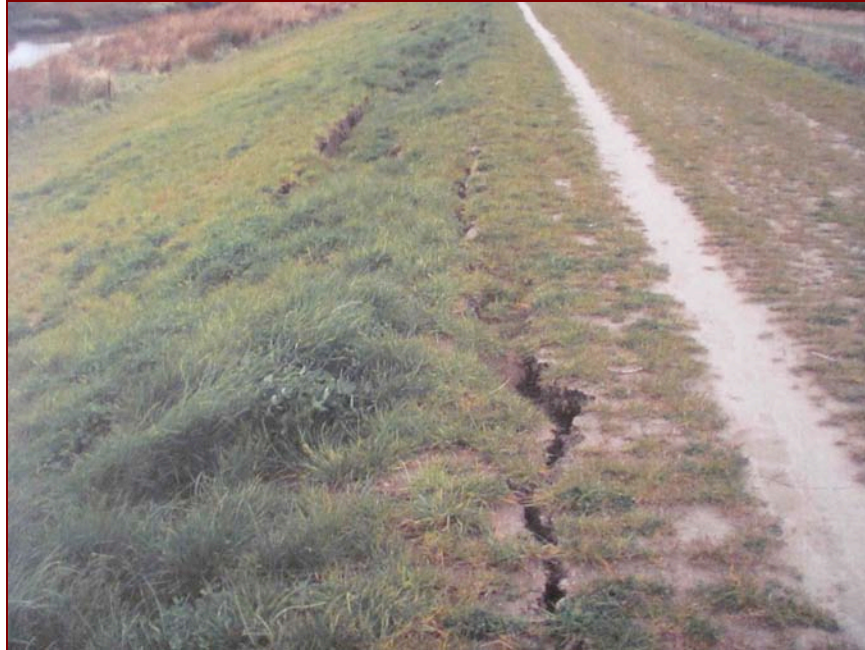
Figure 47. Moderate Damage - Stopbank
