Cleanfill Site Investigations, Marlborough 2010

Technical publication No 10-010

Mark Davies
Principal Contaminated Land Engineer
Sustainable Environmental Engineering Limited

Marlborough District Council
Seymour Square
PO Box 443
Blenheim 7240
Phone: 520 7400
Website: www.marlborough.govt.nz

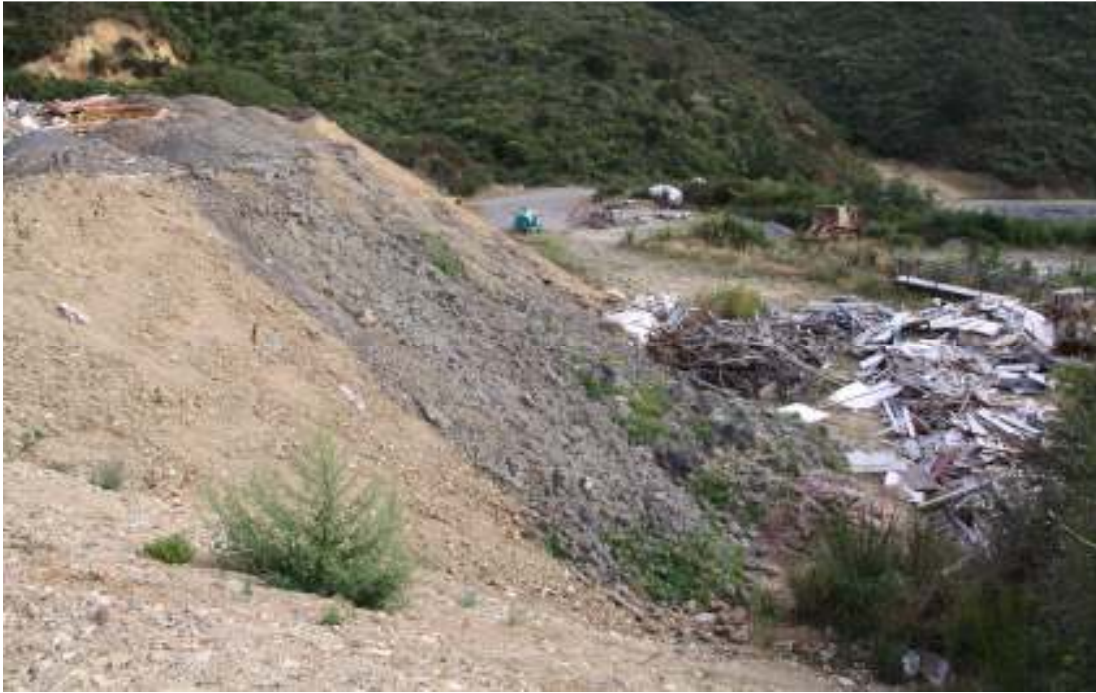
Photo 3: Picton Earthworks. View of the upper platform tip face and the middle platform with large quantities of timber placed on it

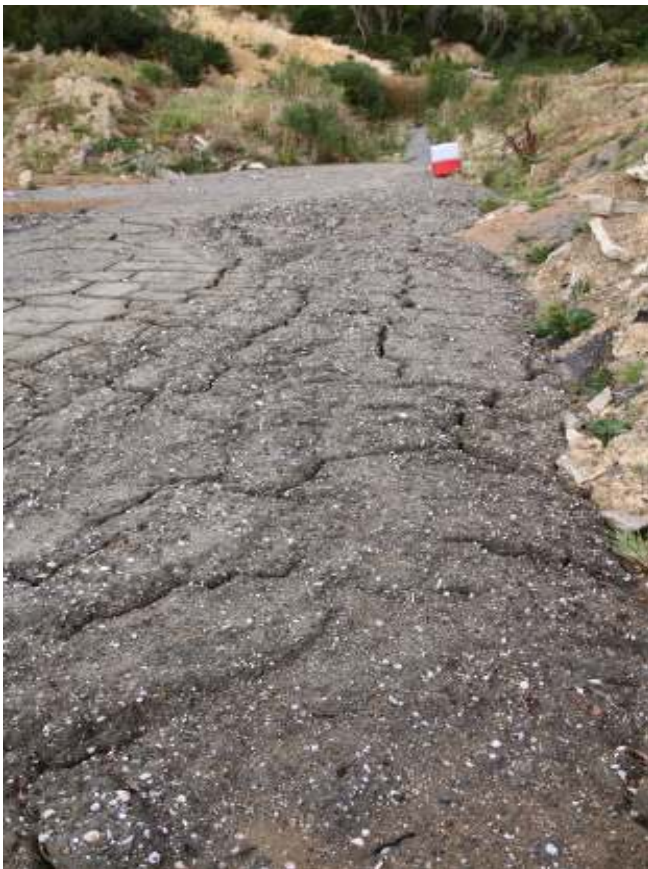
The soils in tests pits TP1 to TP3 consisted of a 600mm to 1m thick, heterogeneous, brown/tan, dry, slightly clayey FILL layer with sub angular to angular clasts of bedrock varying in size from 20mm to 400mm. Underlying the cover layer were the dredged marina sediments, which comprised of a dark grey, slightly moist, slightly clayey, sandy SILT with seashells scattered throughout. Photo 4 (Appendix 5) shows the nature of the dredged sediment.

The figures highlighted in Table 1 above indicates the soil samples, TP1 and TP2 taken from the marina dredged sediments contained elevated concentrations of copper and lead greater than the MDC 'trigger values'. Copper and lead are often found in antifouling paints/products used on boats. In addition soil samples from TP7 and TP8 contained concentrations of lead and zinc greater than the MDC 'trigger values'.

Photo 4: Picton Earthworks. View of the Picton Marine dredged sediments

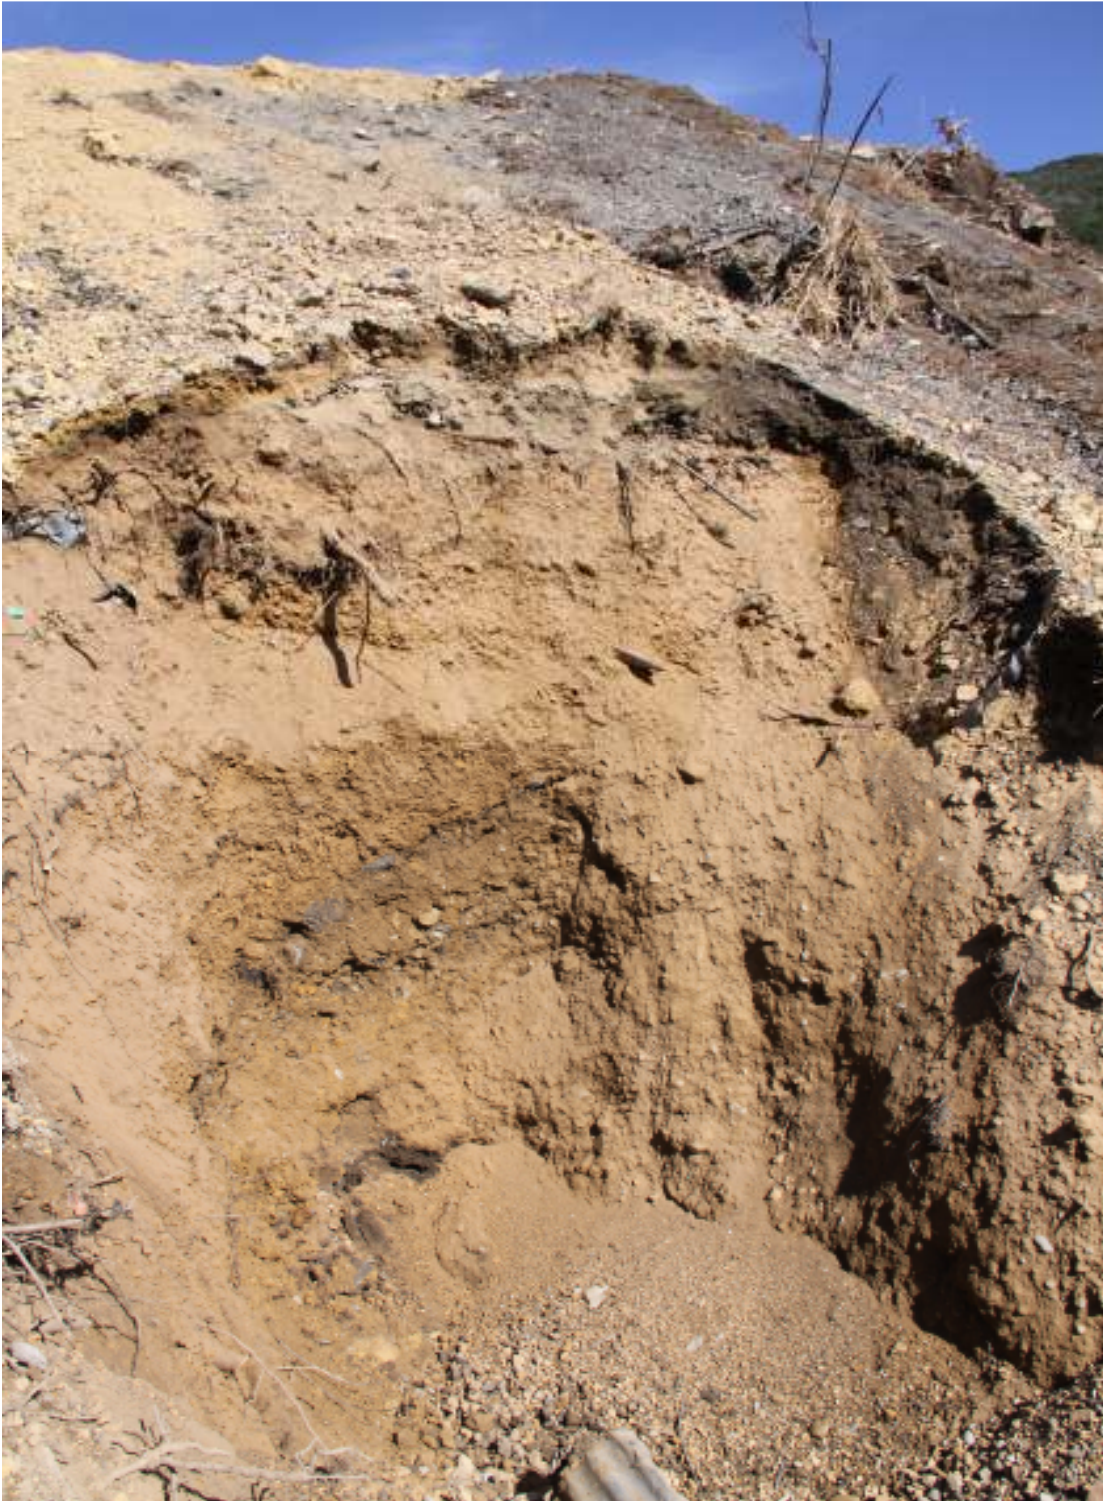
The soil in the two test pits (TP 9 and TP10) excavated in the base of the tip face ranged from a heterogeneous brown, dry to slightly moist, silty sandy gravel FILL to a silty sandy clayey FILL (Photo 5). The gravel was sub angular to angular in nature and ranged in size from 20mm to 60mm. Minor amounts of wood (roots) were present in the fill (<1%). One sheet of corrugated iron was present in the shallow fill.

Photo 5: Picton Earthworks. Test Pit 9 typical materials in the tip face

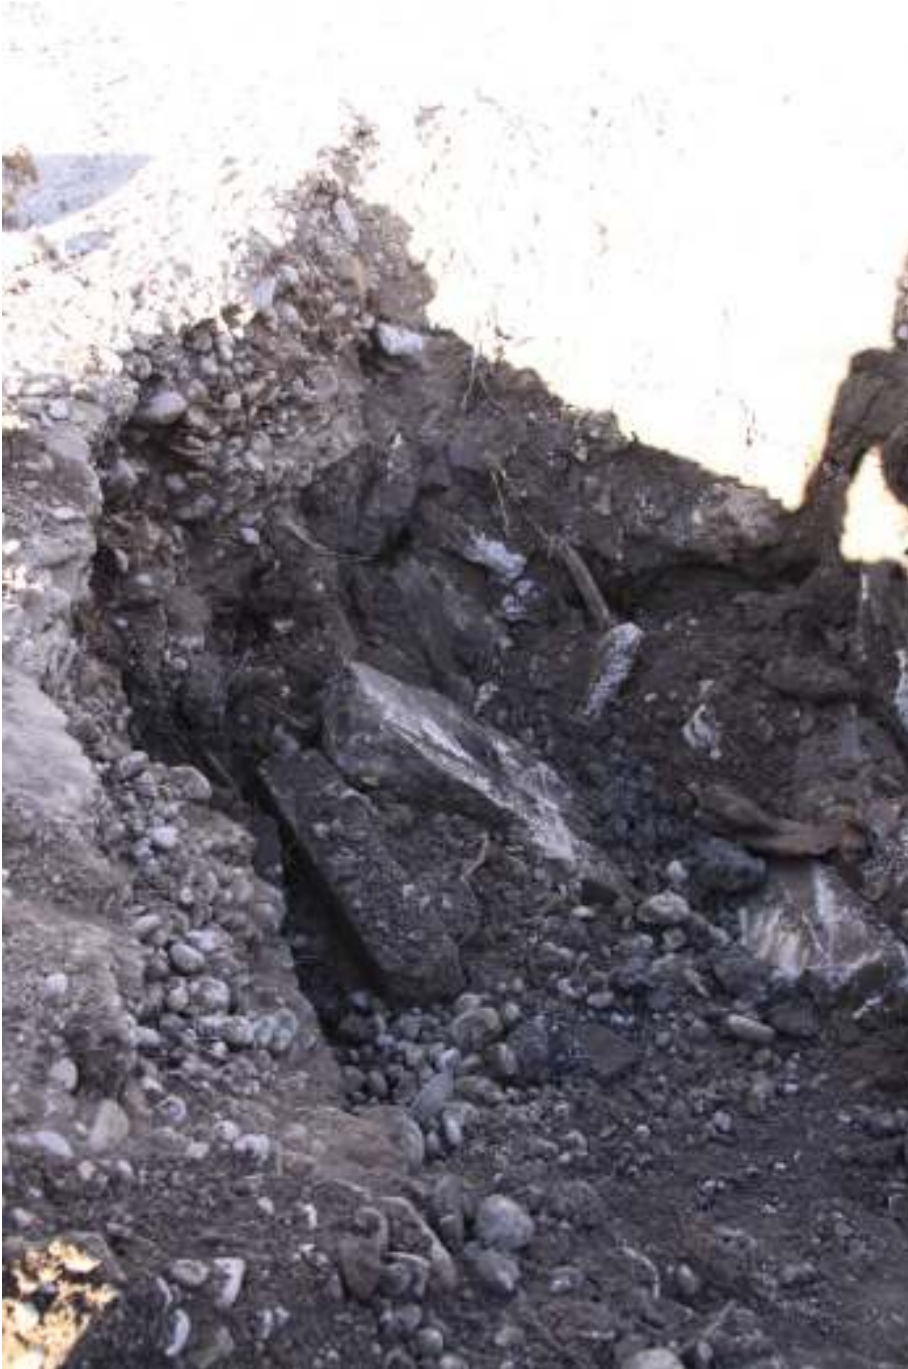
Underlying the gravel in the western area of the cleanfill site were large blocks of concrete with rebar (>1m) making up between 20 and 60% of the fill. Surrounding the concrete was a heterogeneous mix of dark grey, slightly moist, silty sandy gravelly fill with occasional patches of silty clay. Minor amounts (<5%) of mesh netting, wood and metal were noted within the fill. The large concrete blocks limited the vertical extent of the excavation.

Photo 12: Tuamarina Track - Test Pit 1 - showing large blocks of concrete

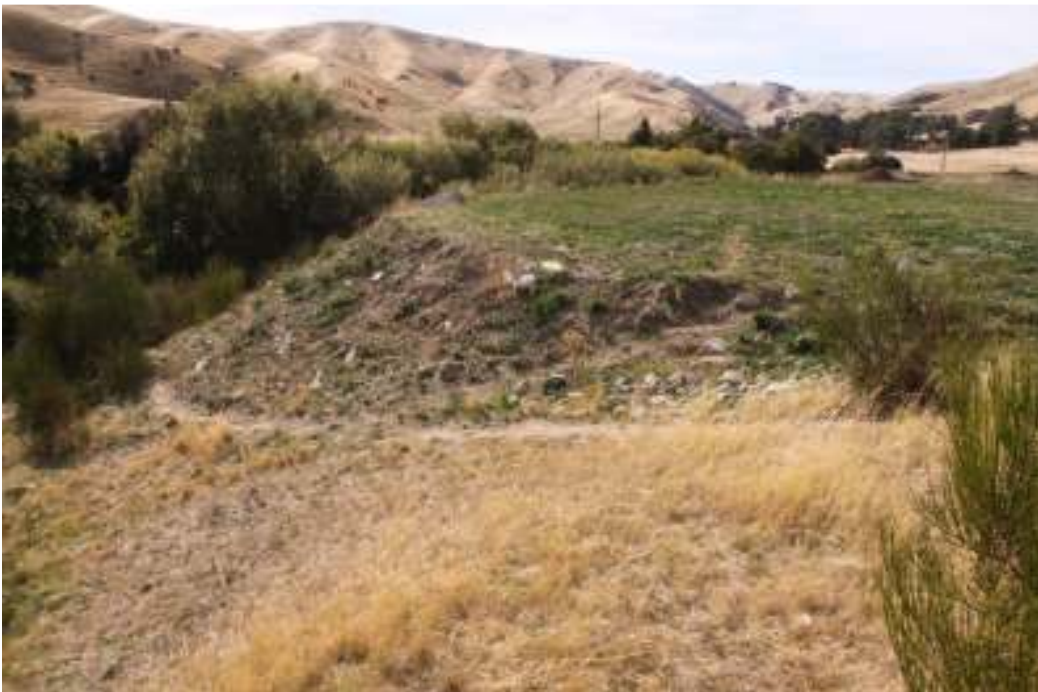
Photo 16: Taylor Pass Road- View of the tip face showing the depth of fill and the close proximity of the ephemeral stream

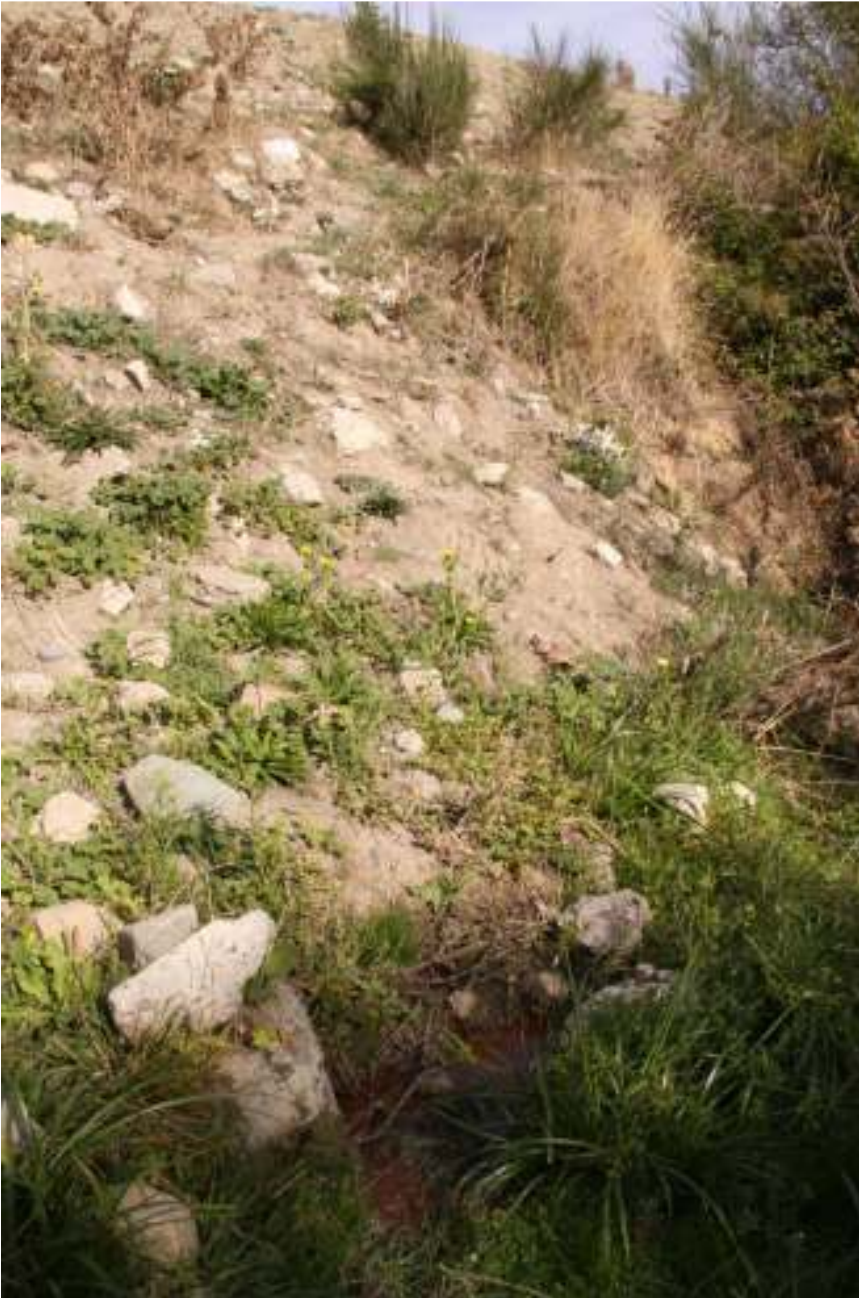
Colloidal iron rich leachate was noted emanating from the base of the cleanfill site (Photo 17 and 18) and flowing into the ephemeral stream. Sediment samples were taken for chemical analysis the results of which are detailed in Section 6.6 below.

Photo 17: Taylor Pass Road - View showing leachate migrating from the base of the cleanfill site

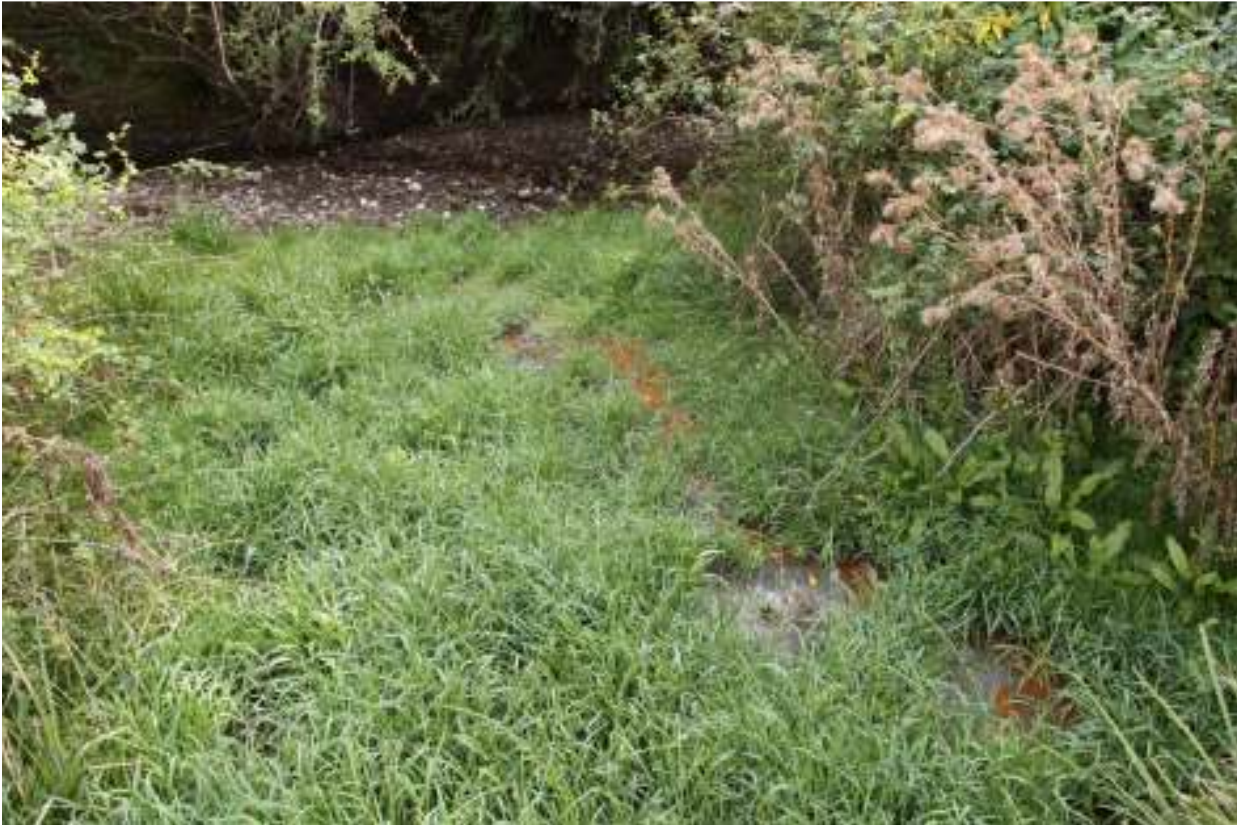
Photo 18: Taylor Pass Road - View showing leachate from the cleanfill site flowing into the unnamed ephemeral stream

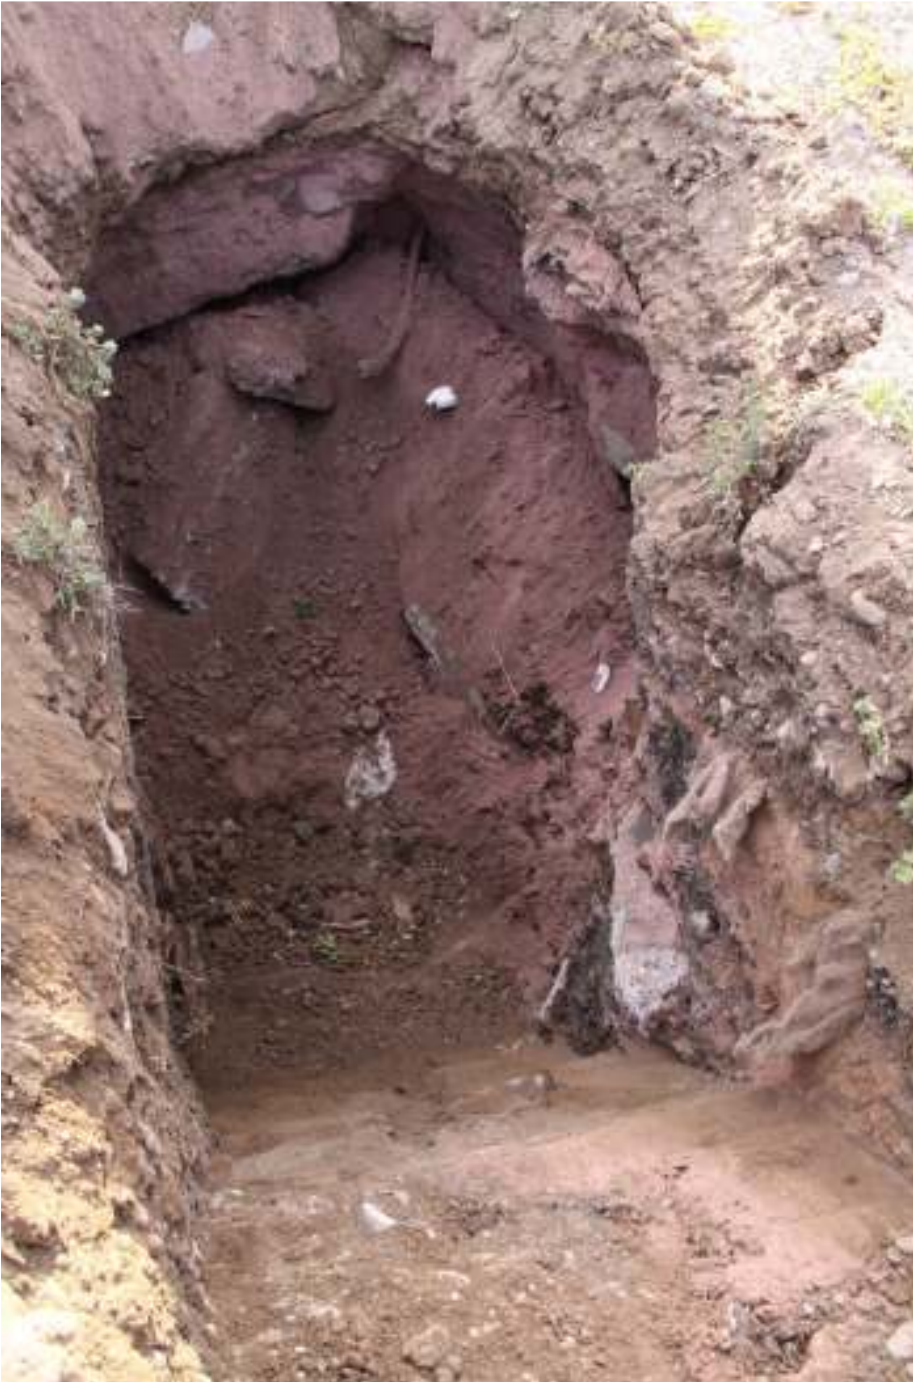
Test Pit 4 contained a 700mm to 900mm thick layer of brownish pink, dry, loose, fine to medium grained sand with minor amounts of cut metal objects (Photo 19 in Appendix 5). The sand is thought to be from a sand blasting process. Samples of the sand were taken for chemical analysis the results of which are discussed in Section 6.6 below.

Photo 19: Taylor Pass Road - TP4 - Sand blasting materials
