# Winery Wastewater Monitoring Report 2011-12

(Clr Jerram) (Report prepared by Brenda Pottinger)

C270-26

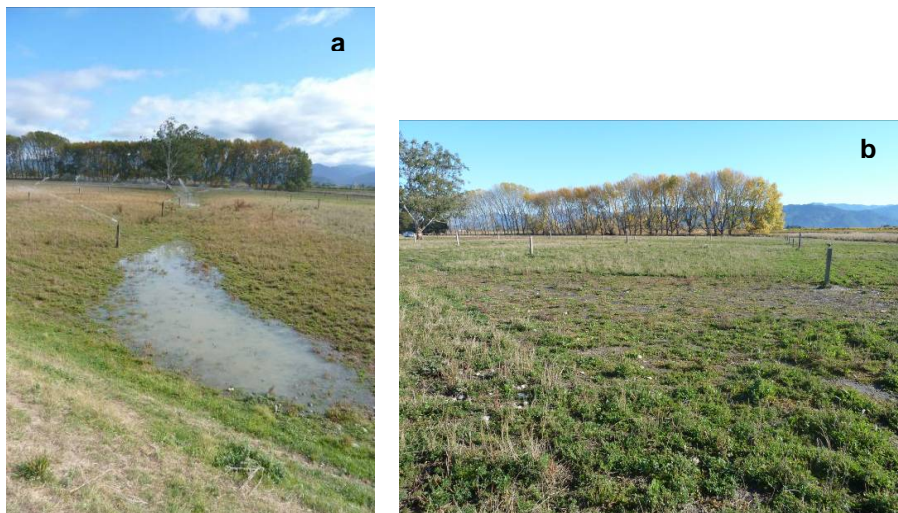
14. The main issue observed during inspections involved ponding in the disposal fields of three wineries (Figure 2). Ponding can occur because irrigation rates are too high, wastewater is applied to soils that have reached field capacity (i.e. irrigating during high rainfall events), the disposal area is too small for the volume of wastewater discharged, or poor management of the wastewater system and disposal fields. Over-irrigation can lead to leaching of excess water to groundwater, and with it salts (e.g. sodium [Na<sup>+</sup>] and potassium [K<sup>+</sup>]), organic carbons (e.g. sugar and ethanol) and nutrients (e.g. nitrogen and phosphorous) not used by soil microorganisms or held by the soil matrix. Of particular importance is the potential for Na<sup>+</sup> and K<sup>+</sup> to accumulate in the soil profile, which may result in altered soil structure or poor plant growth. These potentially negative effects require more intensive research and understanding. More comprehensive monitoring is also required with specific wineries to determine the causes of ponding to ensure adverse environmental effects are prevented or remediated.

**Figure 2:** a) Example of ponding in disposal area - irrigation to this block was ceased immediately and no further wastewater was applied for the remainder of vintage.  
b) Disposal block with no further ponding after irrigation ceased.

15. Short term corrective actions undertaken by the three wineries to address ponding included: ceasing discharge for the rest of vintage to allow a rest period for the soil; using an alternative disposal area for discharge; holding excess wastewater in storage until the consented daily volumes could be met; reducing the volumes of wastewater applied and/or improved management of the wastewater and irrigation systems. Actions taken should help to avert the potential for wastewater entering underground aquifers, overloading of soil and altering of soil structure. More long term actions may include soil remediation (soil ripping and planting of different pasture species to improve uptake of wastewater), alterations to the wastewater and irrigation systems for more optimal volumes discharged, or retiring disposal areas and moving to land that is more appropriate for discharge.
