Seismic Assessment of Old Nurses Quarters, Wairau Hospital, Blenheim

Initial Seismic Assessment Report

for Old Nurses Quarters at Wairau Hospital, Blenheim

6th July 2018

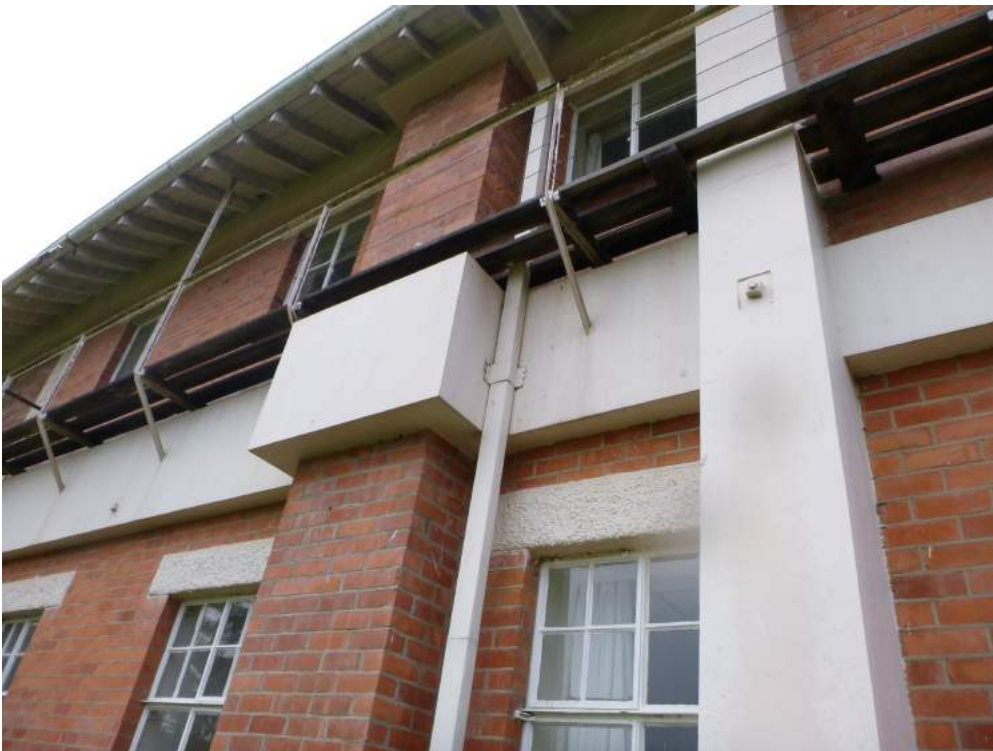
The original 2-story building was strengthened at some point by the addition of concrete buttresses and concrete bond beams at first floor and roof level on the exterior of the building. No drawings of these strengthening works have been sighted. A report by Sinclair Knight Merz (SKM) in 2002 indicates the building was strengthened in 1943.

Photo 14: Buttressing and bond beams to original building

- Install additional concrete buttresses to the exterior of the building.
- Investigate size of foundations to existing buttresses and strengthen as necessary.
- Strengthen the brick walls by installing strong-backs to the walls.
- Removal of brick chimneys.
- Strengthen the first floor and roof diaphragms.
- Install roof bracing.

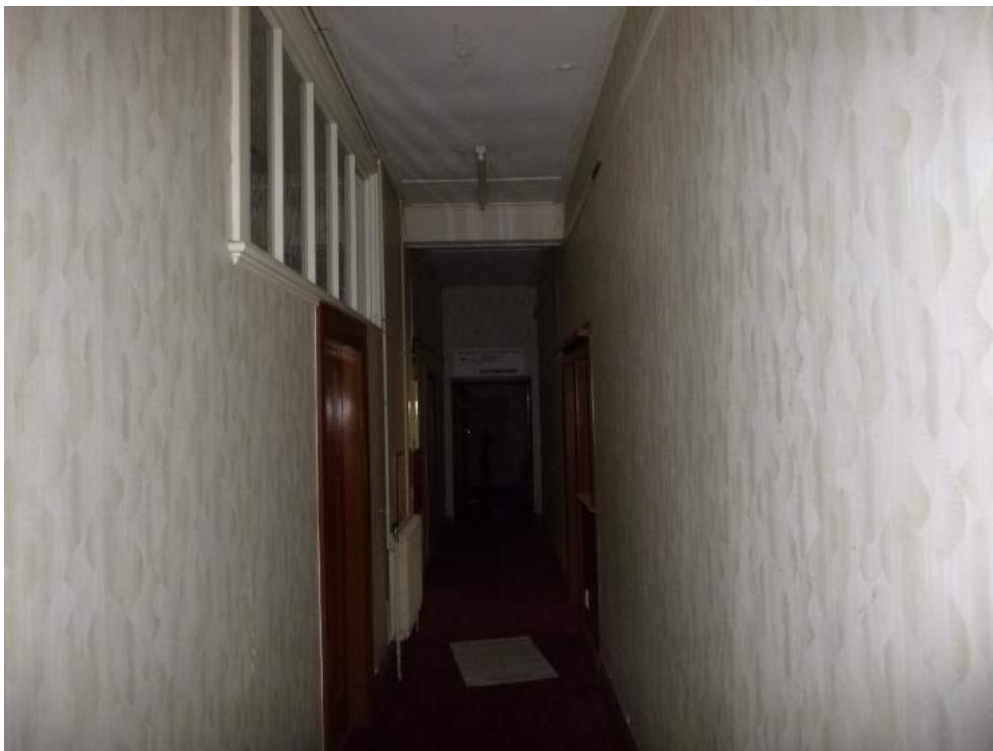
Photo 16: Loadbearing corridors at lower level

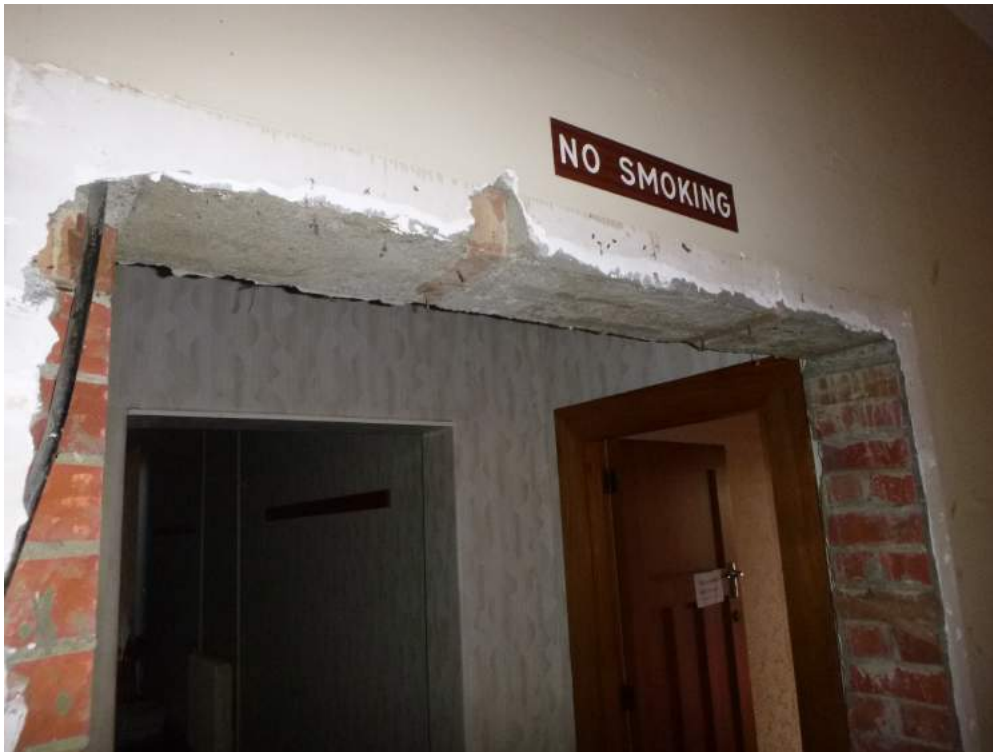
Photo 17: Opening in corridor walls – loadbearing brick

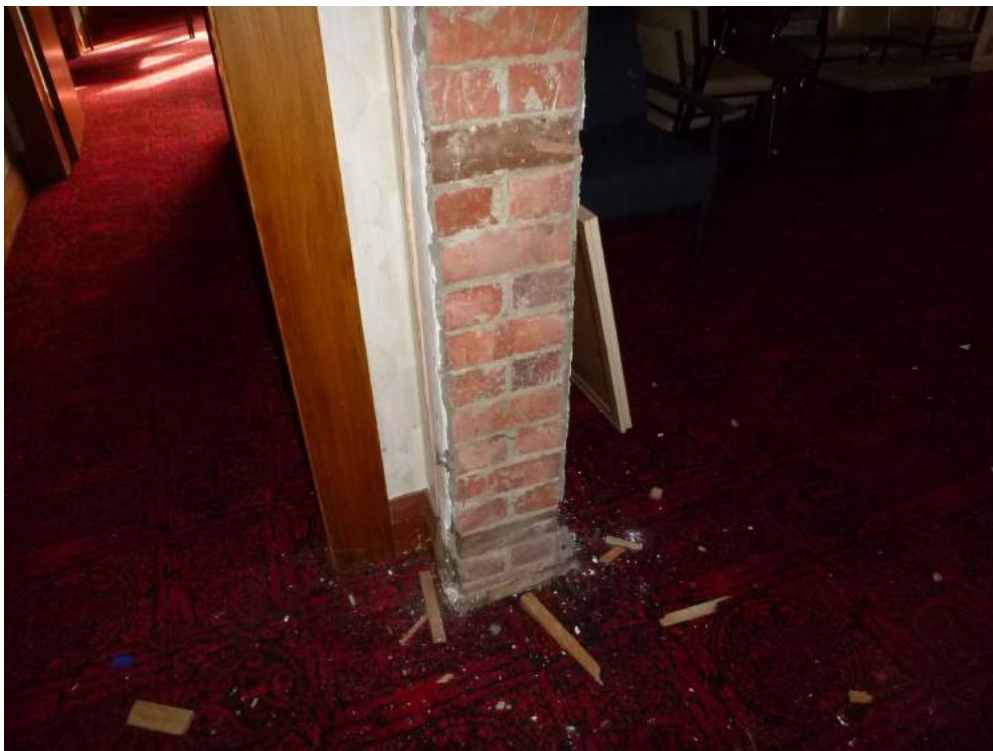
Photo 18: Brick walls of corridor

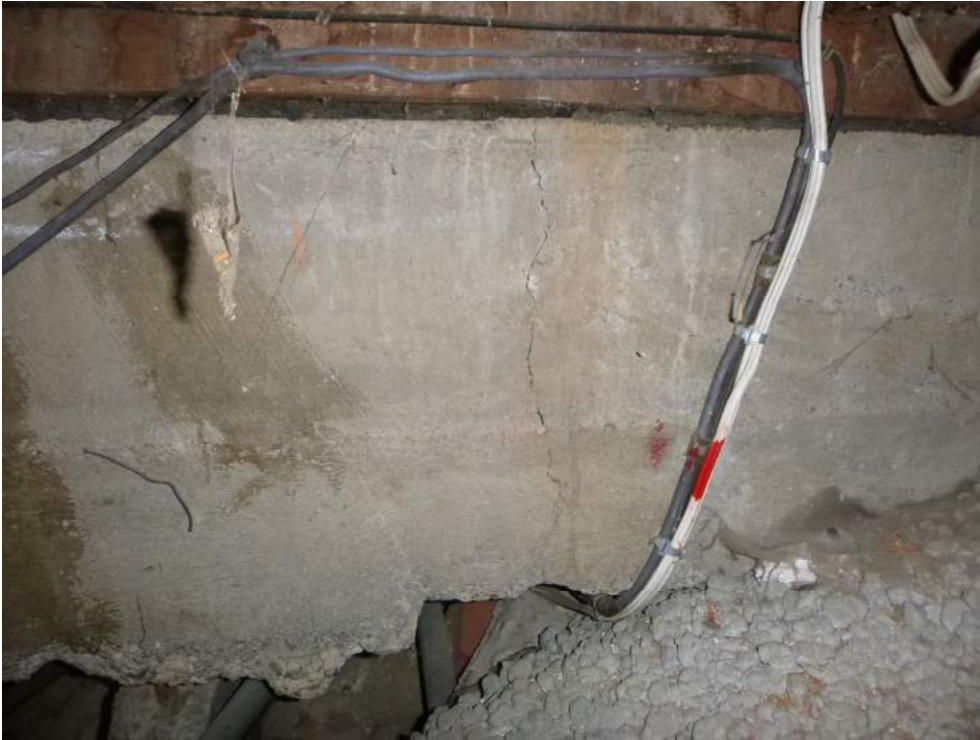
Photo 25: Crack in foundation wall at dining room

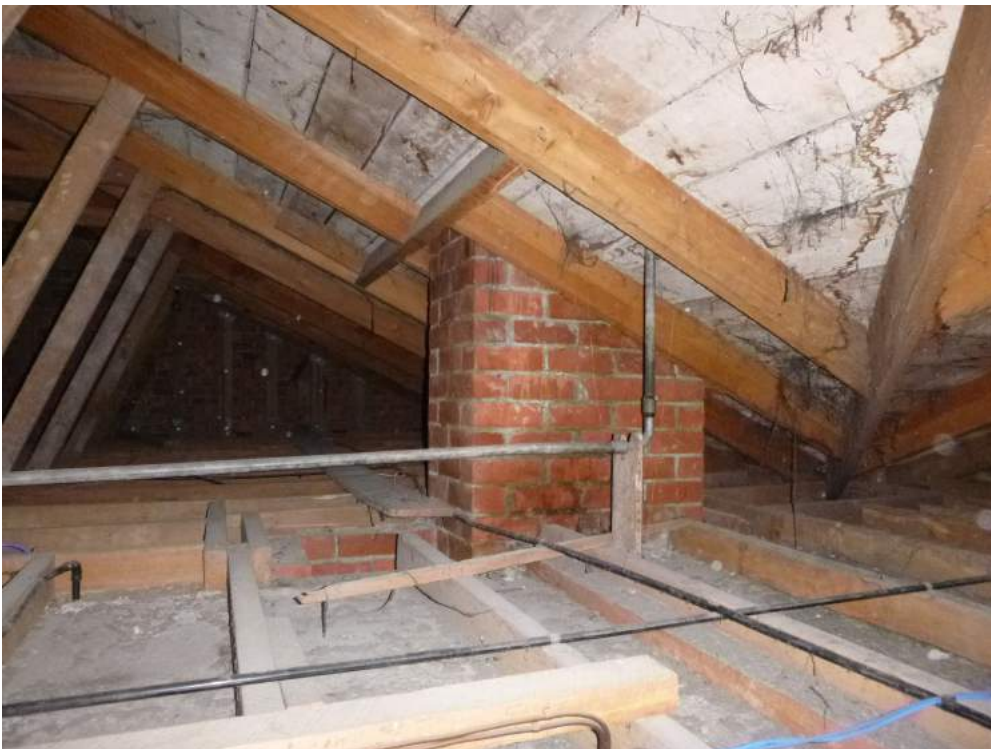
Photo 26: Timber roof framing, timber sarking, brick chimneys

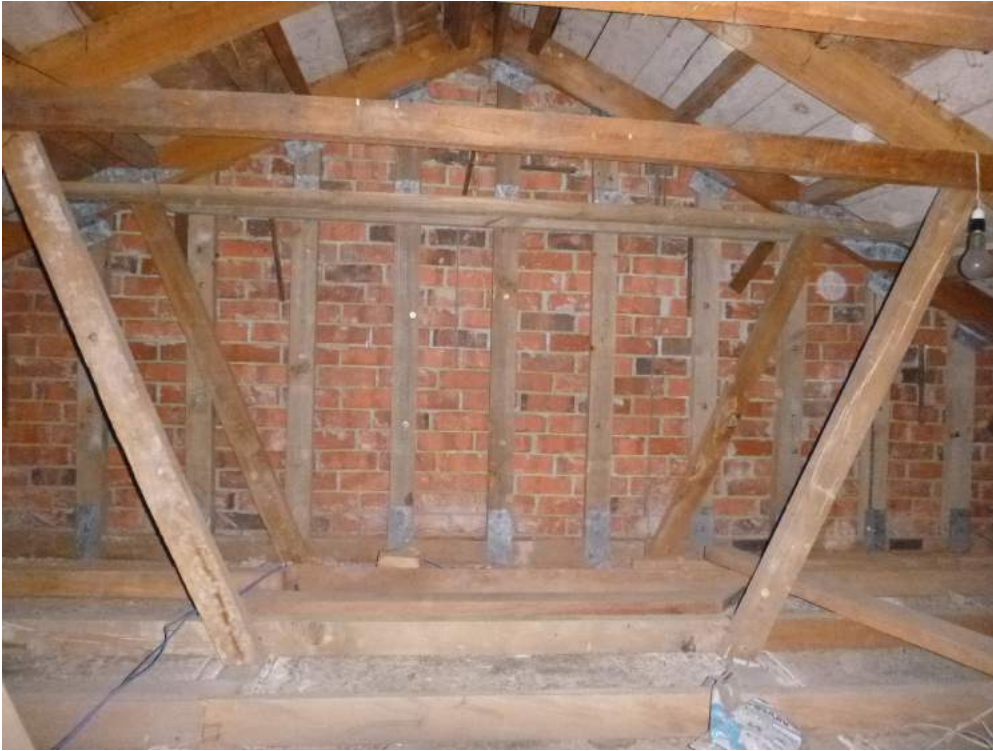
The building was converted to Board Administration and Public Health offices in 1982. As part of these renovations the brick gable ends of the original building were strengthened.

Photo 27: Brick gable wall with strong-back strengthening

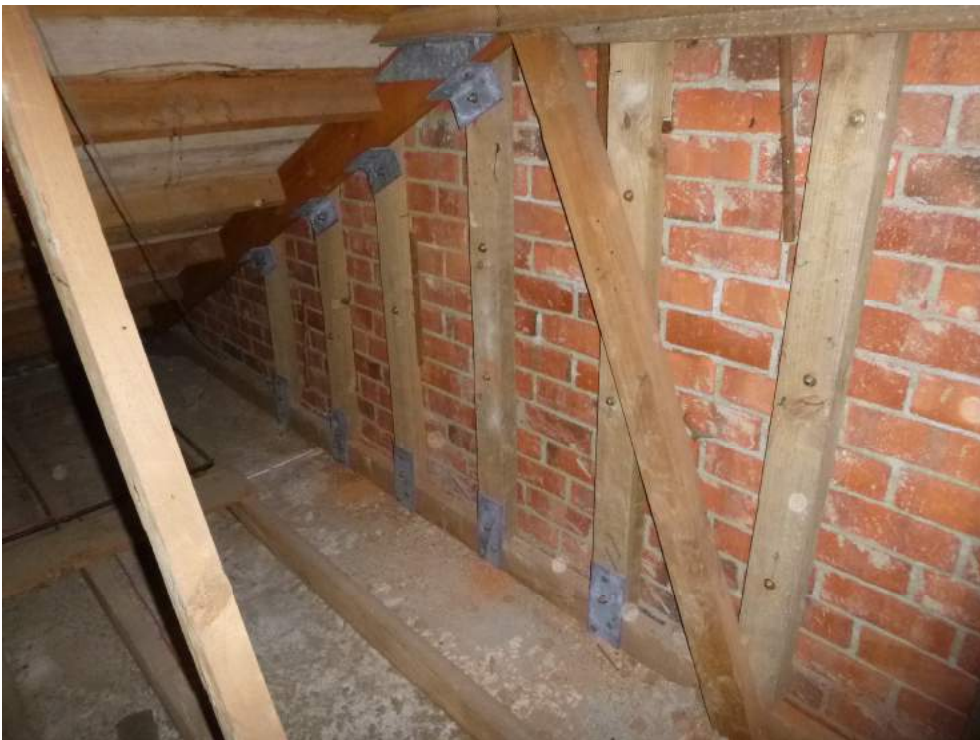
Photo 28: Connection brackets at brick gable wall

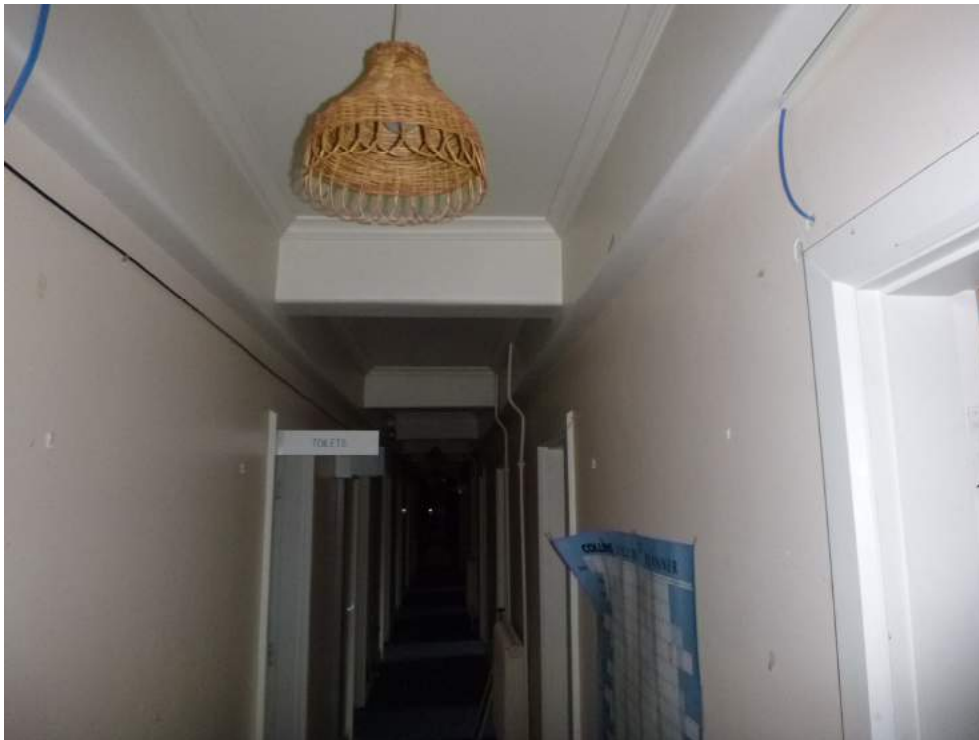
Photo 29: Bond beams over corridors in south-west extension

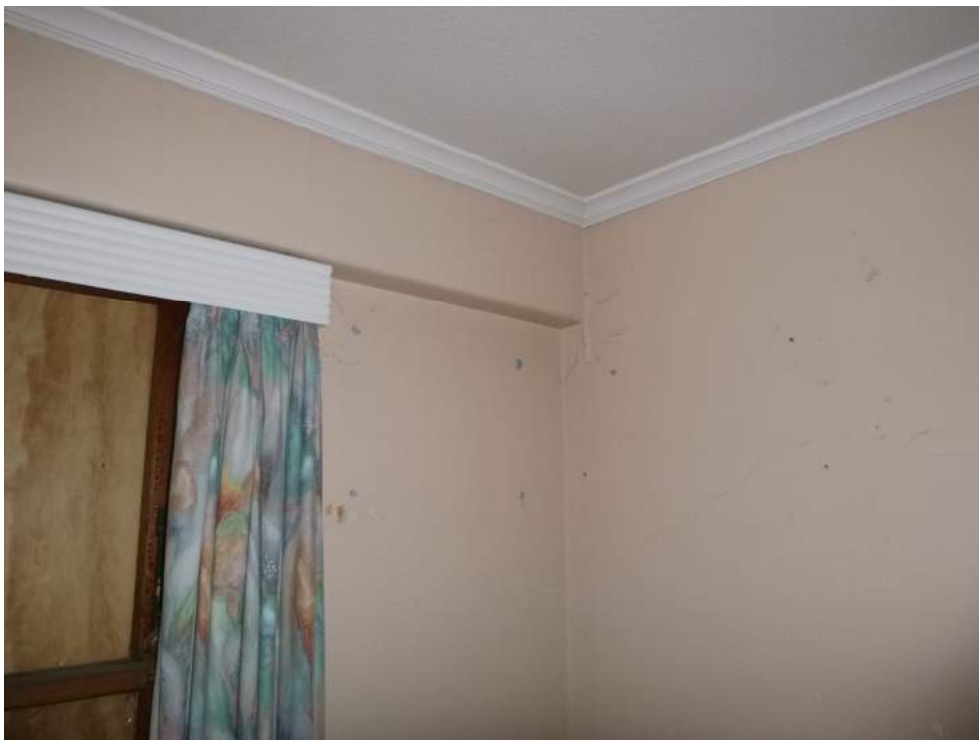
Photo 30: Bond beams over exterior wall in south-west extension

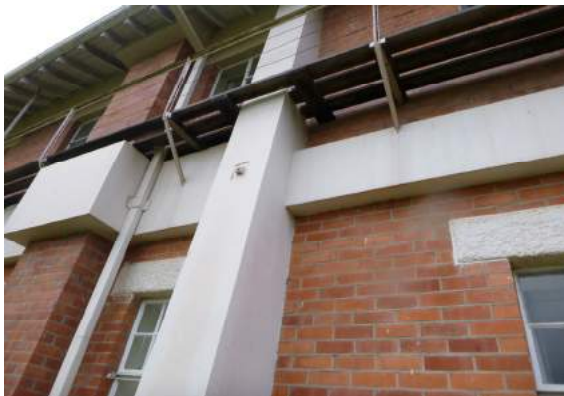
Concrete buttresses and bond beams added to exterior of building

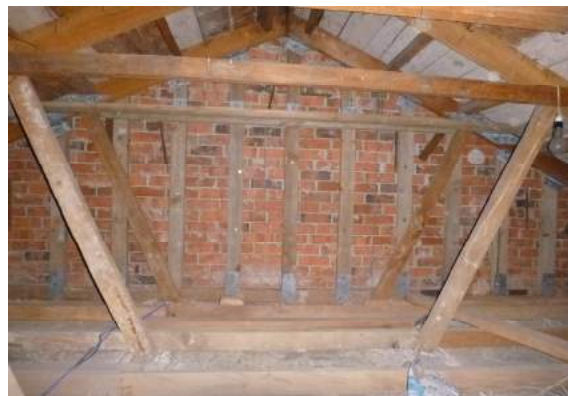
Strengthening to Gable Walls

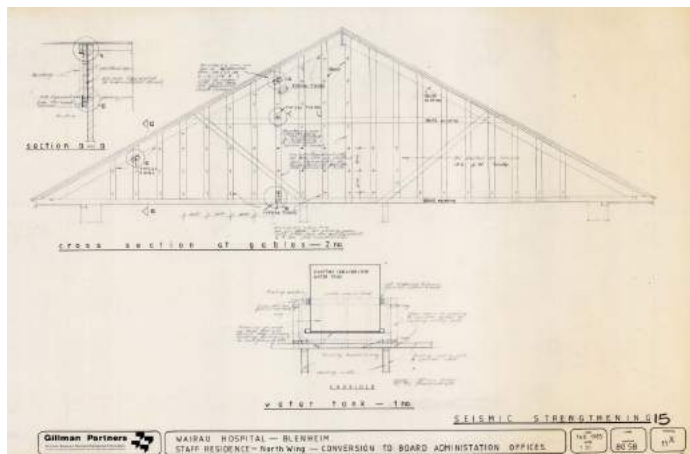
Details of Seismic Strengthening to Gable Wall
