**MARLBOROUGH
DISTRICT COUNCIL**

Dairyshed Effluent and Stream Crossing Survey 2016/2017

**Technical Report No: 17-004
July 2017**

MDC Report No. 17-004

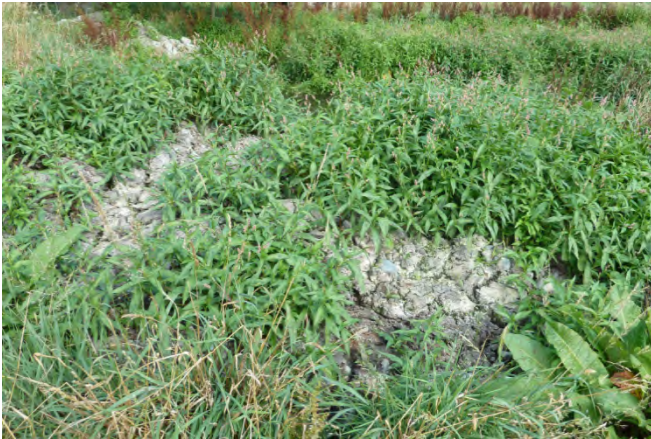
Effluent pond is full with vegetation and solids build-up

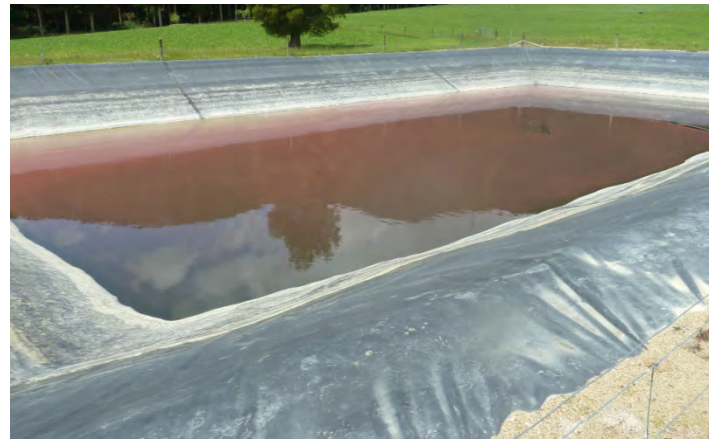
Effluent pond has plenty of free-board available
