**Phase I: Reconnaissance report on landslides  
caused by the 16–18 July 2021 rainstorm in the  
Marlborough region**

**GNS Science Report 2022/08  
March 2022**

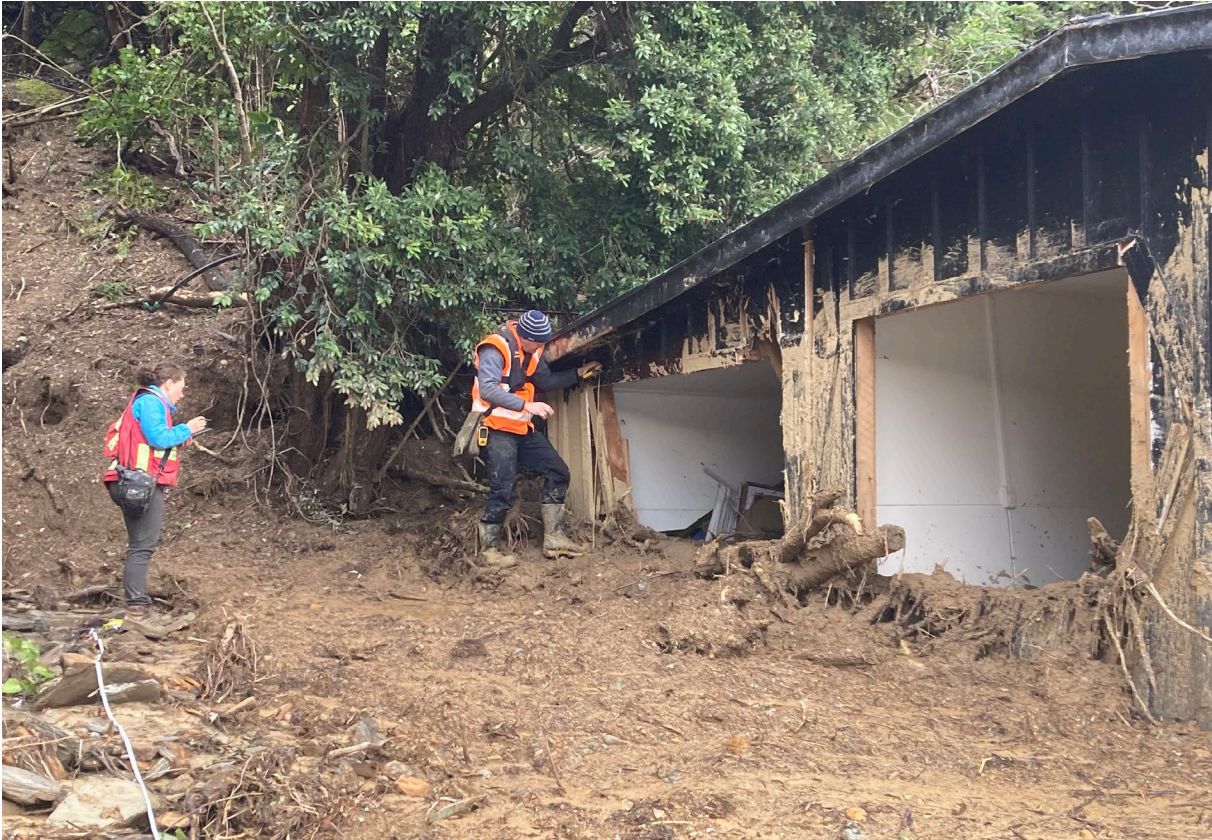
Figure 2.5 Surveying of landslide debris; measuring inundation along building side. We measured maximum run-up signs (here, above the building windows) not the height of the debris at the time of survey (here, at the base of the windows).

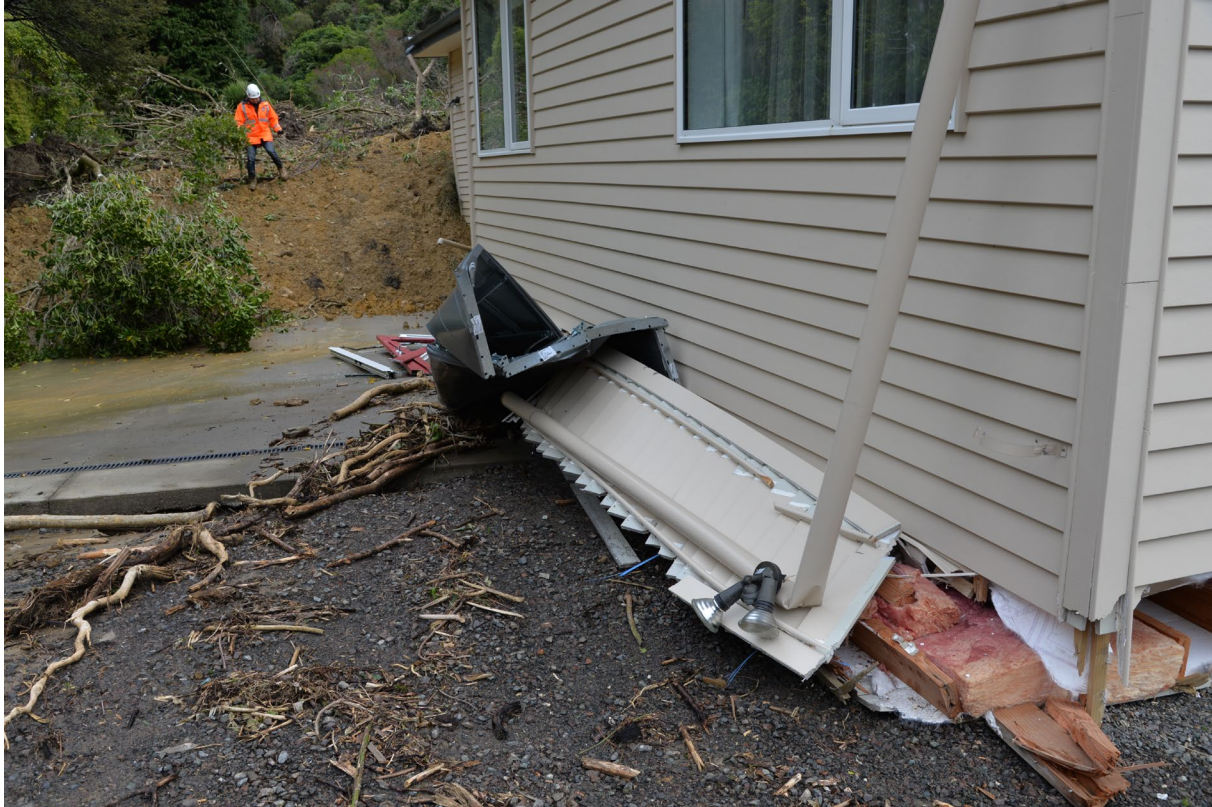
Figure 2.6 Inspecting and assessing structural damage to a home impacted by a debris avalanche.

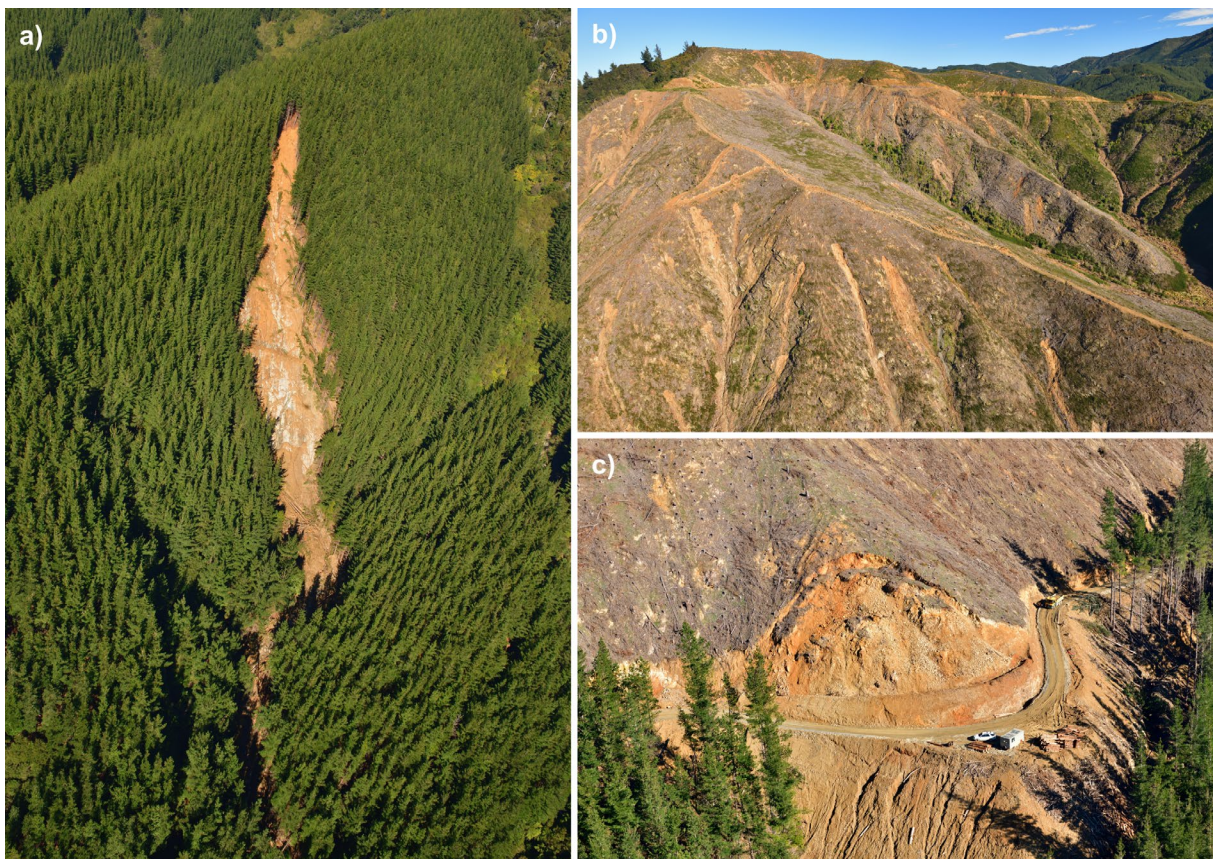
Observations from the reconnaissance flight indicate that the main types of landslides triggered by the storm event were debris avalanches and debris slides, which often coalesced downslope to form channelised debris flows and floods (see Appendix 1), several of which impacted houses and dwellings (see Section 3.2). Most were shallow (<5 m, Figure 3.1a, b), but several deeper-seated landslides and slumps were also observed (Figure 3.1c), some of which also involved local cracking and slumping (Figure 3.1c). There were several small debris avalanches and slides on the coastal slopes of the Sounds (Figure 3.2). See Appendix 1 for further examples of landslides.

Figure 3.1 Types of landslides observed. (a) Debris slide/flow initiated in shallow regolith, probably at the regolith-bedrock interface, on slopes with established exotic forest cover (Cullen Creek catchment, near Linkwater). (b) Shallow debris flows on recently logged slopes near Onamalutu. (c) Slump in recently harvested area on Daltons Road, Pelorus.

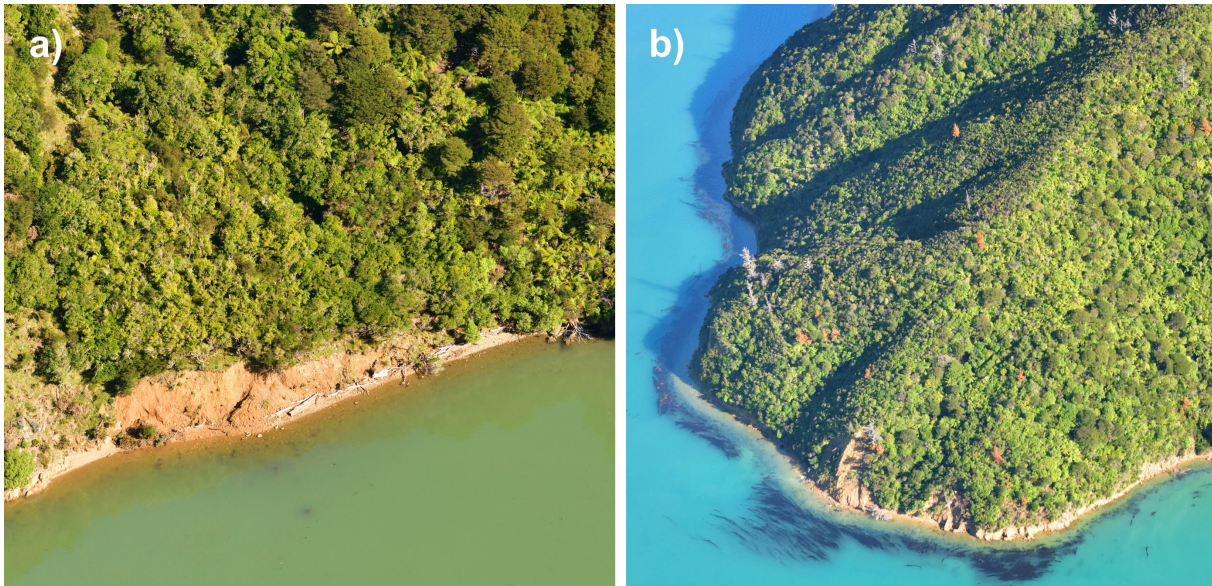
Figure 3.2 Small debris avalanches on coastal slopes in regenerating native bush and scrub. (a) Pipi Beach, Hikapu Reach, Pelorus Sound; (b) Ngaionui Point, Tory Channel.

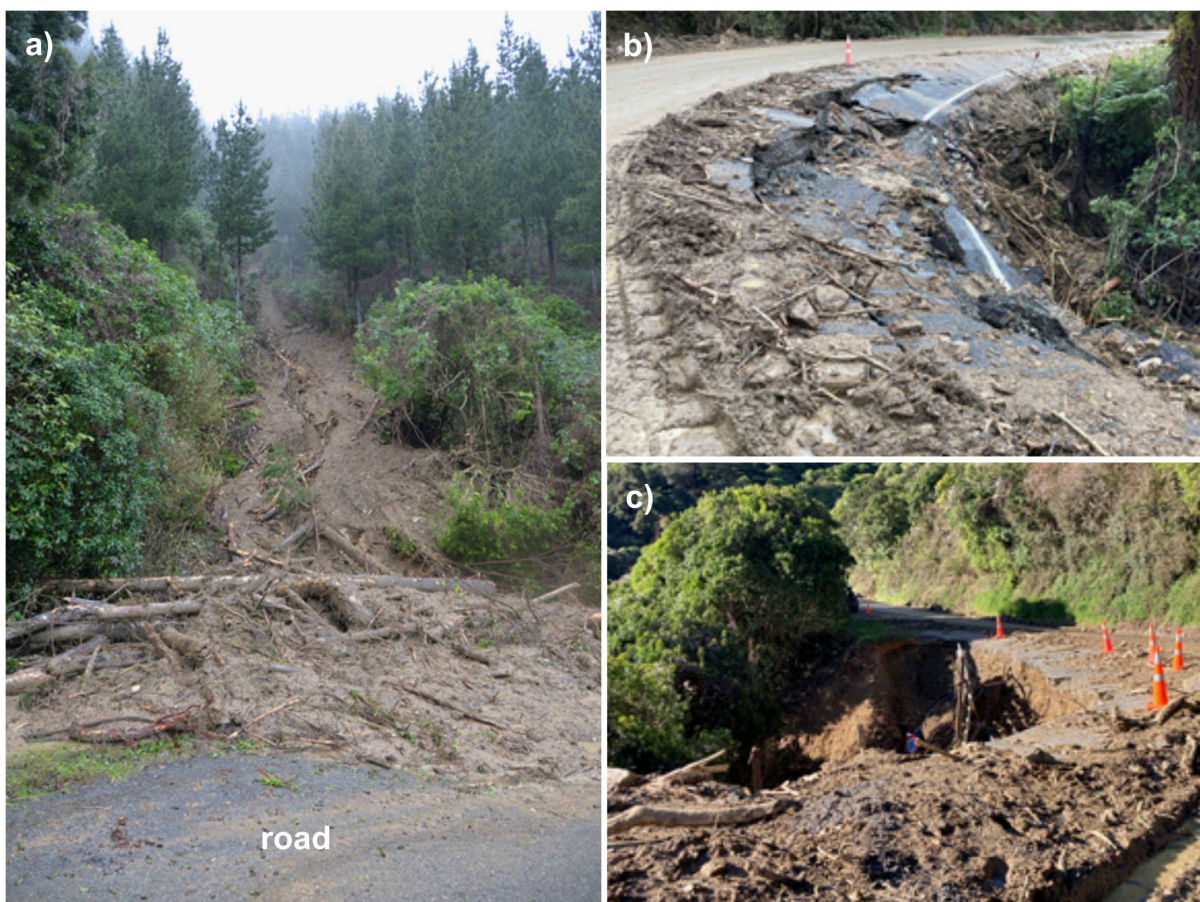
Figure 3.4 and Table 3.1 show the washouts and landslides noted along roads en route to field assessment sites. Approximately 57 events were observed in recently harvested forestry blocks and on cut and fill slopes adjacent to the roads. Access to much of Kenepuru Road was impossible due to road damage and blockages from landslides; hence, the landslides we observed along the road are only a fraction of the true number. Of the hundreds of landslides initiated along Marlborough road corridors during the storm, over 100 required engineering mitigation and 20–30 are large instabilities that continue to move (D Mason, WSP, pers. comm. 2021). Further analysis of landslide distribution along road corridors will be presented in the Part II report.

Figure 3.4 Examples of landslides impacting the Marlborough region. (a) shows a debris flow from a channel above the road travelling across and down the road; (b) and (c) show fill slope failures that caused road closures.

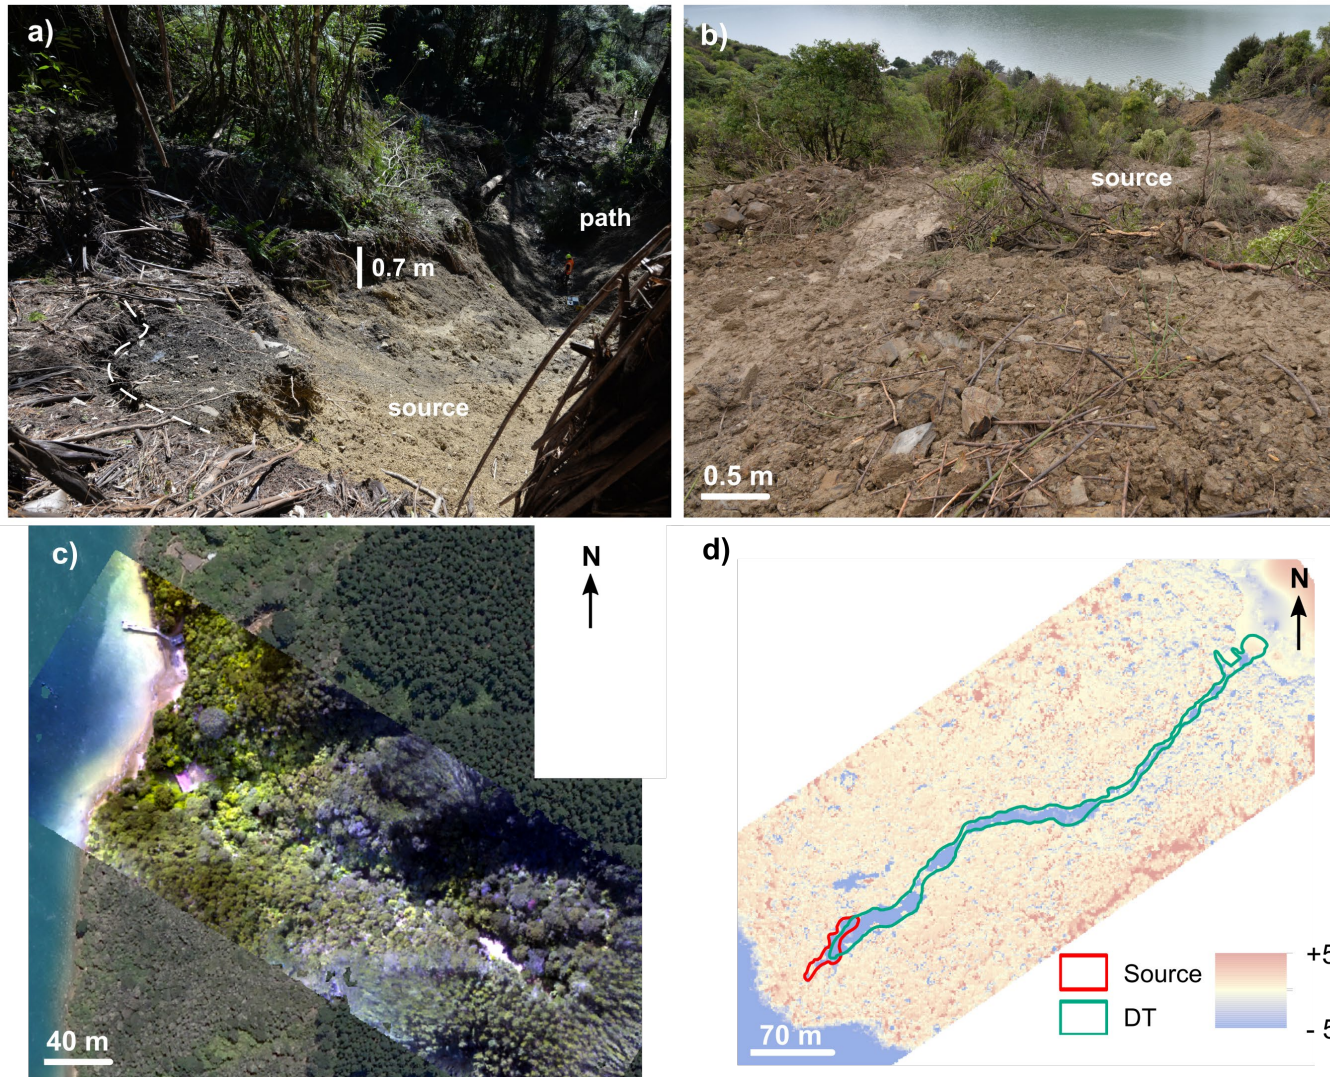
Figure 3.5 Examples of landslides visited during field assessments. (a) Debris flow-flood source area with tension cracks and remaining block above headscarp (dashed white curve). (b) Debris avalanche source area showing texture of material that failed, including blocks and large woody debris. (c) Sample UAV 3D model orthophoto, highlighting the steep, densely vegetated terrain. Source area is a highly reflective area at lower right, and debris travelled to the sea in the existing gully. (d) Sample UAV model – 2020 LiDAR DSM difference model, showing areas of deposition (red), erosion (blue) and the mapped landslide source and debris trail (DT).

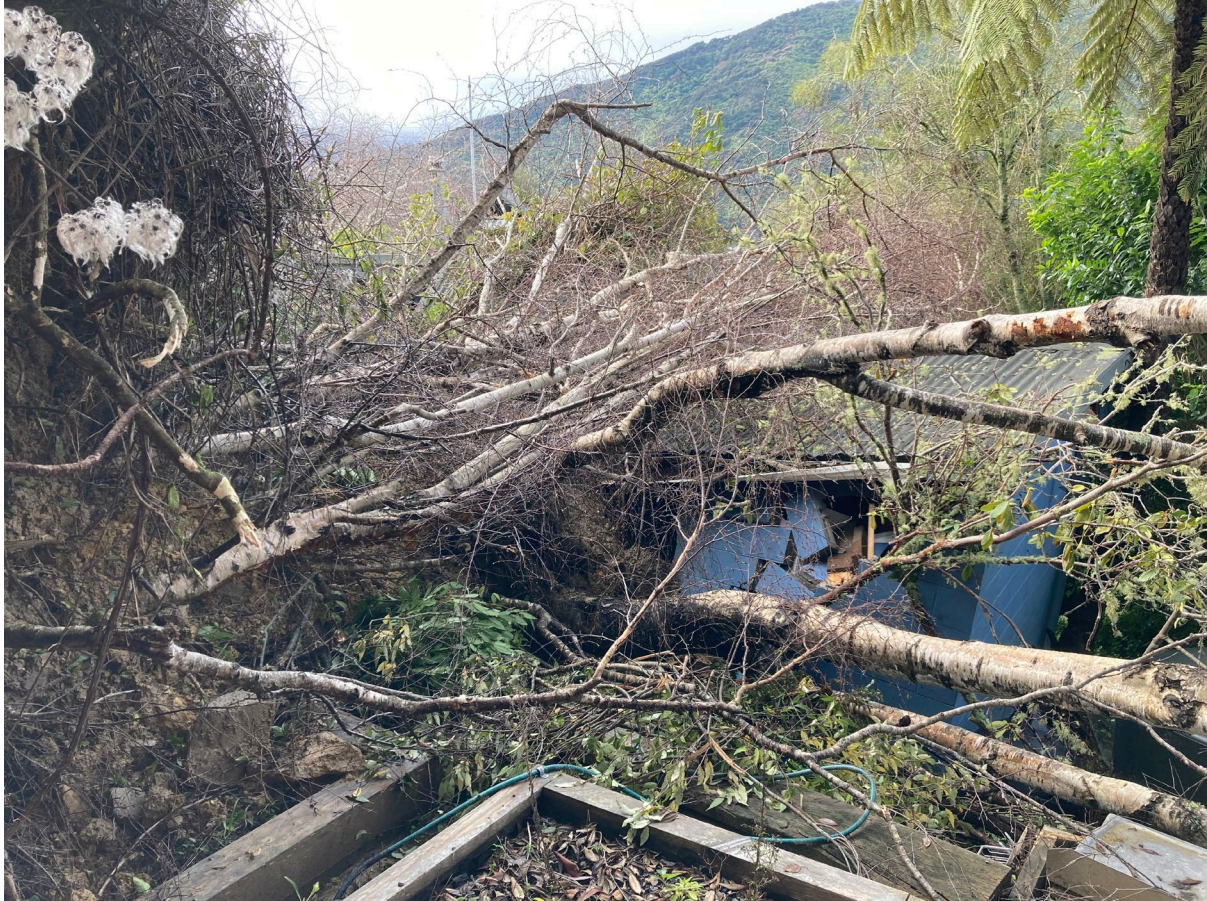
Among the 18 surveyed buildings, four of them were classified as R2 colour tagging (entry prohibited, severe damage to building, Table 3.4). They were either buried or washed away by debris or had collapsed (ground floor destroyed by debris). Despite the severe damage, no deaths or injuries were reported, as the houses were vacant during the event. Most of the houses were holiday homes in Queen Charlotte Sound.

Figure 4.2 Damage to a building from large woody debris.

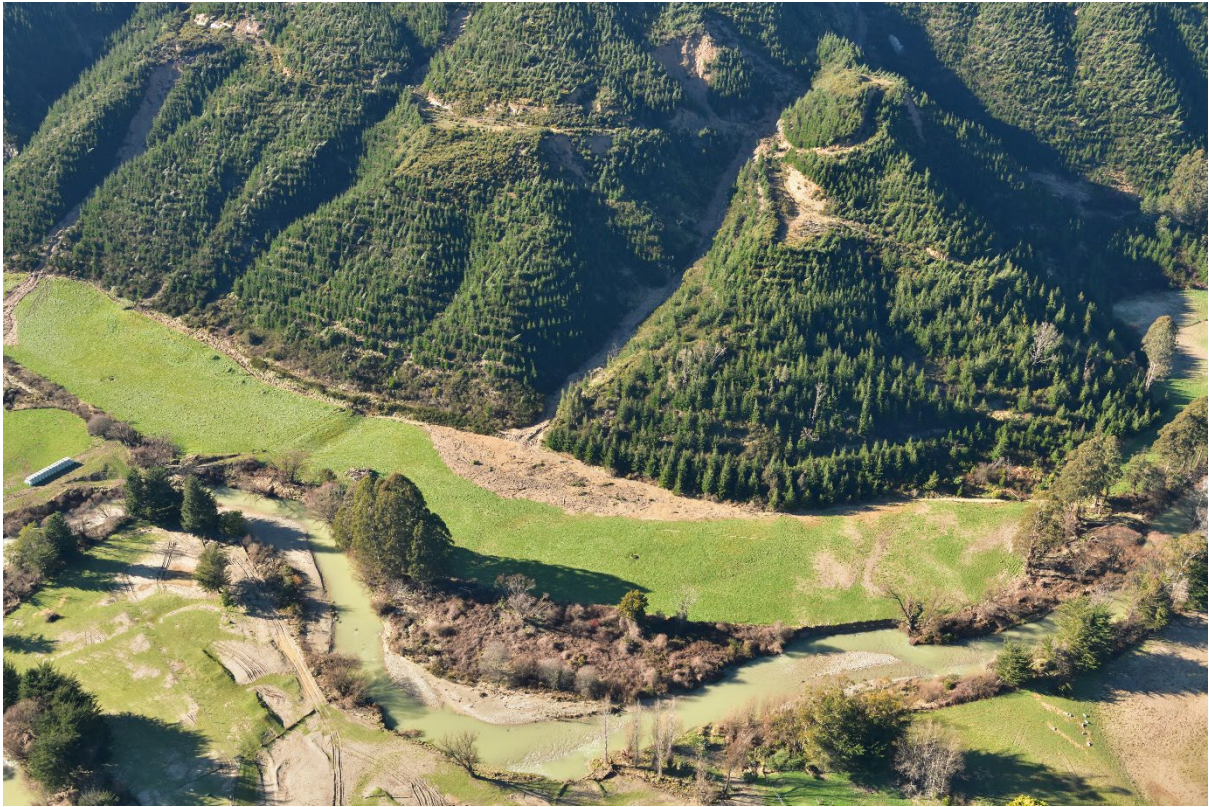
Figure A1.1 Channelised debris flow from established forestry, possibly associated with the forestry road or earlier forestry infrastructure (skid site/landing), Ohinemahuta River, Onamalutu.

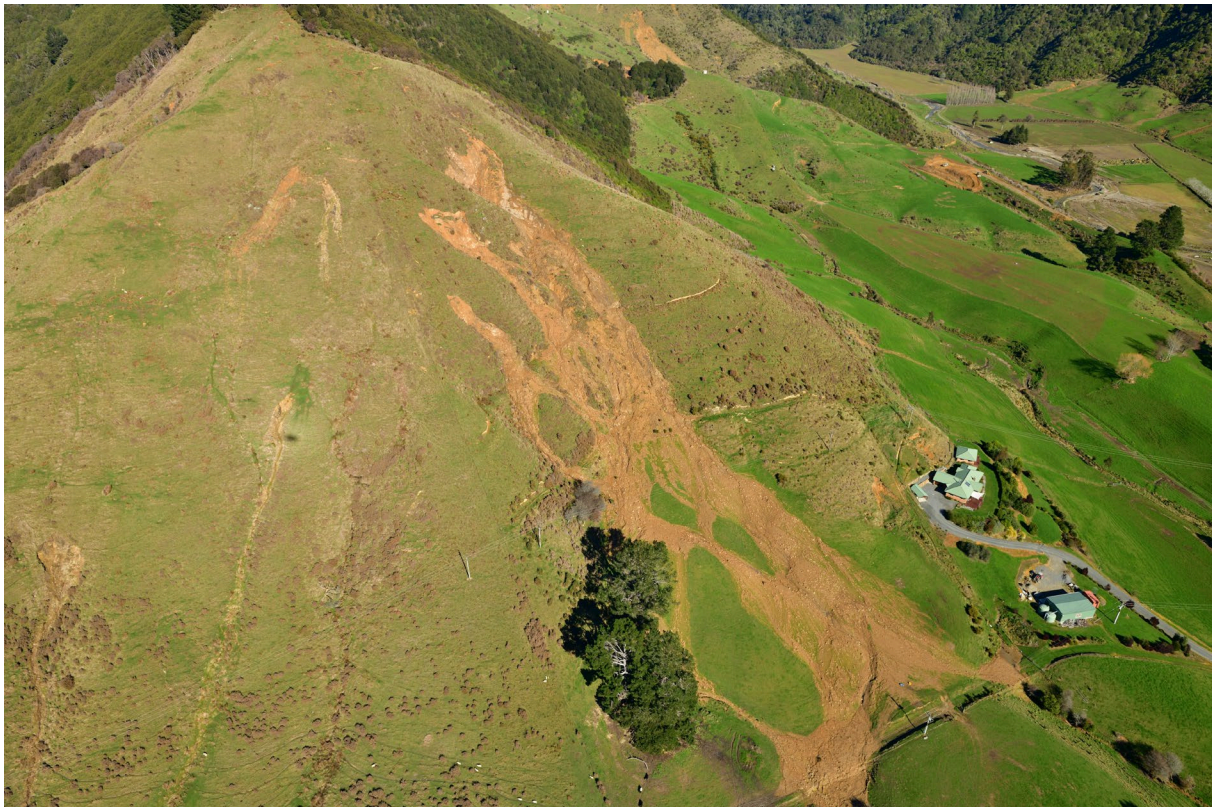
Figure A1.2 Coalesced debris flow deposits from shallow debris flow/slides on steep pasture slopes at Oruapuputa, south side of Mahakipawa Arm, Pelorus Sound.

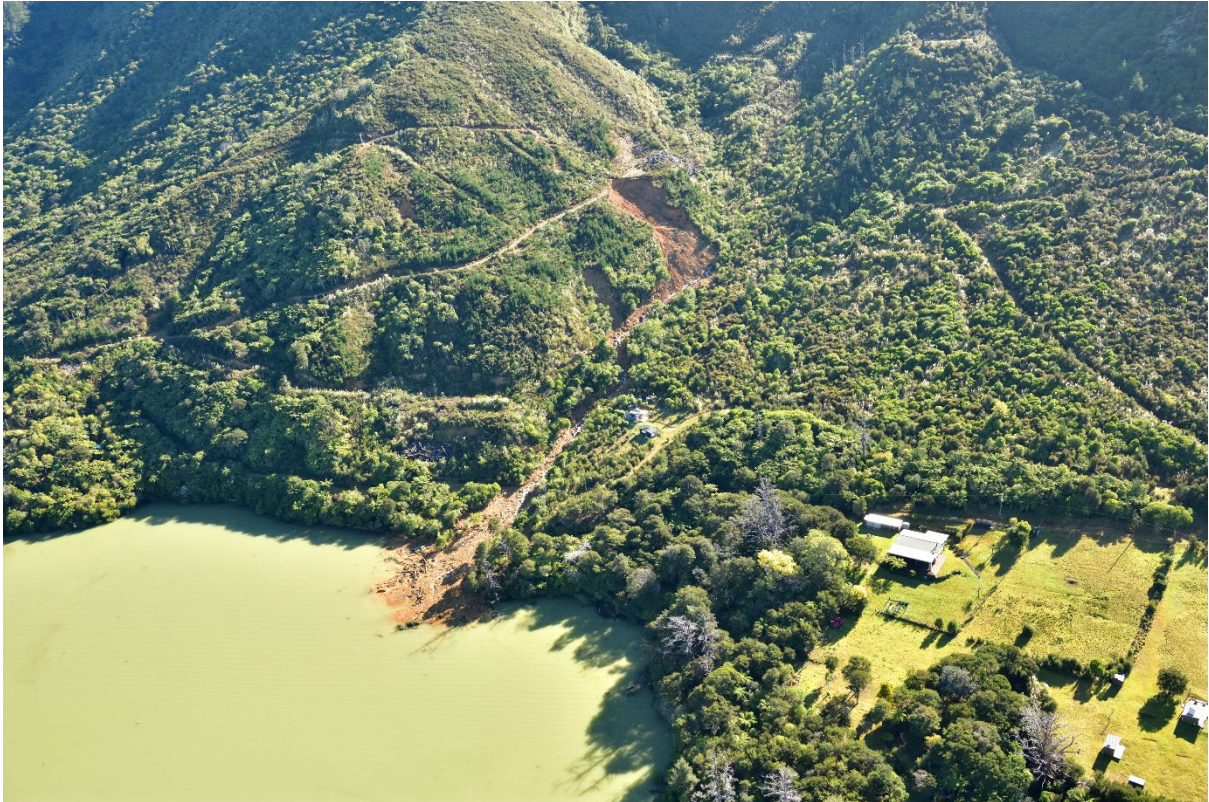
Figure A1.3 Debris slide/slump and flow initiated from older forestry landing, Pelorus Sound, near Black Point.

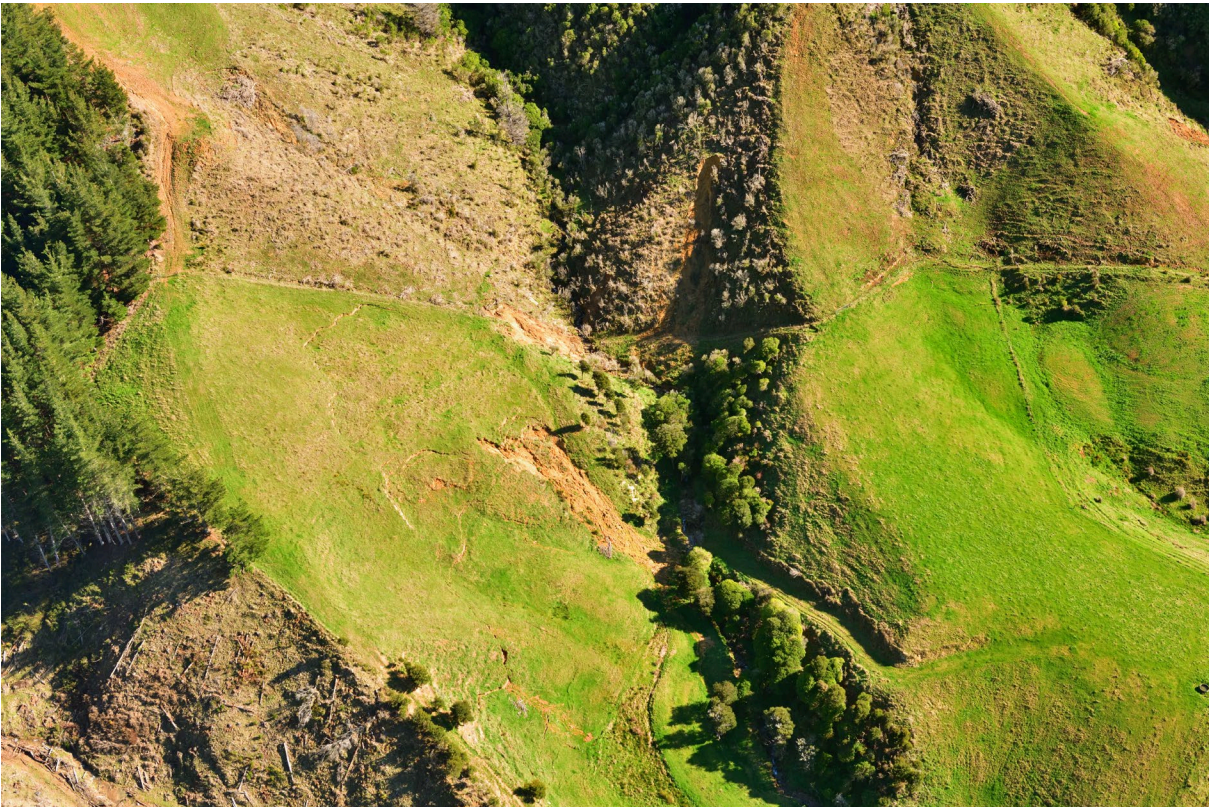
Figure A1.4 Incipient landslide on steep pasture slope showing cracking and minor flow, Cullensville Rd, Linkwater.

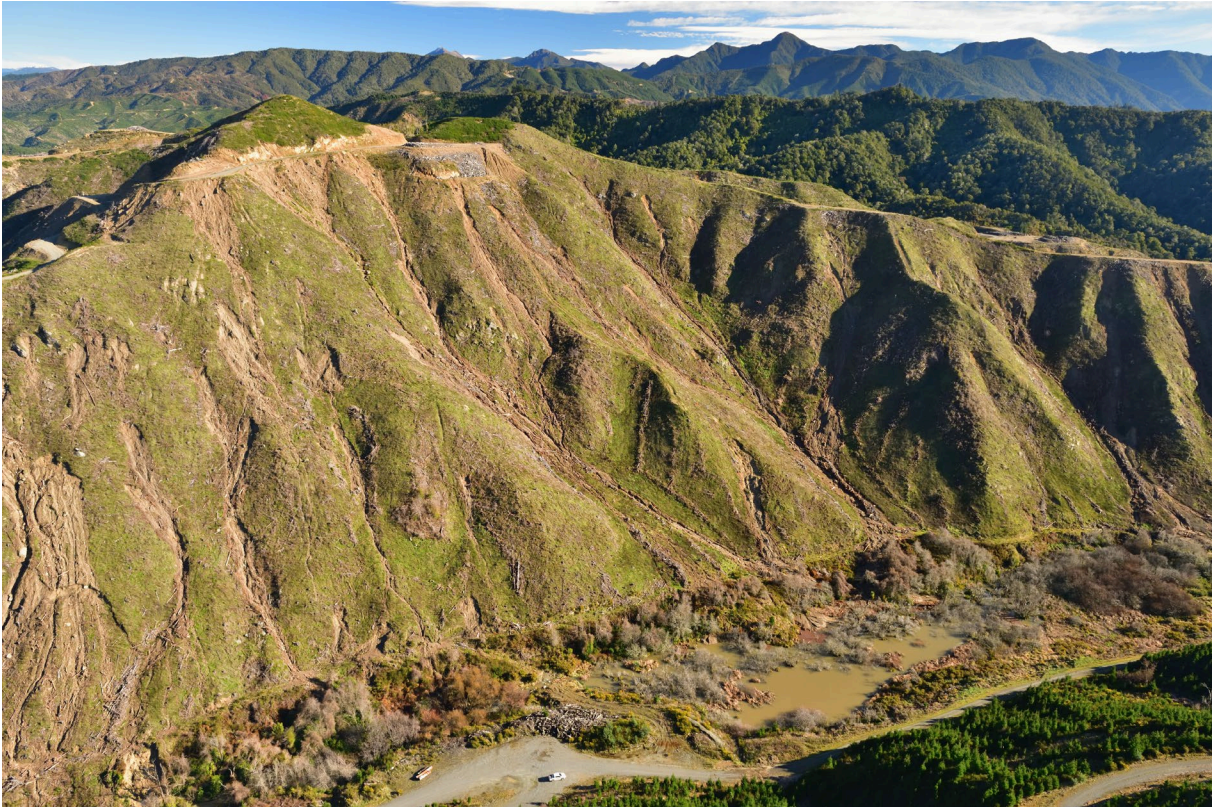
Figure A1.5 High-density landsliding on recently logged slopes near Onamalutu.

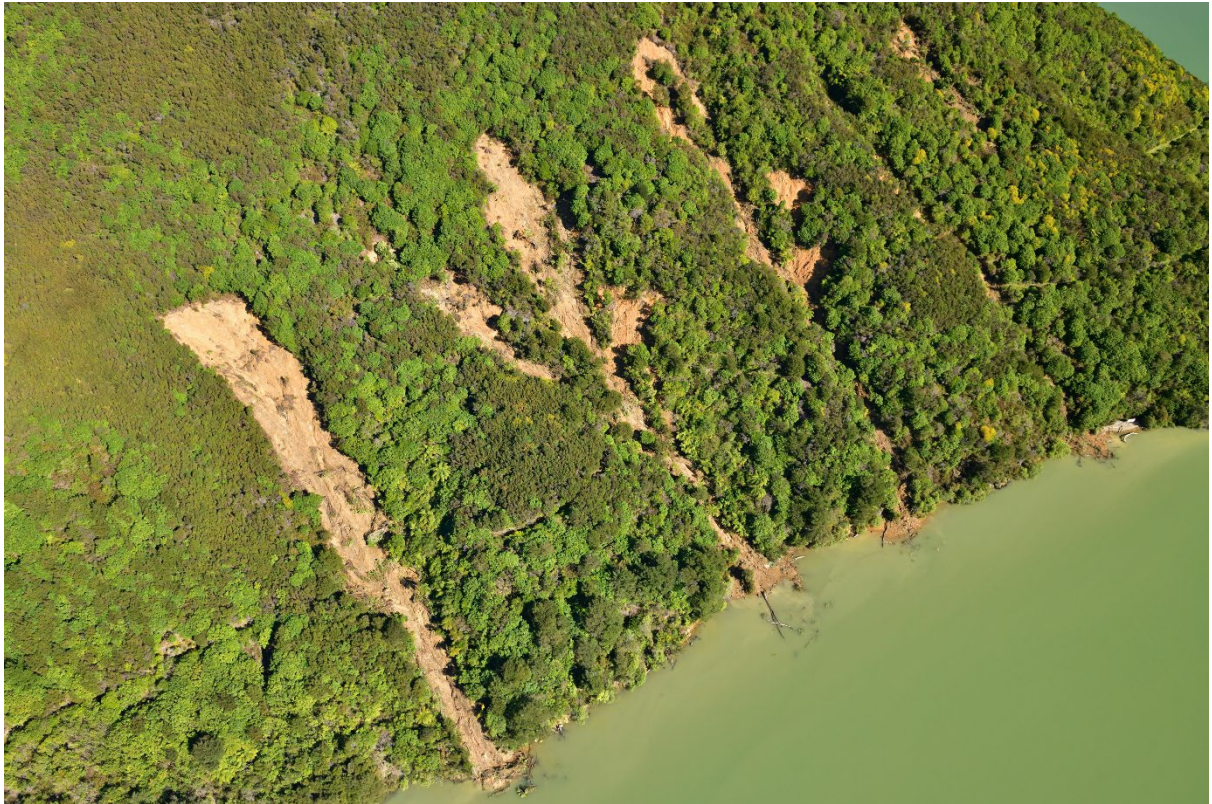
Figure A1.6 Debris slide/flow on slopes with regenerating indigenous forest and scrub land cover initiated in colluvium in swales or gully heads at Moenui, near Havelock. This area received some of the highest rainfall in the storm event.

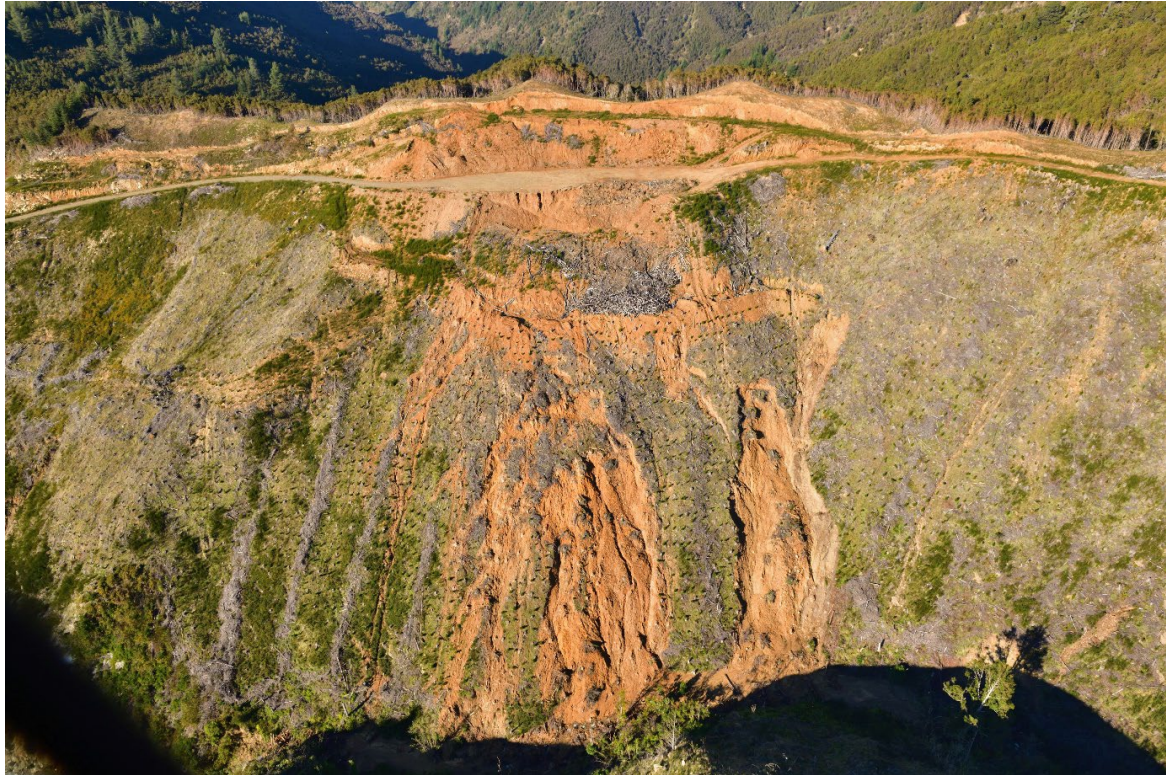
Figure A1.7 Mid-slope failures and debris avalanches/flows on newly planted exotic forest slope. Also possibly shows a collapsed landing or skid site. Root raking has occurred up and down the slope, which means that a machine has been down the slope and the surface was likely very disturbed prior to failure.

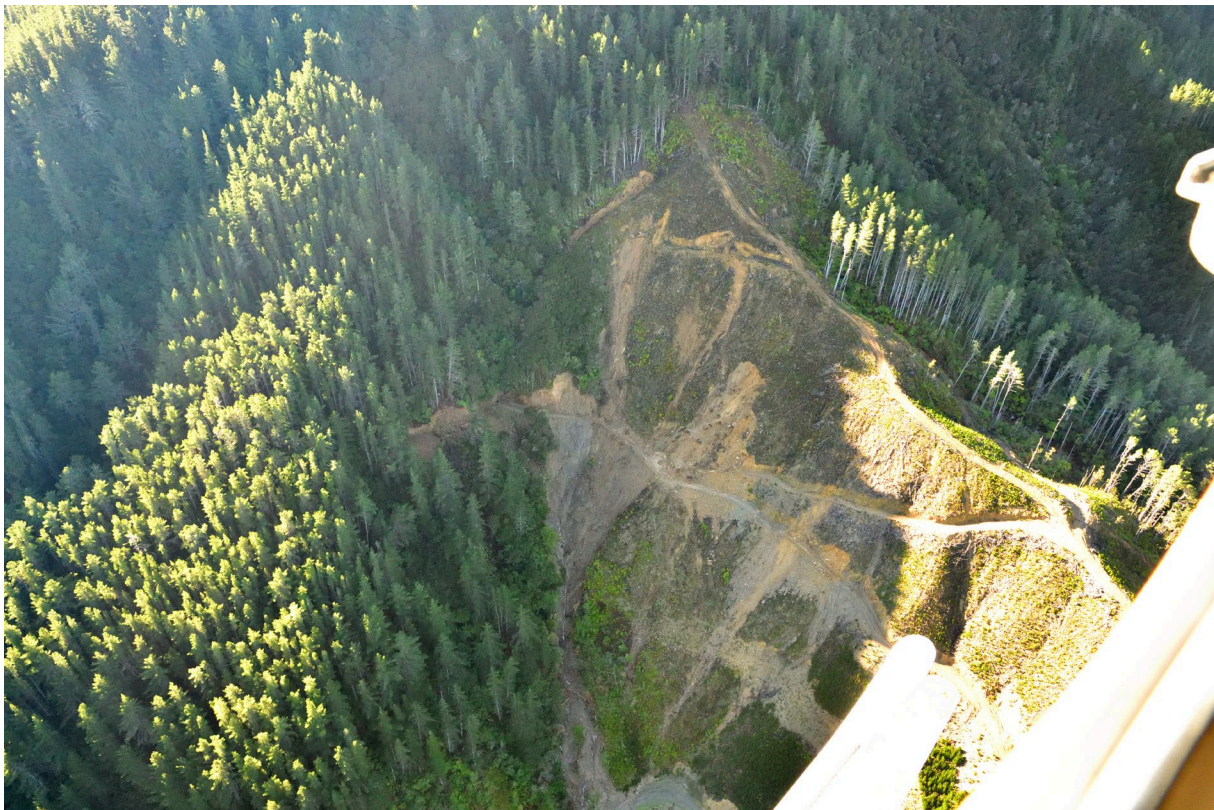
Figure A1.8 Debris flows on cleared exotic forest slopes near Koromiko.

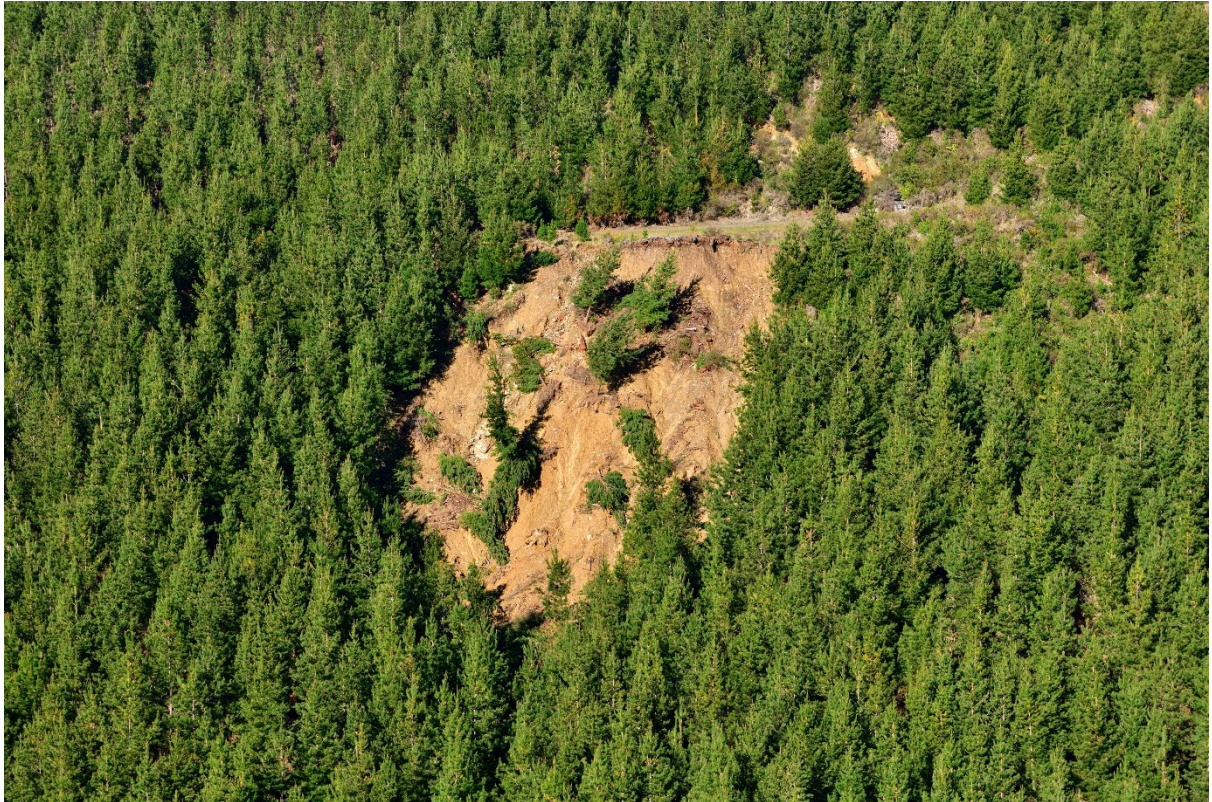
Figure A1.9 Debris avalanche from a collapsed older landing, constructed from slash and fill, in exotic forestry near Havelock.

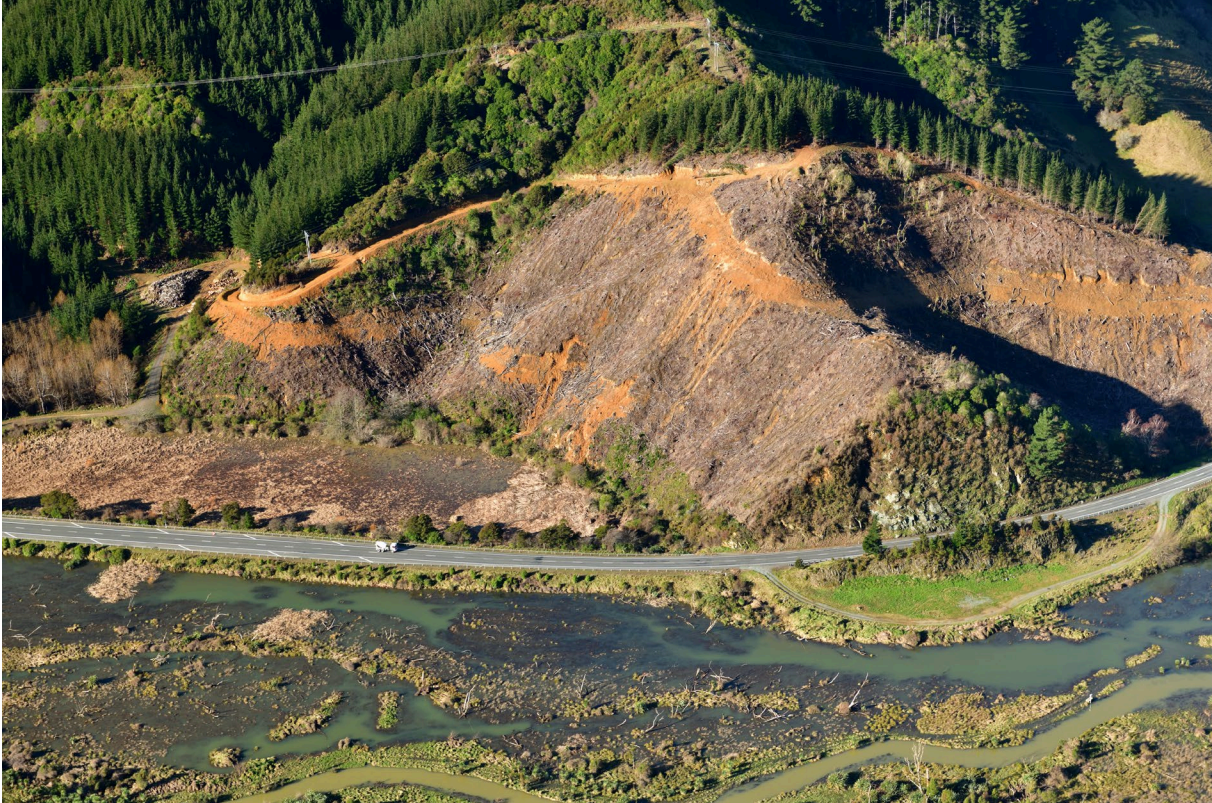
Figure A1.10 Landslides initiated from forestry roads and on newly harvested exotic forest slopes near Para.

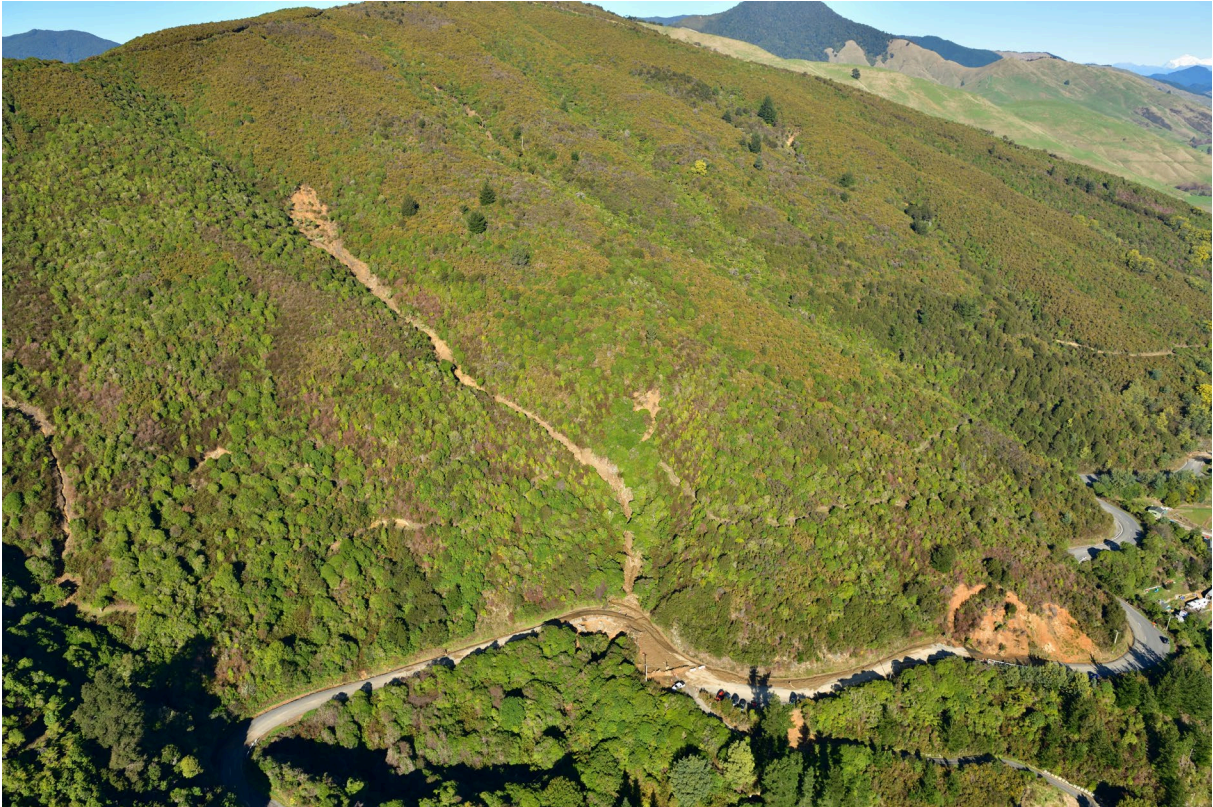
Figure A1.11 Debris slide/flow on regenerating indigenous forest/scrub slopes. Note also the rotational slump above road (lower right), Mahakipawa Road, Havelock.

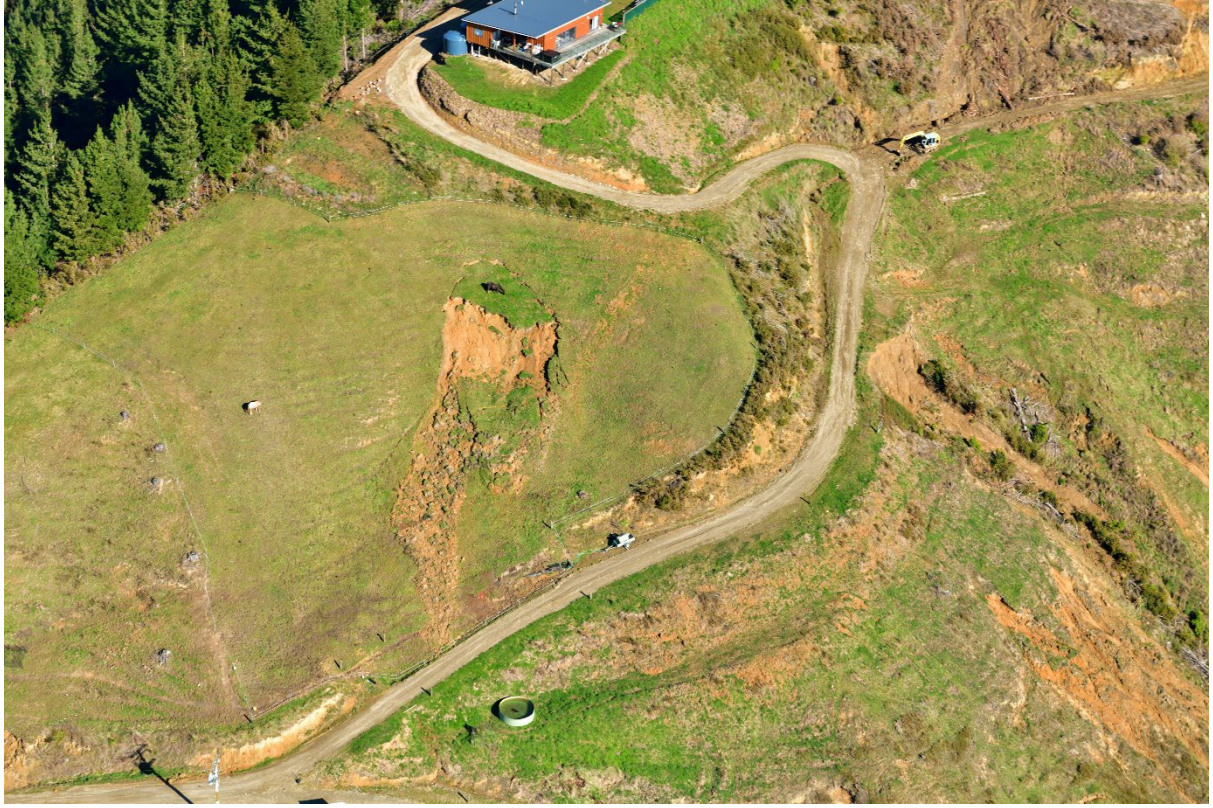
Figure A1.12 Deeper-seated landslide and incipient landslide/slump in pasture, also showing cracking, near Havelock.

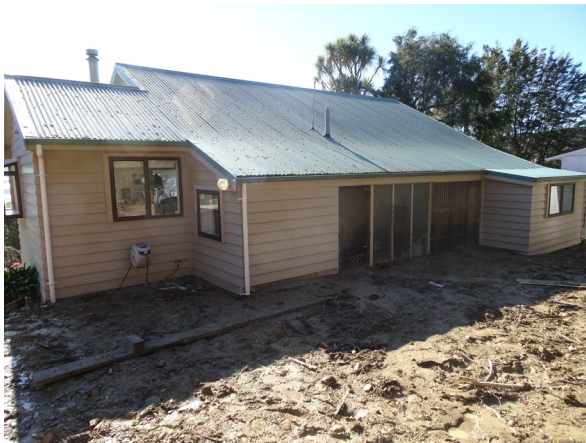
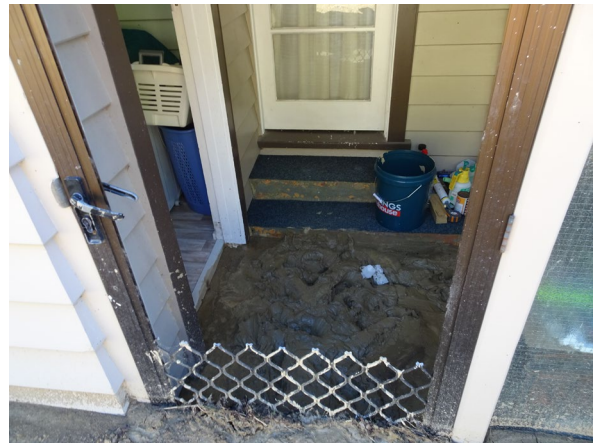
DS1 – Insignificant: Minor non-structural damage.

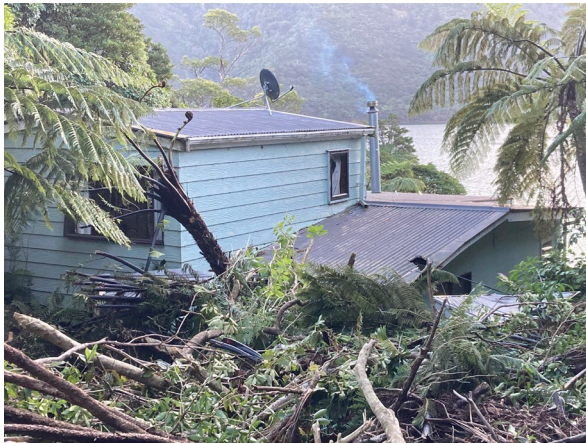
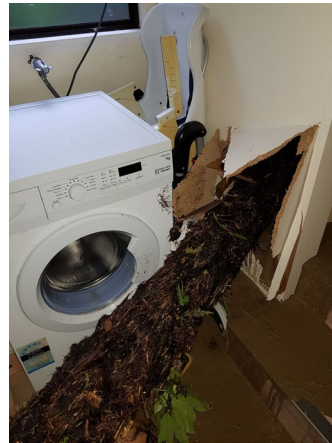
DS2 – Light: Non-structural damage only.

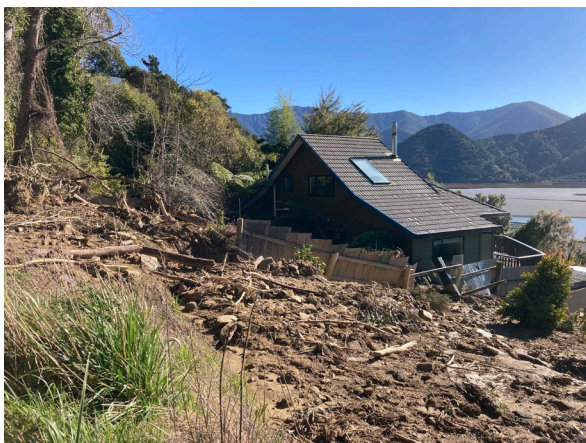
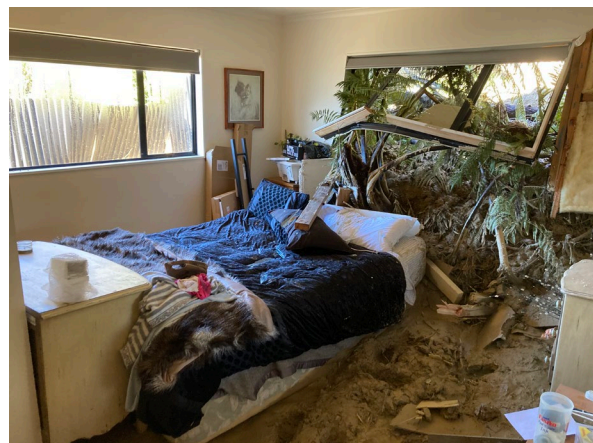
DS3 – Moderate: Repairable structural damage.

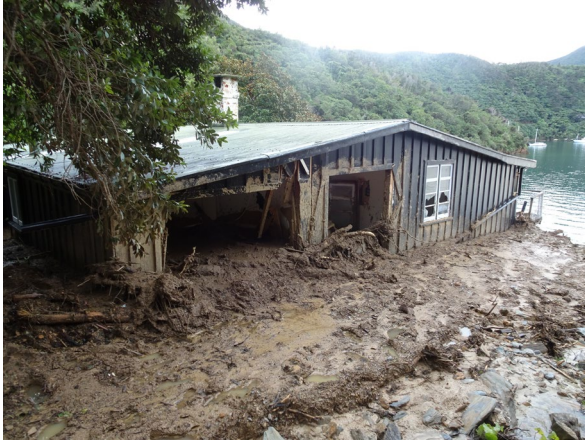
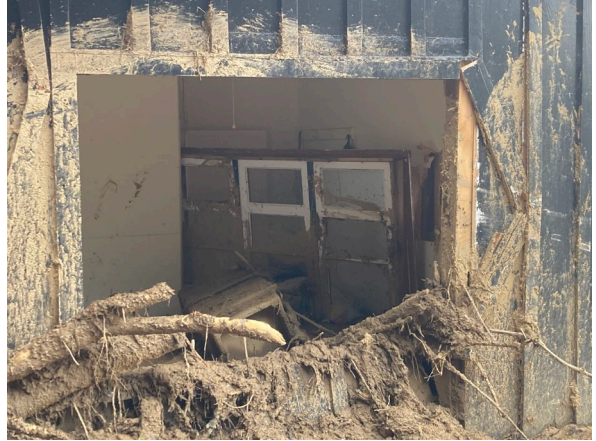
DS4 – Severe: Irreparable structural damage.

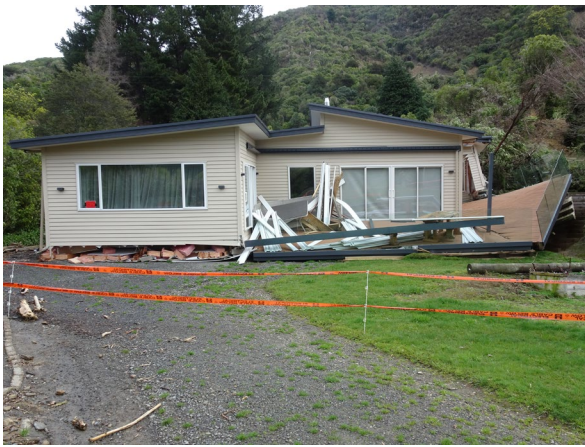
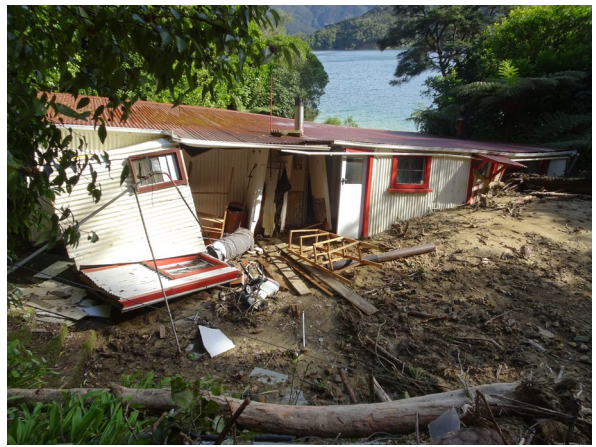
DS5 – Critical: Structural integrity fails.
