MARLBOROUGH SOUNDS HARBOUR

NAVIGATIONAL RISK ASSESSMENT REVIEW

Prepared For : Marlborough District Council
Report Number : 09NZ190
Issue : 1
: December 2009

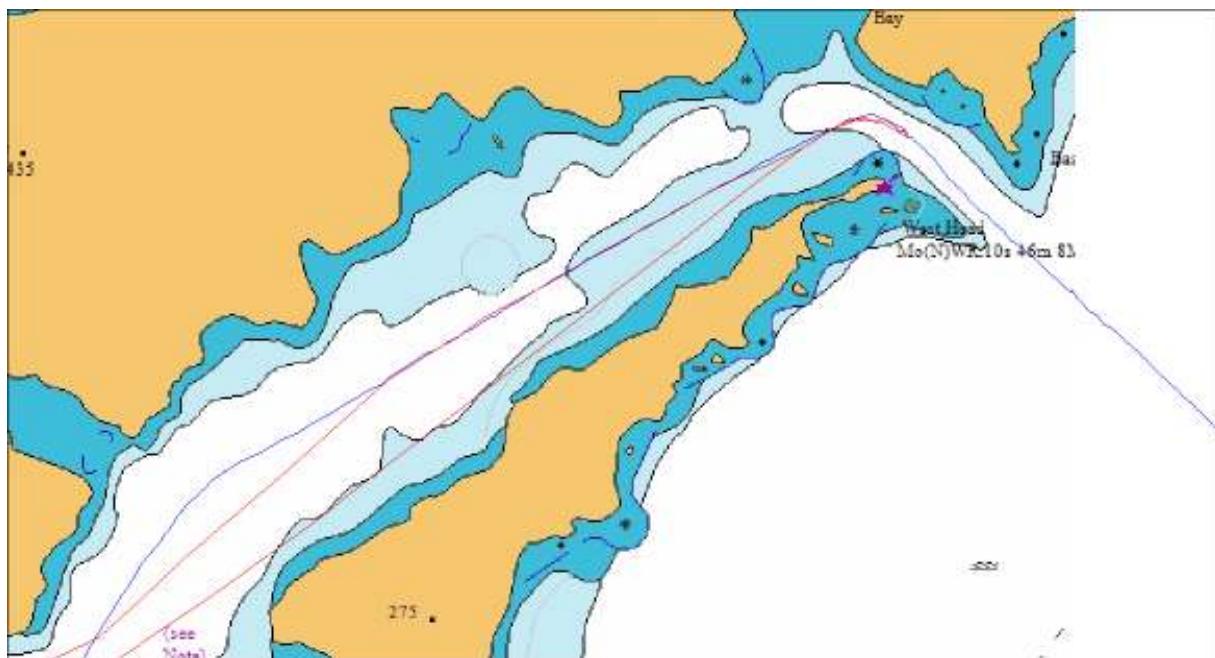
Figure 2: Record of Inbound Passenger Vessel Via Tory Channel – Pilot

Pilotage was the subject of recommendations arising out of the 2005 risk assessment. Pilotage has now been taken in house by Port Marlborough, it being the sole pilotage service on the Queen Charlotte Sound. The ongoing development of pilotage is now a matter for the Port Company, which has indicated it was taking an assessment of its operations at the commencement of this review. Pilotage is key to movement risk management and its effective Safety Management Interface with shipping is vital. As part of the risk review and to assist with frequency, extracted AIS data of some reported incidents were reviewed and the data combed for vessel interaction in key hazard areas. Pilotage boarding occurs at Tory Channel entrance and the following data extract is from a record of boarding activity in the area, which occurred within the timescales of the assessment of changed risk quantum. It is included to assist in the development of the Marlborough Safety Management system and demonstrates the value of recorded data to improve Safety Management awareness. Figures 2 and 3, reference the same boarding event.

The referenced boarding event occurred in the middle of the vessel transit from sea into Tory Channel in the timescales of this rescored work. Sea conditions on that day were marginal at the entrance, probably making

8. A review of Pilotage boarding from AIS data, underpins the practical need for Marlborough Harbour to develop an effective harbour monitoring interface. This would assist in decision making for marginal conditions and adherence to procedures based on best practice. Such procedures should be developed.
