**MARLBOROUGH
DISTRICT COUNCIL**

Water Quality in the Are Are Creek Catchment

**Technical Report No: 15-004
May 2015**

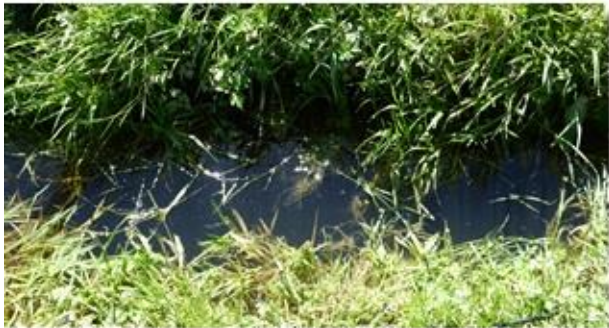
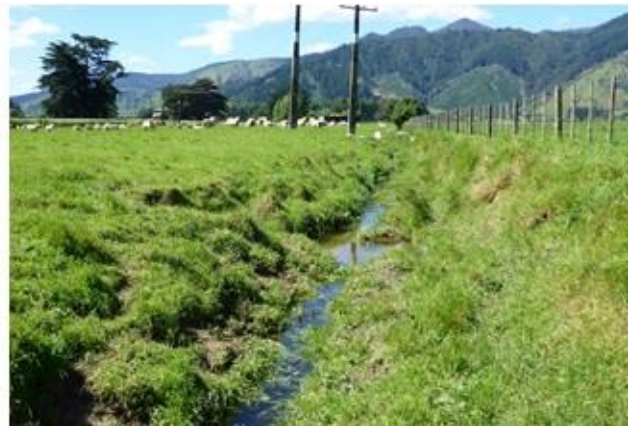
Stream runs through pasture, with no riparian buffer zone. Although fenced on one side, stock (sheep) access, or evidence of stock access (trampled banks, grazed riparian grass) was noted on most sampling occasions, with high stock densities observed during the May 2014 sampling trip.

Water was usually slightly turbid, with a high proportion of the bed covered with fine sediment. The channel was narrow and relatively deep.

Figure 18: Site 15 on 21 November 2013 (left) and looking upstream on the same day (right).

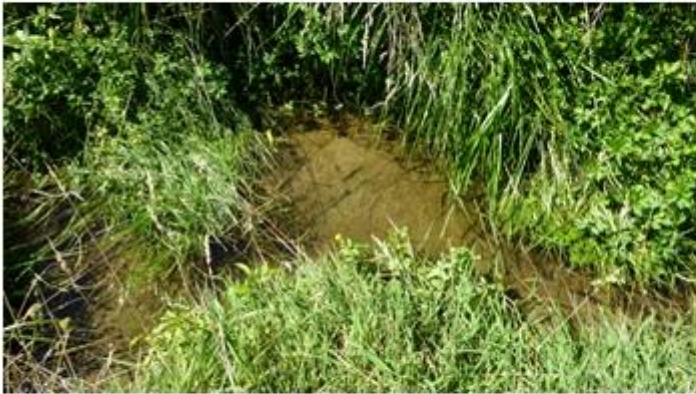
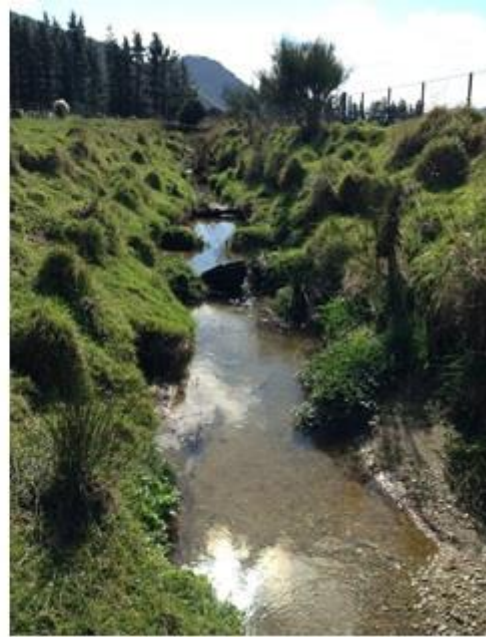
Stream runs through pasture, and although it is fenced on both sides, sheep access to the banks and channel was observed on two occasions, and evidence of recent sheep access (faeces and hoof-prints) was present on a further two occasions. The riparian zone was grazed or long grass on both banks, with significant bank erosion occurring over the winter months.

The stream channel supported large growths of aquatic plants or algae during the warmer summer months, and on several occasions a large proportion of the bed was covered by fine sediments. The water was observed to be clear or slightly turbid on all six occasions.

Figure 19: Site 13 on 6 March 2014 (left) and looking upstream on 8 September 2014 (right).

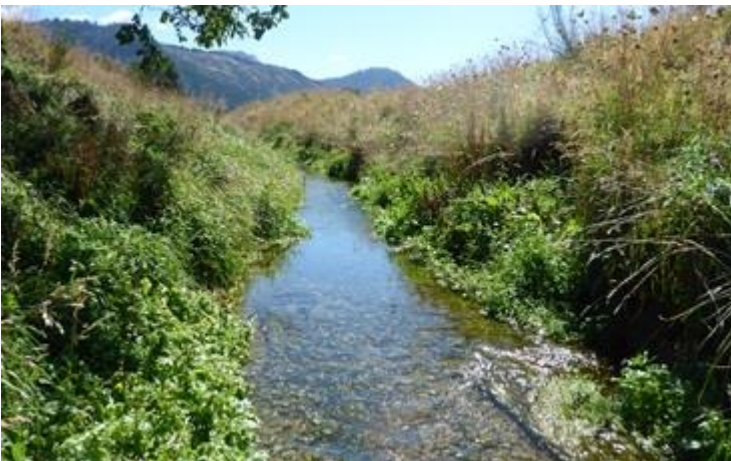
No stock access observed. Adjacent land use is pasture (beef). The riparian zones on both banks contain long grasses, predominantly. At least 50% of the bed was covered by algae on all four sampling occasions, with a small amount of fine sediment (5% cover) observed on three occasions. Some emergent aquatic plants were present in March 2014 (10% cover). The water was clear on all four occasions.

Figure 20: Site 12, looking upstream on 6 March 2014.

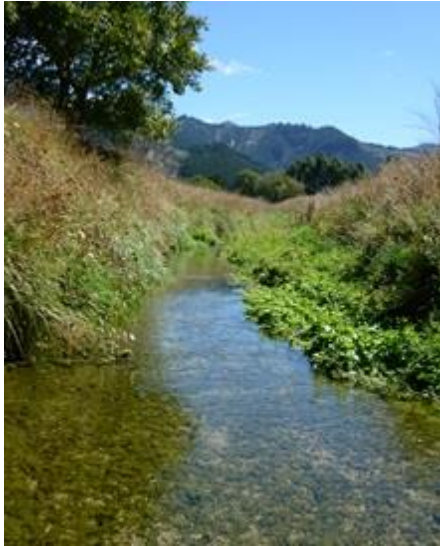
No stock access observed. Adjacent land use is pasture (beef and sheep). The riparian zones on both banks contain long grasses, predominantly. 80 to 90% of the bed was covered by algae on all four sampling occasions, with some fine sediment (5 – 30% cover) also observed.

Figure 21: Site 10 on 6 March 2014

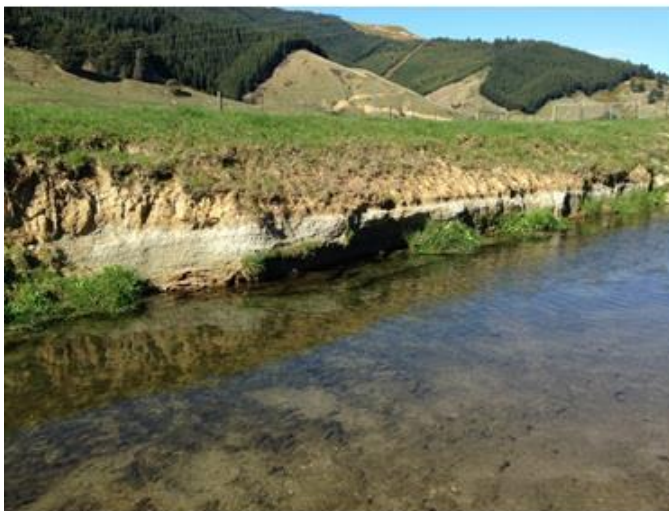
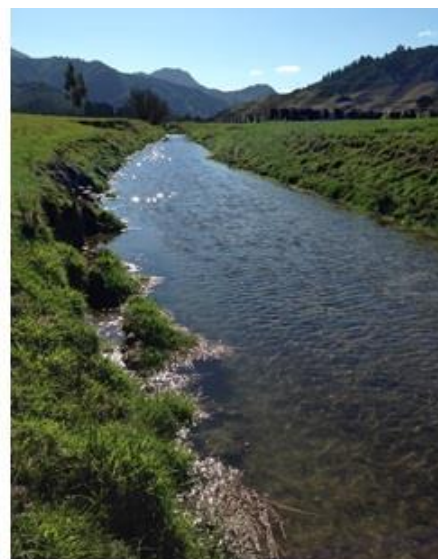
No stock access was observed at the times of sampling, but there was evidence of stock access on previous occasions. The adjacent land use was pasture (beef cattle), and the riparian zones of both banks comprised short grasses. Long brown filamentous algae covered approximately 95% and 60% of the bed in June and September, respectively. In September 2014, fine sediment covered 70% of the bed.

Figure 22: Site 22, erosion on left bank (left) and looking downstream (right) on 8 September 2014

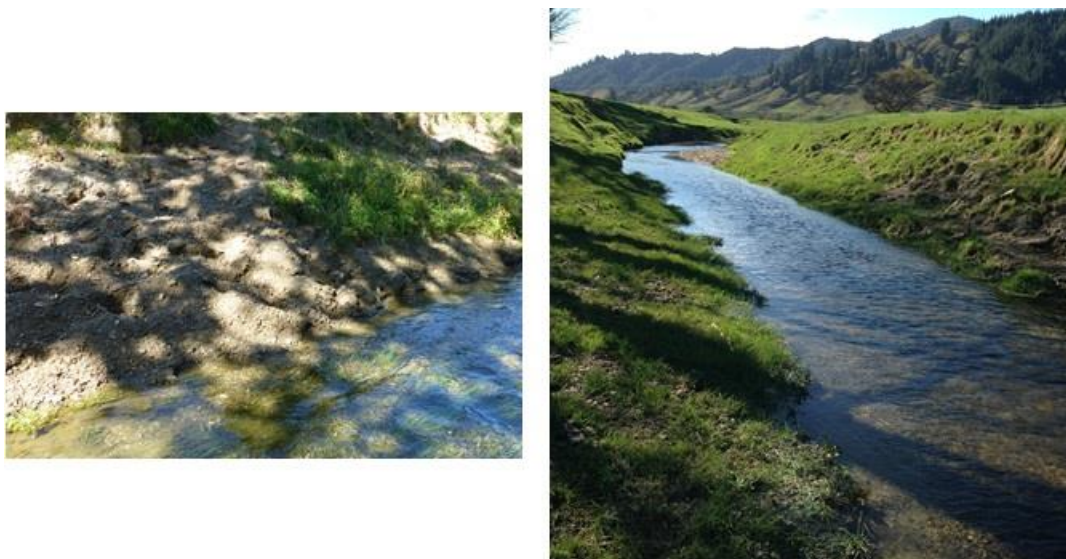
Stock were not observed on the river banks or in the river on any of the six sampling occasions, but the presence of hoof-prints on the banks and bed, and dried cattle faeces, suggested that recent access by cattle had occurred prior to sampling in November 2013 and March, May and September 2014. The adjacent land use was pasture (beef cattle), and the riparian zones of both banks comprised grazed grasses. Coverage of the river bed by algal mats and filamentous algae ranged from 50% to 95%, and submerged aquatic plants covered around 5, 20 and 50% of the bed in November 2013, March and June 2014, respectively. Fine sediment covered a proportion of the bed on each sampling occasion, with percentage cover ranging from 5% in November 2013 to 60% in March 2014.

Figure 23: Site 7 on 6 March 2014 (left - note stock trampling) and 8 September 2014.

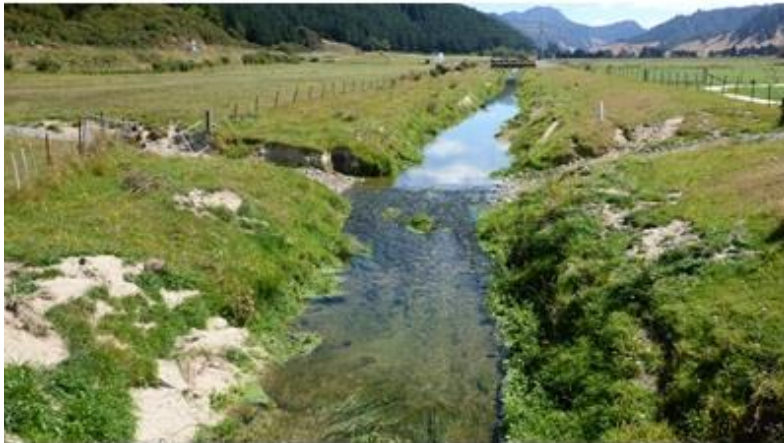
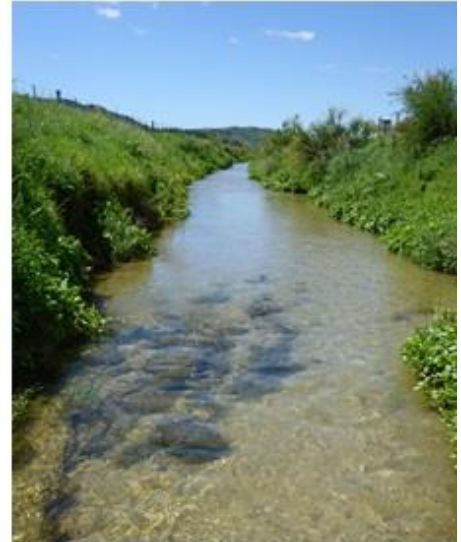
The adjacent land use was mainly pasture (dairy), with some vineyards. The riparian zone on both banks comprised medium to long grasses (grazed), with some patches of bare earth. No stock access to the channel was observed, but evidence of prior access by cows was noted in November 2013. It was also noted that some run-off from adjacent paddocks is likely to have occurred via the old stock crossing upstream of the bridge (see photograph below). Periphyton was estimated to cover at least 70% of the bed on all five occasions (predominantly filamentous algae on three occasions, and algal mats on two), with 10% cover by submerged macrophytes also recorded in March 2014. Coverage by fine sediments ranged from 10 to 40%.

Figure 24: Site 6, looking upstream on 21 November 2013 (left) and looking downstream on 6 March 2014.

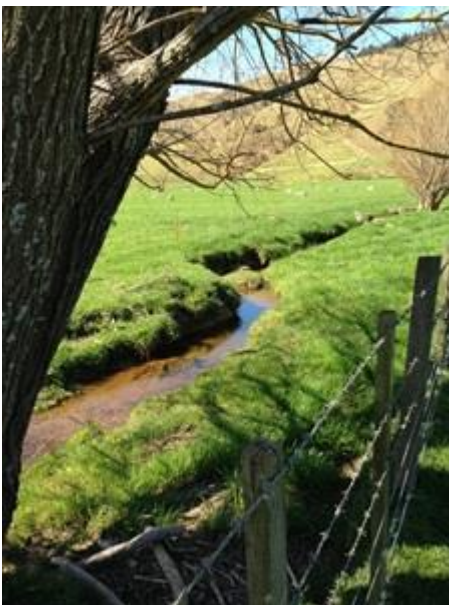
Flows through pasture (sheep), with no riparian buffer zone: pasture is grazed right to the edge of the stream. Has permanent fencing on true left bank, and at times, temporary fencing on true right bank. Stock access to the stream was observed in July 2014, and evidence of stock access was found in November 2013. On the other three sampling occasions, stock were excluded from the stream. Observations of periphyton and sediment cover of the bed were made in November 2013, July 2014 and September 2014: in November, 70% of the bed was covered with fine sediment, and 10% with algal mats, whereas in July and September, algae covered 80% to 100% of the bed, with 10% to 20% cover by fine sediment.

Figure 28: Site 16, looking upstream on 8 September 2014.

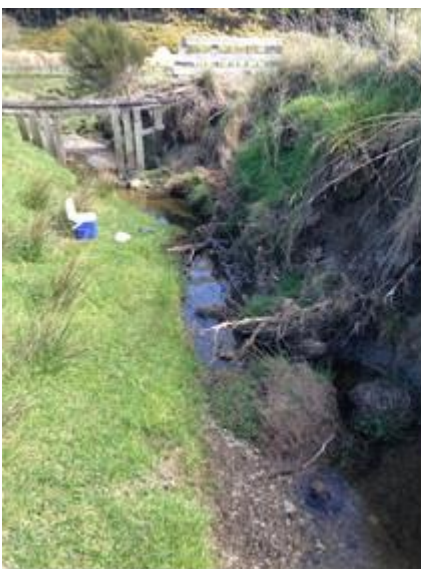
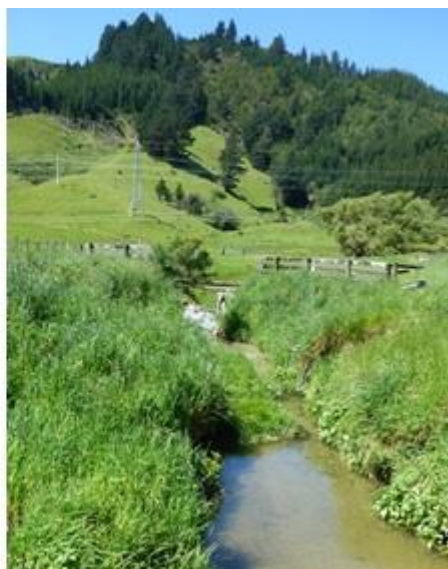
In its lower reaches, this tributary flows through pasture (sheep), with the riparian zones of both banks comprising grasses and bare earth (especially from the June 2014 sampling, onwards, when bank erosion was noted). Stock access to the stream was not observed. Sampling was not carried out at this site in March 2014, due to very low flow. Flow was also low in June 2014. Periphyton cover at the site varied, ranging from 20% to 80%, and estimates of cover by fine sediment ranged from less than 5% (July) to 40% (November).

Figure 30: Site 14, looking downstream on 6 March 2014 and looking upstream on 21 November 2013.

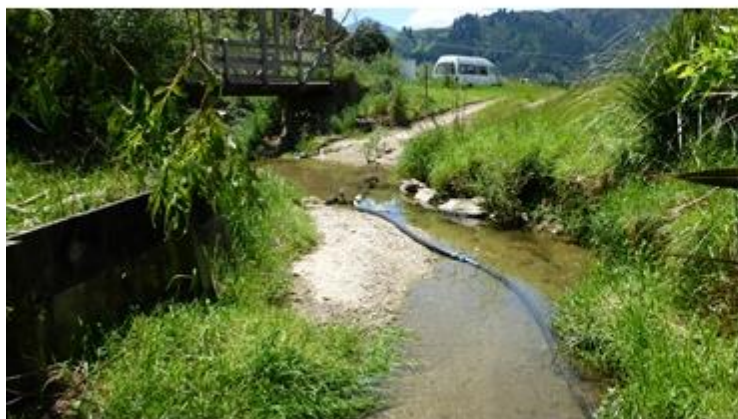
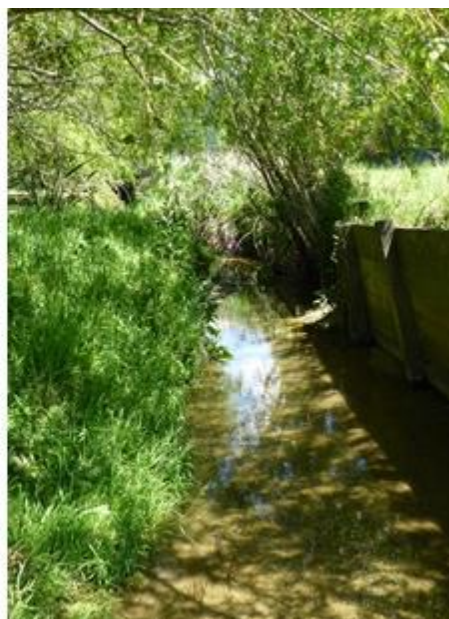
The surrounding land use is pasture (deer, sheep, cattle) and a gravel road, with a riparian buffer of long grasses and trees (2 m wide) on the true left bank, and long grasses (1 m wide) on the true right bank. Stock access to the creek was observed in November, when deer had access upstream of the site. No stock access was observed in May or July. Periphyton covered at least 80% of the bed on all three occasions, with algal mats dominant in November (90% cover) and July (80% cover), and short filamentous algae in May (90% cover). Fine sediment covered around 60% of the bed in November, but only 10% and 20% in May and July, respectively.

Figure 31: Site 8, looking downstream toward the ford (left) and looking upstream on 21 November 2013.

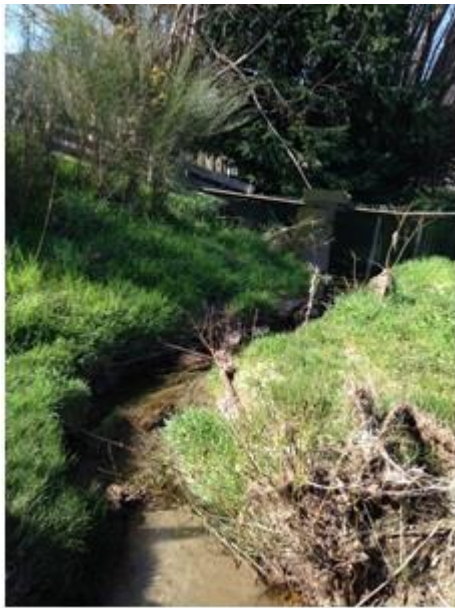
Adjacent and upstream land use is pasture (sheep). There is no riparian buffer zone, with grazed grass extending right down to the channel edge. On two of the three sampling occasions, sheep were observed with access to the channel upstream. High coverage by filamentous algae (90%) and fine sediment (80%) were observed in June. In July, 40% of the bed was covered with submerged macrophytes, and fine sediment covered 20% of the bed. In September, filamentous algae covered only 20% of the bed, and fine sediment was less apparent, covering only 5%.

Figure 32: Site 23, looking downstream on 8 September 2014.

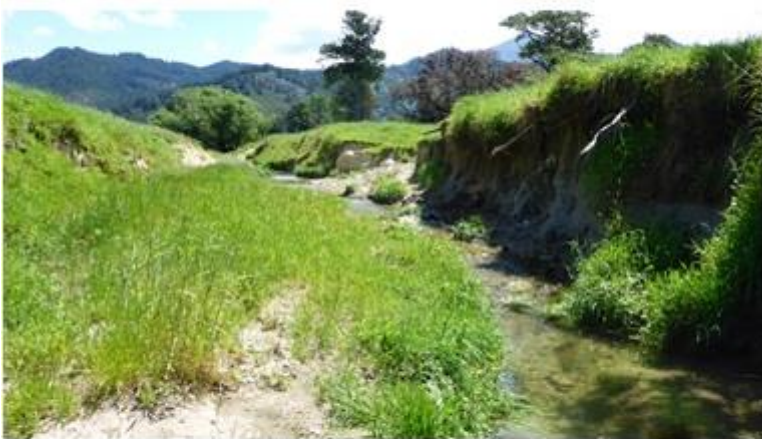
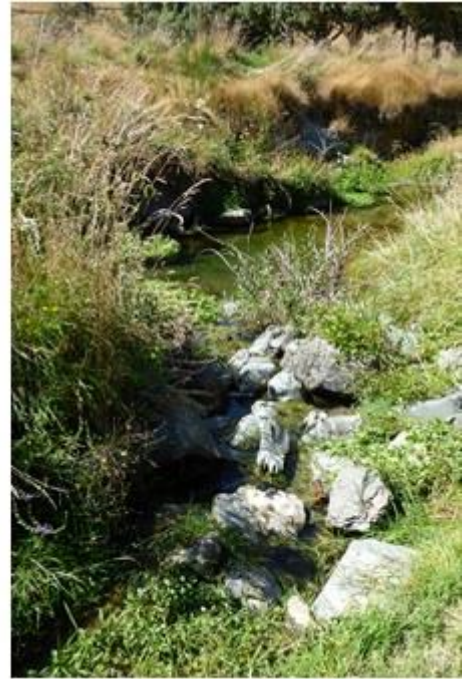
At its lower end, this tributary flows through pasture (beef cattle), and there is no riparian buffer zone, with grazed grass extending right down to the channel edge. Stock access, or evidence of recent access, was observed on three of the four sampling occasions. Fine sediment covered around 80% of the bed in November, but was less evident in March, May and June 2014, when coverage was estimated at 10% or lower. In March, the channel was full of emergent macrophytes (60% cover) and filamentous algae (40% cover); in May, 60% of the channel was covered with thin brown algal mats; and in June, short brown filamentous algae covered 80% of the bed.

Figure 33: Site 11, looking upstream on 21 November 2013 and looking downstream towards the confluence with Are Are Creek on 6 March 2014.

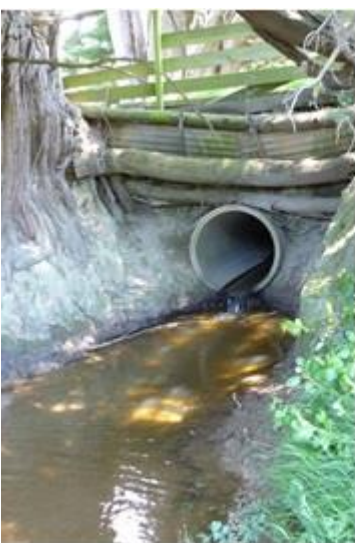
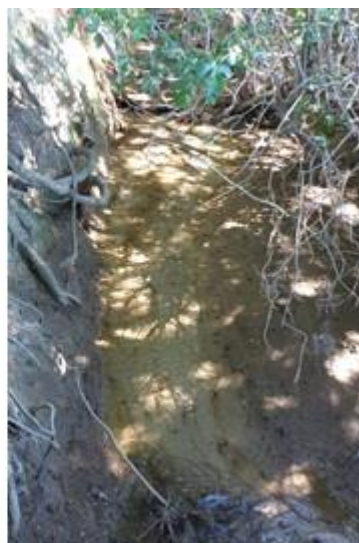
This small tributary flows through pasture, but the riparian zones on both banks at this site support large conifers. No stock access to the channel could be seen from the site. A high proportion of the bed was covered with fine sediments on all three sampling occasions: 100% in November, 95% in May and 50% in June. Extensive periphyton cover was not observed in November or May, but around 90% of the bed was covered by filamentous algae in June.

Figure 34: Site 9, downstream of the culvert just upstream of the confluence with Are Are Creek (left) and upstream of the culvert (right) on 21 November 2014.

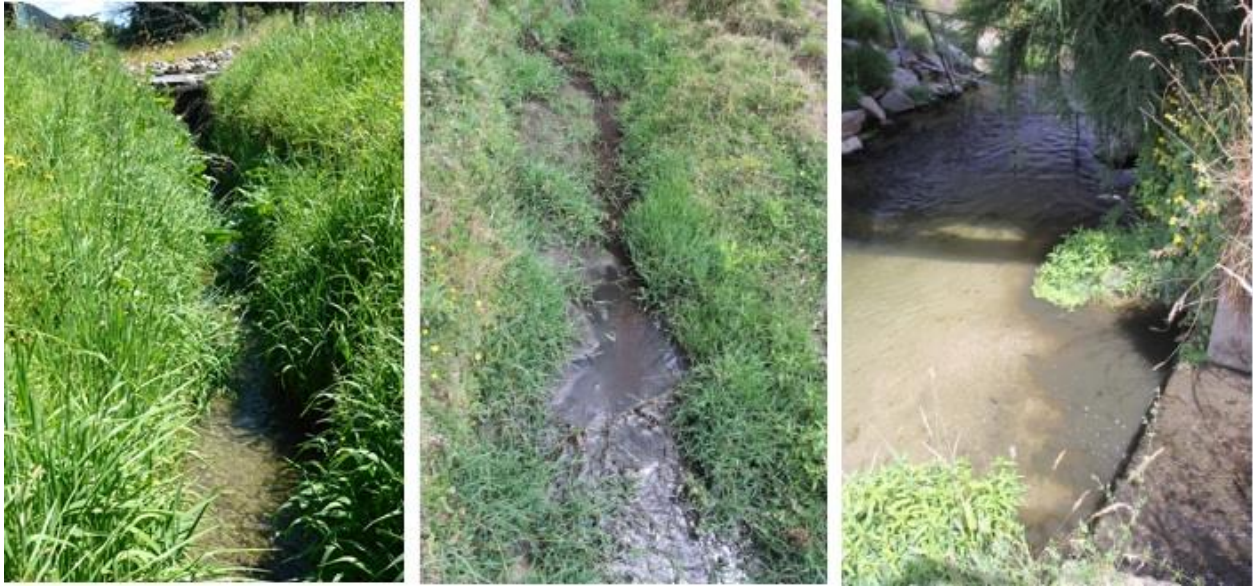
The adjacent land use at this site is pasture. The riparian zones on both banks contain long grasses. No stock access was observed at the site. A high proportion of the bed was covered with fine sediment on both sampling occasions: 80% in November and 100% in May. In November some filamentous algae were also present (around 30% cover). On both occasions, the water was observed to be turbid with a yellowish colouration. The site had a strong odour of cattle faeces on both occasions, which may have been coming from the yard. In May, the yard was observed to be very boggy and paddocks on the farm had large ponds on them.

Figure 35: Site 5 on 21 November 2013. The tributary a few meters downstream from Site 5 (middle) and at the confluence with Are Are Creek (right) during the investigation on 14 January 2015.
