Marlborough District Council

METHYL BROMIDE MONITORING REPORT DECEMBER 2010

January 2011

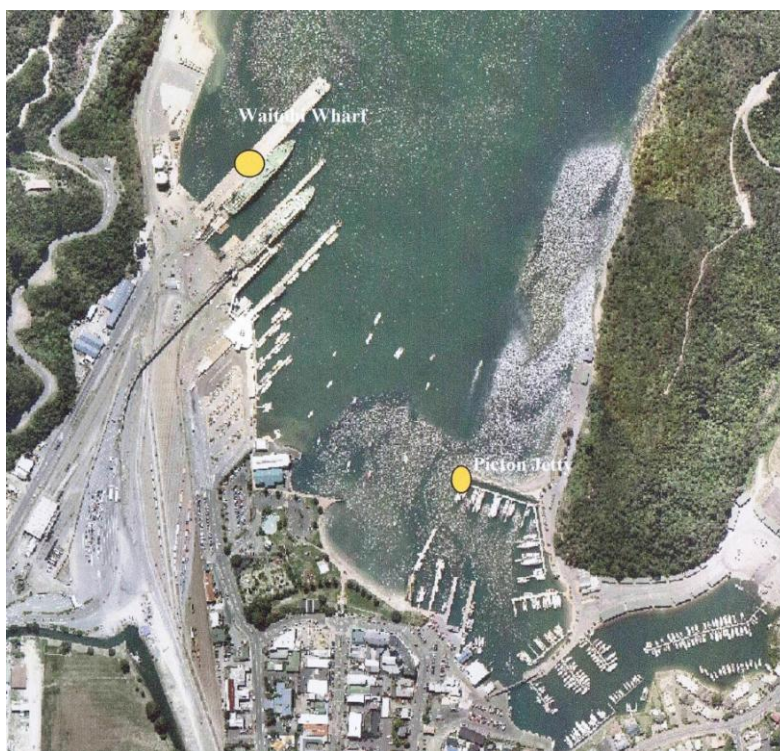
■ **Figure 1: Picton MDC Methyl Bromide Monitoring Sites**

MDC selected two sampling locations within the Picton community. The first site was located at the seaward end of Waitohi Wharf with the second site located at the opening of the Picton Jetty (See Figure 1). Figure 1 depicts where the fumigation was being carried out at the time the MDC-commissioned monitoring was being performed. The Waitohi Wharf site was selected due to its relatively close location to Port Marlborough fumigation facility at Shakespeare Bay while the Picton Jetty was selected to assess if methyl bromide could be transported to eastern Picton. Both sites were also secure so to avoid any tampering with the monitoring unit by the general public.

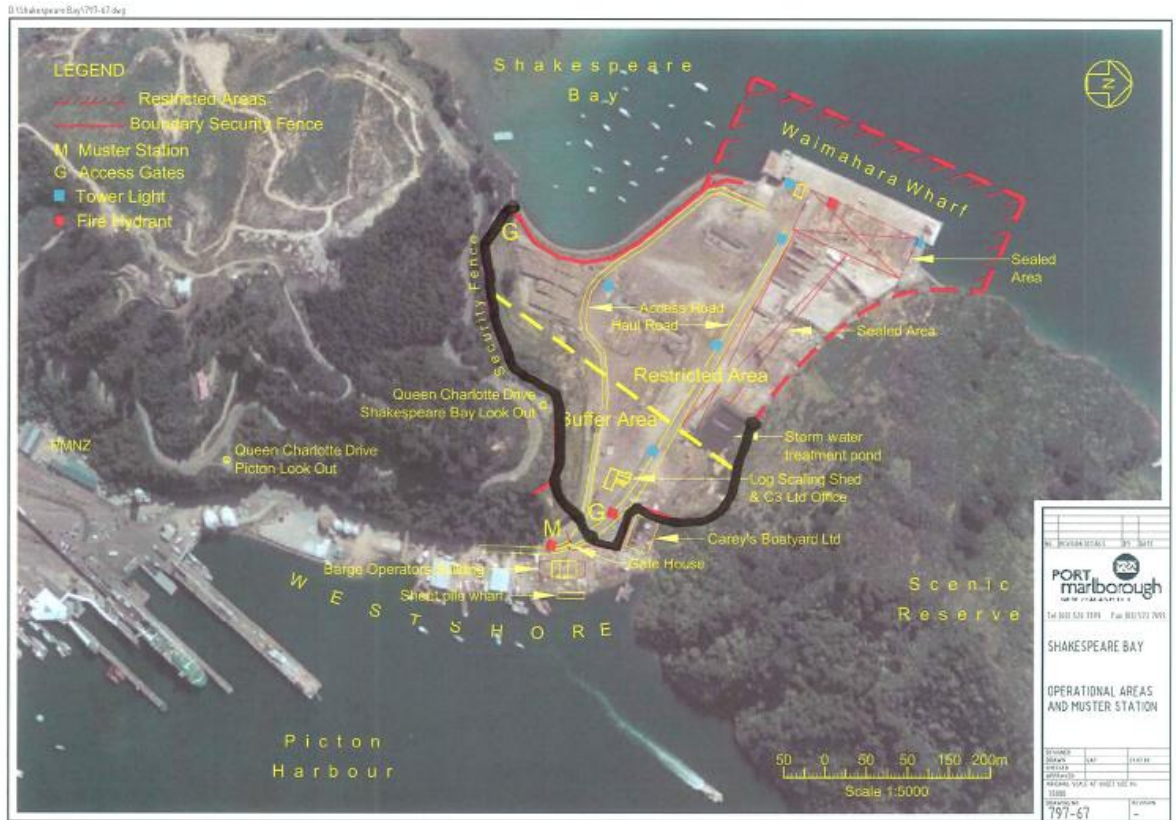
■ **Figure 2: Port Marlborough Fumigation Facility**

Figure 2 presents the Port Marlborough fumigation facility at Shakespeare Bay.

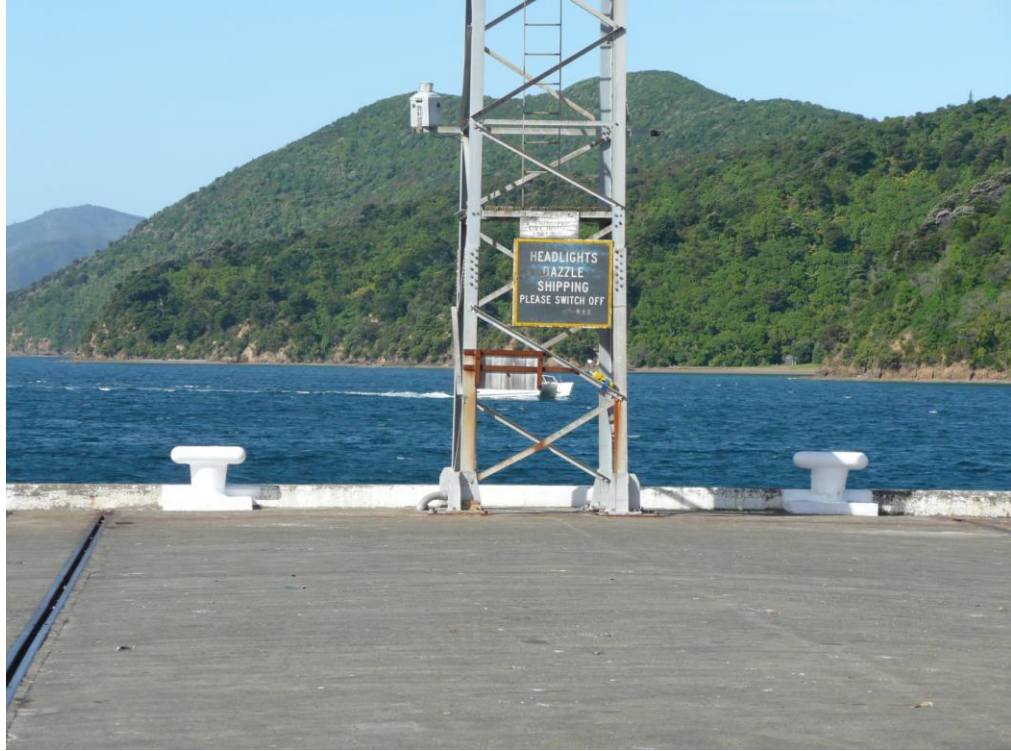
■ **Figure 3: Waitohi Wharf PID Monitoring Site**

The Waitohi Wharf PID analyser was deployed at the seaward end of the wharf (See Figure 3). Waitohi Wharf serves as the ferry terminal and over the duration of the monitoring there were a number of arrivals and departures of the both the Inter-Islander and Bluebridge ferries. Vehicle traffic on the wharf was limited to the field technician and ferry staff during the arrival and departure of the Inter-Islander. However, this traffic was at least 50 meters to the south of the analyser. The northerly wind direction meant these sources would not be detected by the instruments.

While there were a number of power boats within the harbour they are required to stay clear of the ferry terminals. Hence up wind of the PID was the open harbour with no significant sources of VOC's.

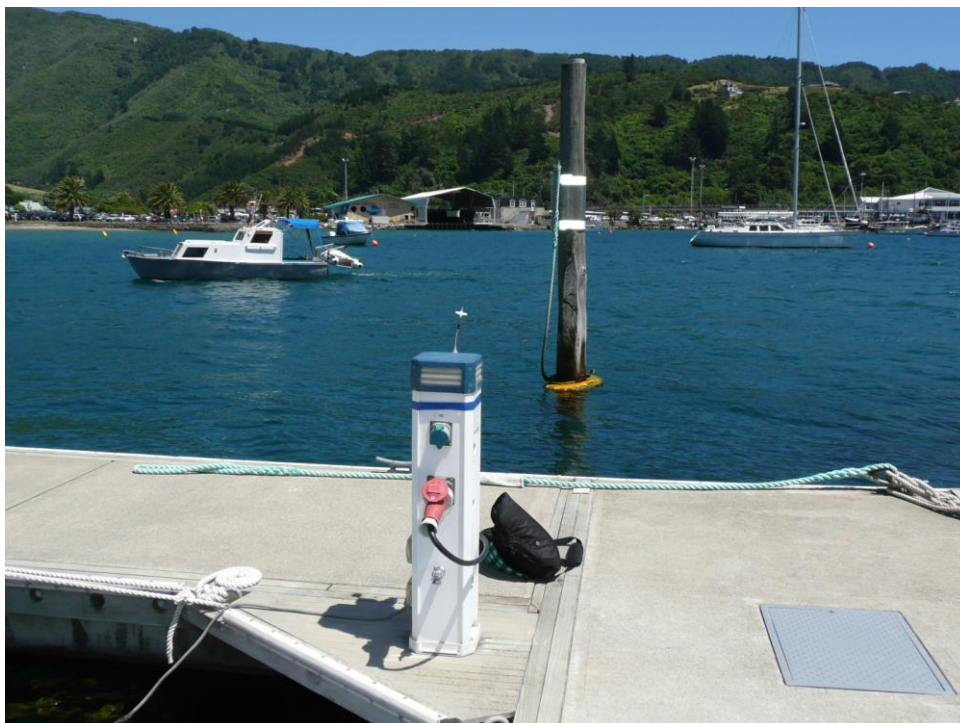
■ **Figure 4: Picton Jetty PID Monitoring Site**

The Picton Jetty PID was deployed at the opening to the Picton Marina (see Figure 3). Access to this portion of the marina was restricted owners of the berthed vessels. Vessels at the entrance to the marina were a potential source of VOC's. On a single occasion a concentration of 0.5 ppmv was observed as an older boat entered the marina. No other vessels appeared to register on the PID. A public car park was located on shore approximately 25 m to the east of the analyser. However, the northerly wind direction resulted in the up wind environment being Picton harbour. While there were a number of vessels operating within Picton harbour, it is unlikely that these would emit significant VOC particularly given the speed restrictions with the harbour limits and their distance from the analyser.

At approximately 18:10 hours the PID (Picton A PID) analyser initially deployed began to register total VOC concentrations above background levels. The back up PID with the field technician displayed a concentration of 0.0 ppmv. At this time there was no boat traffic and there were no apparent other sources of VOC's. A GASTEC detector tube was used which indicated the methyl bromide concentration was less than 1 ppmv. While there were no apparent sources of VOC's, the PID concentration continued to increase. The back up unit display 0.0 ppmv. The back up unit was subsequently deployed at the Picton Jetty (Picton B PID).

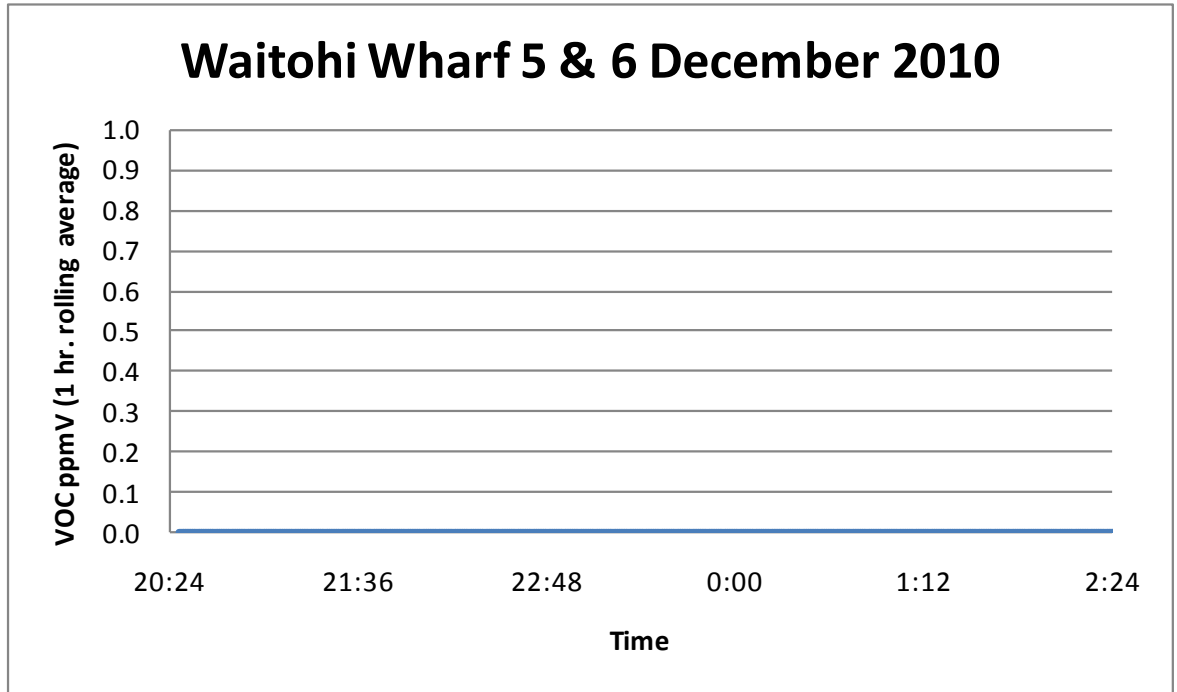
■ **Figure 5: Waitohi Wharf Methyl Bromide Data, 5 to 6 December 2010**

The results of the ambient total VOC monitoring performed at the Waitohi Wharf on 5 and 6 December 2010 indicate that the concentration was below detection limit of the analyser of 0.1 ppmv. Data from the Waitohi Wharf PID analyser was lost for the period 14:45 to 19:26 as the instrument was re-started due to a pump fault. However, the field observation (see Table 1) indicated no VOC's were detected over this period.

The following section presents the results of the ambient methyl bromide monitoring performed within the Picton community on 5 and 6 December 2010. Figures 5 and 6 present the 1-hour rolling average total VOC data from the PID analysers for Waitohi Wharf and Picton Jetty respectively. Appendix B presents the Ambient Air Monitoring Site Evaluation Form for the current fumigation. Included in the form is the calibration zero and span data for each of the analysers deployed. Appendix C presents the raw data from each of the instruments. Appendix D contains the calibration certificates from the instrument suppliers.

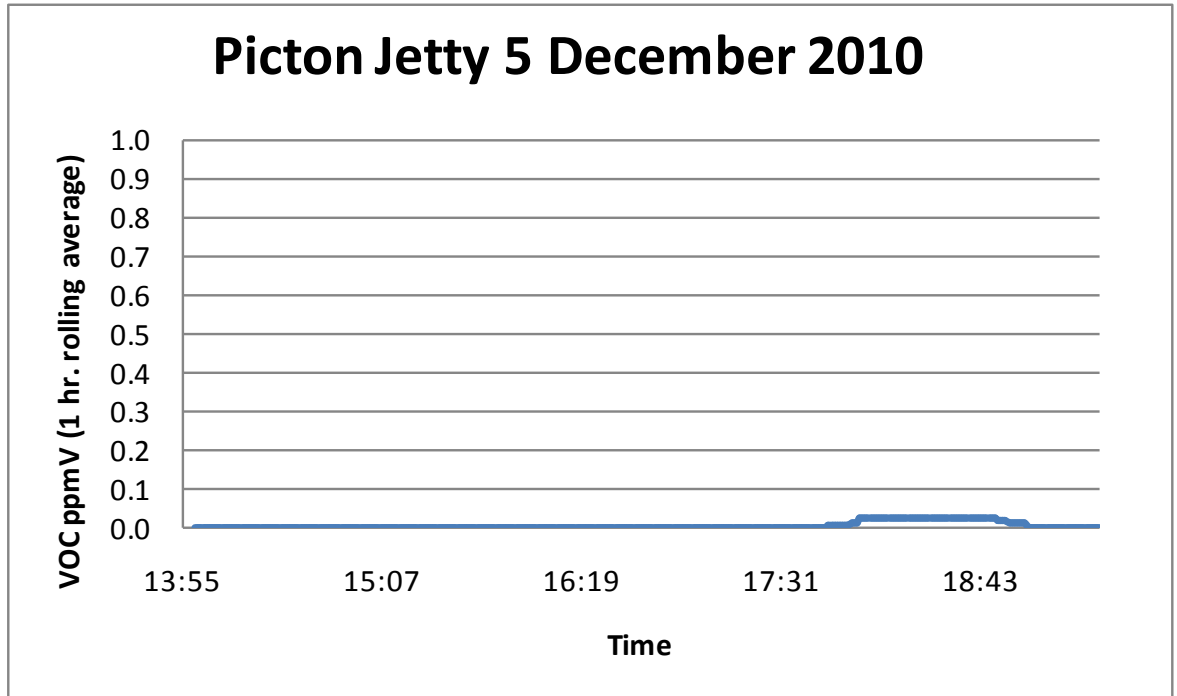
■ **Figure 6: Picton Jetty Methyl Bromide Data, 5 December 2010**

The results of the ambient VOC monitoring performed at the Picton Jetty on 5 December 2010 indicate that the concentration was at or below detection limit of the analyser. The PID analyser initially deployed at Picton Jetty (Picton A PID) began to drift from around 18:00 hours to register VOC concentrations over 52 ppmv by the end of the monitoring period (refer to Appendix C). GASTEC tubes were drawn at 18:10, 18:36 and 21:36 hours, all of which indicated that the concentration of any methyl bromide in the air was less than 1 ppmv. A second PID (Picton B PID) analyser was deployed at the Picton Jetty site at 18:36 hours. The data from the second PID was used for the period 18:36 to 19:26 when the battery failed.

Appendix 3 presents the raw data for the PID initially located at the Picton Jetty (Picton A PID) and the raw data for the second PID deployed at 18:36 (Picton B PID). The raw data from the Picton A PID for the period 14:00 to 18:36 was combined with the raw Picton B PID data for the period 18:36 to 19:26 hours to calculate the 1-hour rolling averaged data presented in Figure 6.

The ambient concentration of VOC's at both sites was shown to be at or below the detection limit of the analysers, which is approximately 0.1 ppmv. The PID analyser located at the Picton Jetty started to measure VOC's around 18:00 hours. GASTEC tubes drawn at 18:10, 18:36 and 21:36 hours all indicate the methyl bromide concentration was less than 1 ppmv. Site observations at the time did not indicate any significant upwind sources of VOC's. Furthermore the back up PID analyser showed the concentration to be less than 0.1 ppmv. This suggests that the apparent increase in the VOC concentration was due to a fault in the instrument and the analyser was replaced.
