Shoreline Monitoring in Tory Channel and Queen Charlotte Sound

FINAL REPORT

November 2006 – April 2009

Report prepared for the Marlborough District Council

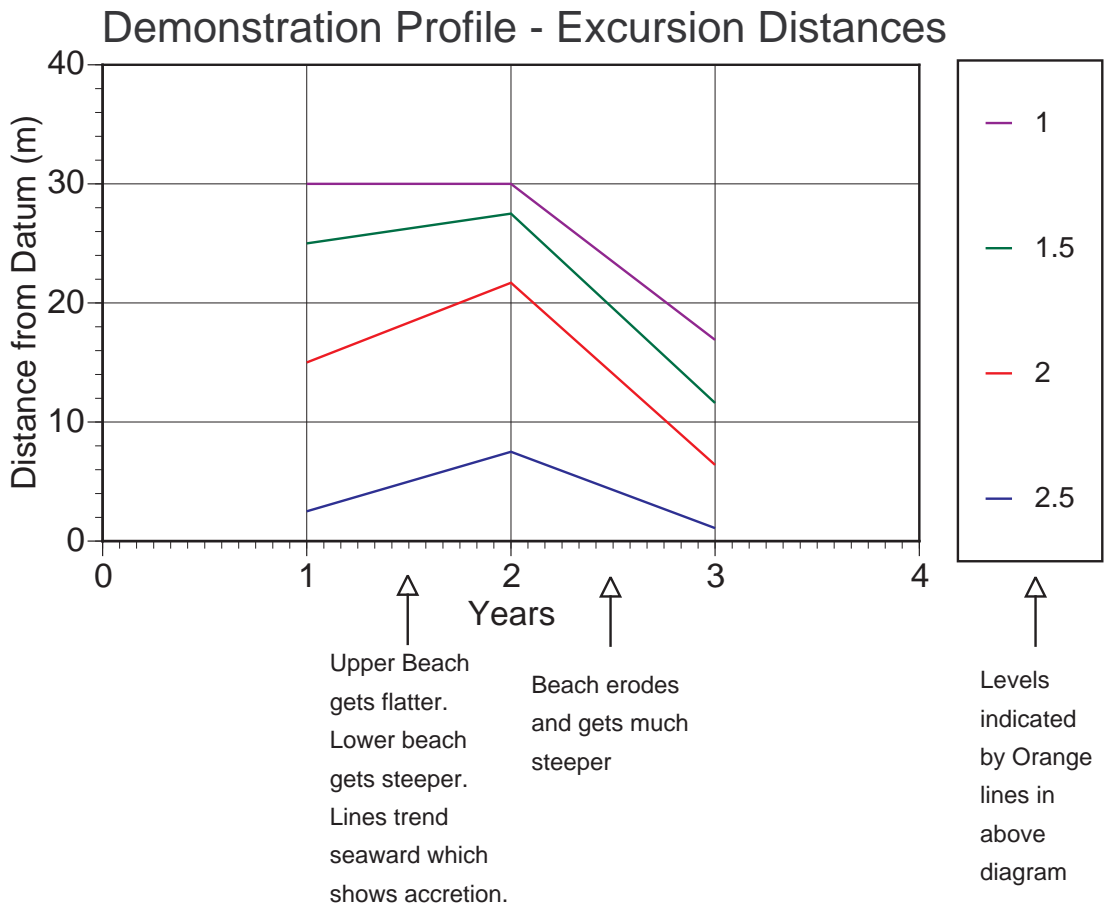
Figure 4 : Excursion Distance Analysis Demonstration

The 'spaghetti' plots of profiles are useful for establishing envelopes of change of the beach shape, but interpretations of changes which have occurred are difficult, due to the clutter of lines that are present. As the data set grows, any useful interpretation based on these plots becomes almost impossible. Excursion distance plots use exactly the same data plotted as a time series, and makes interpretation of beach changes easier. Excursion distance analysis is a method by which three dimensional data sets (distance, height and time) can be illustrated as two dimensional plots. It can be undertaken with either distance or height on the vertical axis, although having distance on the vertical axis is more useful for most purposes. Excursion distances are calculated by determining a set of height values for which calculations will be made. These values are normally equally spaced and in the following figures, are shown in the box on the right hand side of the graph. These numbers are in units of metres above or below the datum (in this case approximate MSL). Using linear interpolation the horizontal distance from the datum is calculated for each of the height values, and these are plotted as a time series with time on the horizontal axis. For each survey this provides a "point contour map" of the profile, and when plotted as a time series, an indication of how levels change through time. The graphs provide a lot of information. If two lines converge, the beach is getting steeper at those contour heights. If two lines diverge, the beach is getting flatter. If the lines trend seaward (increasing values on the distance axis), the beach is accreting. If the lines trend landward, the beach is eroding. Figure 4 attempts to show the methodology of Excursion Distance Analysis.

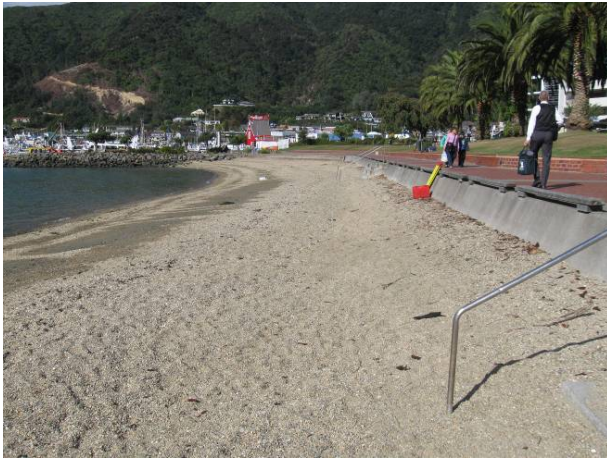
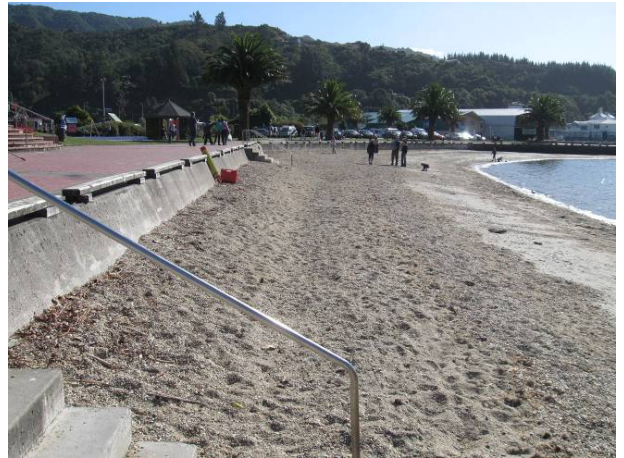
Profile 1: Picton Foreshore

The Picton Foreshore underwent extensive modification with the improvement of the landward side of the retaining wall in late 1997. Sediments on the beach comprise both natural marine sediments and river sand deposited in a beach nourishment programme.

I do not know if further nourishment has taken place since late 1997 or early 1998. If further nourishment has taken place, then the rate of nourishment is clearly appropriate. If there has been no renourishment, then the beach has been very stable since that time. Beach volume has maintained a relatively narrow range since April 1998, between 29.1 m³/m and 32.9 m³/m. There has been no apparent change in sediment characteristics. There is no indication that the seawall has had an adverse effect on beach stability. There is no indication that waves caused by vessel wash in the inner harbour are having an adverse effect on the Picton foreshore beach.

There is no indication that this site is affected by vessel operation, with the beach being relatively stable despite being highly modified. However, I do not have data on the timing and extent of any renourishment programmes.

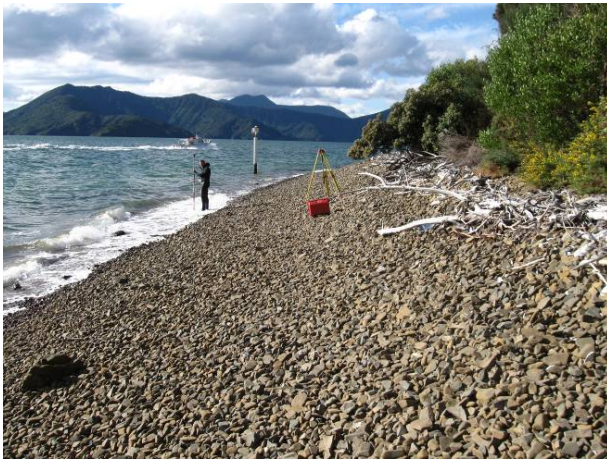
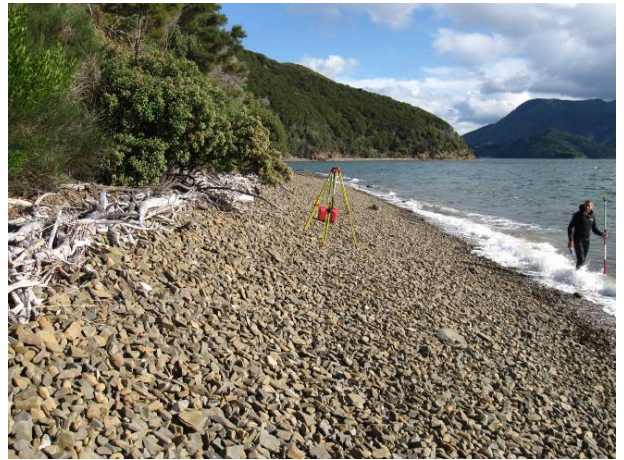
Profile 2: The Snout at Picton Point

Since April 1997, the profile has retreated and significantly steeped, seen particularly by the convergence of lines on the EDA plots. The major cause has been the slow migration of the deepwater channel in a shoreward direction. Beach volumes have followed an almost linear trend of loss over the same period, with the loss of over $6\text{m}^3/\text{m}$. There have been no apparent changes to sediment composition. The reason for the channel migration is not clear, although the site does receive considerable wake energy.

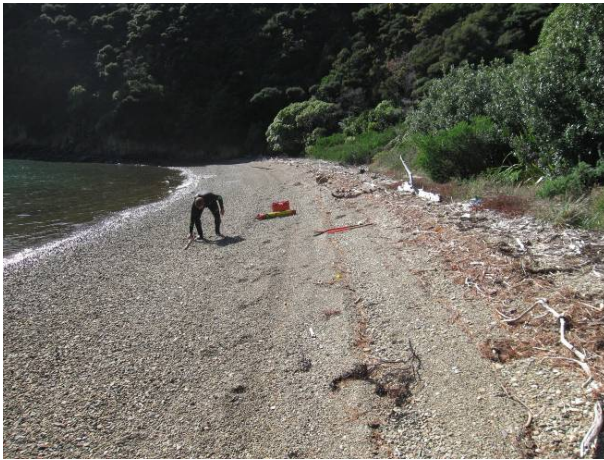
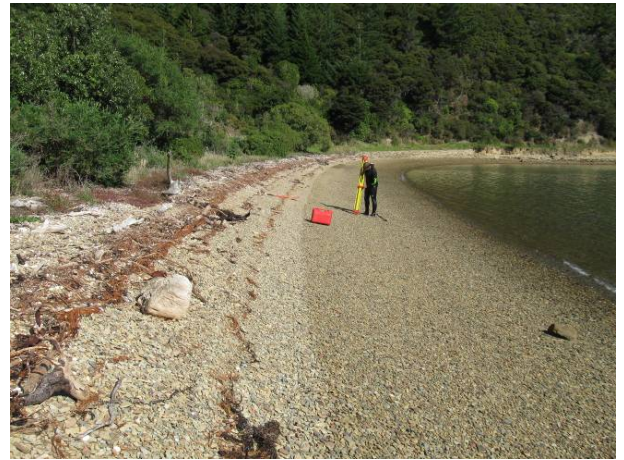
Profile 3: Double Bay

The Double Bay beach profile has changed within a very narrow range over the period April 1997 to April 2009. The most recent profile data sits close to the centre of the long-term sweep, with beach volume in 2009 being almost the same as it was in April 1997. There has been a minor steeping of the beach with the construction of a berm and a minor lowering of the mid-beach surface, although this peaked in 2002, and there may be an erosion trend developing. The profiles clearly reach closure depth at about -0.5m. In recent times, a (very thin) fining of the surficial sediment appears to have reversed.

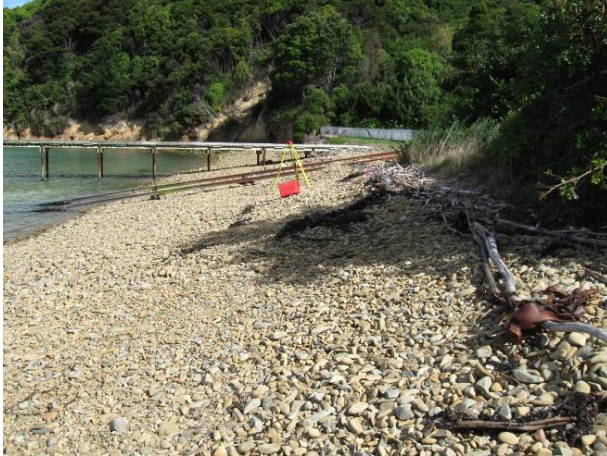
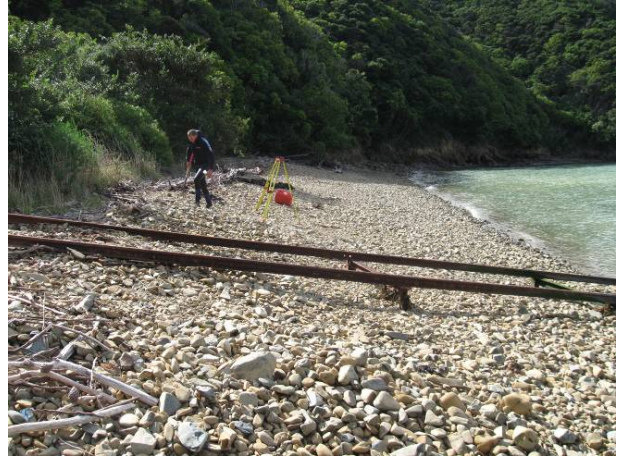
Profile 4: Ngaionui Bay

The long-term history of this site has been discussed in previous reports. The site is complicated by relatively frequent human modifications (although the nature of any works and their frequency in recent times is not known). It is also complicated by the presence of a landslide at the western end of the beach, with sediment redistribution within the compartment. It was very clear that fast ferry operation contributed to significant beach accretion, and that all wakes and natural processes, coinciding with a sediment supply from the slip, have all contributed to slow beach building. However, since 2006, the beach has been relatively stable, with minor adjustments to the beach berm. Since 2006, beach volume has varied little.

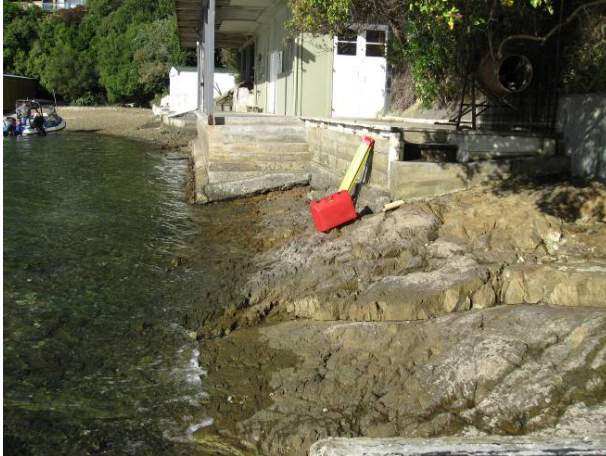
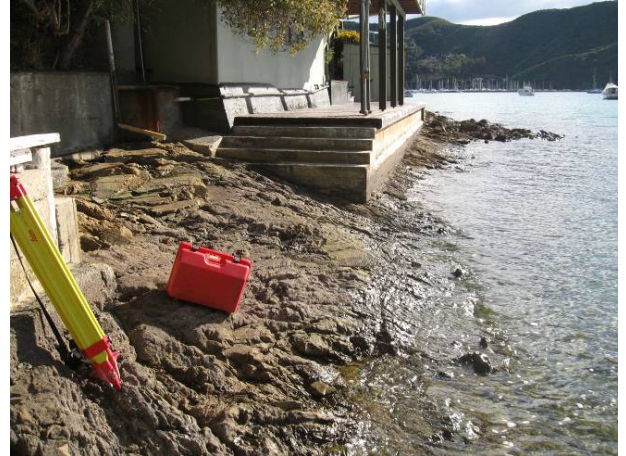
Profile 5: Blackmore's at Waikawa

Between April 1999 and November 1999, sand on the small beach started to disappear. By November 2001, the beach had been stripped to bedrock, and it has remained essentially devoid of sediment since that time. Further loss of sediment is therefore not possible. There has been no recovery since the fast ferries slowed down in December 2000. Minor changes in profiles and volumes recorded since that time are likely to be the result of slightly different survey alignments, and possibly minor changes in sediments on the lower profile.

Profile 5 (Blackmore's at Waikawa) was established at the request of Council. This site demonstrated erosion, but is now stripped to bedrock, but it is unlikely that the reason for the loss of sand is ever going to be known. As previously noted, I see no good reason for maintaining this site.

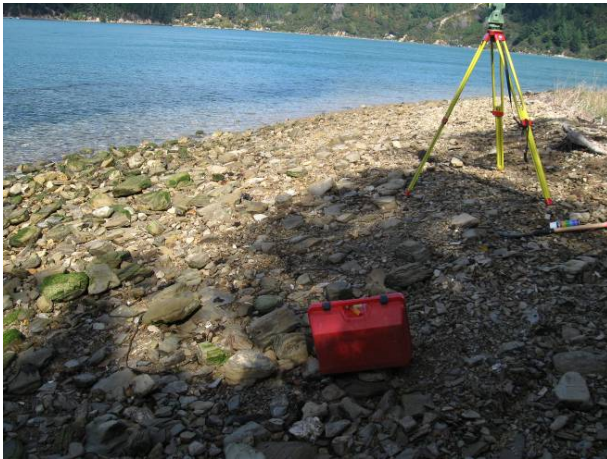
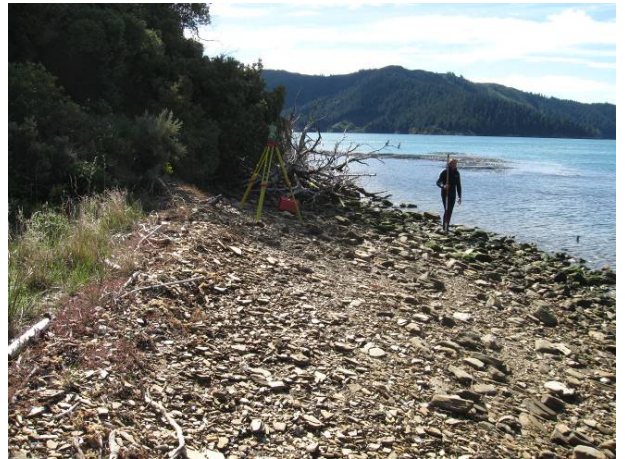
Profile 6: Moioio Island 2

Moioio Island 2 is at the eastern end of the beach on the island, near the slip that has been of considerable concern to Te Ati Awa. This profile has a record going back to November 1995 and until 1999 the beach profile demonstrated seasonality, with a build up of a berm on the upper beach over the winter months, and its removal over the summer months, after which time, seasonal patterns have not been evident. The beach experienced significant accretion up to 2005, with a significant reversal for a period between November 2000 and April 2002 (coinciding with the slowing of the fast ferries possible affecting sediment mobility from the slip source). Since 2005, however, the beach has been eroding, particularly on the upper and middle sections. A significant berm remains at the top of the profile, and the lower beach remains extended into the deep water channel.

The most significant effect on this profile has almost certainly been the adjacent slip. Major fluctuations in beach shape and volume, and indeed the general accretion, are almost certainly related to sediment supply from periods of activity and inactivity of the slip. It is therefore assumed that the slip has been relatively inactive since 2006.

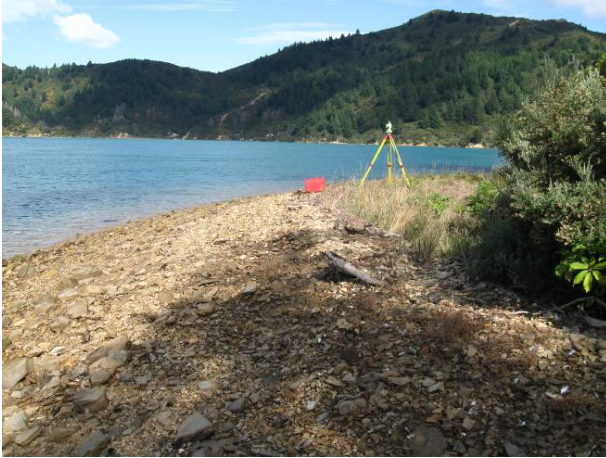
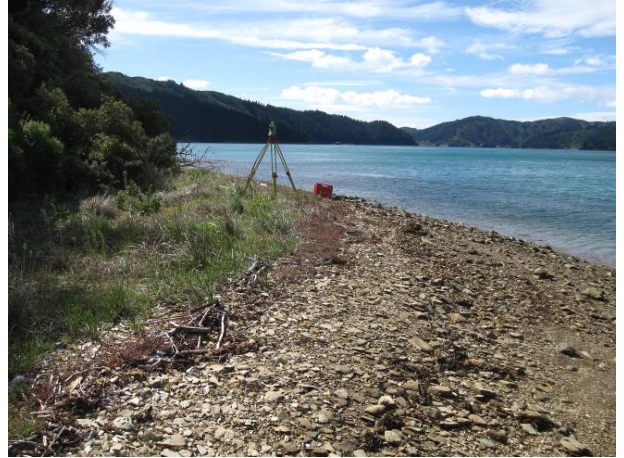
Profile 7: Moioio Island 1

The Moioio Island 1 profile is to the west of Profile 6. There was remarkable seasonality up to the winter of 1999,, with the growth of a berm over winter and its loss over summer. Up until the end of 2000, the upper beach was generally stable, with seasonality, and with the lower beach accreting into the channel. Up to 2006, like Profile 6, the whole profile accreted rapidly with very substantial volume increases. There was substantial accretion of the upper beach between May 2000 and May 2006, with a major increase in volume, particularly between May 2000 and April 2001. Like Profile 6, there has been a reversal since 2006, with the entire profile retreating, although a substantial berm remains. This profile is almost certainly reacting principally to sediment supply.

There is little doubt that the beach changes taking place on this profile are related in part to ferry operation (evidenced by the very strong seasonal signal when fast ferries were operating seasonally), but they are affected significantly by changes to sediment supply. The accretion event observed on Profile 6 between April 2003 and April 2004 is reflected on Profile 7 between November 2004 and April 2005.

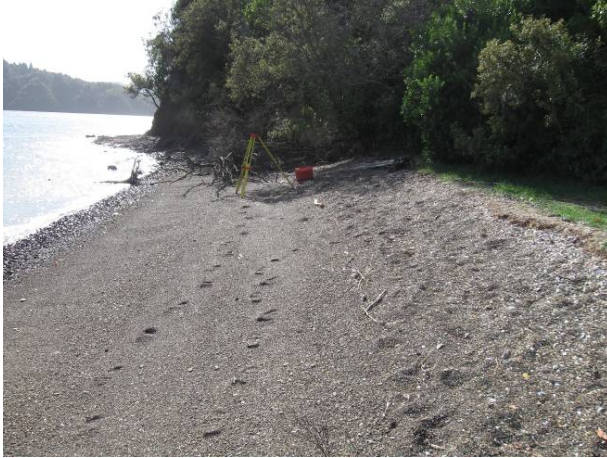
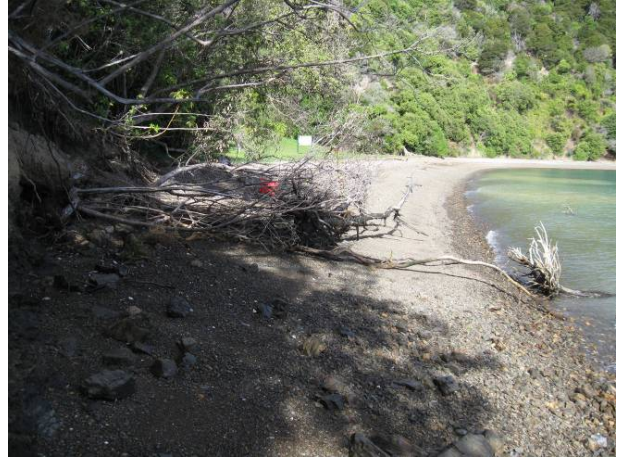
Profile 8: Bobs Bay

Bob's Bay has demonstrated an almost linear erosion trend since 1995 across the whole beach profile down to the change in slope (and probable closure depth) at about –1 m. Most of the beach has lowered in level by about 1m. Volume data shows a loss of 17 m³/m since 1995. This erosion is very significant within the context of beaches in this study. The beach slope has stayed relatively constant.

The location of this profile is at the northern end of the beach, adjacent to a headland of significance to Te Ati Awa. It may be that the erosion is accompanied by accretion elsewhere in the embayment.

The cause of the erosion is not known. The site is well inside Mabel Island, and all major shipping movements should be at low speed with small wakes. There is also limited fetch, so natural waves should also be small. The mechanism of sediment transport away from the profile line, and where the sediment goes could be investigated if erosion at this particular point becomes of concern.

The Bob's Bay profile has been continuously eroding. Erosion may be caused by all vessel wakes in the high traffic area near Picton (including the many small boats that pass quite close to the shore at this point), but may be entirely natural. Should erosion at this site be of particular concern, another profile towards the southern end of the bay should be established, to determine if the whole beach is eroding or if sediment is being redistributed within the embayment. In the longer term, some process studies could be considered.

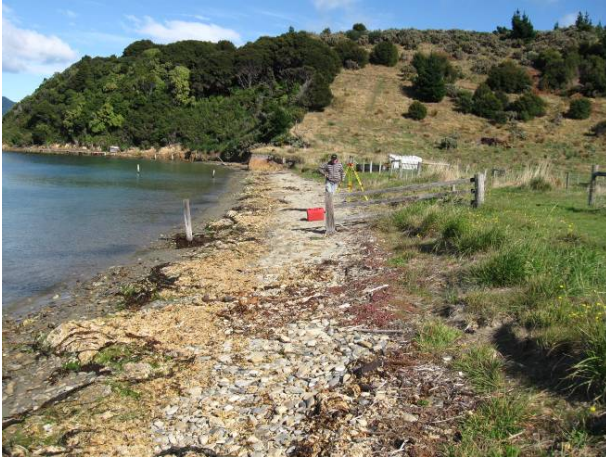
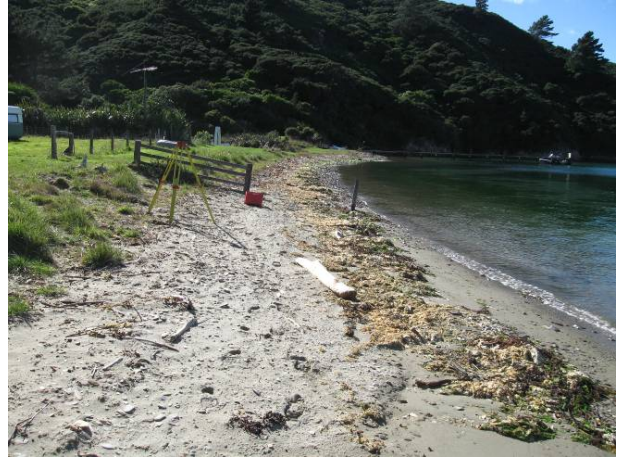
Profile 9: Te Awaiti Bay

Despite frequent changes in surficial sediments (more common up to 2003), with the deposition and removal of a small quantity of fine sediment, the beach profile has changed little. Beach volumes were relatively stable up until 2001, but then increased significantly, possibly coinciding with the slowing of the fast ferries. Volumes have reduced slightly since peaking in 2004, but some redistribution of sediment has occurred with deposition at the top of the beach. Photographs indicate that the sediment deposited at the top of the beach may have an aeolian origin.

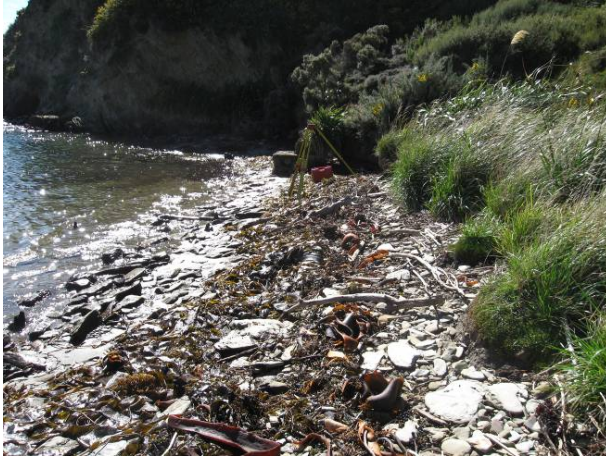
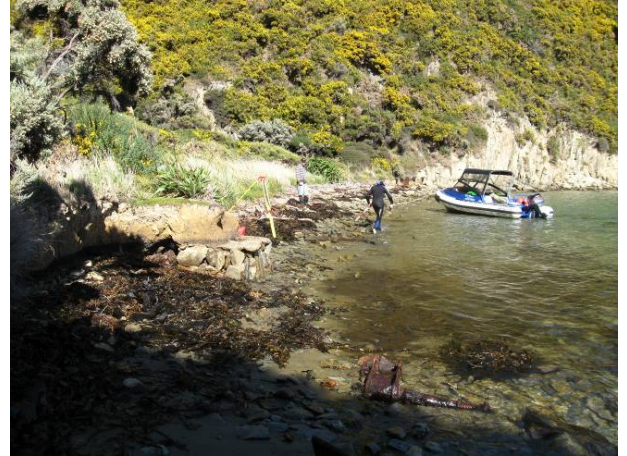
Profile 10: Tipi Bay

There has been some retreat of the upper beach scarp (approximately 1m) and a corresponding increase in the level of the middle to lower beach, but the changes have generally been minor. Because of the relatively coarse nature of the sediments, the placement of the survey staff can have significant impact on the apparent appearance of the profile line. Overall, beach volumes have reduced only a little.

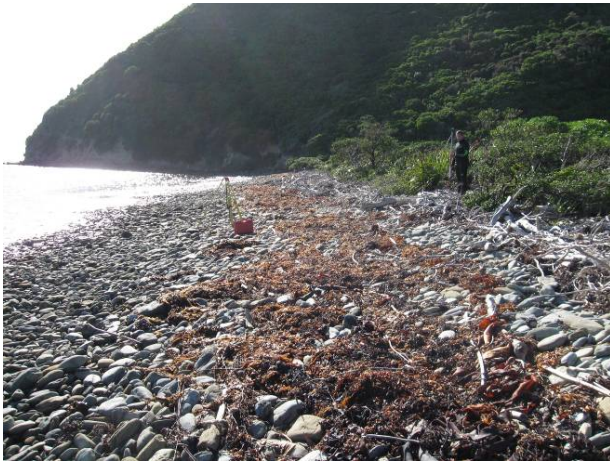
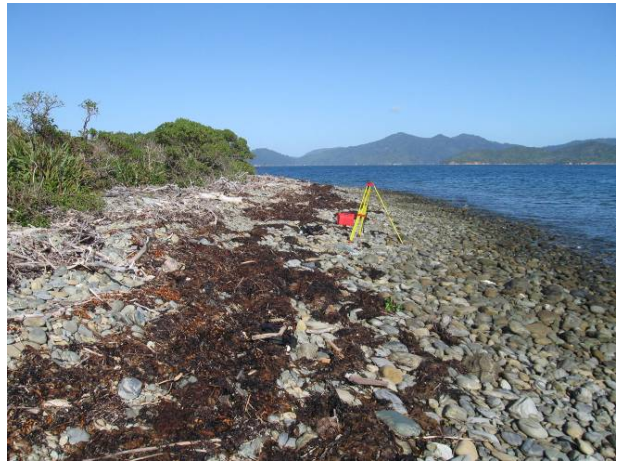
Profile 11: Long Island

The Long Island profile is relatively exposed to storm events that cause waves to propagate through the northern entrance to Queen Charlotte Sound. There is considerable variability in the level of the upper beach, with the build up and removal of a berm, although this has been less evident since about 2000. The level of the middle and lower beach also shows some variability, but with no obvious seasonal trends. There has been an overall decrease in sediment volume over the last 12 years. There are no significant sedimentary trends.

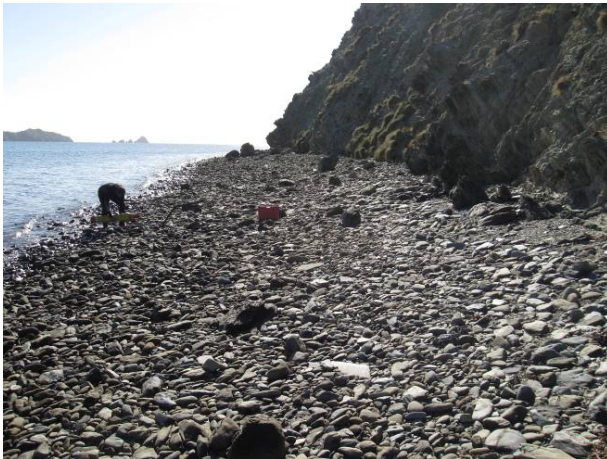
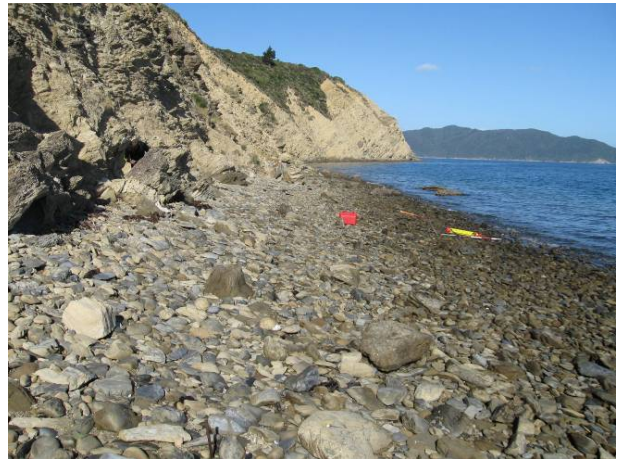
Profile 12: Clark Point

This profile, with a similar aspect to Profile 11 (Long Island), has shown no significant change in level, volume or sedimentary characteristics since 1997.

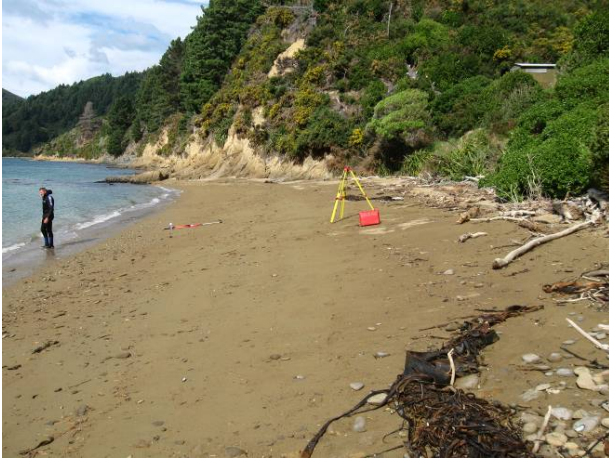
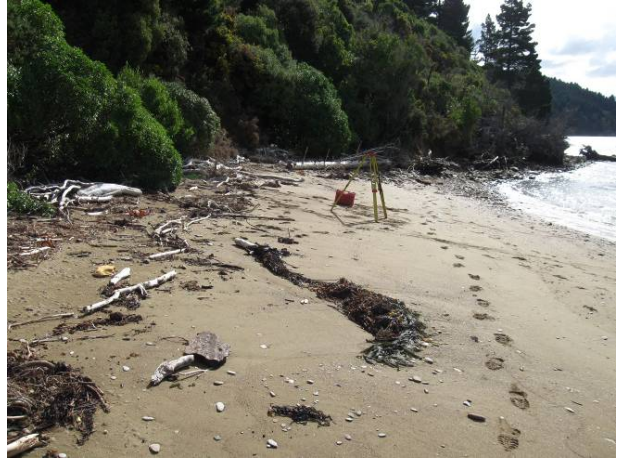
Profile 13: Slip Beach

The photographs indicate that the dominant sediment type is sand with some small cobbles and pebbles.

Although no obvious relationships between ferry operations and beach change were able to be determined, it is apparent that the considerable variability in the profile ceased about the same time as fast ferry operations ceased. Slip beach has a considerable fetch into Queen Charlotte Sound to the north, and natural waves may be substantial. However, wave measurements at this site have indicated substantial wake events that continue for unusually long periods of time.

Because of its unusual exposure, extreme seasonality, unusual wakes and, for the area, fine sediments, this location continues to be of particular interest.

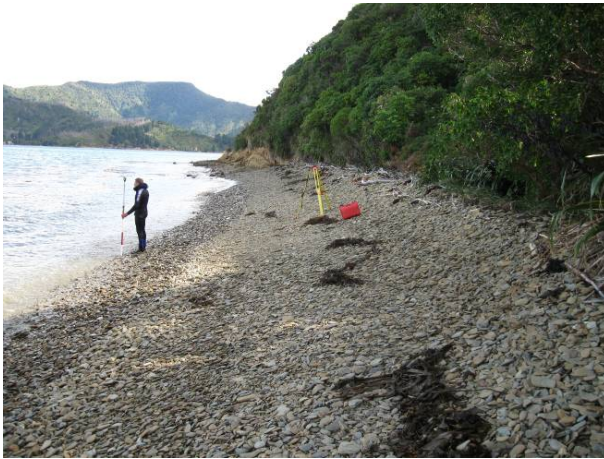
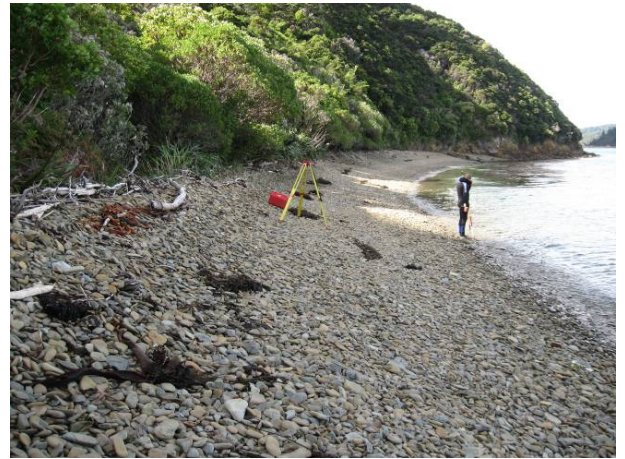
Profile 14: Ngaionui Point

Given its proximity to the sailing line of vessels in Tory Channel, the beach at Ngaionui Point probably changed significantly when the fast ferry first started operation, and that the beach form has generally held since that time. There was a slow trend towards accretion up until about April 2002, and a trend of erosion since that time, reflecting the start of a return to pre-fast ferry conditions. The beach is now lower than at the start of surveys. However, it is unknown what its status is compared to the situation prior to fast ferry operation.

Apparent changes at the very lower beach are probably the result of different survey placement. There have been no significant changes in sediments.

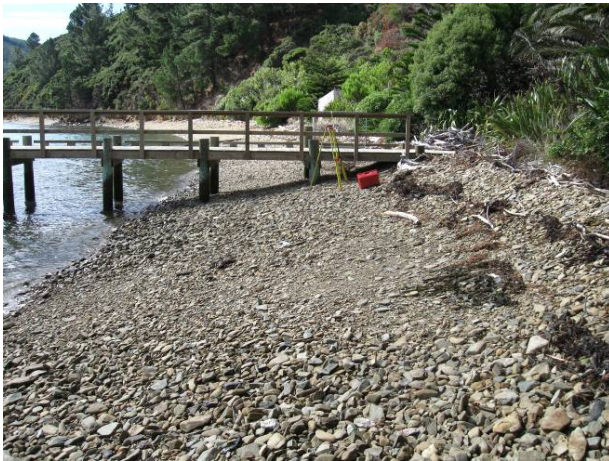
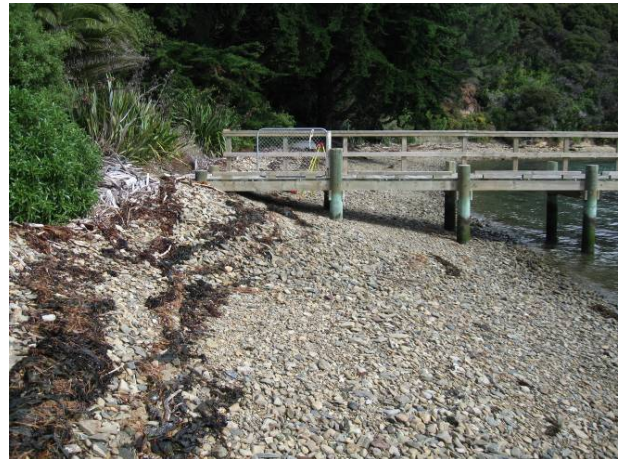
Profile 15: Te Weka Bay

The Te Weka Bay profile, has been generally stable over the 2006-2009 survey period, and since surveys began. The development of an upper beach berm and the reduction in level of the middle beach during the period of fast ferry operation is evident (reaching a peak in April 2000). The berm has remained generally intact since that time

There have been no significant changes in sediment characteristics.

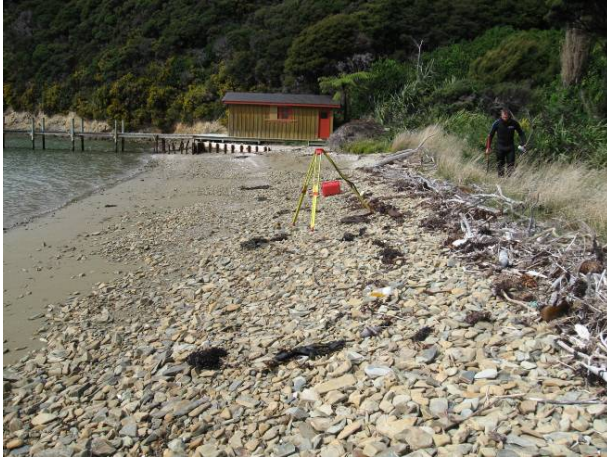
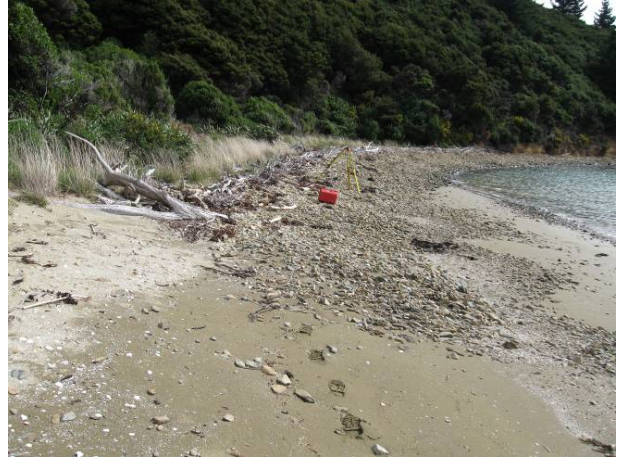
Profile 16: McMillan's Bay

This profile line is clearly being influenced by longshore transport of gravels from west to east. It may also be that there is transport of sand either onshore or alongshore. It is most likely that the mechanism of accretion is the result of ferry generated wake waves. The rate of accretion dropped markedly about the time the fast ferry operation ceased, probably the result of a reduced ability of the waves to transport sediment.

McMillan’s Bay is quite unusual in the context of the Tory Channel, being wide and with a relatively small slope. It has a wide ‘surf’ zone, unlike almost all other shorelines in the area.

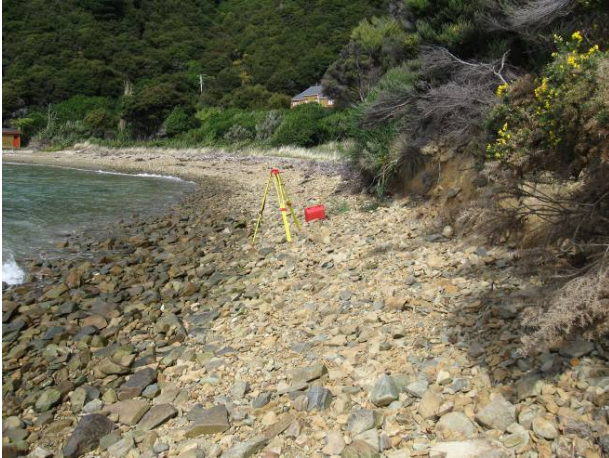
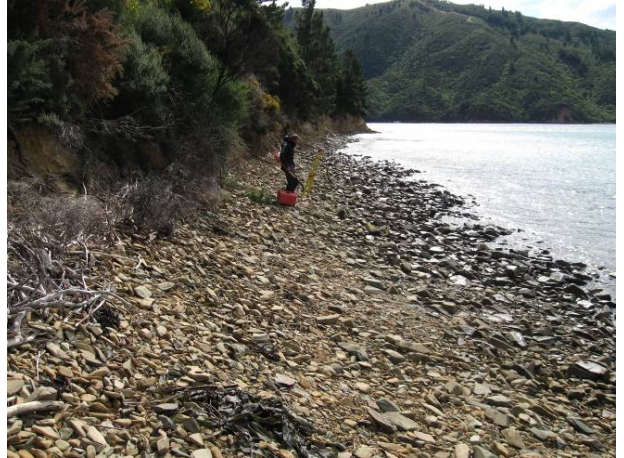
Profile 17: McMillan's Side

Beach volumes increased until 2001, with most of the accumulation on the lower profile. Since that time volumes have decreased, with most loss coming from the mid to upper beach. There is no indication of erosion at the upper beach scarp.

The reason for the major deposition between November 1999 and May 2000, reflected also on Profile 16, is unknown. However, there must have been a significant increase in sediment supply, perhaps a slip in the vicinity of Arrowsmith Point. After fast ferry operation ceased in 2000, there was a change from sediment accumulation to sediment loss, which has continued through to 2009. This occurred at the same time as a change from sediment accumulation to stability on Profile 16. Changes in this profile reflect changes in vessel operations, but there also appears to be a sediment supply control.

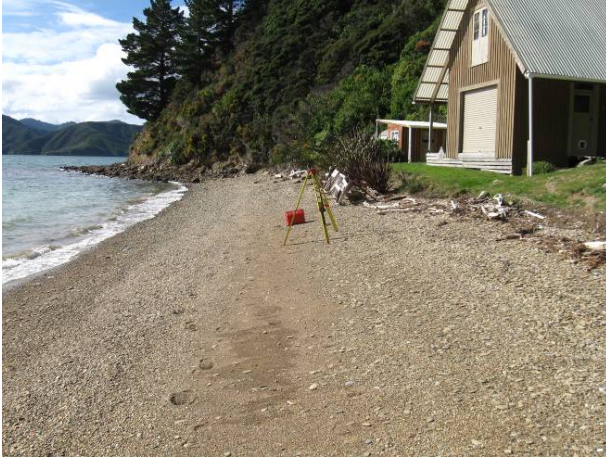
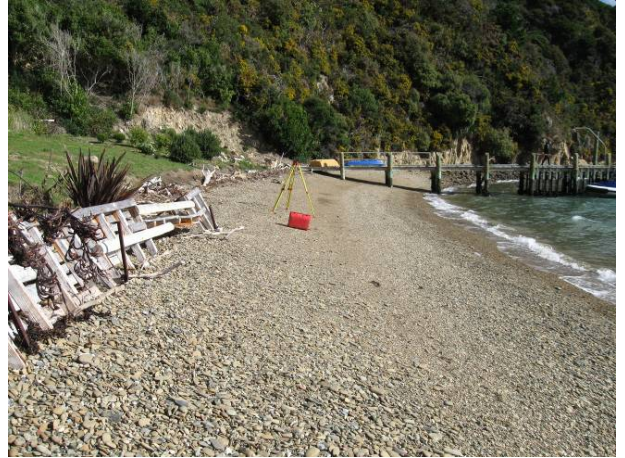
Profile 18: Dieffenbach West

There has been no significant change in the profile shape or in sediment volume since 1997. At times there is more sand on the beach, and it has been more persistent in recent times.

During 2000 a small cottage was built at the northern end of this beach, and in 2003 a boatshed was built and a minimal wooden seawall constructed adjacent to the profile line. The seawall does not appear to be affecting beach processes, but it is also not providing any significant protection to the land.

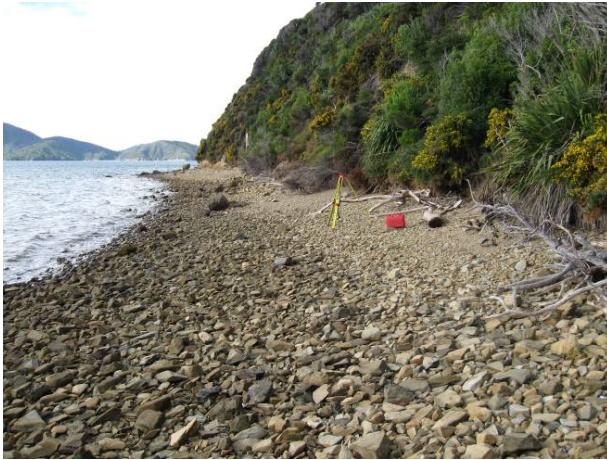
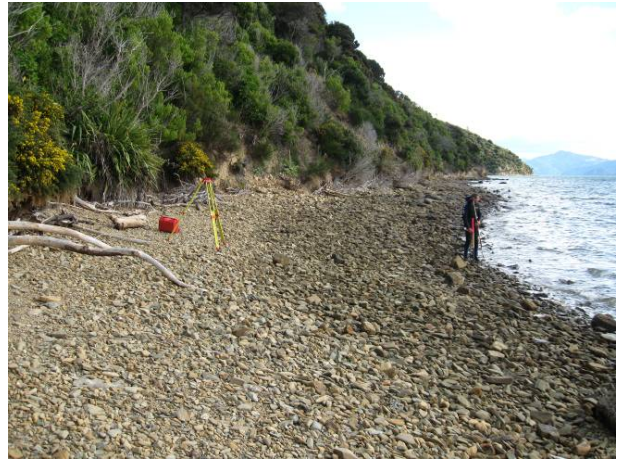
Profile 19: Curious Monkey

Overall the beach has been stable since 1997. However, there was slow accretion through to the end of 2000, and slow erosion since that time, the change coinciding with fast ferry operation ceasing.

There have been no notable changes in sediment characteristics.

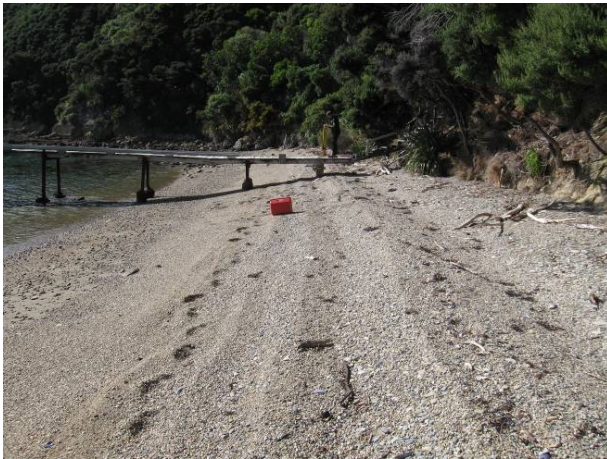
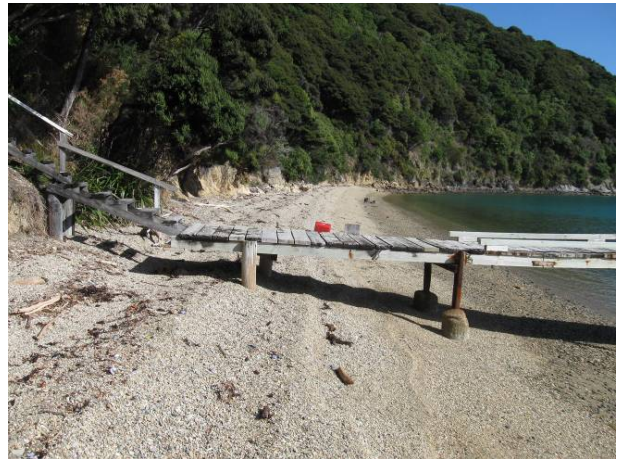
Profile 20: Patten's Passage

There is considerable variability on the upper and middle beach, but overall stability, with perhaps an erosion trend in recent years. Small berms build and are removed on the upper beach, with no particular seasonal pattern. Sediments are gravels and sands, and there is frequent banding, but no significant trends are obvious.

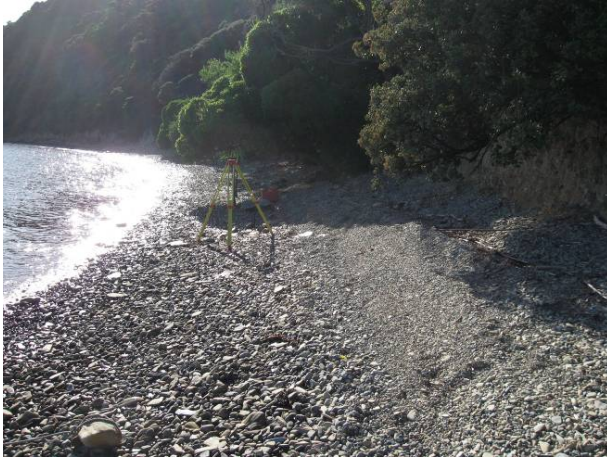
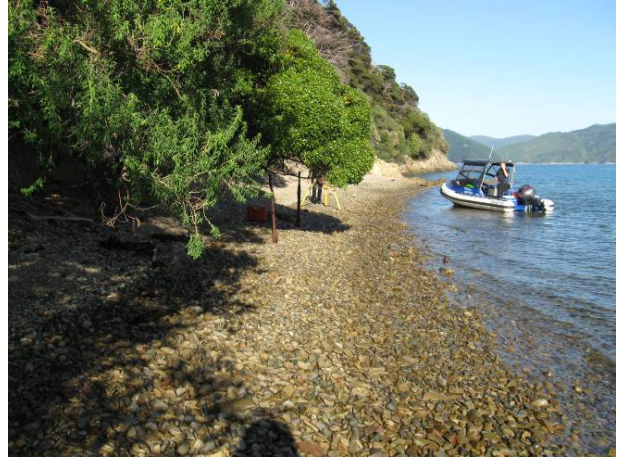
Profile 21: Blumine Island

Blumine Island has a similar aspect to the Patten's Passage profile. Up until 2003 changes were generally minor, with no seasonality shown. Since 2003, there has been a slow erosion trend, with some seasonality. Significant erosion at the beach scarp at the top of the beach has been reported by the surveyors in the last year, and the profile line has been extended landward to cope with this. There are insufficient data to report on this change at the present time.
