Are Are Creek Catchment Baseline Water Resource Report

✦ Prepared for
Marlborough District Council

✦ July 2008

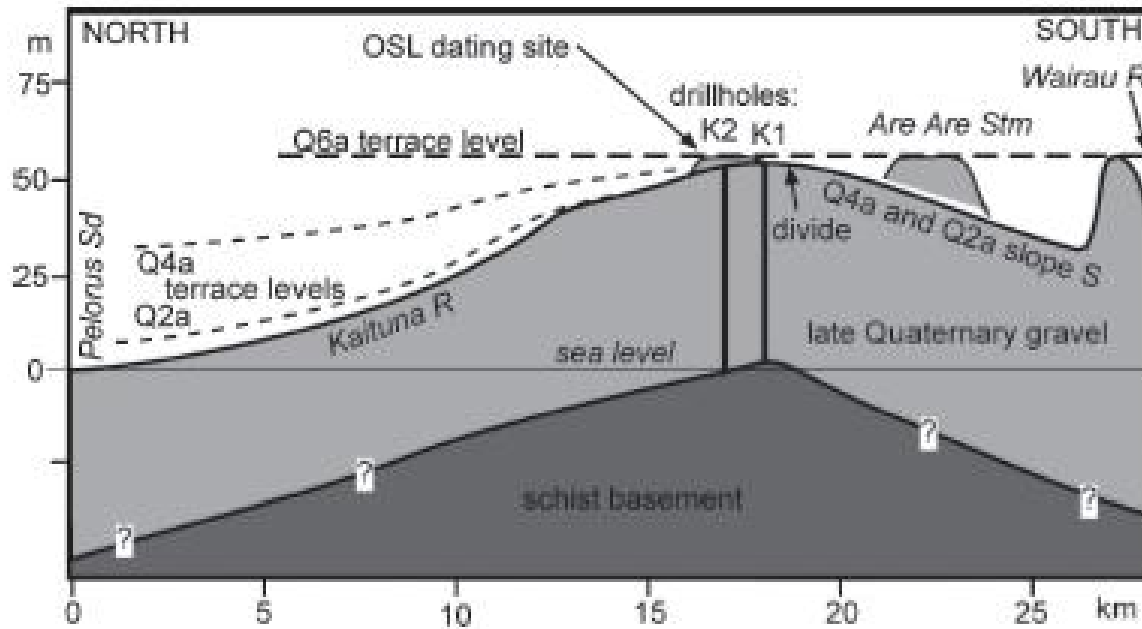
Figure 4 : (From Craw et al, 2007)

Fig. 2 Sketch cross-section through the Kaituna valley from Pelorus Sound (left) to the Wairau River (Fig. 1). Schist basement boundary is projected from valley walls, and constrained by drillholes K1 and K2 (Wopereis 1999). The topographic profile follows Kaituna River and the Are Are Stream. Locations of Q6a terrace remnants, above the rivers, are indicated. 100x vertical exaggeration.

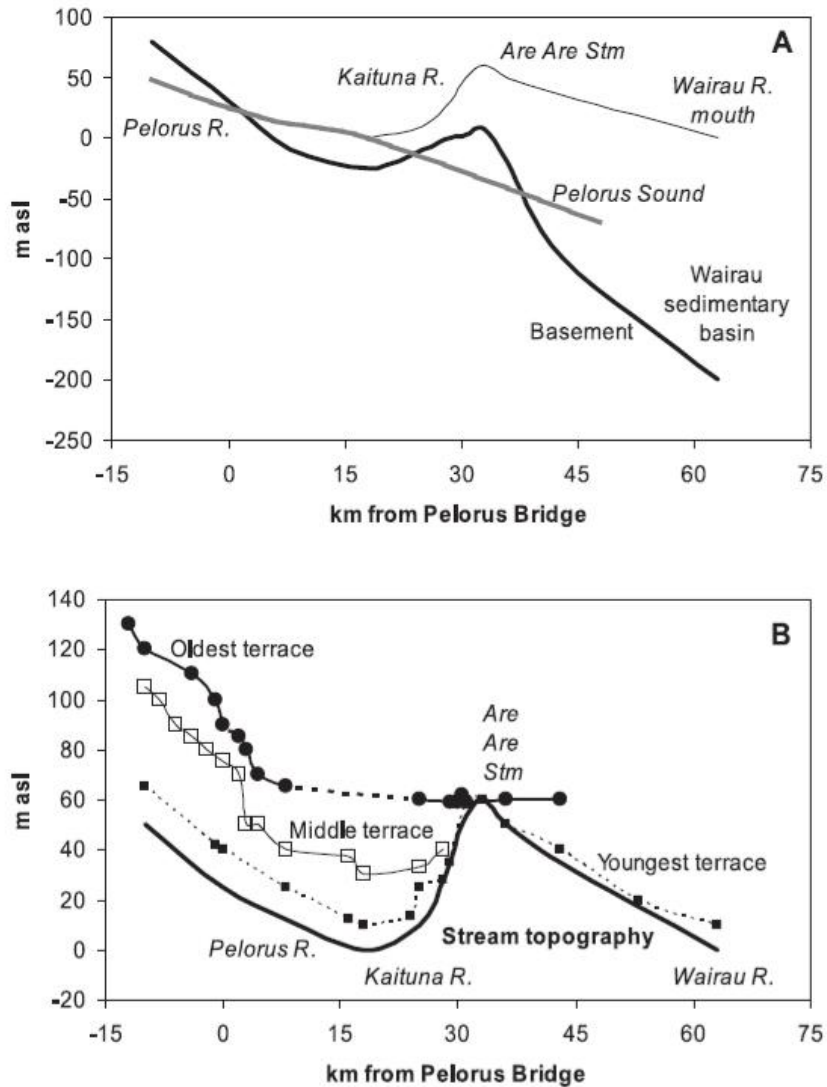
Figure 6 : (From CRAW & J WATERS, 2007)

Fig. 4. Topographic profiles of rivers and terraces described in this study, with heights (in metres) above sea level (m asl) plotted with distance from Pelorus Bridge (Fig. 2a) (a) Present profiles of Pelorus River (extended down Pelorus Sound, after Singh 1994), and Kaituna valley to the sea via the Wairau River. Bedrock profile down Pelorus River and through the Kaituna valley is estimated from field observations and drillhole data of Mortimer & Wopereis (1997). (b) Terrace profiles for the three terraces mapped in this study in the Pelorus and Kaituna valleys (see text for details), in comparison with the present topographic profile along the valleys. Symbols on profiles represent observation sites.

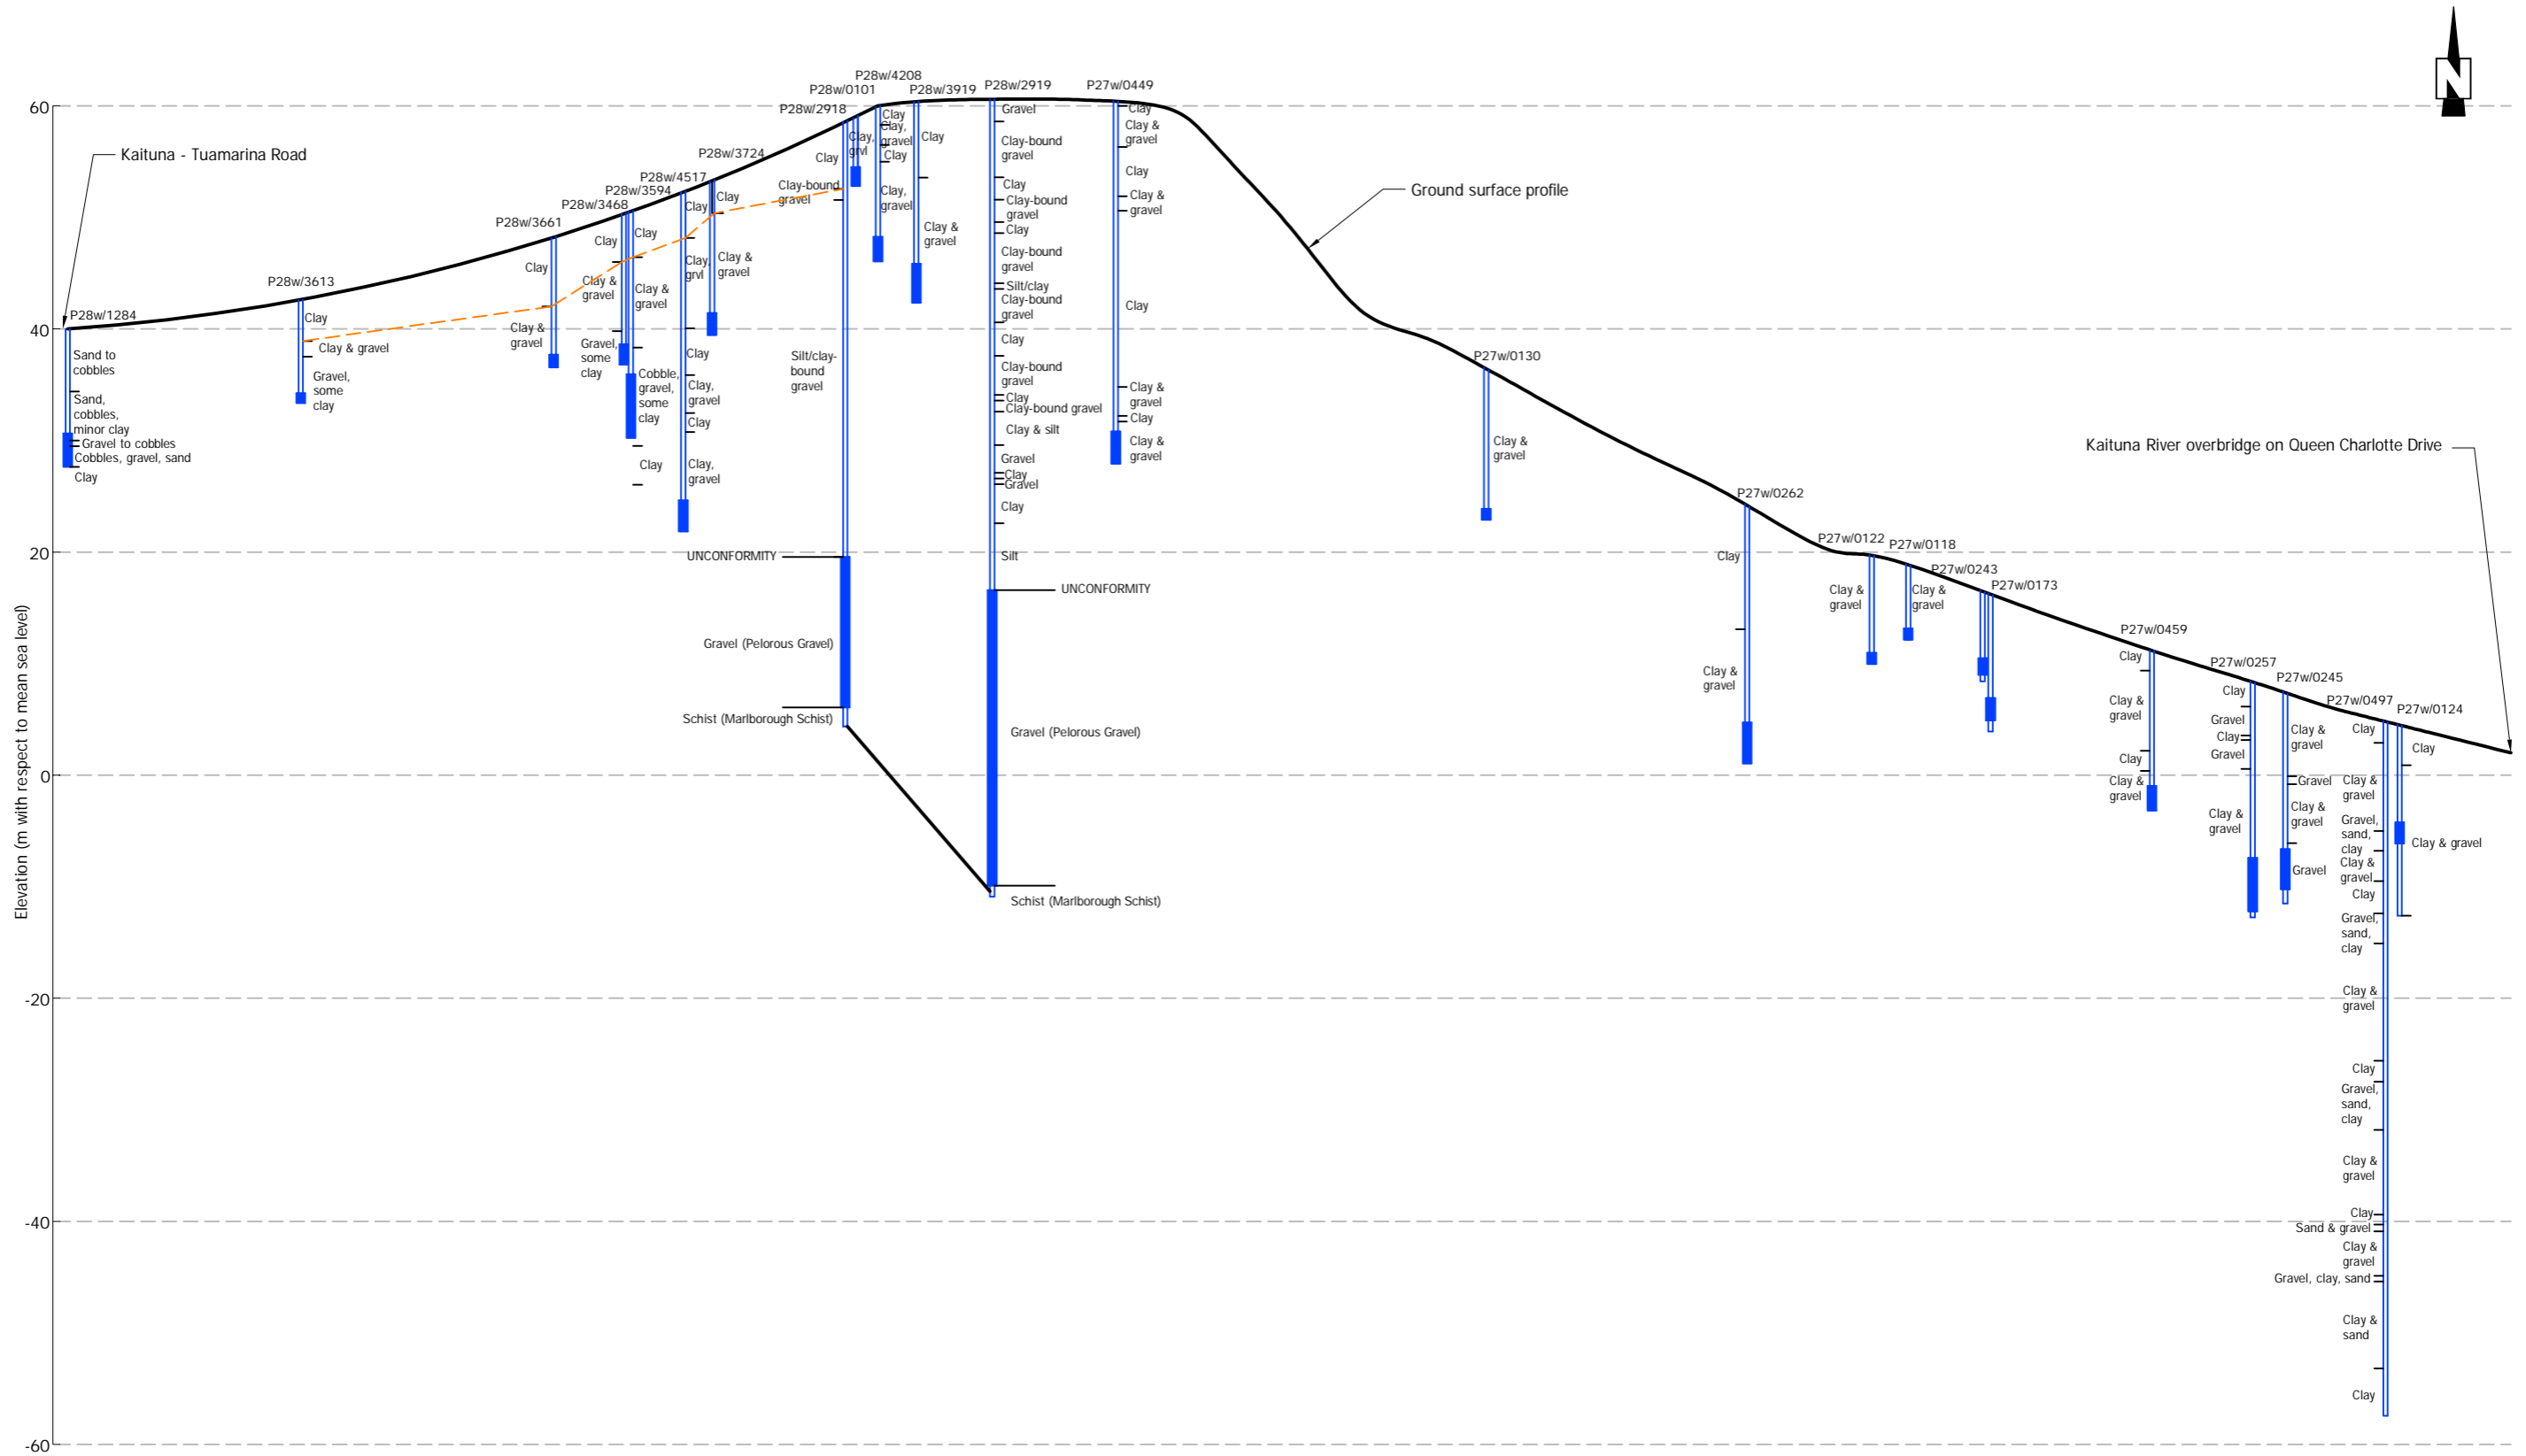
Figure 17 : HYDROGEOLOGICAL CROSS-SECTION

- ← Bore (Geological descriptions summarised from drillers logs)
- ← Well Screen

Figure 17 shows a schematic hydro geologic section from north-south along the Kaituna River valley and the Are Are Creek valley. The section has a significantly exaggerated vertical scale and shows the drillers description of the strata from each borehole along with the position of the well screen, which indicates the most permeable water bearing zone in each well.

The cross-section indicates the variable nature of the strata, the predominance of clay and gravels but the absence of any consistent layering of permeable gravel layers and intervening low permeability aquitards, with the exception of a possible surface fine grained clay strata along Are Are Creek. Below this the strata is probably best characterised as a variable mixture of lenses dominated by either gravel or clay.

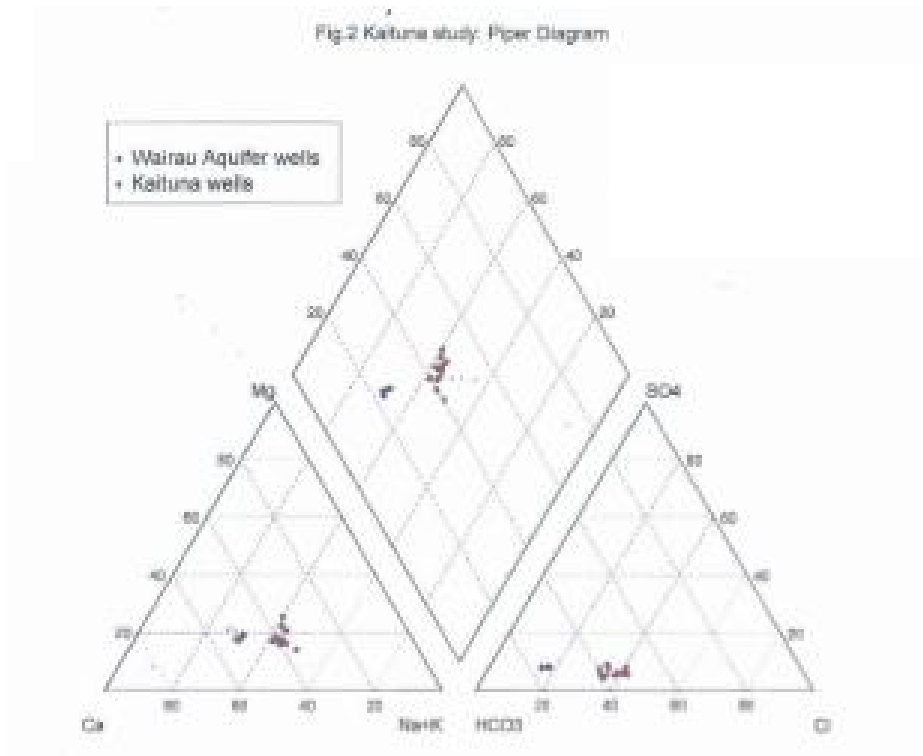
Figure 23 : (C.B Taylor , Report to MDC , August 2004)

Fig.3 Comparative hydrochemistry (Kaituna)

From L to R, groups are northern tributaries, terrace wells, Wairau Aquifer, Wairau River
