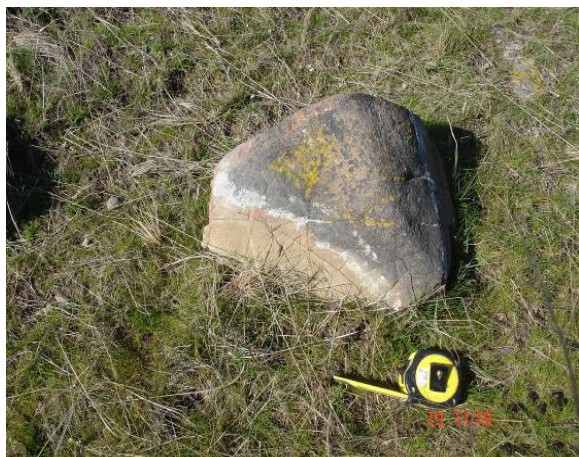
Figure 67. A boulder on a ridge with characteristic wind faceted shape (ventiforms) aligned in the prevailing wind direction.

67) resulting from abrasion by strong winds. Many small stones that occur somewhat randomly in loess on the upper slopes were probably blown from the ridges. Larger stones (Fig. 68) also occur randomly within the loess and have probably been deposited by solifluction, a process whereby thawing material slides down-slope on a firm or frozen surface. The fragic horizon probably represents an interval of severe cold with soil freezing, as is suggested by the vesicular structure that is present, the small voids being left after ice crystals in the soil have thawed. It is also possible that during this period of extreme cold and loess deposition, soluble salts accumulated in the soils, perhaps even forming a salt pan.

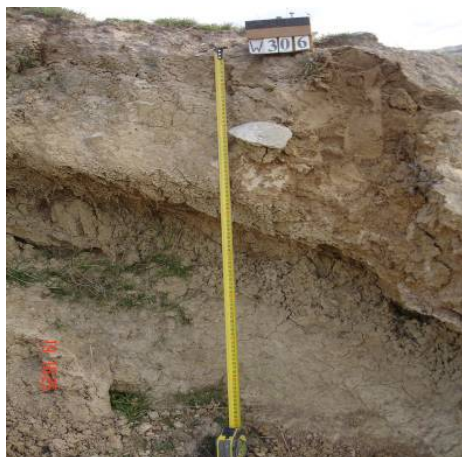
Figure 68. A solitary boulder with the long axis aligned down-slope, deposited by solifluction.

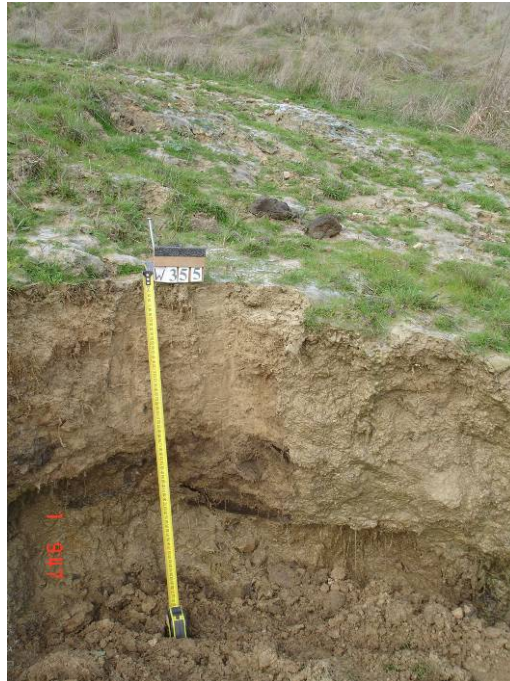
Figure 69. A thick deposit of predominantly fine silty sediment (colluvium) on the floor of a gully accumulating by sheet flow. The sediment is built up by runoff during rain events with coarser material added in heavier storms.

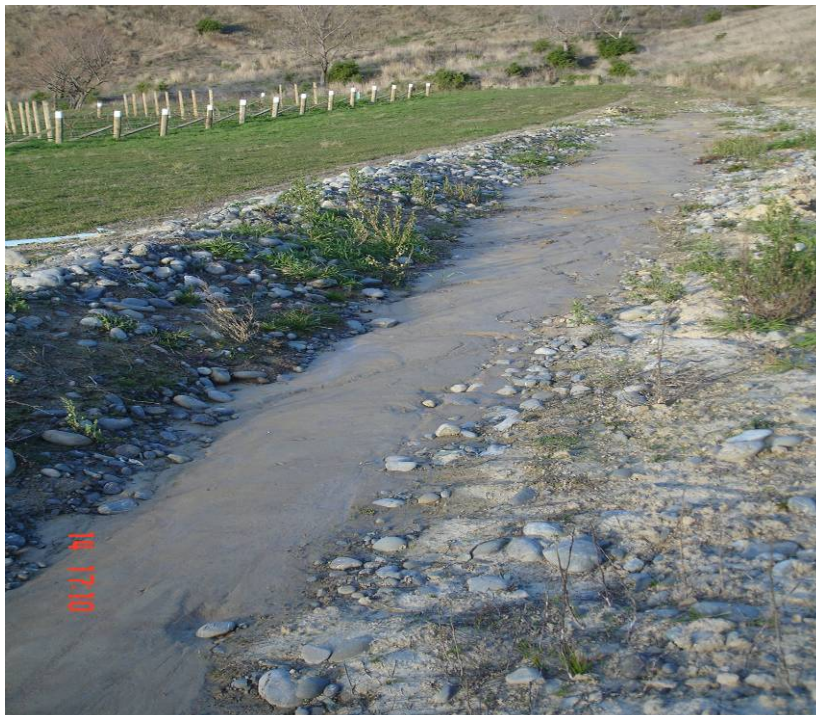
Figure 70. This runoff diversion barrier has trapped a small amount of silt and emphasises the ongoing loss of fine soil material from adjacent hill and steep slopes. Without the barrier, the silt would have ended up in the waterways of the Wairau Plain.

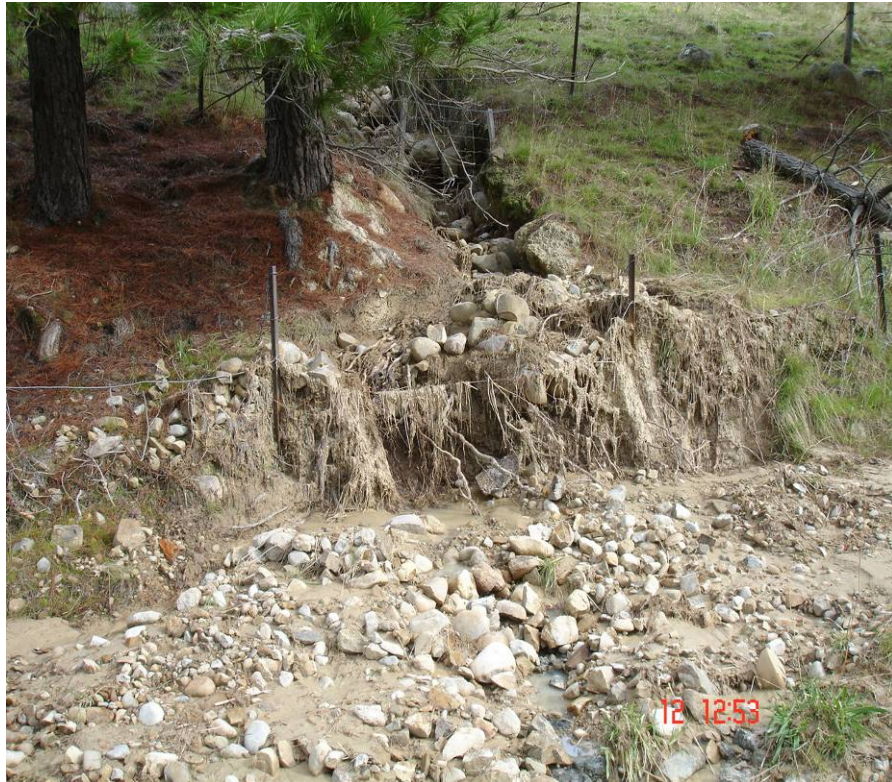
Figure 71. Coarse sediment accumulating at the foot of a small gully from an eroding catchment above. The size of the clasts is indicative of the high volume and velocity of the runoff waters.

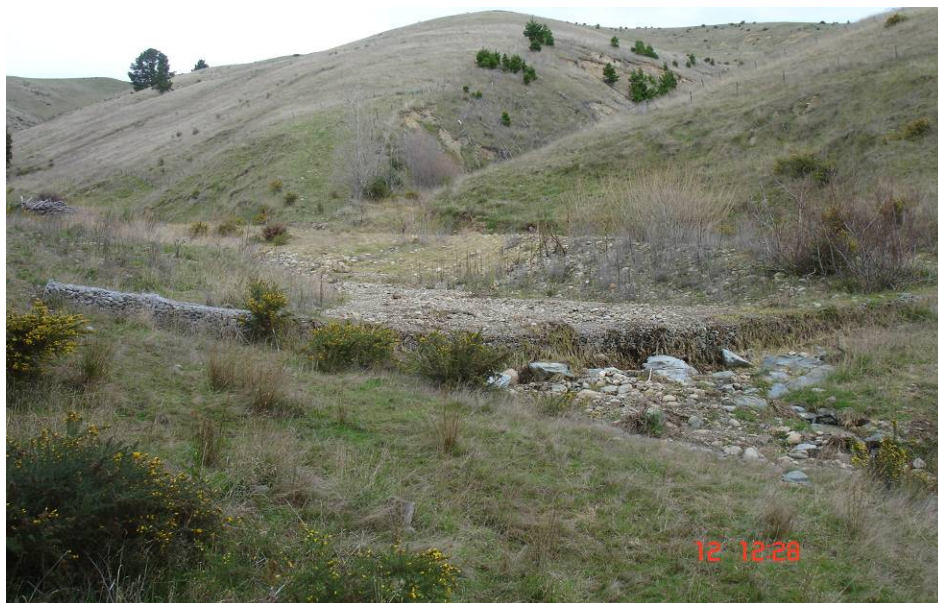
Figure 72. A sediment retention dam built by the Marlborough Catchment Board as part of erosion control measures. Impounded sediments are periodically removed to maintain the sediment retention function, but a better alternative might be to build a new structure on top of the retained sediments.

In the past, some sediment retention dams were built as part of the soil conservation work in the Wither Hills and have successfully retained large amounts of coarse sediment (Fig. 72). It is suggested that new dams be constructed on top of the existing accumulated sediments, as flattening the valley

floor profile would be expected to impede the down-valley movement of a debris flow, as well as retaining the sediments that result from erosion within the catchments.

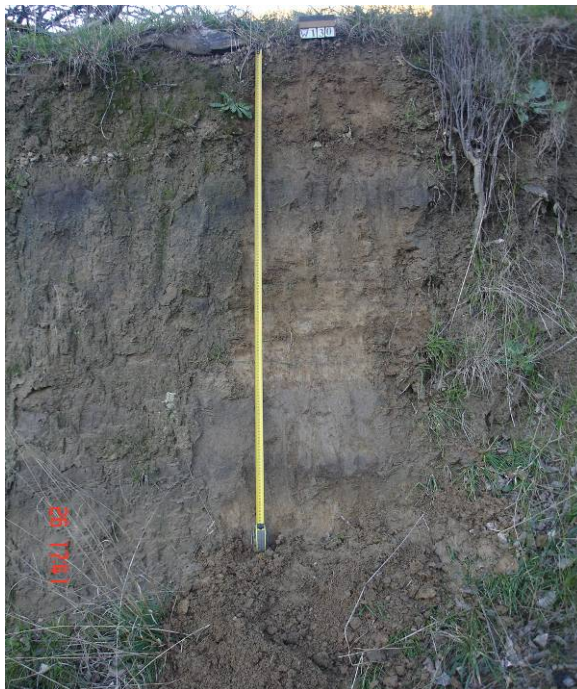
Figure 73. Buried soils are marked by the old dark coloured A horizons in sediments on a gully floor. The sequence indicates episodic erosion and sedimentation with periods of stability over an unknown length of time.

The principle off-site consequences of the erosional instability in the Wither Hills and Redwood Hill area are the removal of soil materials with their re-deposition on the adjacent lower lying surfaces, along with serious loss of water quality in drainage waters on the plains. There is ample evidence for the redistribution and deposition of materials from the valley sides to the floors of the gullies and the plains (Figs. 69-73). Fine sediments may accumulate on the floor of a gully, being trapped by grasses, if the flow rate is slow (Fig. 69). However, considering the large volumes of loessial materials that have been lost, it is likely that much of this material has been removed into the waterways of the plains and carried away as suspended sediment (Fig. 70). Even during times of low flow, waterways adjacent to the hills commonly are yellow coloured. Coarse sediments also end up on the gully and valley floors (Figs. 71 & 72). The deposition of sediments downstream is clearly episodic and related to major storm events as is illustrated by the presence of flood layers with buried topsoils in sediments adjacent to streams (Fig. 73).

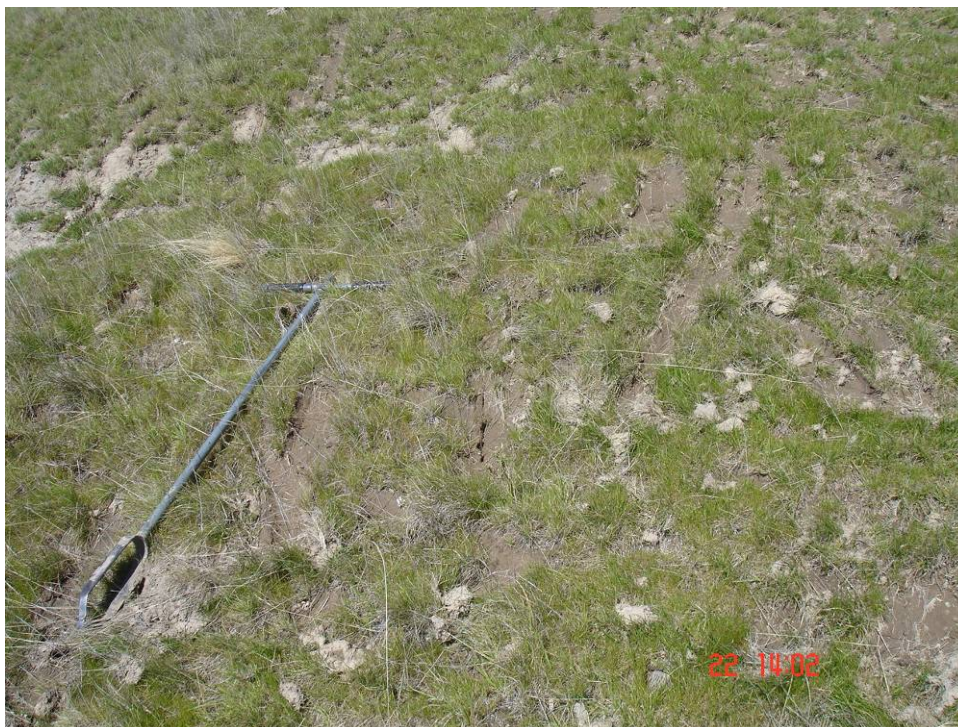
Figure 74. Saturated soil on a hill slope showing the effects of stock on topsoils with both pugging and down-slope foot sliding. This leads to decreased pasture cover and exposes the soil to accelerated sheet erosion. Stock tracks also accumulate water, which may be channelled through a crack and into an under-runner.

Soil loess however, is not confined solely to natural erosion processes but is exacerbated by stock. It was observed in many places during the survey that stock were causing down-slope movement of topsoil due to animals feet sliding on the saturated soil, with the bared soil then being subject to sheet erosion (Fig.74). Appropriate stock management is clearly an important part of minimising the soil losses.

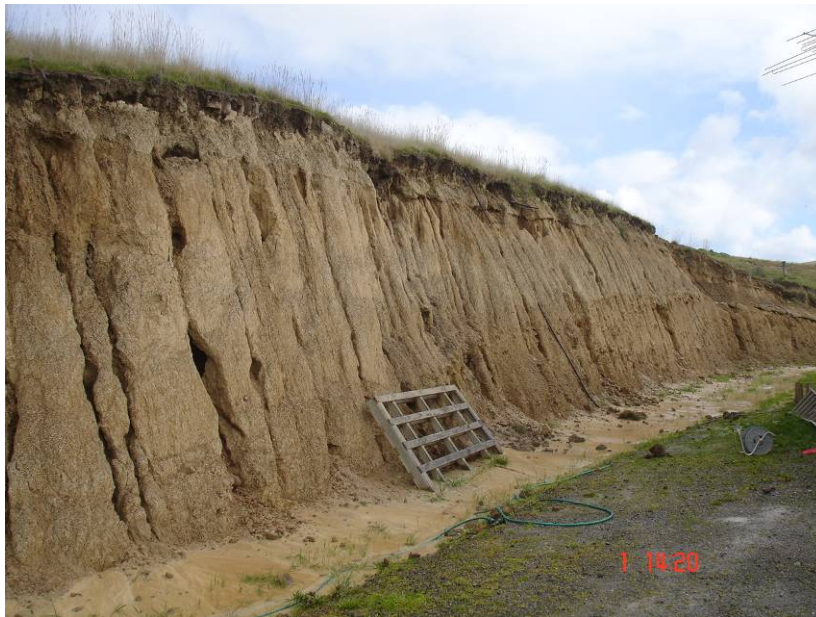
Figure 75. The building platform at this site is on stable underlying gravels. The layered dispersible loessial materials have scattered piping channels that will have originated somewhere up-slope. Rill erosion is taking place on the face of the cutting and dispersed soil sediment is accumulating at the foot of the cutting and being removed in suspension. The erosion will continue but is unlikely to pose a serious risk to the building structure. There is no evidence of mass movement (slumps) occurring in these materials.

Building on lower elevation moderately sloping land with a loessial cover is possible, provided the structure is on the underlying conglomerate and there is adequate distance between the batter and the structure to allow for the movement of soil on the slopes above (Fig. 75). Care should also be taken with the disposal of runoff water.
