**MARLBOROUGH  
DISTRICT COUNCIL**

# Recreational Water Quality Report 2012-13

**Technical Report No: 13-006  
June 2013**

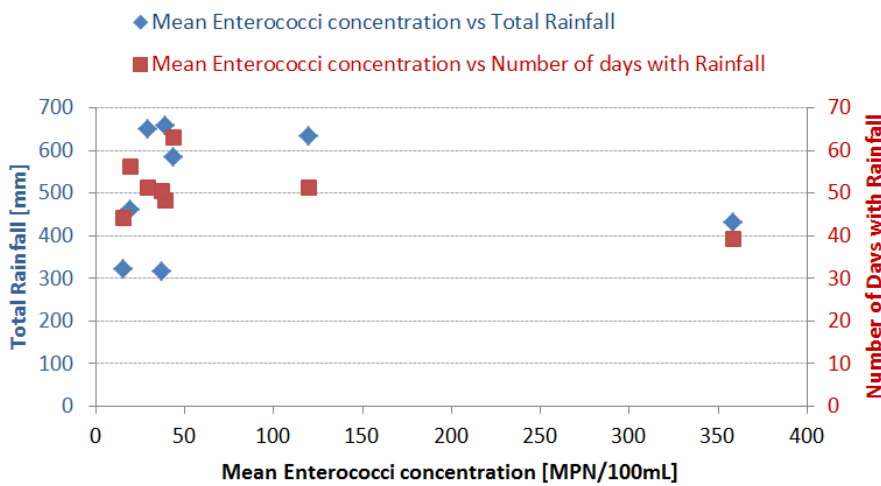
**Figure 1: Scatter plot of Mean (average) Enterococci concentration at Ngakuta Bay and Total Rainfall as well as Number of Days with Rainfall during the sampling season at Waikawa at Boons Valley.**

The range of bacterial concentrations measured at any one site is usually very large (between <2 and >2000) compared to the number of samples taken during a summer season (20). Because the data consists of weekly spot samples rather than a continuous dataset the timing of the sampling in relation to rainfall and flood events has a great effect. The result is that yearly statistics can show great variability especially at sites that regularly exceed the Recreational Water Quality Guidelines. That this large variation is not the result of differences in total rainfall amounts or flow patterns is supported by the fact that even at sites that have high bacterial counts only during and shortly after rainfall no correlation could be found between the average bacteria concentration and the total Rainfall during the season (Figure 1). Other statistics like mean flow, the number of days with Rainfall, the number of days with flows above the long term Mean do not show a correlation with bacterial levels during the same period either (Figure 1 and Figure 2).

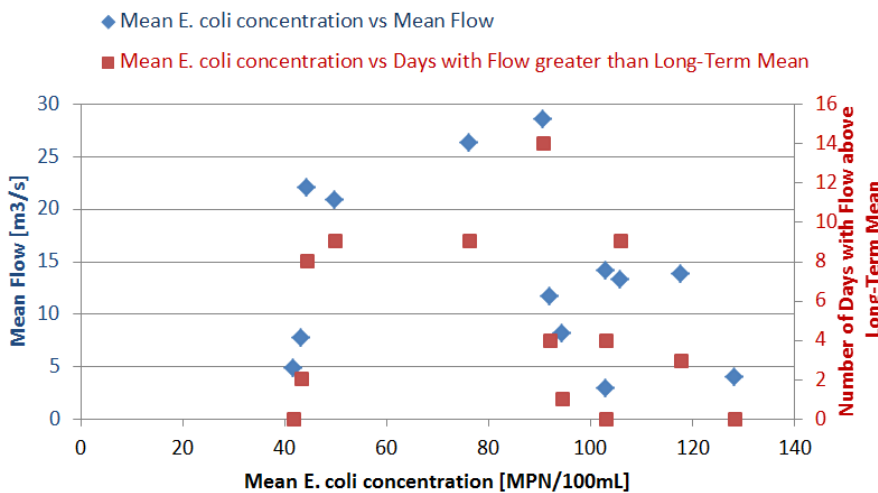
**Figure 2: Scatter plot of Mean (Average) E. coli concentration in the Pelorus River at Pelorus Bridge and Mean Flow as well as Number of Days with Flow above the Long-Term Mean Flow at Pelorus at Bryants.**

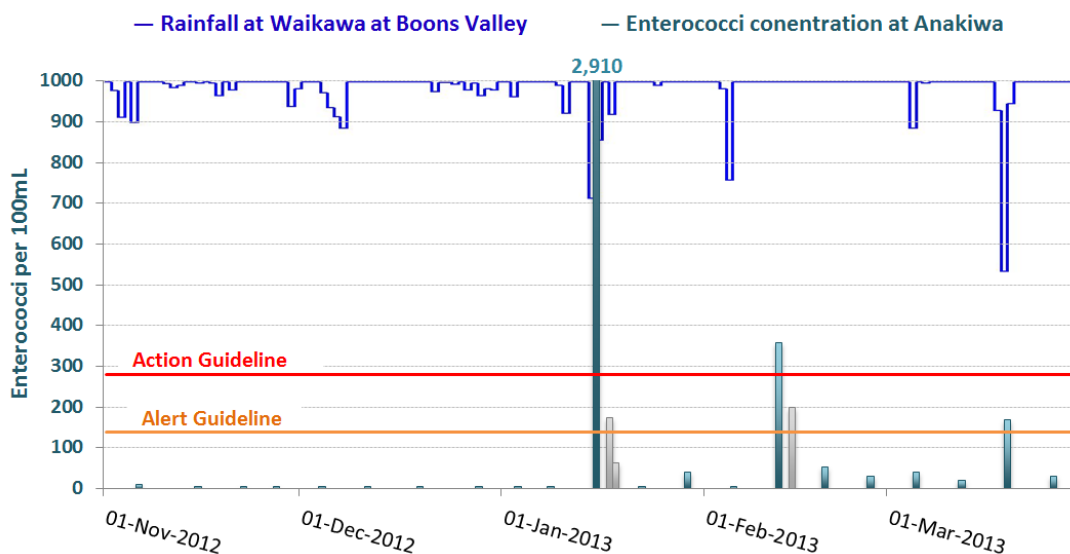
**Figure 3: Enterococci concentrations measured in Anakiwa (results that are not from routine samples are shown in grey) and Rainfall at Waikawa at Boons Valley.**

Anakiwa is located at the innermost part of the Queen Charlotte Sound. The microbiological water quality is influenced by the surrounding residential development, but most likely also by Duncan Stream which drains farm land and flows into the Sound 1.2km from the site. There have been two exceedences of the Action Guideline and one exceedence of the Alert Guideline in Anakiwa this summer. Sampling has shown that high Enterococci concentrations at this site only occur during and shortly after rainfall in the area.

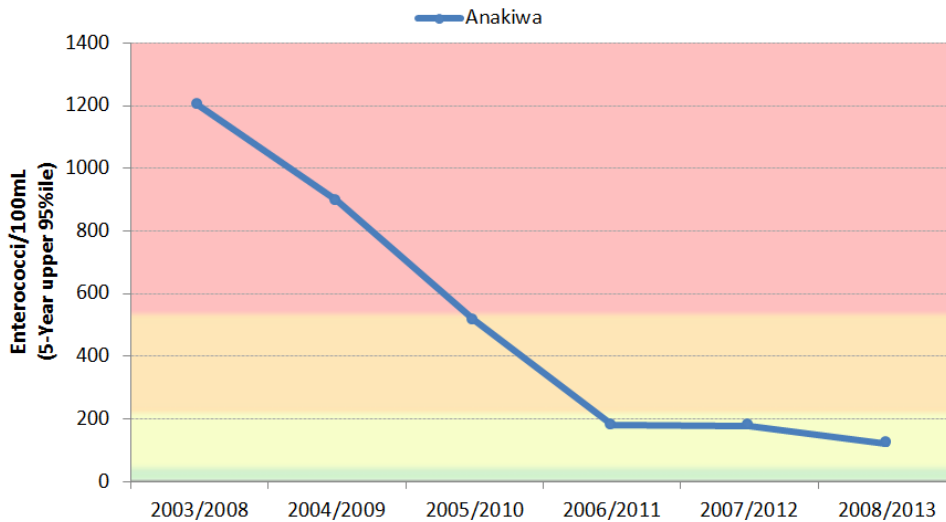
Figure 4: 5-Yearly upper 95%ile of Enterococci concentrations in Anakiwa. The Background colouring is based on the Microbiologica Assessment Categories.

The microbiological water quality has been improving significantly over the years (Figure 4) and the site has now a SFR Grade of “Good”.

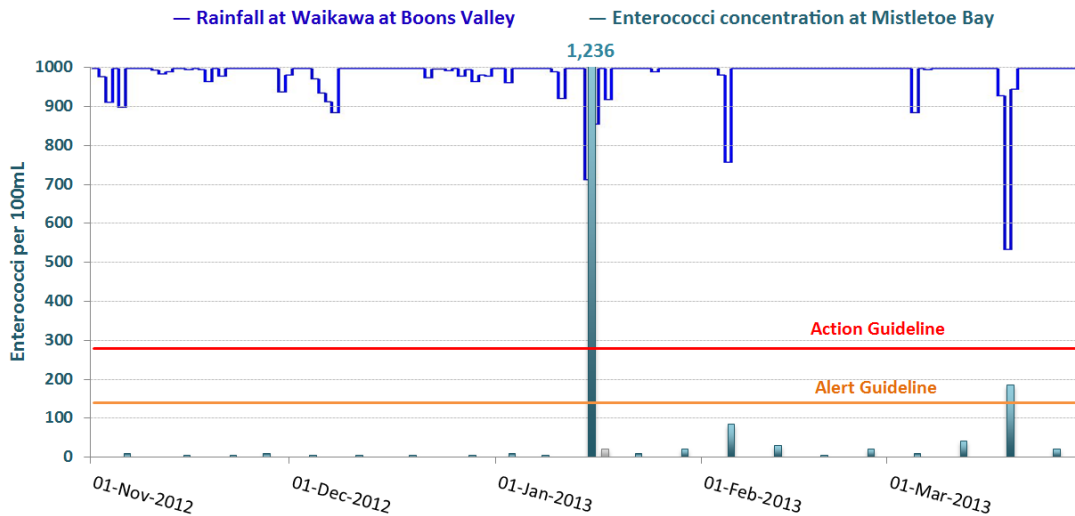
Figure 5: Enterococci concentrations in Mistletoe Bay during the summer months of 2012/2013 and Rainfall at Waikawa at Boons Valley.

Mistletoe Bay is surrounded by bush-clad hills with the Mistletoe resort and only a few houses in the wider bay. The water was considered unsafe for contact recreation on only one occasion following heavy rainfall in the area (Figure 5).

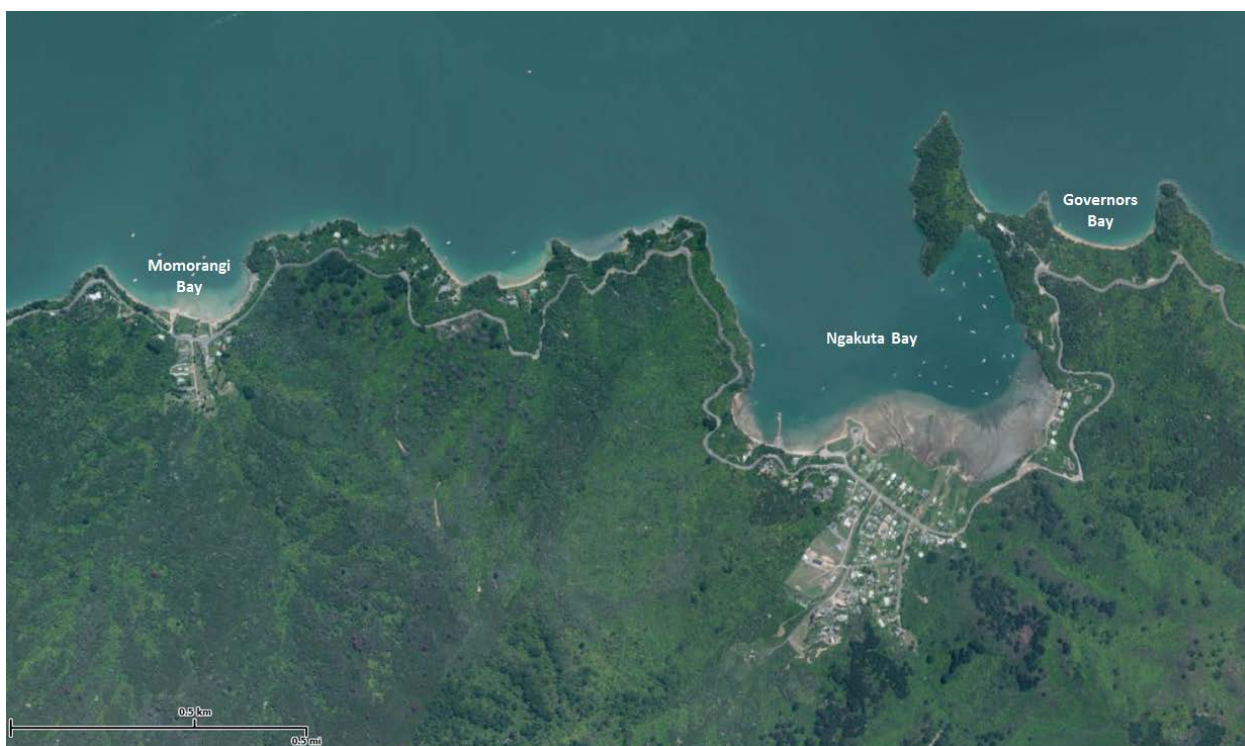
**Figure 6: Aerial Photo of Momorangi Bay, Ngakuta Bay and Governors Bay.**

Momorangi Bay, Ngakuta Bay and Governors Bay are neighbouring bays in the Queen Charlotte Sound. Ngakuta Bay is the largest and most enclosed bay in this group and has the greatest residential development in its catchment with nearly 100 houses and holiday homes. Although Momorangi Bay is much smaller than Ngakuta Bay it has a very popular campground along the beach which attracts more visitors during the warmer months of the year than the other two bays combined. A pipe system for the sewage was put in place in 2006 and sewage is irrigated into the bush above the settlement. Governors Bay has no residential development in the catchment.

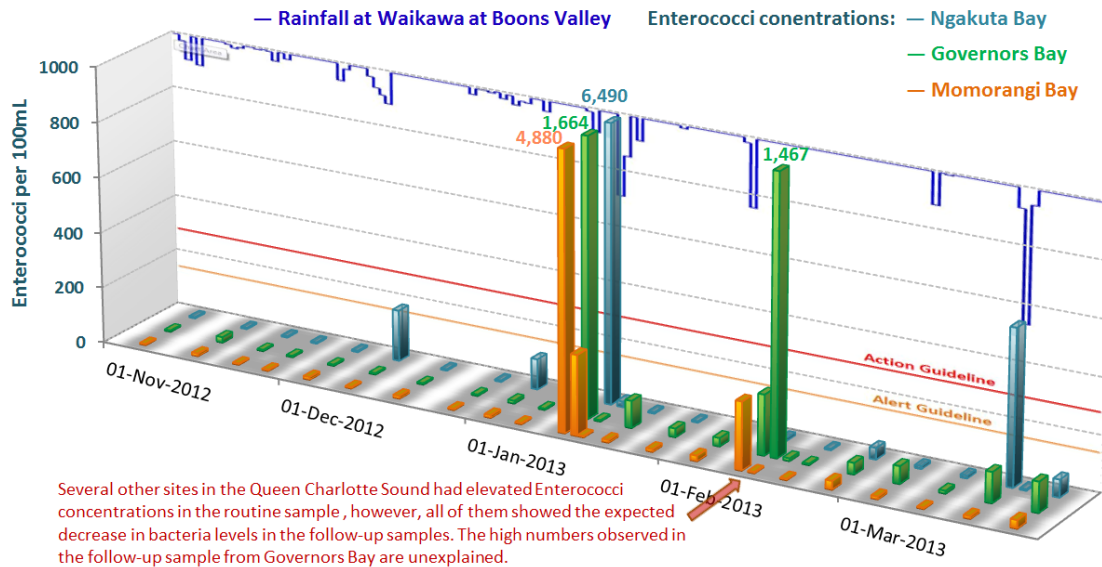
**Figure 7: Enterococci concentrations in Ngakuta Bay, Governors Bay and Momorangi Bay during the summer months of 2012/2013 and Rainfall at Waikawa at Boons Valley.**

Ngakuta and Governors Bay had Enterococci concentrations exceeding the Action Guideline in two samples taken during the summer of 2012/2013, while Momorangi Bay exceeded this Guideline only on one occasion. Exceedances in Momorangi Bay and Ngakuta Bay were linked to rainfall.

Although the January exceedance of the Action Guideline in Governors Bay was clearly linked to rainfall the second exceedance in mid February was not as easily explained (see Figure 7). The routine sample showed slightly elevated levels which were clearly linked with a recent rainfall event because samples from other sites in the Queen Charlotte Sound (Anakiwa, Picton Foreshore) had increased Enterococci concentrations as well. While the follow-up samples from the other effected sites taken two days later showed a decrease in Enterococci concentrations, bacteria levels in Governors Bay had increased substantially and exceeded the Action Guideline despite no further rainfall in the area. The water was clear and calm when the sample was taken and there was no obvious source of contamination. Governors Bay was added to the program last summer and has not been sampled previously. Further sampling will show whether this is a regular occurrence.

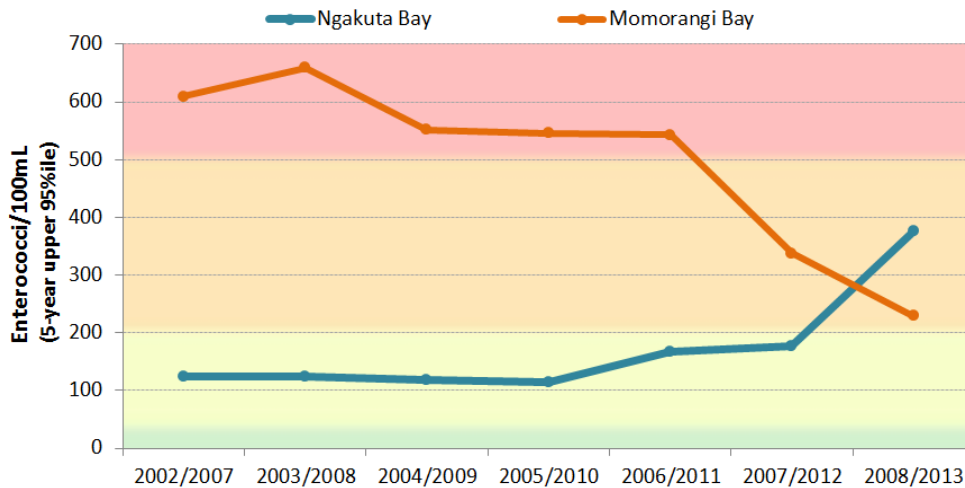
**Figure 8: 5-Yearly upper 95%ile of Enterococci concentrations in Ngakuta Bay and Momorangi Bay. The Background colouring is based on the Microbiologica Assessment Categories.**

The long term trend shows an improvement in the microbiological water quality of Momorangi Bay (Figure 8). Microbial Source Tracking carried out in 2011 showed that faecal contamination was neither of human nor ruminant origin and it was concluded that wildfowl might be a major source of faecal bacteria. Large numbers of Ducks have been observed in the Bay in the past and the Department of Conservation has erected signs discouraging the feeding of Ducks which, together with the upgrade of the sewage system, might have contributed to the improvement in microbiological water quality.

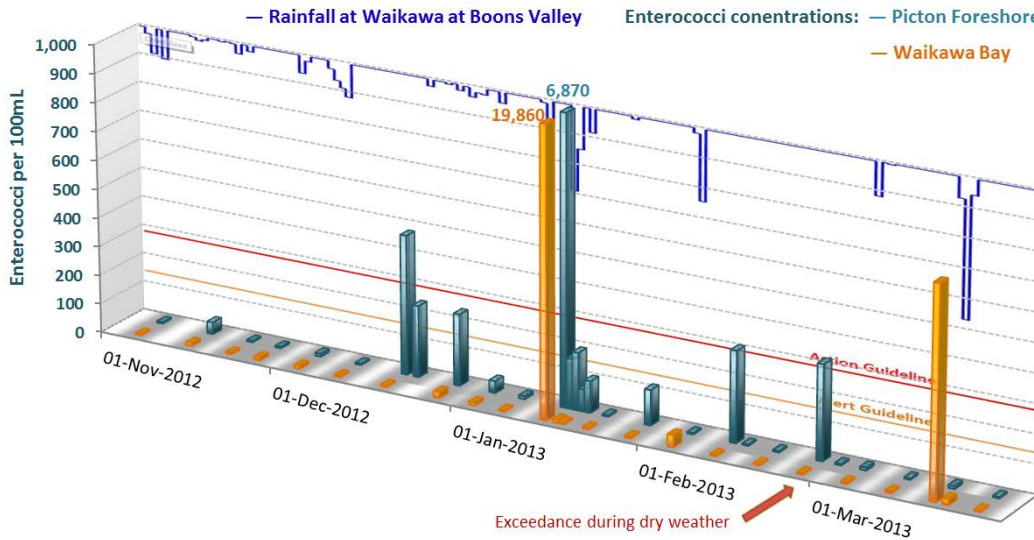
**Figure 9: Enterococci concentrations at Picton Foreshore and Waikawa Bay during the summer months of 2012/2013 and Rainfall at Waikawa at Boons Valley.**

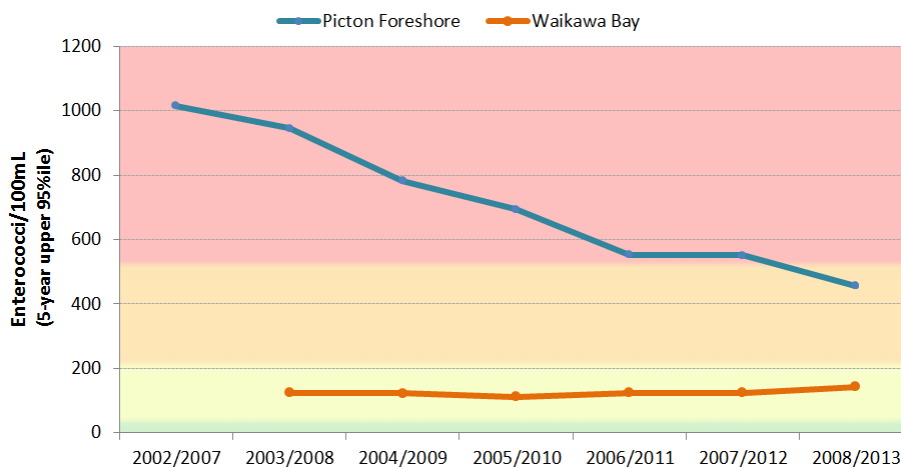
**Figure 10: 5-Yearly upper 95%ile of Enterococci concentrations at Picton Foreshore and Waikawa Bay. The Background colouring is based on the Microbiological Assessment Categories.**

Nevertheless, continued upgrades and maintenance of the storm water and sewage network have resulted in a steady decline of Enterococci concentrations observed at Picton Foreshore (Figure 10). The improvement in recreational water quality has been so significant that the SFR Grade was able to be changed from “Very Poor” to “Poor”.

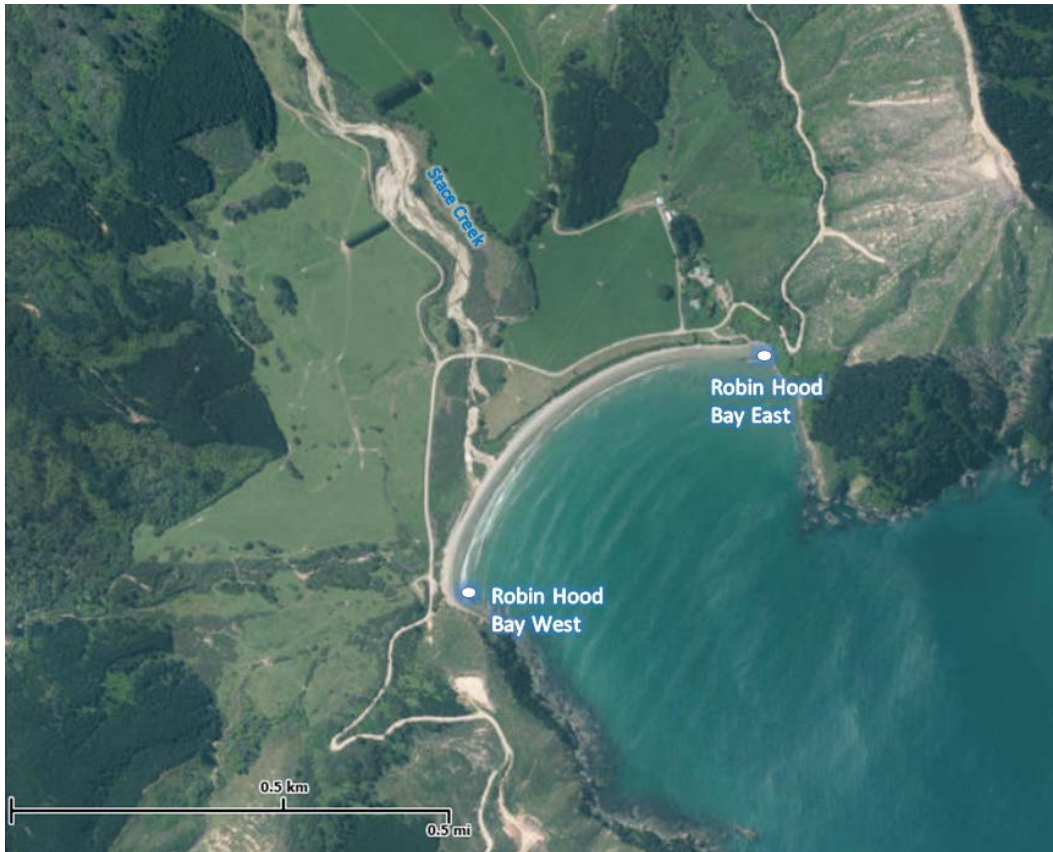
**Figure 11: Aerial photo of Robin Hood Bay.**

The microbiological water quality in Robin Hood Bay is potentially impacted by Stace Creek which has pastoral land in its catchment close to the mouth. This might explain the higher Enterococci concentrations observed during smaller rainfall events compared to Whites Bay. However, following a heavy rainfall event in March bacterial counts in Robin Hood Bay were considerably less than in Whites Bay. Nevertheless, all three sites were considered unsafe for contact recreation on that occasion (Figure 12).

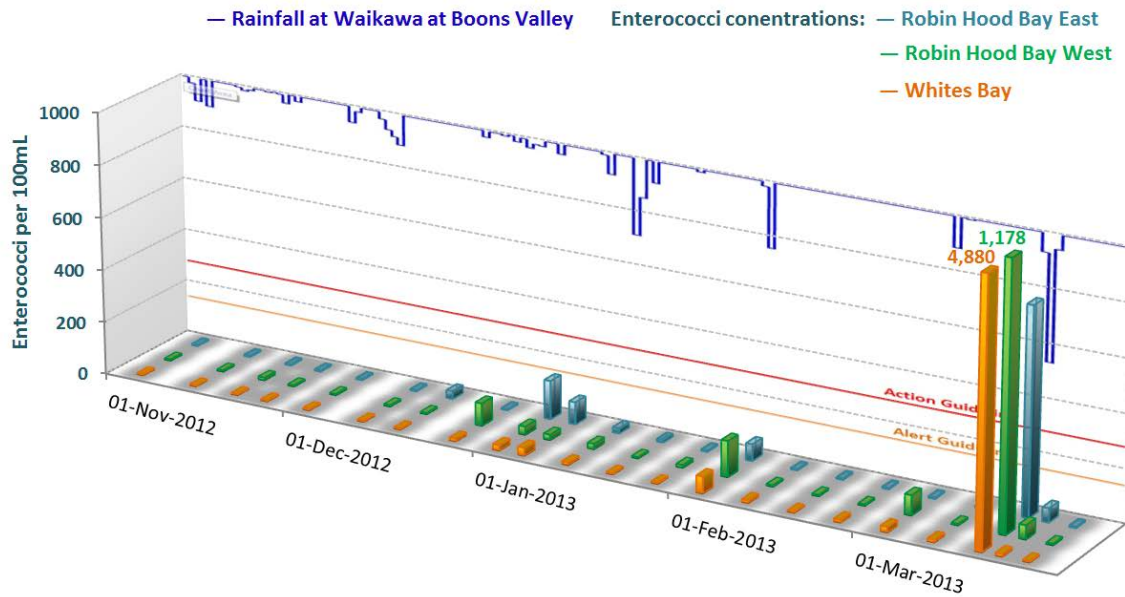
Figure 12: Enterococci concentrations in Robin Hood Bay and Whites Bay during the summer months of 2012/2013. Also shown is the rainfall recorded at Waikawa at Boons Valley.

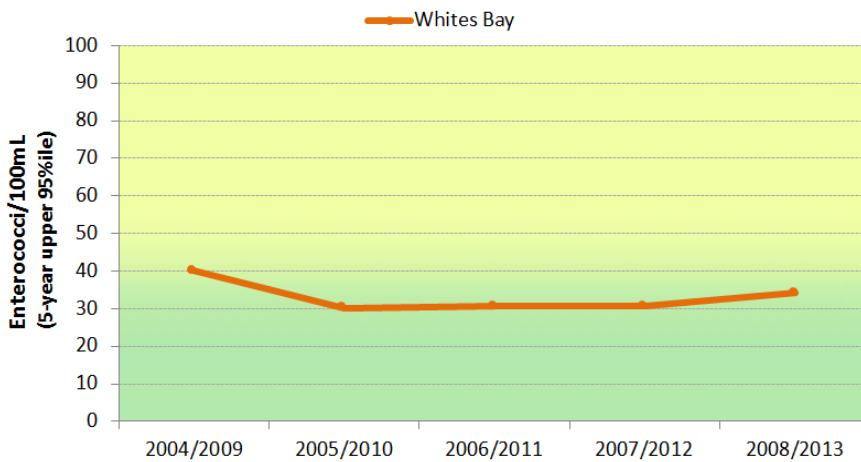
Figure 13: 5-Yearly upper 95%ile of Enterococci concentrations at Whites Bay. The Background colouring is based on the Microbiological Assessment Categories.

Despite a huge increase in visitor numbers during the summer, recreational water quality in Whites Bay has been very good and the water was considered safe for contact recreation for more than 97% of the time since weekly monitoring started in 2004. There has been little change in the microbiological water quality over the years (Figure 13).

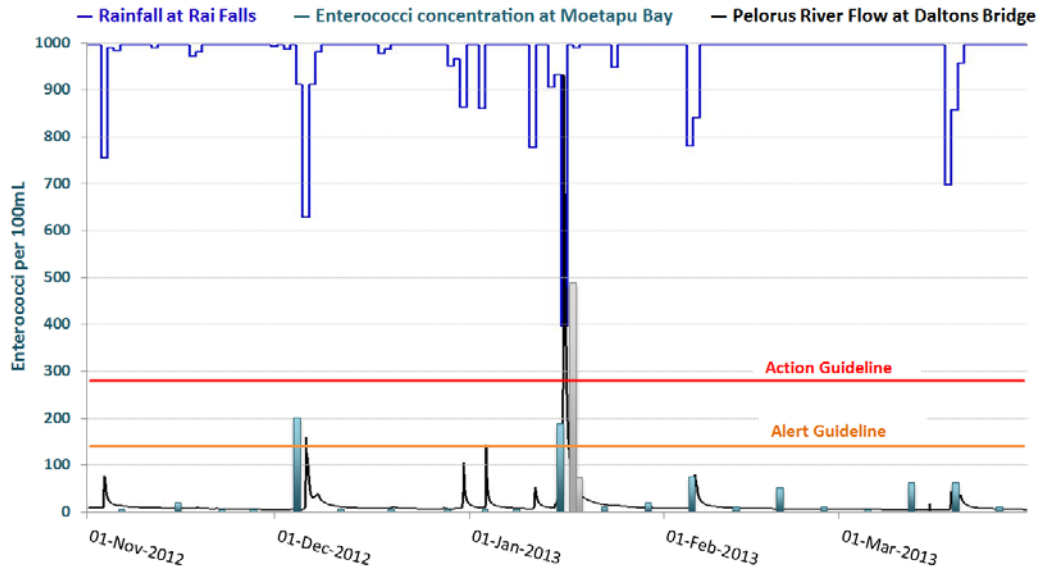
**Figure 14: Enterococci concentrations in Moetapu Bay in the summer months of 2012/2013 (results that are not from routine samples are shown in grey). Also shown are the simulated Flow of the Pelorus River at Daltons Bridge (calculated from the flow of the Rai River at Rai Falls and the Pelorus River at Bryants) as well as the Rainfall recorded at Rai Falls.**

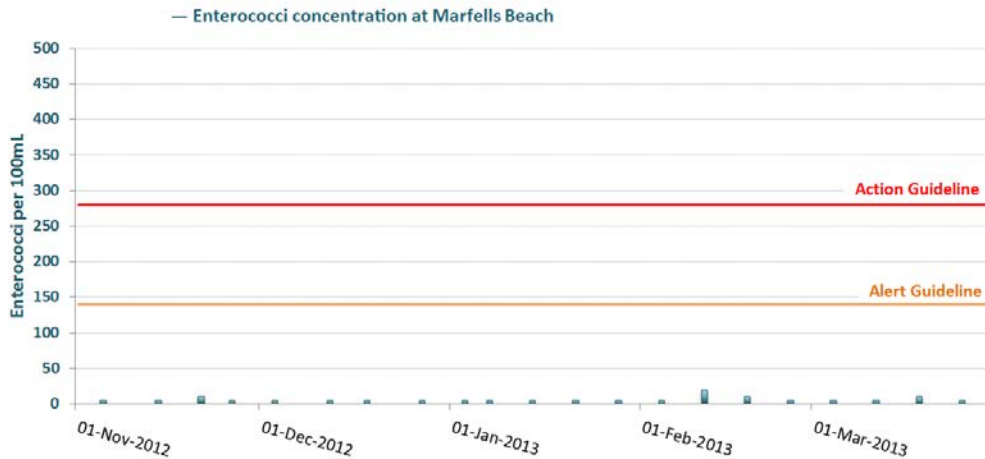
**Figure 15: Enterococci concentrations at Marfells Beach in the summer months of 2012/2013.**

Marfells Beach has been one of the sites with the best microbiological water quality in the past and again had very low Enterococci concentration during the whole summer period. Unlike other coastal beaches sampled it is a large open beach. This is why the low intensity pastoral agriculture in the catchment and large seagull numbers have little effect on Enterococci concentrations.

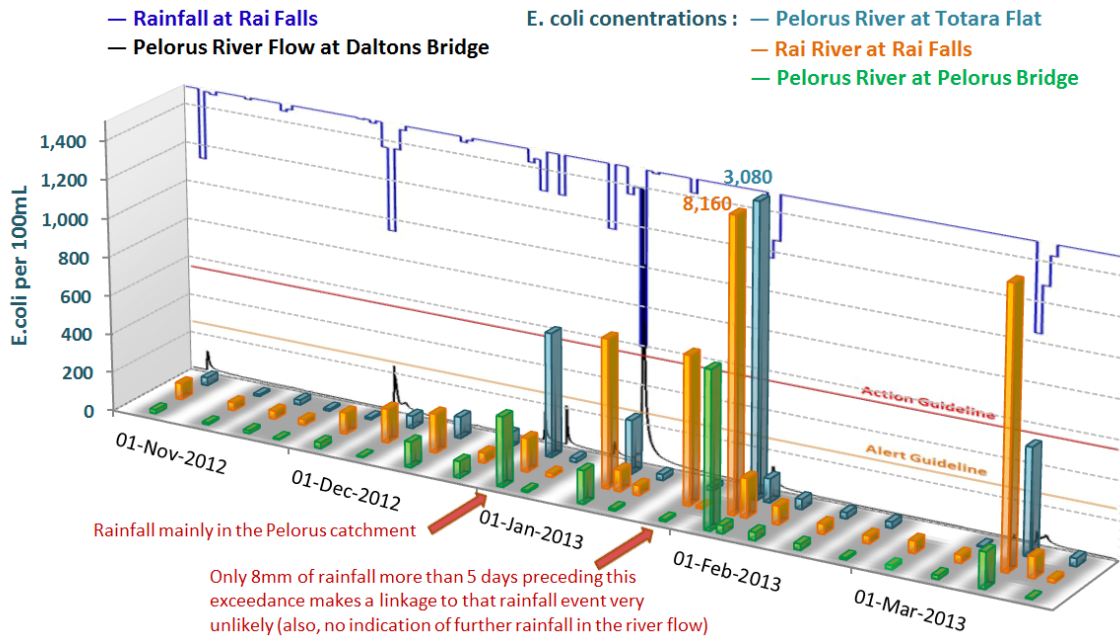
**Figure 17: E. coli concentrations at Rai River at Rai Falls and Pelorus River at Pelorus Bridge and Totara Flat during the summer of 2012/2013. Also shown are rainfall recorded at Rai Falls and the simulated flow of the Pelorus River at Daltons Bridge (calculated as the sum of the flows measured at Pelorus River at Bryants and Rai River at Rai Falls).**

High E. coli levels in samples from the Rai River at Rai Falls are not always linked to rainfall. One exceedance of the Action Guideline during dry weather was again observed during the 2012/213 summer (see Figure 17).

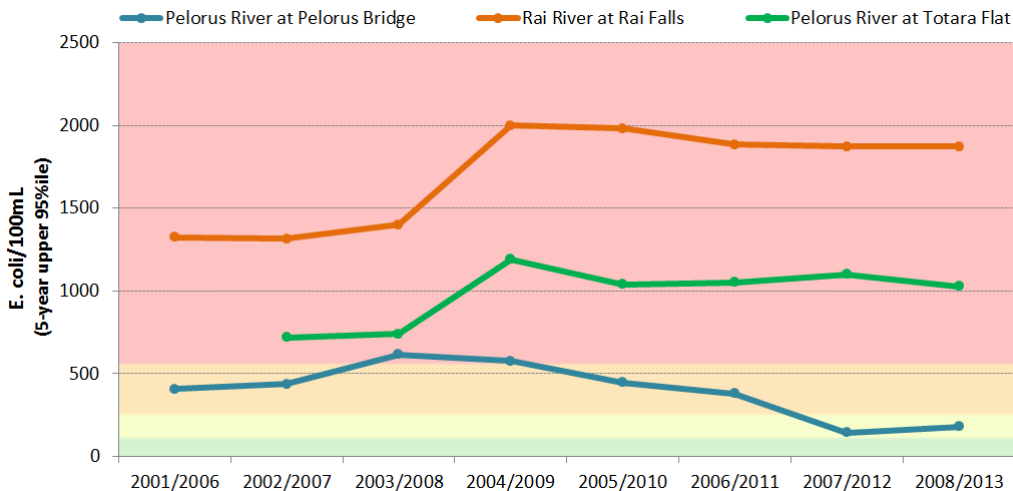
**Figure 18: 5-Yearly upper 95%ile of E.coli concentrations in Rai River at Rai Falls and Pelorus River at Pelorus Bridge and Totara Flat. The Background colouring is based on Microbiological Assessment Categories.**

The long term trend shows a slight improvement of microbiological water quality in the Pelorus River at Pelorus Bridge. The trend in E. coli concentrations in the Pelorus River at Totara Flat follows closely the pattern observed for the Rai River at Rai Falls (Figure 17), but concentrations are usually lower. This indicates that the majority of faecal contamination in the Pelorus River at Totara Flat originates from the Rai River and the generally good microbiological water quality of the Pelorus River upstream of the Rai River provides significant dilution. As a result the SFR Grade of the Pelorus River at Totara Flat is “Poor”, but is better than the “Very Poor” SFR Grade for the Rai River at Rai Falls. Both sites showed a steep increase in E. coli levels until 2008/09, but concentrations appear to have stabilized and are even slightly decreasing in the Rai River.

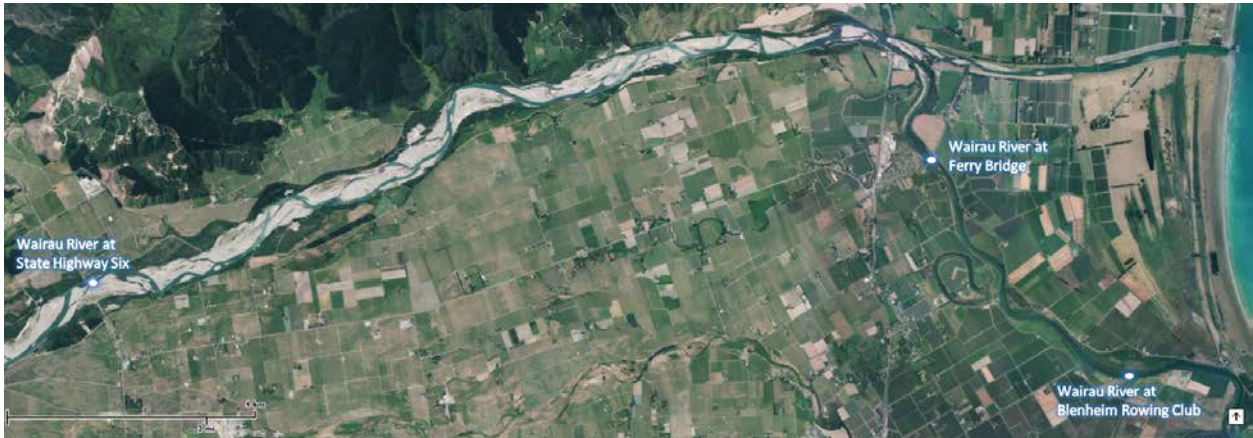
Figure 19: Aerial photo showing the sampling sites along the Wairau River.

In the summer months of 2012/2013 the Wairau River was sampled at three locations. The Wairau River at Ferry Bridge and Wairau River at Blenheim Rowing Club have been monitored as part of the Recreational Water Quality Program for many years. A Beach survey carried out in 2011 identified that the River is also very popular around the State Highway Six Bridge with several swimming spots in close proximity.

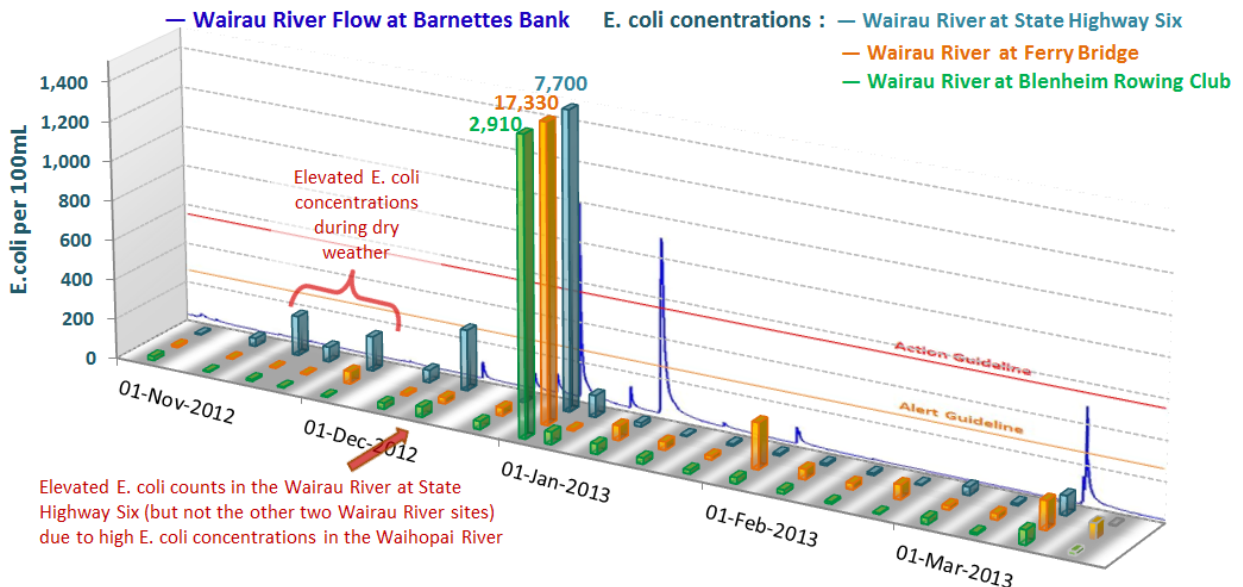
Figure 20: E. coli concentrations at the three Wairau River sites during the summer of 2012/2013. Also shown is the flow in the Wairau River at Barnett's Bank (close to State Highway One).

Last summer microbiological water quality was deemed unsafe for contact recreation at all three sites on only one occasion during a flood event in early January. Flows were high and the water very turbid when those samples were taken.

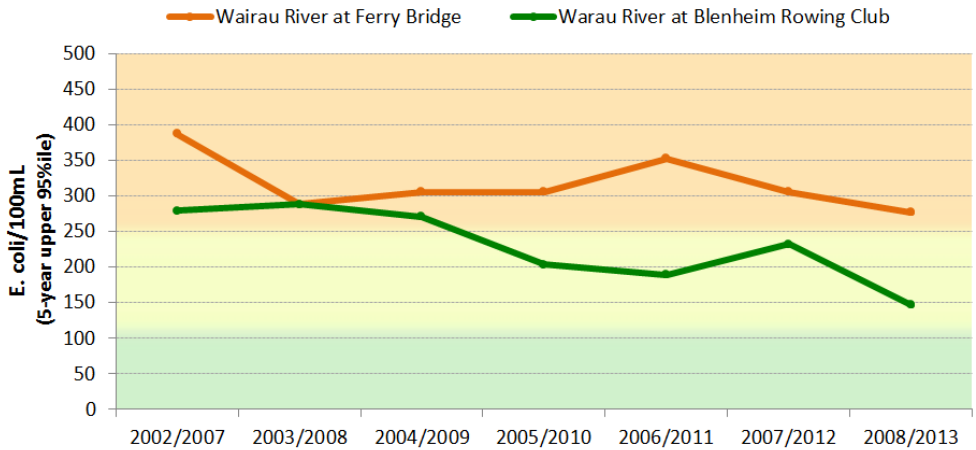
**Figure 21: 5-Yearly upper 95%ile of E.coli concentrations in the Wairau River at Ferry Bridge and Blenheim Rowing Club. The Background colouring is based on Microbiological Assessment Categories.**

E. coli concentration in the Wairau River at Ferry Bridge and Blenheim Rowing Club generally only exceed the Recreational Water Quality Guidelines during high flows. Microbiological water quality at the Blenheim Rowing Club has improved over the years, but there has been little change at the Ferry Bridge (Figure 21). The SFR Grade for the Wairau River at Ferry Bridge is “Fair” while the SFR Grade for the Wairau River at Blenheim Rowing Club was able to be raised from “Fair” to “Good”.

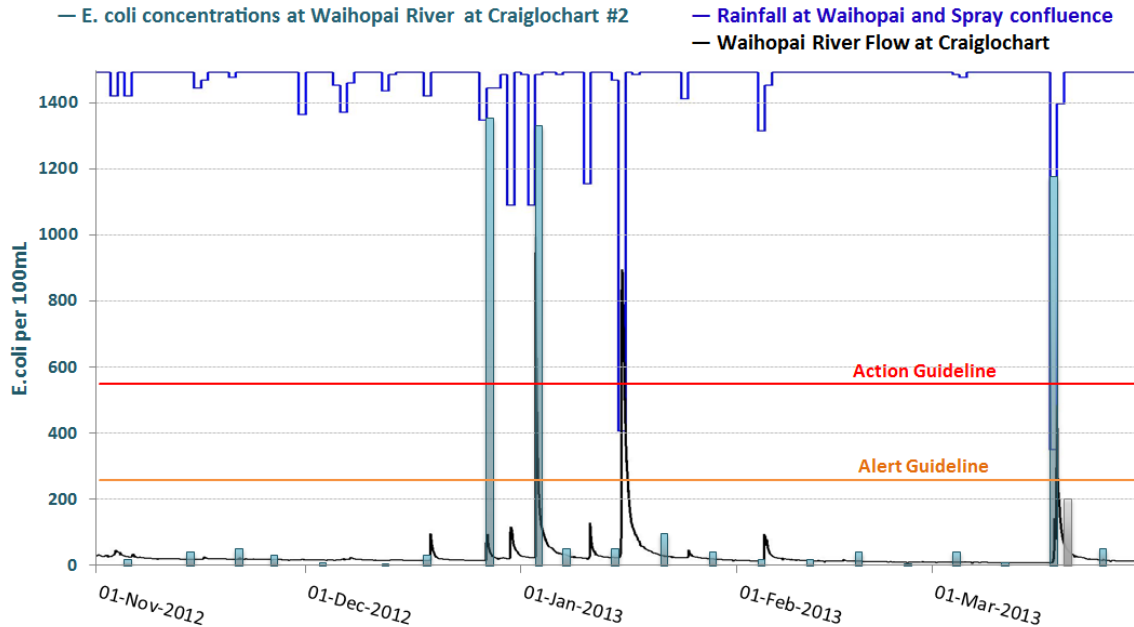
Figure 22: E. coli concentrations in the Waihopai River at Craiglochart #2 during the summer of 2012/2013. Also shown is the flow of the Waihopai River at Craiglochart (#1) and the rainfall recorded at the confluence of Waihopai River and Spray.

E. coli concentration in the Waihopai River at Craiglochart #2 exceeded the Action Guideline on four occasions during last summer. All Exceedances were observed during or shortly after rainfall and the water was very turbid when samples were taken.

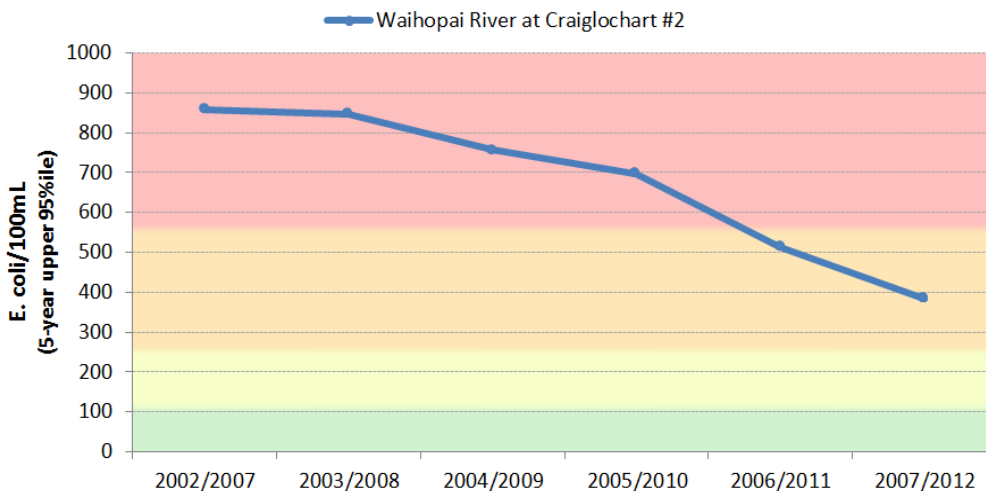
Figure 23: 5-Yearly upper 95%ile of E.coli concentrations in the Waihopai River at Craiglochart #2. The Background colouring is based on Microbiological Assessment Categories.

The long term trend shows a substantial improvement in microbiological water quality over the years (Figure 23) and the change has been significant enough to justify a change of the SFR Grade of the site from “Poor” to “Fair”.

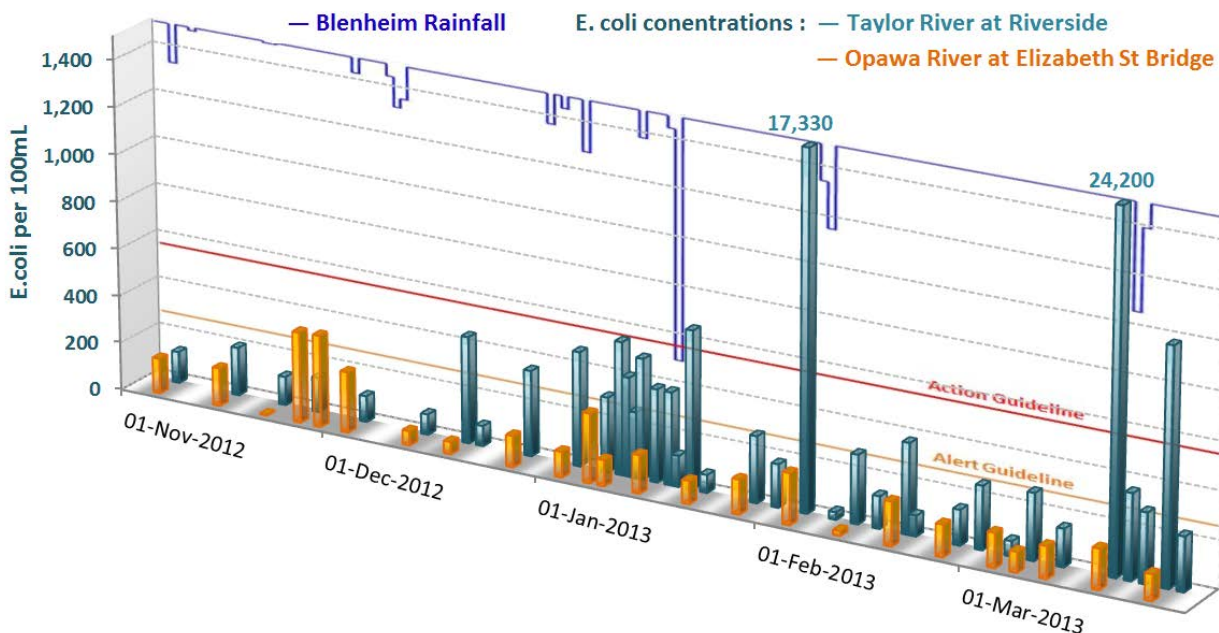
**Figure 24: E. coli concentrations at Taylor River at Riverside and Opawa River at Elizabeth St Bridge during the summer of 2012/2013 and the Rainfall measured in Blenheim.**

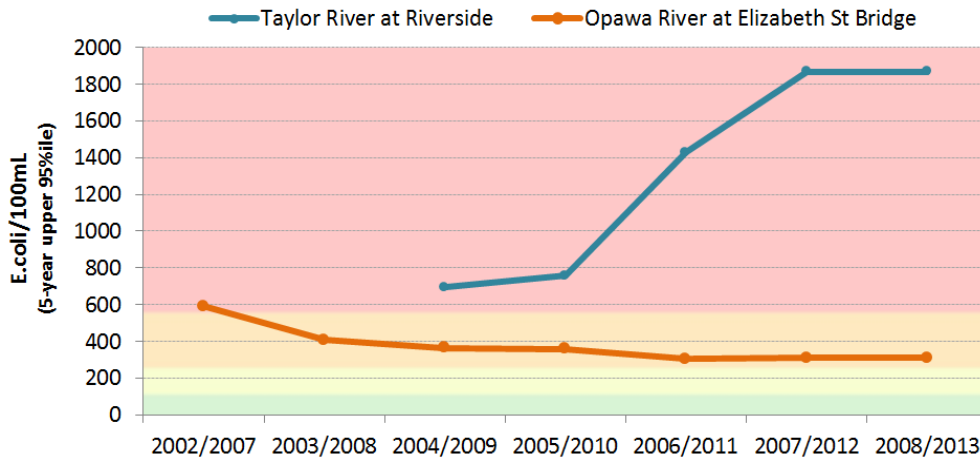
**Figure 25: 5-Yearly upper 95%ile of E.coli concentrations in Taylor River at Riverside and Opawa River at Elizabeth St Bridge. The Background colouring is based on Microbiological Assessment Categories.**

Both sites had elevated levels of E. coli in most of the samples taken during the summer. Nevertheless, the Opawa River only exceeded the Alert Guideline at the start of the season and was considered safe for contact recreation for the remaining time. A similar pattern of generally elevated E. coli counts, but rare guideline exceedances has been observed in previous years. The two exceedances seen last season were not related to rainfall. Generally bacteria levels in the Opawa River have decreased slightly over the years (see Figure 25). The site has a SFR Grade of “Fair”.

The Taylor River had the poorest microbiological water quality of the sites sampled as part of the program. E. coli concentrations were above the Alert Guideline most of the time and exceeded the Action Guideline on 5 occasions. Subsequently, warning signs were placed around the site for a total of 28 days. While some of the exceedances were clearly the result of rainfall a number of them occurred during dry weather. This is reflected in the SFR Grade of “Very Poor”. This summer the highest number of routine samples had E. coli concentrations above both Guideline values since the site was added to the program in 2004 and the long term trend shows a steep increase in E. coli concentrations (Figure 25).

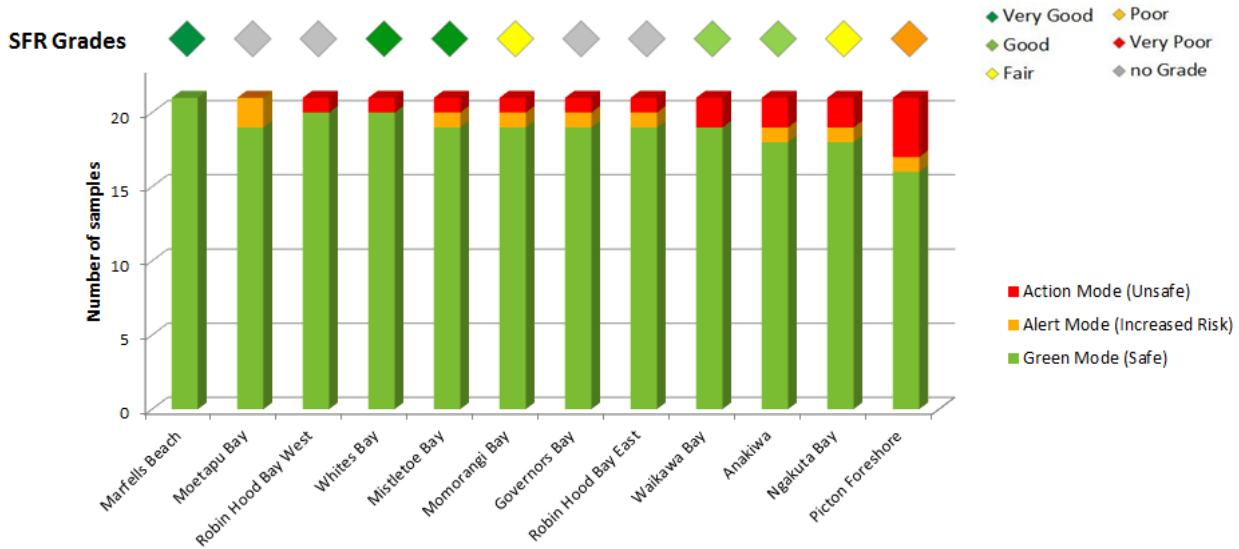
Figure 26: Coastal sites ranked based on the number of routine samples within the different Modes outlined by the Recreational Water Quality Guidelines. Shown above are the SFR Grades for the sites.

Apart from the Taylor River at Riverside, all sites were safe for contact recreational use for at least 80% of the time, 100% at Marfell's Beach. Figure 26 and Figure 27 show the sites ranked based on the number of routine samples in the "Modes" defined by the Recreational Water Quality Guidelines (Chapter 2.1). Also shown are the Suitability for Contact Recreation Grades (SFR Grades) for the sites and it can be seen that the microbiological water quality this summer has been better than usual for some sites and worse for others. This underlines the great variability observed between different years. The SFR Grades provide a long term measure of recreational water quality while the results of individual samples are relevant for a particular day.

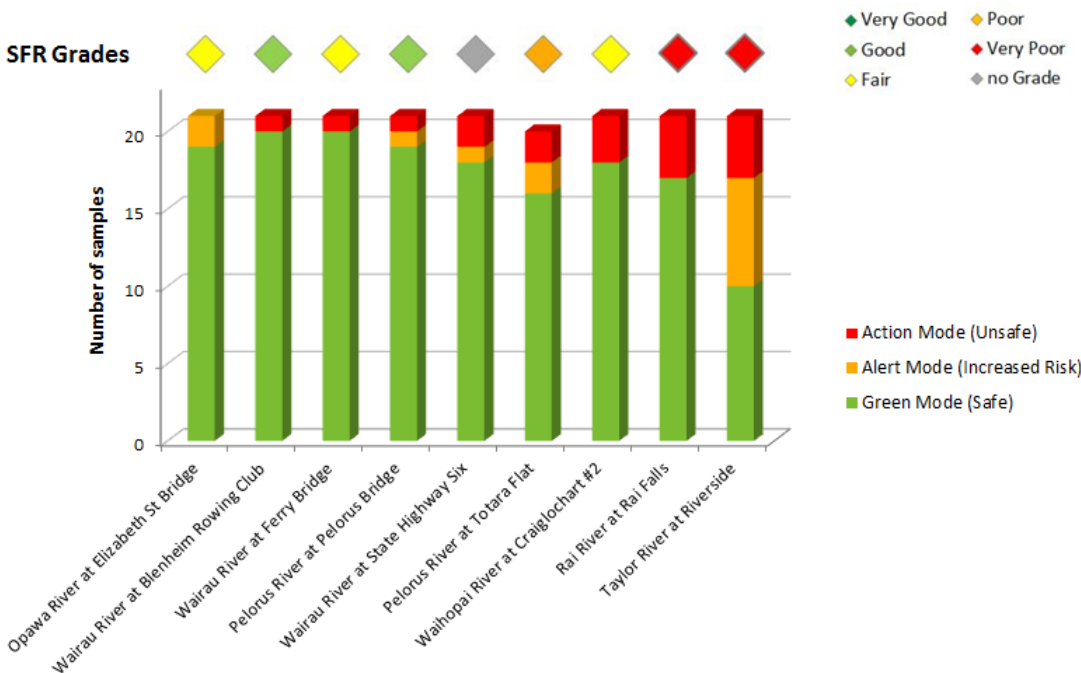
Figure 27: River sites ranked based on the number of routine samples within the different Modes outlined by the Recreational Water Quality Guidelines. Shown above are the SFR Grades for the sites.

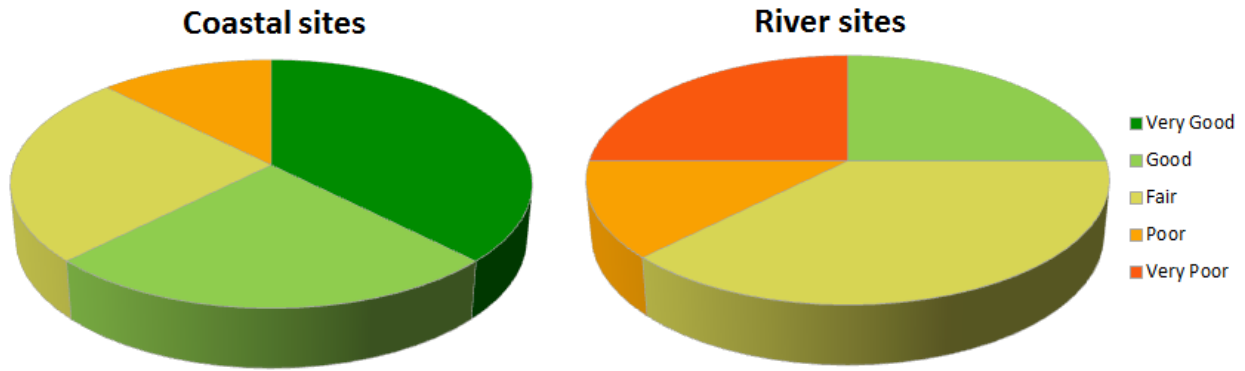
**Figure 28: Distribution of SFR Grades for Coastal and River sites.**

Over 50% of the coastal sites have a SFR Grade of either "Very Good" or "Good" and only one site, Picton Foreshore has a Grade of "Poor". The majority of river sites are either "Good" or "Fair". (Figure 28). When combining the SFR Grades for coastal and river sites, more than 40% of the sites have a Grade of "Very Good" or "Good" and 25% are graded "Poor" or "Very Poor".

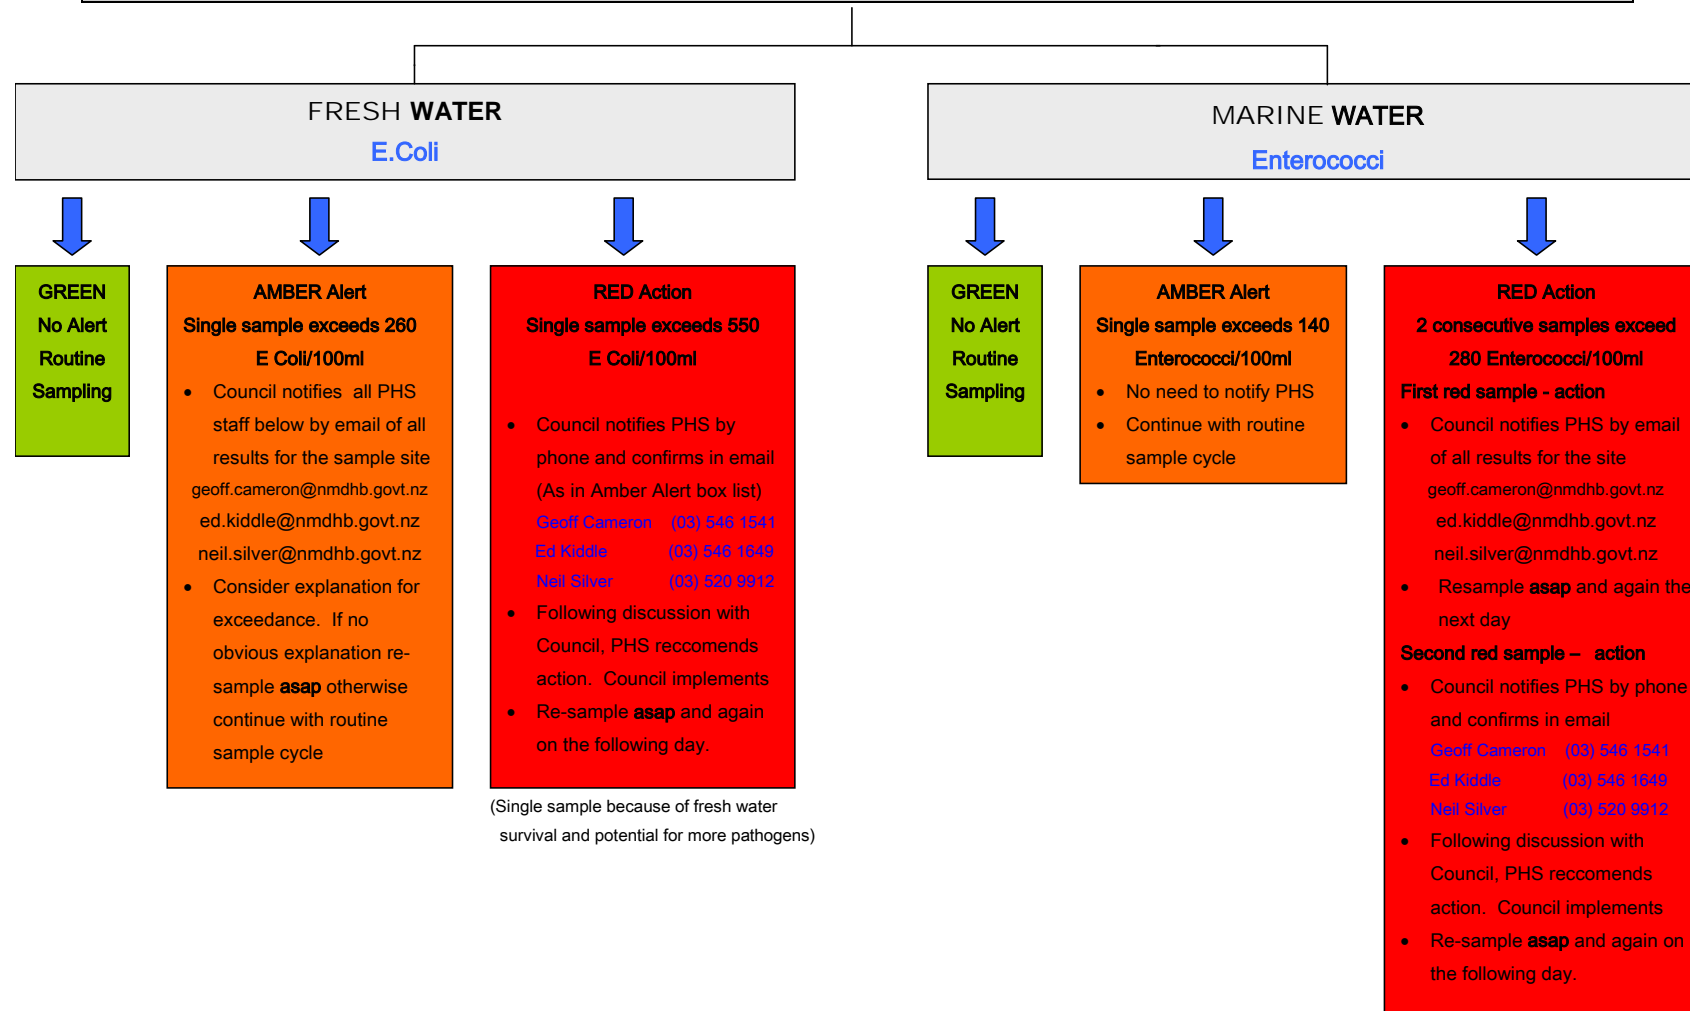
Based on Microbial water Quality Guidelines Page D9 (Box 1) and E9 (Box 2)

As soon as analysis results were received from the laboratory the Marlborough District Council website ([www.marlborough.govt.nz](http://www.marlborough.govt.nz)) was updated in order to provide the public with up-to-date information. If bacteria concentrations were above the Alert or Action Guideline (Chapter 2.1) possible causes were considered and the District Health Board was informed. A joint decision was then made on how to proceed. Warning signs were usually erected at the site if bacteria levels were above the Action guideline and the site was sampled more frequently until bacteria concentrations were at a low enough level for the water to be considered safe again. A flowchart outlining the process is shown in Appendix 1.
