**MARLBOROUGH  
DISTRICT COUNCIL**

# Recreational Water Quality Report 2013-2014

**Technical Report No: 14-002  
June 2014**

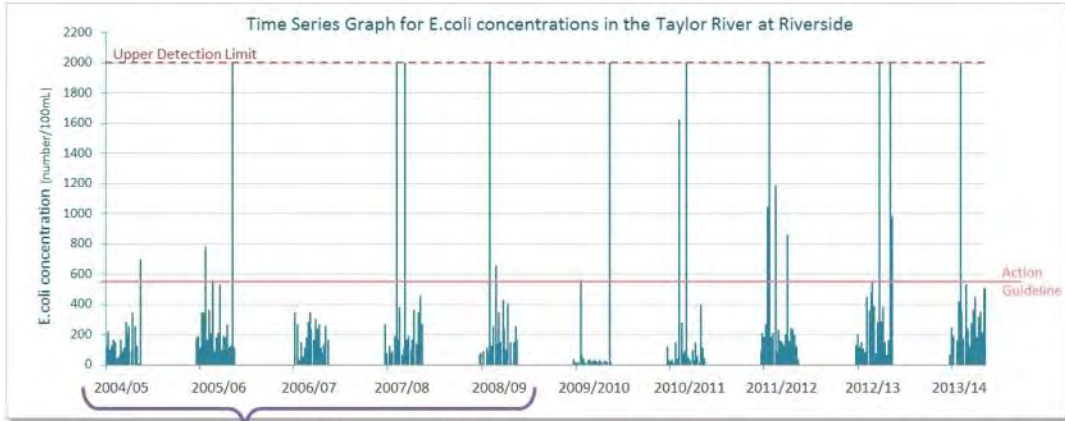
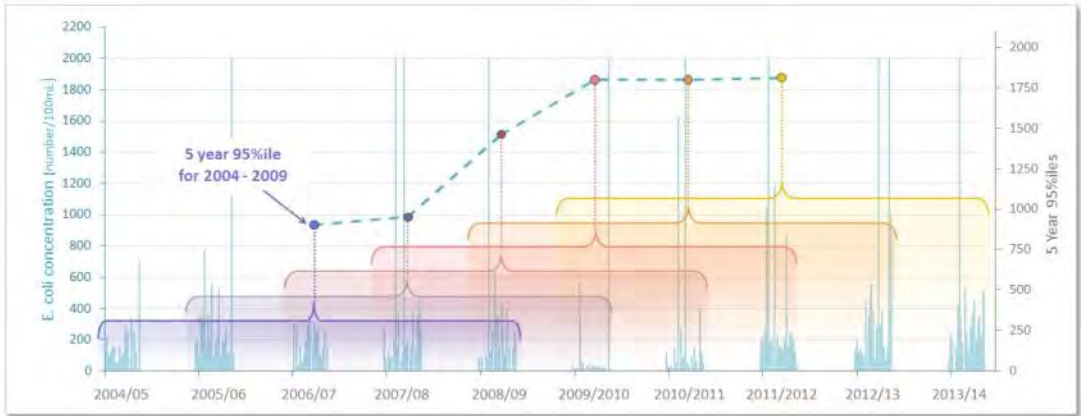
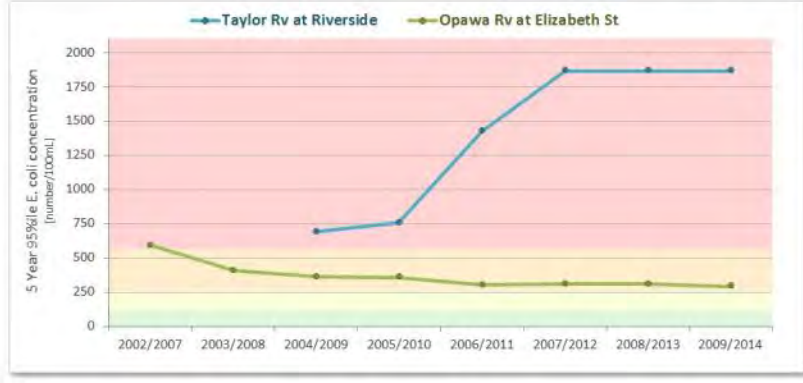
Because of the weather related variability of the results, the data from five summers is combined

The data is ranked (ordered) based on the E. coli concentration values to find the 95 Percentile (95%ile)

The purpose of the program is to assess if the water is safe for contact recreation, therefore, the focus is on high E. coli concentrations. However, the highest 5% are likely to occur during flooding when people are unlikely to swim in the river. Subsequently the 95%ile is chosen.

The 95%iles for all 5 year intervals are calculated

The change over time (Trend) can now be seen and compared with that of other sites

To put the values into context, the background colouring of the graph is based on the Microbiological Assessment Categories (MAC) used for the grading of sites (SFR Grade).

Although the Seasonal Kendall Trend Test provides a statistical method of assessing changes over time, it only recognises consistently downward or upward trends. This means changes in trend during the time period analysed are not picked up, resulting in no trends being found at all (i.e. when an increasing trend turned into a decreasing trend and vice versa). In order to see possible trend changes, the Microbial Assessment Category values (5-year 95%iles) were plotted over time (see Figure 2).

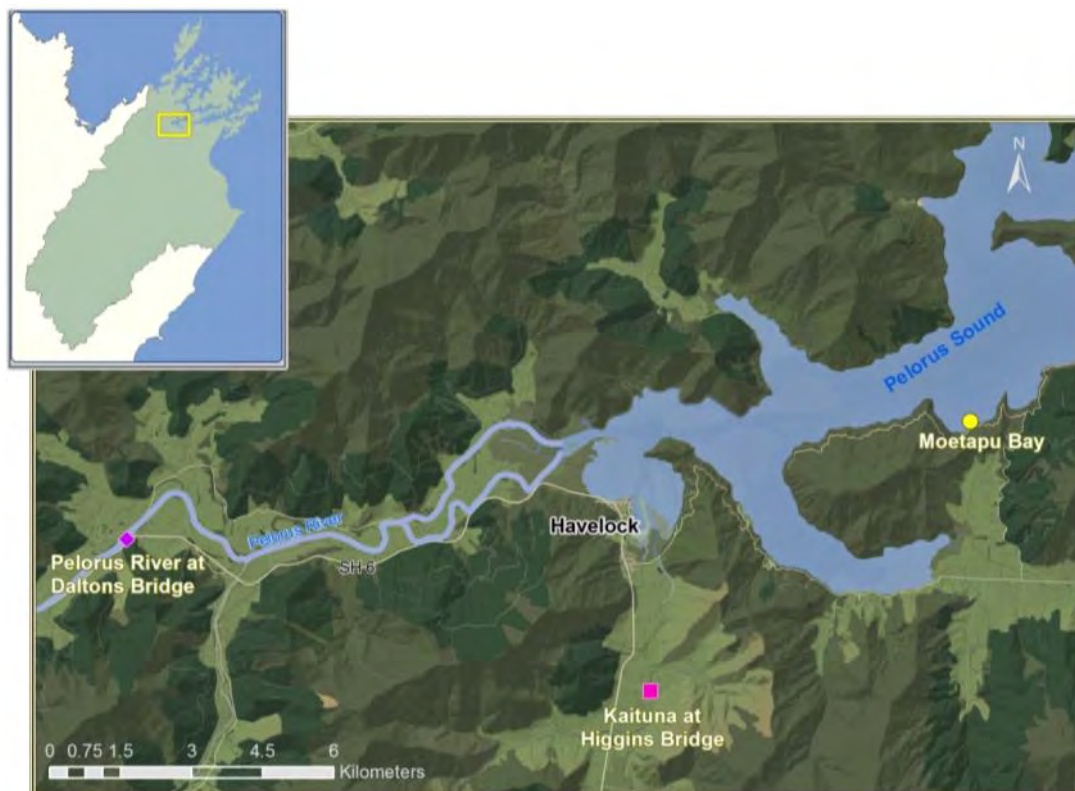
**Figure 3: Map of the Moetapu Bay sampling sites and rainfall and flow recorders.**

Moetapu Bay was recently added to the program as a result of a beach usage survey carried out in 2011 [MDC, 2012b]. It is the only site located in the Pelorus Sound and water quality is impacted by the Pelorus River when the river is in flood. A substantial number of homes and batches are located in the catchment of the wider bay; however, samples are taken at a DoC campground with only a limited amount of residential development in the immediate vicinity.

None of the samples taken from Moetapu Bay this summer indicated unsafe concentrations of faecal bacteria at the site. The highest Enterococci concentrations were observed mid-March, during the largest flood of the Pelorus River this season.

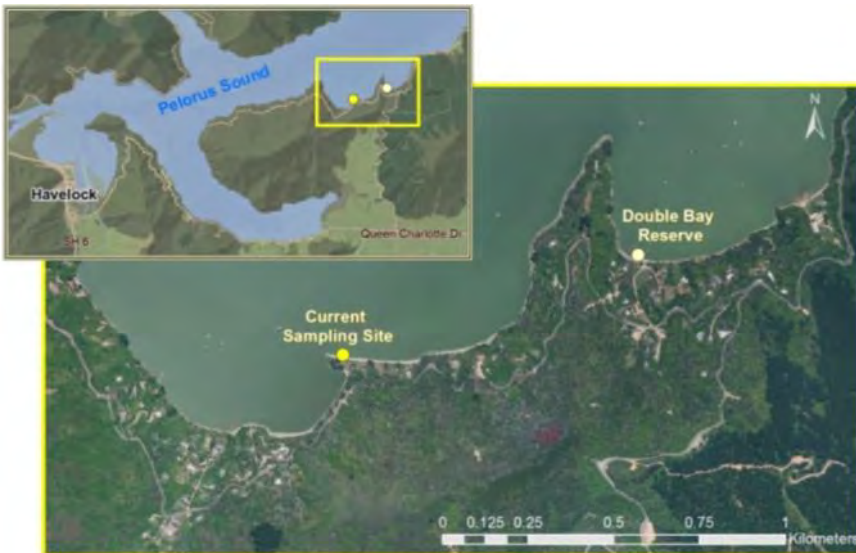
Figure 5: Double Bay Reserve and current Moetapu Bay sampling site.

Field observations have shown that nearby Double Bay Reserve has a significantly larger number of visitors than the DoC campground where samples are currently taken (Figure 5). Double Bay also has a greater number of homes and batches in the immediate catchment. The greater usage and potentially larger impact of residential development on water quality at the Double Bay Reserve compared to the current sampling site, suggest that a review of the location of the sampling site is advisable. Shifting the site, however, will mean that a SFR Grade for Moetapu Bay cannot be established in the near future. The SFR Grade is important as it provides a measure for the general suitability of the site for contact recreation, since actual sampling of sites is limited to once a week. A possible option is to sample both sites for a limited number of seasons. If water quality is similar at both locations, a SFR Grade can be established using the date from the current site and monitoring continued at Double Bay only. If Enterococci concentrations are significantly different, monitoring should be focused on the site with generally higher faecal contamination.

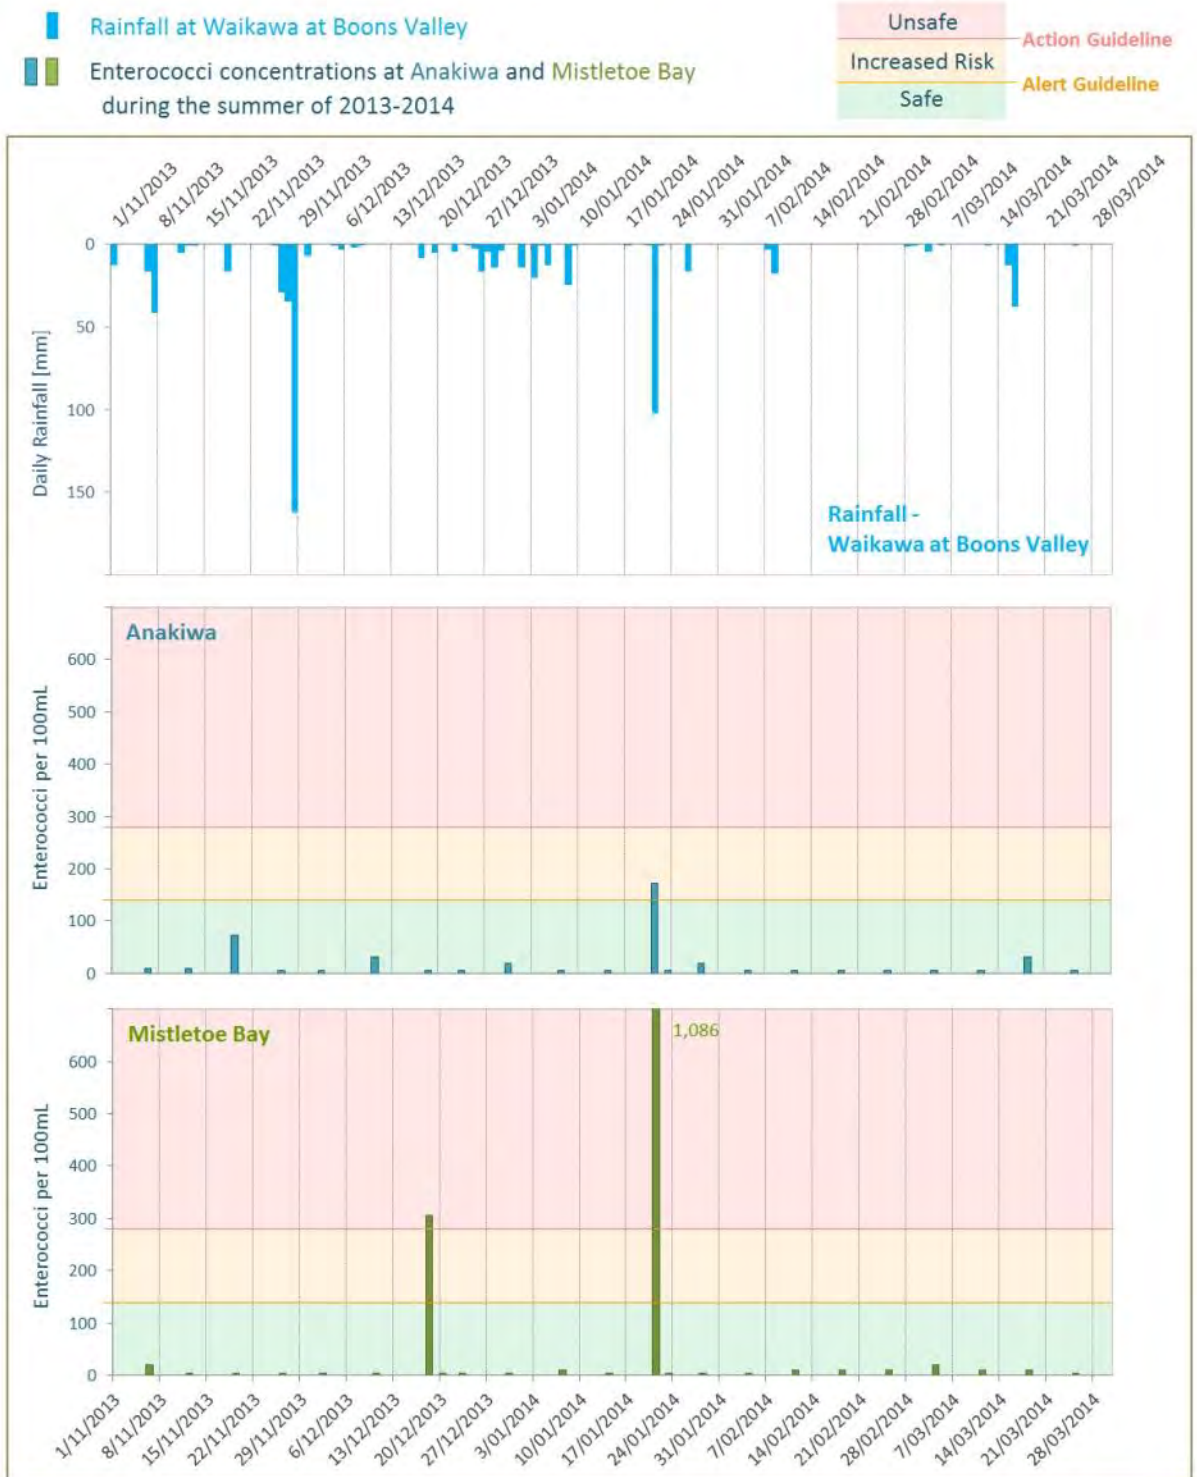
Figure 7: Results for Anakiwa and Mistletoe Bay for the summer season of 2013/2014.

Despite the greater number of potential sources of faecal contamination in Anakiwa Bay a rainfall event mid-December resulted in very high Enterococci concentrations in Mistletoe Bay while the concentration in Anakiwa did not reach unsafe levels. A second sample containing unsafe faecal bacteria concentrations was taken from Mistletoe Bay during dry conditions. Anecdotal evidence points to boat(s) moored in the bay at the time. Unfortunately illegal dumping of sewage from boats is very difficult to verify unless it is witnessed by coincidence. The occasionally high Enterococci concentrations observed at Mistletoe Bay during rainfall, however, should be investigated with targeted sampling during rainfall events to determine the source of the contamination using faecal source tracking methods.

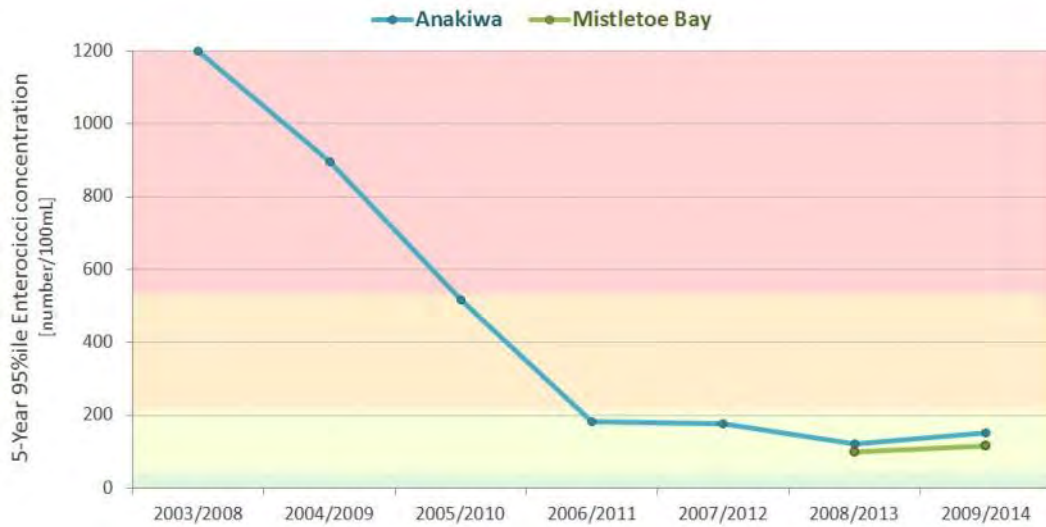
**Figure 8: 5-Year-95%iles for Anakiwa and Mistletoe Bay.**

There has been a significant reduction in the level of faecal contamination at Anakiwa since 2008 and water quality continued to be good in recent years. The requirement for the fencing of water ways on dairy farms may lead to further reductions in faecal contamination as a result of potential water quality improvement in Duncan Stream and Ada Creek.

Despite the two exceedances of the Alert Guideline at Mistletoe Bay this summer, microbiological water quality remains slightly better than at Anakiwa, resulting in the better SFR Grade of 'Very Good' for Mistletoe Bay compared to a SFR Grade of 'Good' for Anakiwa.

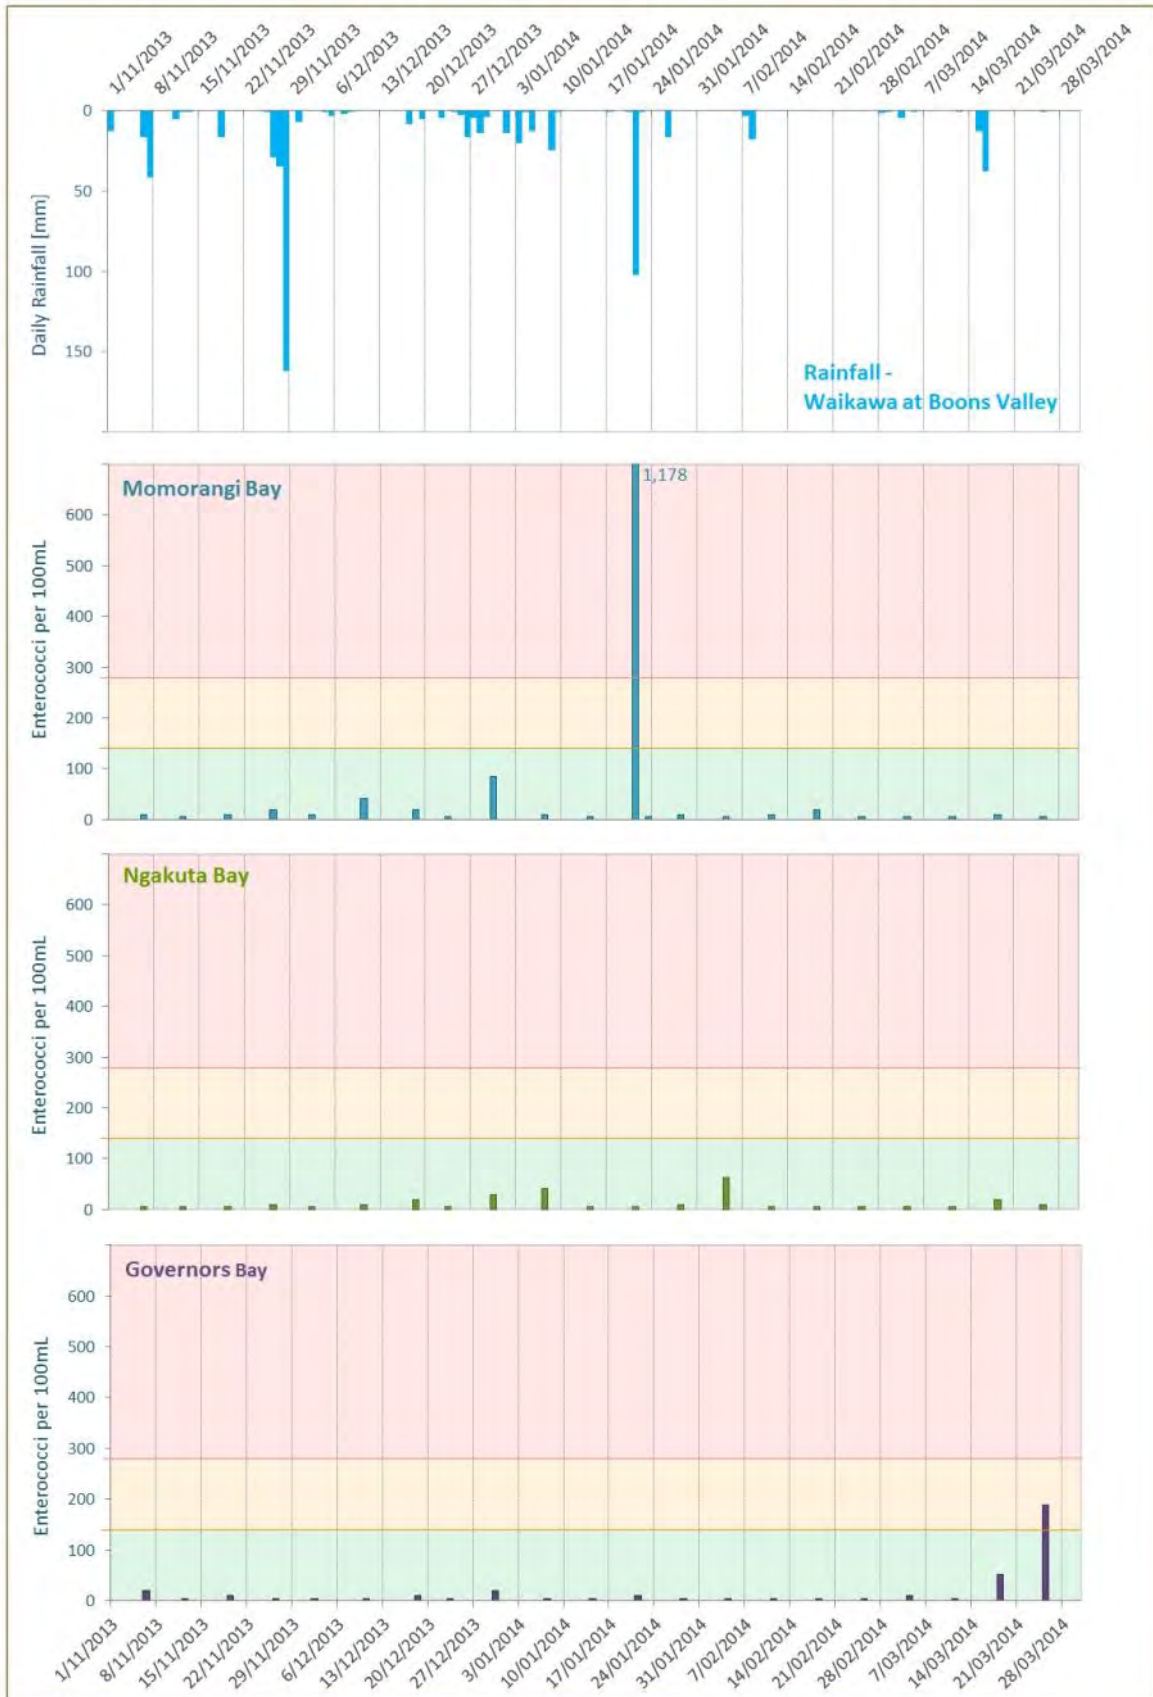
► Figure 11: Results for Momorangi, Ngakuta and Governors Bay for the summer season of 2013/2014.

The only sample with unsafe Enterococci concentration in this group was taken from Momorangi Bay during heavy rainfall. Surprisingly, the same rainfall event did not cause elevated faecal bacteria levels at Ngakuta Bay or Governors Bay. The slightly elevated Enterococci concentration in a sample taken from Governors Bay at the end of the summer season is unusual. However, there may have been a discharge from a boat or a localised rain shower on the day the sample was taken, as a small amount of rainfall was recorded at Waikawa.

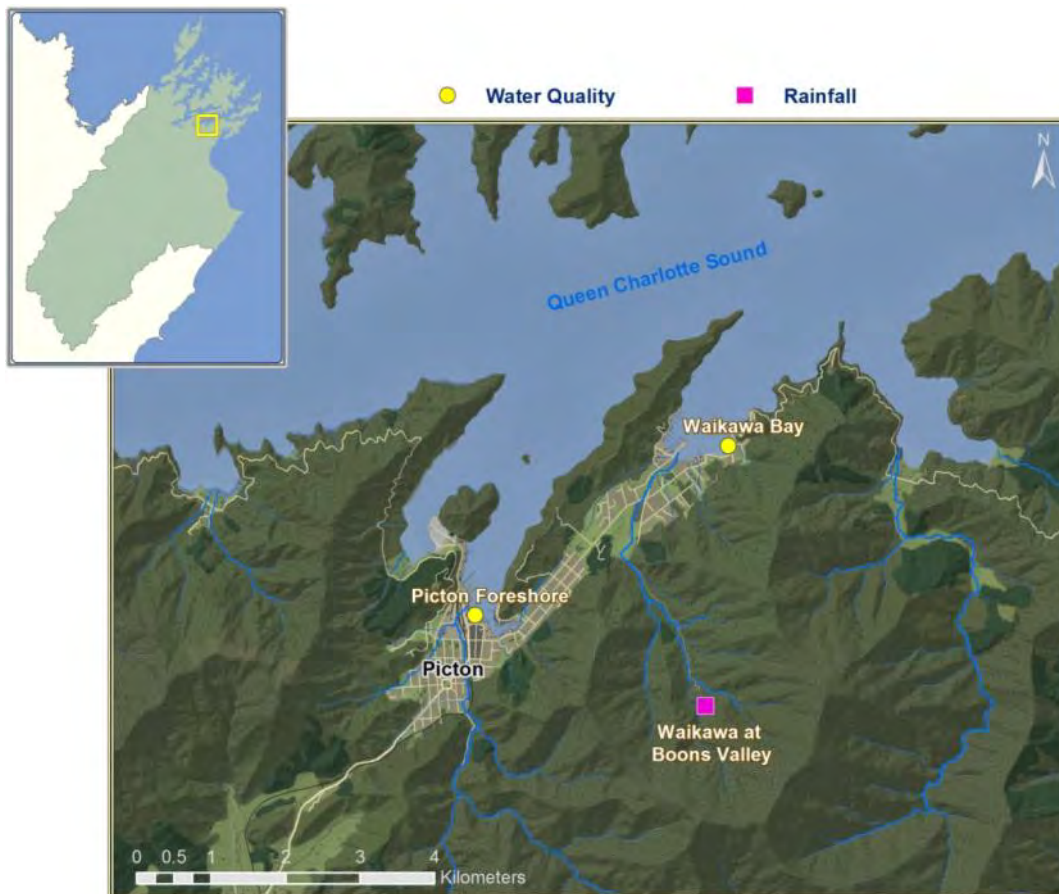
Figure 14: Map of the sampling sites and rainfall recorder.

The water quality of Picton Foreshore and Waikawa Bay are both influenced by the urban environment that surrounds these sites. The substantially greater amount of residential development of the Picton Township is reflected in the poorer water quality at the Foreshore.

Four samples taken from the Picton Foreshore this summer had Enterococci concentrations in exceedance of the guidelines. All of these samples were taken shortly after rainfall. Unlike previous season, this summer Enterococci concentrations stayed below guideline values during dry periods. The only sample with unsafe faecal bacteria levels from Waikawa Bay was taken during heavy rainfall.

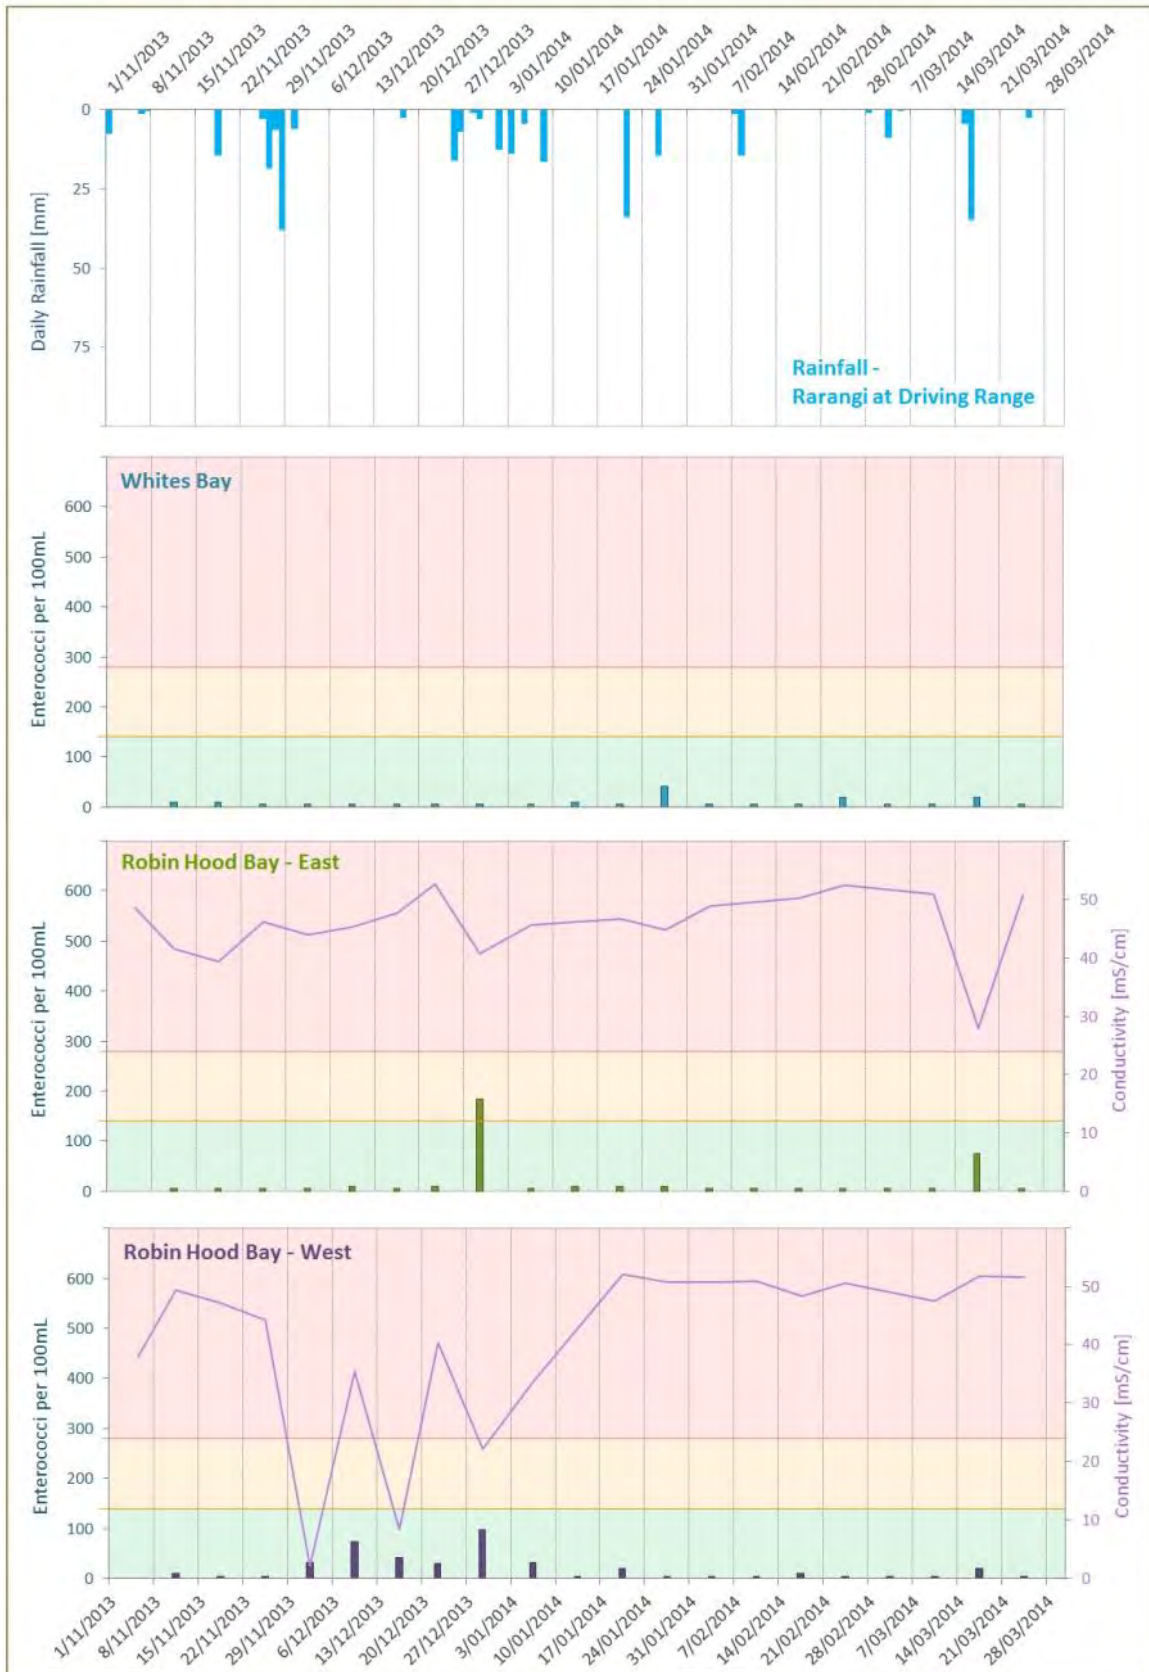
► Figure 20: Results for Whites Bay and the two Robin Hood Bay sites for the summer season of 2013/2014.

None of the samples taken from Whites Bay and Robin Hood Bay this season had unsafe concentrations of faecal bacteria. Concentrations were particularly low at Whites Bay, while one sample taken from Robin Hood Bay East exceeded the Alert Guideline.

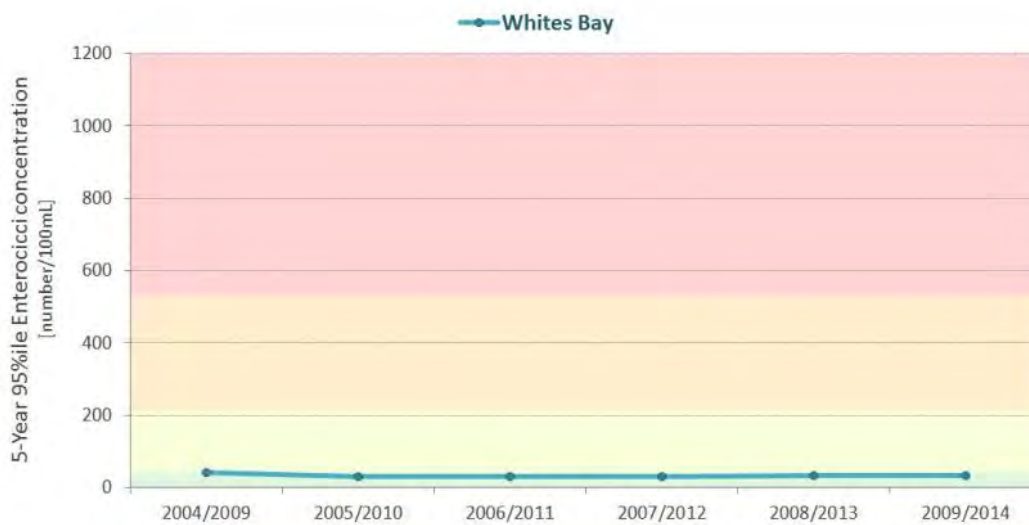
**Figure 21: 5-Year-95%iles for Whites Bay.**

There has been very little change of Enterococci concentrations at Whites Bay and the site continues to have very good water quality.

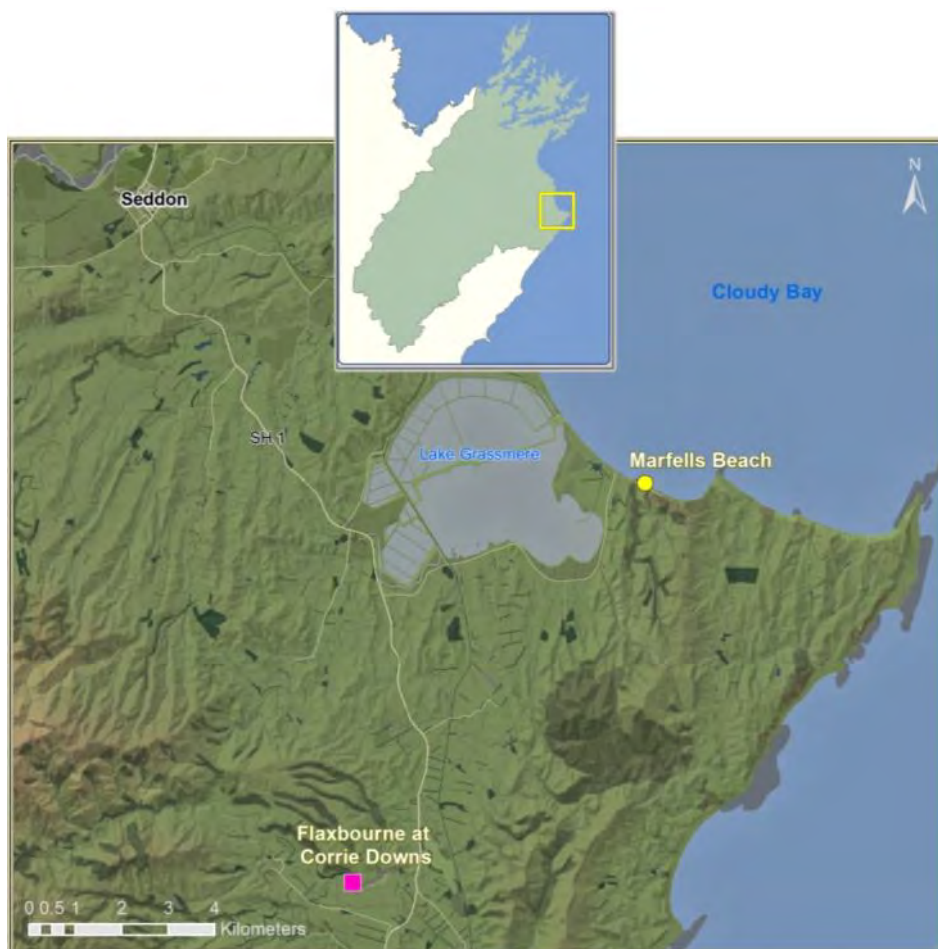
Figure 23: Map of the sampling sites and rainfall recorder.

Marfells Beach is the most Southern sampling site, located on the lower East Coast of the region. There are no large rivers or streams flowing into the sea close to the site, which means that the surrounding low intensity pastoral farming has little effect on the water quality. A popular DoC campground is located next to the beach and there are usually more than 100 seagulls on the beach. After storms large amounts of seaweed can be found along the shore. There is some evidence that Enterococci bacteria can potentially replicate in decaying seaweed [Anderson, 2000]. Nevertheless, Marfells Beach has the best water quality of all sites sampled as part of the Recreational Water Quality Program.

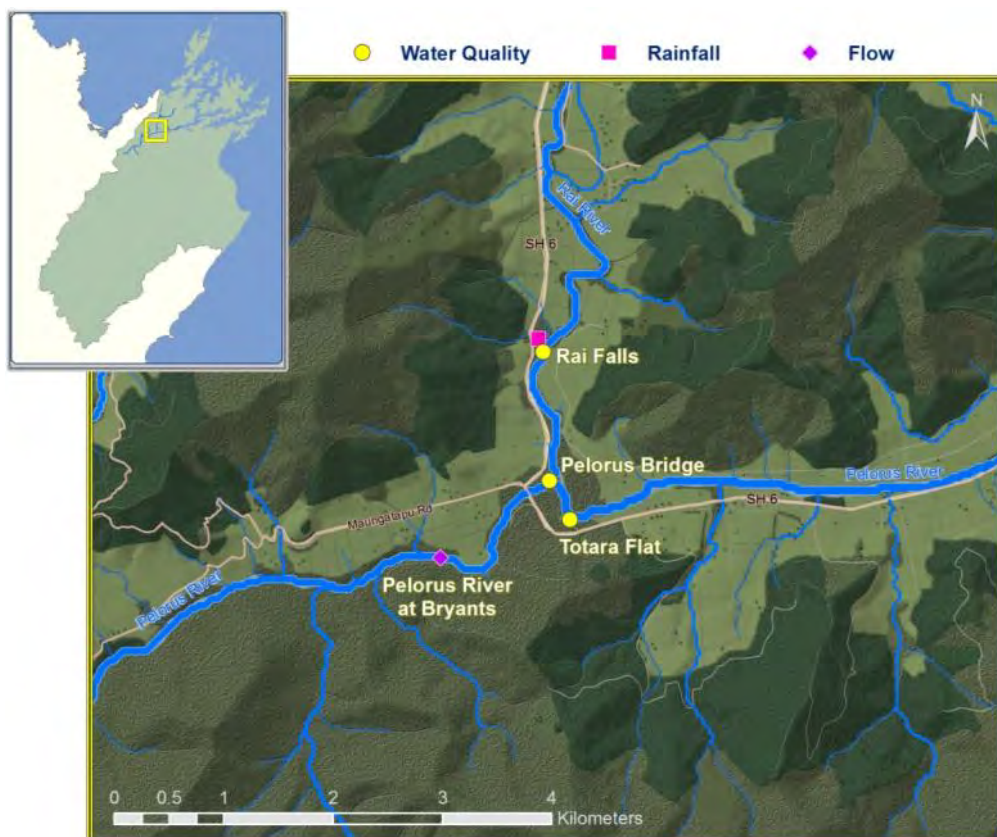
Figure 25: Map of the sampling sites as well as rainfall and flow recorders.

The Pelorus River has two popular swimming sites that are sampled as part of the Recreational Water Quality program, Pelorus Bridge and Totara Flat. The Rai River, which is sampled at the Rai Falls, flows into the Pelorus River approximately 300m upstream of Totara Flat. Consequently, water quality in the Pelorus River at Totara Flat is strongly influenced by the Rai River.

Only one sample, taken during a rainfall event from the Rai River at Rai Falls, had unsafe *E. coli* concentrations during this summer season. On the same occasion faecal concentrations at the two Pelorus River sites were also elevated, but did not reach unsafe levels. Microbial source tracking of *E. coli* in samples taken from the Rai River at Rai Falls in 2011 showed that up to 100% of faecal contamination originates from ruminant sources. The presence of bovine markers indicated that cows might be the main source of that contamination [Cornelisen et al., 2012]. The Rai River catchment is one of the largest dairy catchments in the region, but a small amount of dairying and other pastoral land use can also be found in the Pelorus catchment.

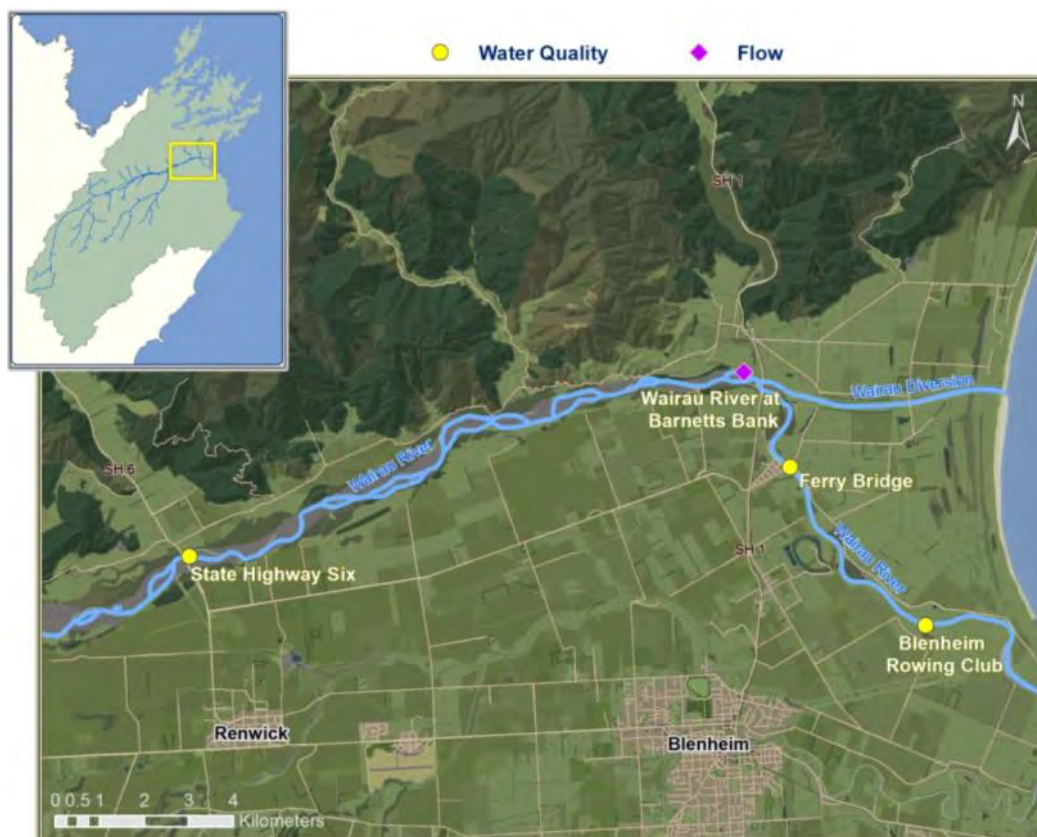
Figure 31: Map of the sampling sites and flow recorder.

There are three sites along the Wairau River that are sampled as part of the Recreational Bathing Water Quality program. The two sites located furthest downstream, Ferry Bridge and Blenheim Rowing Club, have been part of the program for some time, while the site at the State Highway Six Bridge was added recently as a result of a beach usage survey carried out in 2011 [MDC, 2012a].

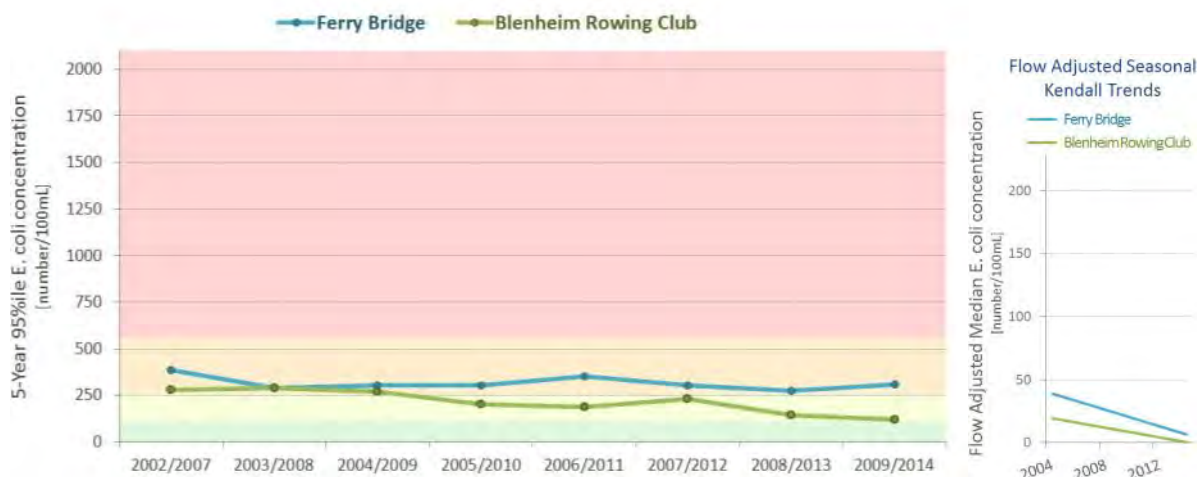
**Figure 33: 5-Year-95%iles and flow adjusted Kendall Trend for the Wairau River at Ferry Bridge and Blenheim Rowing Club.**

E. coli concentrations at Blenheim Rowing Club have been decreasing since monitoring began in 2002 and continue to do so. Consequently, a review of the SFR Grades last year resulted in a Grade change from 'Fair' to 'Good'. The water quality improvement was also confirmed by the Seasonal Kendall Trend Test analysis. The trend analysis also showed a statistically significant reduction of E. coli concentrations at the Ferry Bridge site. Nevertheless, faecal bacteria levels remain higher than at the Blenheim Rowing Club, resulting in the lower SFR Grade of 'Fair'.

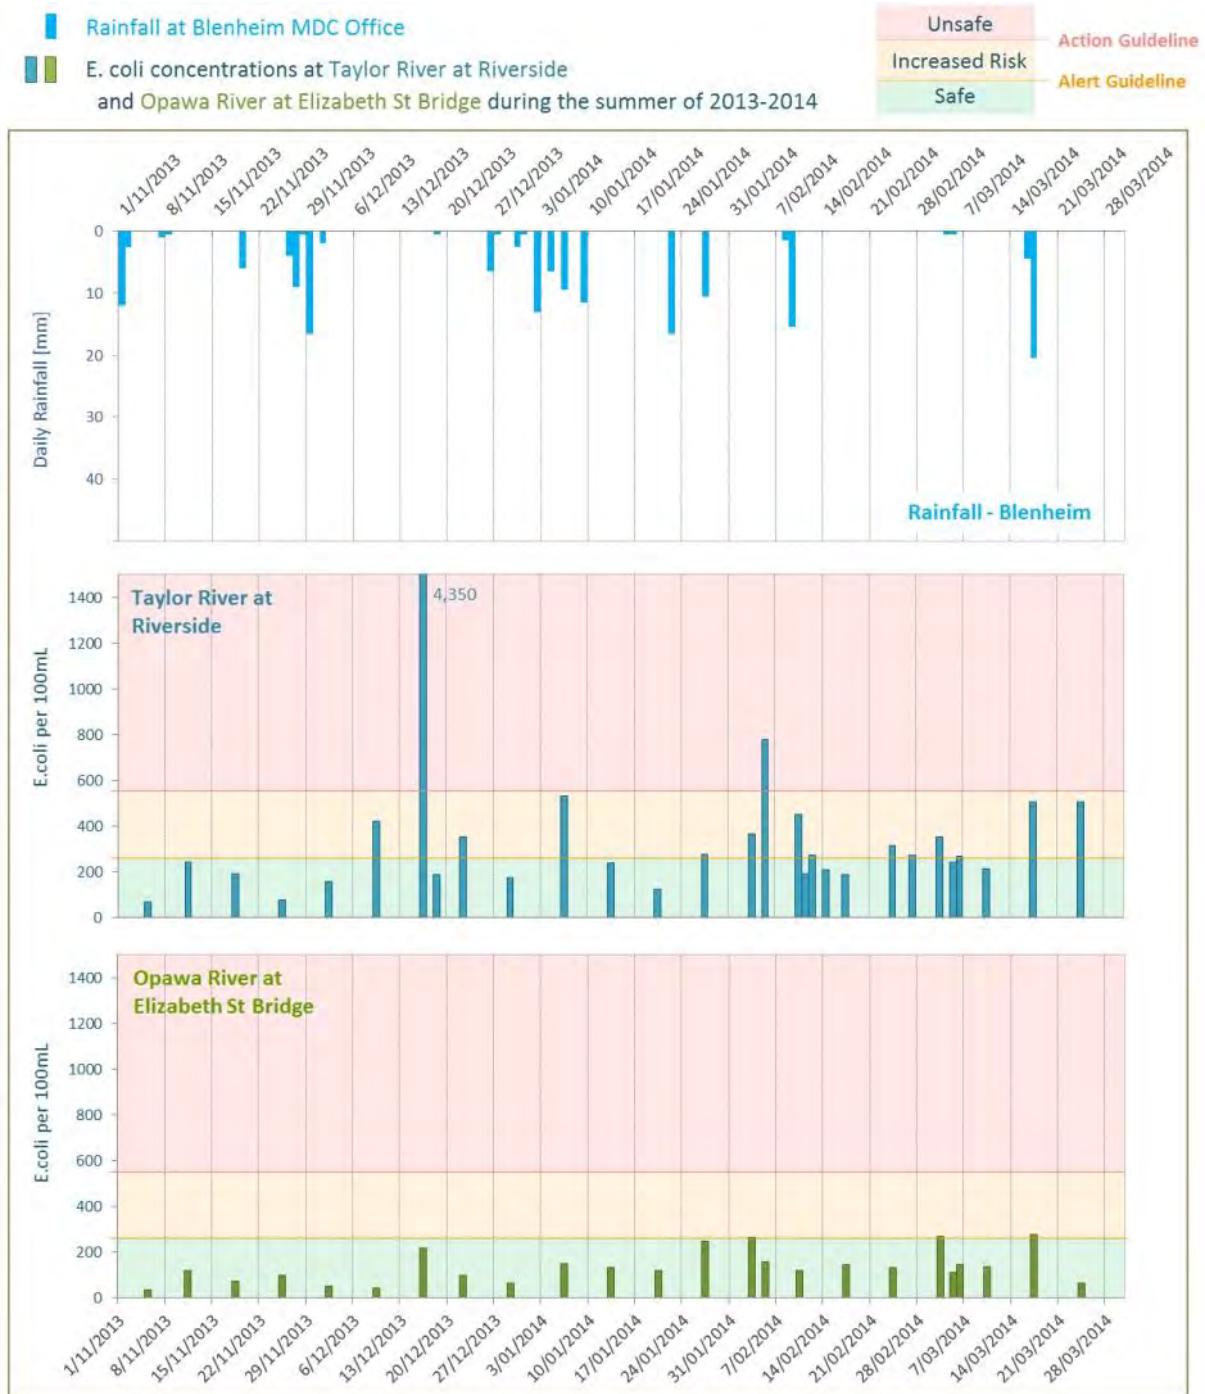
**Figure 36: Results for the Taylor River at Riverside and Opawa River at Elizabeth St for the summer season of 2013/2014.**

The Taylor River continues to contain elevated *E. coli* concentrations at the Riverside sampling site with numbers sporadically reaching levels unsafe for contact recreation. The highest concentrations were again measured during low flow conditions. Nevertheless, flow is not a very good predictor of *E. coli* levels, which indicates that other factors are of greater importance.

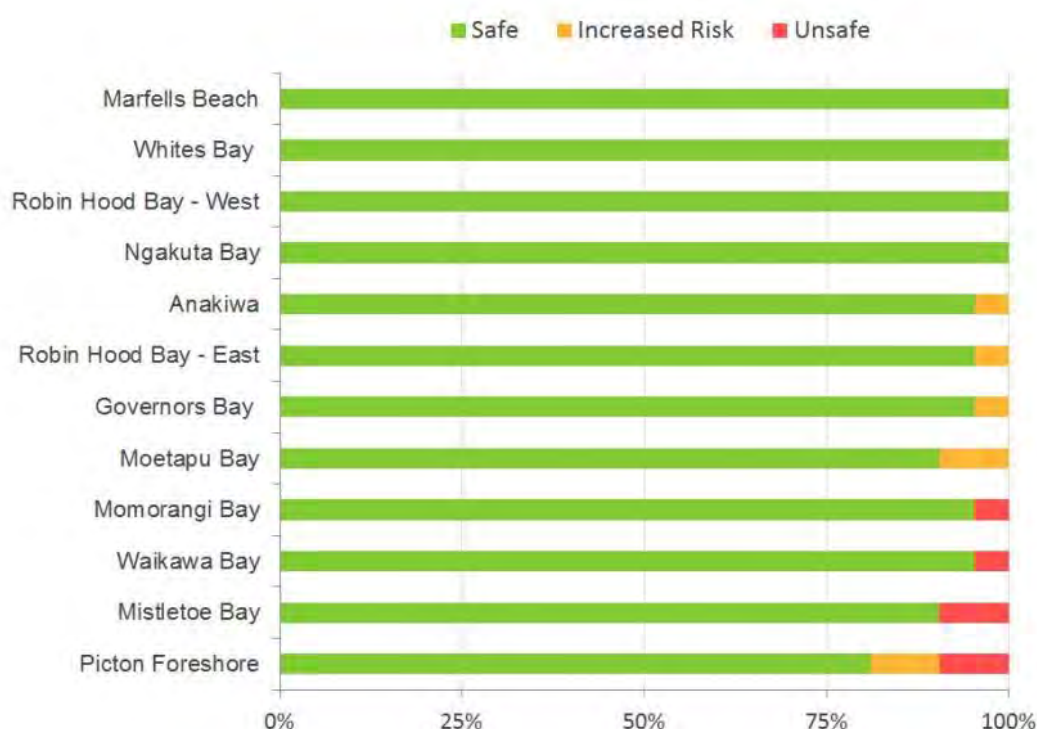
**Figure 39: Compliance of coastal beaches with the Recreational Water Quality Guidelines.**

Four coastal sites had faecal bacteria concentrations below the guideline values during the whole season. Another four coastal sites had one or two exceedances of the Alert Guideline, but faecal contamination did not reach levels considered unsafe for contact recreation. The remaining four coastal beaches had at least one sample with Enterococci concentrations above the Action Guideline (see Figure 39).

As was the case in previous seasons, Picton Foreshore had the worst microbial water quality while Marfells Beach had the lowest Enterococci concentrations [MDC, 2013a]. This is reflected in the SFR Grades for these sites; 'Poor' for Picton Foreshore and 'Very Good' for Marfells Beach.

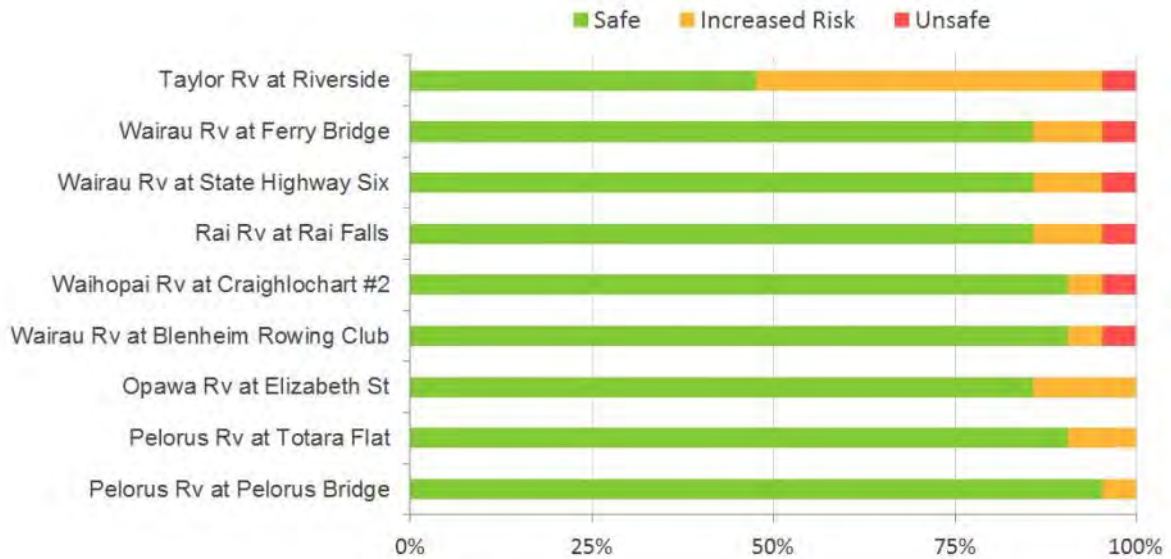
**Figure 40: Compliance of River sites with the Recreational Water Quality Guidelines.**

Of the River sites, the Taylor River at Riverside again had the worst water quality with less than 50% of the samples below the guideline values. However, only one sample taken from this site exceeded the Action Guideline. Apart from the two Pelorus River sites and the Opawa River at Elizabeth St, all other sites had also one sample with *E. coli* concentrations in excess of the level considered safe for contact recreation (see Figure 40).

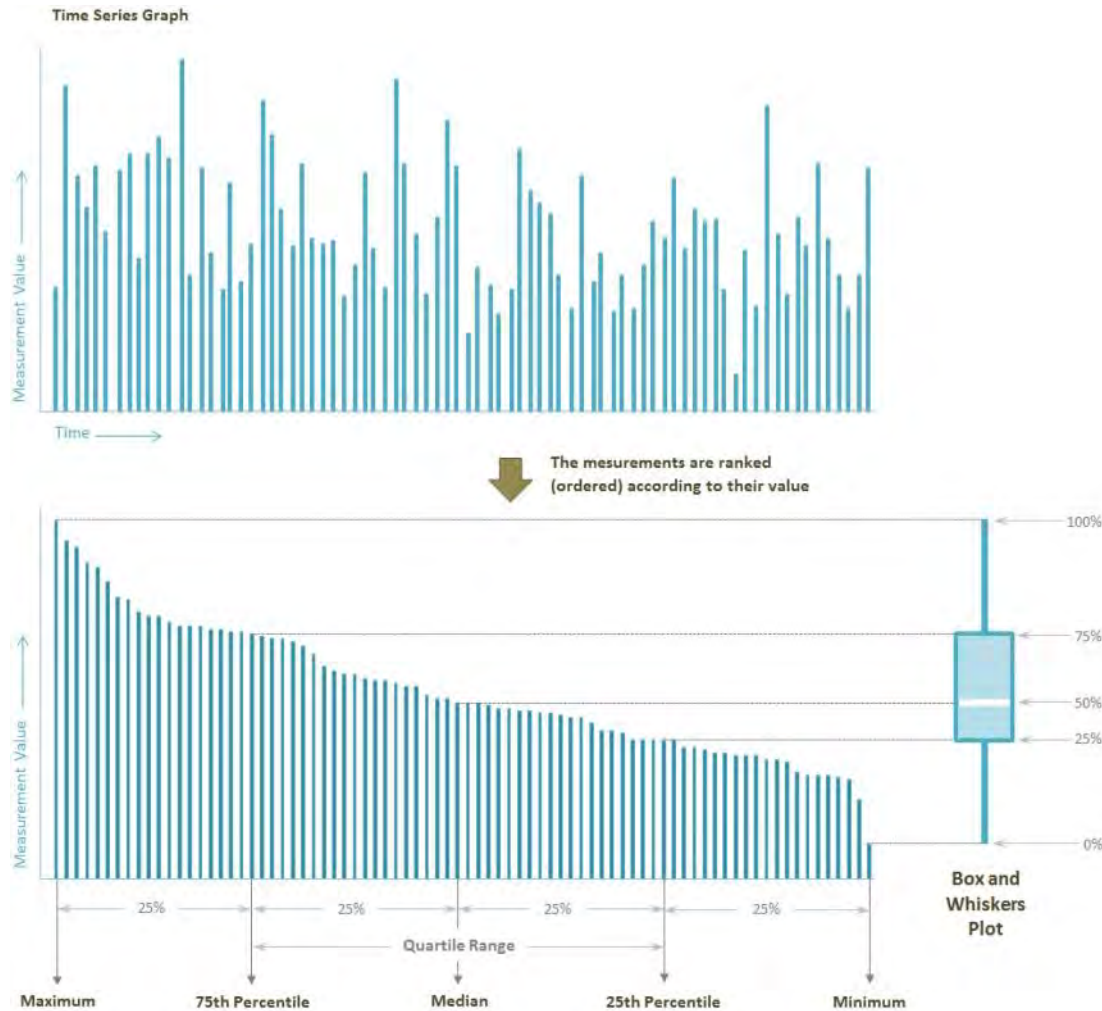
The Plots were created from the results of the routine sampling only. The first figure shows how Box and Whiskers Plots are created. Note that concentrations in the Box and Whiskers Plots for the actual sample results are on a logarithmic scale and only sites with a minimum of 3 years of record are shown.

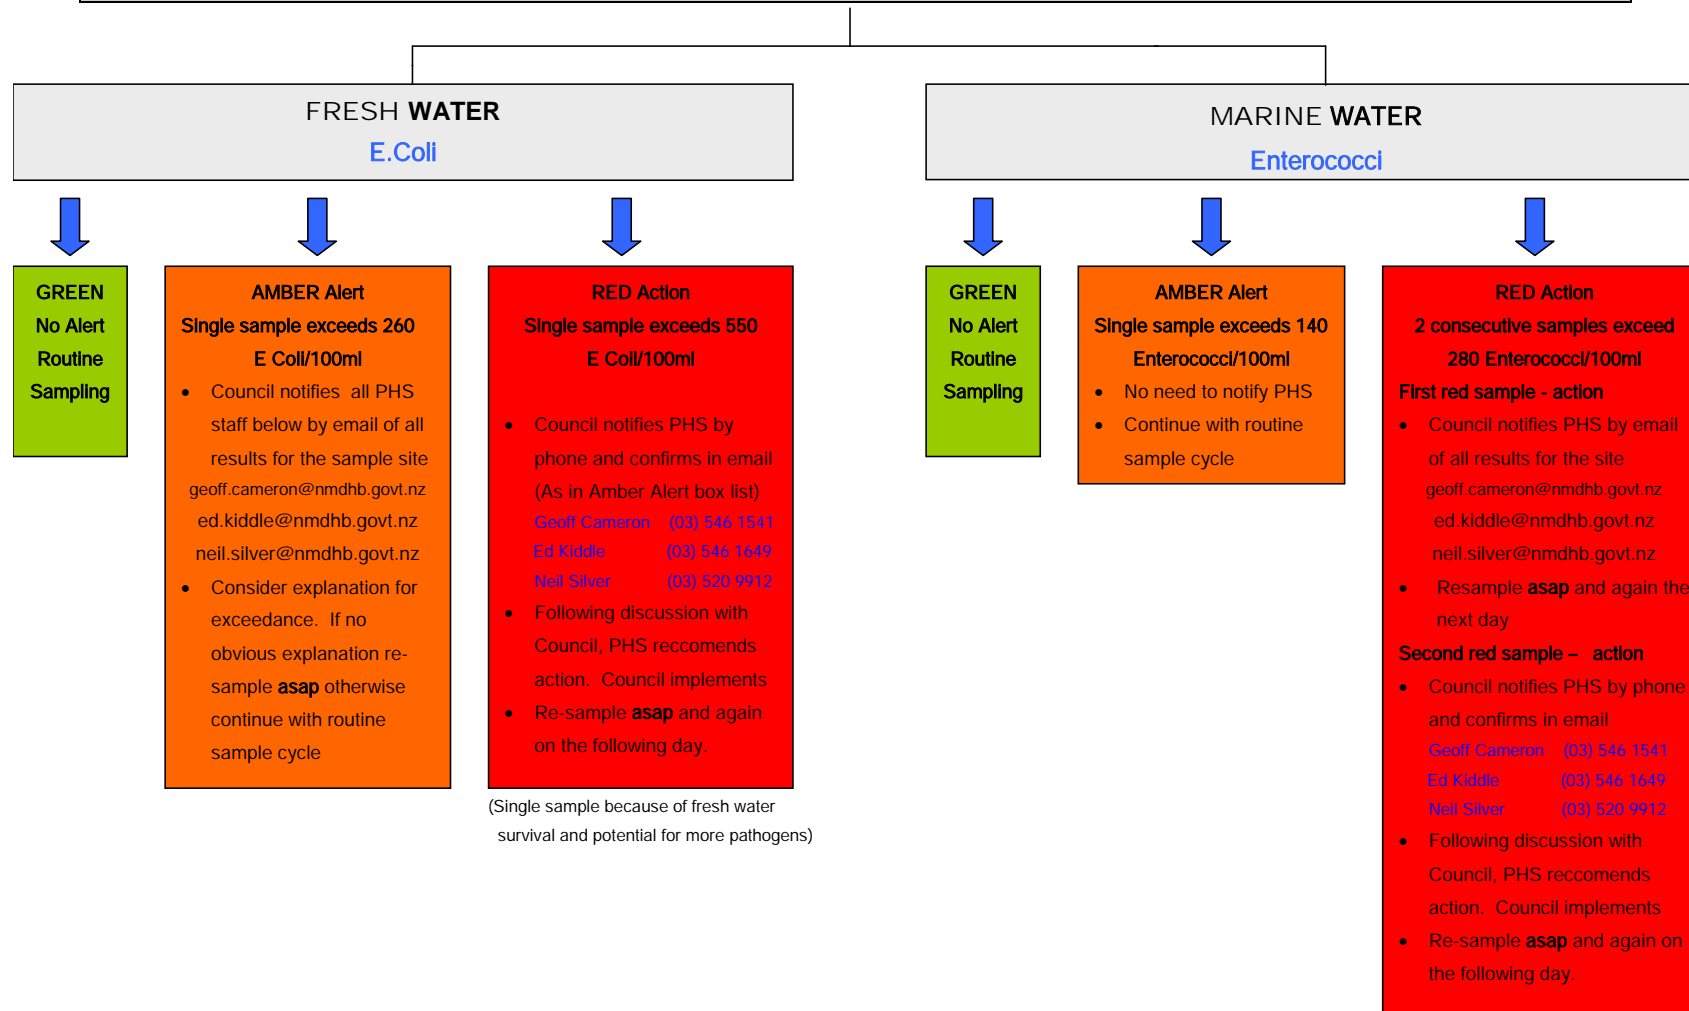
### RECREATIONAL WATER SAMPLE EXCEEDANCES – RESPONSE PROCEDURE

Based on Microbial water Quality Guidelines Page D9 (Box 1) and E9 (Box 2)

As soon as analysis results were received from the laboratory the Marlborough District Council website ([www.marlborough.govt.nz](http://www.marlborough.govt.nz)) was updated in order to provide the public with up-to-date information. If bacteria concentrations were above the Alert or Action Guideline (Table 1) possible causes were considered and the District Health Board was informed. A joint decision was then made on how to proceed. Warning signs were usually erected at the site if bacteria levels were above the Action guideline and the site was sampled more frequently until bacteria concentrations were at a low enough level for the water to be considered safe again. A flowchart outlining the process is shown in Appendix 4.
