**MARLBOROUGH
DISTRICT COUNCIL**

Recreational Water Quality Report 2014-2015

**Technical Report No: 15-006
August 2015**

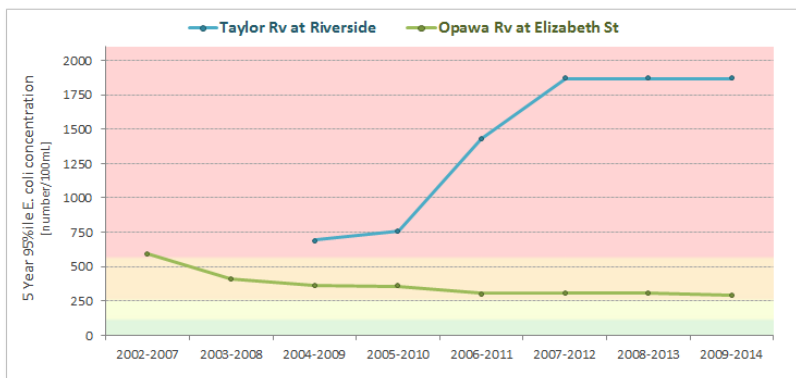
► **Figure 2: Creation of 5-Year-95%ile Graphs, used to display long-term trends.**

Because results are weather dependent there is substantial variation between summer seasons, therefore the data from five summers is combined

The purpose of the program is to assess if the water is safe for contact recreation, therefore, the focus is on high E. coli concentrations. However, the highest 5% are likely to occur during flooding when people are unlikely to swim in the river. Subsequently the 95%ile is chosen.

The data is ranked (ordered) based on the E. coli concentration values
to find the 95 Percentile (95%ile)

The 95%iles for all 5 year intervals are calculated

The change over time (Trend) can now be seen and compared with that of other sites

To put the values into context, the background colouring of the graph is based on the Microbiological Assessment Categories (MAC) used for the grading of sites (SFR Grade).

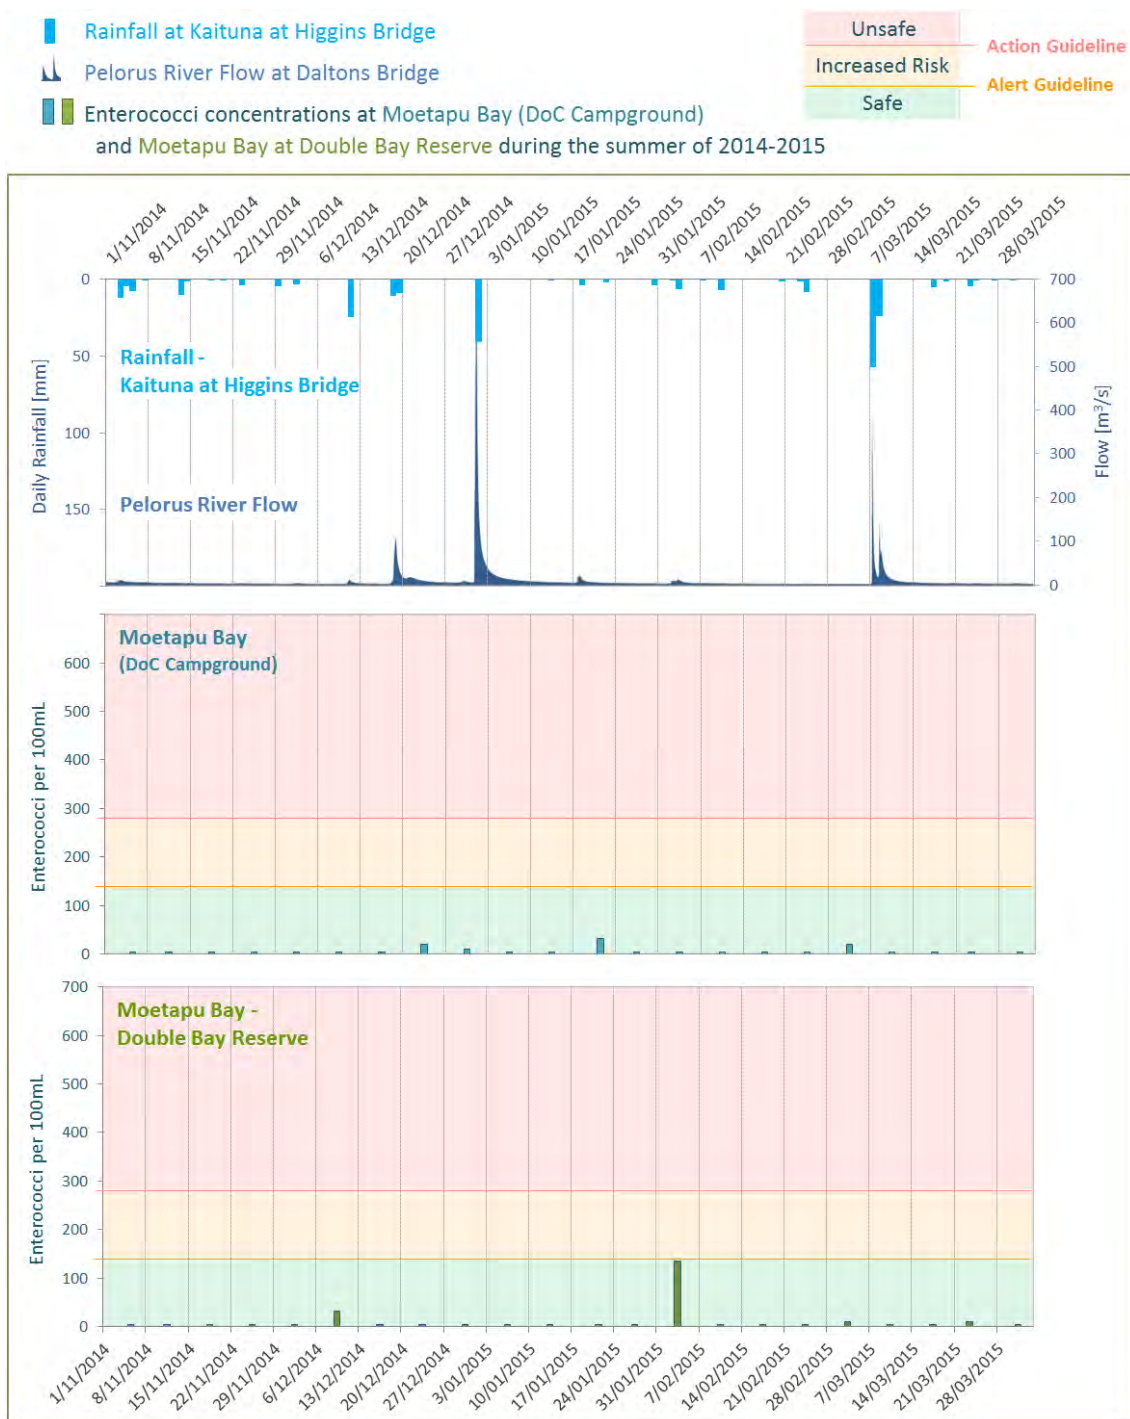
Figure 4: Results for Moetapu Bay for the summer season of 2014/15.

Two larger floods of the Pelorus River did not coincide with sampling dates and are therefore not reflected in the Enterococci results for the two Moetapu Bay sites. In the future only one of the sites should be sampled. This season again, more users were observed in the Double Bay Reserved than at the DoC campground. The greater usage combined with a larger number of potential sources for faecal contamination result in an overall greater risk for recreational users. For this reason, monitoring should continue at the Double Bay Reserve only.

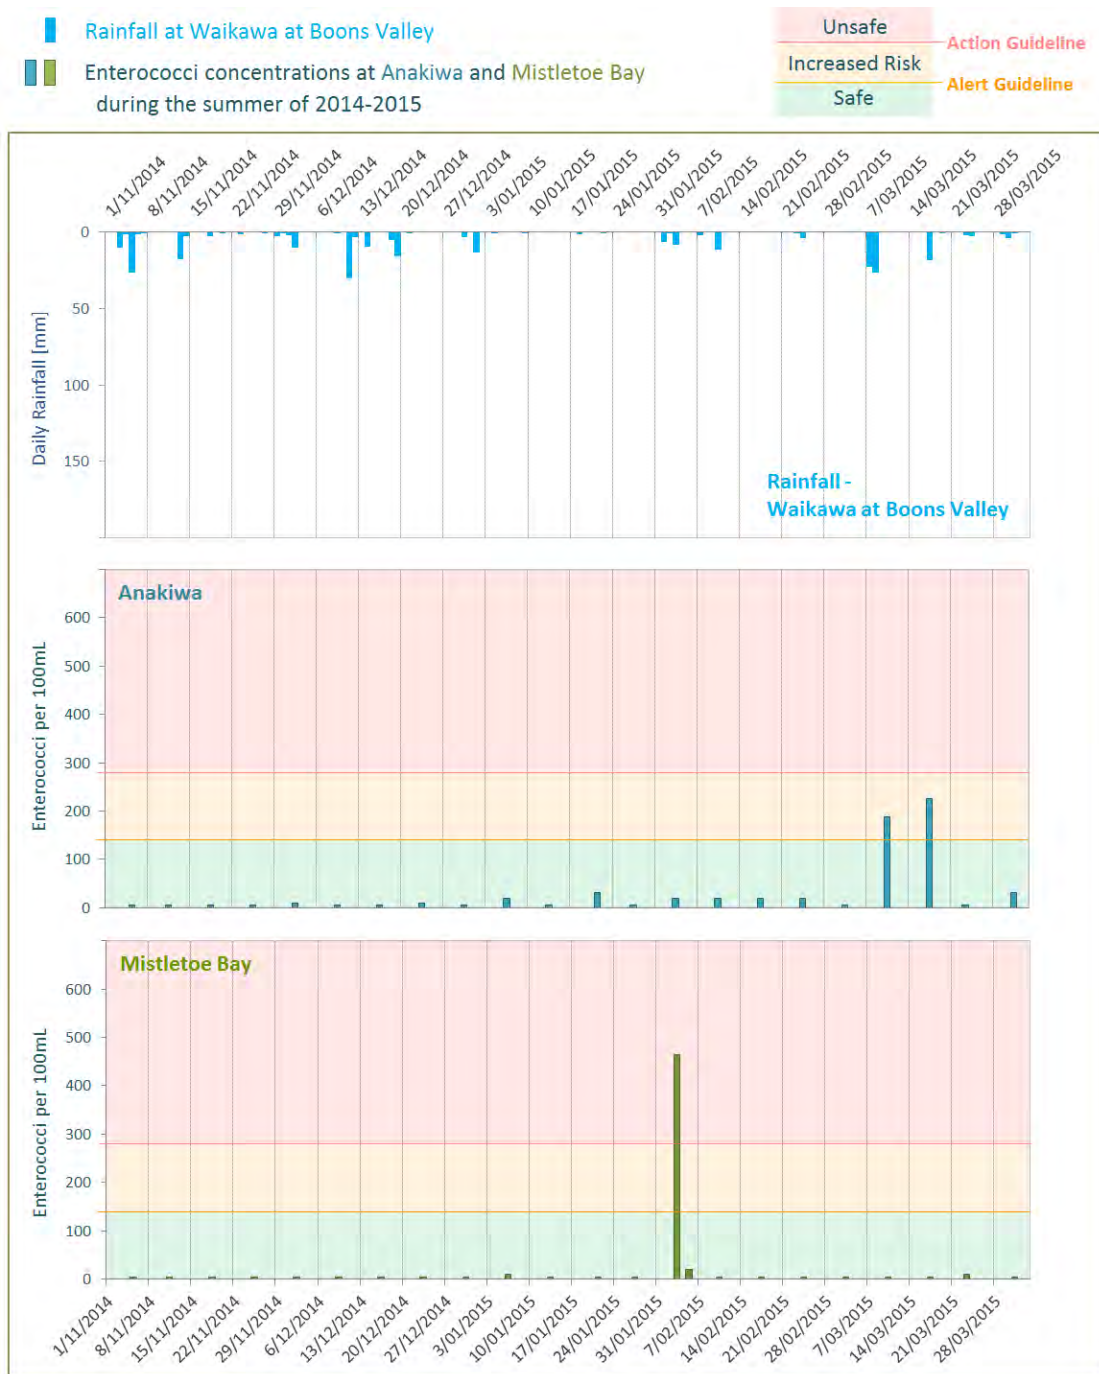
Figure 6: Rainfall recorded at Boons Valley and enterococci concentrations measured in Anakiwa and Mistletoe Bay during the summer season of 2014/15.

The only sample with Enterococci bacteria concentrations indicating potentially unsafe faecal contamination was taken from Mistletoe Bay following rainfall. Although the amount of rainfall recorded at Waikawa was low, there could have been localised heavy showers effecting smaller areas only. This might explain the comparatively low Enterococci numbers in Anakiwa Bay on the same day. Conversely, two samples taken from Anakiwa in March with Enterococci concentrations above Alert Guideline levels were taken after rainfall, but Enterococci concentrations in Mistletoe Bay remained low. It needs to be noted, that the water was discoloured in only one of the samples from Anakiwa, while it was clear and calm when the other samples with high bacteria counts from Anakiwa and Mistletoe Bay were taken. This means, that there were no visible signs of contamination of the water from run-off, which is concerning particularly in regard to the higher bacteria counts in Mistletoe

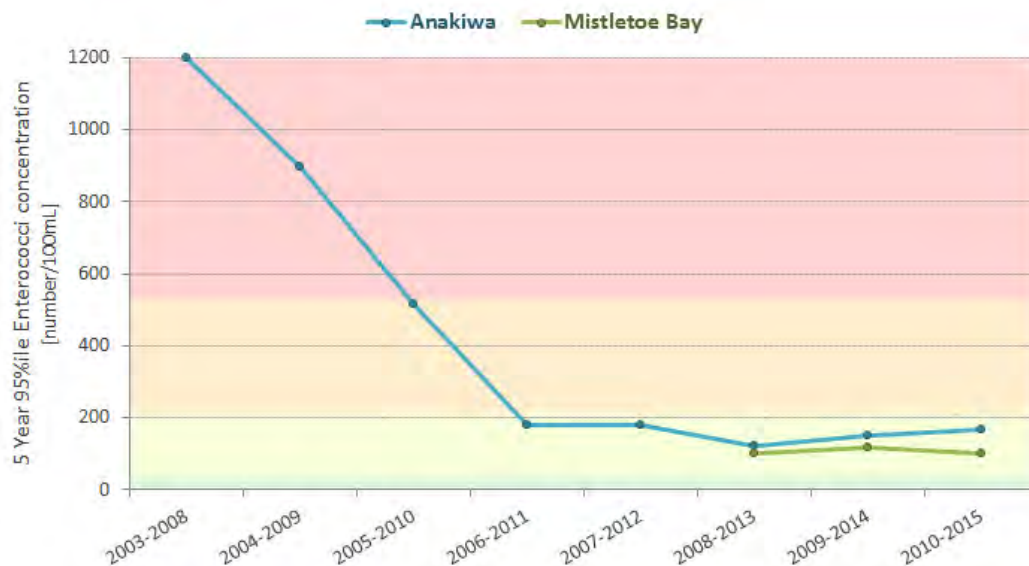
Figure 7: The 5-year-95%ile Enterococci concentrations in Anakiwa and Mistletoe Bay for all of the summer seasons monitored.

Long term trends show no significant changes in recent years (Figure 7). Enterococci concentrations remain comparatively low at both of the sites. The 5-year 95%ile Enterococci concentration measured in Anakiwa are slightly higher than those observed in Mistletoe Bay. Consequently, the SFR Grade for Anakiwa is 'Fair', while Mistletoe Bay is graded as 'Good'.

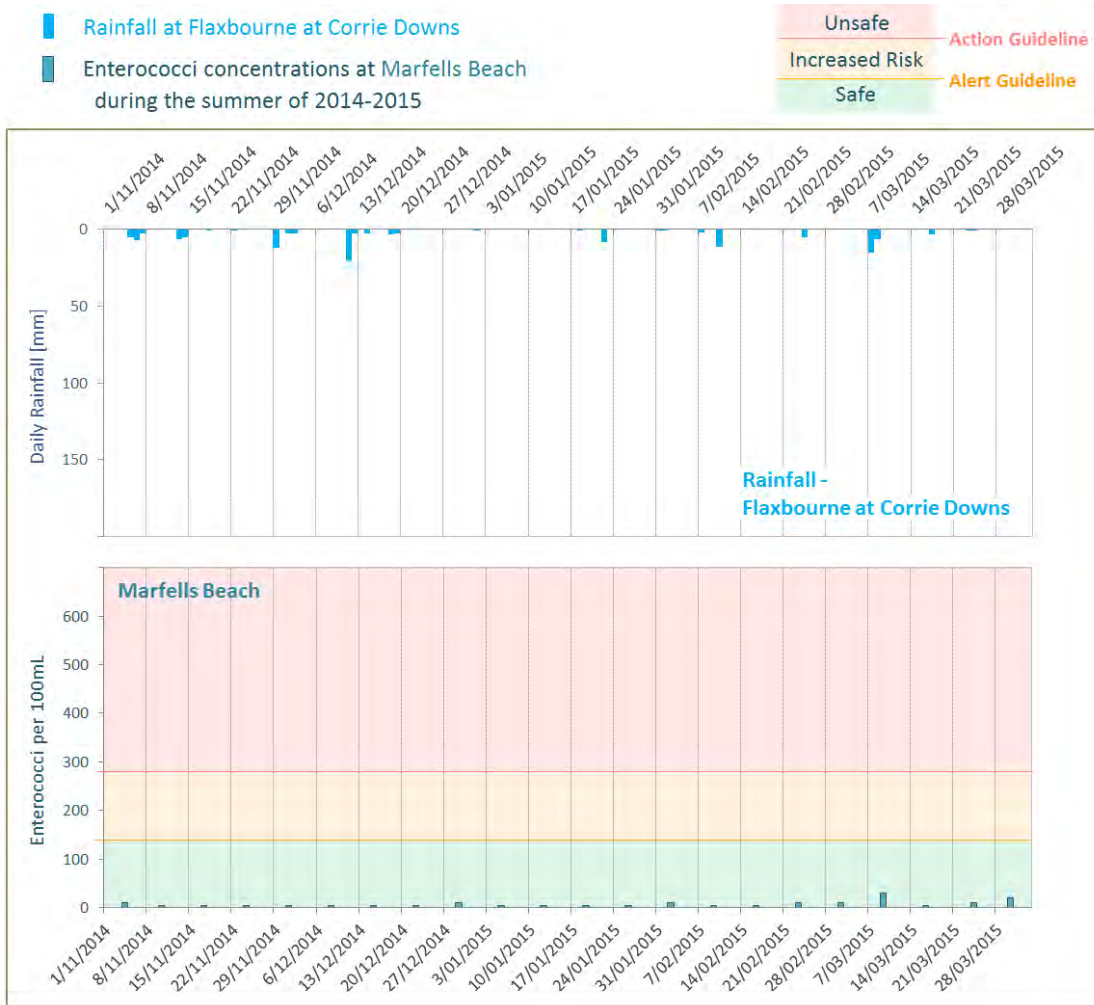
Figure 19: 2014/15 summer season results and the 5-year-95%ile Enterococci concentrations for Marfells Beach.

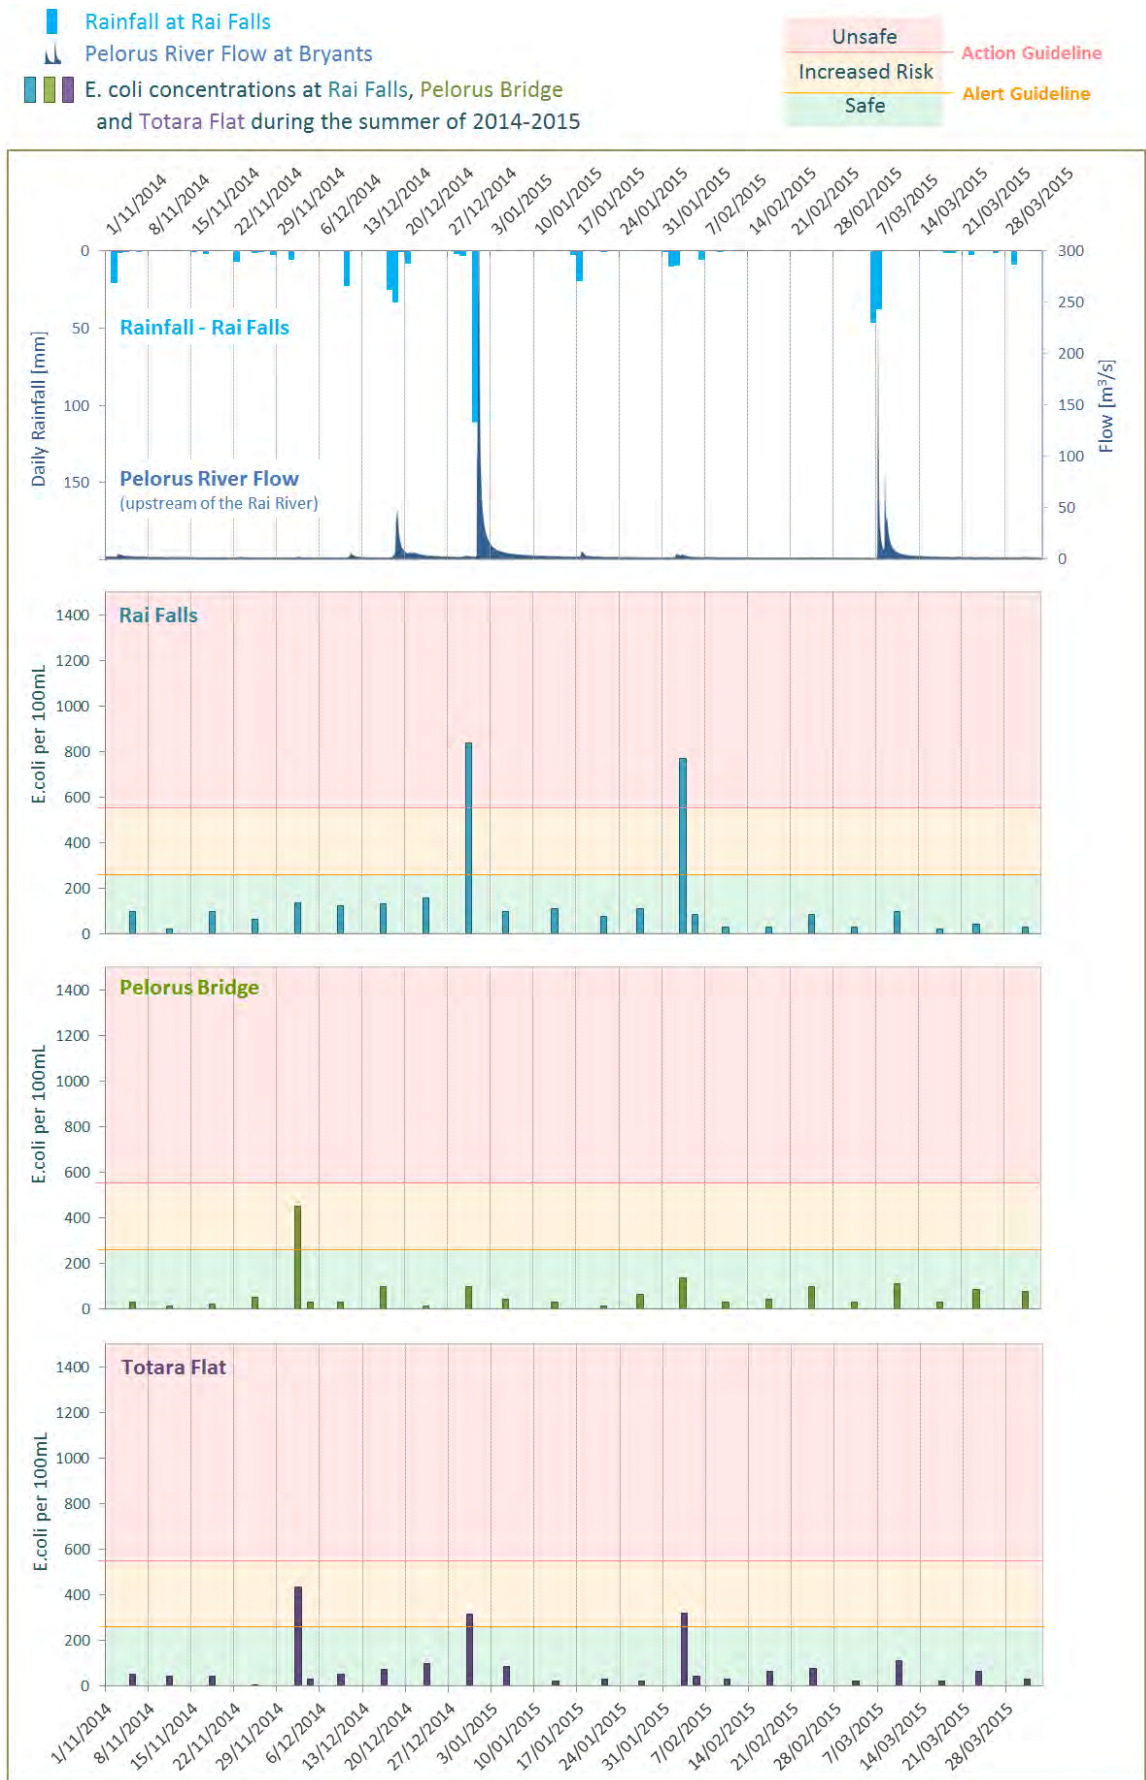
Figure 21: 2014/15 summer season monitoring results for the Rai and Pelorus River sites.

E. coli concentrations were consistently elevated in the Rai River during the first three months of the summer, but guideline values were exceeded on only two occasions shortly after small amounts of rain had fallen (Figure 21). Following the second exceedance, *E. coli* concentrations were generally lower, which might indicate that the faecal bacteria source causing the previously elevated level was either washed out or removed. Both exceedances of *E. coli* guidelines in the Rai River were caused by relatively small rainfall events⁴, and the water remained clear during the first event and was only slightly turbid on the second occasion. This means potential recreational users had no visual clues pointing to the faecal contamination at the site. This emphasises that the appearance of water is not always a reliable indicator for water quality.

The two exceedances in the Rai River also resulted in elevated *E. coli* concentrations at Totara Flat, but concentrations did not reach levels of concern to human health there. An earlier exceedance of the Alert guideline at the Totara Flat was caused by a localised rainfall event in the upper Pelorus catchment, which also caused the only exceedance of a guideline at the Pelorus Bridge site.

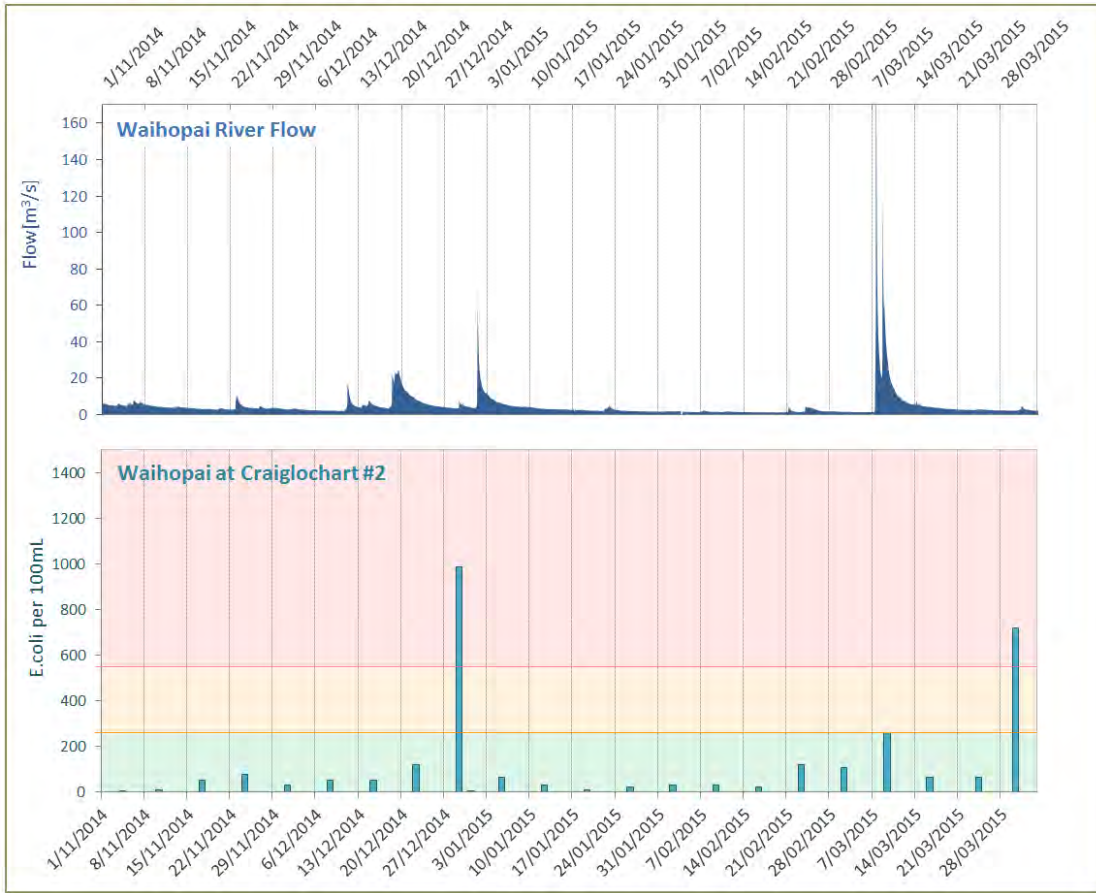
Figure 25: Results for the 2014/15 summer season and 5-year-95%iles for the Waihopai River at Craiglochart #2.

Two samples taken from the Waihopai at Craiglochart #2 had *E. coli* concentrations above the levels considered safe for contact recreation (Figure 25). Both samples were taken at only slightly elevated flows that were caused by heavy rainfall restricted to small areas in the catchment.

A very intense rainfall event in early March resulted in the largest flood of this season and caused significant erosion in the upper Waihopai catchment. As a result the river was discoloured for the remaining summer period. Subsequently, the high *E. coli* concentrations in late March were unlikely to have resulted in a significant health risk to the public.

The long-term trend shows increasing *E. coli* concentrations after a steady reduction in the first years of continuous monitoring. It is unclear what is causing the reversed trend. Field notes show that dog faeces and rubbish, including nappies, are frequently found at the site. This is very unfortunate as it is not only potentially increasing the risk to recreational users in regard to infection with pathogens, but also diminishes the aesthetic value of the site and therefore the recreational enjoyment for the visitors.

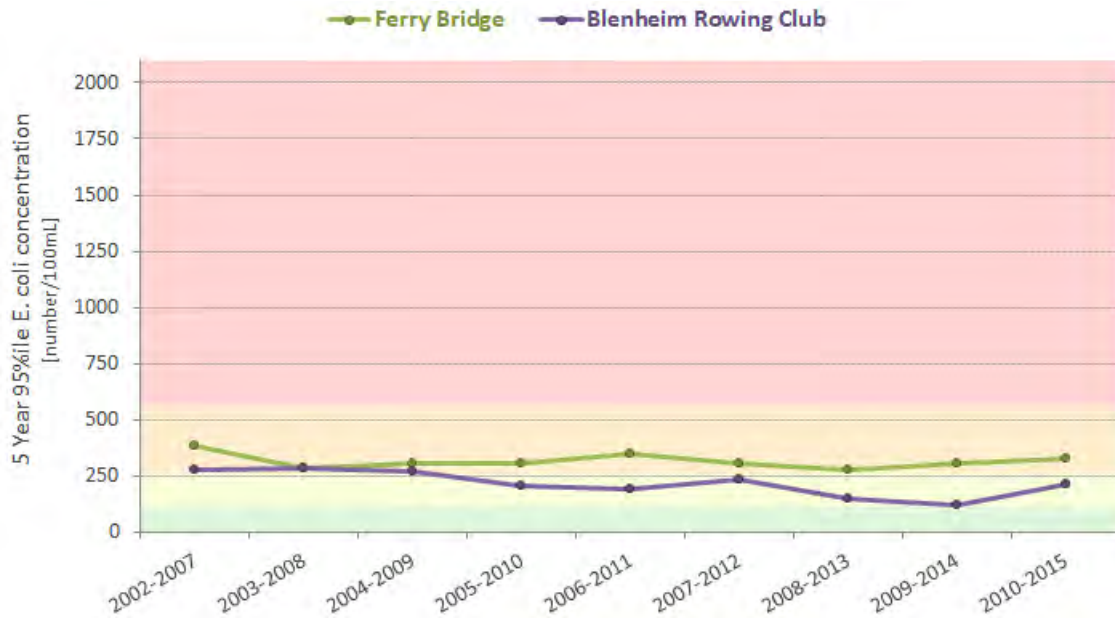
Figure 28: The 5-year-95%ile E. coli concentrations in the Wairau River at Ferry Bridge and the Blenheim Rowing Club for all of the summer seasons monitored.

The long-term trend shows a small improvement in recreational water quality for the site at the Blenheim Rowing Club, but very little change for the site at the Ferry Bridge (Figure 28). The Blenheim Rowing Club site has an SFR Grade of 'Good', while the slightly poorer water quality at the Ferry Bridge is reflected in a SFR Grade of 'Fair'. The site at State Highway Six has not been monitored for a sufficiently long period, to allow the assignment of a SFR Grade.
