**MARLBOROUGH
DISTRICT COUNCIL**

Recreational Water Quality Report 2016-2017

**Technical Report No: 17-005
July 2017**

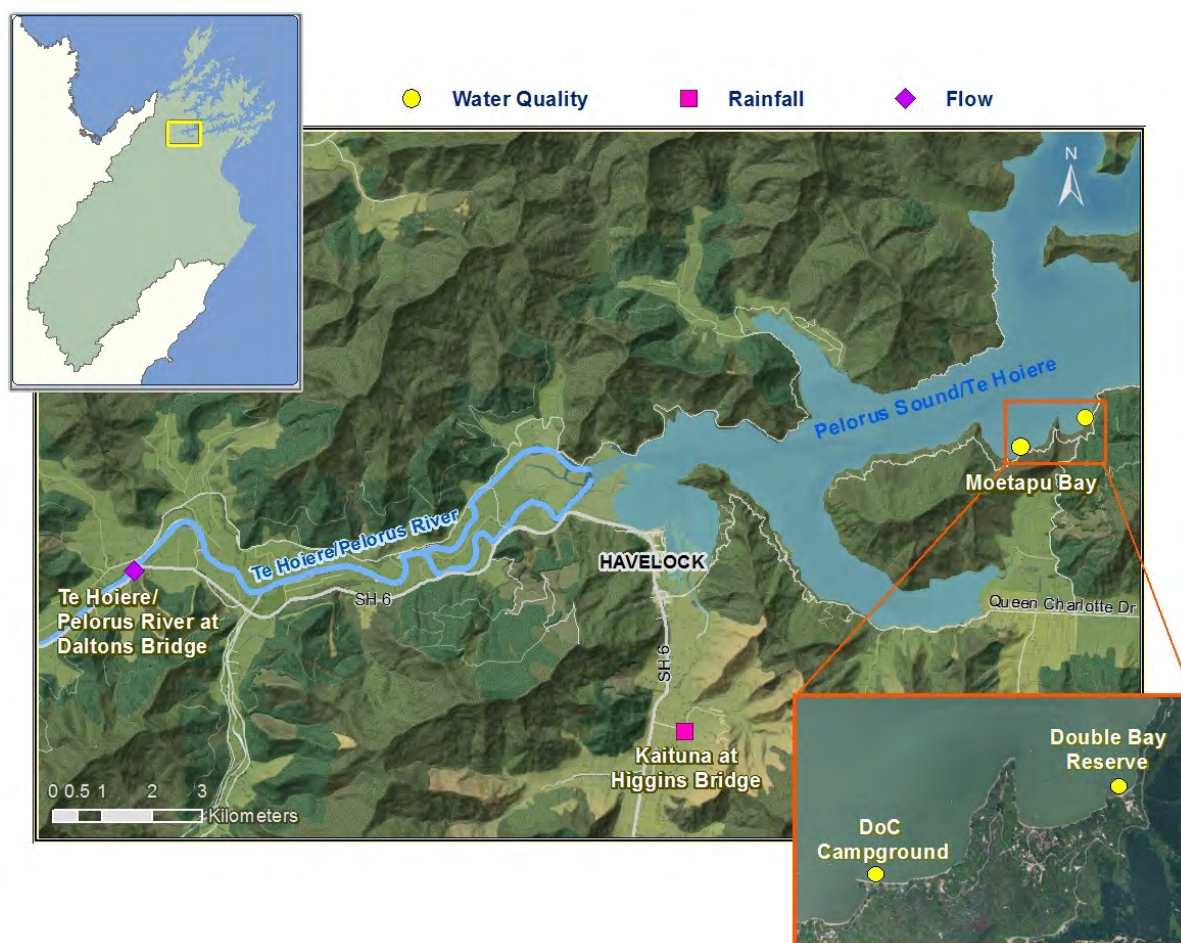
Figure 2: Location of the Moetapu Bay sampling sites, the (simulated³) Te Hoiere/Pelorus River flow recorder and the Kaituna at Higgins Bridge rain gauge.

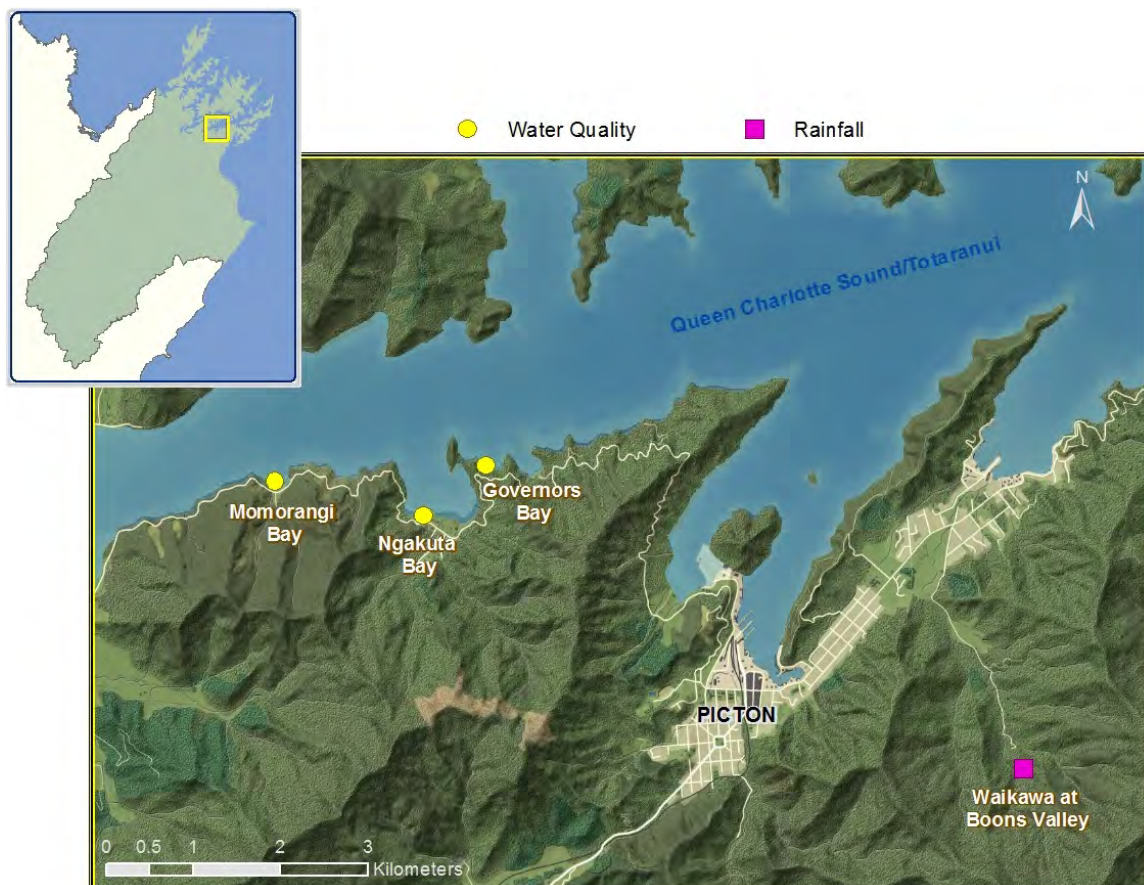
Figure 9: Map showing the sampling sites at Momorangi Bay, Ngakuta Bay and Governors Bay, as well as the rainfall recorder at Boons Valley.

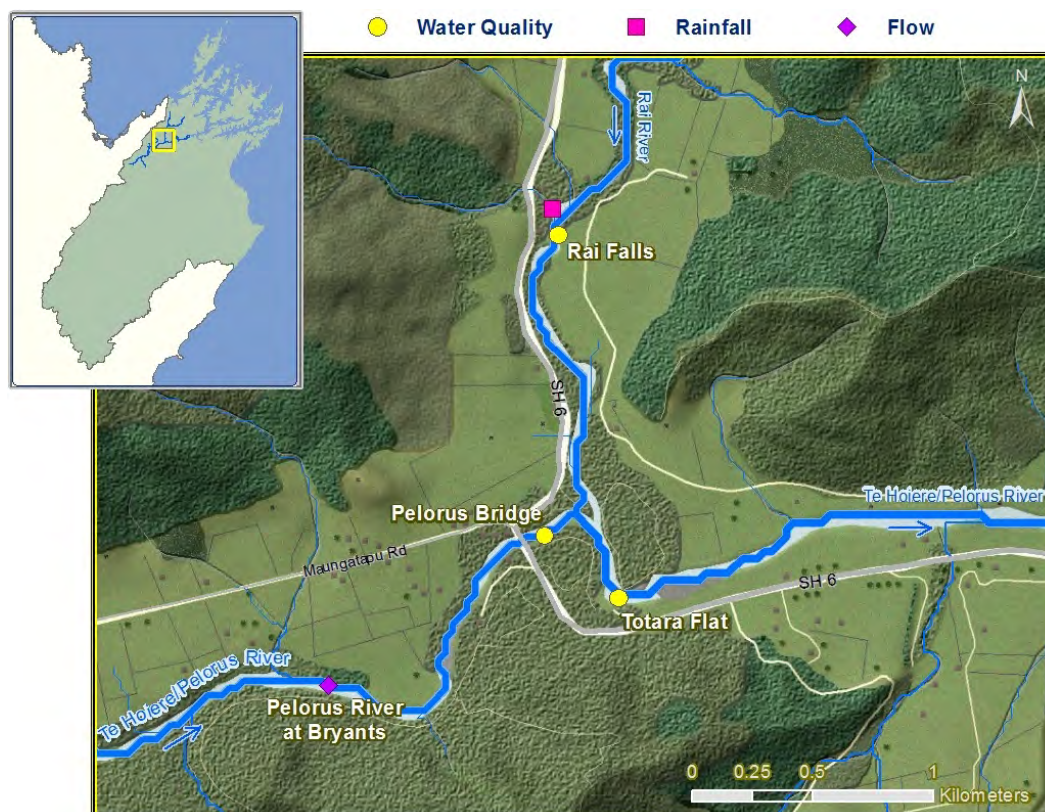
Figure 22: Locations of the Te Hoiere/Pelorus and Rai River sampling sites as well as nearby rainfall and flow recorders.

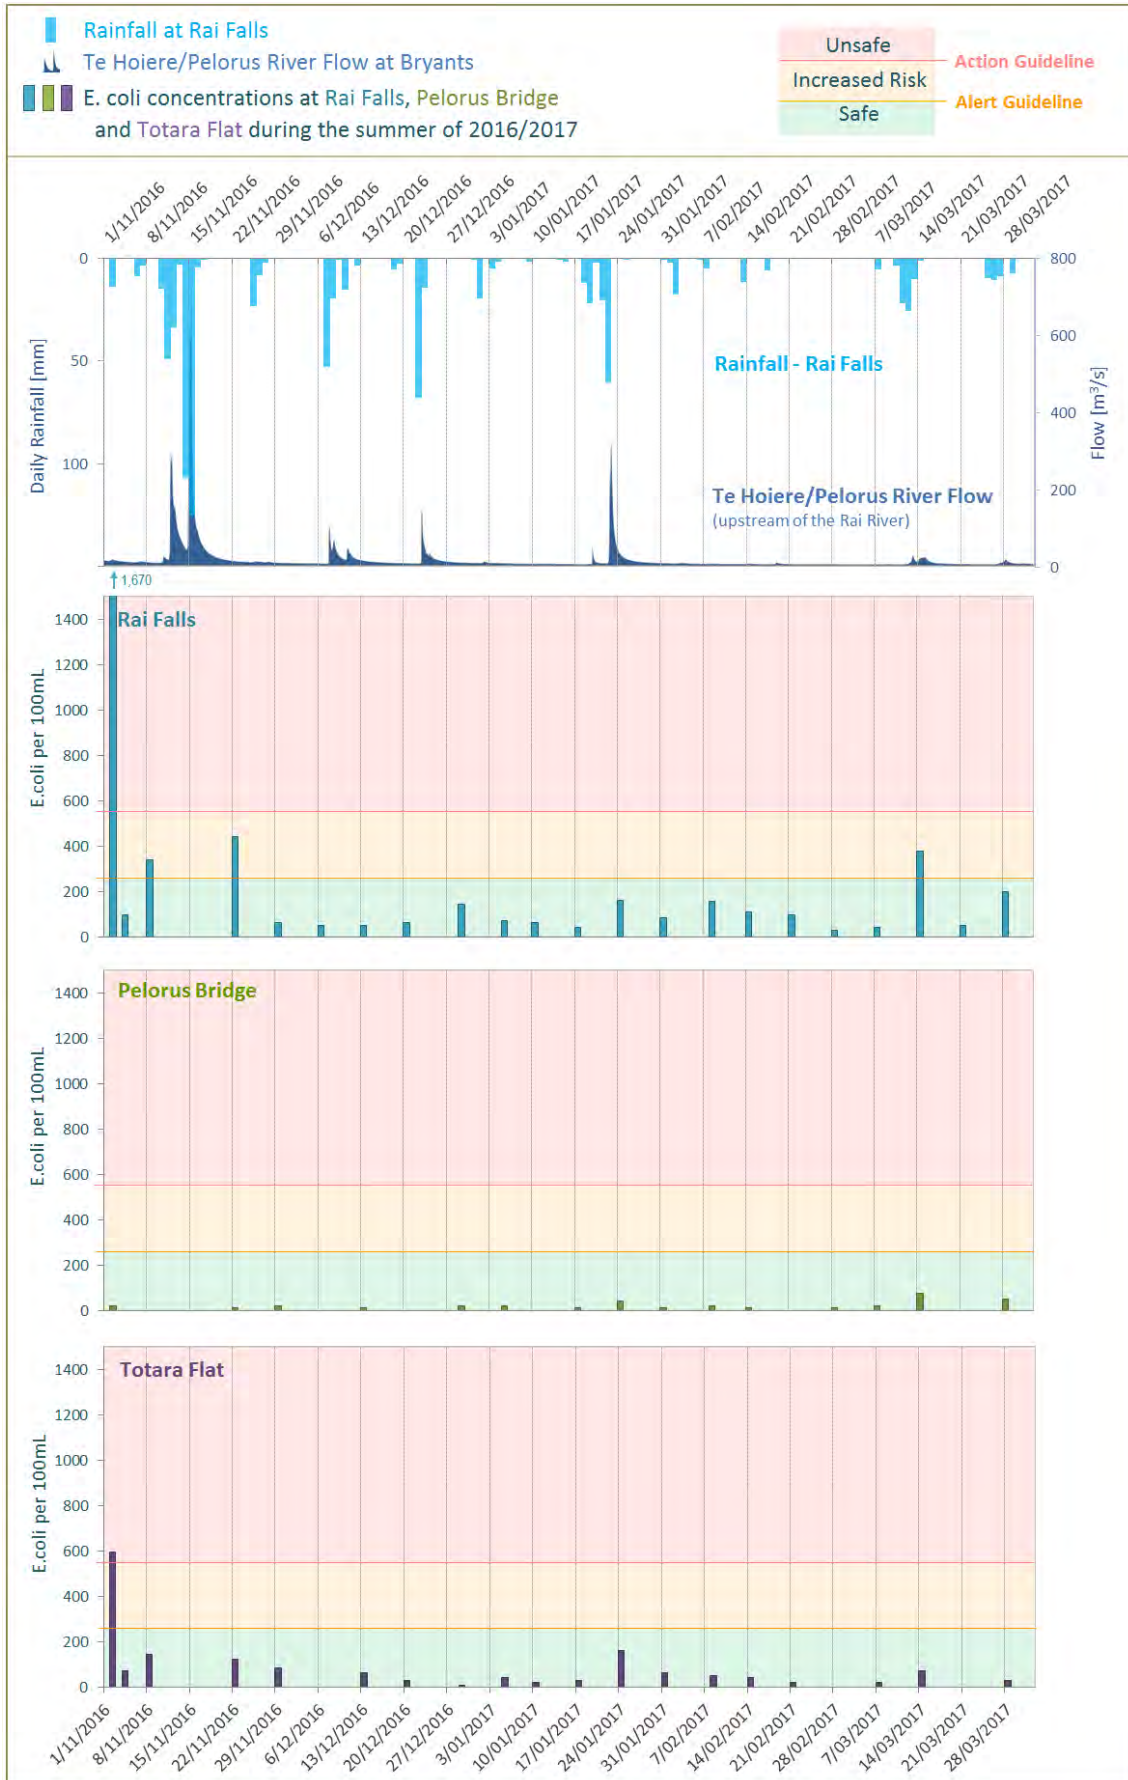
Figure 23: E. coli concentrations in the Rai and Te Hoiere/Pelorus River in the 2016/17 summer.

A rain event that was most intense in the Rai River catchment caused the only exceedances of the Action Guideline for the Rai River at Rai Falls and Te Hoiere/Pelorus River at Totara Flat this sampling season (Figure 23).

No samples were taken during heavy rainfall in mid-November shortly after the “Kaikoura Earthquake”. Damage to roads and other infrastructure meant that no recreational water quality samples were taken in the weeks following the earthquake. The rainfall event caused significant flooding and it could be expected that *E. coli* concentrations were very high, but it is unlikely that persons were swimming in the river at the time.

As in other years, *E. coli* concentrations were generally highest in the Rai River and lowest in the Te Hoiere/Pelorus River at the Pelorus Bridge. This is reflected in the SFR Grades for the sites. The bacterial water quality of the Rai River at Rai Falls is graded ‘poor’, while the Te Hoiere/Pelorus River is graded ‘fair’ at Totara Flat and ‘good’ at the Pelorus Bridge.

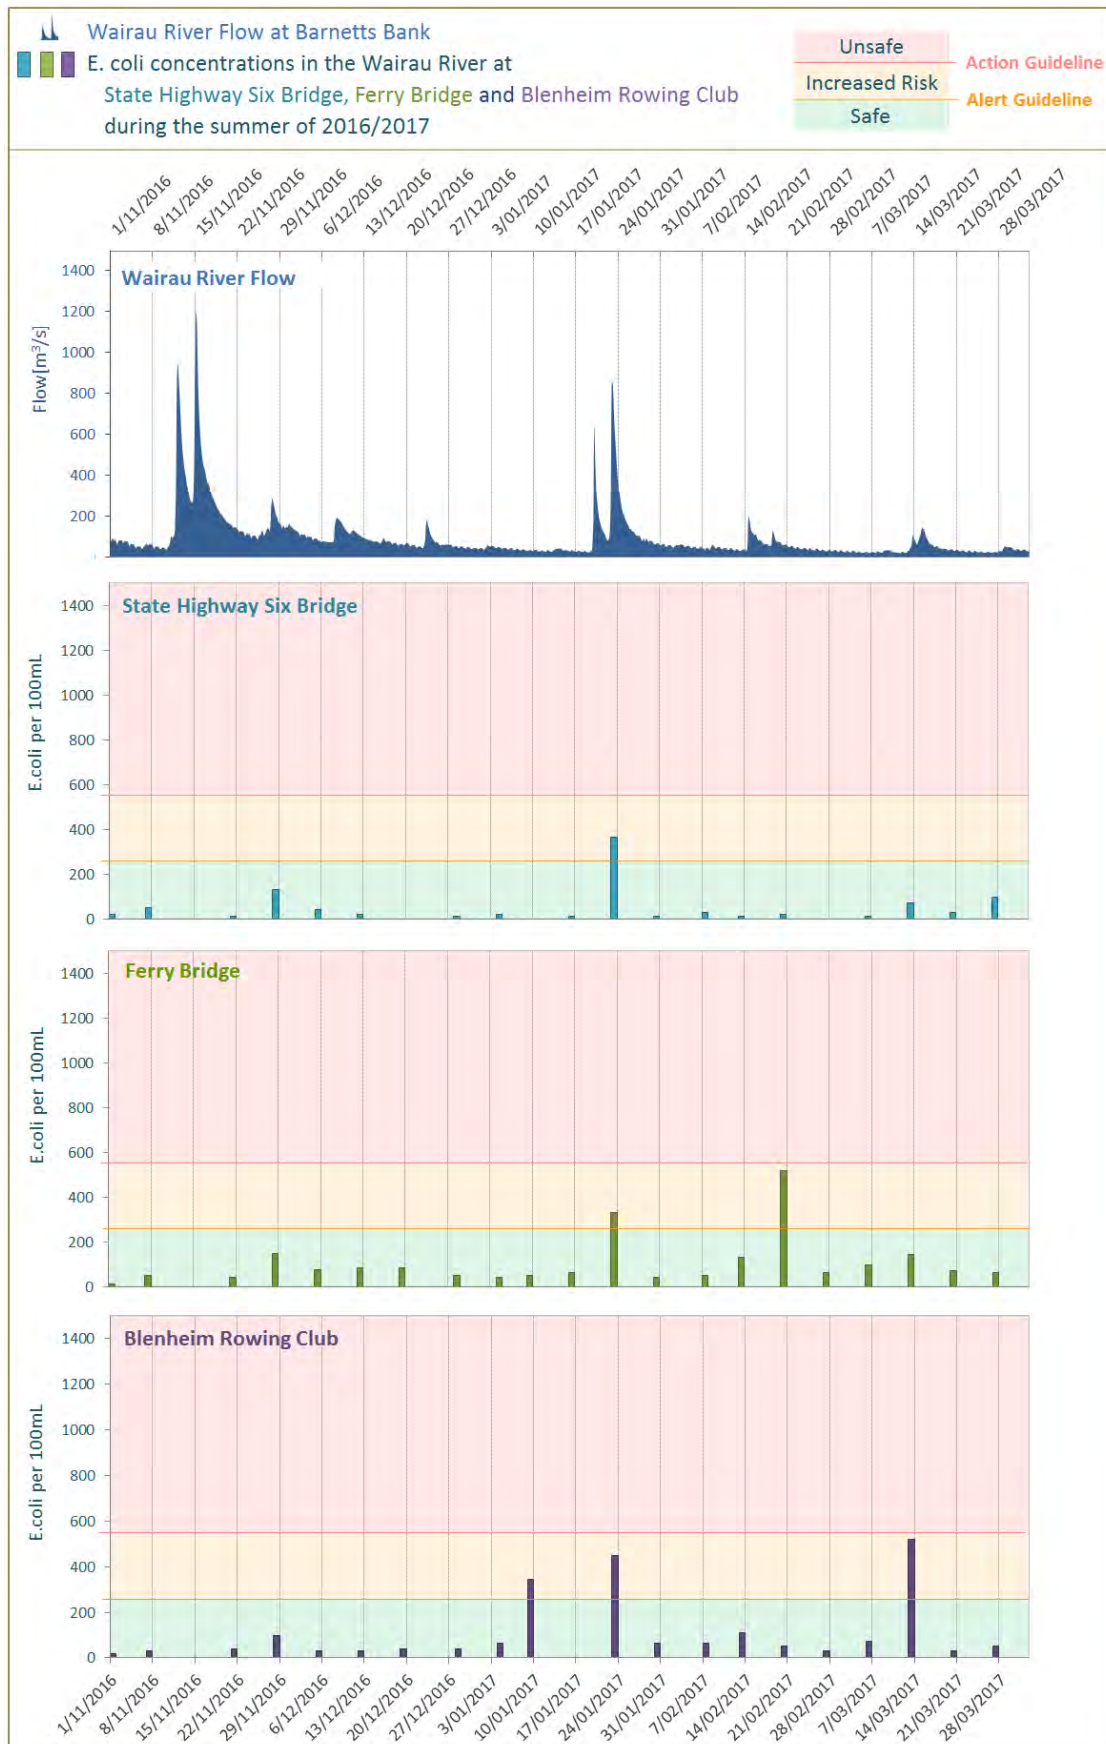
Figure 29: E. coli concentrations at the three Wairau River monitoring sites during the 2016/17 summer season.

None of the samples taken from the Wairau River this summer season had unsafe *E. coli* concentrations, however, as was noted in Section 5.7, no samples were taken during a large flood event following the “Kaikoura Earthquake” in November 2016. A number of samples had elevated *E. coli* concentrations above the Alert Guideline, but these were all associated with increased river flows or localised rainfall events. The highest number of guideline exceedances was recorded at the Blenheim Rowing Club. Field notes indicated that the water was either slightly turbid or turbid when the samples were taken, which means that there were visual clues for the degraded water quality at the time.

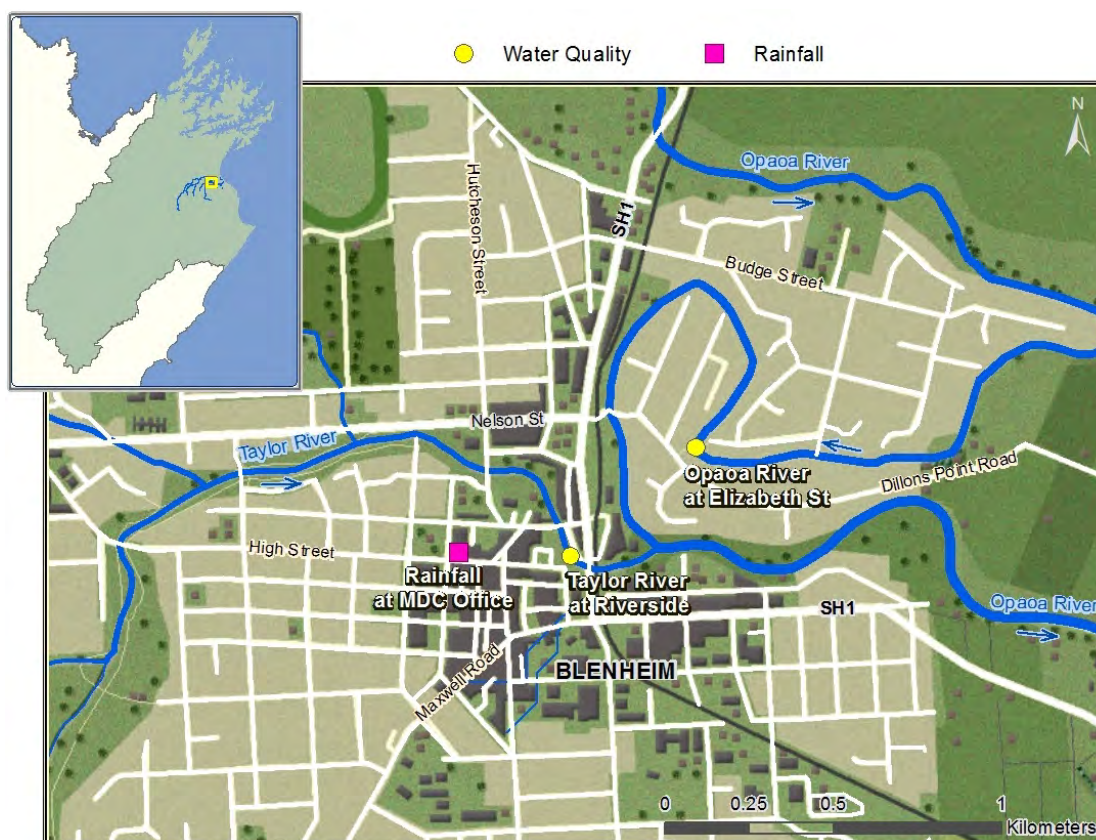
Figure 31: Location of the Taylor River and Ōpaoa River sampling sites as well as the Blenheim MDC rainfall recorder.

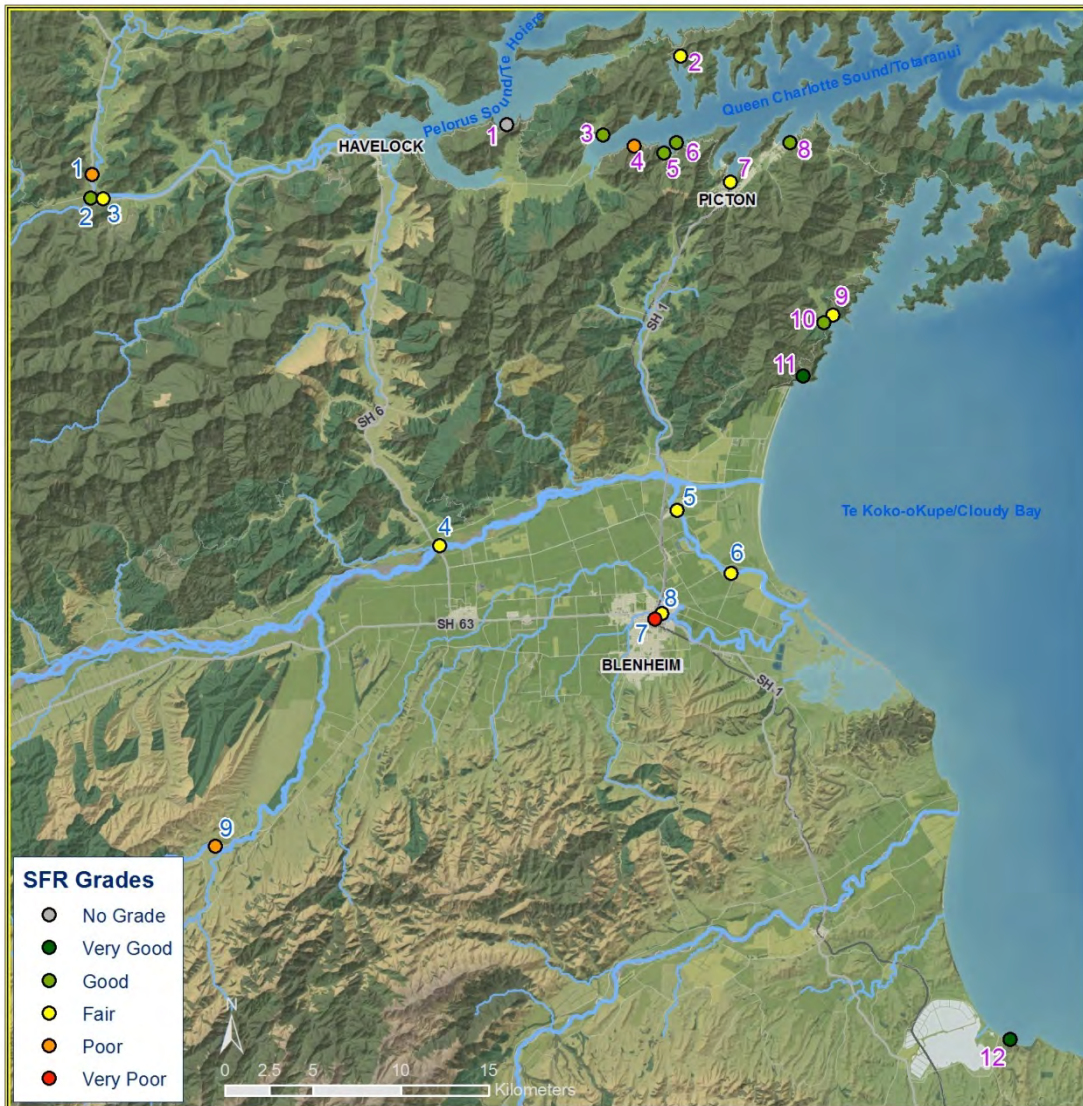
Type	No.	Site	Easting	Northing	SIC (Sanitary Inspection Category)	MAC (Microbiological Assessment)	SFR Grade (Suitability for Contact Recreation Grade)
Coastal Sites	1	Moetapu Bay	1671600	5432100		insufficient data	
	2	Mistletoe Bay	1681470	5436007	Moderate	C	Fair
	3	Anakiwa	1677073	5431495	Moderate	B	Good
	4	Momorangi Bay	1678817	5430879	Moderate	D	Poor
	5	Ngakuta Bay	1680514	5430489	Low	B	Good
	6	Governors Bay**	1681310	5431030	Low	B	Good
	7	Picton Foreshore	1684298	5428815	Moderate	C	Fair
	8	Waikawa Bay	1687695	5431090	Low	B	Good
	9	Waikutakuta/Robin Hood Bay East*	1690115	5421285	Low	B	Fair
	10	Waikutakuta/Robin Hood Bay West*	1689595	5420930	Low	C	Good
	11	Pukatea/Whites Bay	1688425	5417793	Very Low	A	Very Good
	12	Marfells Beach	1700194	5380089	Very Low	A	Very Good
River Sites	1	Rai Rv at Rai Falls	1648018	5429266	Moderate	D	Poor
	2	Te Hoiere/Pelorus Rv at Pelorus Bridge	1648077	5428091	Low	B	Good

3	Te Hoiere/Pelorus Rv at Totara Flat	1648262	5427731	Moderate	C	Fair
	4	Wairau Rv at State Highway Six*	1667780	5408150	Moderate	C	Fair
	5	Wairau Rv at Ferry Bridge	1681274	5410163	Moderate	C	Fair
	6	Wairau Rv at Blenheim Rowing Club	1684319	5406605	Moderate	C	Fair
	7	Taylor River at Riverside	1680023	5403987	High	D	Very Poor
	8	Ōpaoa River at Elizabeth St Bridge	1680393	5404310	Moderate	C	Fair
	9	Waihopai River at Craiglochart #2	1655029	5391098	Moderate	D	Poor

Figure 35: SFR Grades for the sites currently monitored.

Overall, the majority of sites currently monitored as part of the Recreational Water Quality program have a SFR Grade of “Fair”, with the second highest number of sites grades as “Good” or “Very Good” and only a few sites with SFR Grades of “Poor” or “Very Poor” (Figure 35).
