**MARLBOROUGH  
DISTRICT COUNCIL**

# Recreational Water Quality Report 2019-2020

**Technical Report No: 20-004  
May 2020**

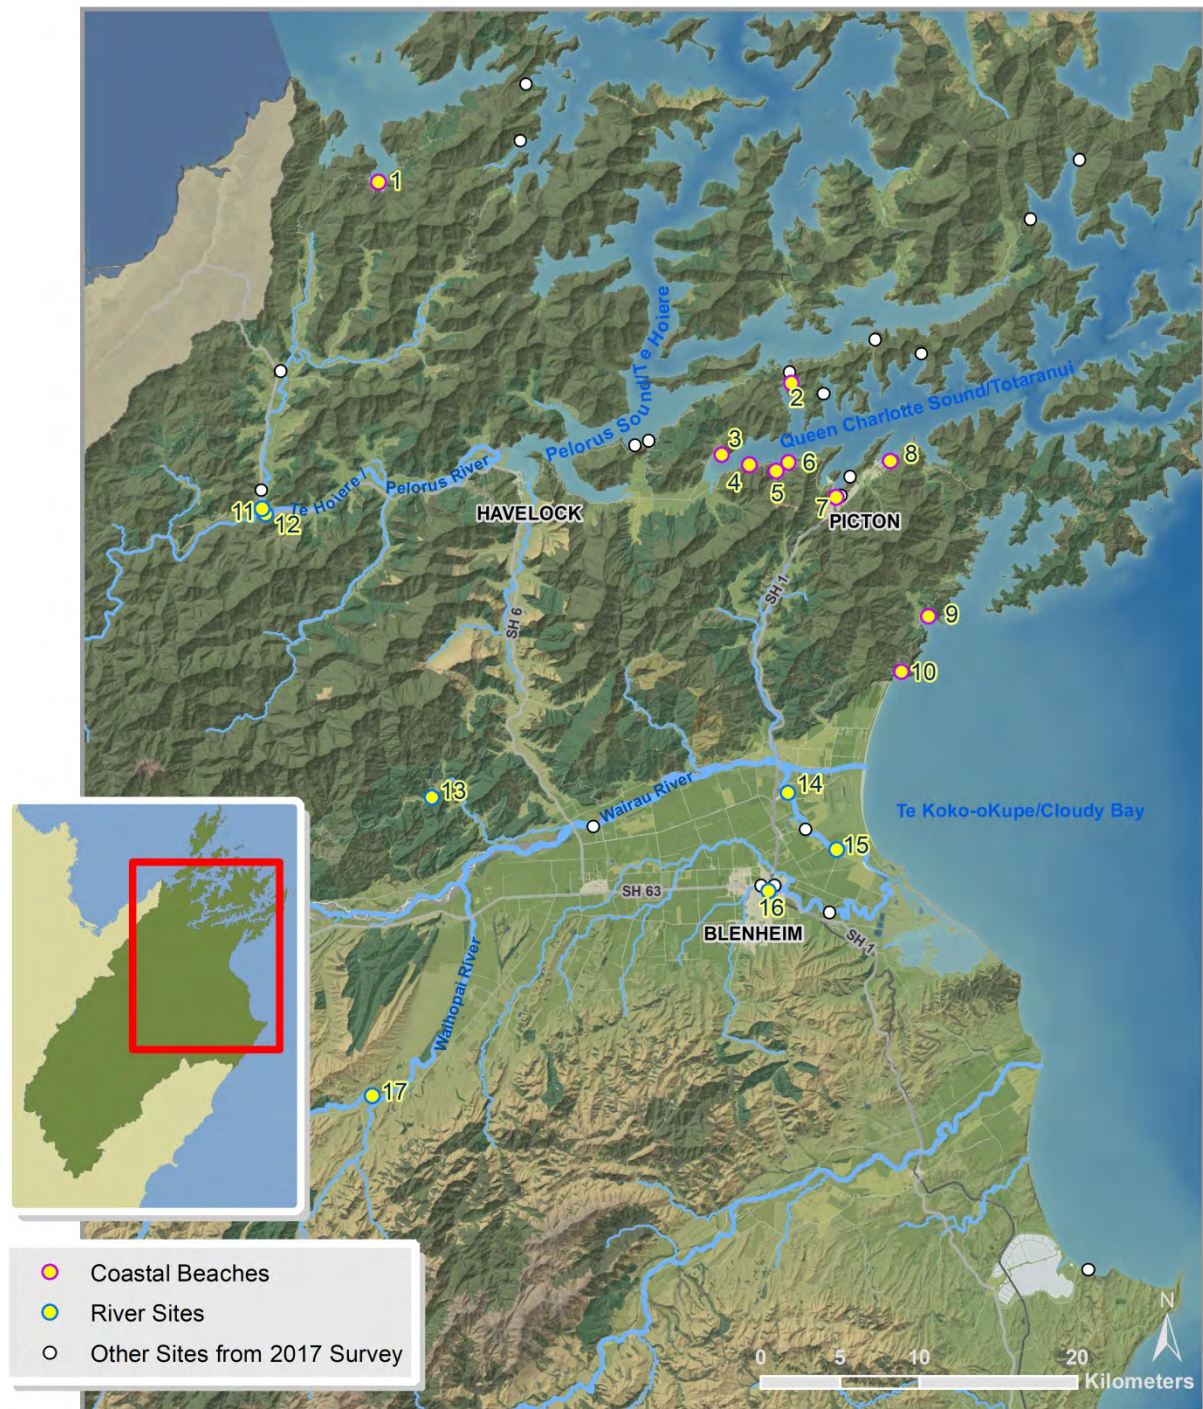
No.	Site	Easting	Northing
1	Okiwi Bay	1655355	5448685
2	Mistletoe Bay	1681470	5436007
3	Anakiwa	1677073	5431495
4	Momorang Bay	1678817	5430879
5	Ngakuta Bay	1680514	5430489
6	Governors Bay	1681310	5431030
7	Picton Foreshore	1684298	5428815
8	Waikawa Bay	1687695	5431090
9	Waikutakuta/Robin Hood Bay East	1690115	5421285
10	Pukatea/Whites Bay	1688425	5417793

No.	Site	Easting	Northing
11	Te Hoiere/Pelorus Rv at Pelorus Bridge	1648077	5428091
12	Te Hoiere/Pelorus Rv at Totara Flat	1648262	5427731
13	Ohinemahuta Rv at Onamalutu Domain	1658791	5409896
14	Wairau Rv at Ferry Bridge	1681274	5410163
15	Wairau Rv at Blenheim Rowing Club	1684319	5406605
16	Taylor River at Riverside	1680023	5403987
17	Waihopai River at Craiglochart #2	1655029	5391098

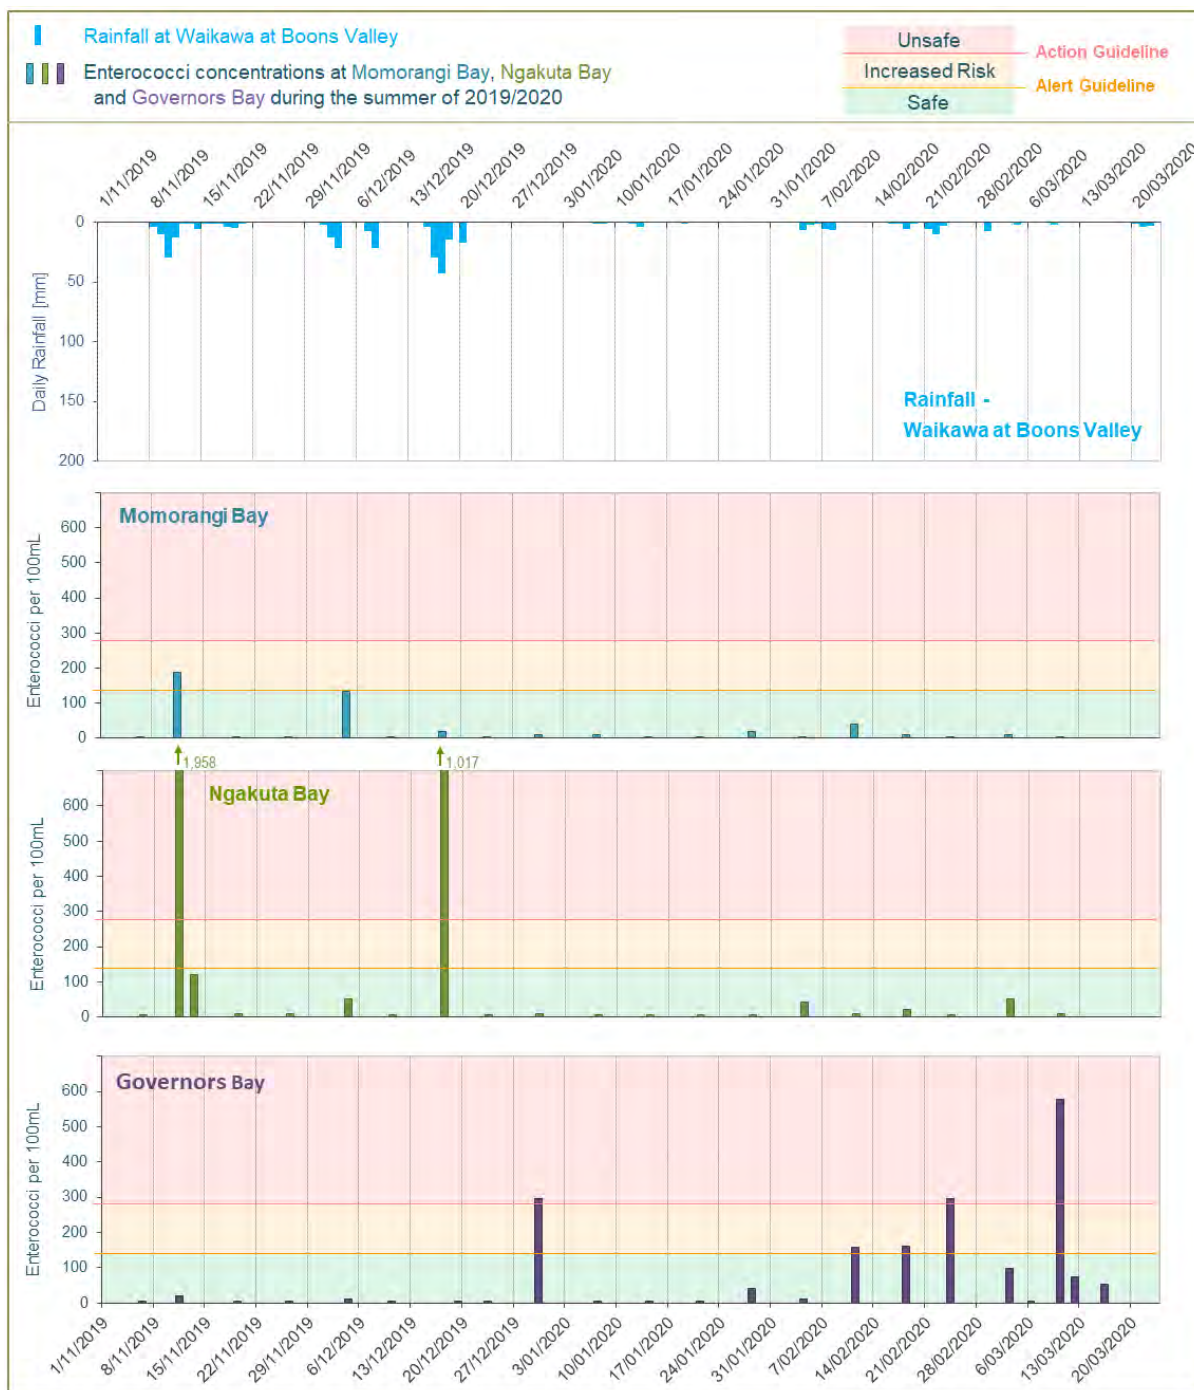
**Figure 7: Enterococci concentrations at Momorangi Bay, Ngakuta Bay and Governors Bay during the 2019/20 summer season.**

High Enterococci concentrations in Momorangi and Ngakuta Bay were observed only as a result of rainfall (Figure 7). However, bacteria concentrations were significantly higher in Ngakuta Bay. Visitor numbers during the height of summer were likely similar in both bays. The difference lies in the way human waste is dealt with. Momorangi Bay has a community sewage treatment system. After some problems in 2015 and 2016, the Department of Conservation invested in upgrades and repairs. This work resulted in a significant improvement in water quality. Batches and homes in Ngakuta Bay have individual sewage treatment systems. Overflowing septic tanks are therefore a possible reason for the much higher bacteria concentration observed during rainfall. Additional samples taken this summer

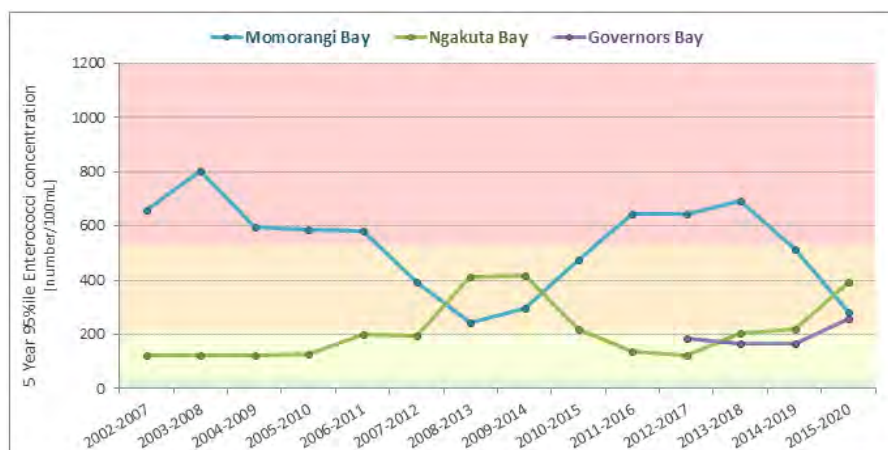
Figure 9: The 5-year 95%ile Enterococci concentrations for Momorangi Bay, Ngakuta Bay and Governors Bay.

The long-term trends show increasing Enterococci concentrations for Ngakuta Bay and Governors Bay. For Governors Bay, this has resulted in a change from an SFR Grade of Good to a Grade of Fair. The SFR Grade of Ngakuta Bay remains unchanged as Fair. Momorangi Bay is also graded Fair, however, for this bay the long-term trend is showing improving water quality.

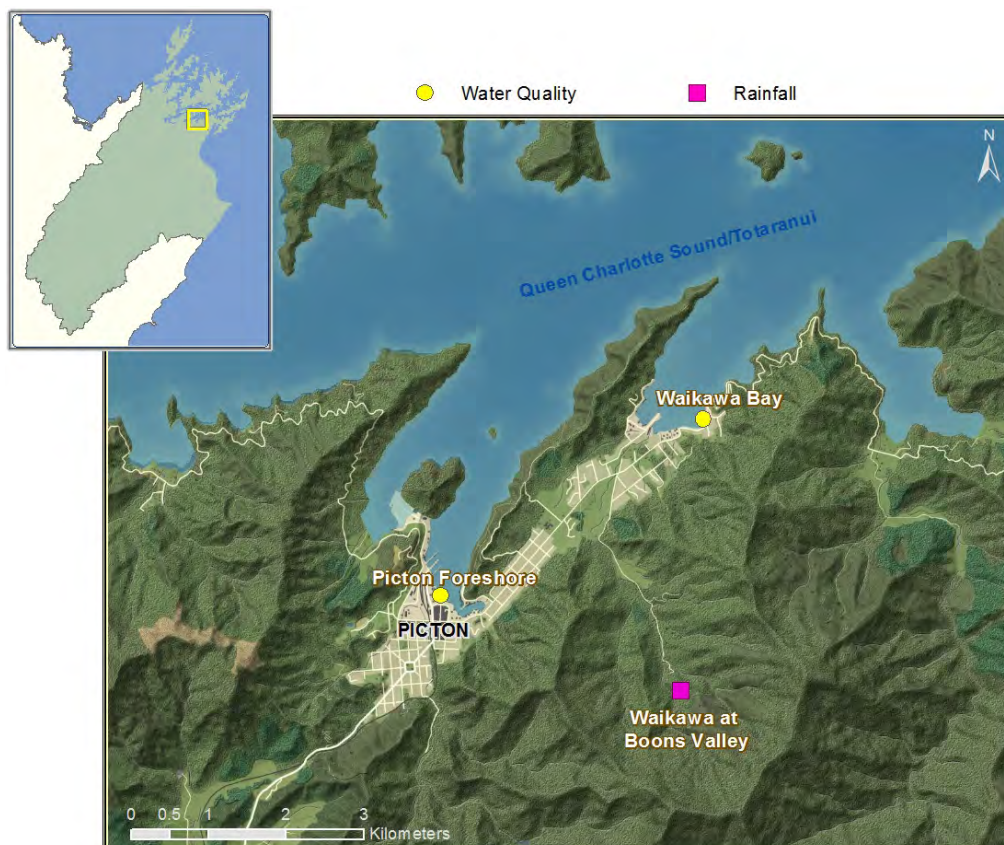
**Figure 10: Locations of the Picton Foreshore and Waikawa Bay sampling sites as well as the rainfall recorder at Boons Valley.**

The water quality of the Picton Foreshore and Waikawa Bay are both influenced by the urban environment that surrounds these sites. The substantially greater amount of residential development influencing the Picton Foreshore is reflected in generally poorer water quality.

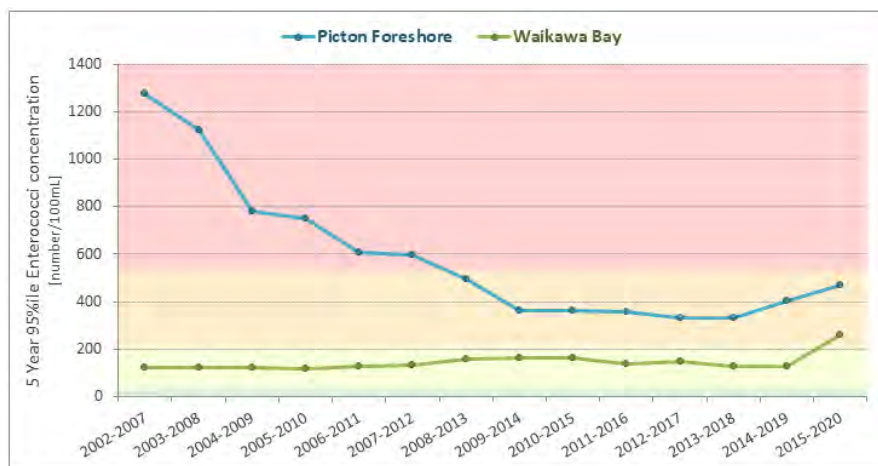
Figure 12: The 5-year 95%ile Enterococci concentrations for Picton Foreshore and Waikawa.

The long-term trends show an increase in Enterococci concentrations for both sites. The greater number of samples taken during rainfall this summer is the likely cause for this. It is only of concern should the upward trend continue in the following seasons.

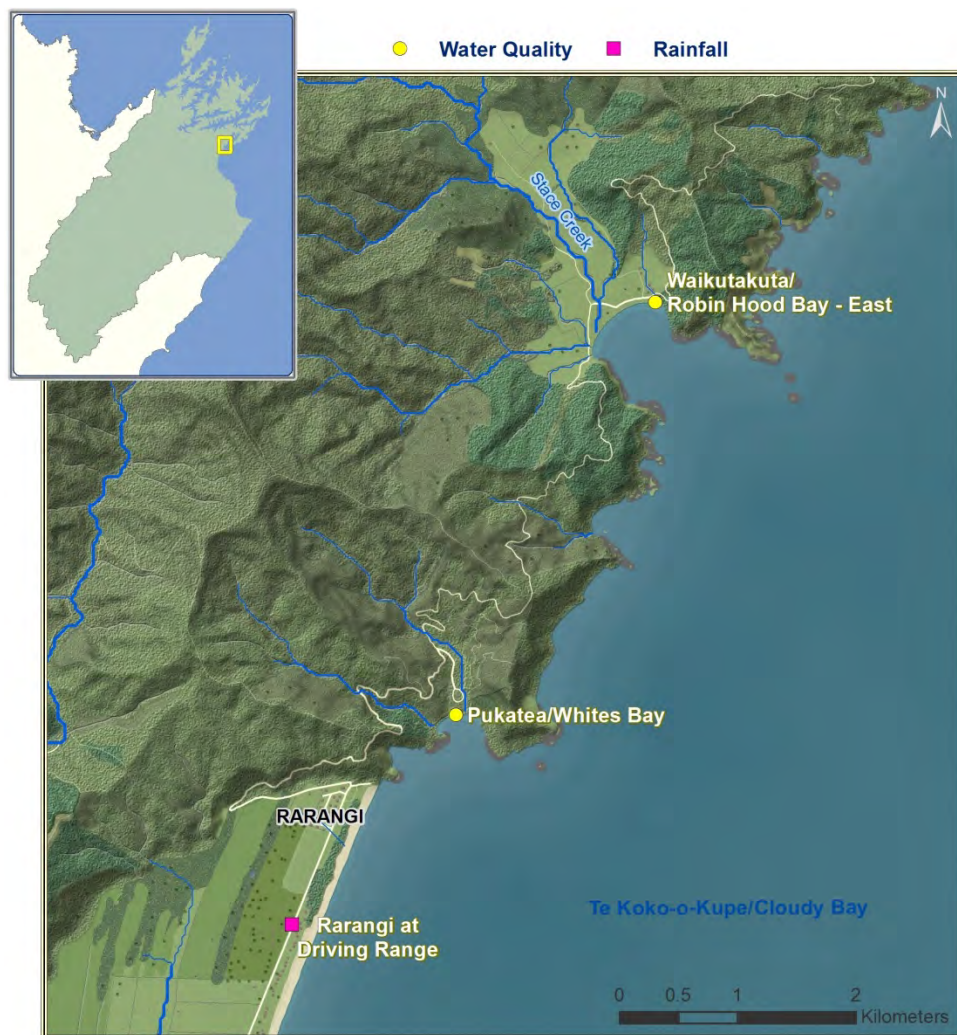
Figure 13: Locations of the Pukatea/Whites Bay and the Waikutakuta/Robin Hood Bay East sampling sites, as well as the Rarangi rainfall recorder.

Pukatea/Whites Bay and Waikutakuta/Robin Hood Bay are located on the upper East Coast of the region. Pukatea/Whites Bay is one of the most popular beaches in Marlborough. A Department of Conservation campground is the only human influence in the bay and consequently water quality is generally very good. Waikutakuta/Robin Hood Bay, located only a few kilometres north of Pukatea/Whites Bay also offers a campground, but has a much larger catchment. Several streams flow into the bay. The largest, Stace Creek, drains 90ha of pasture, which has a potential to affect the water quality in the bay. Waikutakuta/Robin Hood Bay is sampled at the swimming beach on the North-East side of the bay, which is also used to launch boats.

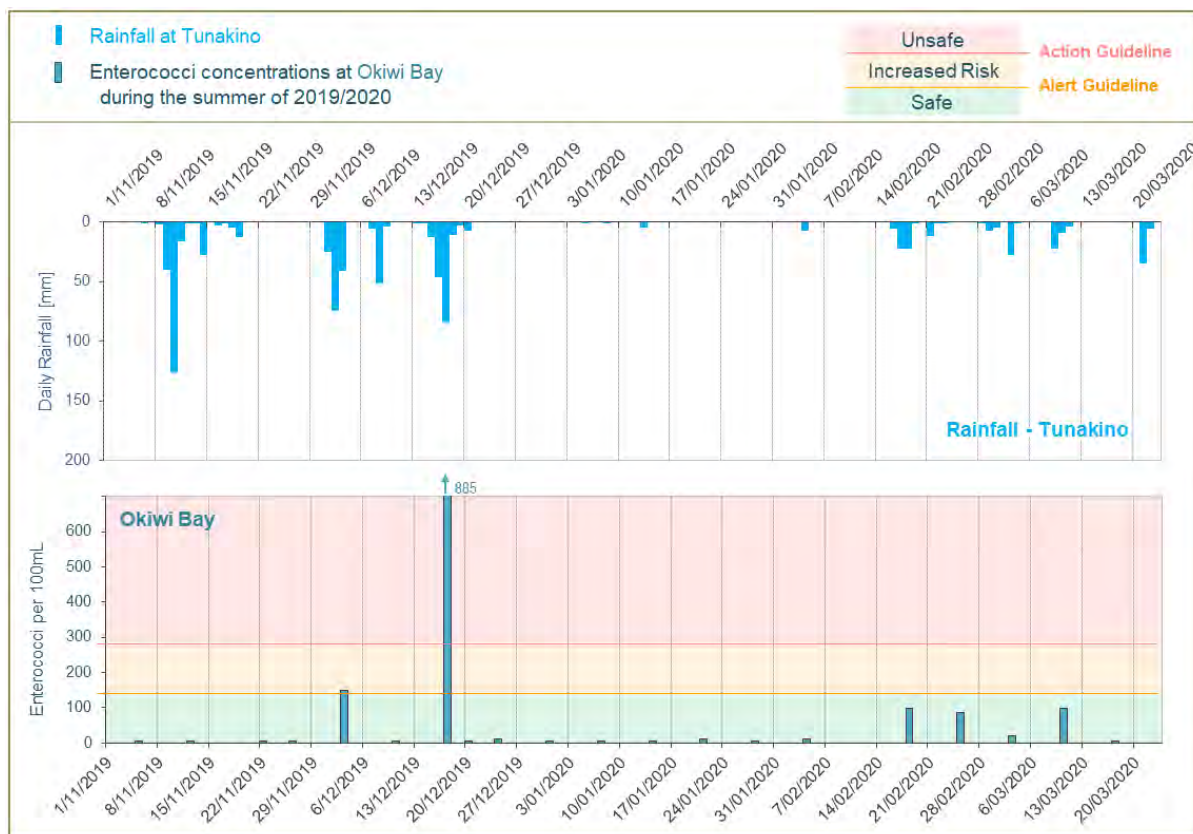
Figure 17: Enterococci concentrations at Okiwi Bay over the 2019/20 summer season.

Elevated Enterococci concentrations in Okiwi Bay were exclusively associated with rainfall. The highest bacteria concentration was observed in December. The sample was taken during several days of rain. More than 150mm of rainfall were recorded at the nearby Tunakino recorder. A follow-up sample taken two days later showed that Enterococci concentrations had returned to safe levels. Okiwi Bay has only recently been added to the programme. This means that we do not yet have sufficient data to assign a SFR Grade to this site. However, based on this season's results the site would likely be graded as Good or Fair.

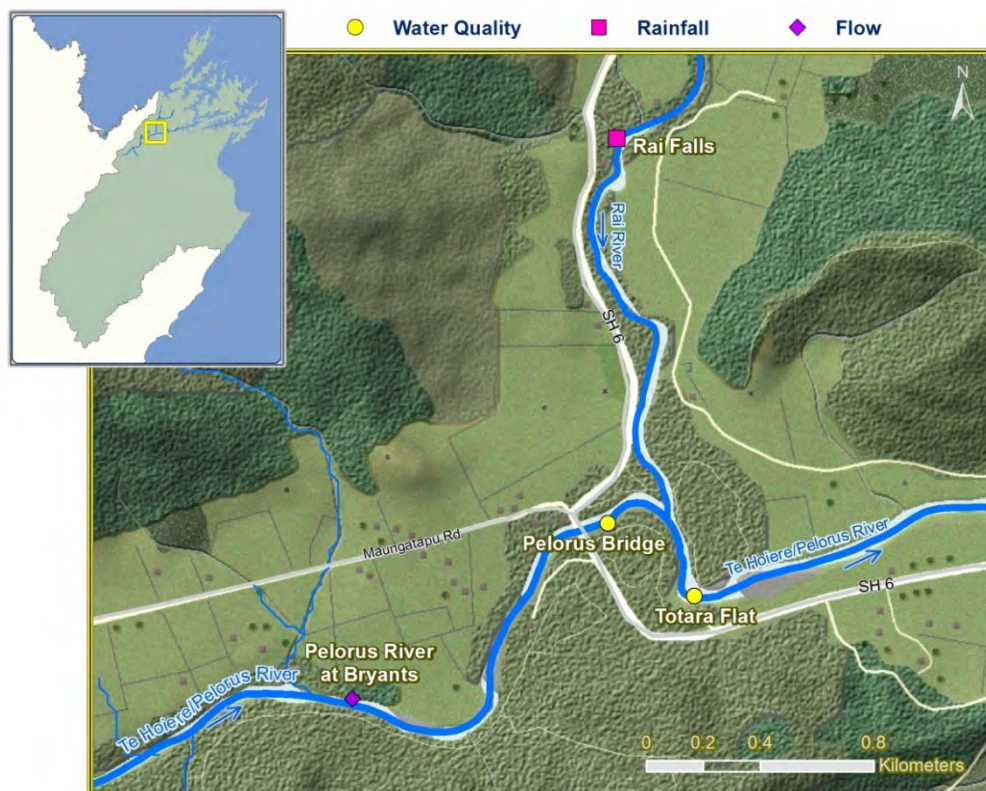
**Figure 18: Locations of the Te Hoiere/Pelorus River sampling sites as well as nearby rainfall and flow recorders.**

The Te Hoiere/Pelorus River has two popular swimming sites that are sampled as part of the Recreational Water Quality programme, Pelorus Bridge and Totara Flat. Pelorus Bridge is the most popular river site in the region for both, local residents and visitors. The large proportion of native vegetation upstream also means that it has the best water quality of all river sites monitored.

The Rai River drains one of the main dairy catchments of the region. It flows into the Te Hoiere/Pelorus River between the two sampling sites, approximately 300m upstream of Totara Flat. Subsequently, water quality at Totara Flat is strongly influenced by the water quality of the Rai River.

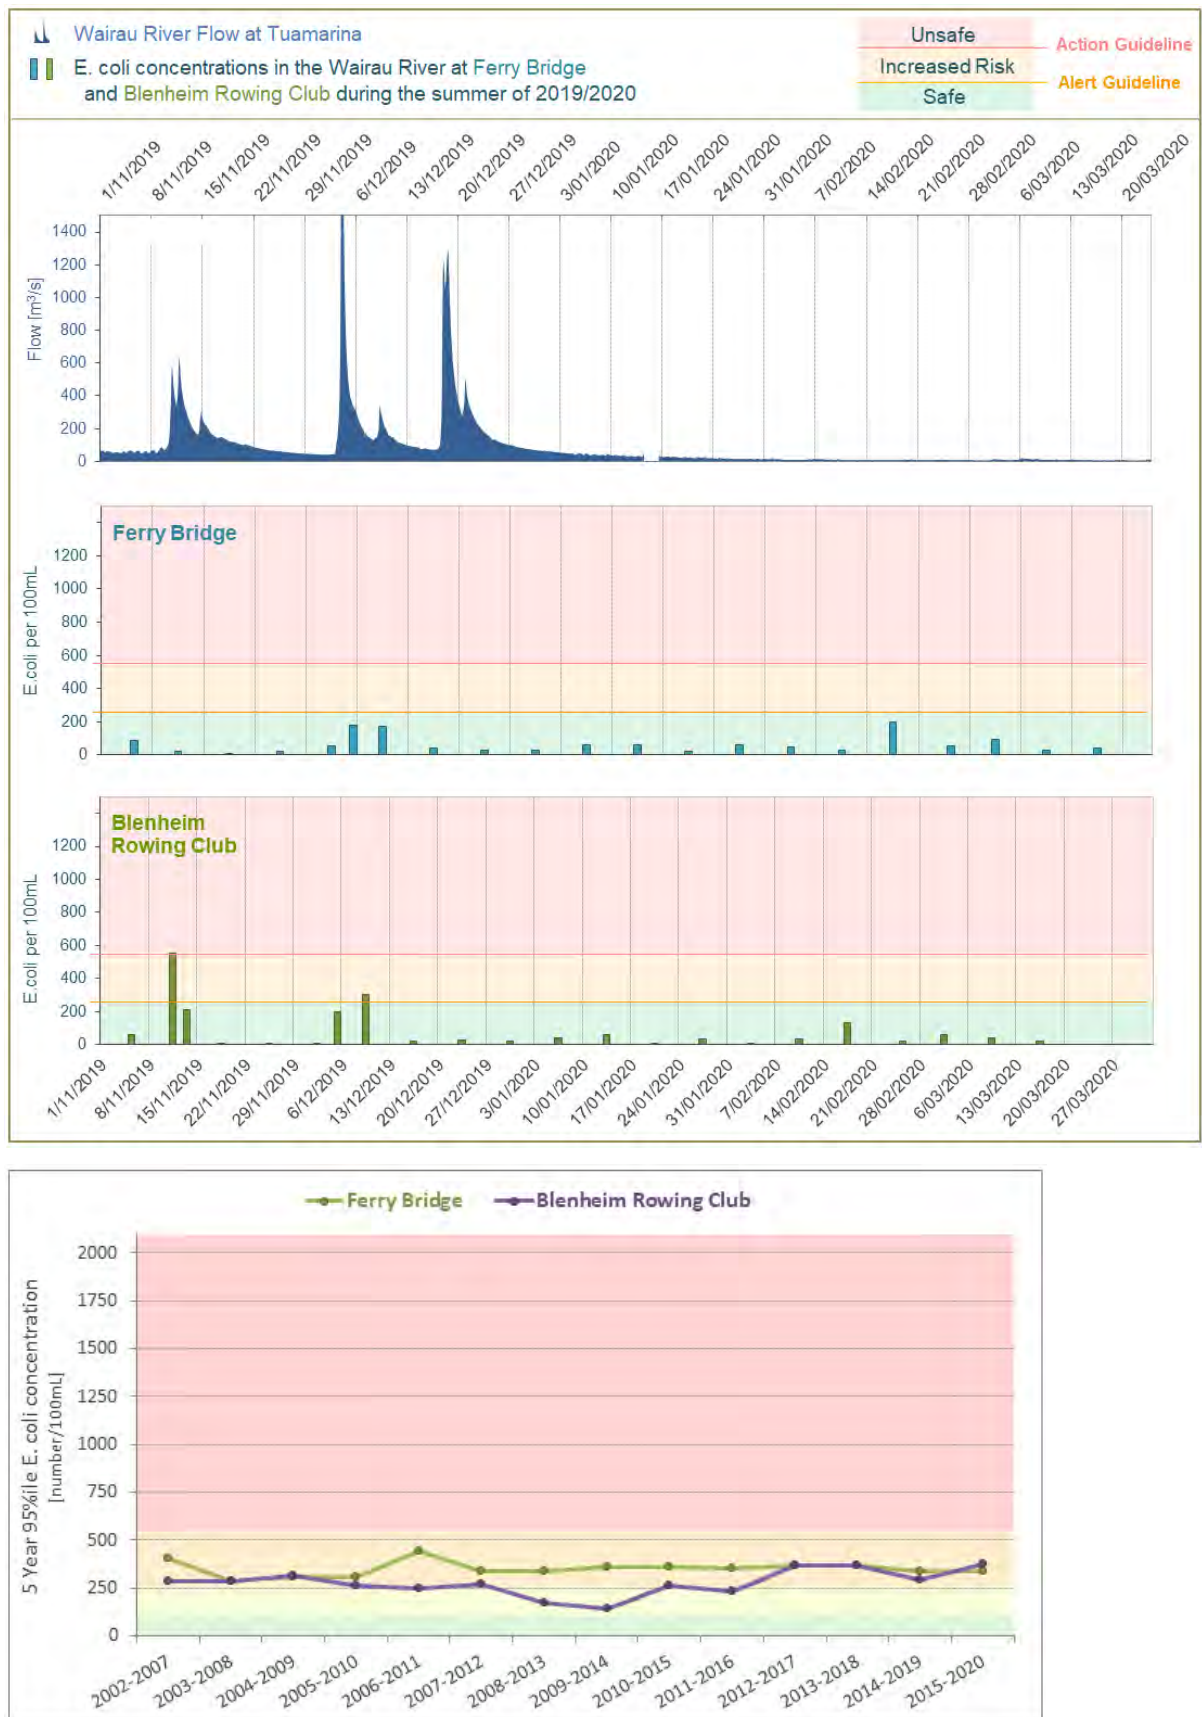
Figure 25: TOP: E. coli concentrations in the Wairau River at Ferry Bridge and the Blenheim Rowing Club during the 2019/20 summer; BOTTOM: The 5-year 95%ile E.coli concentrations for the two sites.

The long-term trends show that recreational water quality at the Ferry Bridge remained unchanged, but has been more variable at the Blenheim Rowing Club. For several years, faecal bacteria levels were lower at the Blenheim Rowing Club. In recent years, however, *E. coli* concentrations have slowly increased. The start of the increase coincides with the Seddon Earthquake in 2013. There was noticeable damage to the land along the river at the time. It is possible that there was also damage to nearby private sewage treatment systems. Sources from all parts of the catchment that receive rainfall contribute to the bacterial load during high flows. It is therefore difficult to distinguish local sources of faecal contamination. Nevertheless, should *E. coli* concentrations at the Blenheim Rowing Club further increase, an investigation into local sources needs to be initiated. Both sites now have a SFR Grade of Fair.

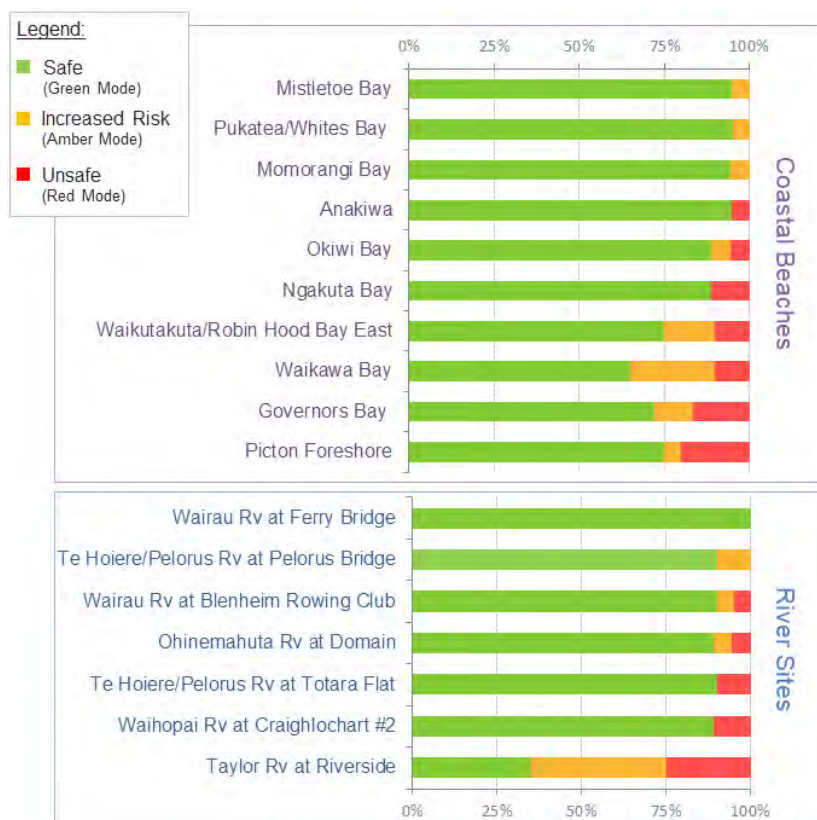
**Figure 32: Percentage of routine samples within the different Modes for all sites sample during the 2019/20 summers season.**
