**Marine Farm Lighting and Marking Plan –  
MPE763, MFL446, U040217 (Site no.8396)**

### Marine Farm Inspections – Otanerau Bay

Marine Farm Site 8396 the resource consent of which is registered to NZ King Salmon Co Ltd was inspected for compliance on 30<sup>th</sup> August 2012 at 1555. Below is a table that shows the lights, and marking required for this site and compares that with what is currently on the site.

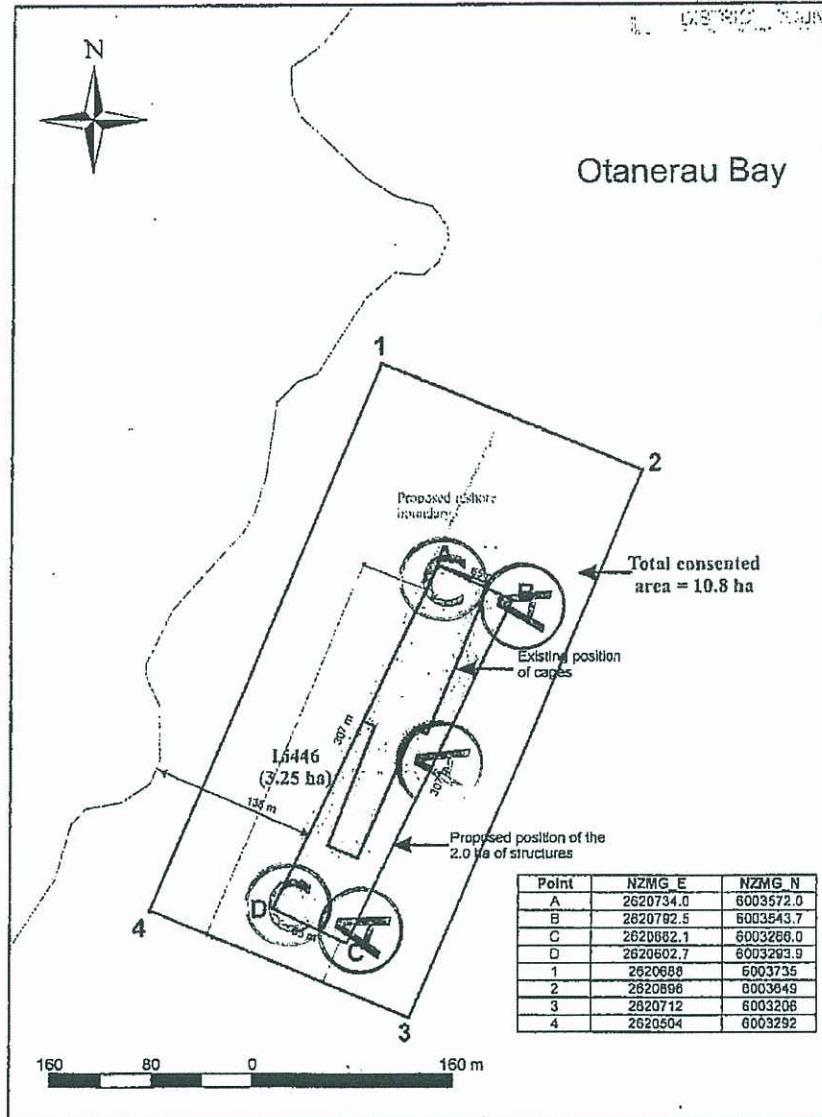
Structures and lighting plan:

1. That each end of each longline display an orange buoy, as shall the middle of each of the seawardmost and landwardmost longlines.
2. That a yellow light, radar reflector and a band of reflective tape 50 millimetres in width be displayed in the positions marked 'A' on the attached structures plan. The lights shall be solar powered and shall have the following characteristics:

3. That radar reflectors and a band of reflective tape 50 millimetres in width be displayed in the positions marked 'B' on the attached structures plan.
4. That a band of reflective tape 50 millimetres in width be displayed in the positions marked 'C' on the attached structures plan.

Figure 1: Proposed layout of the Otanerau Bay salmon farm (2.0), showing the present position of the farm.
