The Microbiological Quality of Marlborough Freshwater Recreational Sites

2005-2006

May 2006

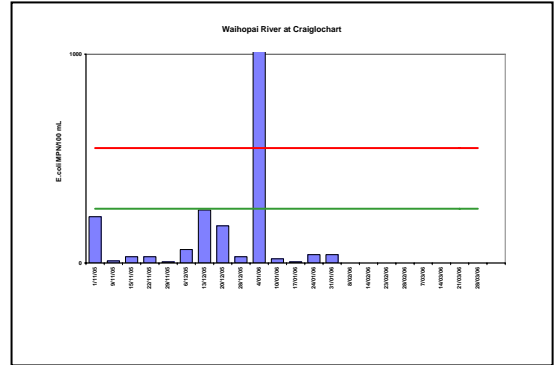
Waihopai River at Craighlochart

Result charts are shown in **Appendix 1** with site details. The charts show the date of each sampling event and the number of E.coli bacteria compared to the alert (>260<550) and action (>550) mode guideline values.

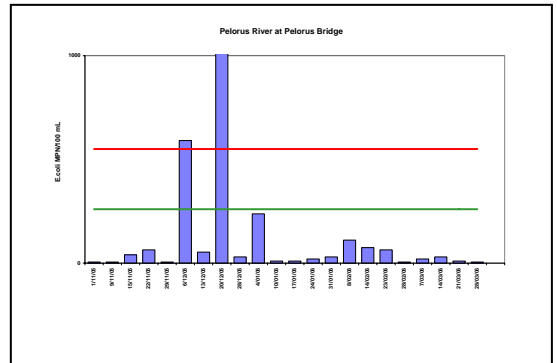
Pelorus River at Pelorus Bridge

The water quality of the Rai and Pelorus River sites was generally very good, with some high results associated with rain events. However, the Rai River at the Falls failed to meet the guideline for four of the 22 sampling events (18%).

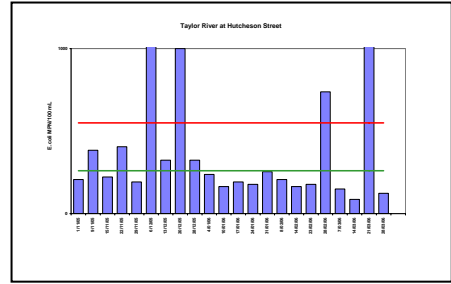
Taylor River at Hutcheson Street

This summer the Taylor and Opawa Rivers had the poorest water quality, with Hutcheson Street Bridge and Riverside failing to meet the guideline for 18% and 14% of the sampling events respectively. Rain appears to cause an increase in bacteria numbers at these two sites. However high results occur at times when there is no effect from rain.

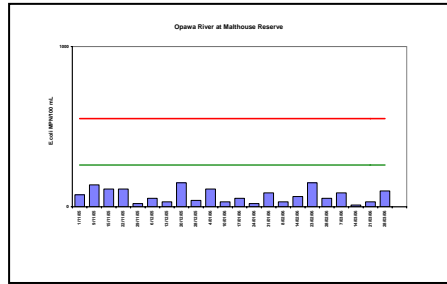
The Opawa at Malthouse site showed a great improvement in water quality, with all of the sampling results complying with the guideline. Remedial work was carried out on septic tanks discharging above this site at the end of last summer. This has resulted in no further discharges of domestic wastewater and a great improvement in the water quality.

The Opawa River at Malthouse Reserve has been re-graded to low, following remedial works to septic tanks above the site. The health risk factor has been reduced, and this season's monitoring results have all been below the guideline.

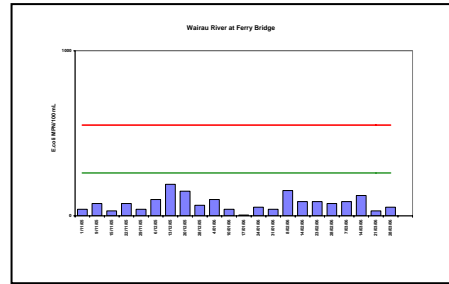
Wairau River at Ferry Bridge

Water quality in the Wairau River and Diversion was very good. There was one exceedence at both the rowing club sites, with none at the Ferry Bridge site, or at the Wairau Diversion site. The Wairau sites have previously been allocated "poor" and "very poor" suitability for recreation grades. The water quality results for 2005-2006 suggest it would be timely to reassess the catchment surveys and recalculate the suitability for recreation grades.
