**MARLBOROUGH
DISTRICT COUNCIL**

Surface Water Quality Monitoring Report, 2016

**Technical Report No: 16-006
October 2016**

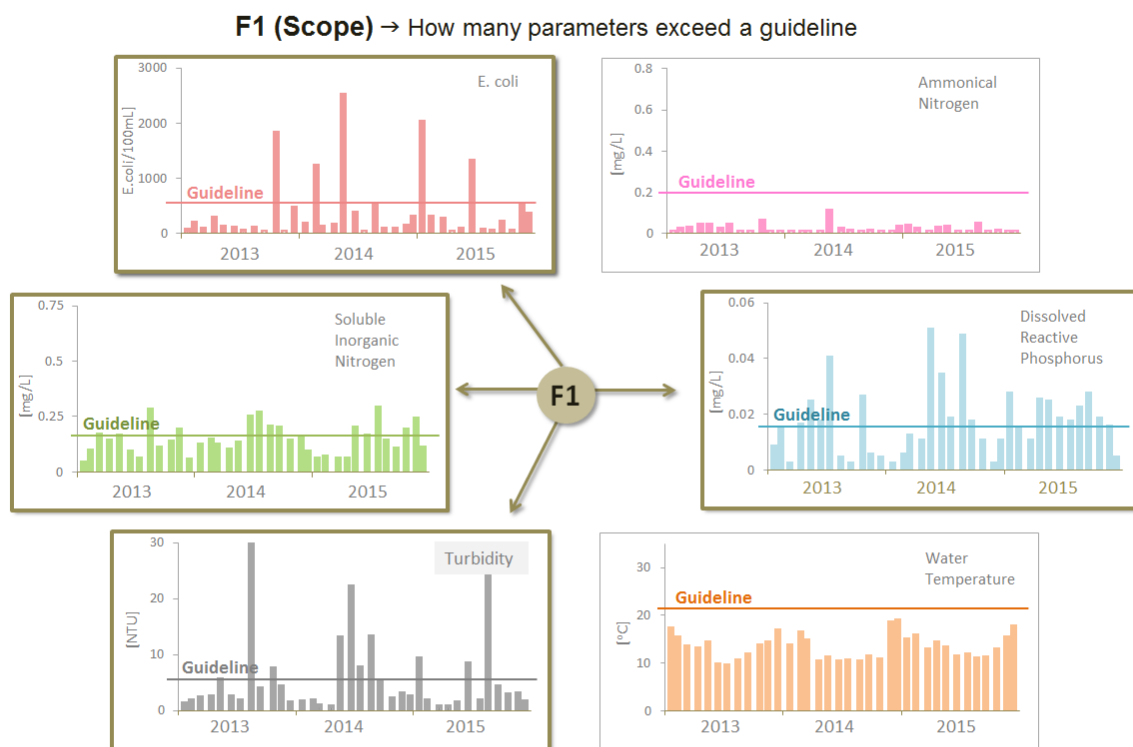
Every measurement that exceeds a guideline reduces the score in three parts, called 'Factors' (F1, F2 and F3). What these Factors represent is shown below.

F2 and F3 are parameter specific:

Figure 3: The Factors of the Water Quality Index calculation.

The formulas for the calculation of the Factors can be found in the Appendix.

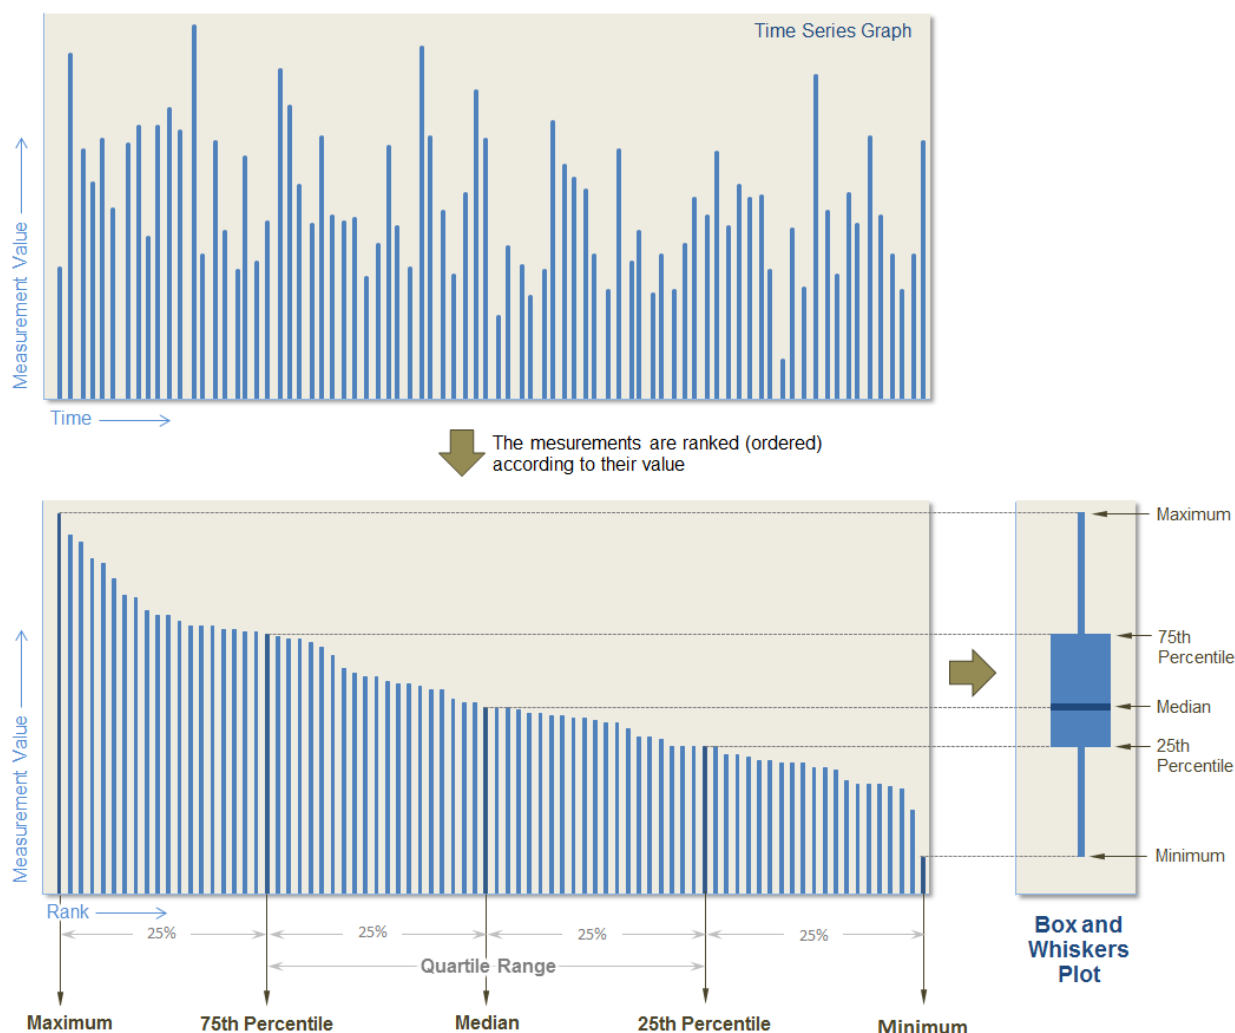
Figure 5: How Box and Whiskers Plots are created.

As in the previous annual reports, the Marlborough region has been divided into seven sub-regions (Figure 4). This reduces the number of sites that will be reported on at once, but also allows the comparison of sites with similar rainfall and flow patterns. The results for each sub-region are presented in a separate section. These sections start with a map of the sub-region and a summary table outlining some of the site and catchment characteristics. This is followed by a large figure with a number of graphs. This figure has three parts. The top shows the Water Quality Index for each site together with the contribution of individual parameters to the reduction of the Index. Below that is a bar graph showing the parameter contributions based on the parameter specific factors, F2 and F3, only (excluding F1). This provides a better representation of the actual contribution of individual parameters to the deterioration in water quality. The lower half of the figure shows the parameter results as box and whiskers plots. These plots are a great way of showing the distribution of parameter values. Figure 5 explains how box and whiskers plots are created.

The main intention of the figure is to show patterns, distributions and relative differences. The actual numerical result values for the water quality indices and statistics, such as the Median, Percentile values and Maxima can be found in Appendices 6.5 and 6.6. Individual sampling results for most parameters can be downloaded from the LAWA website (www.lawa.org.nz)

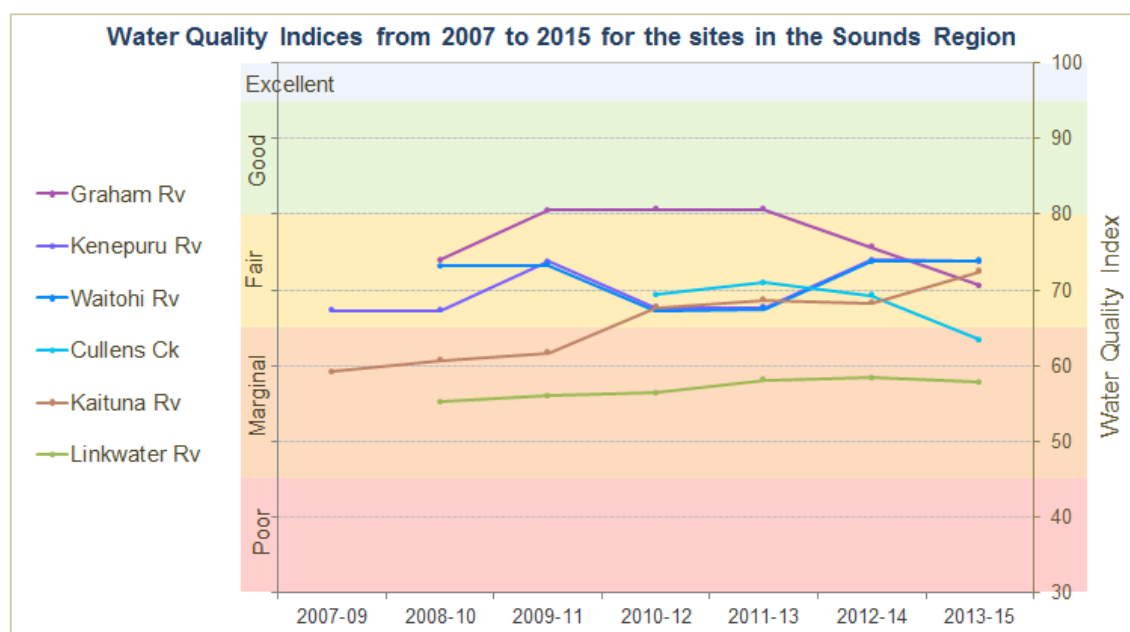
Figure 8: Change over time of the Water Quality Indices for the sites in the Sounds Region.

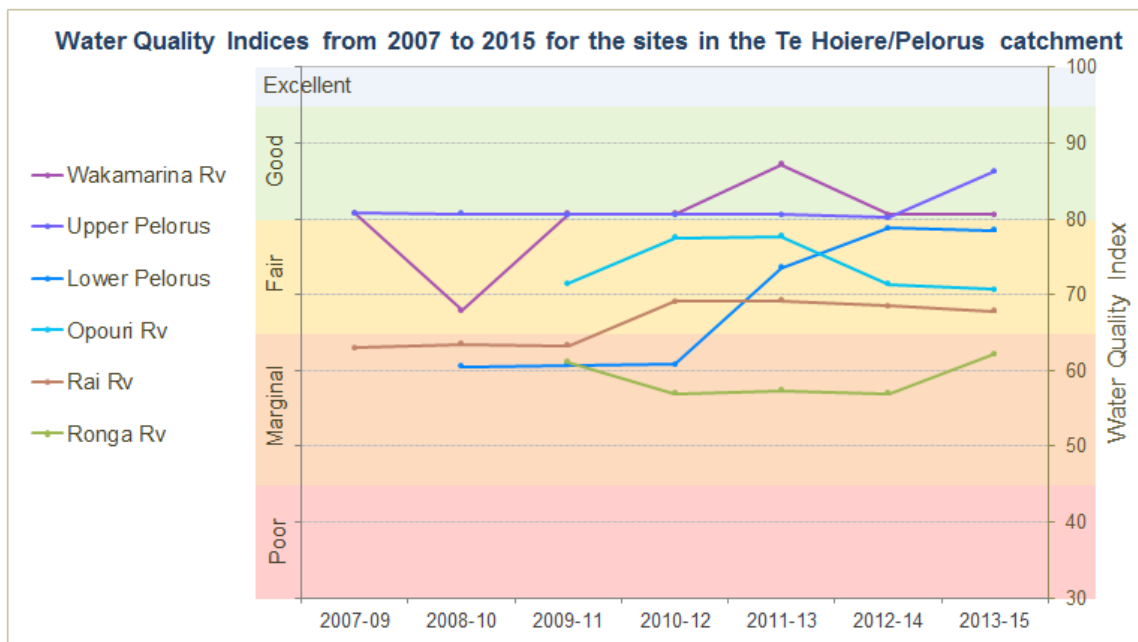
Figure 11: Change over time of the Water Quality Indices for the sites in the Te Hoiere/Pelorus catchment.

Water quality in the Ronga River has consistently been in the marginal category, while on the opposite end of the scale, the Upper Te Hoiere/Pelorus River has remained in the good category since monitoring began in 2007. The Wakamarina River has good water quality as well, but the Water Quality Index for this site is much more variable. This is caused by occasional exceedances of the guidelines for several parameters, including E. coli, turbidity and pH.

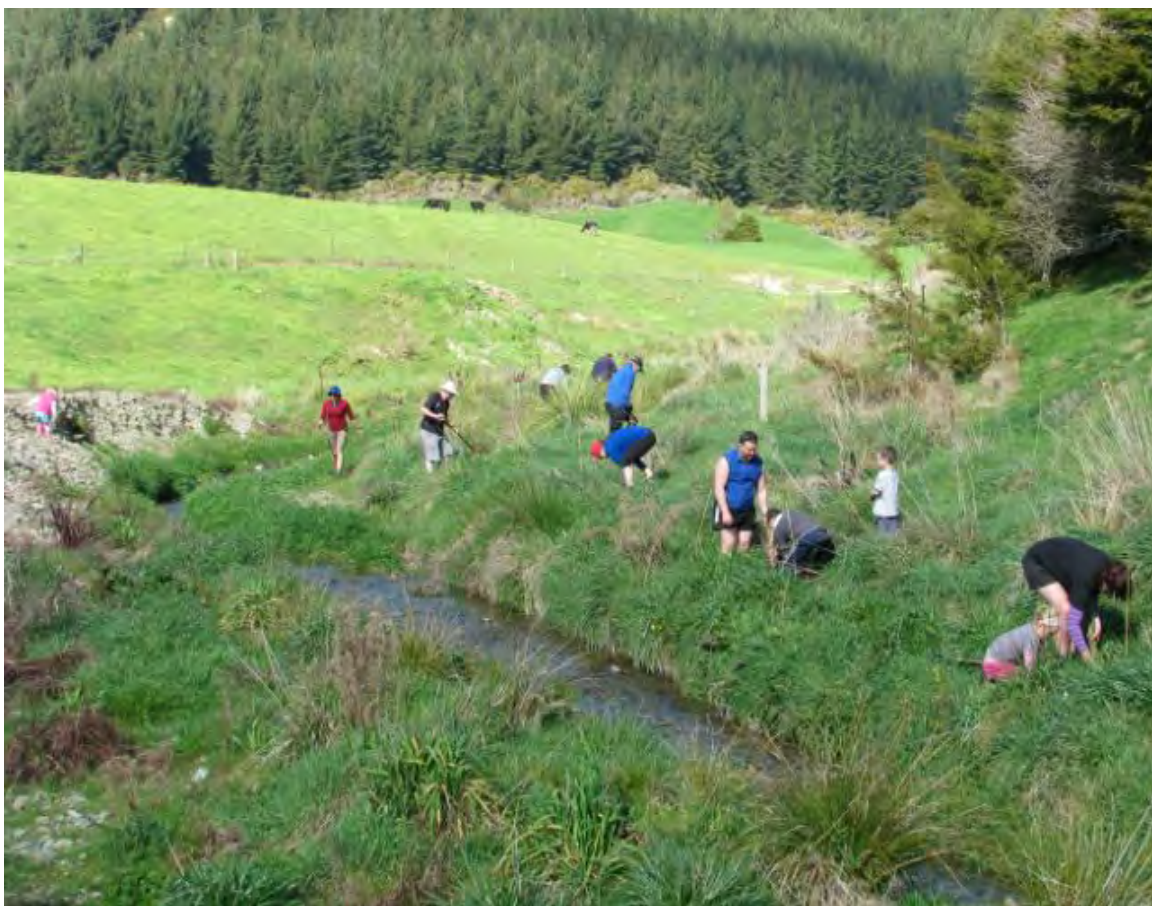
Figure 12: Riparian planting along a small fenced tributary of the Lower Te Hoiere/Pelorus River.

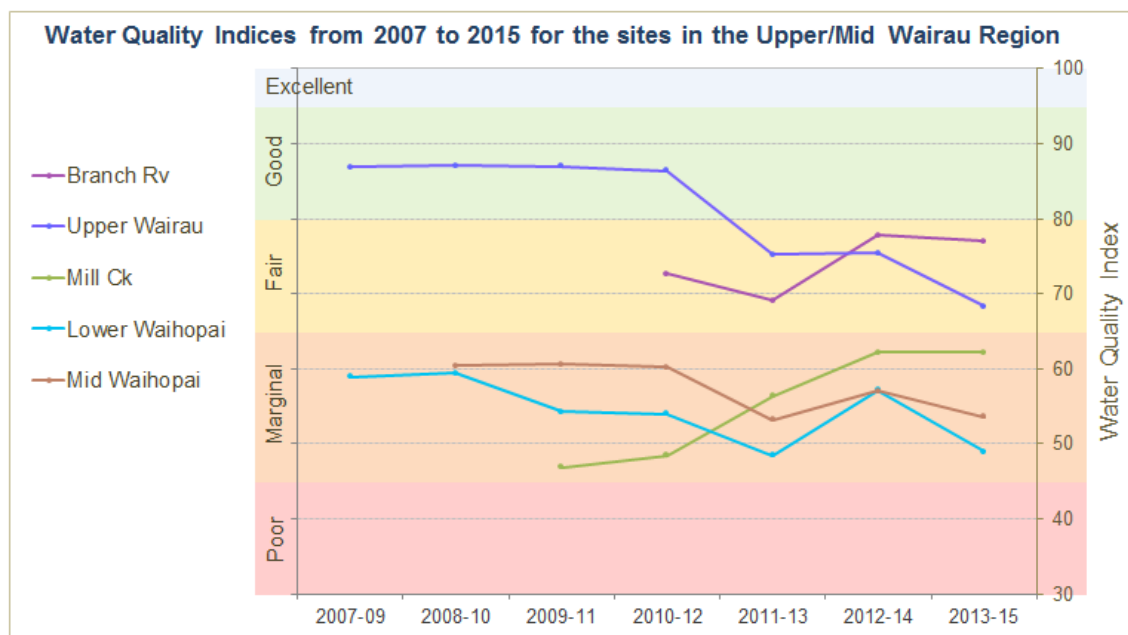
Figure 16: Change over time of the Water Quality Indices in Upper and Mid Wairau catchment.

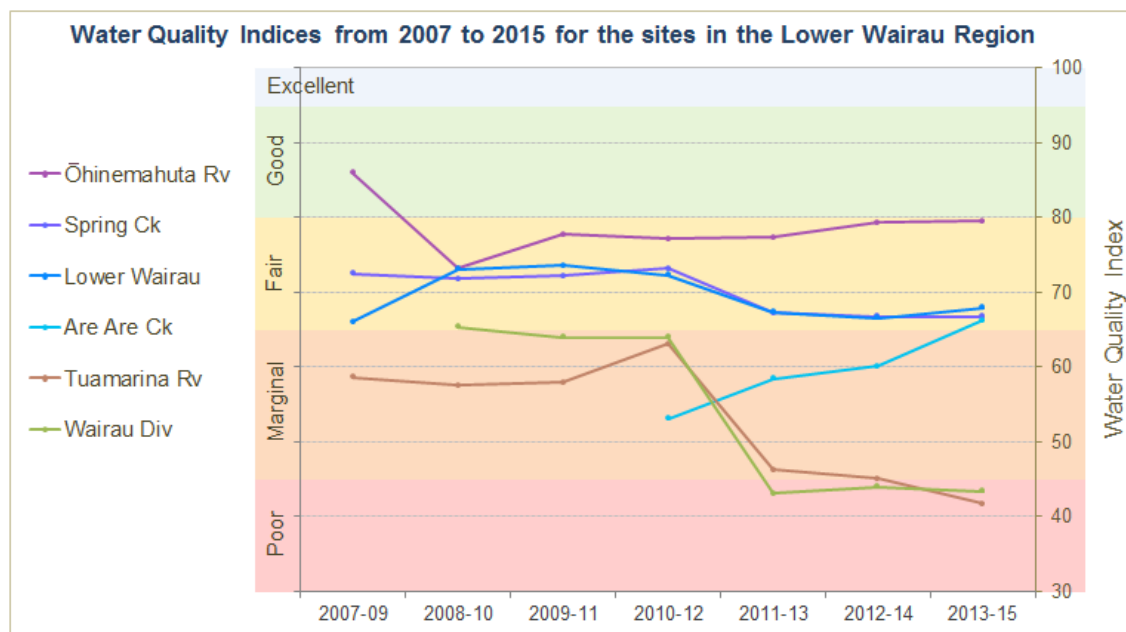
Figure 19: Change over time of the Water Quality Indices in the Lower Wairau catchment.

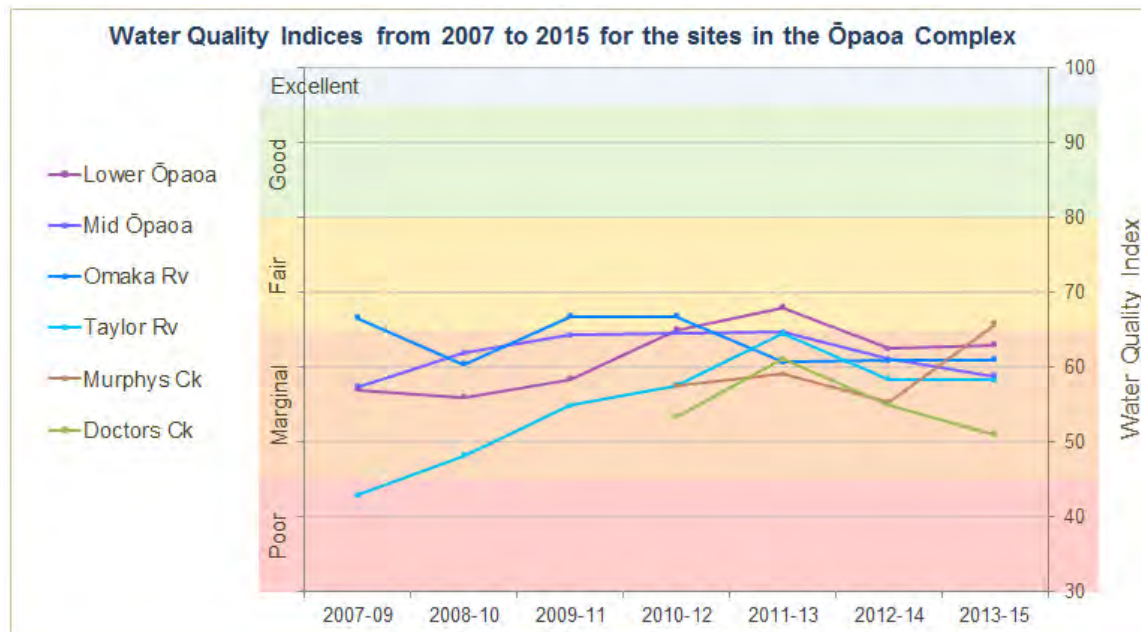
Figure 22: Change over time of the Water Quality Indices in the Ōpaoa Complex.

Despite the increase in *E. coli* concentrations, the Water Quality Index for the Taylor River is showing improvements (Figure 22). This is due to a combination of factors, including a significant reduction in nitrate concentration and improved pH levels (Table 8).

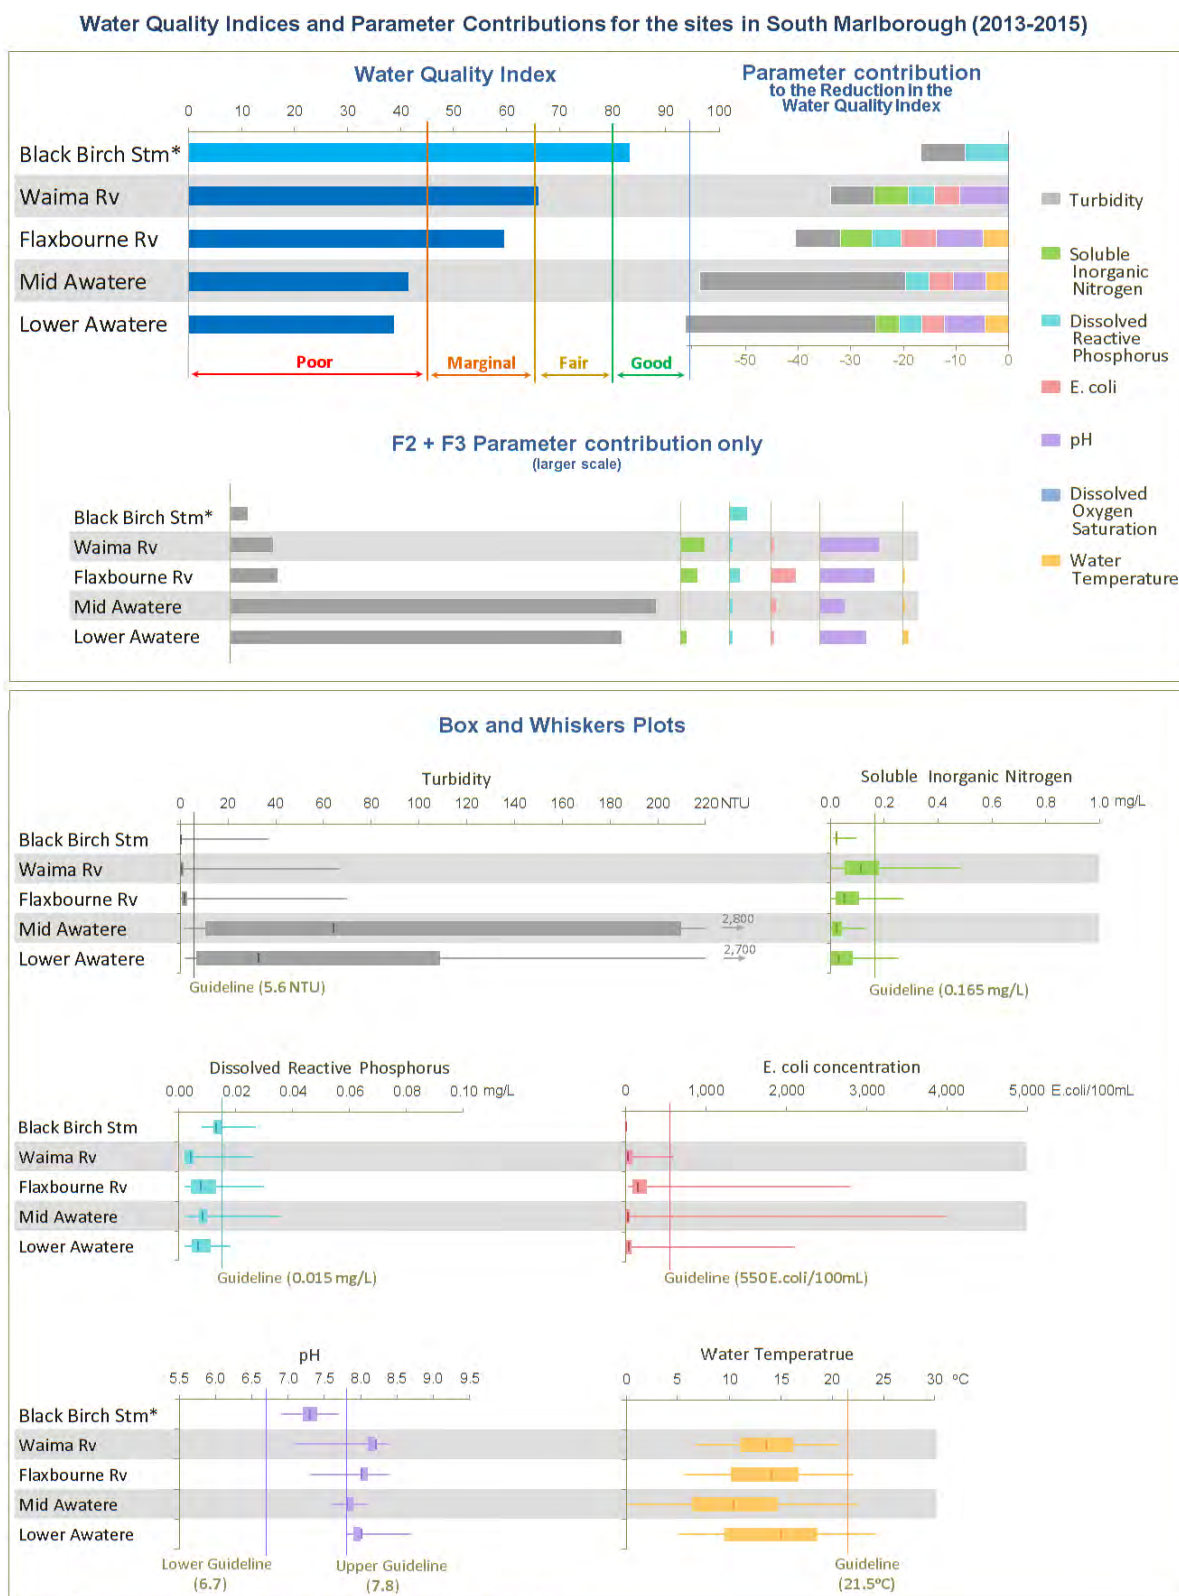
Figure 24: Water Quality Indices and parameter contributions for the monitoring sites in South Marlborough for the period 2013-2015.

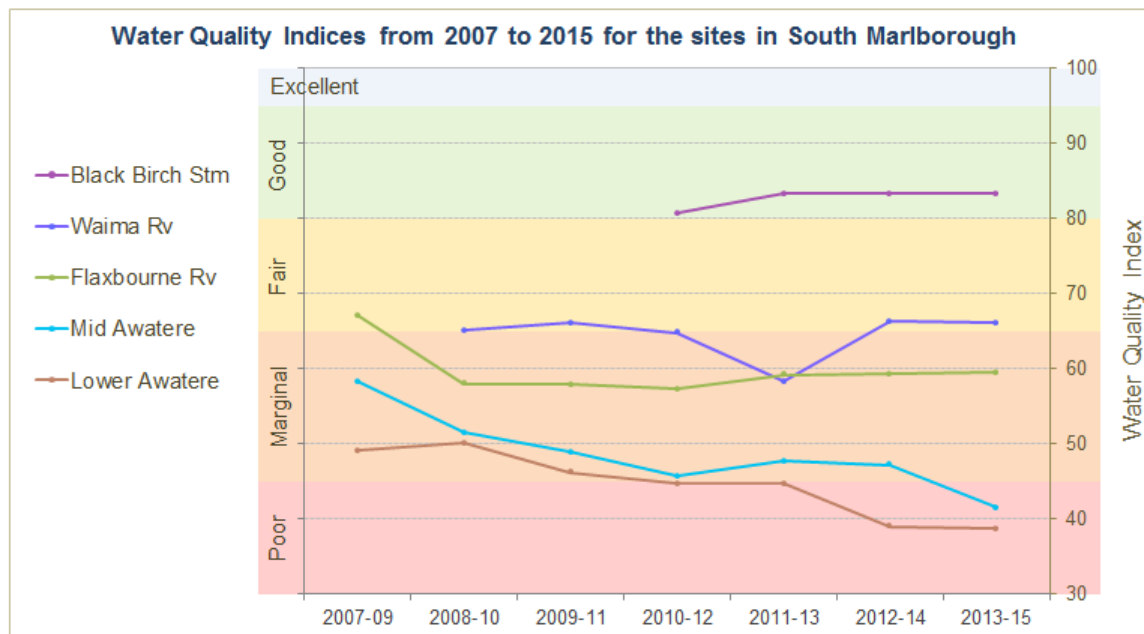
Figure 25: Change over time of the Water Quality Indices in South Marlborough.

Black Birch Stream flows into the Awatere River, which has substantially poorer water quality. However, the parameters which cause the greatest reduction in the Water Quality Index are elevated predominantly due to natural causes. High turbidity and pH values are the result of high mudstone and limestone content in the geology of the Awatere River catchment. Nevertheless, there is a large amount of infrastructure associated with irrigation water takes in the lower Awatere. Maintenance of these intakes generally causes significant increases of turbidity during the work. Trend analysis shows a significant increase in turbidity for both sampling sites, however, which indicates that the source is likely to be located in the upper catchment (Table 9). Since trend data is flow adjusted, the increase in turbidity is not a result of changes in flows during sampling. The majority of the upper catchment is extensively farmed pasture and it is unclear what is causing the increased turbidity, but greater erosion is the most likely explanation. The increase in turbidity caused a significant reduction in the Water Quality Indices for the two Awatere River sites, which have shifted from the marginal into the poor category (Figure 25).

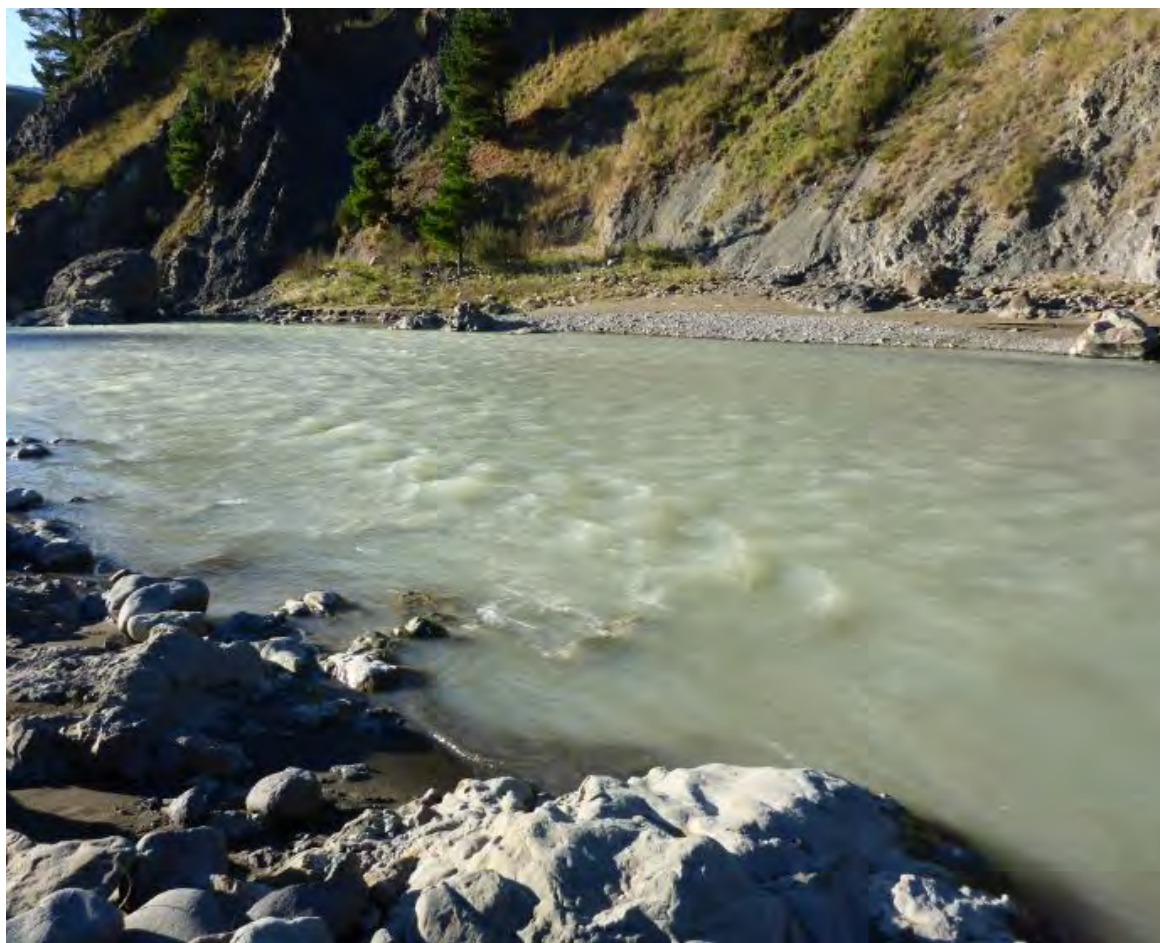
Figure 26: Typical turbid appearance of the Awatere River at the mid Awatere monitoring site.

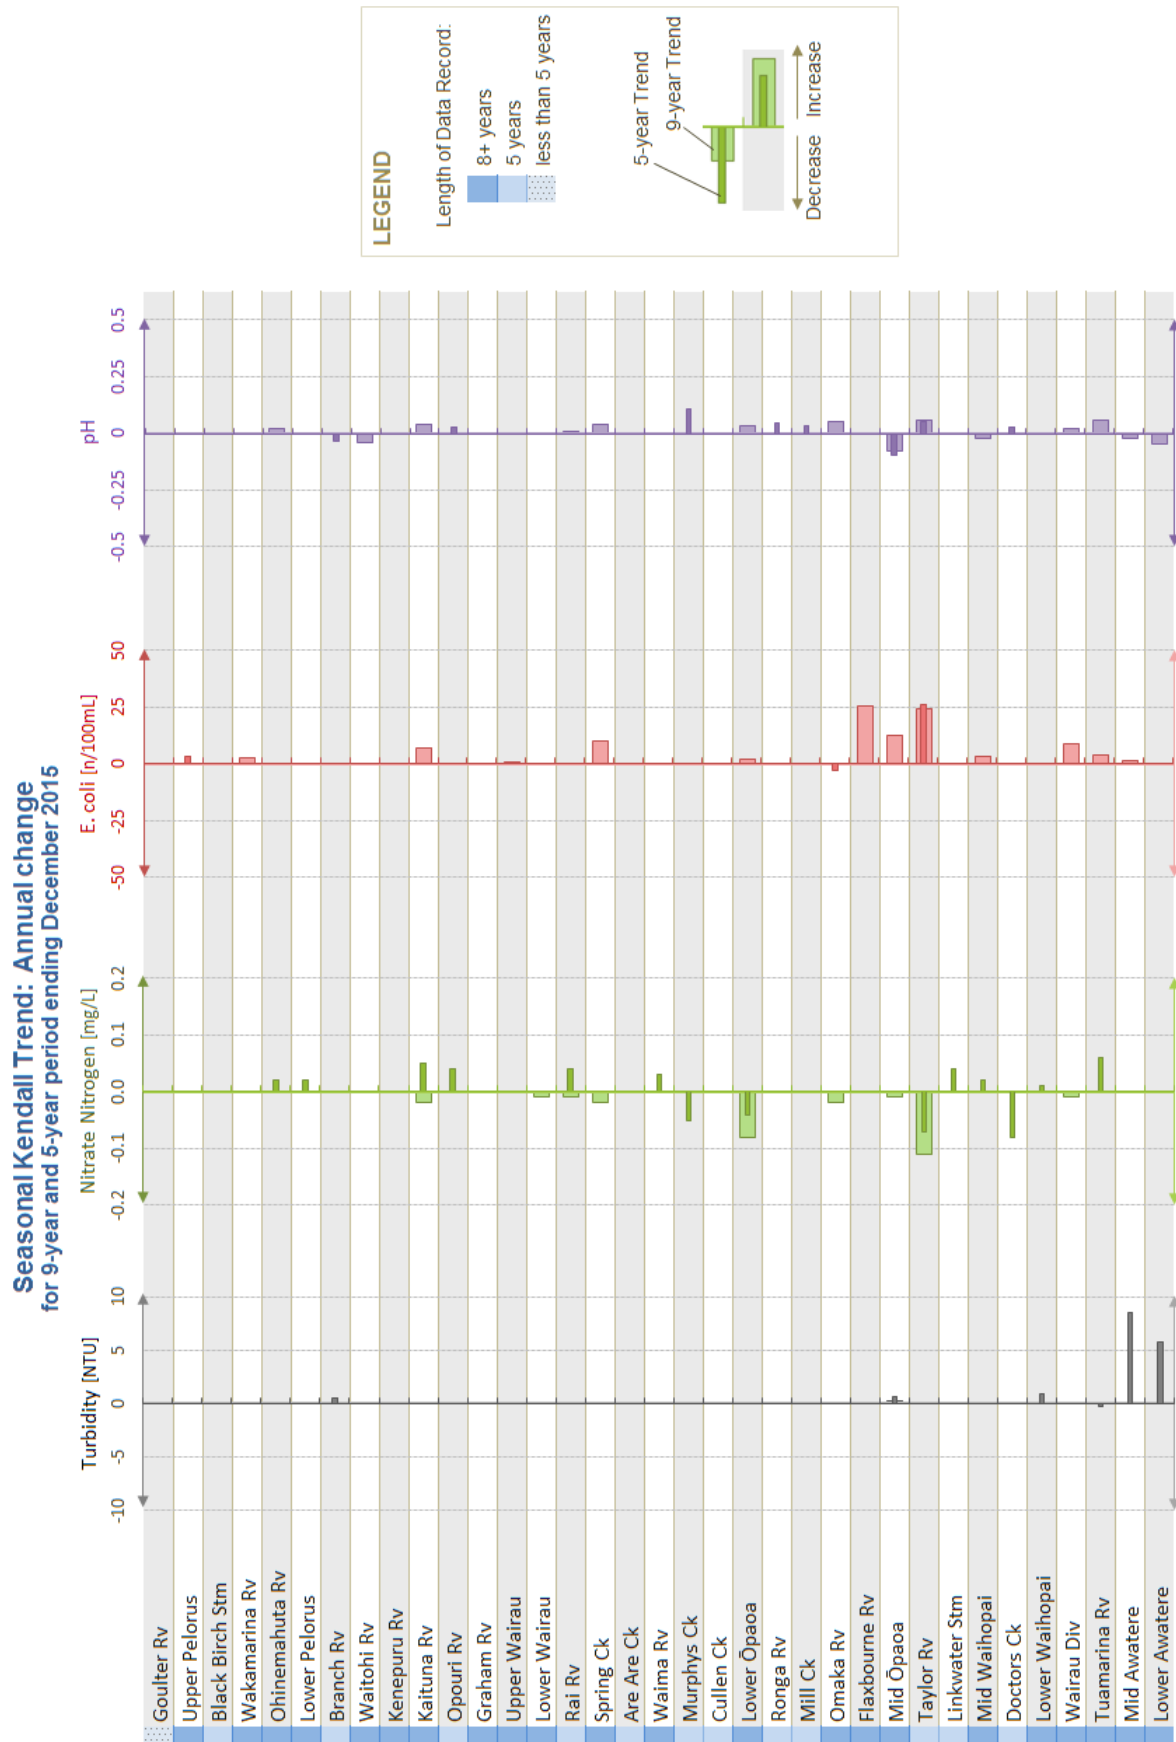
Figure 28: Annual change based on the five-year (2011-2015) and nine-year (2007-2015) trend analysis for all sites monitored.

Unlike Water Quality Index data, the data used for trend analysis is flow adjusted. Trend analysis, done as part of this report, identified an increasing trend for turbidity in the Branch River, but not the Upper Wairau River (Figure 28). This indicates that some of the increases in the Branch River are not flow related. Recent harvesting of production forestry in the catchment is a possible source of additional fine sediment in this waterway. Field notes for the Graham River identify gravel extraction and associated bank erosion as the cause for elevated turbidity.
