Marlborough Roads Recovery Update

Wednesday 13 October 2021 Next update: 20 October 2021

Snapshot for the week 4-8 October

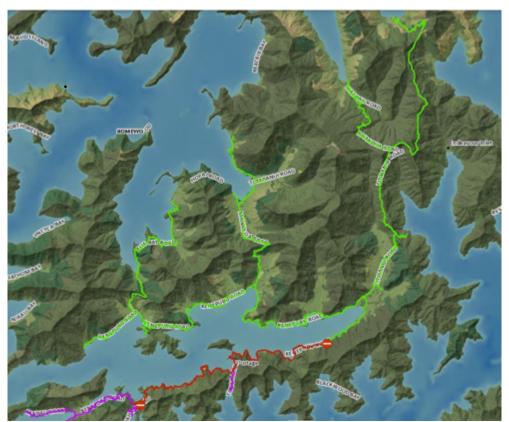
From this site at RP 20.5 to Portage, a geotechnical drill rig is scheduled to undertake sampling on Thursday and Friday this week from 8am to 5pm. While this work is subject to change, this stretch of road remains closed.

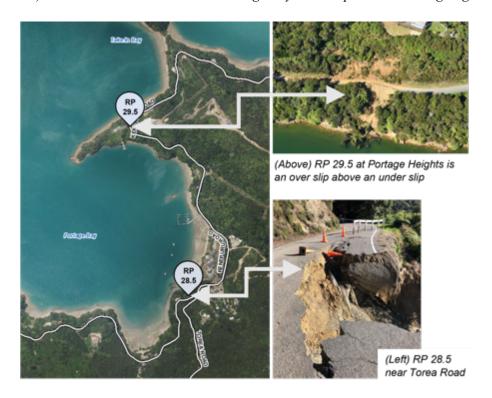
(Below) RP 28.5 and RP 29.5 around Portage Bay are complex sites undergoing design work.

There are three significant sites in the design and review stage where construction work will not be visible in the short-term. These are slips at RP 20.5, 28.5 and 29.5 (see maps below). Further updates will be released when more information is available on these sites.

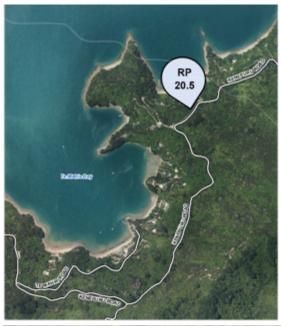
(Left) The "water tank slip" at RP 20.5 is a complex site, which occurred well after the July storm. It is located about 1km east of the Onahau Road turnoff.

Access on Kenepuru Road, between Onahau Road and Sandy Bay Road, is restricted by the water tank slip (RP 20.5) which occurred after the July storm. This section of road is closed, and we are working with affected residents to help them access their properties during this period.

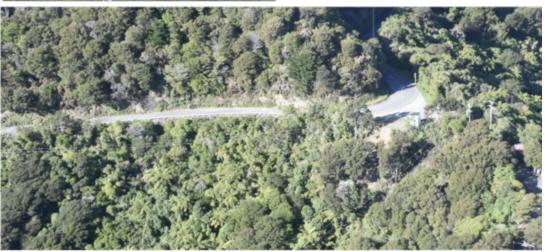
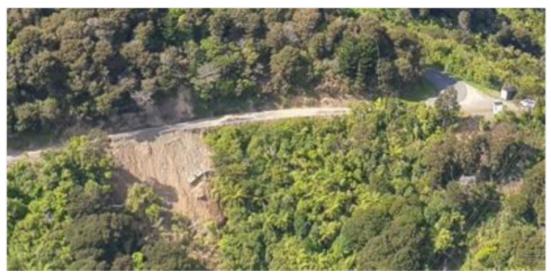
Below, the "before" photo (top) was taken 28 July with no visible faults.

The slip in the "after" photo (bottom) occurred after a later rain event.

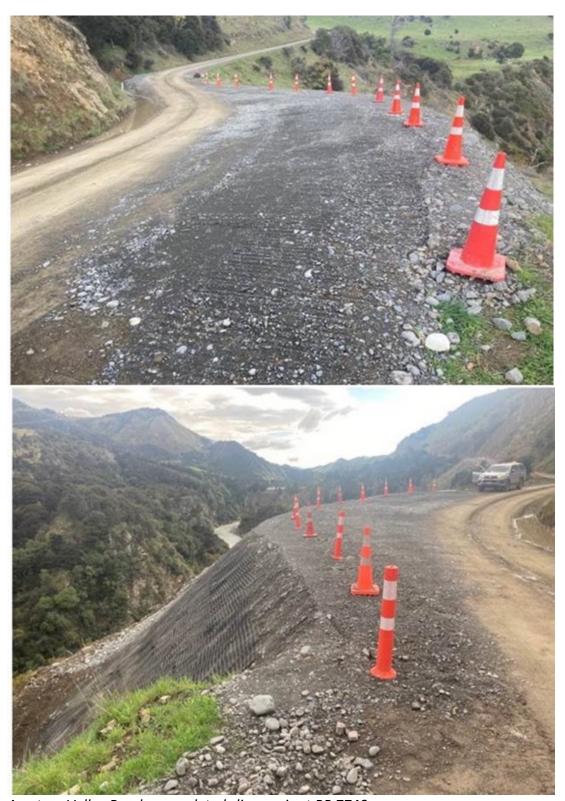
Awatere Valley Road – completed slip repair at RP 7740

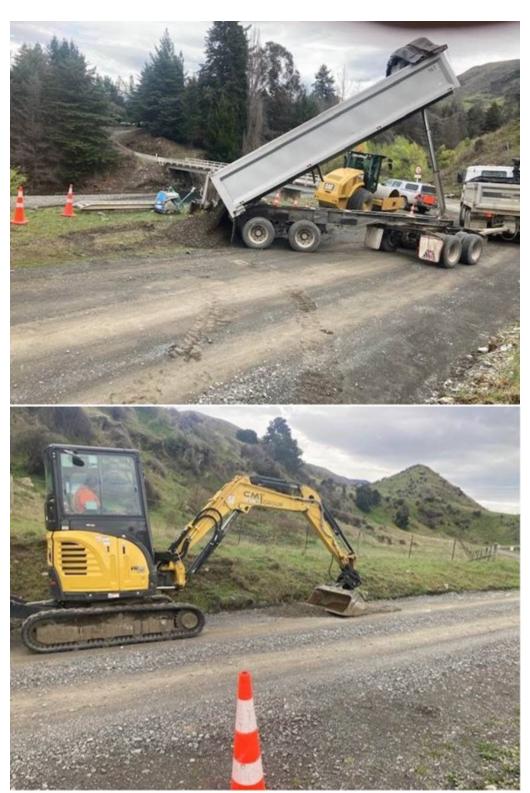
Surface and water table repairs at RP 980 - the Grey River Bridge, between Limestone Bridge and Moleswo

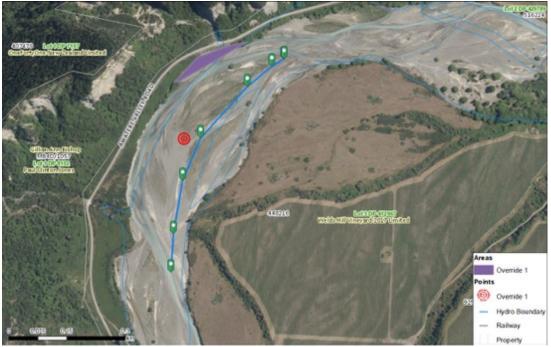
Above: Medway Road - Jordan River. The river is undercutting into the bank on the left (shown in purple) to the marked blue channel further to the right.

The Awatere River is undercutting the road at two locations and will require rerouting to protect the road. These locations are Jordan River to Medway Road, and Jordan River to Limestone Bridge. We are now in the process of obtaining approvals and undertaking ecological surveys to prepare for this work in order to channel the river away from the road and provide a long-term solution for these areas.

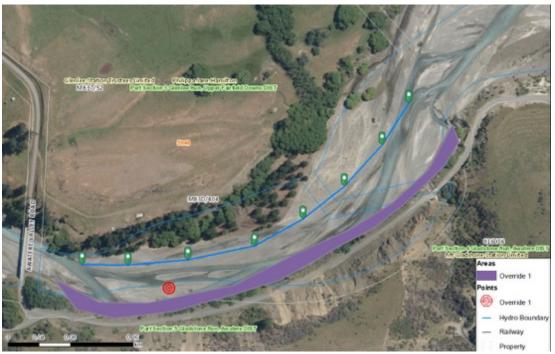
Above: Jordan River - Limestone Bridge. The river is undercutting into the bank shown in purple towards the bottom of the image and will be diverted to the marked blue channel further up the image.

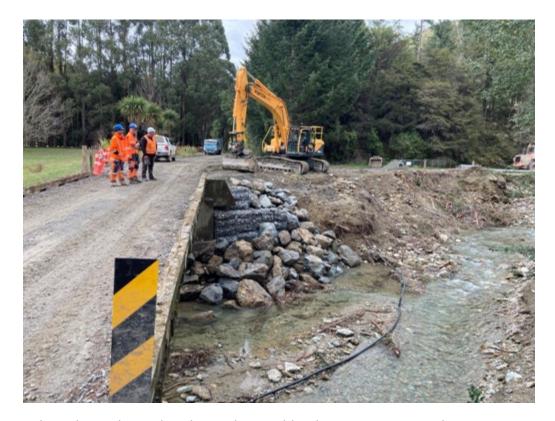
Repair work on the Enchanted Bridge in the Northbank Area is now complete

Structural repairs to the Enchanted Bridge gabion rock baskets and slope stabilisation are complete.
