Marlborough Roads Recovery Update

Tuesday, 28 September 2021

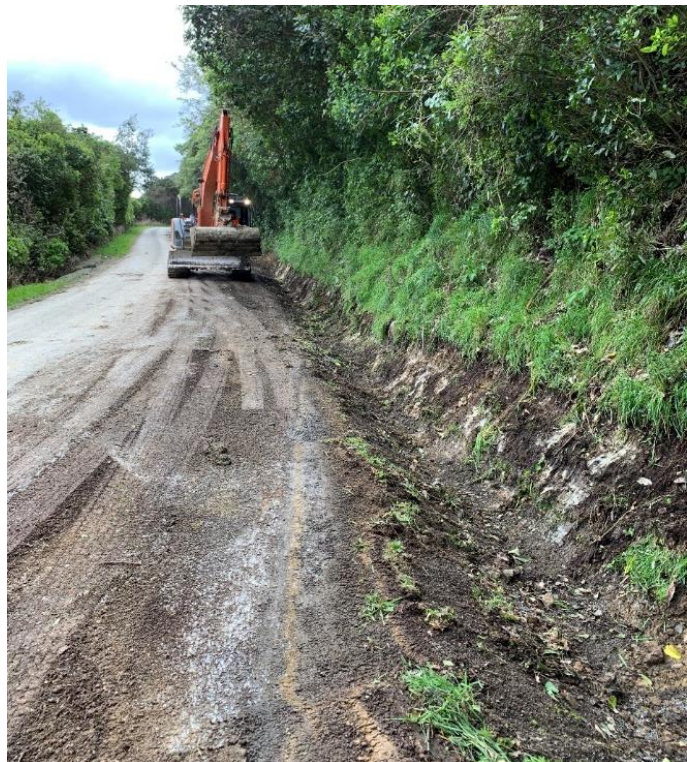
At Linkwater Hill, one crew is working to re-form water tables (right) while another crew is working to clear a large slip (pictured below).

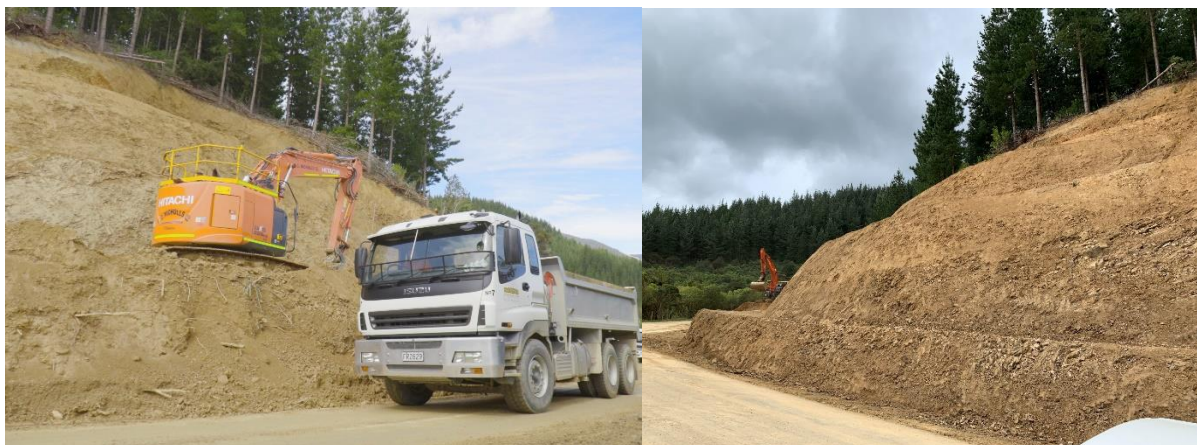
This large slip is located on the Kenepuru Road, about 3.4 kilometres from Queen Charlotte Drive, and 1.3 kms before Moetapu Bay Road.

The left photo below shows work on Monday 20 September and the right photo shows the site as of yesterday, 27 September.

Progress at this site was briefly delayed last week due to weather.

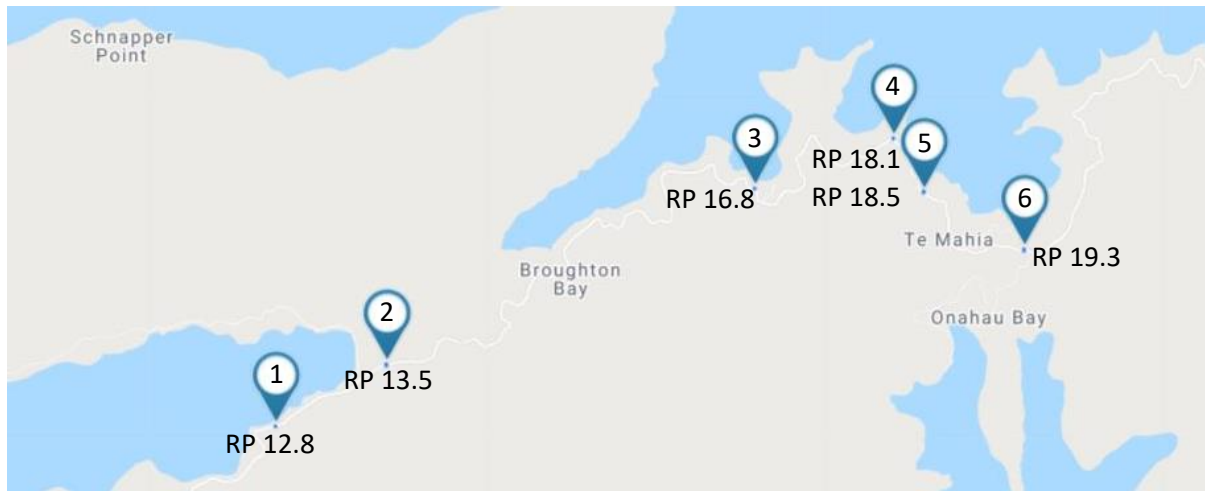
Meanwhile, another crew is continuing its way towards “the rock” site. As of yesterday afternoon, this crew was clearing the last area before reaching the site, near the Onahau Road turnoff. Below shows a map of recent work, where the goal is to pave the way for trucks and equipment to travel between “the rock” and a Mahau spoil site.

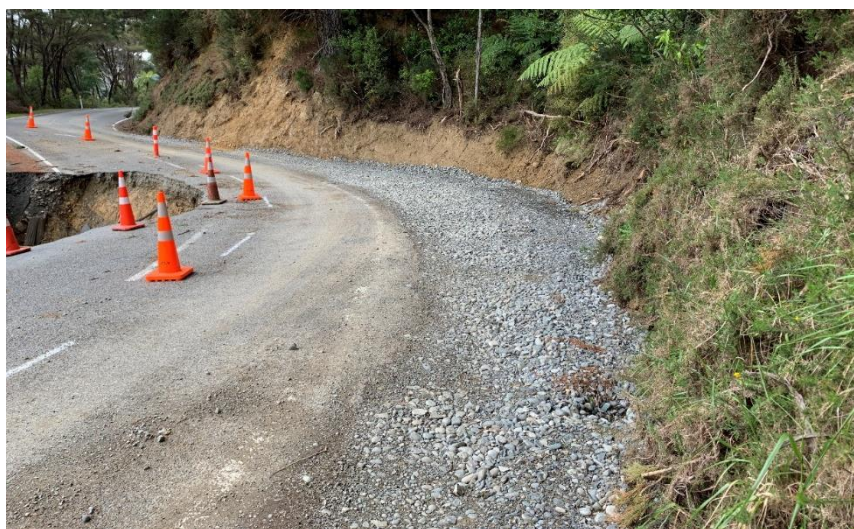
1. (Right) Crews have widened the road at route position (RP) 12.8 to allow heavy equipment through.

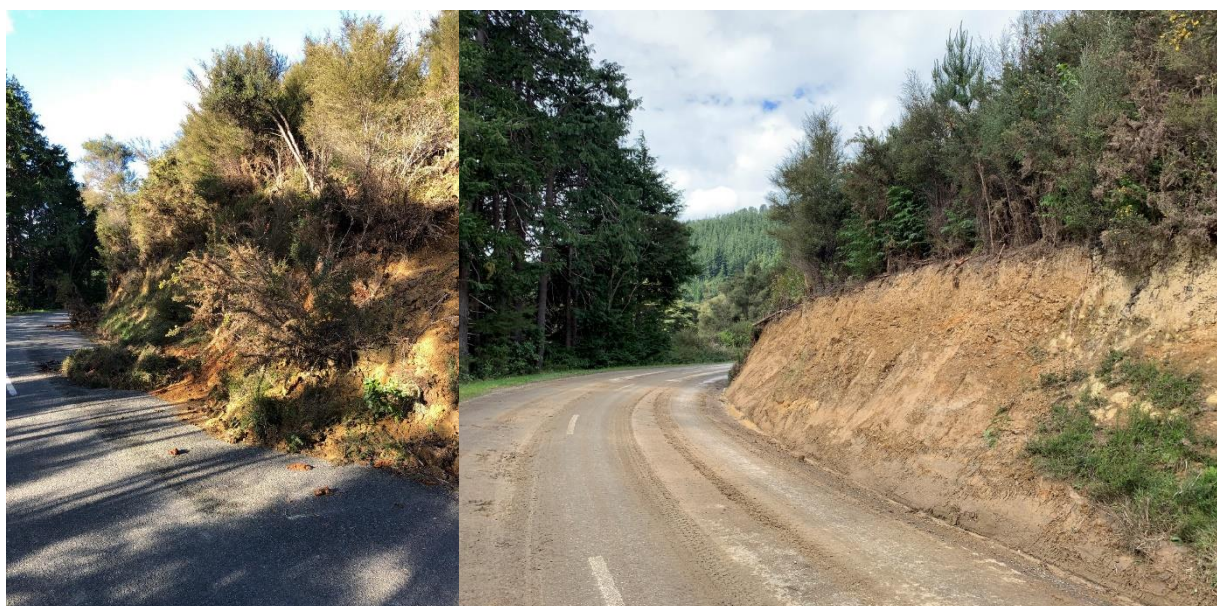
2. (Below) A slip has been cleared at RP 13.5. The storm left an estimated 80 cubic metres to be removed (pictured left). A photo taken yesterday (right) shows the recently cleared slip.

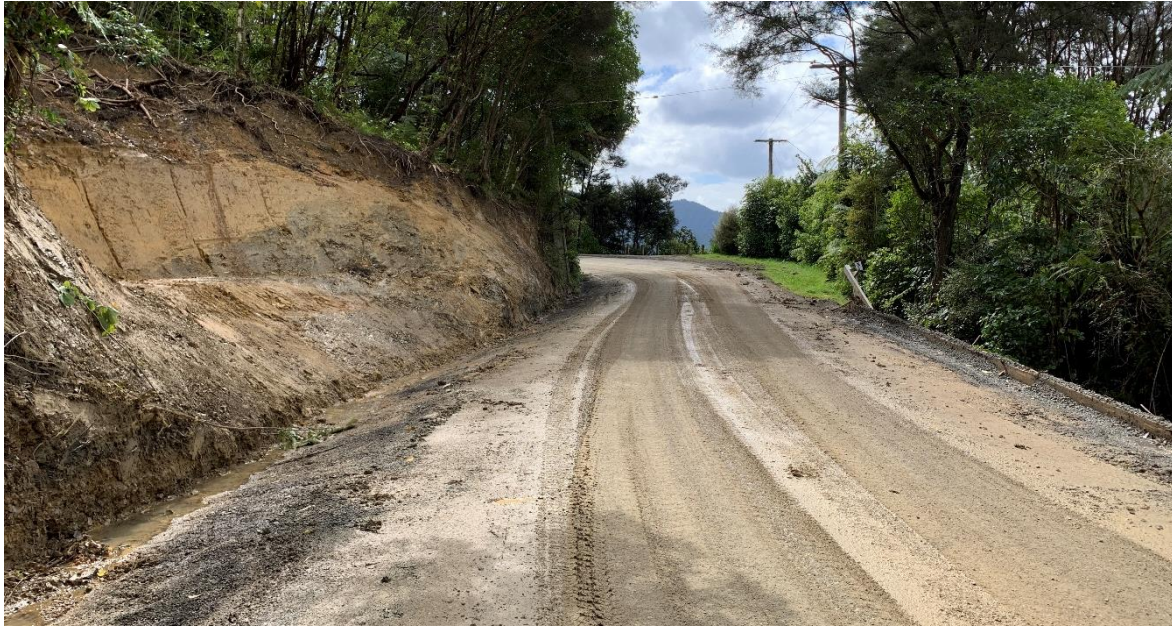
3. At RP 16.8 (below), another large slip has been cleared, removing an estimated 400 cubic metres of spoil and debris.

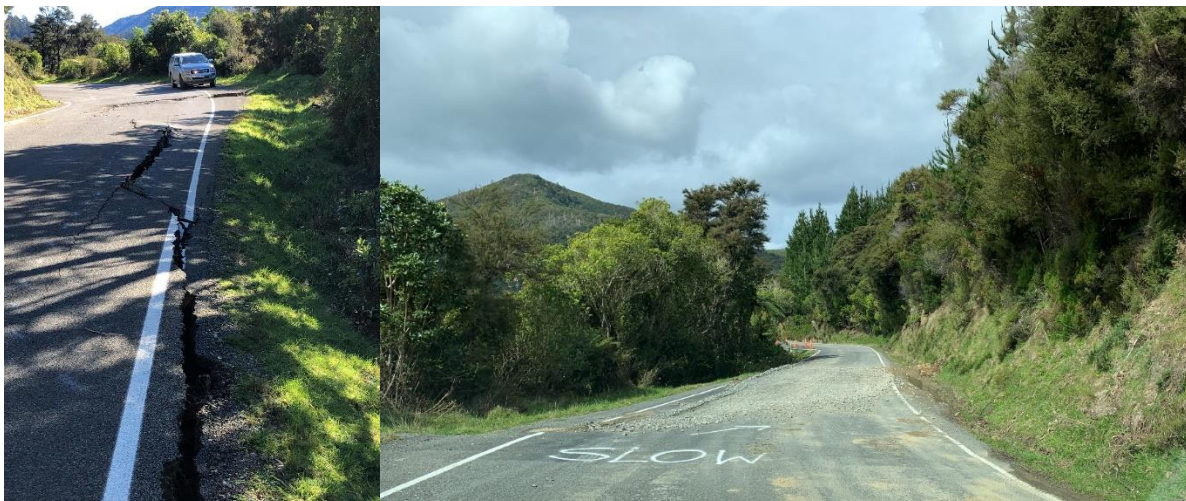
4. At RP 18.1 (below), the left photo shows the damage, an underslip over 100 metres long. The photo on the right shows where the road slump has been levelled.

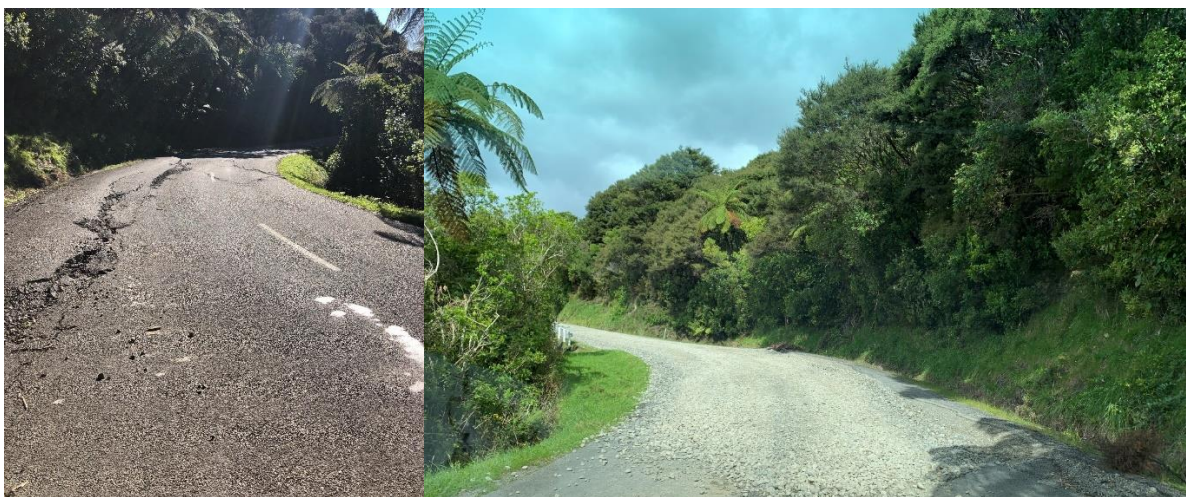
5. At RP 18.5 (below), the left photo is an underslip, where 110 metres of road has dropped. The photo on the right shows where the road slump has been levelled.

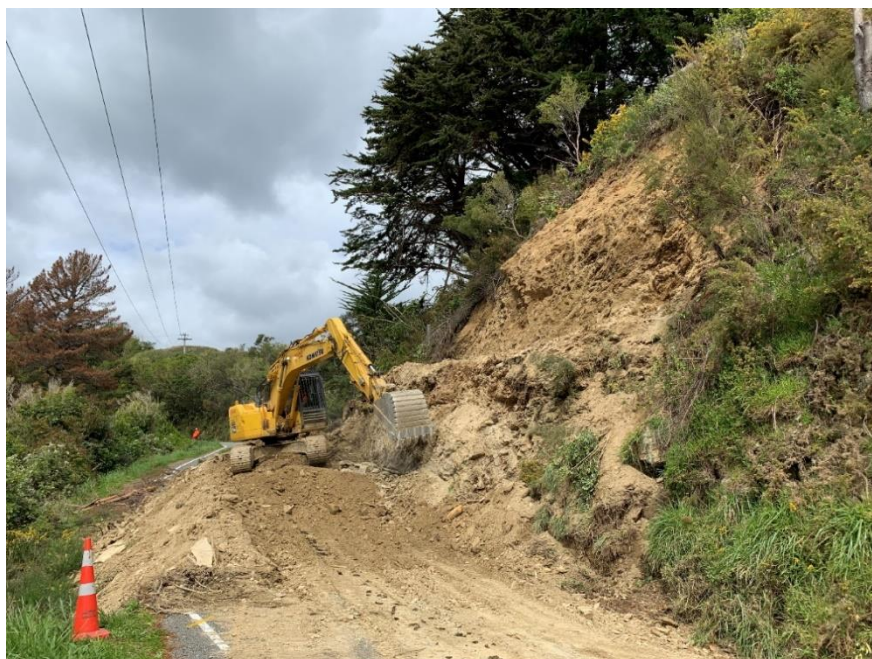
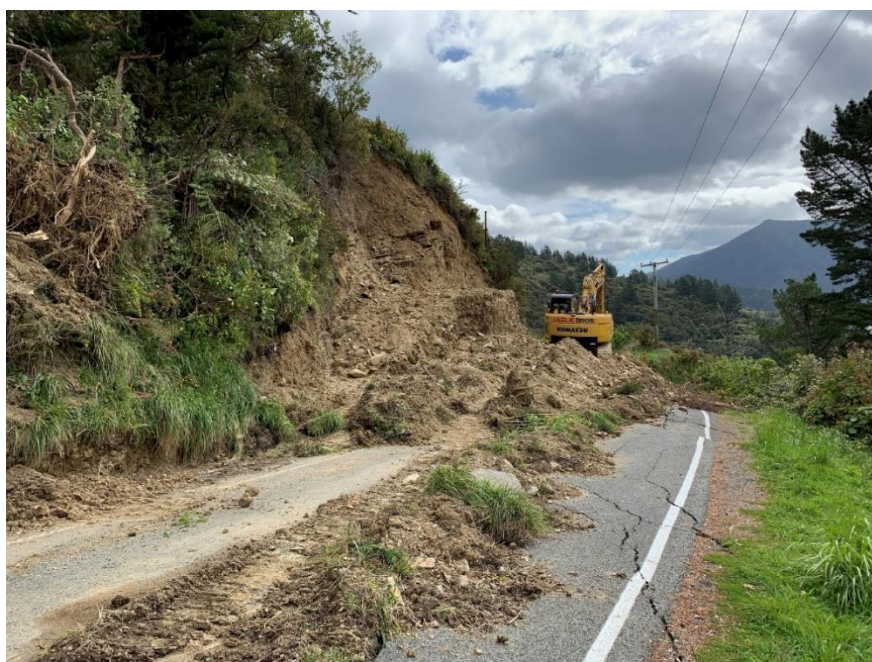
6. Yesterday, crews are pictured below working at removing the bank to allow sufficient road width to get loaded trucks past the shoulder slumping at RP 19.3, Onahau Road intersection.

The work in the photos above will allow crews to remove spoil and debris from “the rock” site and truck it to the Mahau Road spoil site.

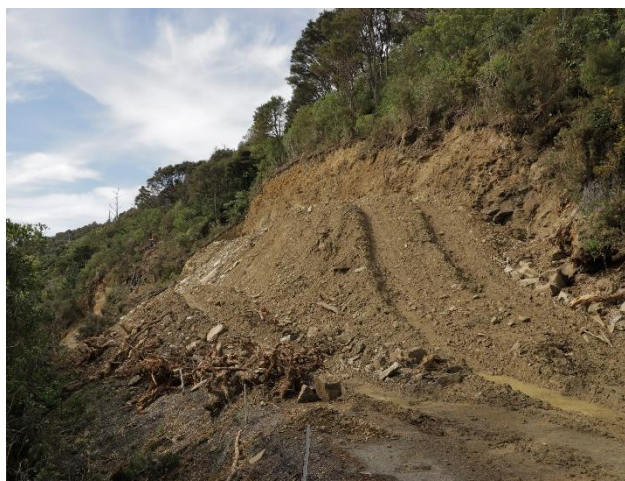
The photo on the right shows the debris that must be removed from the site of “the rock” near the Mistletoe Bay turnoff.

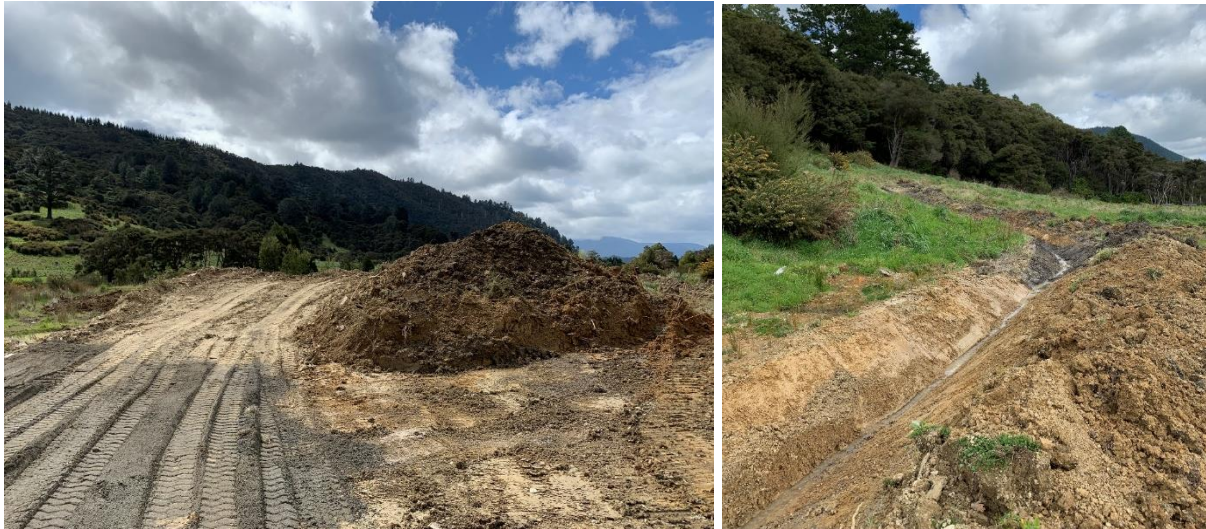
Mahau Road spoil site

Work is being done at the Mahau Road site to manage spoil dumping and drainage run off. A special thanks to the Sumby family for allowing the spoil site on their land.
