# Lake Elterwater

## A basis for discussion

Prepared by: John Preece  
WetlandsNZ

For: Marlborough District Council

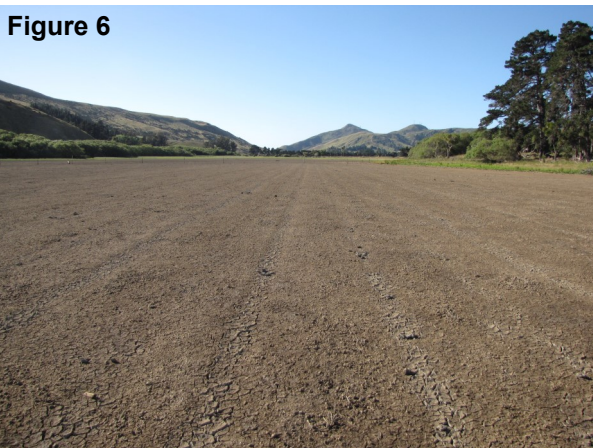
At least 8 years (Table 1) with a completely dry lake have been documented (mainly from McConchie, 2009). Some additional records indicate that the lake has gone dry 10 times since 1900, 5 prior to dams being completed by 1978 (so 1 in 15.6 years) and 5 post dam completion (1 in 7.6 years). Part of this is attributable to the drop in lake level in 1955 due to the outlet and drain created by a local to alleviate bank erosion caused by high lake levels. Figures 6 & 7 shows the lake bed at the southern end, in December 2016.

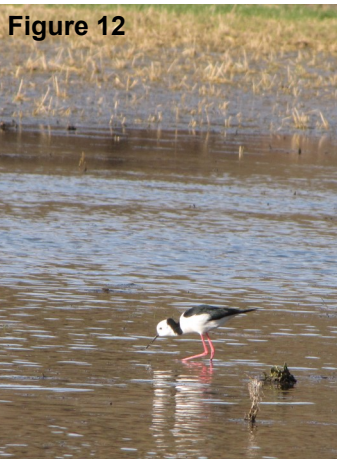
Shallow water is by far the largest community when the lake has water. The shallow depth of water and gently sloping lake bed produce large areas of shallow edge much favoured as feeding areas for bird species such as the pied stilt, shown in Figure 12. The rapid transition from shallow water to vegetated lake bed is illustrated in Figure 13.

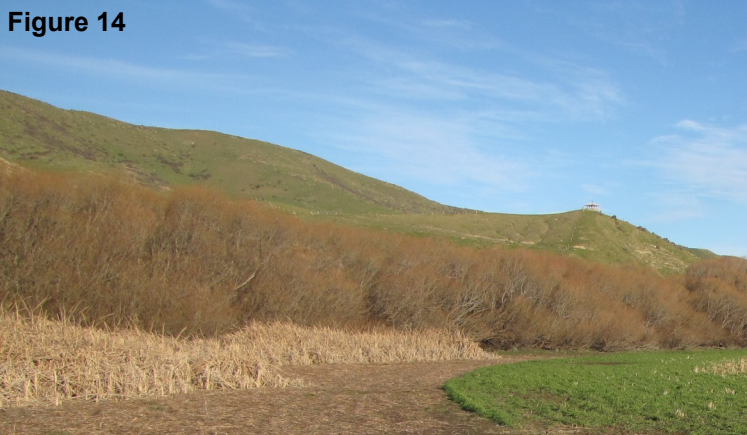
Willows are the largest vegetation community by area and biomass. They are all crack willow (*Salix fragilis*), and mostly mature trees. There does not seem to have been significant spread in recent years. Most areas have a closed canopy, with little regeneration of native species beneath. Figure 14 shows a willow community (with raupo in front) on the eastern side of the lake in winter, while Figure 15 shows part of the same communities in summer. Swamp nettle (*Urtica linearifolia*) has been reported (D. Barker, pers. comm.) from the understory. *Carex virgata* and cabbage tree (*Cordyline australis*) are occasionally present.

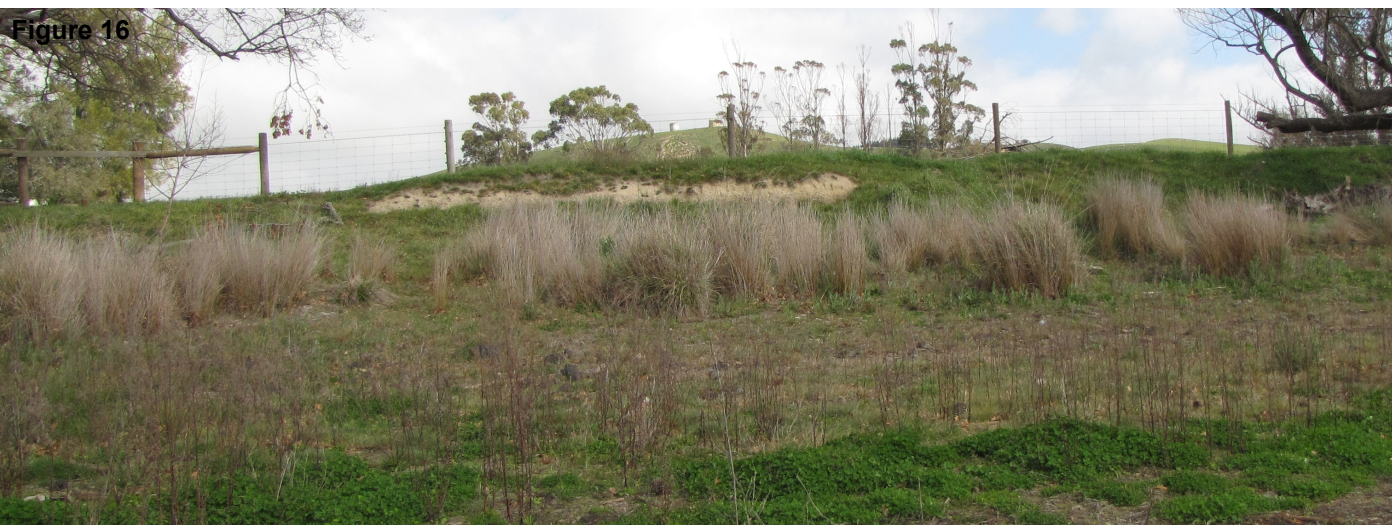
These communities are dominated by *Juncus edgariae*, with *J. sarophorus* also present. They often have a range of other species present. Typically they occupy the high shore area of the lake bed, as shown in Figure 16 below showing a narrow strip of rushland on the western side of the lake. Some larger areas occur at the head of the lake on the eastern side, and within the 'lagoon' area on the eastern side of the lake.

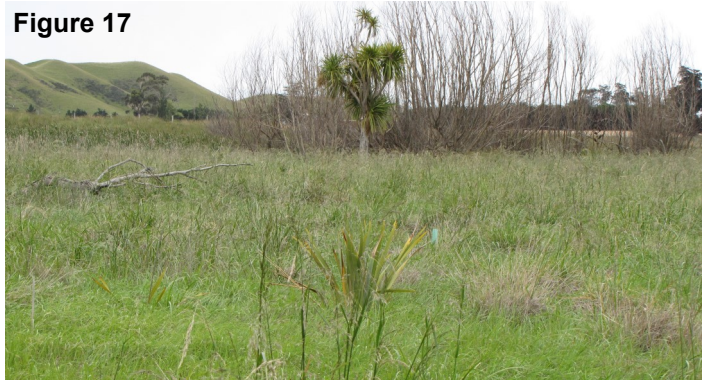
Figure 17

These are areas of introduced species of grasses at the highest lake levels. The largest of these areas is at the head of the lake, shown in Figure 17.

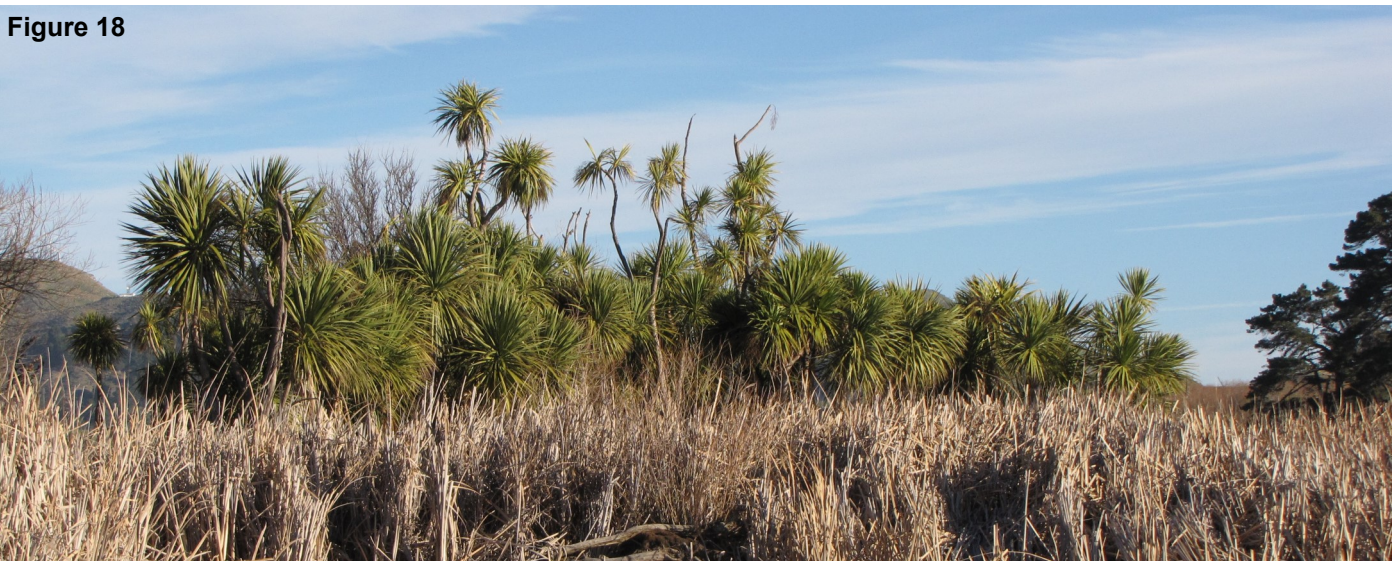
Cabbage trees (*Cordyline australis*) are found around most of the edge of the lake, but only in one small area are there sufficient to map as forest. Almost all are mature trees, with all young plants having been very heavily grazed. Figure 18 shows the area in winter.

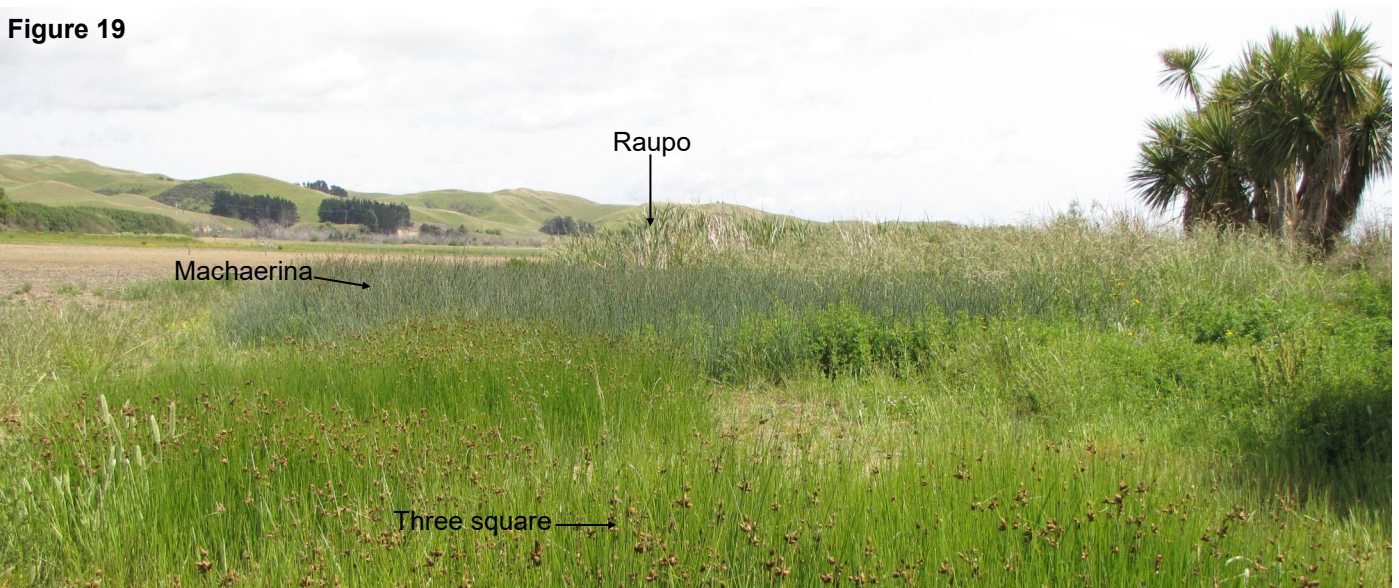
Figure 19

*Machaerina rubiginosa* (formerly *Baumea rubiginosa*) is present in only one small stand, sandwiched between three square and raupo. It was heavily trampled by stock over winter, but has recovered well in summer, as shown in Figure 19.

Three square (*Schoenoplectus pungens*) is not visible during winter, but when early summer comes colonies pop up very quickly. By December 2016 none were observed as large areas, but the number of colonies was increasing. A typical colony was shown in Figure 19, while Figure 26 shows a close up view. Of interest is that three square is typically a plant of saline areas, often found towards the freshwater end of estuaries. This may indicate a saline influence on the vegetation, reinforced by the presence of Bachelor's button.

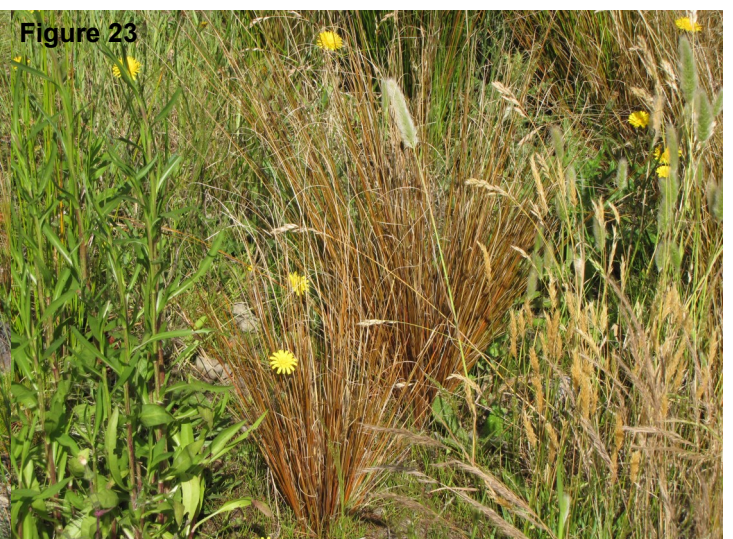
The most common of these communities is dominated by two sedges; the small, clump forming slender clubrush (*Isolepis cernua*), and the larger *Carex buchananii*. Slender clubrush forms cushions and is the dominant species within the community, while *C. buchananii* occurs as individuals scattered throughout. This community occurs in substrates with a high proportion of gravel, sorted by wave action. Figure 22 shows the nature of this community, with cushions of *Isolepis* interspersed with individuals of *C. buchananii*, shown in Figure 23.

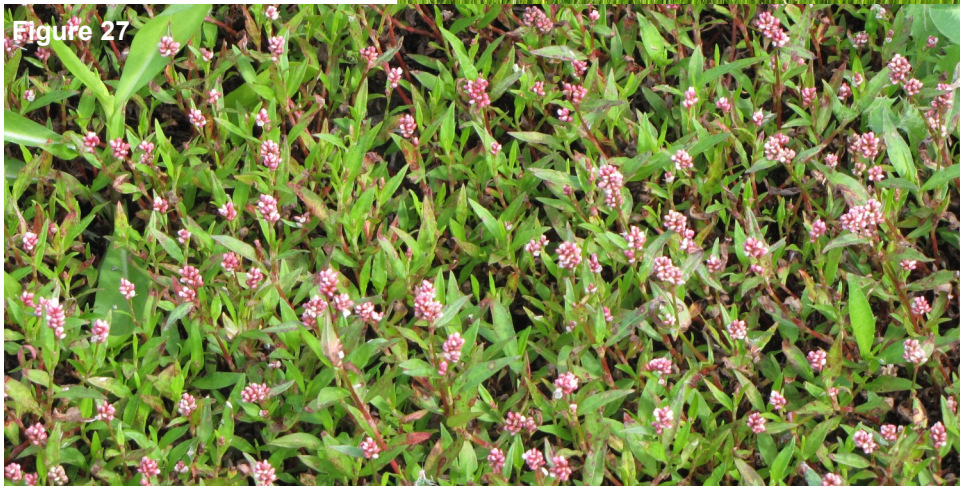
In some areas willow weed (*Polygonum persicaria*) has developed very quickly into large communities. One such area is shown in Figure 27. This is another soft sediment community.

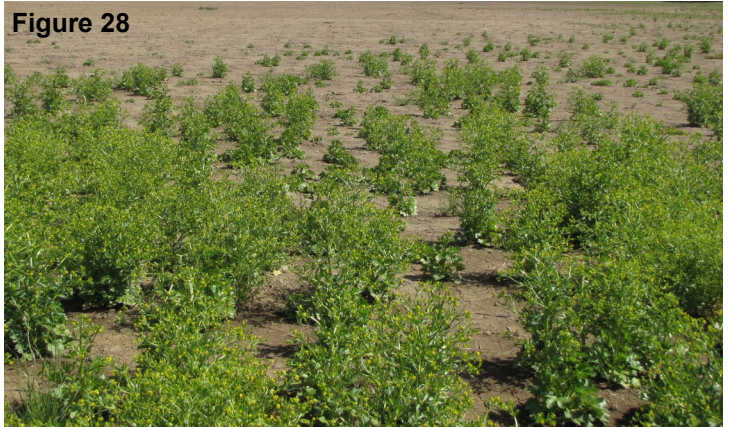
Figure 28

Celery buttercup (*Ranunculus scleratus*) occupies large areas, especially toward the southern end of the lake. This community occurs on soft sediments, and is illustrated in Figure 28.

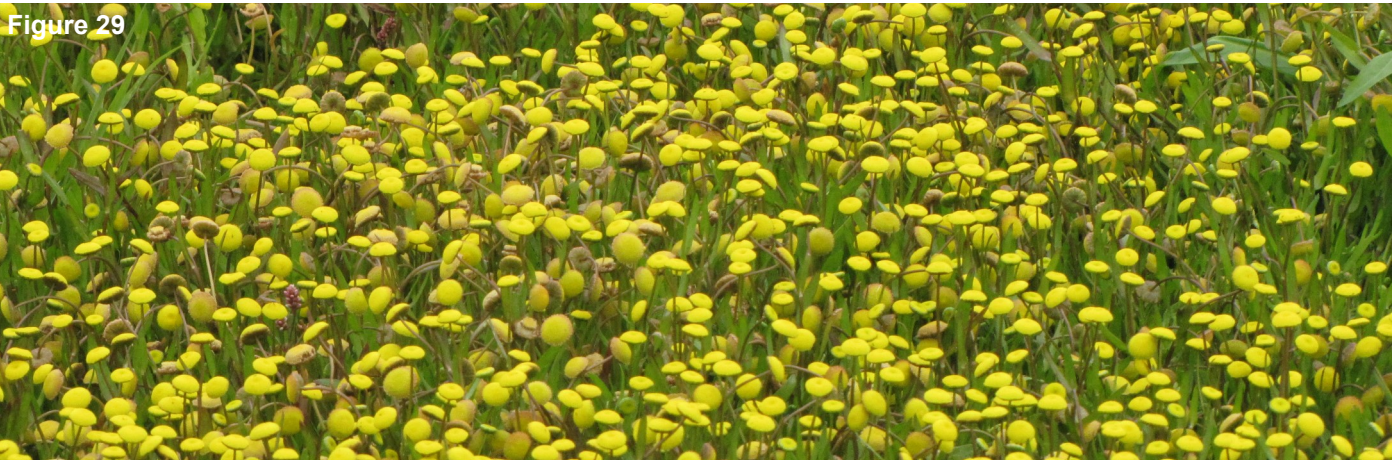
By far the most dramatic of these ephemeral communities in early summer was that dominated by Bachelor's button (*Cotula coronopifolia*). This is a community occurring quite high up the shore, sometimes being adjacent to raupo on the western side of the lake. Figure 29 shows it in full flower, a spectacular sight en masse.

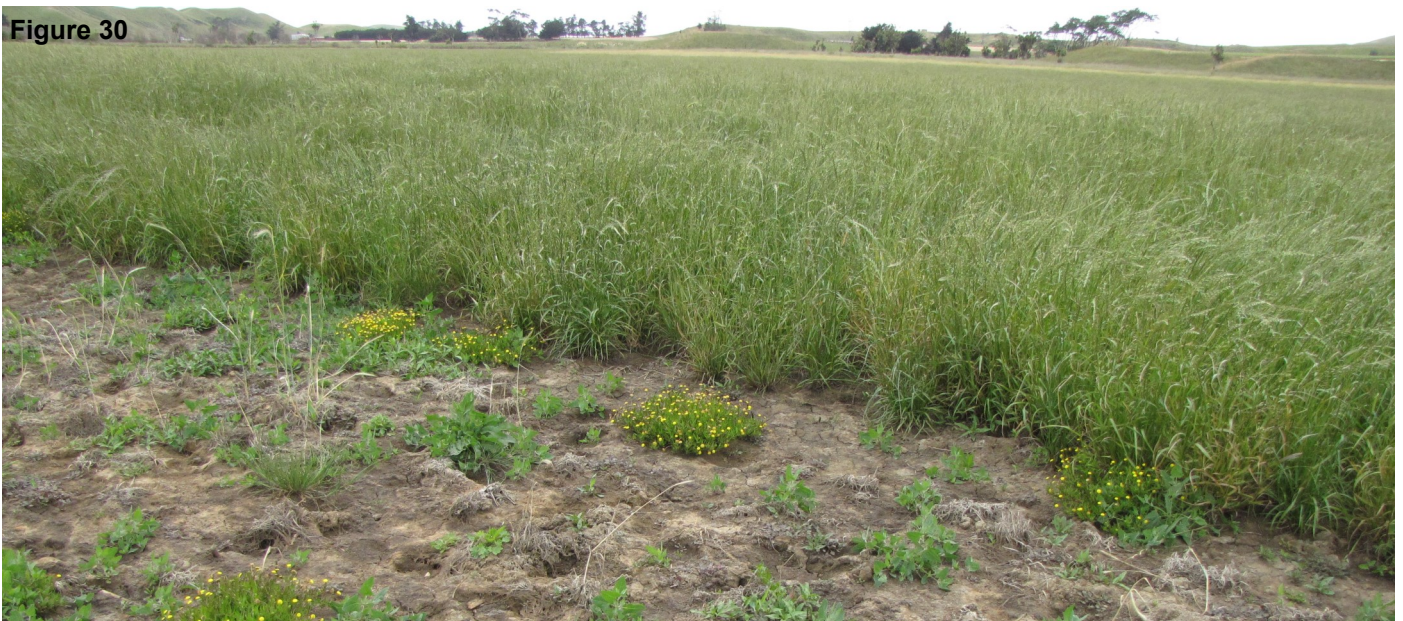
Much of the lake bed had been planted in ryegrass and oats, with the fertility of the lake being reflected in the crop. Figure 30 shows the edge of the planted crop in mid-December. The height of the crop is approximately 1.5 metres.

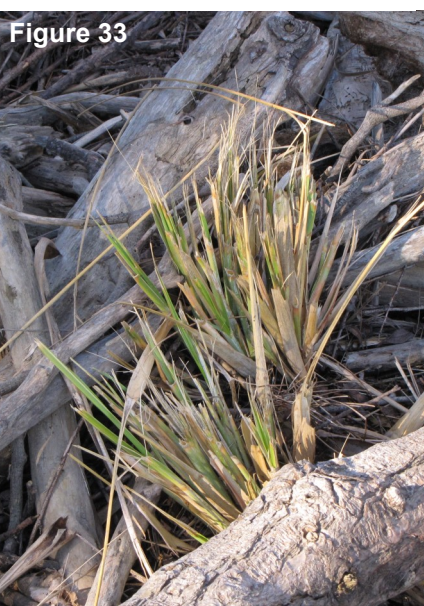
Forage crops have been planted over approximately 75% of the mapped lake bed. Evidence of cattle grazing was observed over much of the lake bed with cattle feeding in both dry areas and grazing in the water. Some of the grazing on lake margins appeared to be more long term than a one off seasonal event. Figure 33 shows a small cabbage tree grazed almost to the ground, protected only by driftwood, while Figure 34 shows heavy grazing pressure on an edge community. The effect of the edge grazing has been to almost eliminate recruitment of native shrub and tree species to edge communities. Continuation of this edge grazing regime will result in reduction in area and viability of these already small communities.

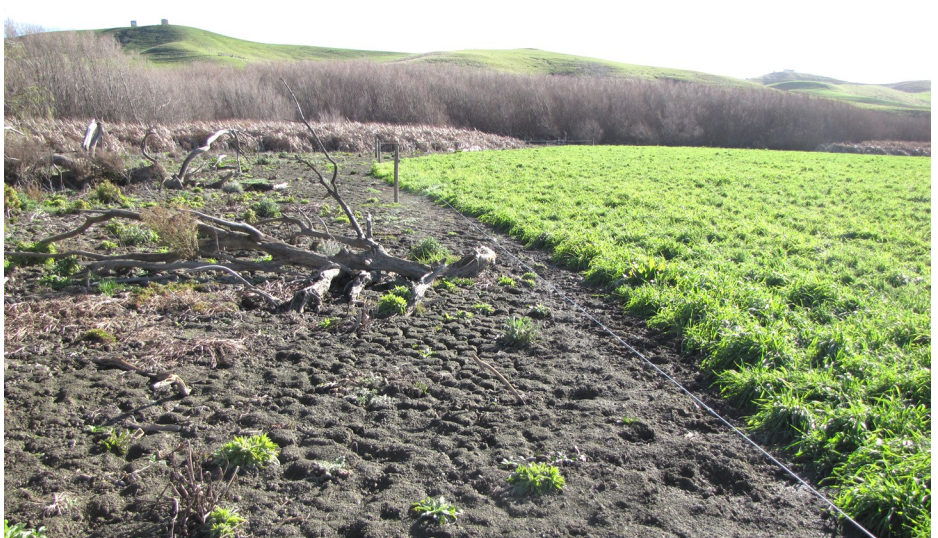
**Figure 35**

Planting of crops has caused displacement of natural communities, as shown on Figure 35. In this case it is a sparsely vegetated area, but some of these communities developed much more vegetation later in the season. Crop planting and grazing has introduced a wide range of weeds, which, combined with the crops, has had a major influence on the natural character of the communities of the lake bed.

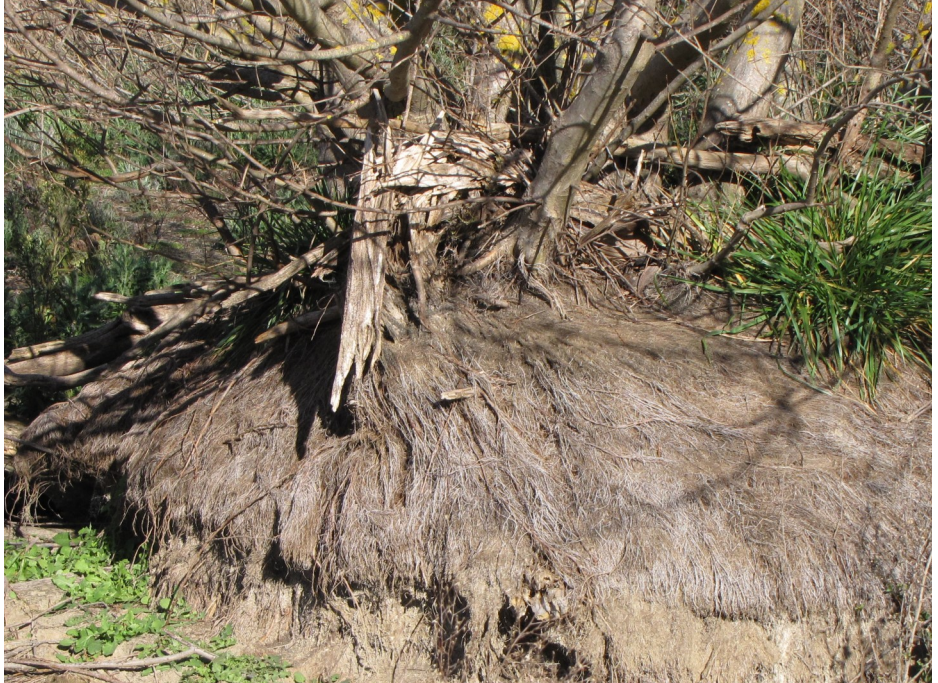
**Figure 36**

Figure 36 shows the potential erosive effects when full lake and high winds coincide. The long fetch of waves down the lake can generate substantial waves with considerable potential to cause erosion in unprotected areas. A number of areas at the southern end (but many other areas also) of the lake show signs of bank erosion and have some rudimentary “protection” in place. This situation is almost certainly exacerbated by grazing of the lake edge, which has not allowed development of the natural edge vegetation which would provide degree of protection against erosion. In walking around part of the lake almost no natural regeneration is apparent, with heavy grazing pressure from cattle destroying almost all young plants.

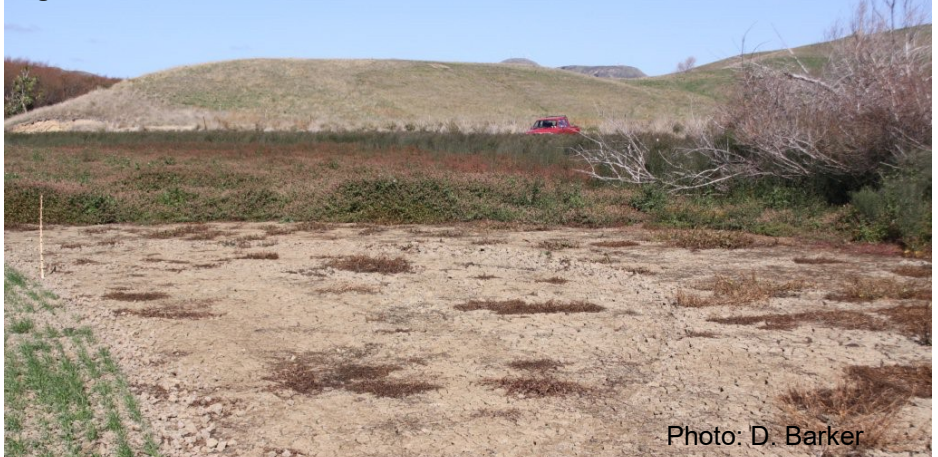
**Figure 37**

Herbicide application to lake bed communities is shown in Figure 37, and while it may be that the majority of species sprayed are introduced, it is inevitable that some native species will have been sprayed.

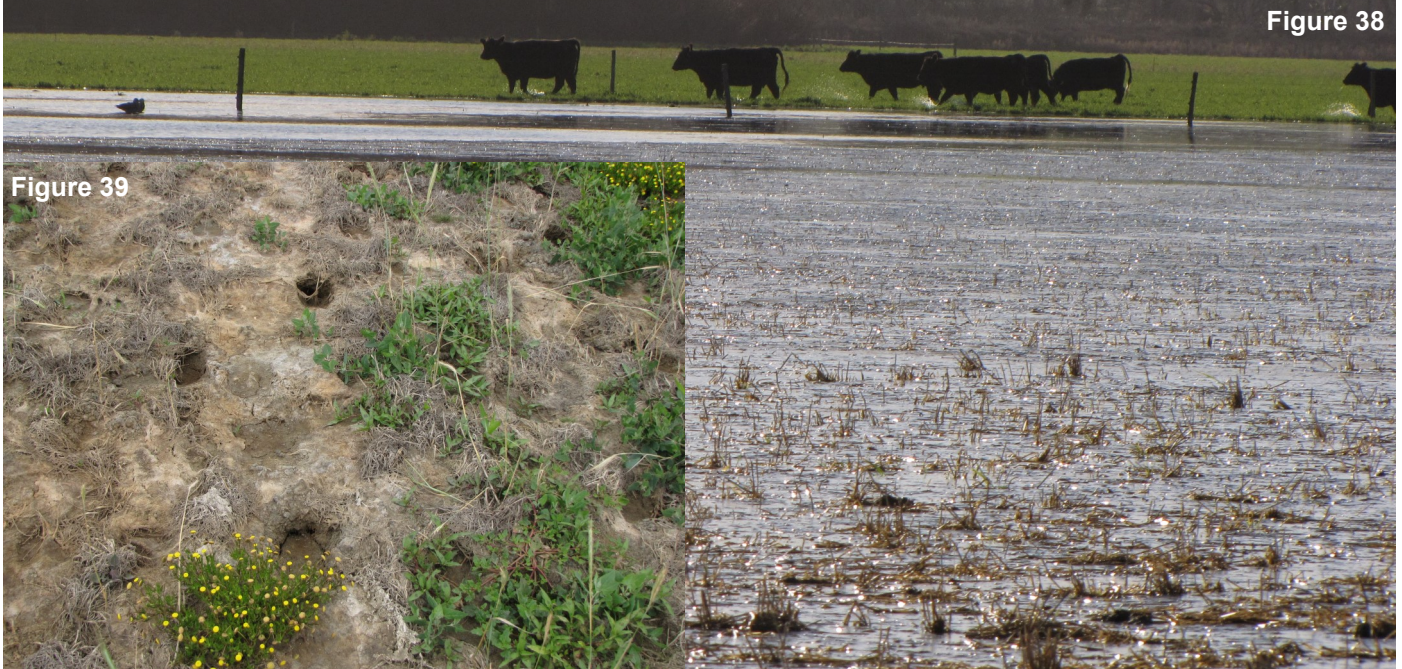
Agricultural activities have had a number of impacts on the lake. These range from direct input of faeces and urine to both the waters and bed of the lake, cattle trampling and vehicle compaction, and herbicide application. Figure 38 illustrates cattle amongst flooded fodder crops. Although the green areas appear to be dry, the lake in fact extends a considerable distance (ca. 80 metres) into the fodder crop.
