**MARLBOROUGH  
DISTRICT COUNCIL**

# Water Quality in the Linkwater Area

**Technical Report No: 19-005  
August 2019**

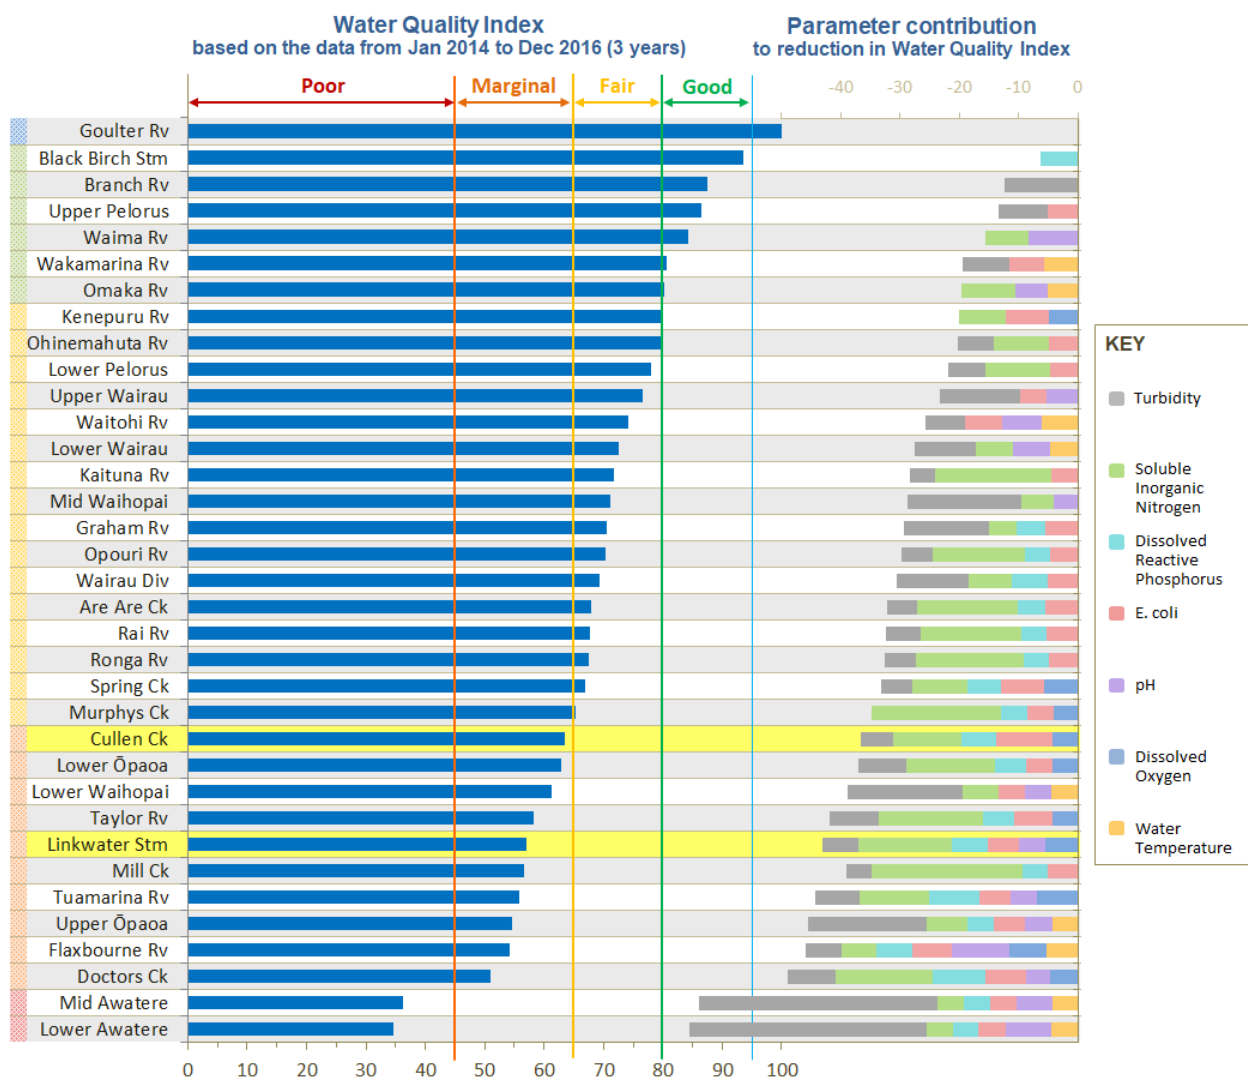
**Figure 8: Water Quality Indices for all sites monitored as part of the State of the Environment programme. The sites are ranked from highest Water Quality Index at the top and lowest index at the bottom. The blue bar on the left side of the graph shows the values of the Water Quality index. The right side of the graph shows the contribution that the different parameters (see KEY) have on the reduction of the water quality index.**

Figure 8 shows the water quality indices for all sites monitored as part of the SoE programme. CullenCreek and Linkwater Stream are highlighted in yellow and it can be seen that both streams had marginal water quality. This prompted a catchment characterisation study with a focus on water quality. The following sections present the results of this study.

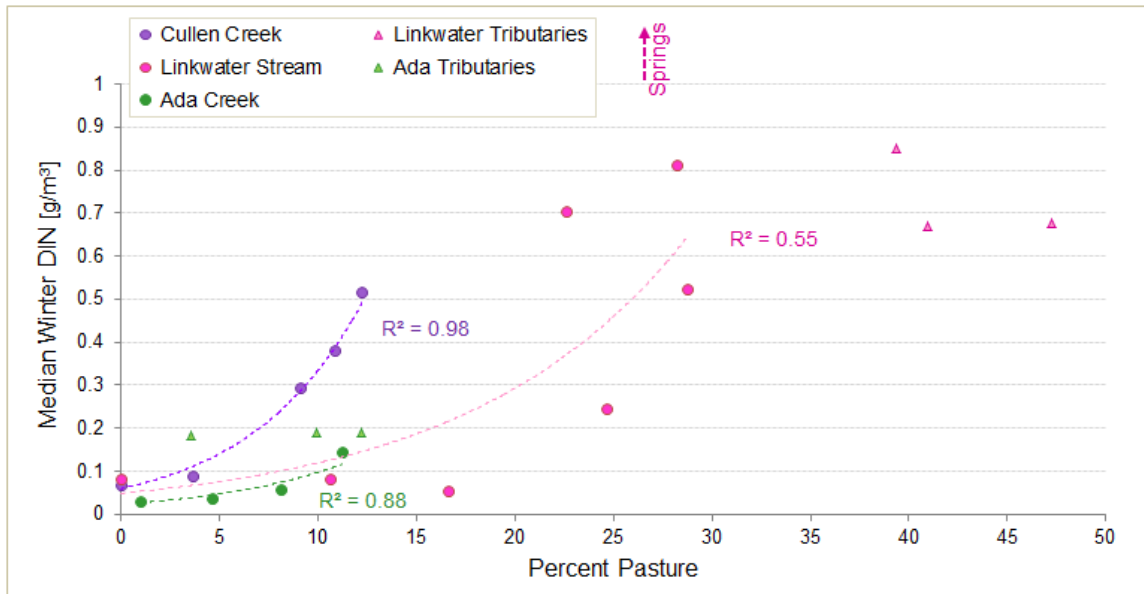
Figure 13: Correlation between winter median DIN concentrations and the proportion of pasture upstream.

DIN levels should change with the proportion of pasture in the area upstream of a sampling site, because leaching from pasture is the main source of DIN in streams. DIN concentrations in Cullen Creek and Ada Stream correlate well with percentage of upstream pasture (Figure 13). This is not the case for Linkwater Stream. The reason is the more complicated underlying geology of the Linkwater Stream catchment.

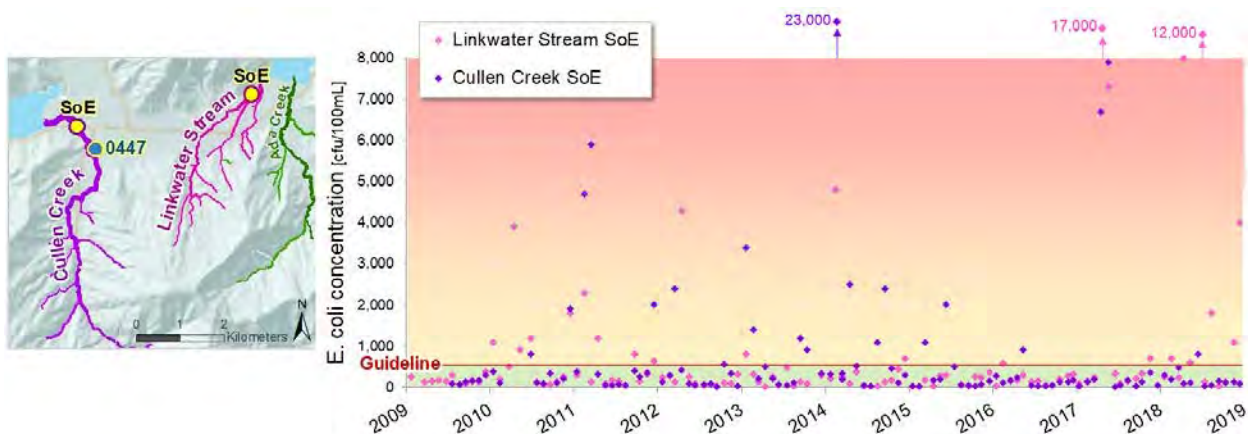
Figure 17: E. coli concentrations at the two SoE sites on Cullen Creek and Linkwater Stream.

In recent years, E. coli concentrations have been noticeably lower, particularly in Cullen Creek. This is likely linked to the requirement by the dairy industry to fence out cattle from larger waterways. Unfortunately, some of the most recent SoE samples from Linkwater Stream had high E. coli levels at comparatively low flows. These samples were taken after the sampling for this study was completed and further investigation might be required.

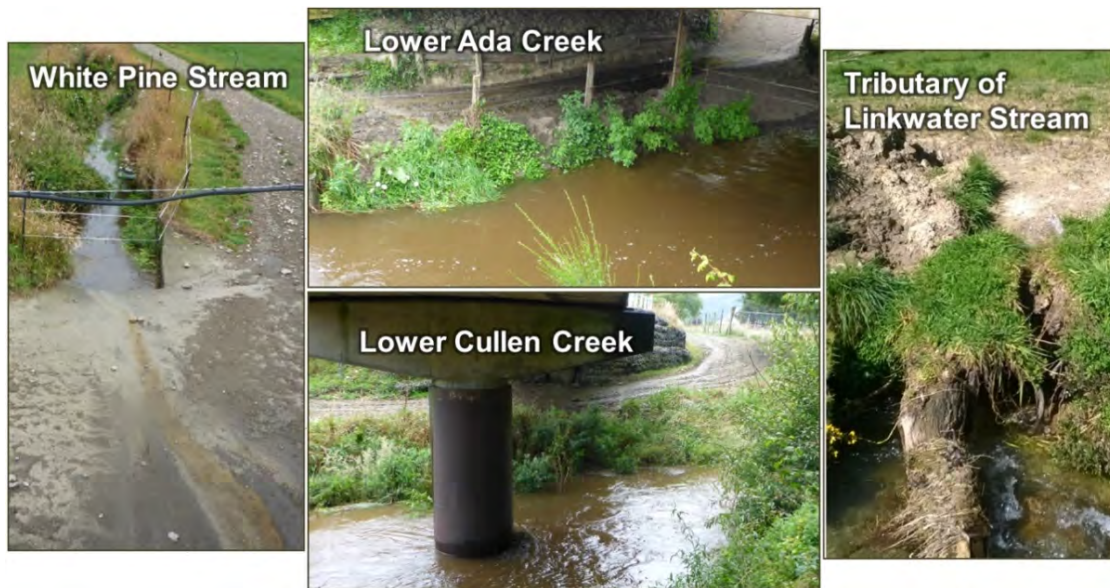
**Figure 20: Examples of rainfall run-off entering streams in the Linkwater area.**

Sampling for the study was done during baseflow only and the samples taken had very low turbidity. Figure 20 shows photos taken during a visit to the area when some rain had fallen. Run-off could be seen entering streams from nearby cattle races. Apart from sediment, this run-off would also wash nutrients and faecal material into the waterways.

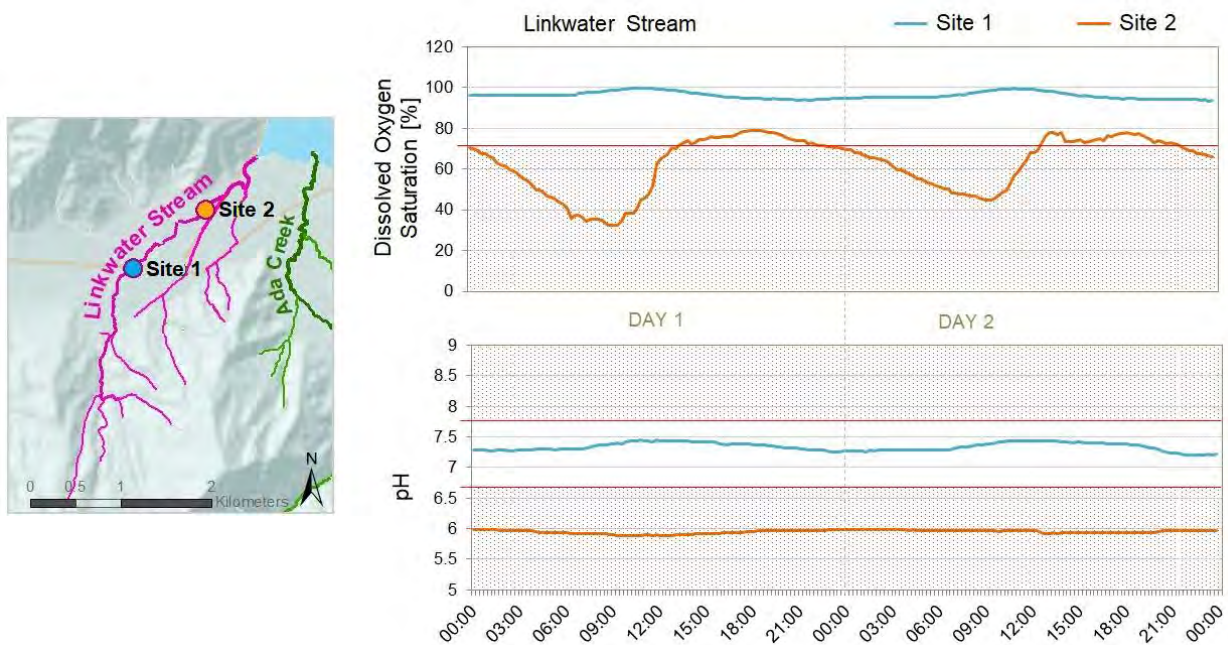
Figure 23: Dissolved Oxygen Saturation and pH measured continuously over two days in Linkwater Stream.

To investigate the variation of water temperature, dissolved oxygen and pH in Linkwater Stream, a monitoring sonde was deployed at two sites. The deployment was done in summer, in pool areas where negative effects on aquatic ecology are most likely. Measurements were taken every 15 minutes over a period of two days.

Water temperatures were consistently sufficiently cool at both sites. Dissolved Oxygen Saturation and pH were at acceptable levels at Site 1, but at Site 2, further downstream, both parameters were below guideline levels most of the time (Figure 23). The most common cause for low pH and oxygen levels in streams is the breakdown of organic material. In Linkwater Stream, there were no obvious signs of accumulated organic matter, such as leaves or other plant material. Animal droppings from cattle upstream (see Section 6.2.3) are a potential source of introduced organic material. Additionally, downstream of Site 2, groundwater is being forced to the surface. Groundwater tends to have lower dissolved oxygen levels. Although, no springs were noted at Site 2 it is possible that groundwater was entering the stream through the stream bed.

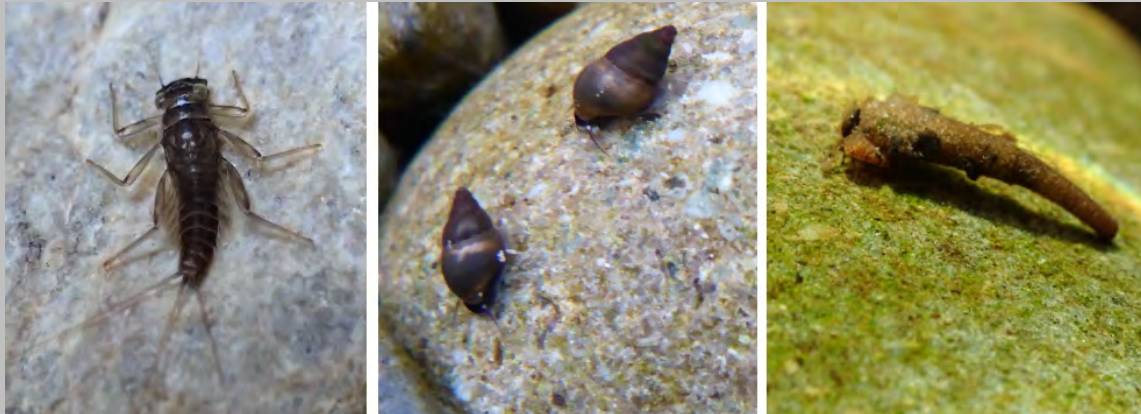
Macroinvertebrates are insects and other soft-bodied animals that can be seen with the naked eye.

The different species have a varying degree of resistance to contamination. Some sensitive species, will not be present in streams with degraded water quality. Stark [33] developed a pollution index based on the number of macroinvertebrates from different species found in a sample. This is the Macroinvertebrate Community Index (MCI). Generally, the higher the MCI score the better the water quality. A MCI score that is higher than 80 is indicative of acceptable water quality.

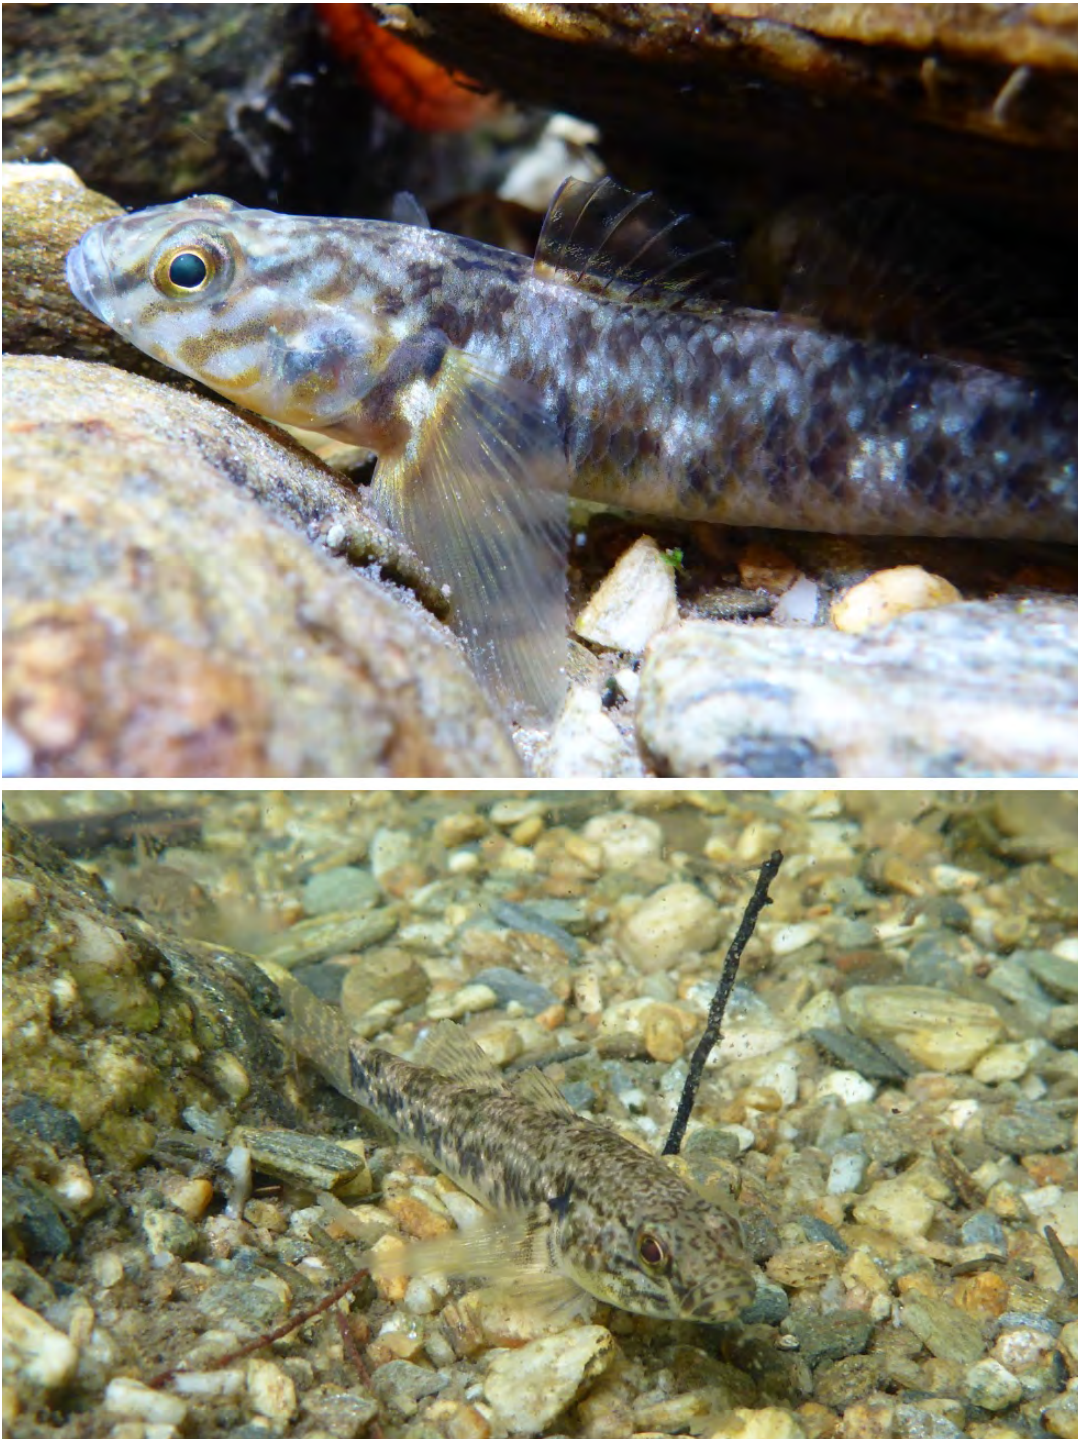
Figure 27: Fish seen in Ada Creek during the water quality study. TOP: Redfin Bully (*Gobiomorphys huttoni*). BOTTOM: Common Bully (*Gobiomorphus cotidianus*).

Fish were not monitored as part of the study. However, during the sampling, Inanga (*Galaxias maculatus*) and Redfin Bully were observed in Linkwater Stream, including the stream reaches flowing through dairy pasture. Comparatively large numbers of fish could be seen in Ada Creek, particularly during dryer periods when fish concentrated in pools (Figure 27).

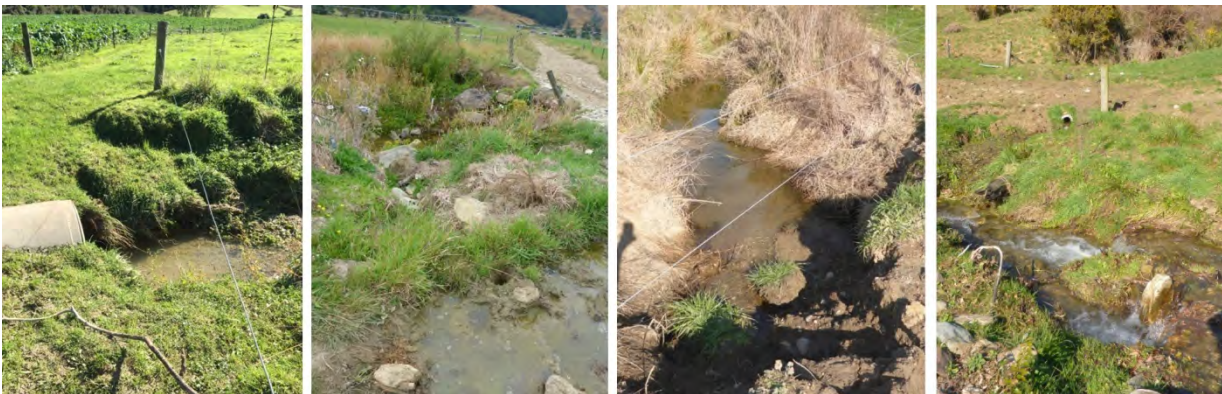
Figure 28: Examples of Critical Source Areas in Linkwater.
