# WINERY WASTES SURVEY

Report prepared by  
Joanne Smart  
Environmental Protection Officer  
April 2008  
Version 1.2

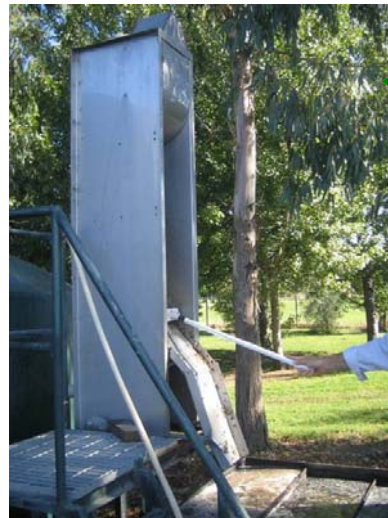
**Screens Need Regular Cleaning**

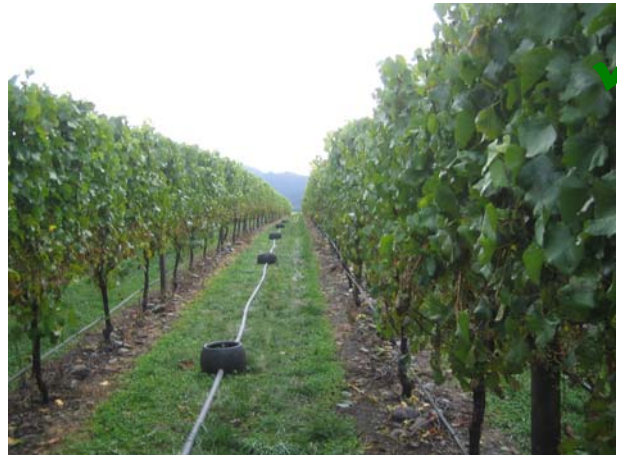
**Regular Shifting Avoids Overloading**

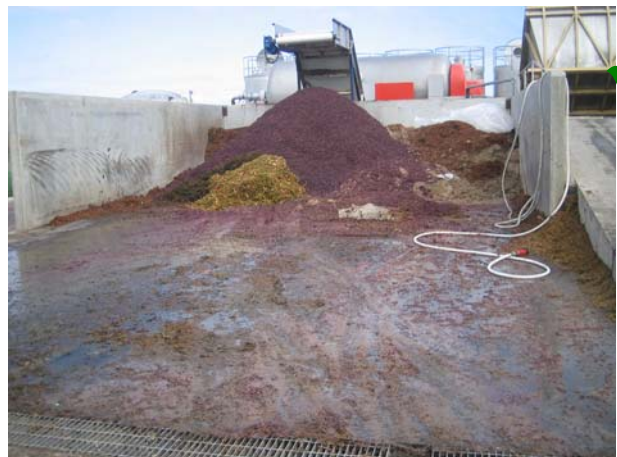
**Grape Marc Stored on Concrete Bunded Pad with Leachate Collection**

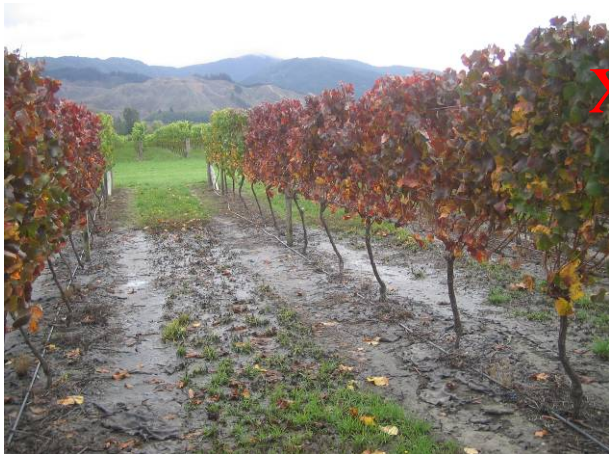
**Overloading Wastewater can Impact on Vine Health**

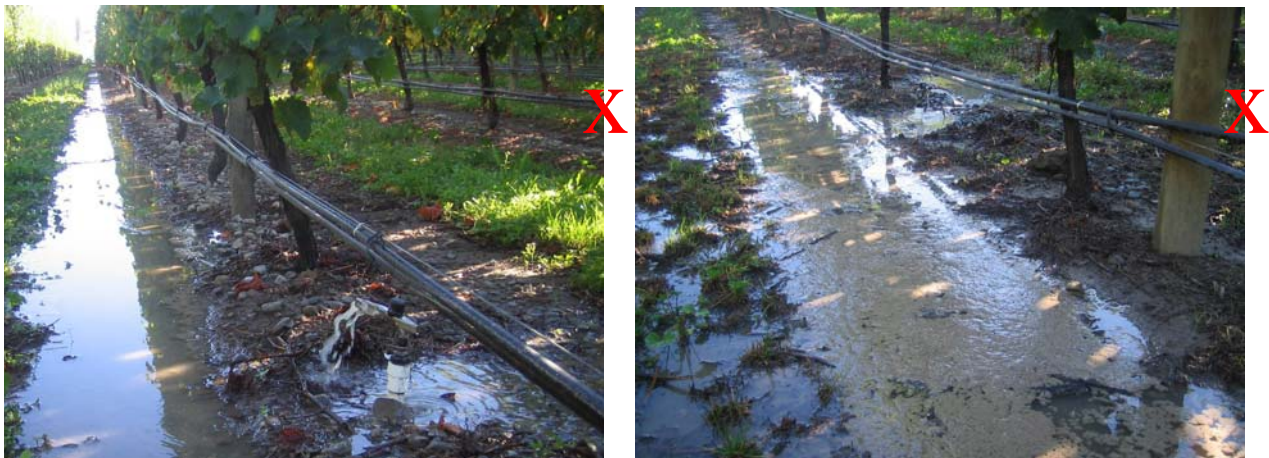
This vintage it was found that there were areas of ponding wastewater. Several sprinklers were blocked up with grape marc and not operating appropriately. When unblocked the sprinklers dripped wastewater to land under low pressure.

The discharge rate exceeded the 10 mm per day requirement in the Proposed Wairau/Awatere Management Plan.

**Overloading of Wastewater to Land**

An Abatement Notice and Infringement Notice have been issued.

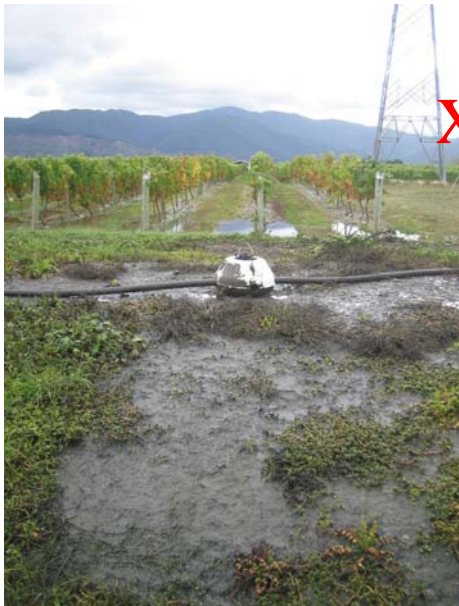
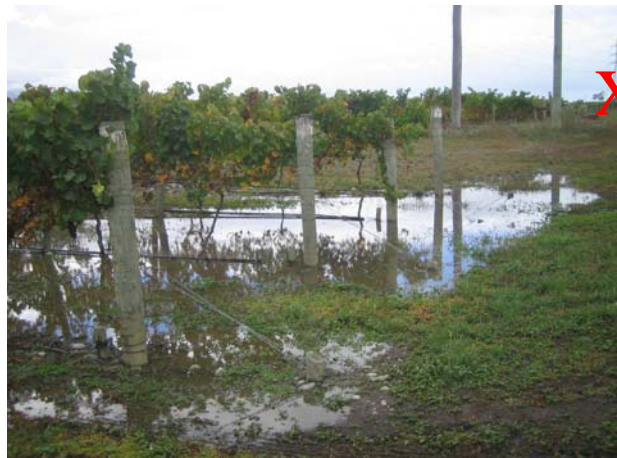
During the week prior to Council's visit the K-line irrigation has not been managed appropriately resulting in a discharge rate exceeding the 10 mm per day requirement in the Proposed Wairau/Awatere Management Plan.

**Overloading of Wastewater to Land**

An Abatement Notice has been issued.

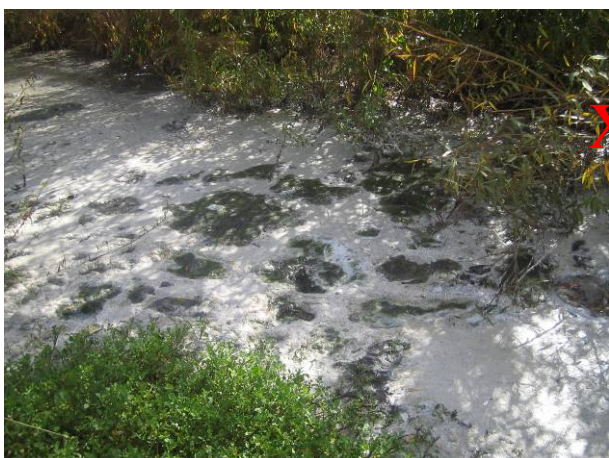
Solid and liquid waste from the RDV was discharged to the stormwater system and entered a waterway.

**Waterway Containing RDV Waste**

Infringement notices were issued to Winery 3 and the winery's General Manager.

The winery also received an Abatement Notice.

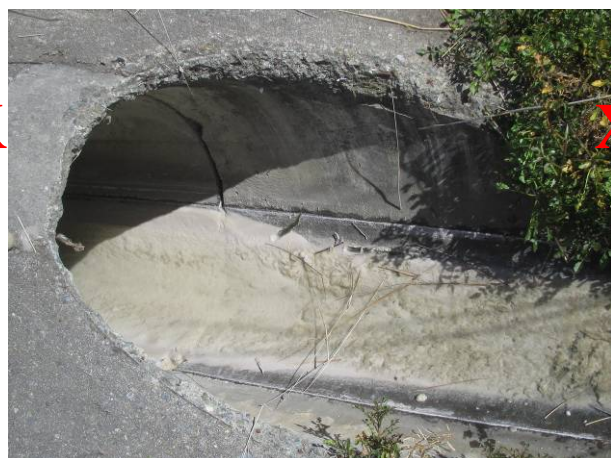
**Stormwater Discharge Pipe Containing RDV Waste**

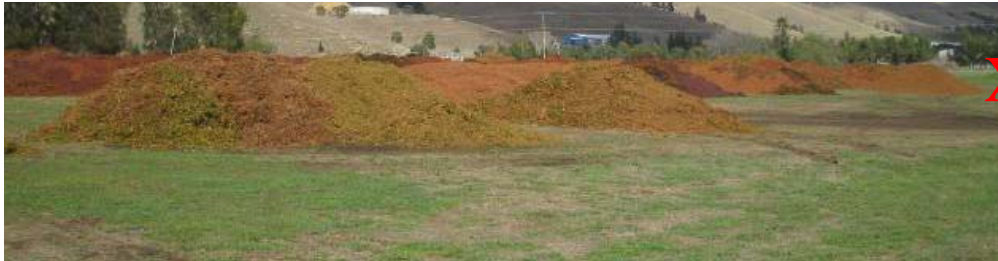
Grape marc had been taken off site and stockpiled on land. There was no leachate collection system in place. The farmer had requested some grape marc for stock feed, but considerably more marc than could be used by this farmer was discharged to land.

As discussed above Winery 3 was stockpiling grape on land. The farmer who was in charge of this land has also been issued an Abatement Notice.

**Grape Marc Stockpiled on Land - No Purpose Built Pad or Leachate Collection System in Place**

A second Abatement Notice has been issued.

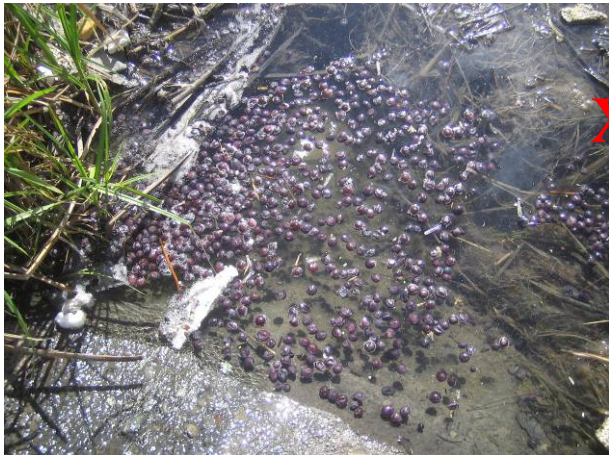
Crates used for hand picking grapes were washed into the stormwater system. This resulted in grapes and wash water entering the co-op drain.

**Grapes in Waterway**

An Infringement Notice has been issued.

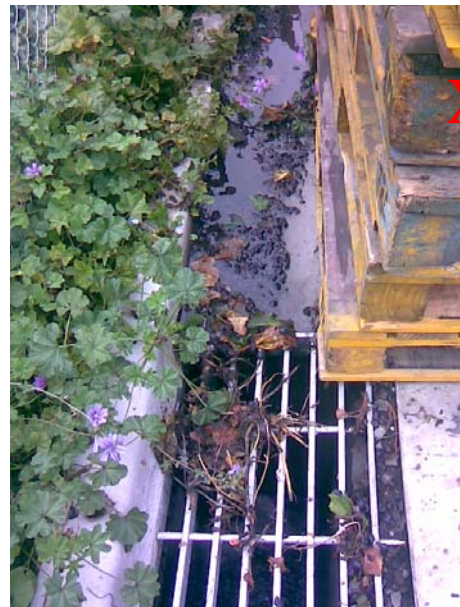
**Grapes and Washwater entering Stormwater Sump**

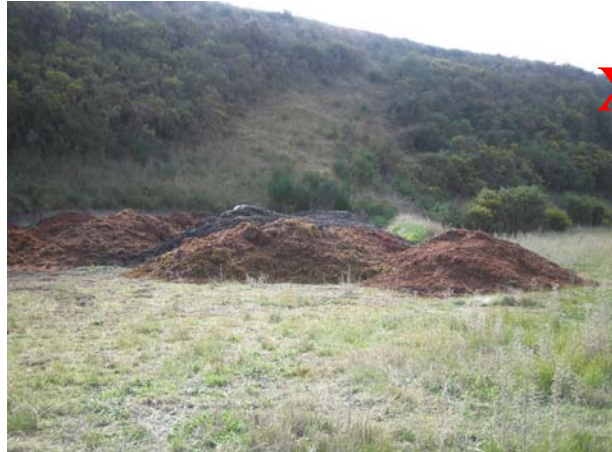
The composting operation was set up on land. There had been an attempt to construct a grape marc pad and leachate collection system, but this system was not operational and the composting was occurring directly on soil.

**Grape Marc Stockpiled on Land - No Purpose Build Pad or Leachate Collection System in Place**

An Abatement Notice has been issued.

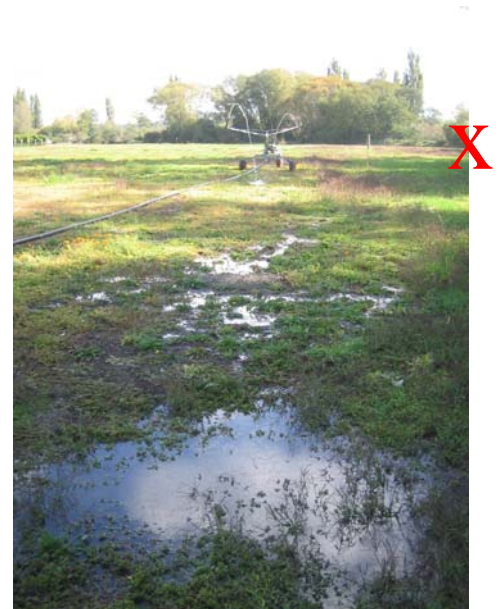
During the first site inspection it was found that winery wastewater was siphoning out of the irrigator under low pressure and causing small amounts of ponding. The winery was requested verbally and in writing to sort this matter out.

The second site visit showed no improvement and winery wastewater was still ponding on the ground and exceeding the 10 mm discharge rate.

**Overloading of Wastewater to Land**

An Infringement Notice has been issued.

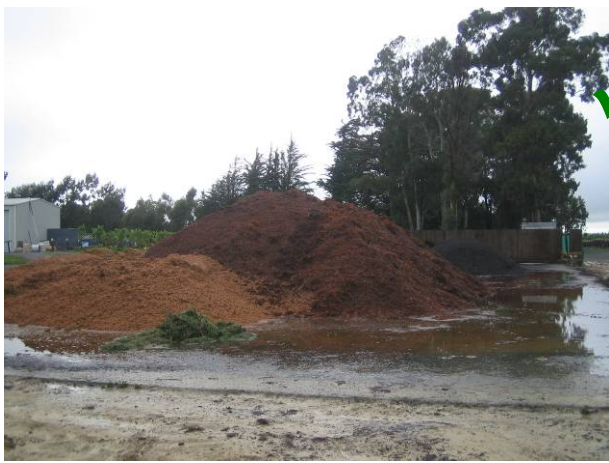
**Grape Marc and Leachate Contained on Concrete Pad. Leachate runs off to Wastewater System**
