RIVERS & LAND DRAINAGE

ASSET MANAGEMENT PLAN 2015-25

Version June 2015

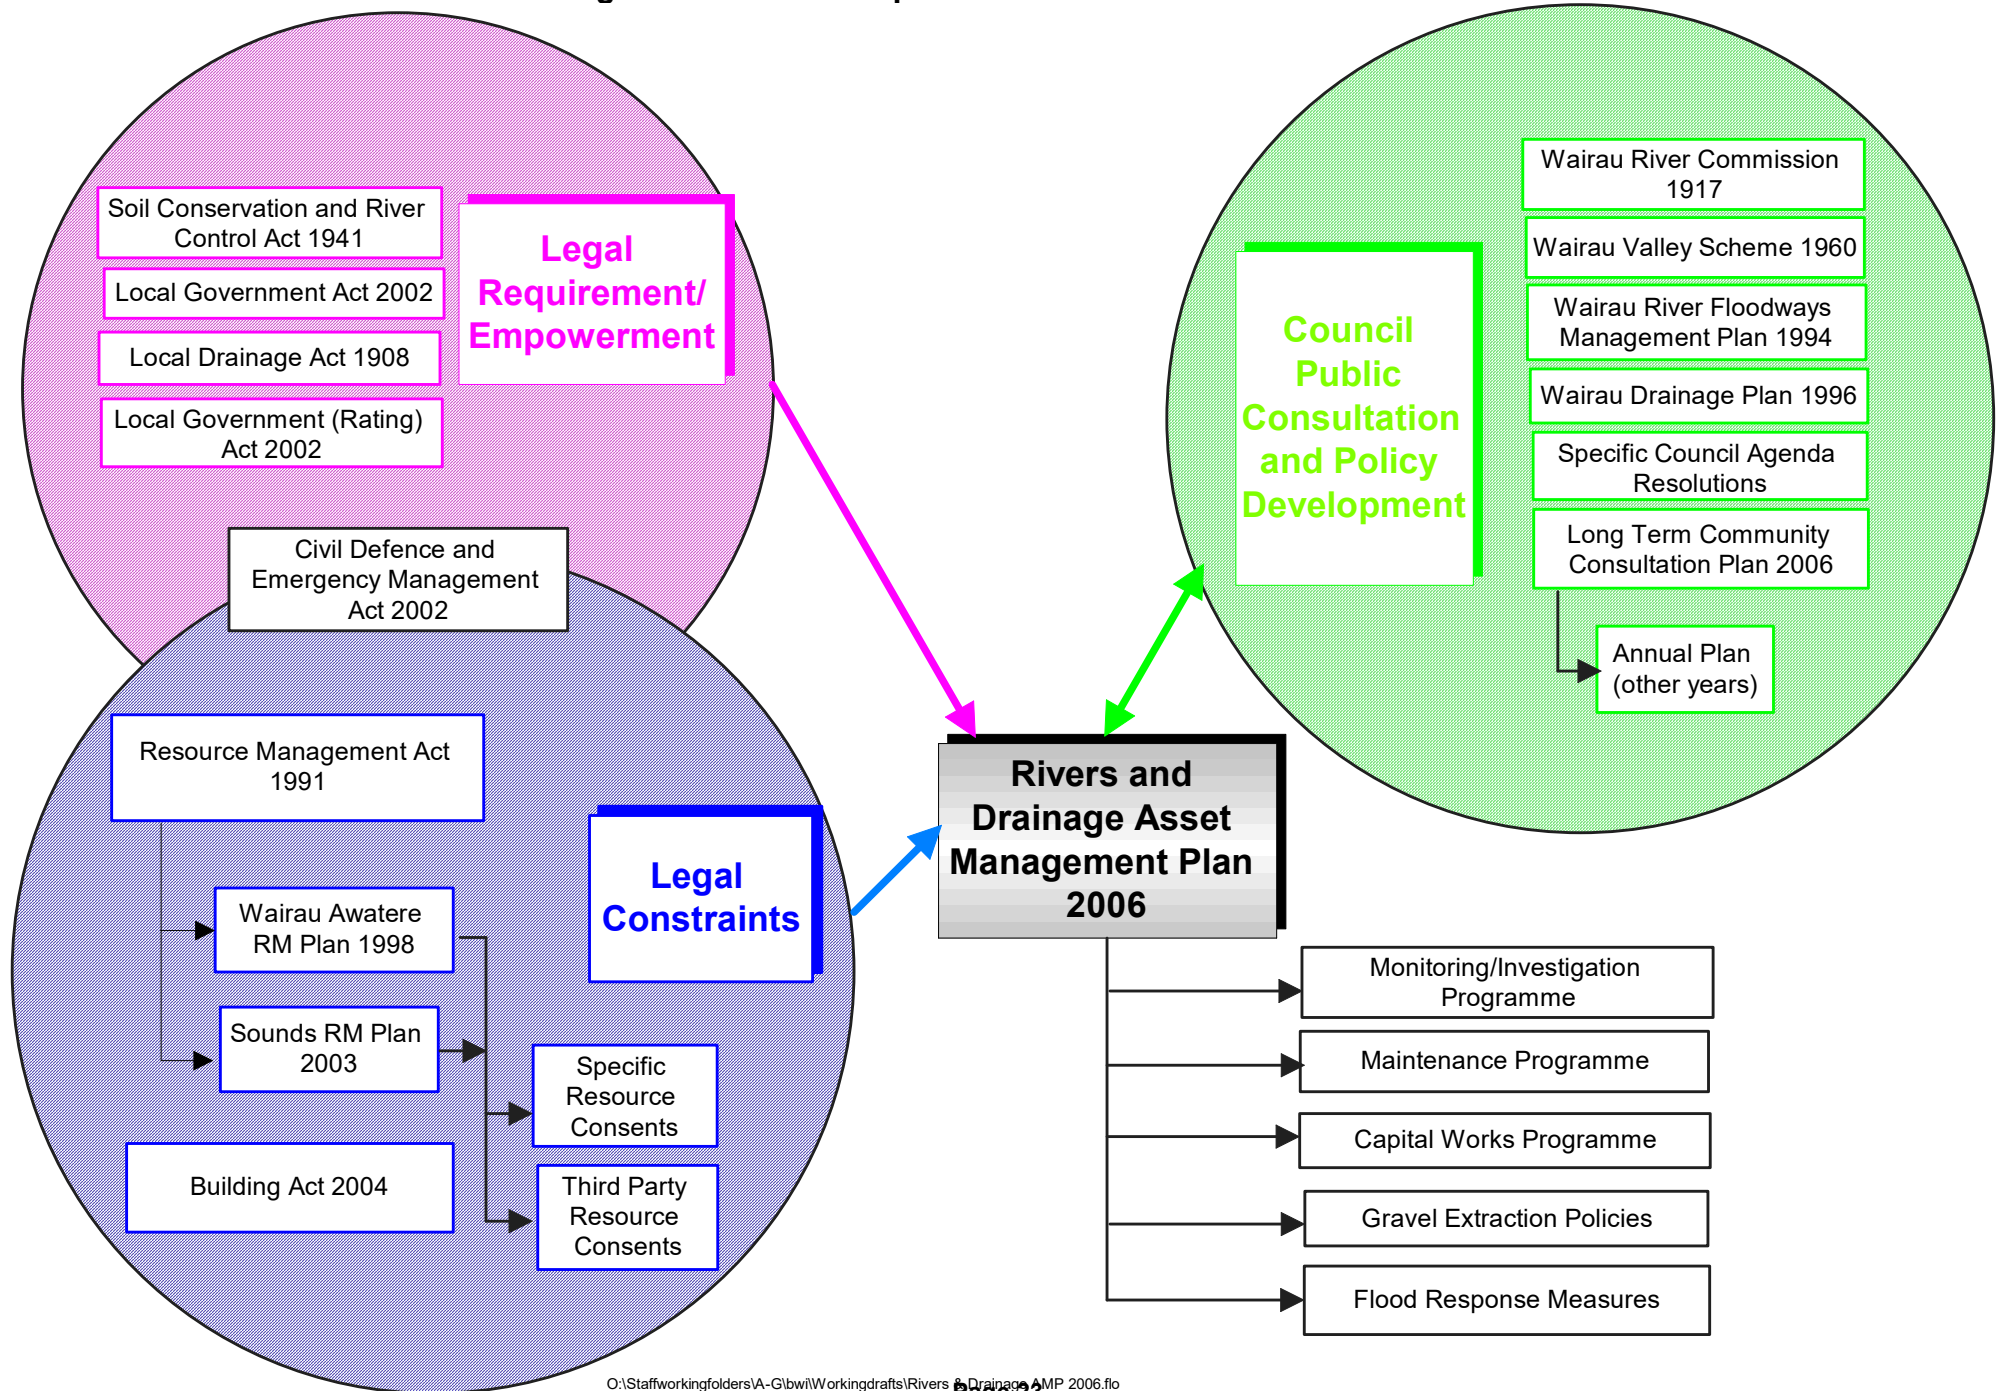
Figure 1: Relationship of AMP with other

The interface of the various documents is depicted diagrammatically on Figure 1.

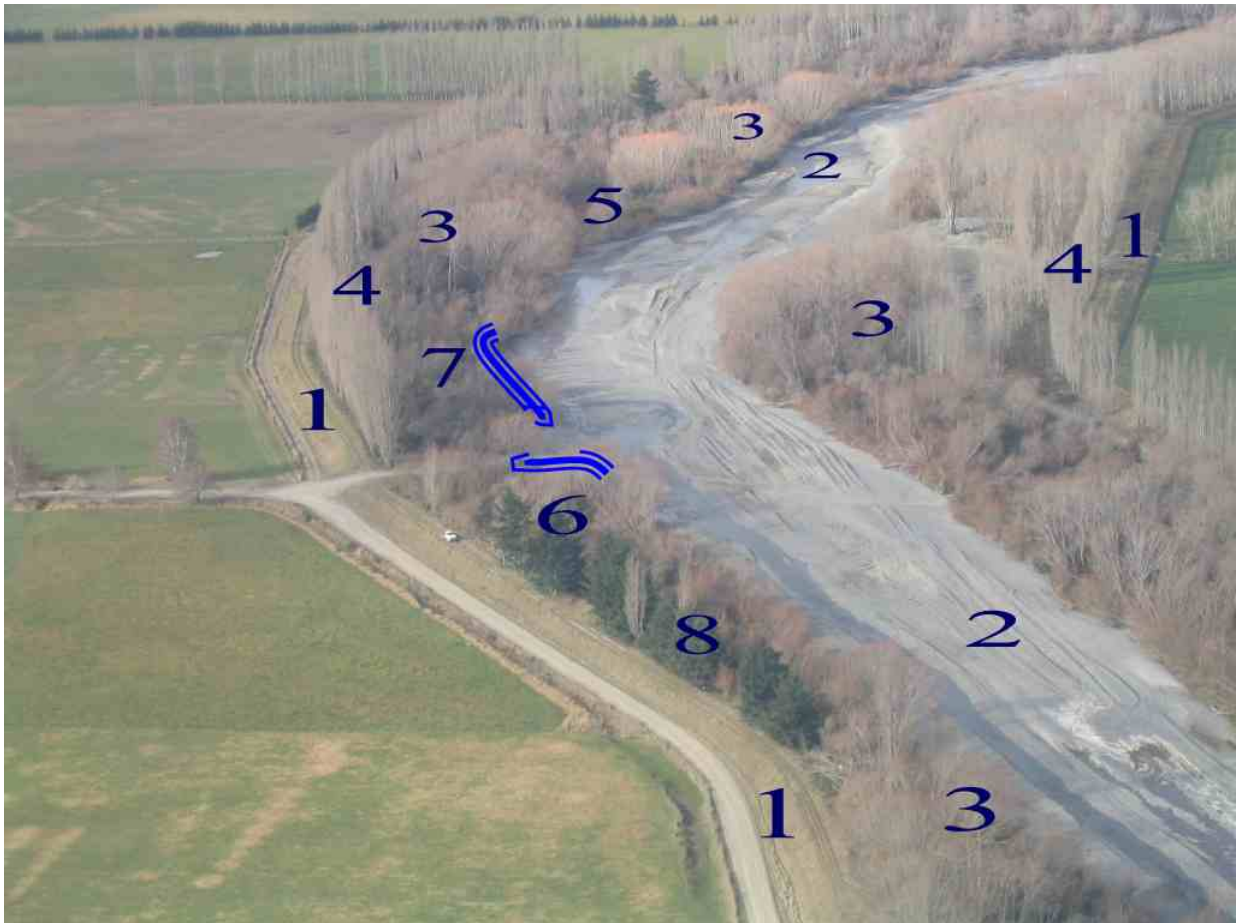
Bank edge protection (rock, structural)

In an area of particularly severe river bank attack on the outside of a bend an earthen groyne or spur bank with a head of heavy erosion resistant rock rip rap (6) offers even greater protection against stop bank attack. Several of these may be placed at regular intervals. In some locations large concrete blocks (sputniks), or gabions of stones in wire mesh baskets is used instead of rock. An alternative to a rock spur bank/groyne is placing a fairly continuous length of rock rip rap (7) along the face of the river bank under heavy river attack. This can extend for tens or hundreds of metres depending on need due to severity of attack, and will reach from the top of the bank to the full depth of the river.

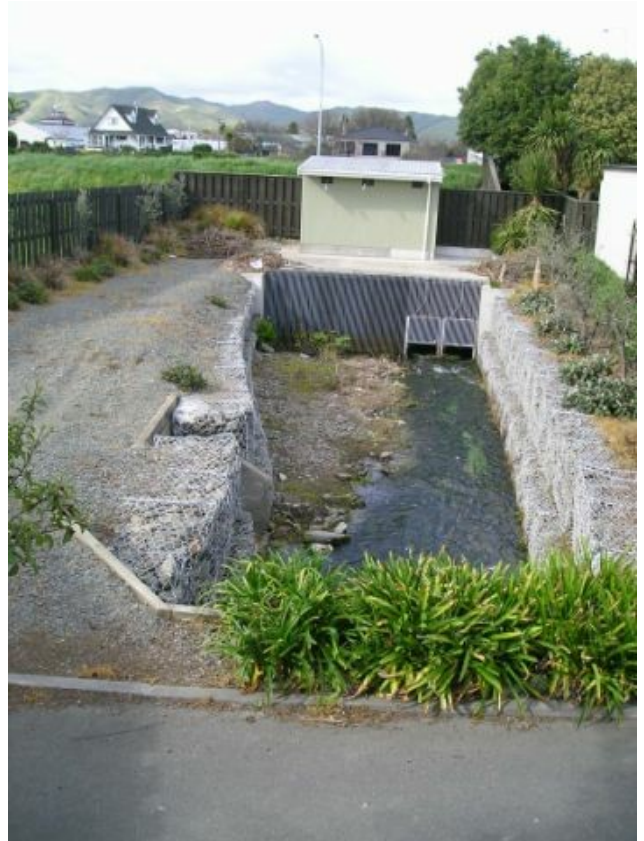
Pipe culverts and floodgates

Pipe culverts under roads and stopbanks are common. In this example the entry to pipe culverts is beside the screens at the end of the channel. When the main river is not in flood the drain outfalls by gravity. A simple floodgate (flapgate) is mounted on the other end of the culvert to prevent back flow from the river when it is in flood.
