REPORT NO. 3865

# DISCHARGES TO THE MOTUWEKA / HAVELOCK ESTUARY

OLIVIA JOHNSTON, LISA FLOERL

Prepared for Marlborough District Council

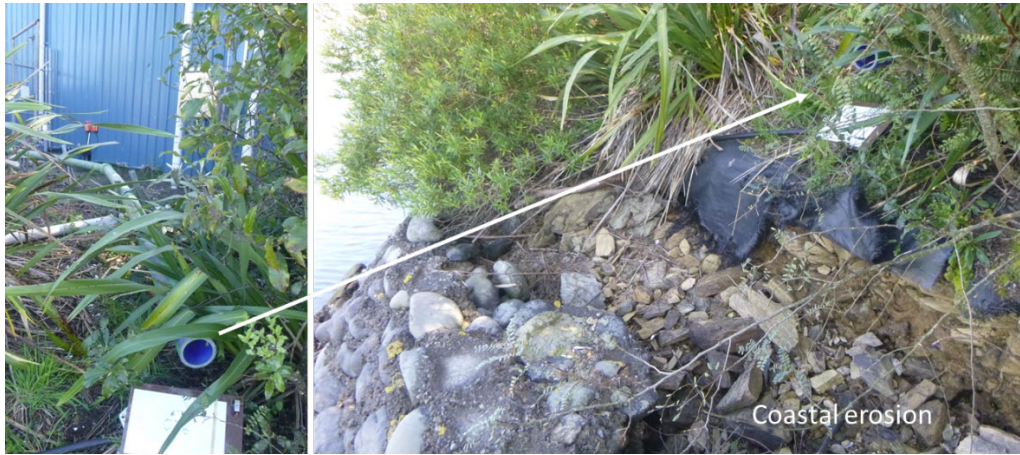
Figure 3. Observation of possible coastal erosion (exposed black geotextile mat and cavity at the top of the seawall) at outfall Site 26. However, the location of this outfall was not matched on Open Data / Smart Maps.

- 9. U150077 – Sanford factory. Possible erosion to the coastal margin at Site 26 (Figure 3).

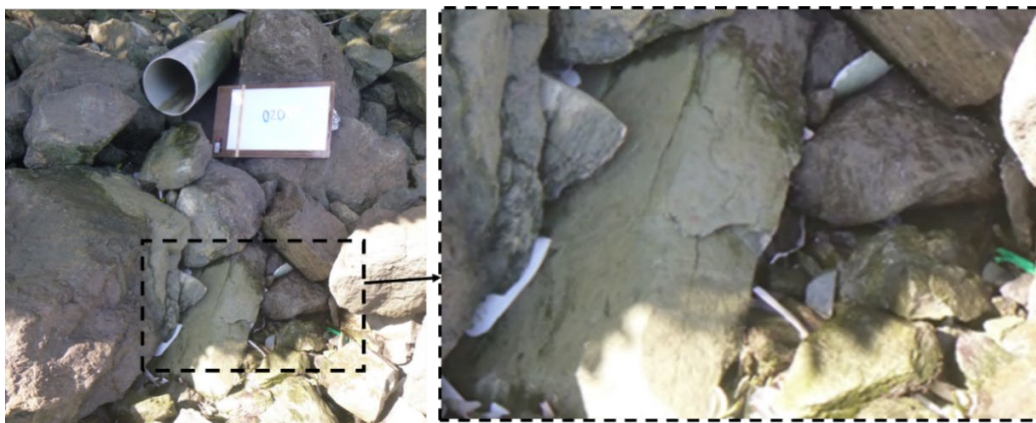
Figure 4. Observation of shell debris at outfall Site 20, possibly relating to consent U110522 (boiler water condensate, stormwater and factory water). No similar shells were observed in any other location along the shoreline searched.

- 10. U110522 – Sanford factory. Broken mature green-lipped mussel shells at outlet (Site 20), possible unconsented discharge of shell debris (Figure 4).

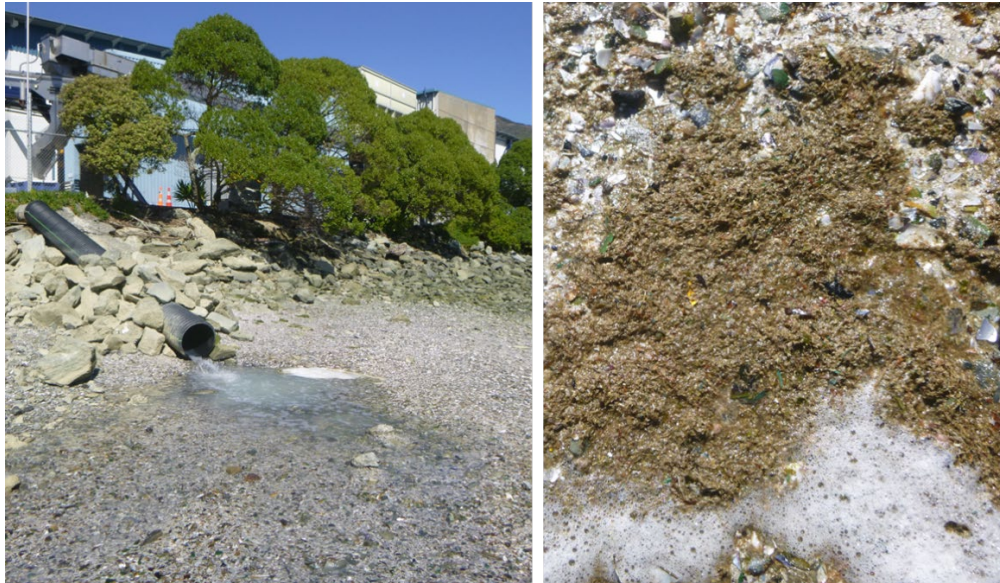
Figure 5. Observation of shell debris and mussel beard at outfall Site 24, possibly relating to consent U960064 (wastewater from a shellfish processing plant) and consent U110522 (which is added to the U960064 discharge stream).

11. U960064 (and U110522 is added to this discharge stream) – Sanford factory. Mussel beard floating on water and shell debris fan both observed (Figure 5).

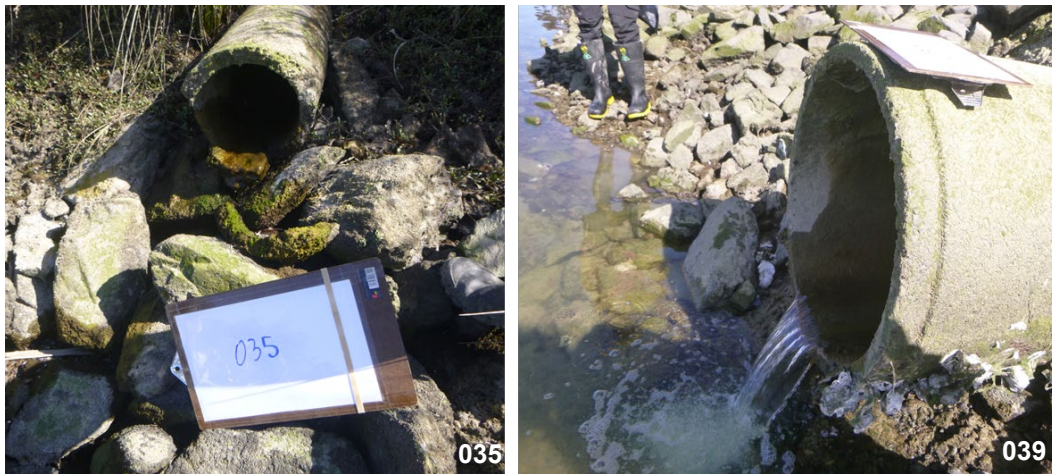
Figure 7. Outfalls (Sites 35 and 39) were observed to have baseflow during the site visit (dry weather conditions).

13. The wastewater overflow outfalls were identified from the infrastructure layer supplied by MDC (Table 1). While it is recognised that there may be a region-wide consent for wastewater overflows in Marlborough, no site-specific consents were found for any of the wastewater overflow sites. One of the wastewater overflow points was found to be blocked (Site 19).
14. The road culverts and causeway through the Estuary had no associated site-specific consent. This possibly pre-dates resource consent requirements. One Estuary causeway culvert was found to be partially blocked.
15. Two stormwater outfalls were observed to have baseflow during dry weather conditions (Sites 35 and 39, Figure 7). This may represent vessel wash-down water from the marina carpark.
