## Marlborough Roads Recovery

Response to 17 July 2021 Event

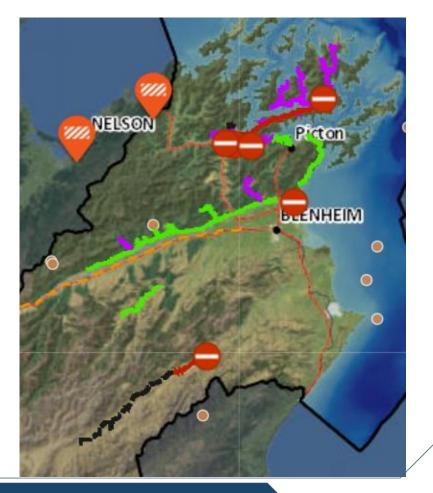
#### **Road Status**

Source: Marlborough CDEM Official Public Information Map

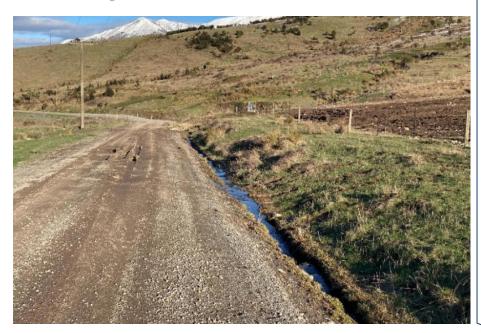
## **Example of: Minor**

Road Awatere and Valley Road

Type **Small**

Scale Water table and road scour

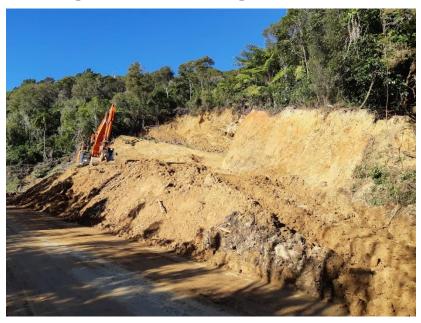
## **Example of: Simple**

Road Queen
Charlotte Dr
2301

Referred **Momorangi** to as **Bay Slip**

Type **Medium**

Scale Above road, Scale estimated 2000m3

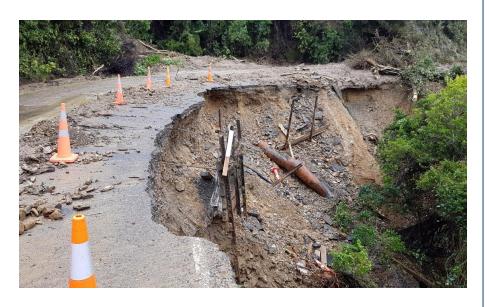
## **Example of: Complex**

Road Mahakipawa and RP Hill 1806

Referred to as Cullens Point

Type **Urgent**

Scale 50m long, up to 8m deep
