# Waitohi and Waikawa Streams Characterisation Study

August 2018

## A Report

### Section 2: A report by the Marlborough District Council that addresses Water Quality in the Waitohi and Waikawa catchments

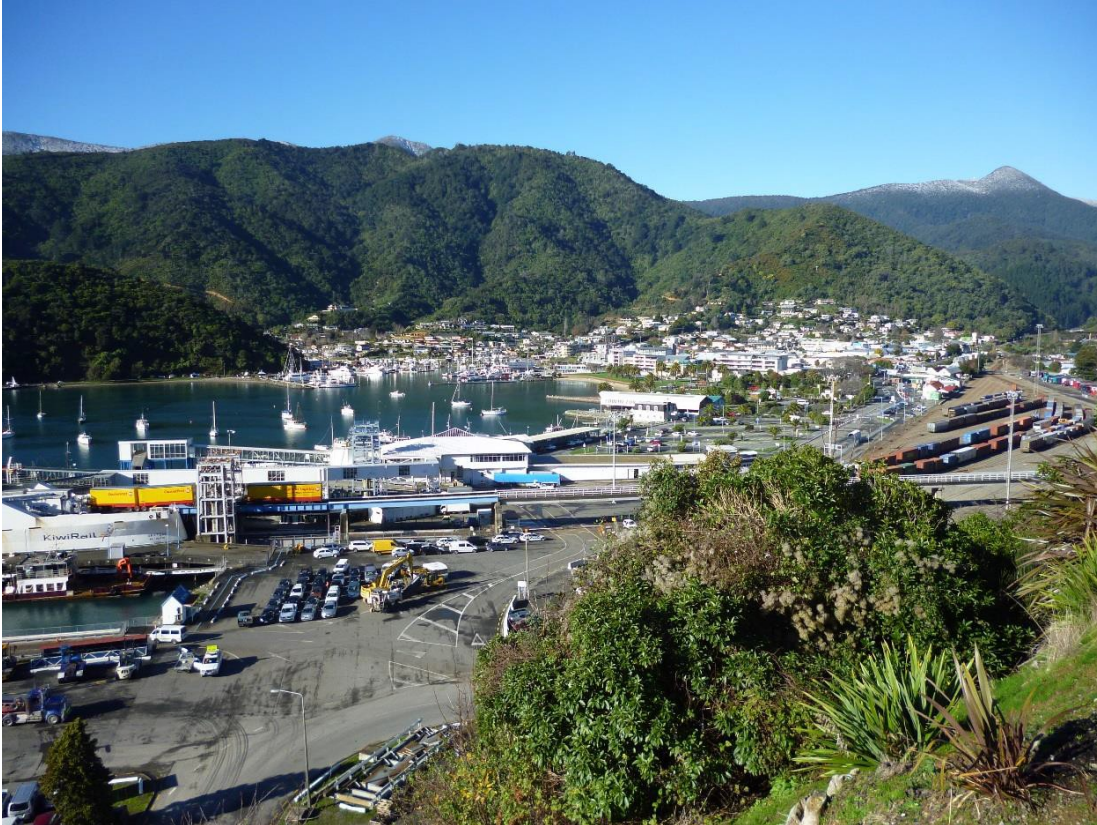
Currently, the Waitohi River runs to the sea beneath the rail yards, with its outlet approximately in the very centre of this image – Photo: Te Ātiawa Trust, circa 2014

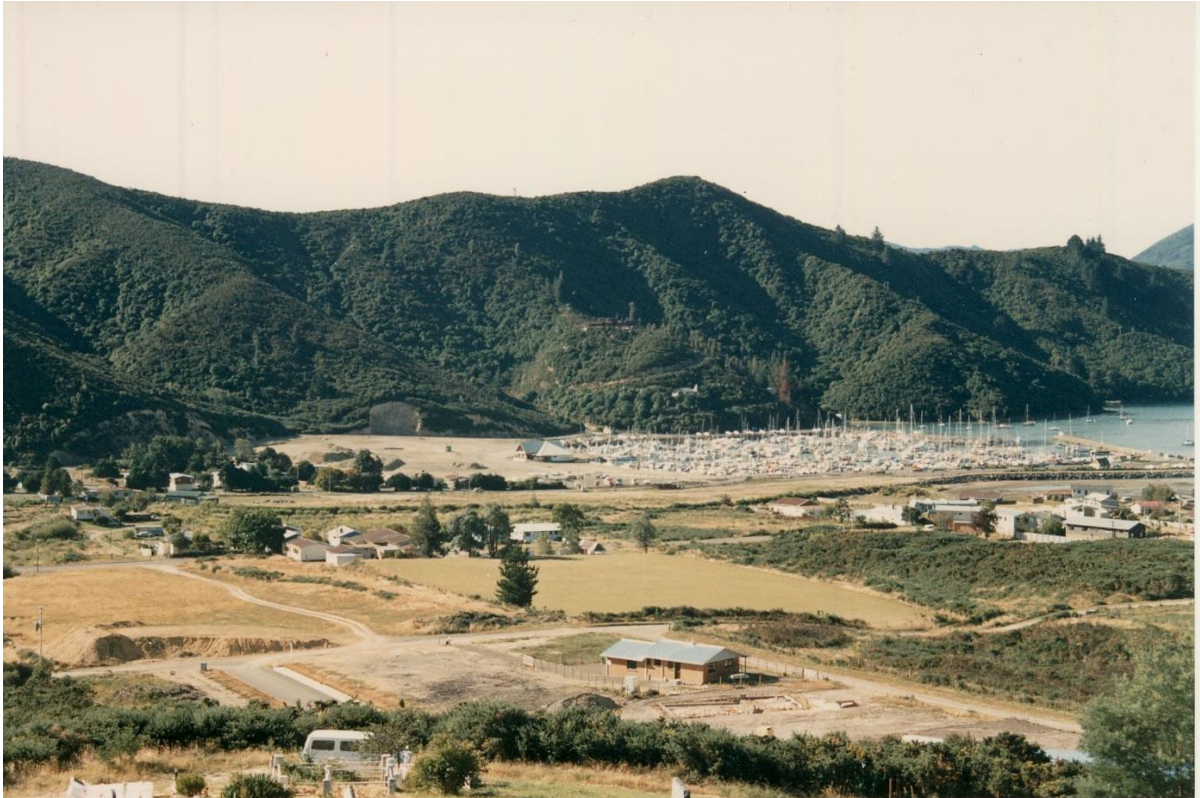
Waikawa Marina in the 1990's showing Waikawa School grounds and early development below Cemetery. Photo taken from top cemetery. Waikawa Stream runs from left to right in the centre of the image. Photo: Mike Taylor Archive

[The second major insult to the lower area of Waikawa Stream and the significant remaining kaimoana beds that had evolved as a consequence of the stream's relationship with the intertidal zone and the wider bay over millenia, was the development of the Waikawa Marina. This development completely changed the character of this substantial area in the southwest of Waikawa Bay. Images that show these changes follow]

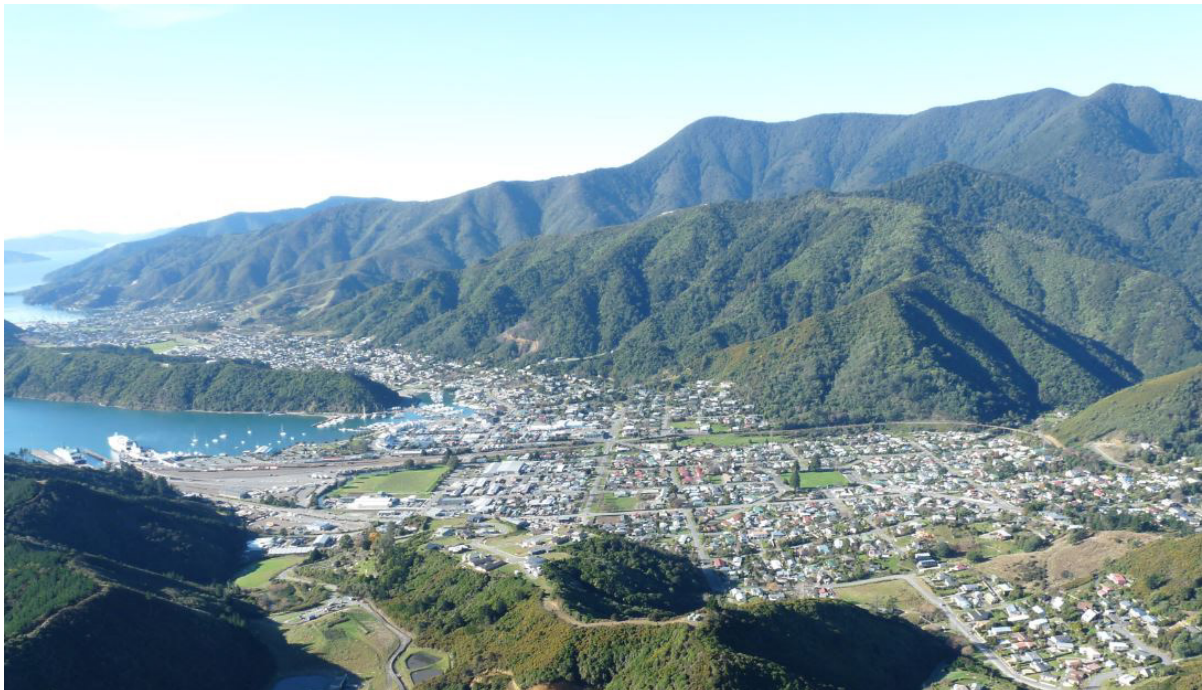
*Figure 2: Aerial view of the lower parts of the two catchments. Picton can be seen in the foreground and the Waikawa catchment in the background.*

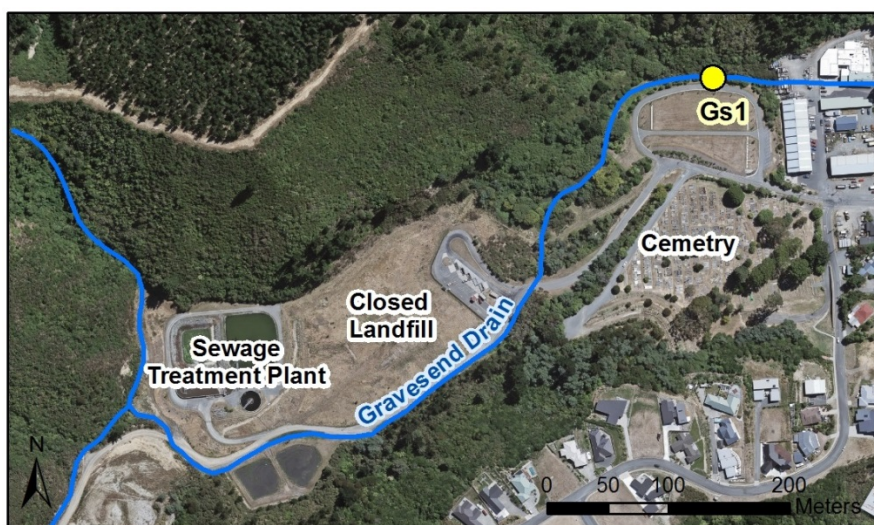
Figure 5: Aerial photograph of the lower sub-catchment of Gravesend Drain.

The very high DIN concentrations in Gravesend Drain, however, are likely to originate from a different source. Although, the stream flows past a cemetery, the gradient of the land causes most of the leachate from this area to reach surface water downstream of the sampling site. However, some influence from the cemetery cannot be ruled out. Nevertheless, it is more likely that activities further upstream are the source of nitrogen. Approximately 400 meters upstream of the sampling site (Gs1) is the location of the Picton sewage treatment plant and a closed landfill. Gravesend Drain flows next to the treatment ponds and closed landfill at a distance of approximately 20 meters (*Figure 5*). Any leachate escaping from these areas is therefore likely to surface in Gravesend Drain.

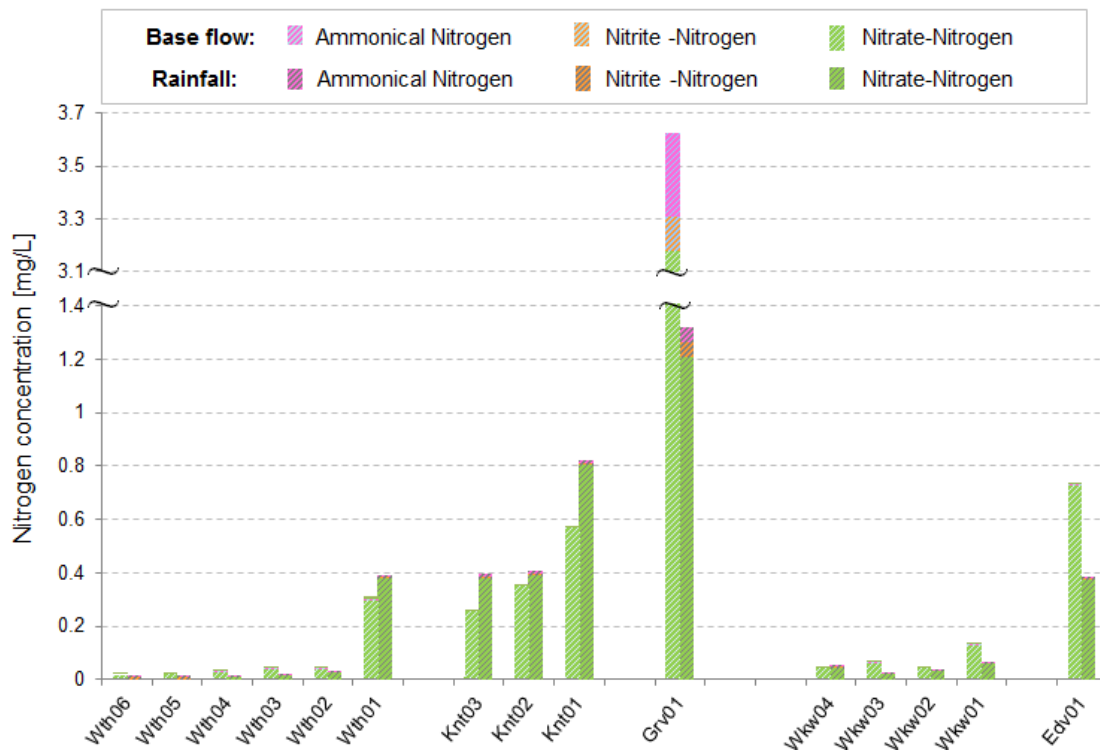
Figure 6: Forms of DIN in the streams of the Waitohi and Waikawa catchments based on median concentrations. Concentrations during base flow and rainfall are shown separately.

In almost all streams monitored in the Waitohi and Waikawa catchments, Nitrate is the main form of DIN (*Figure 6*). The only exception is Gravesend Drain, which has high Nitrite and Ammonical Nitrogen concentrations. High Ammonical Nitrogen concentrations are toxic to aquatic life and concentrations in Gravesend Drain are above the 80% species protection limit in the National Policy Statement for Freshwater Management (NPS-FM).

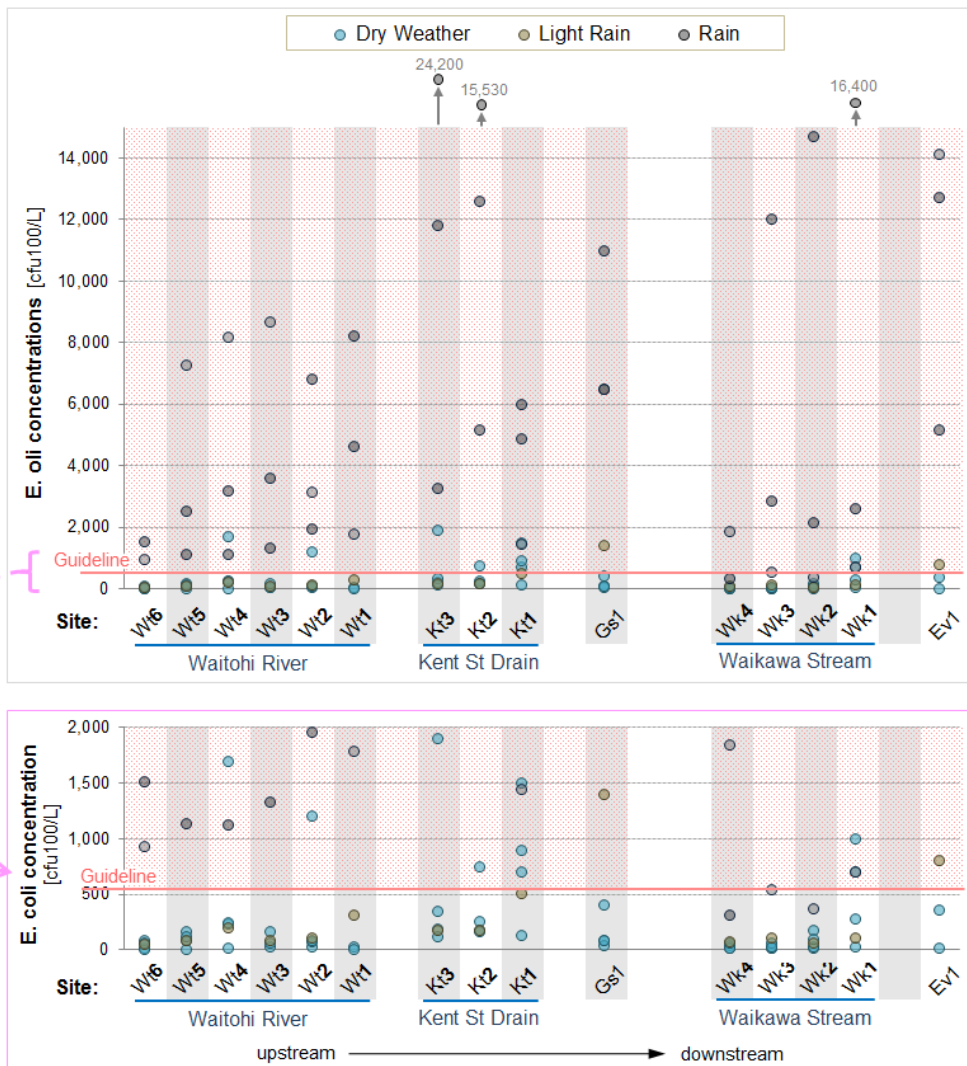
Figure 10: *E. coli* concentrations in Waitohi and Waikawa catchments.

E. coli are bacteria that are used as an indicator for faecal contamination. High E. coli concentrations indicate a greater risk for recreational users of becoming sick when coming in contact with the water. Figure 10 shows the E. coli concentrations measured in the two catchments. The guideline value of 550 cfu/100mL is based on unsafe levels for swimmers as published in the Ministry for the Environment and Ministry of Health Guideline document [9].

During rainfall, E. coli concentrations varied considerably at most of the sites, but were lowest at the two most upstream sites (Wt6 and Wk4). Still, bacteria levels in some of the samples from the upstream sites were well above the guideline level. This is surprising, as the main sources of faecal contamination at these sites would be expected to be native and feral animals. At some of the other sites E. coli concentrations reached levels an order of magnitude higher than those observed at these upstream locations. In the Waitohi River, E. coli concentrations peaked at site Wt3, further downstream than during dry weather conditions. In the other waterways no apparent site-specific pattern for the E. coli concentrations could be observed during rainfall events.

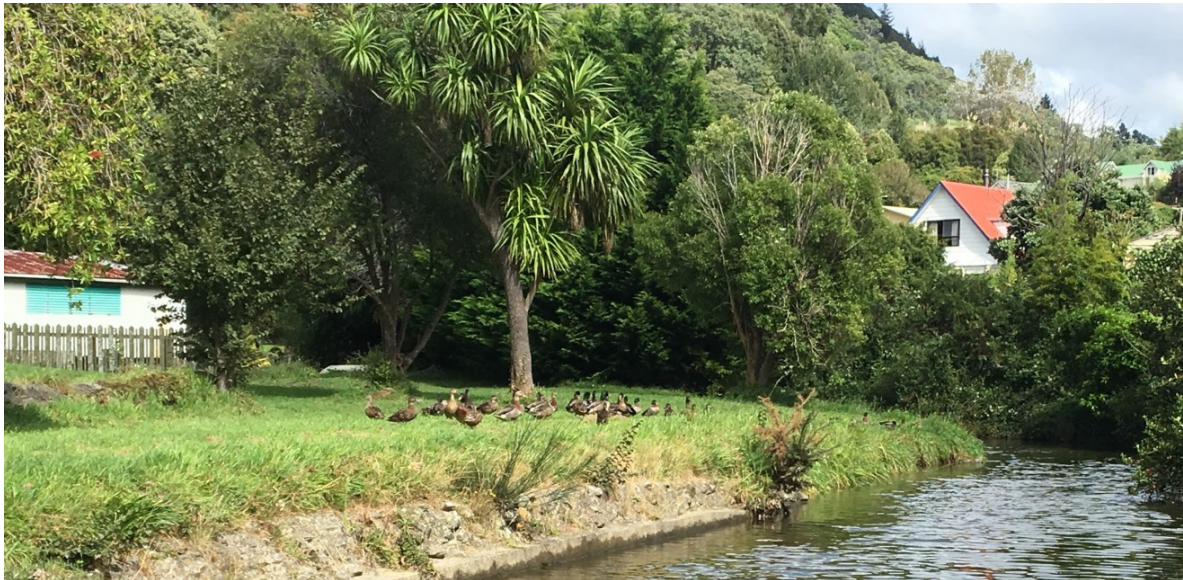
Figure 11: Large number of Mallard Ducks at the Waitohi River at site Wt4.

Mallard ducks, which are the most likely source of faecal contamination (*Figure 11*). The sites located furthest upstream and downstream on Waitohi River had the lowest dry weather *E. coli* concentrations in this catchment.

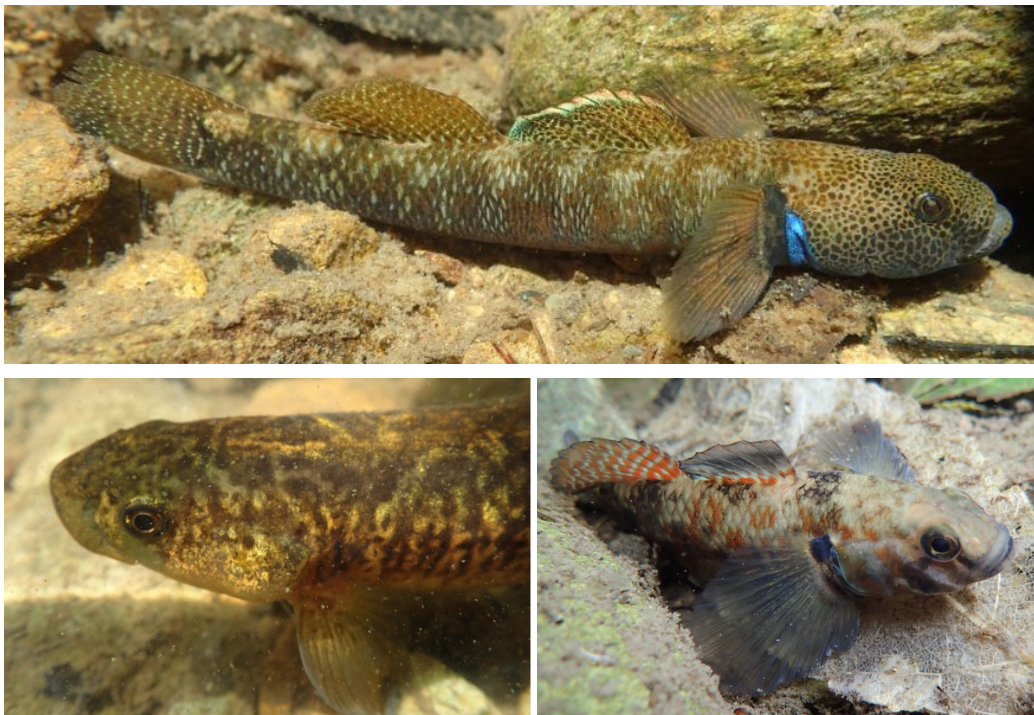
Figure 20: A Blugill Bully (*Gobiomorphus hubbsi*) [top] and a large Koaro (*Galaxias brevipinnis*) [bottom-left] caught in the mid Waitohi River; and a Redfin Bully (*Gobiomorphus huttoni*) [bottom-right] caught in the mid Waikawa Stream.

Fish surveys were carried out in the main streams only. At the two upstream sites monitored (Wt5 and Wk3) a number of Redfin Bullies, Bluegill Bullies and Longfin Eels were found, but also a large Koaro in the Waitohi River (Figure 19 & 18). The lower Waikawa Stream at site Wk2 also had relatively
