**MARLBOROUGH
DISTRICT COUNCIL**

Water Quality in the Tuamarina River Catchment

**Technical Report No: 18-002
January 2018**

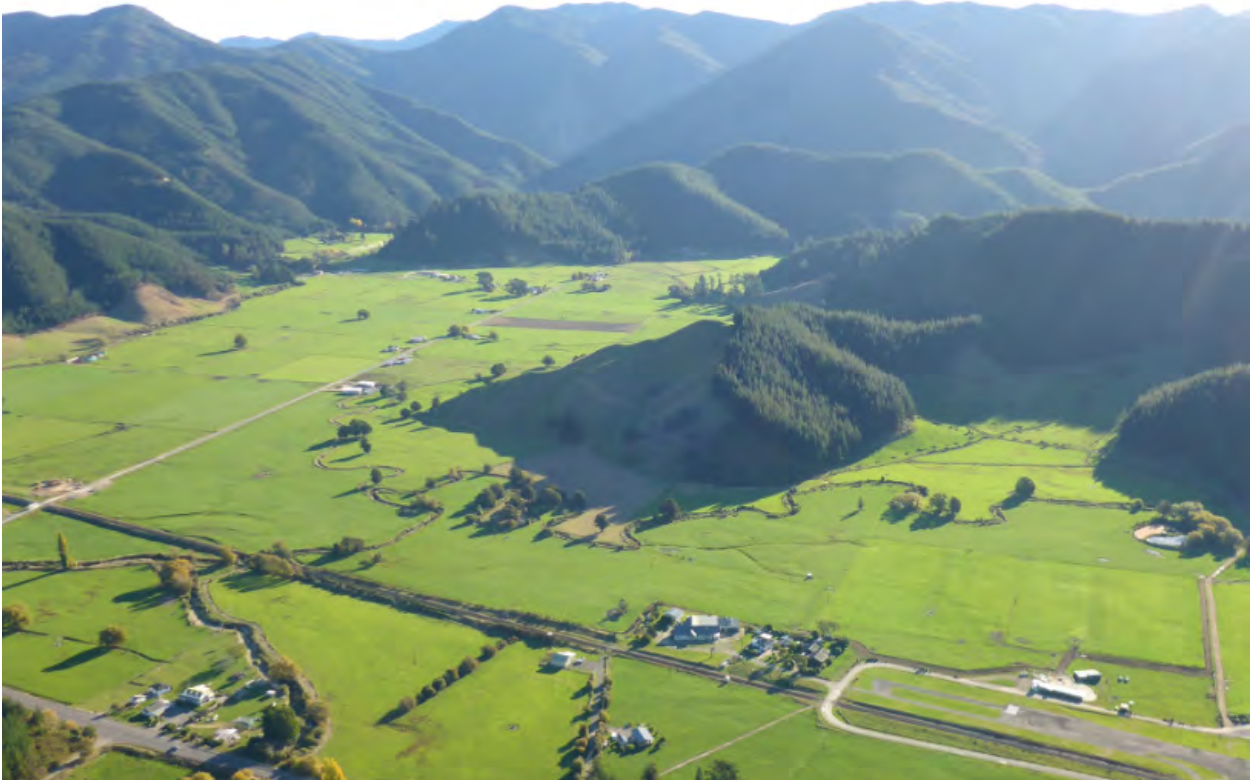
Figure 2: Aerial view of the Tuamarina mid catchment showing the pastoral land use on the river flats and production forestry on the hills.

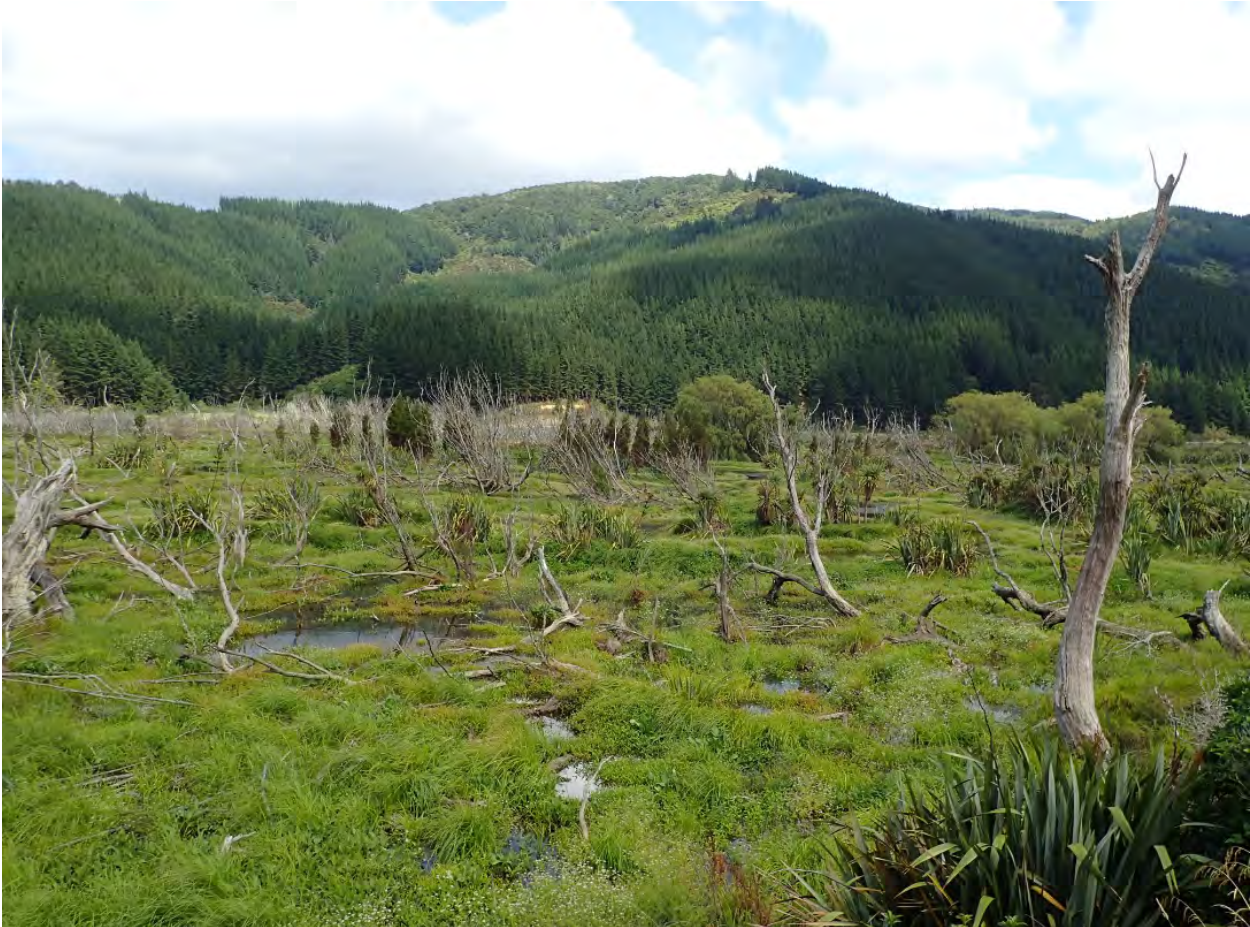
Figure 5: An area of the Para Wetland where aerial willow control was carried out several years ago. Most of the tree trunks have fallen over into the shallow water.

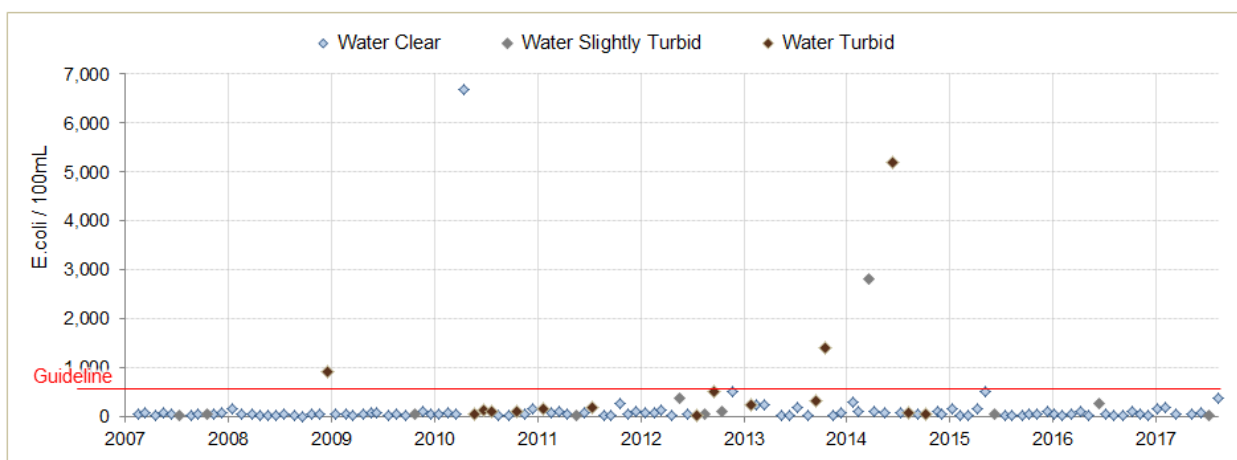
Figure 18: E. coli concentrations in the Tuamarina River just upstream of the Wairau River.

The monthly State of the Environment sampling shows that E. coli concentrations are mainly below guideline level, but can occasionally be very high in the lower Tuamarina River (Figure 18). With the exception of one sample result, high levels are associated with flood events and turbid water. This means that high E. coli concentrations are generally a result of surface run-off during rainfall events.

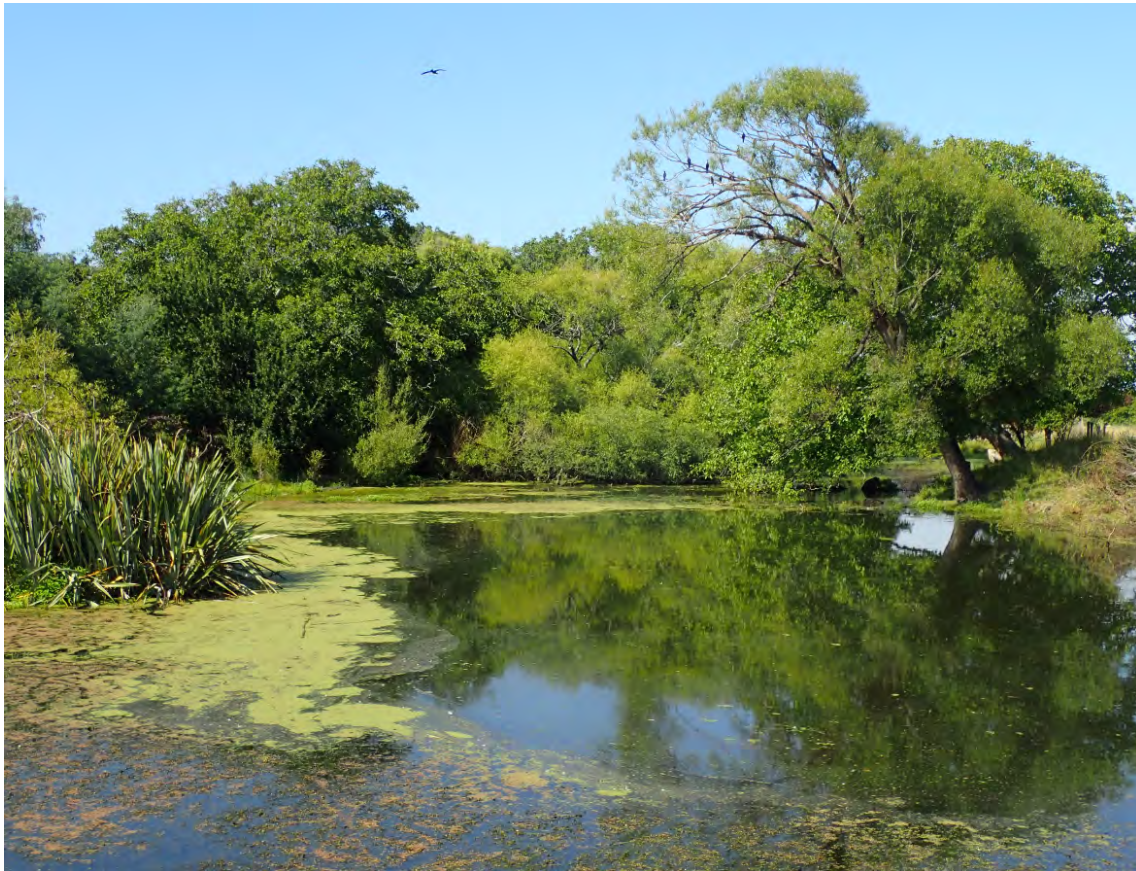
Figure 21: The Tuamarina Lagoon. Note the shags in the tree in the top-centre-right of the picture.

The Lagoon outflow drains a ponded area that is home to a breeding colony of more than 15 shags and a number of ducks (Figure 21). Elevated *E. coli* concentrations are therefore likely a result of wildfowl with higher *E. coli* levels in summer when flows and subsequently, dilution is lower. However, the inflow into Tuamarina River from the Lagoon is very small compared to the flow in the actual river and has therefore little effect on the Tuamarina River water quality.

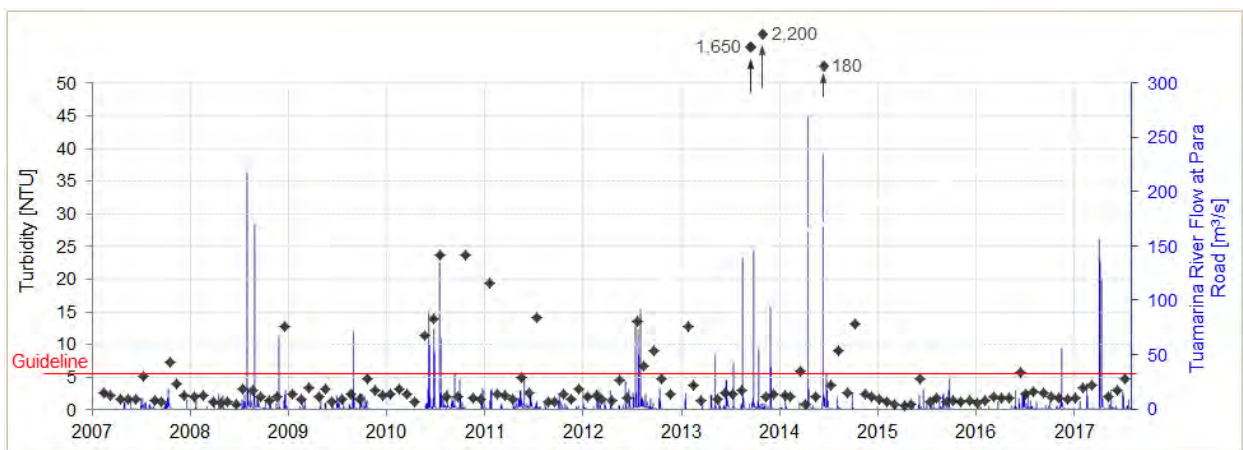
Figure 22: Turbidity in the Tuamarina River at the confluence with the Wairau River (black) and Tuamarina River Flow at Para Road (blue).

One of the reasons for the marginal water quality in the Tuamarina River, prompting this study, were extremely high turbidity measurements taken in 2013 and 2014 (Figure 22). The greatest flood on record was observed in 2014 causing significant erosion along the banks of the Tuamarina River. A sample taken during a smaller, but still substantial flood following the extreme event had a turbidity of 180 NTU; probably a result of continuous bank erosion. However, two of the highest turbidity measurements of 1,650 and 2,200 NTU were taken several months earlier before the record flood had occurred. These turbidity values are a magnitude above the highest levels observed in the neighbouring catchments. For example, the highest turbidity recorded as part of the State of the Environment program in the Waitohi River to the North is 75 NTU. The maximum turbidity in Cullens Creek and Linkwater Stream to the North-East are 62 NTU and 49 NTU, respectively; and the highest turbidity measured in Are Are Creek to the West is 124 NTU.

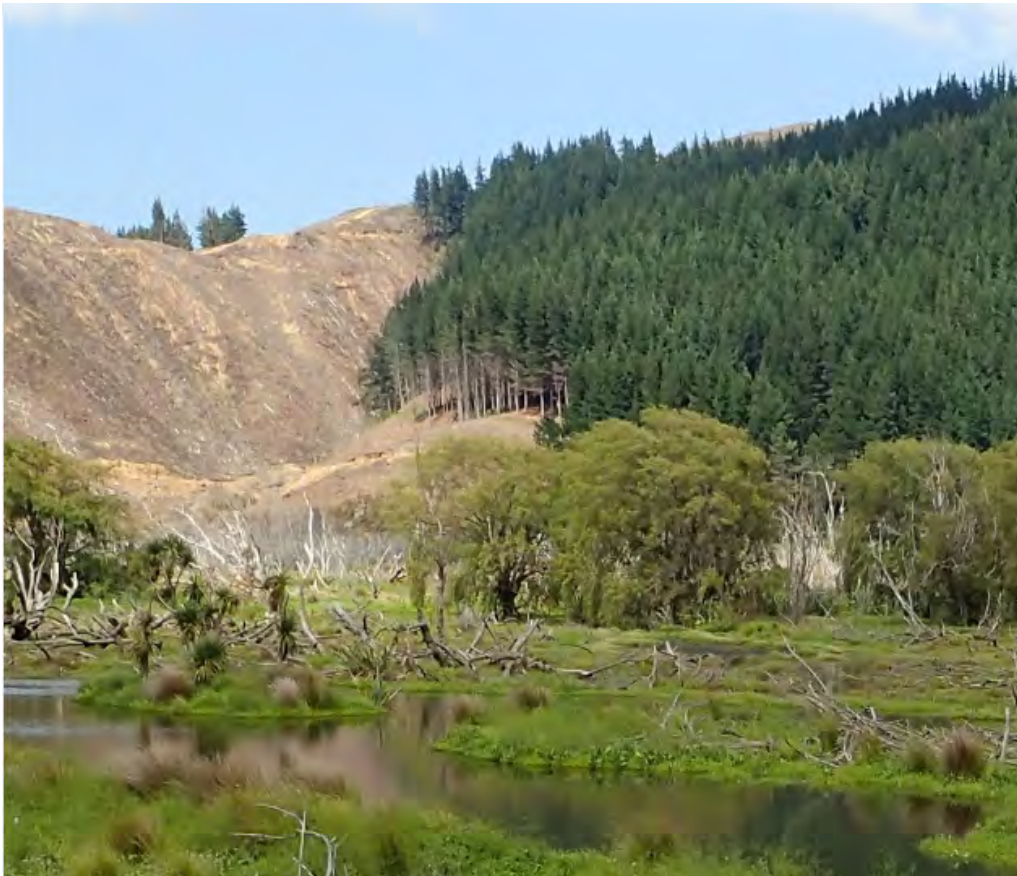
Figure 24: A small area of production forestry recently harvested in the lower reaches of the Tuamarina River at the Para Wetland. Note the steepness of the harvested area, which will likely result in the loss of sediment during rainfall.

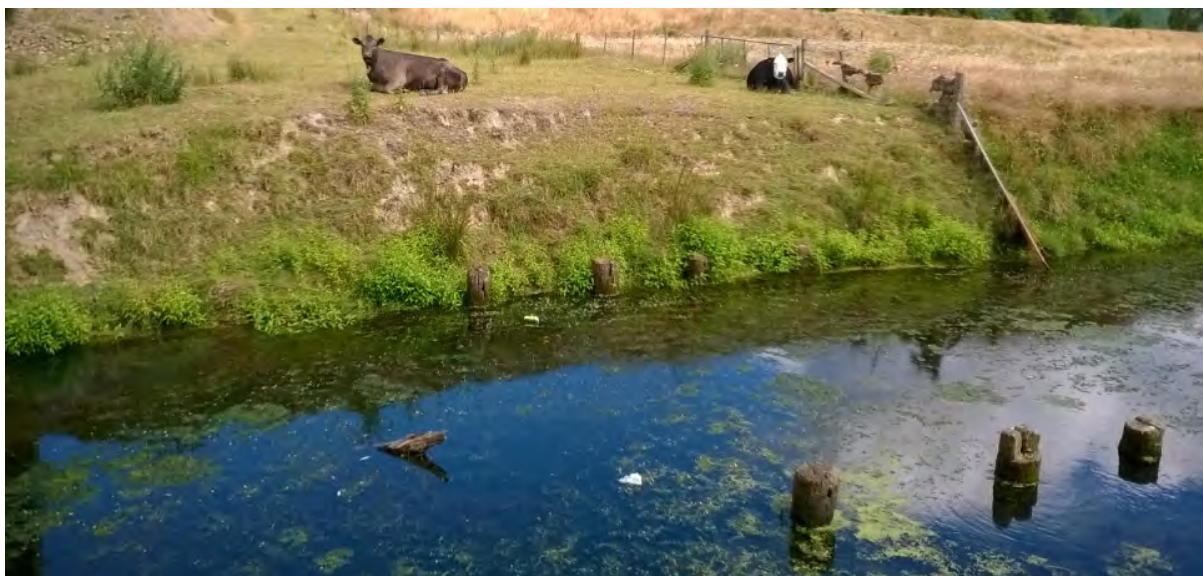
Figure 28: The lack of riparian vegetation on the western bank of the Tuamarina River at the Bush Road (Site 2) causes prolific growth of aquatic plants in the deep river giving it a shallow appearance.

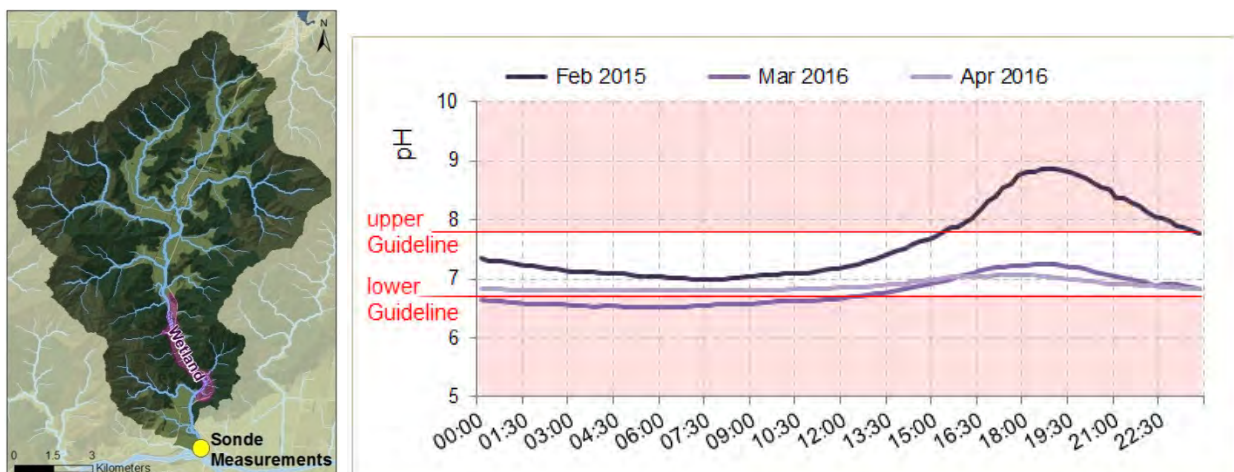
Figure 30: Sonde measurements of pH in the Tuamarina River just upstream of the confluence with the Wairau River.

At all three sonde deployments, peaks in pH values coincided with maximum dissolved oxygen saturations. This is not surprising, as high pH values and oxygen levels are both a result of photosynthetic activity.

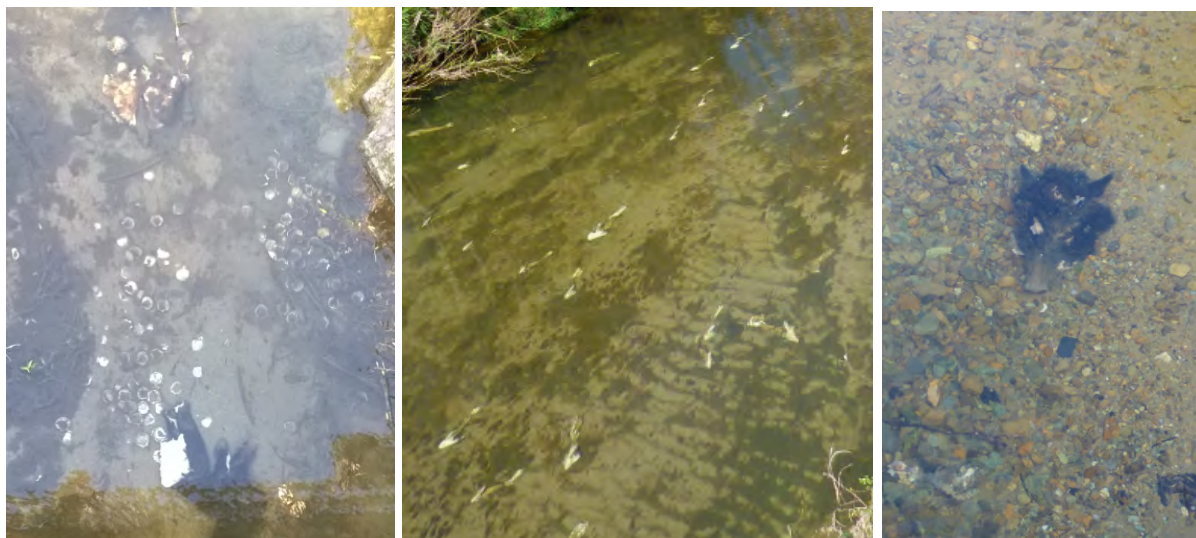
Figure 33: Shellfish shells and pig carcass (left), fish remains (middle) and one of several pig-heads (right) found in the Tuamarina River and some of its tributaries during the 2015/2016 study.

occasions. The decomposition of animal carcasses releases nutrients into the waterway, lowers the pH, but also reduces dissolved oxygen levels.
