METHYL BROMIDE MONITORING REPORT JANUARY 2011

Issue II

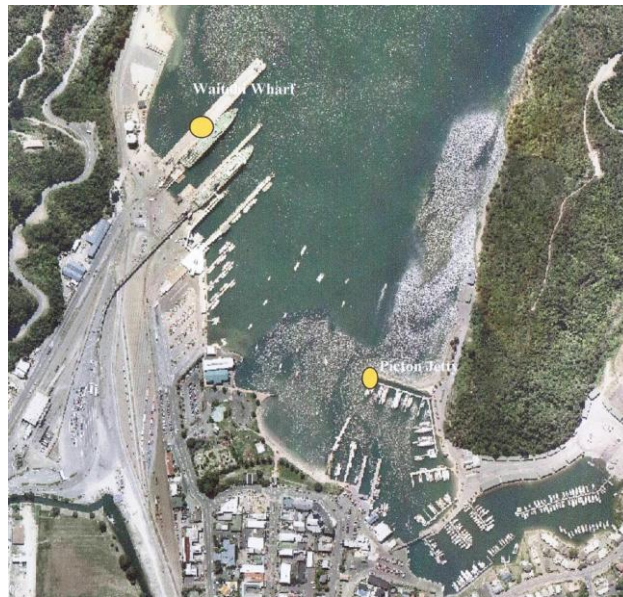
■ Figure 1: Picton MDC Methyl Bromide Monitoring Sites(North is at the top of the page)

MDC selected two sampling locations within the Picton community. The first site was located at the seaward end of Waitohi Wharf with the second site located at the opening of the Picton Jetty (See Figure 1). Figure 1 depicts where the fumigation was being carried out at the time the MDC-commissioned monitoring was being performed. The Waitohi Wharf site was selected due to its relatively close location to Port Marlborough fumigation facility at Shakespeare Bay while the

Picton Jetty was selected to assess if methyl bromide could be transported to eastern Picton. Both sites were also secure so to avoid any tampering with the monitoring unit by the general public.

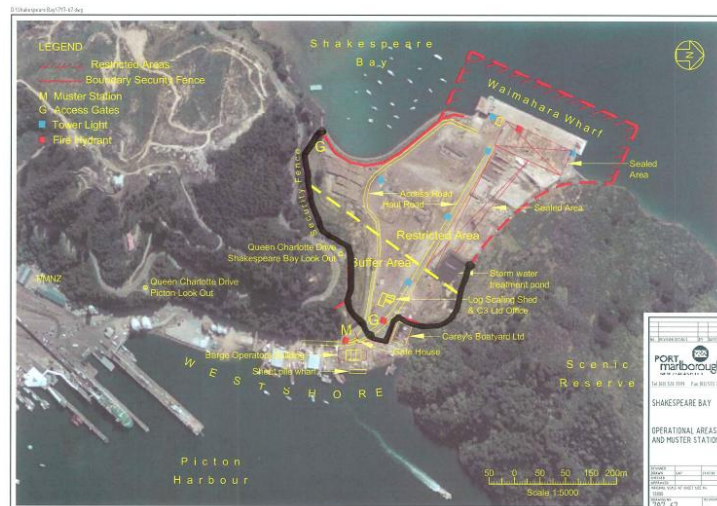
■ Figure 2: Port Marlborough Fumigation Facility(the North direction is to the right of the page)

Figure 2 presents the Port Marlborough fumigation facility at Shakespeare Bay.

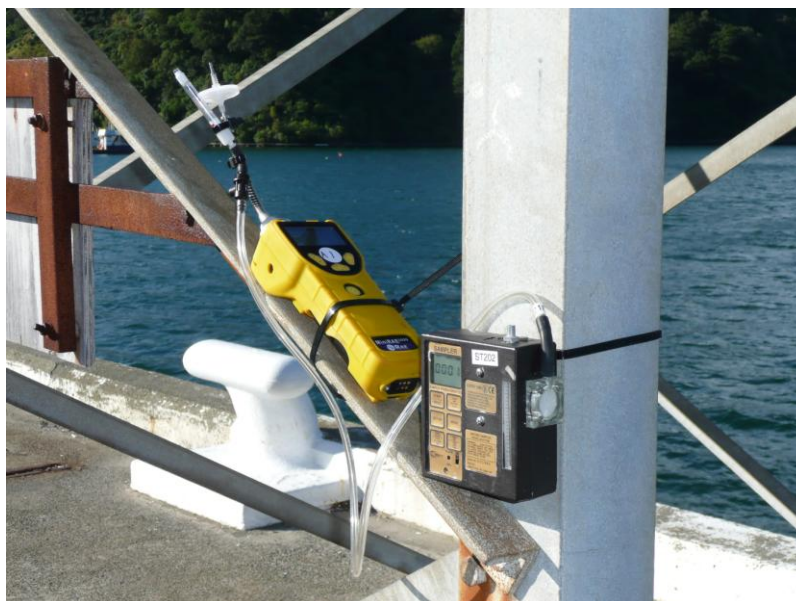
■ **Figure 3: Waitohi Wharf Methyl Bromide Monitoring Site**

The Waitohi Wharf PID analyser was deployed at the seaward end of the wharf (See Figure 3). Waitohi Wharf serves as the ferry terminal and over the duration of the monitoring there were a number of arrivals and departures of the both the Inter-Islander and Blue Bridge ferries. Vehicle traffic on the wharf was limited to the field technician and ferry staff during the arrival and departure of the Inter-Islander. This traffic was at least 50 meters to the south of the analyser. Tables 1 and 2 present the field observations recorded for Waitohi Wharf for 27 and 28 January 2011 respectively.

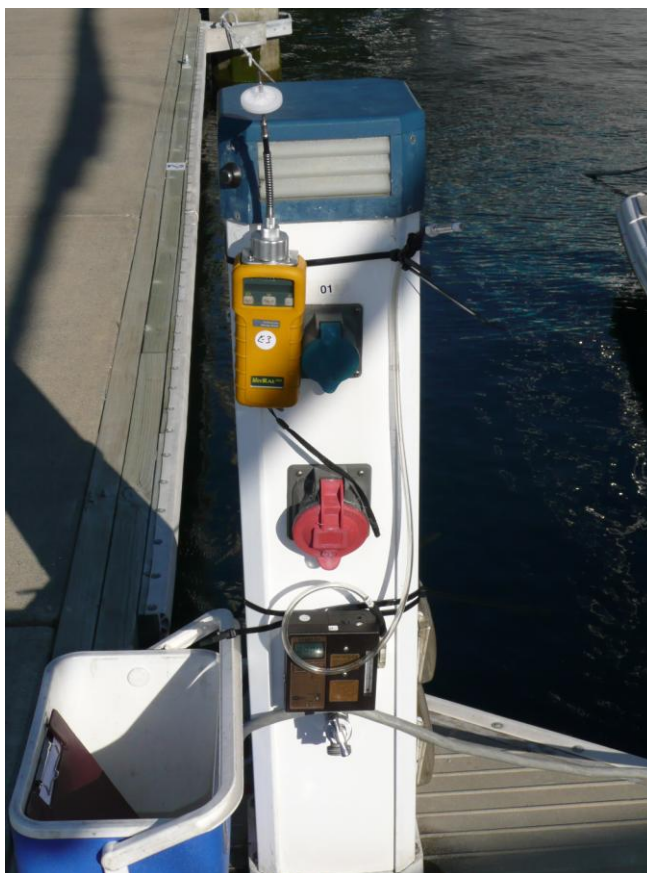
■ **Figure 4: Picton Jetty PID Monitoring Site**

The Picton Jetty PID was deployed at the opening to the Picton Marina (see Figure 4). Access to this portion of the marina was restricted to owners of the berthed vessels. Vessels at the entrance to the marina were a potential source of VOC's. A public car park was located on shore approximately 25 m to the east of the analyser. Tables 3 and 4 present the field observations recorded for Picton Jetty for 27 and 28 January 2011 respectively.

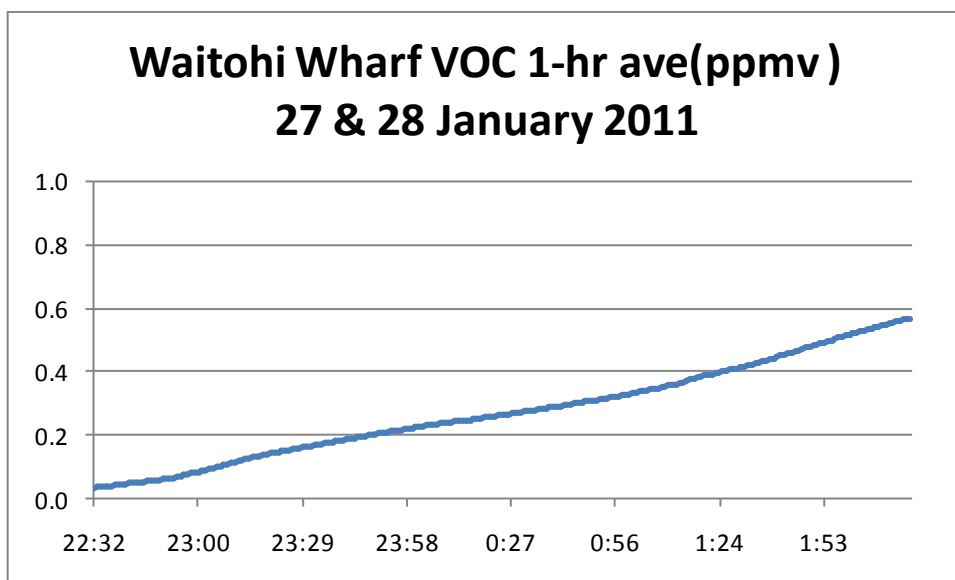
■ **Figure 5: Waitohi Wharf VOC Data, 27 & 28 January 2011**

The results of the ambient total VOC monitoring performed at the Waitohi Wharf on 27 and 28 January 2011 indicate that the concentration of VOCs increased gradually over the night from <0.1 ppmv to approximately 0.6 ppmv. A shortage of GASTEC gas detector tubes meant no methyl bromide-specific spot samples could be taken. However, the USEPA Method TO-17 sorbent tubes would determine if the VOCs detected were actually methyl bromide. Given the odours observed during the monitoring period (see Table 1) and the southerly wind direction, it was likely that the VOCs detected were from the operation of the Inter-Islander and Blue Bridge ferries.

For the monitoring which commenced on 27 January 2011 and was completed early morning on 28 January, the PID analyser located at Waitohi Wharf indicated the total VOC concentration increased from <0.1 to 0.6 ppmv over the duration of the monitoring period. Based on the odours detected at the monitoring site and the southerly wind direction, the observed VOCs were likely to have originated from the operation of the ferries.

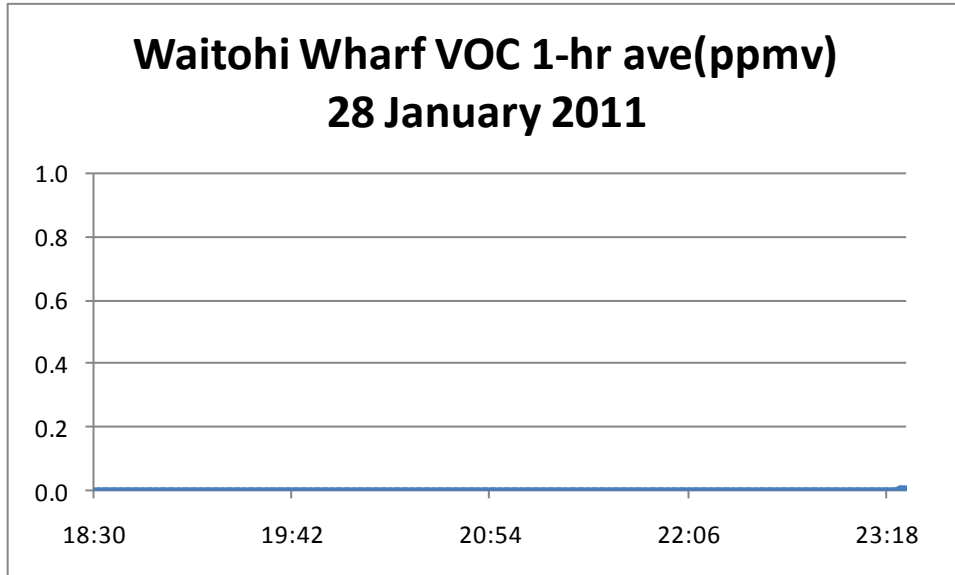
■ **Figure 6: Waitohi Wharf VOC Data, Evening of 28 January 2011**

The results of the ambient total VOC monitoring performed at the Waitohi Wharf during the evening of 28 January 2011 indicate that the concentration of total VOCs was below detection limit of the analyser of 0.1 ppmv. This was despite the north north-westerly winds potentially transporting methyl bromide from Shakespeare Bay to Waitohi Wharf for at least some of the time.

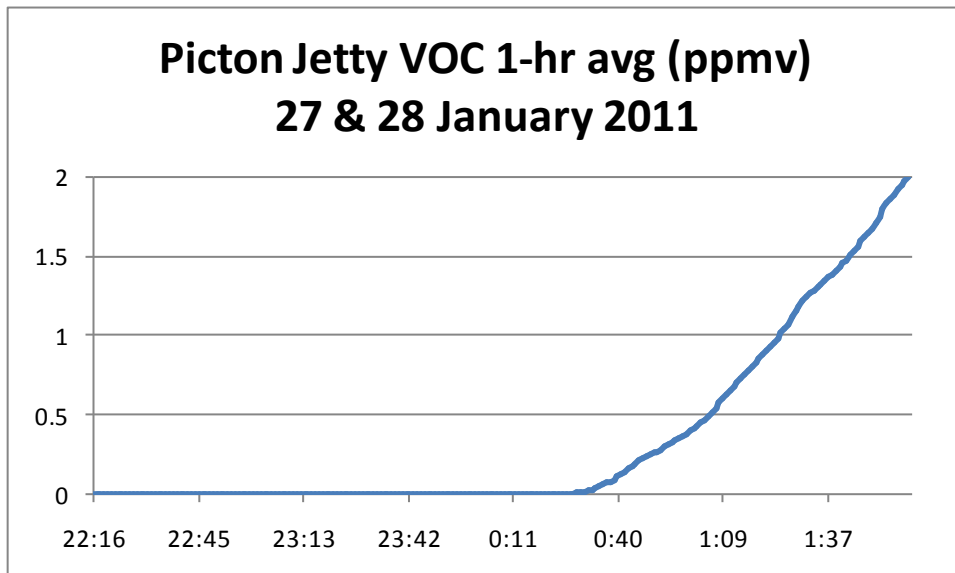
■ **Figure 7: Picton Jetty VOC Data, 27 & 28 January 2011**

The results of the ambient VOC monitoring performed at the Picton Jetty on 27 and 28 January 2011 indicate that the VOC concentration was at or below detection limit of the analyser for the commencement of the monitoring until 00:35 on 28 January 2011. At this point the VOC concentration appeared to increase to 2.0 ppmv at 02:00 on January 2011.

As mentioned previously, a shortage of GASTEC gas detector tubes meant no methyl bromide specific spot samples could be taken. However, the Method TO-17 sampling would determine whether the VOCs detected were actually methyl bromide. Given the southerly wind direction, it was possible that the observed increase in the VOCs concentration was due to emissions from the marina and central Picton. However, it is equally likely that the increase was due to instrumental drift, as little activity was observed within the marina or at the northern end Picton.

The PID analyser located at Picton Jetty during this 27 - 28 January monitoring programme indicated the VOC concentration was at or below detection limit of the analyser for the commencement of the monitoring until 00:35 28 January 2011 when it appeared to increase sharply to 2.0 ppmv by the end of the monitoring period. The southerly wind direction could have transported VOC emitted within the marina or central Picton areas to the monitoring site. However, it is equally likely that the increase was due to instrumental drift, as little activity was observed within the marina or in the northern end of Picton.

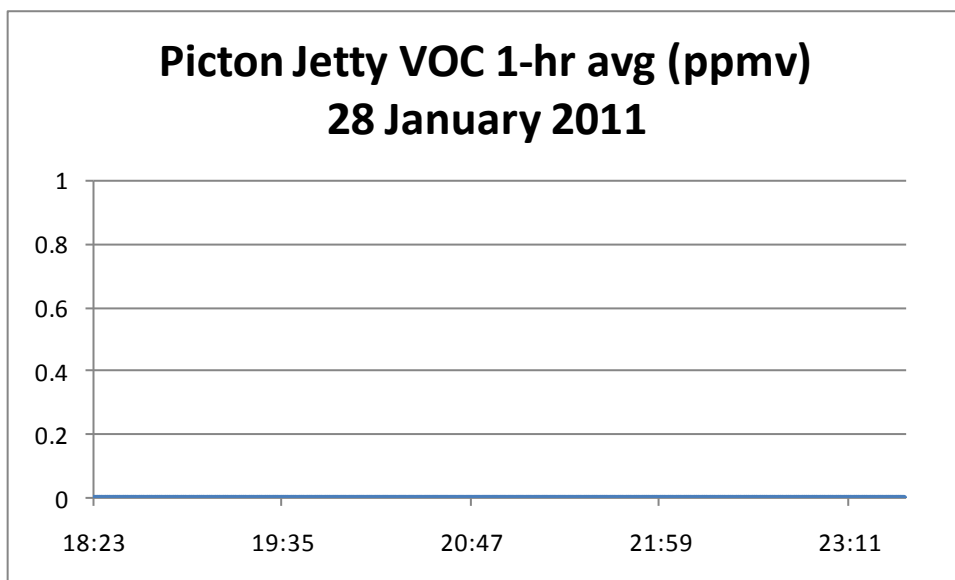
■ **Figure 8: Picton Jetty VOC Data, Evening of 28 January 2011**

The results of the ambient total VOC monitoring performed at the Picton Jetty during the evening of 28 January 2011 indicate that the concentration of VOCs was below detection limit of the analyser of 0.1 ppmv. This was despite the north north-westerly winds acting to transport methyl bromide from Shakespeare Bay to Picton Jetty.

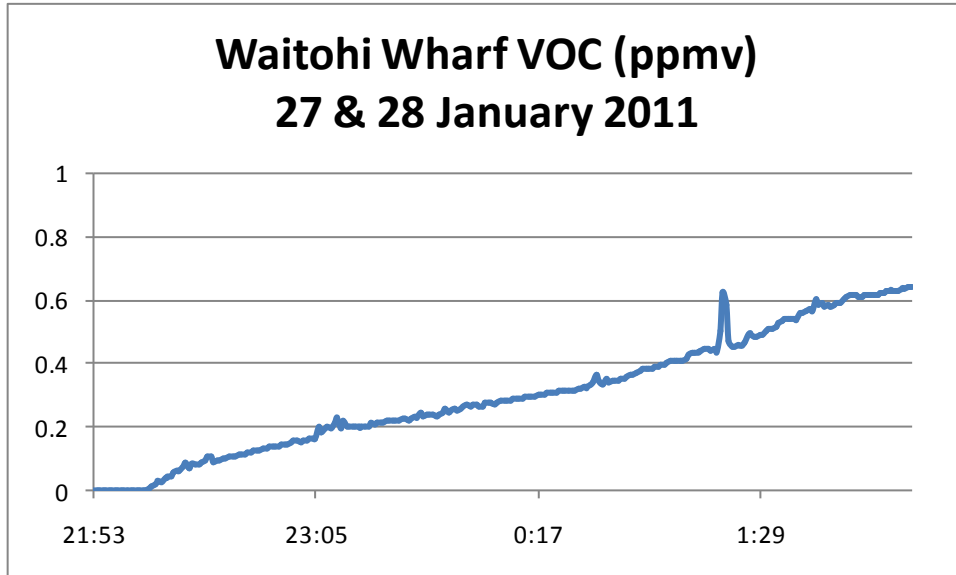
Waitohi Wharf Raw PID VOC Data, 27 & 28 January 2011

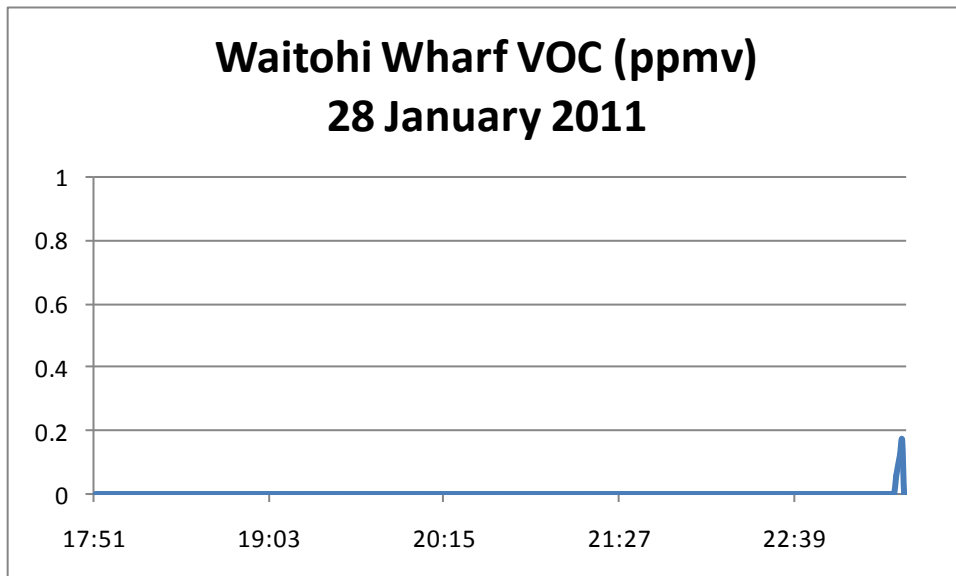
Waitohi Wharf Raw PID VOC Data, 28 January 2011

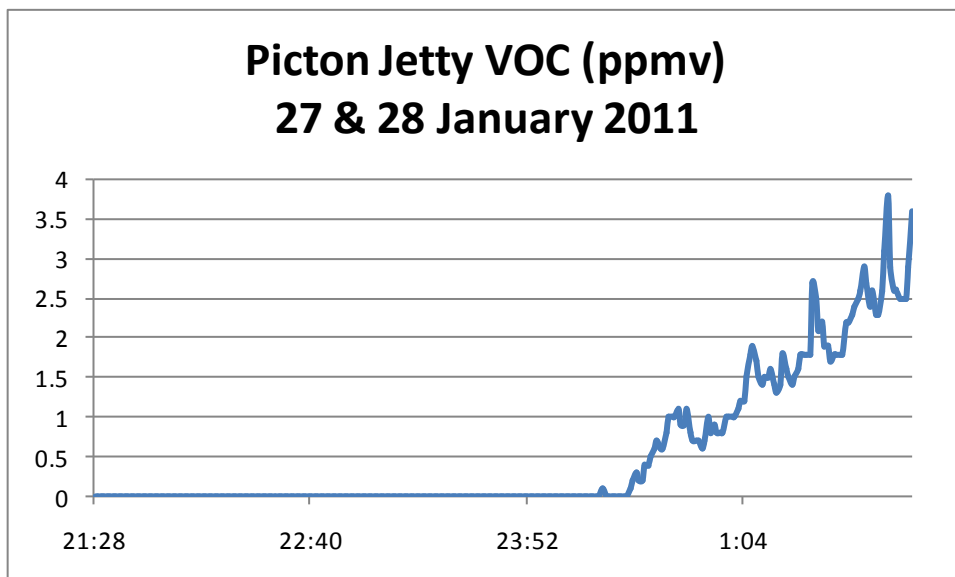
Picton Jetty Raw PID VOC Data, 27 & 28 January 2011

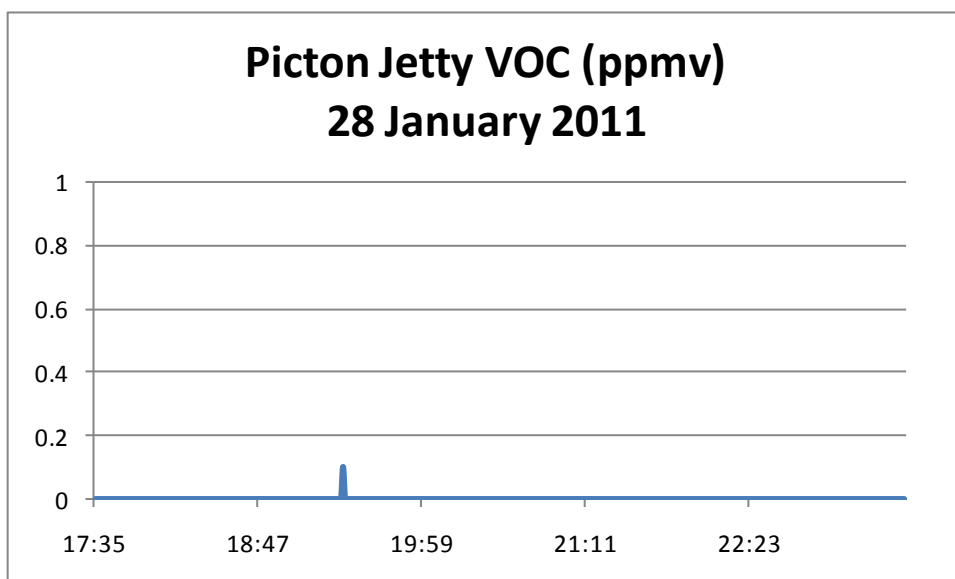
Picton Jetty Raw PID VOC Data, 28 January 2011
