Havelock Estuary, Marlborough

Broad Scale Habitat Mapping and Ecological Assessment

For Marlborough District Council

June 2019

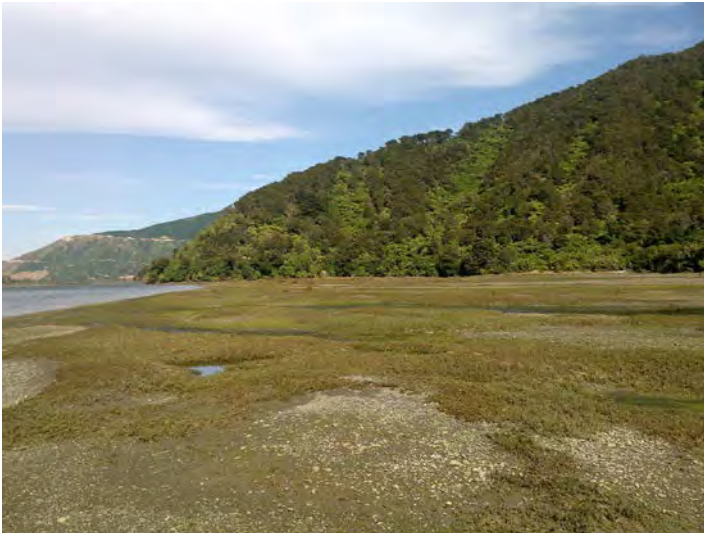
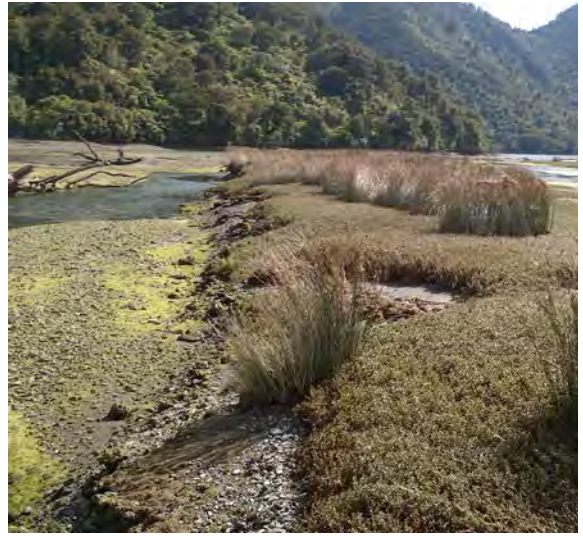
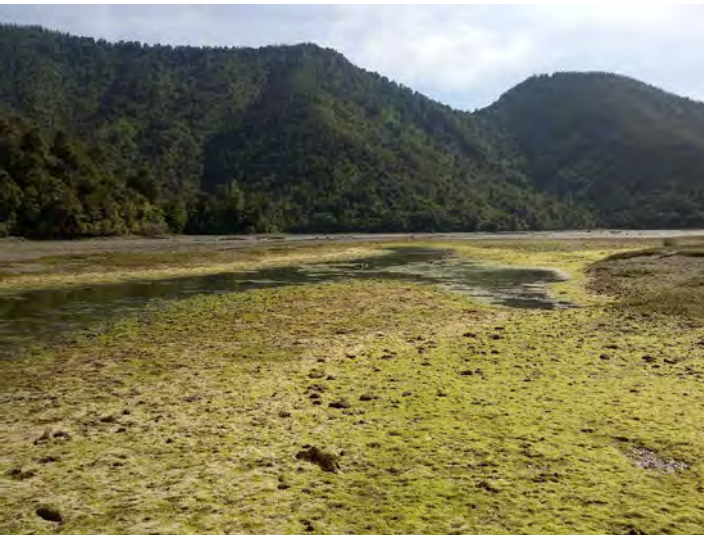
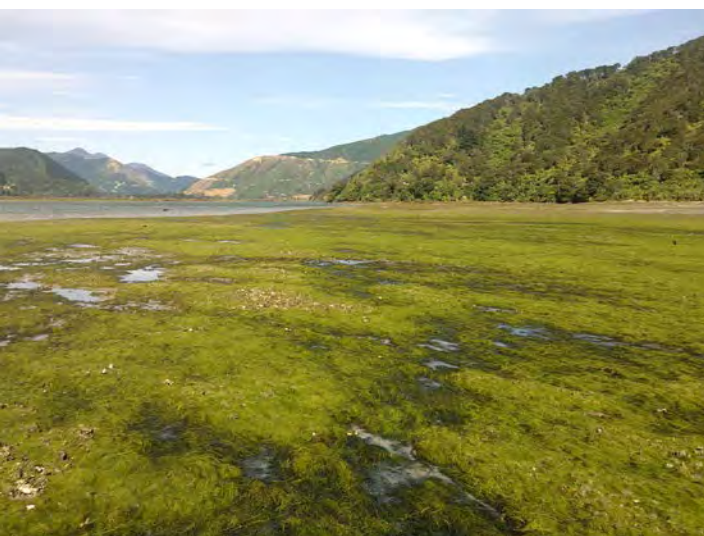
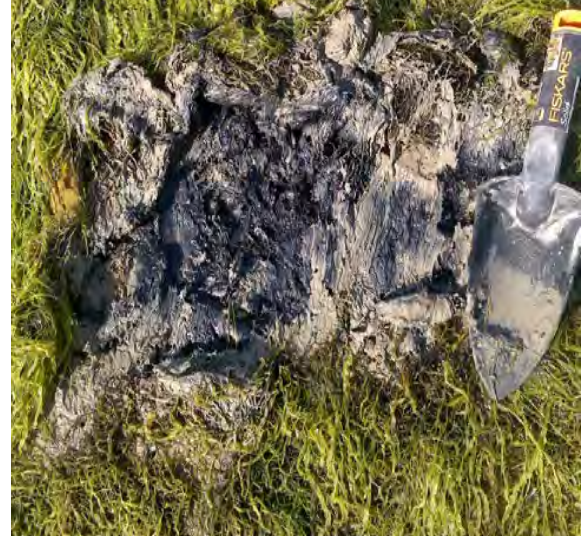
Photo 1-6: Dense macroalgae (*Ulva* spp.) underlain by muddy gravel/anoxic substrata within GEZ and associated herbfield mixed with rushland on the northern edge of the Pelorus River channel near Wakaretu Bay.

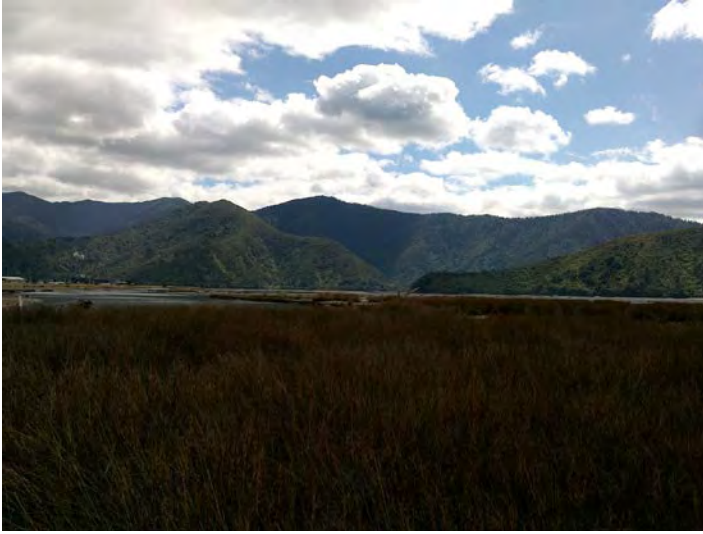
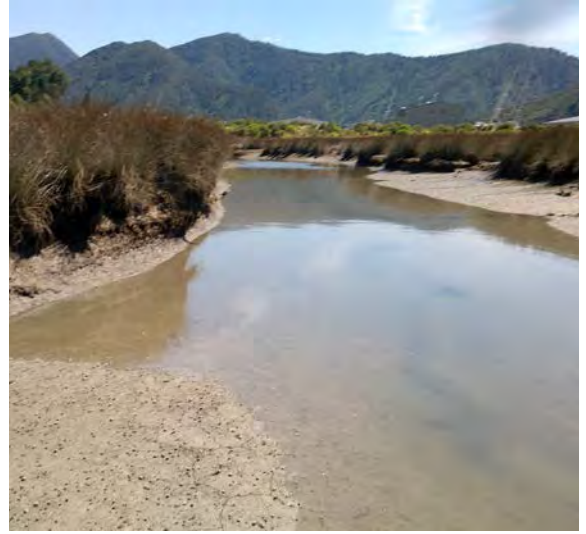
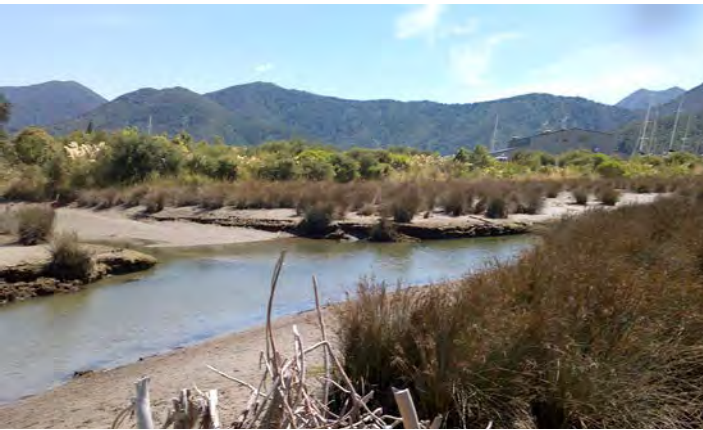
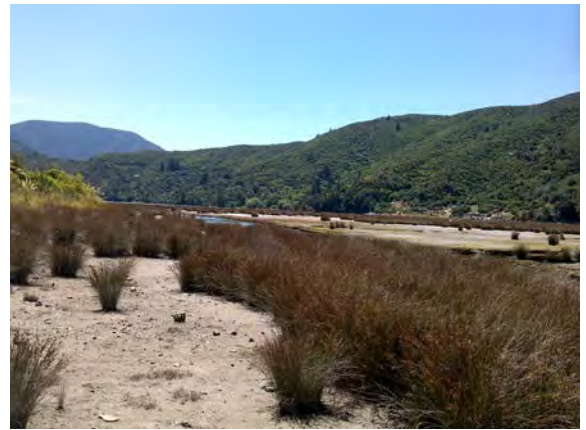
Photo 7-10: Mud-dominated channels flanked by rushland in the upper Kaituna Arm adjacent to Havelock Township.

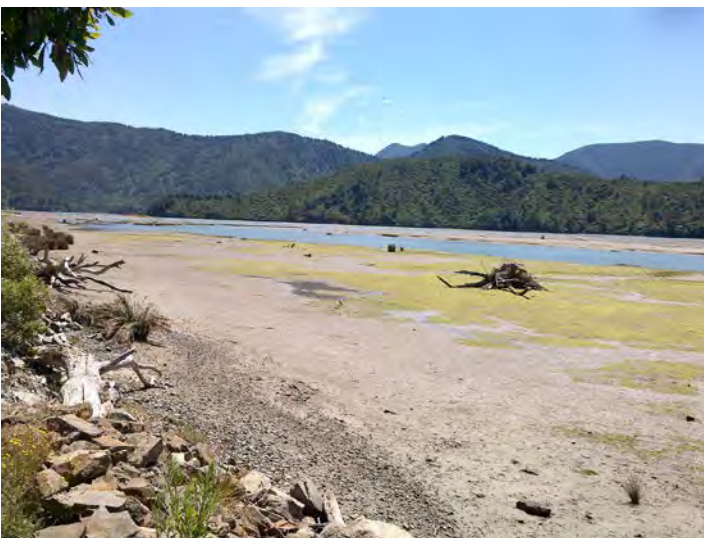
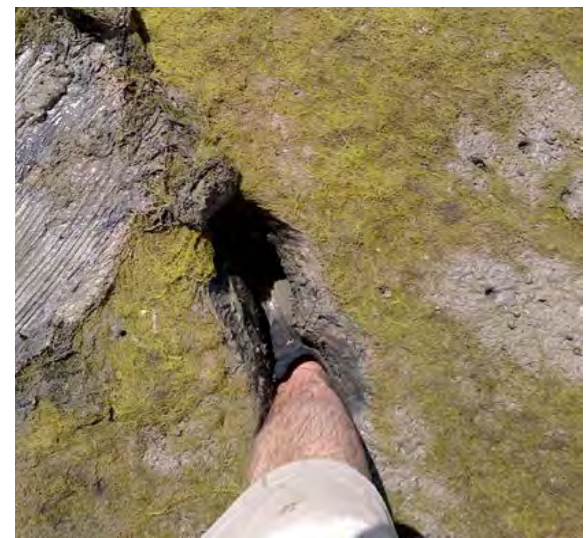
Photo 11-12: GEZ conditions, harbouring a relatively dense macroalgal canopy associated with poorly oxygenated very soft muds, Kaituna Arm opposite Havelock marina.

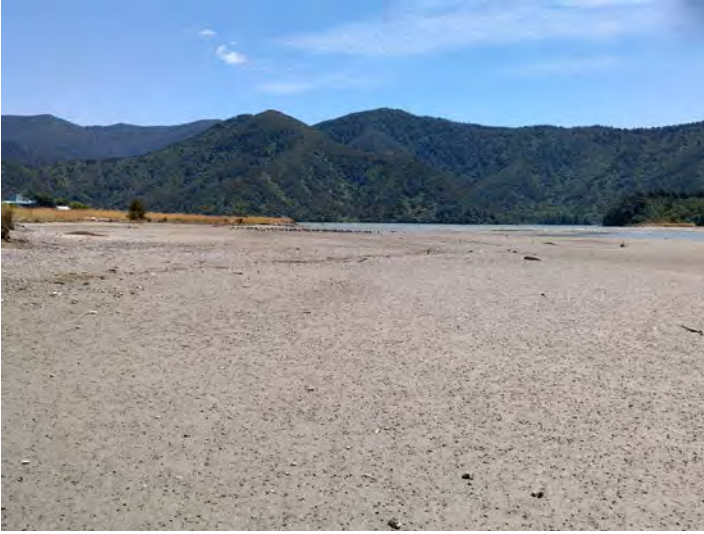
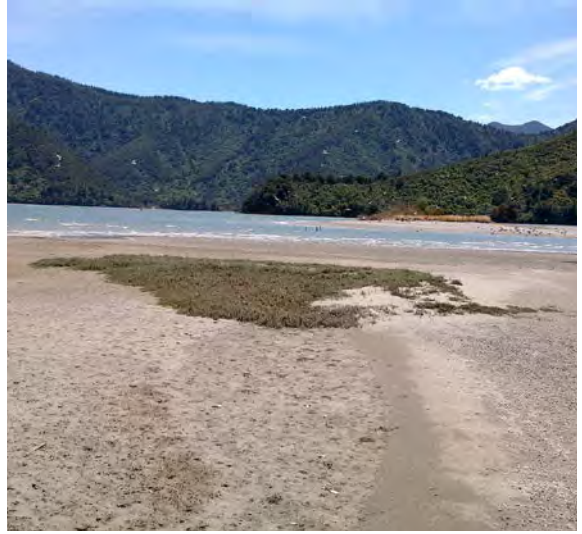
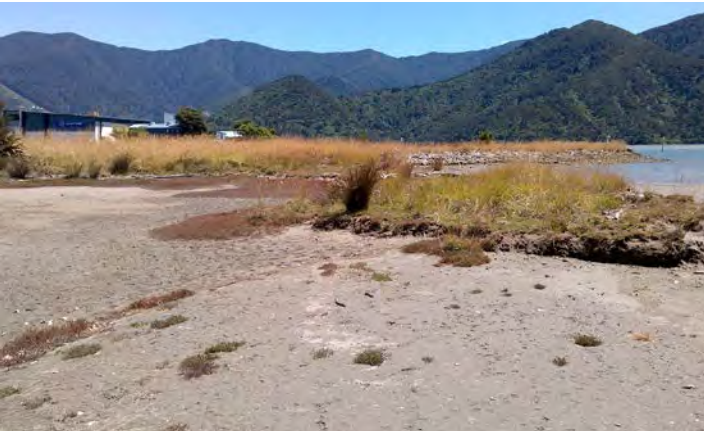
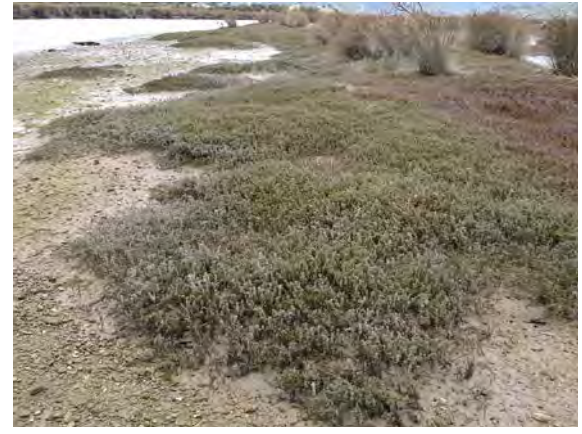
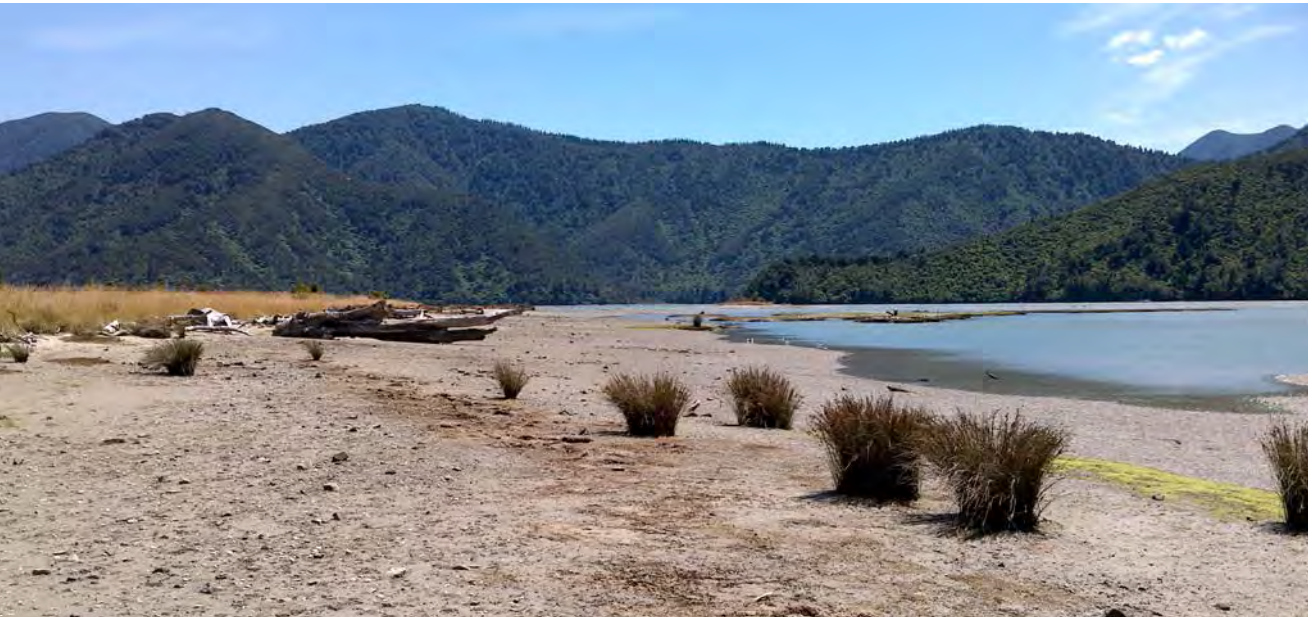
Photo 13-18: Firm muddy sand substrata, patchy herbfields and rushland, western Kaituna Arm opposite Havelock marina.

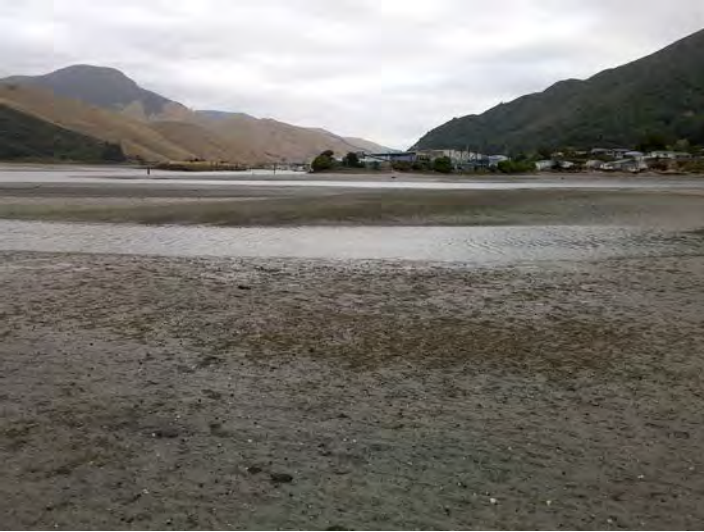
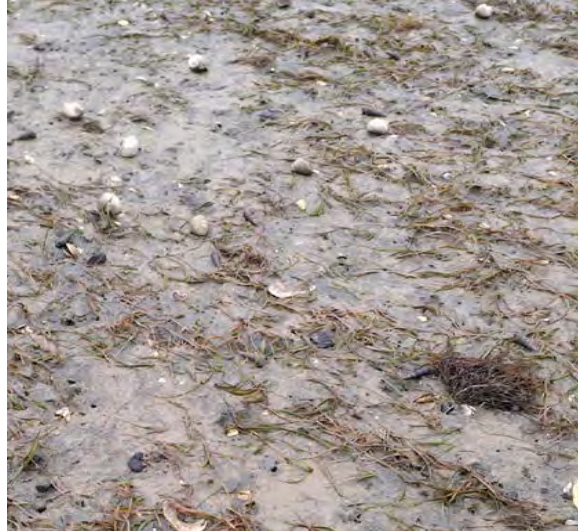
Photo 19-20: Low density seagrass patches in middle estuary nearby Fine Scale Site A.

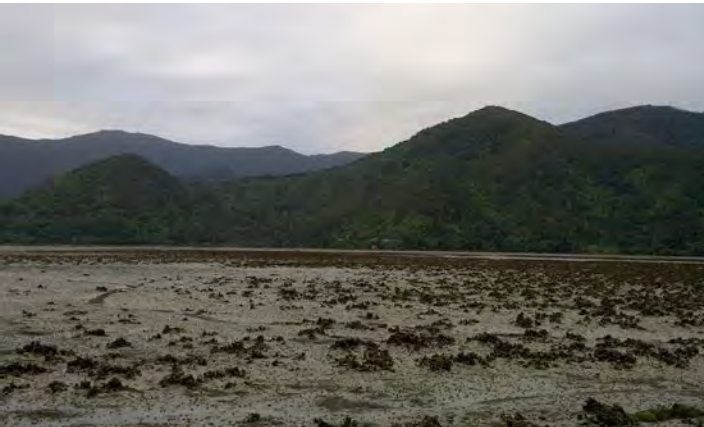
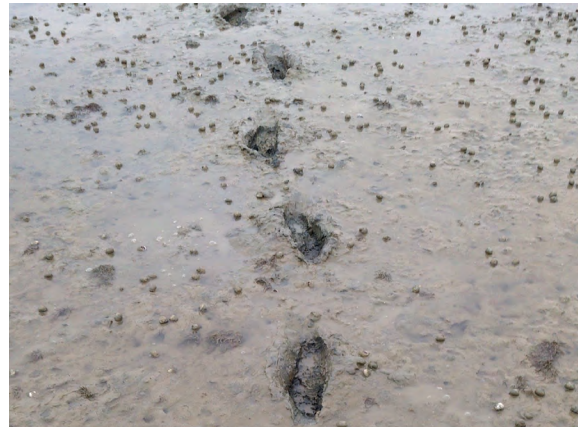
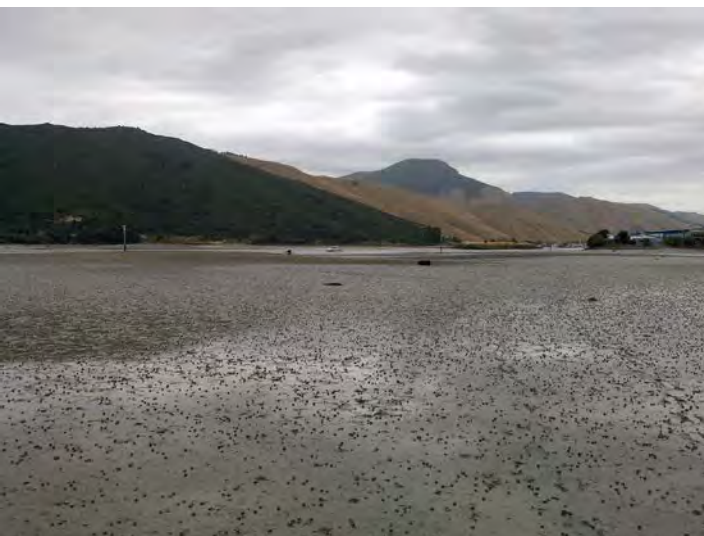
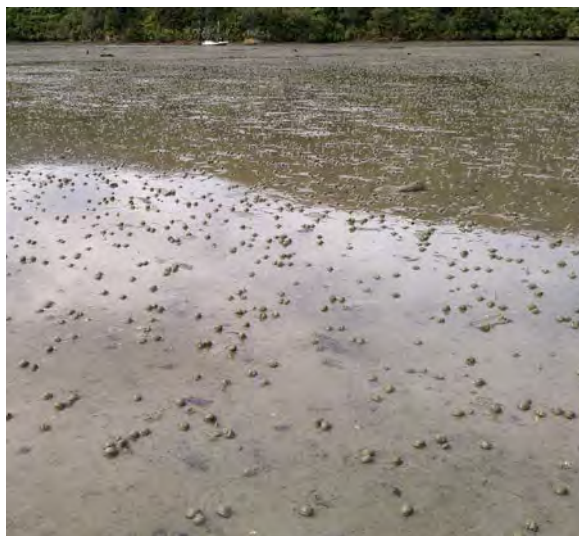
Photo 21-24: Oyster beds among predominantly non-vegetated, soft muddy intertidal flats in the middle estuary.

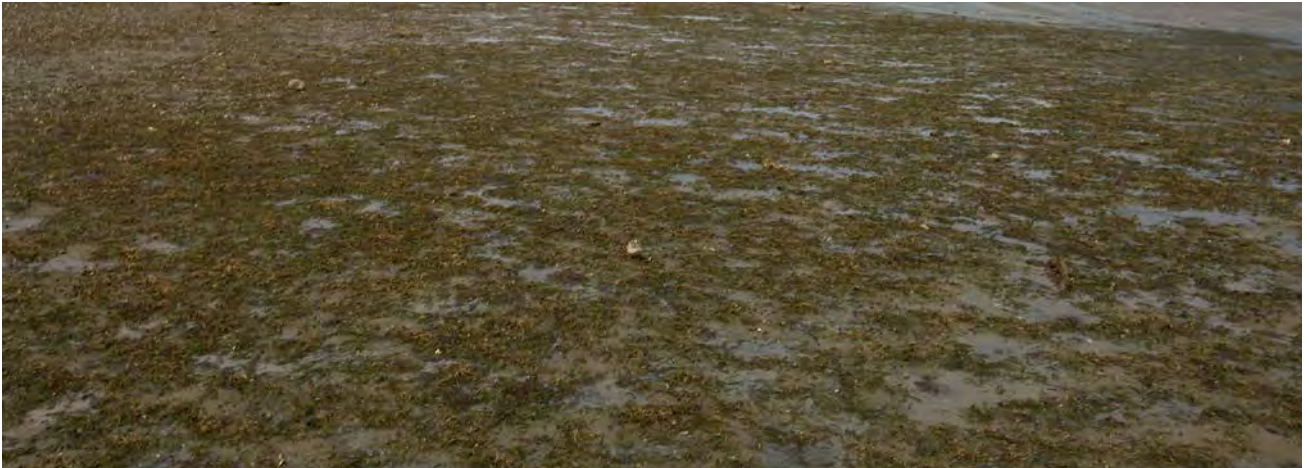
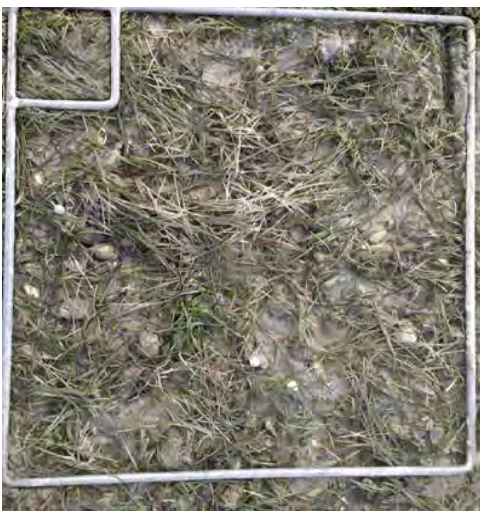
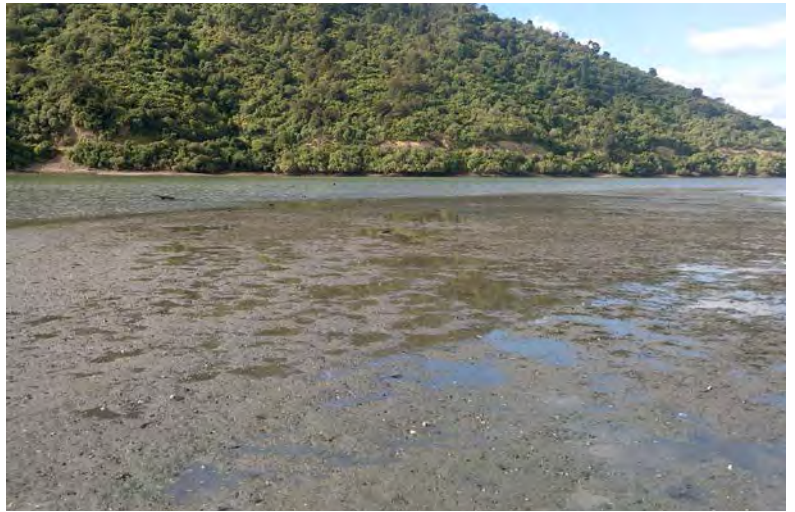
Photo 25-27: Seagrass habitat in the lower estuary, including the boundary between where seagrass was lost between 2014 and 2019 (bottom right photo).

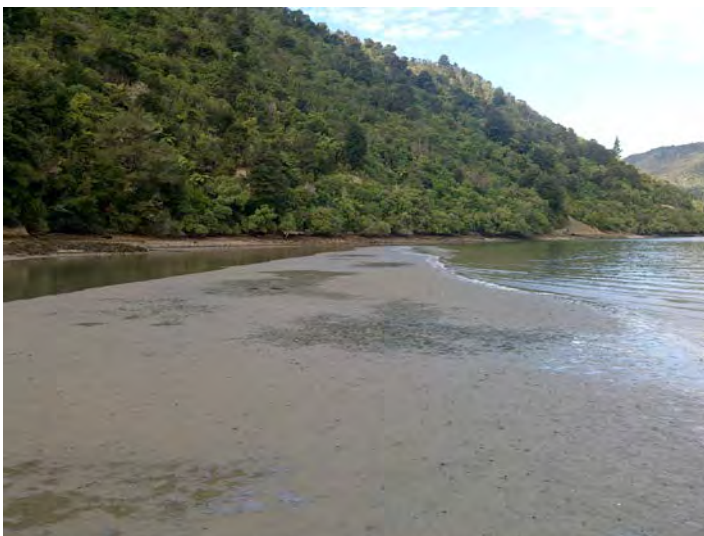
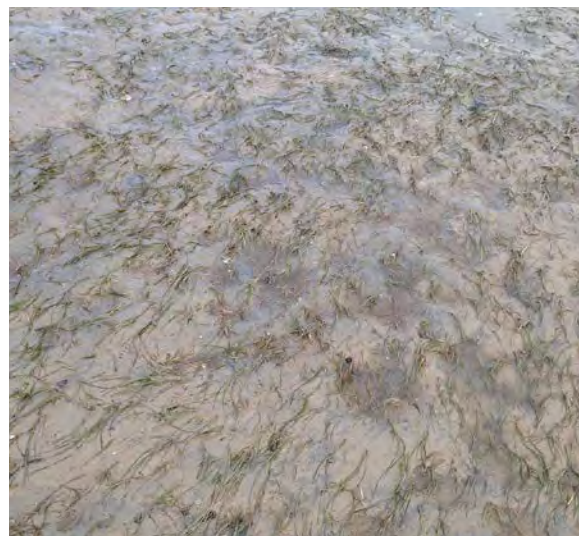
Photo 28-29: Previously unmapped seagrass patches within embayment nearby Shag Point.

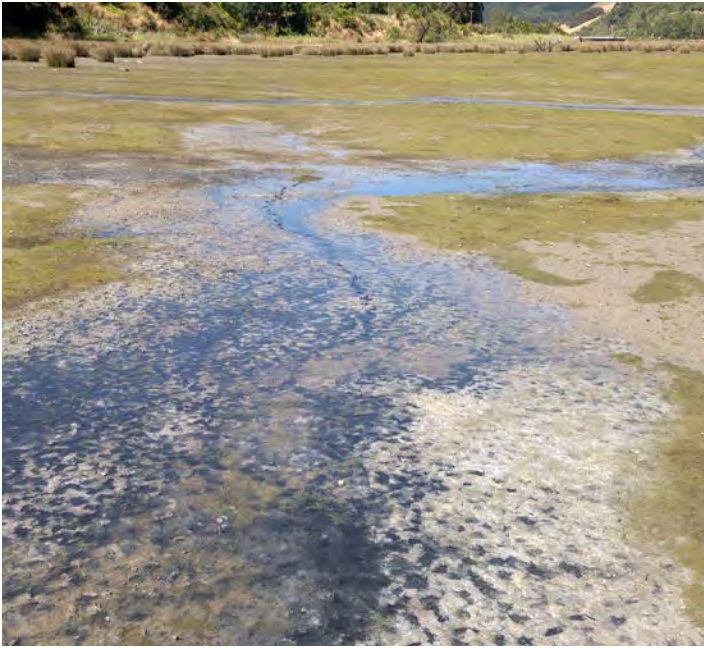
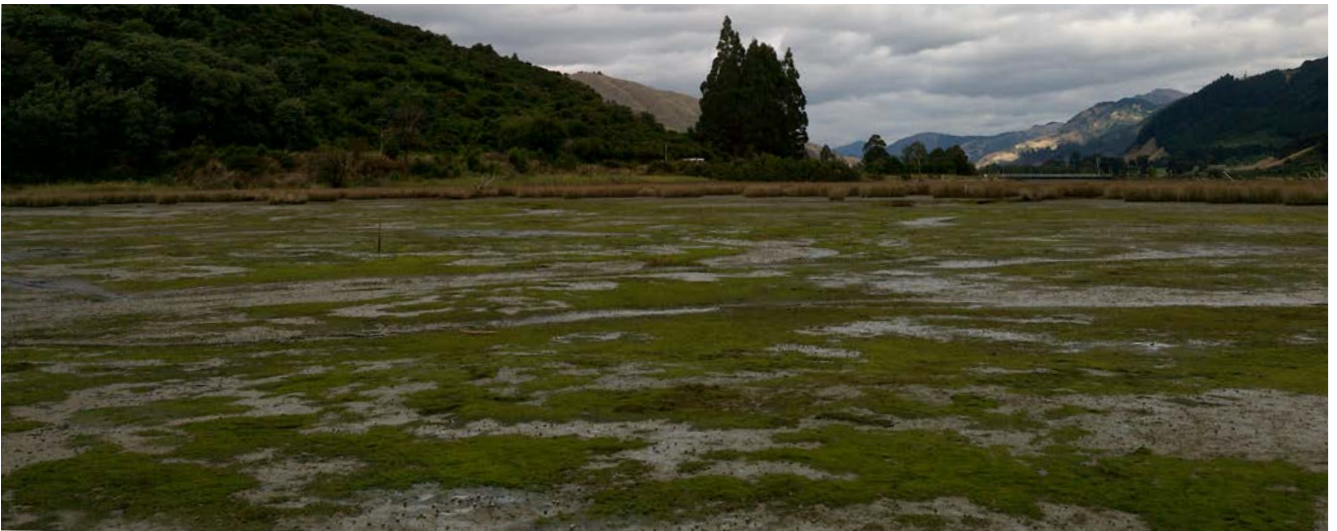
Photo 30-32: Gross eutrophic conditions (GEZ) with highly reducing (poorly oxygenated) sediments in the upper Kaituna Arm where *Spartina* was previously eradicated.

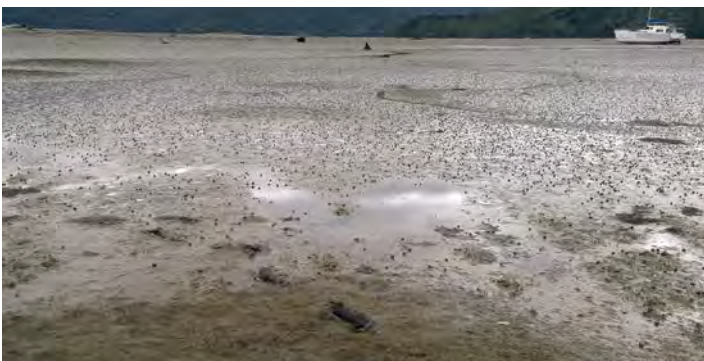
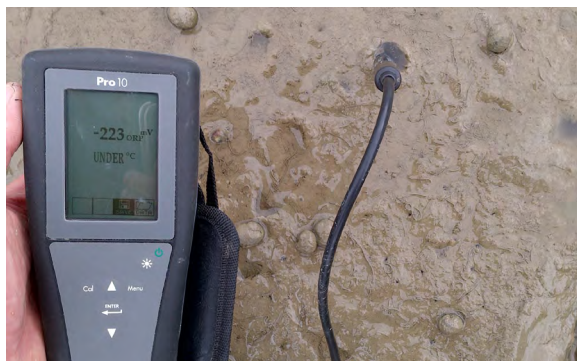
Photo 33-34: Boundary between *Ulva*-dominated GEZ and predominantly non-vegetated, relatively poorly oxygenated soft muds, upper Kaituna Arm.

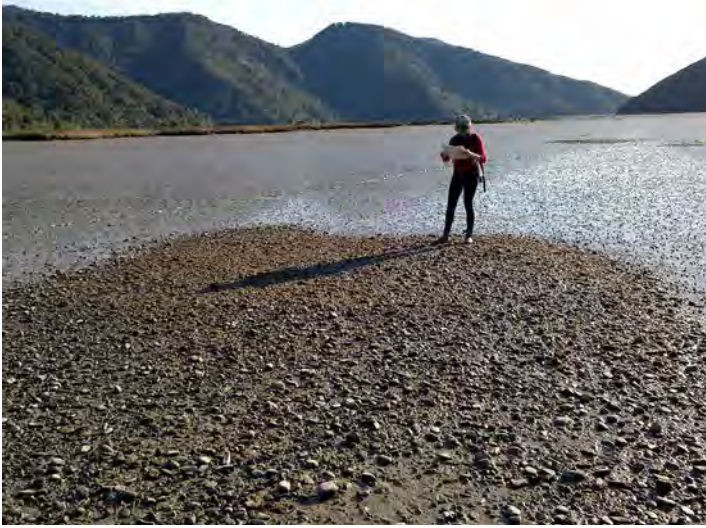
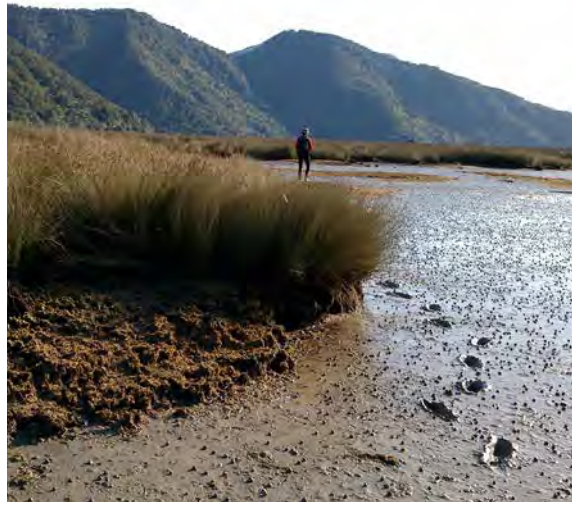
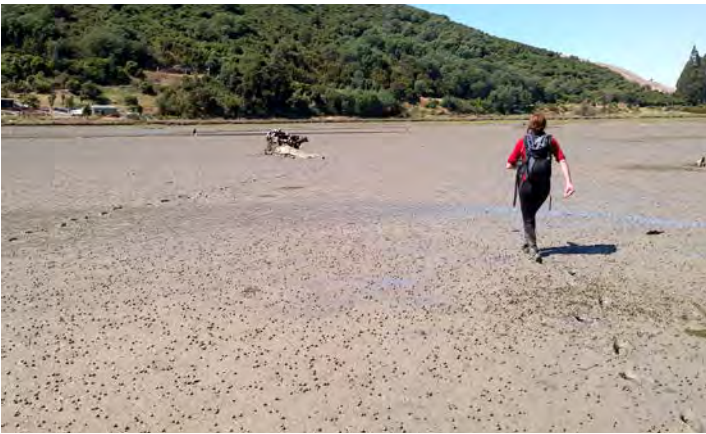
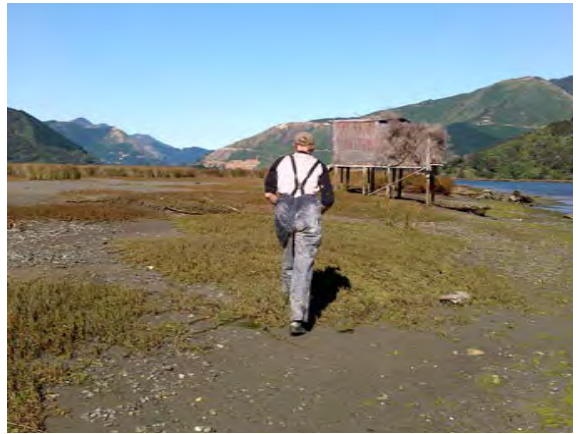
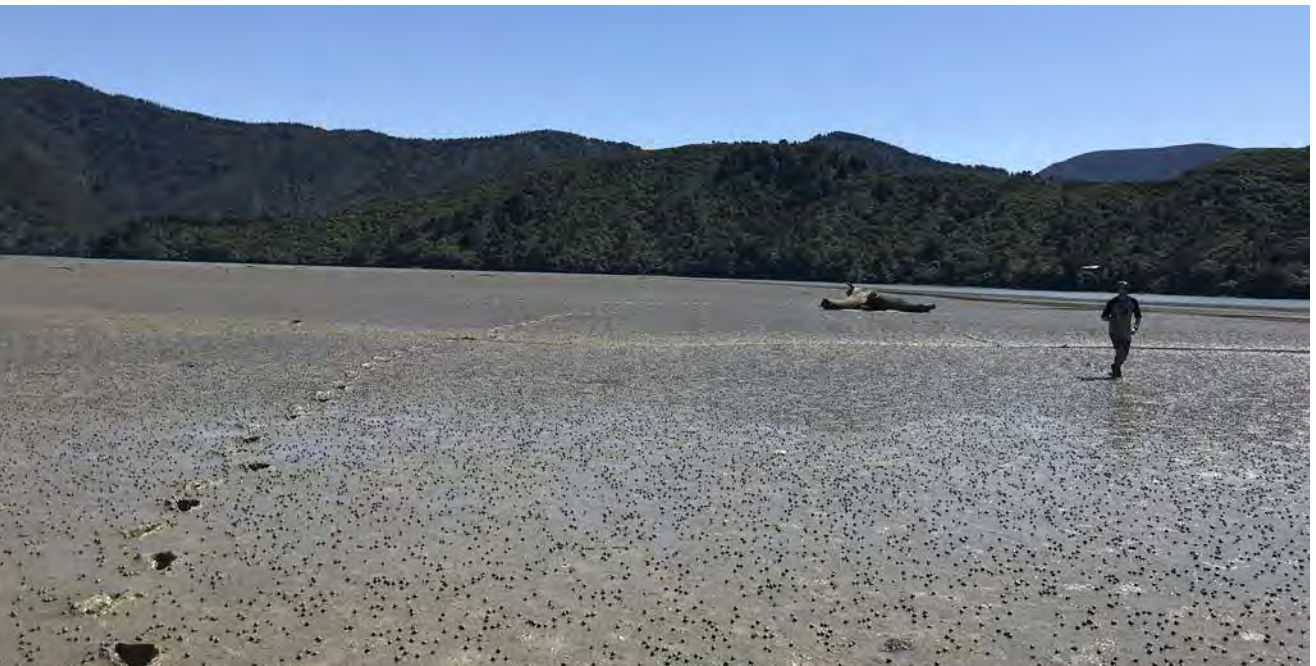
Photo 35-39: Scientists ground-truthing substrata and vegetation types in the eastern settling basin and surrounding habitat.

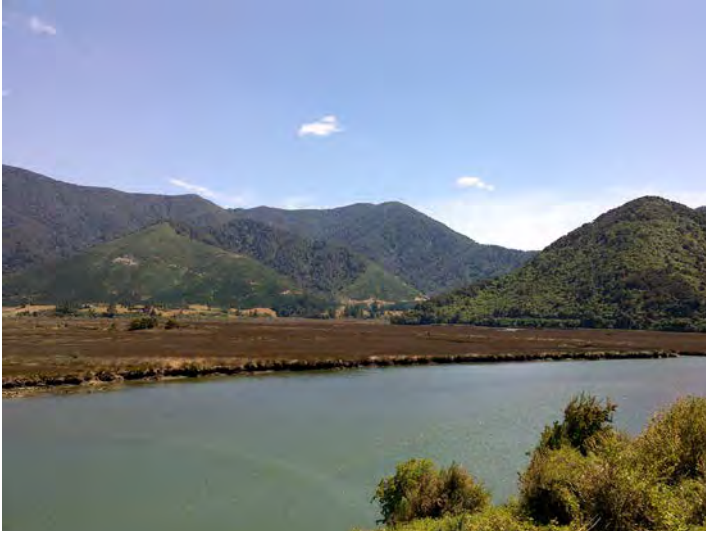
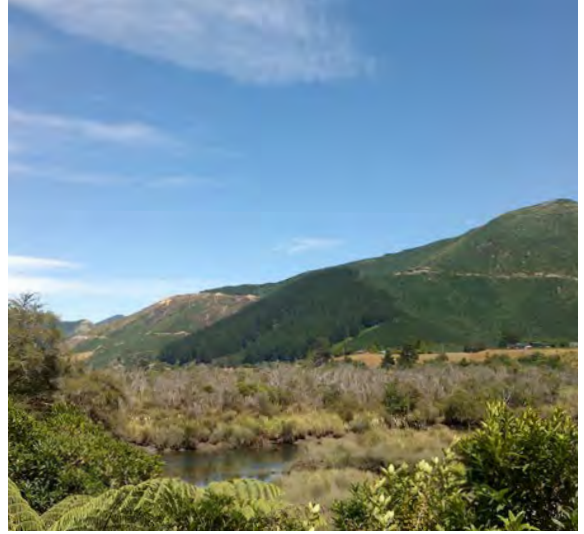
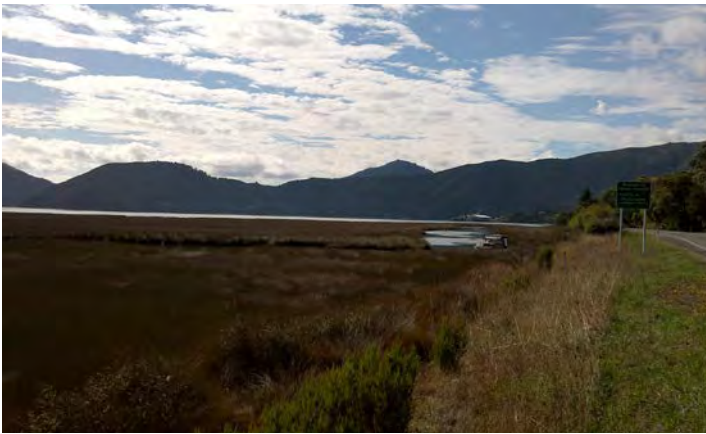
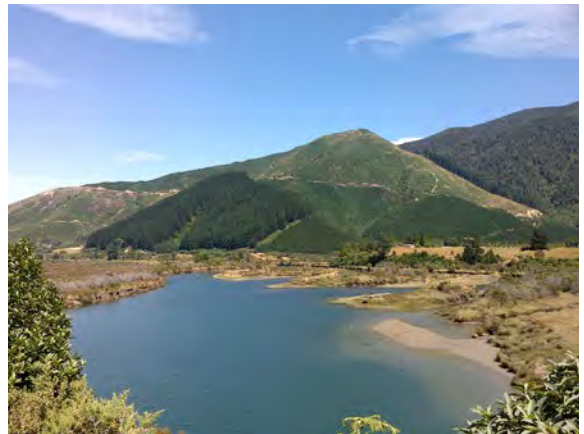
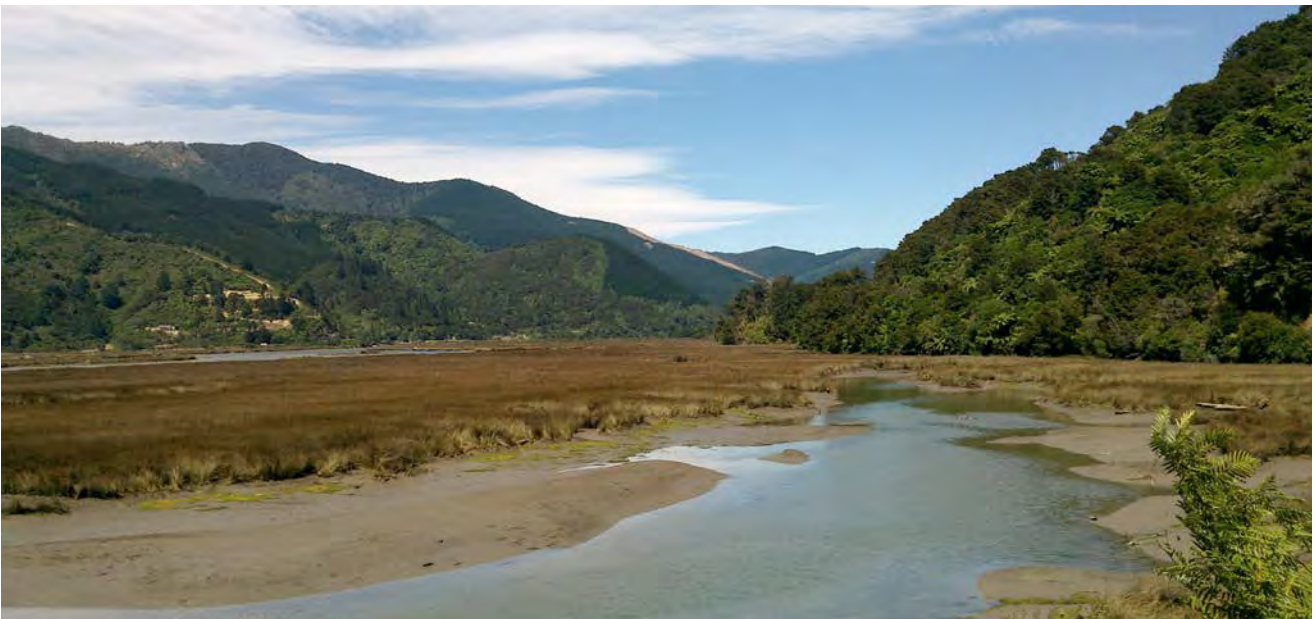
Photo 40-44: Saltmarsh and fringing terrestrial margin, upper Pelorus Arm.
