REPORT NO. 2805

# **PICTON BAYS ENVIRONMENTAL INFORMATION AND HEALTH ASSESSMENT**

EMMA NEWCOMBE, OLIVIA JOHNSTON

Prepared for Marlborough District Council

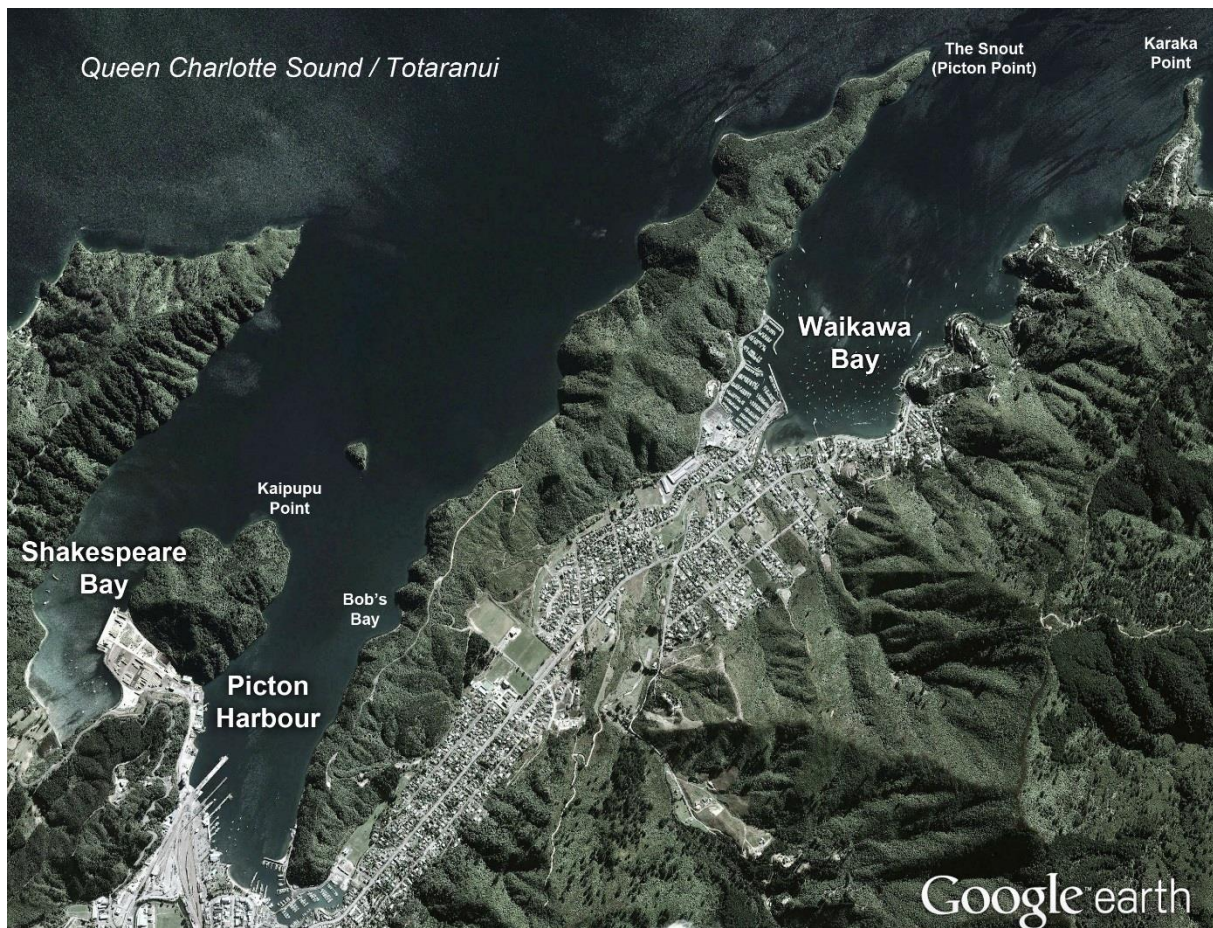
Figure 1. Picton Bays consists of three bays in Queen Charlotte Sound / Tōtaranui: Shakespeare Bay, Picton Harbour, and Waikawa Bay (image edited from Google Earth)

The Picton Bays lie on the southern side of inner Queen Charlotte Sound / Totaranui. Waikawa Bay is the eastern-most of the three. It lies between Karaka Point in the east, and The Snout to the west. To the west of The Snout lie Picton Harbour and Shakespeare Bay, which are separated by Kaipupu Point (Figure 1).

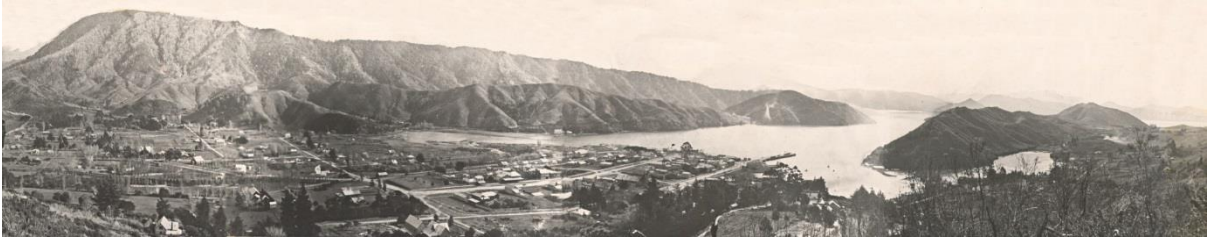
Figure 2. Picton Harbour, date unknown. Photograph supplied by MDC.

land around the Picton Bays has been modified, and widespread removal of native bush is apparent in early photographs (Figure 2, Figure 3). Substantial urban development and foreshore modification date back over a century (Figure 3).

The south-eastern head of Picton Harbour was originally the Kaiaua Lagoon (visible at the right of the image in Figure 2). The lagoon was partially filled in to create Memorial Park, roadways and parking, and the remainder was converted to the Picton Marina. At the centre of the head of the bay lies a popular waterfront area and beach. Wharves have existed for over 100 years on the western side of Picton Harbour. This is now the berthing point for ferries to the North Island. Ferries have increased in size over the years, and from 1994 to 2000 fast ferries operated. These were controversial, and were ultimately restricted, because high-energy wakes eroded the shoreline and disturbed communities.

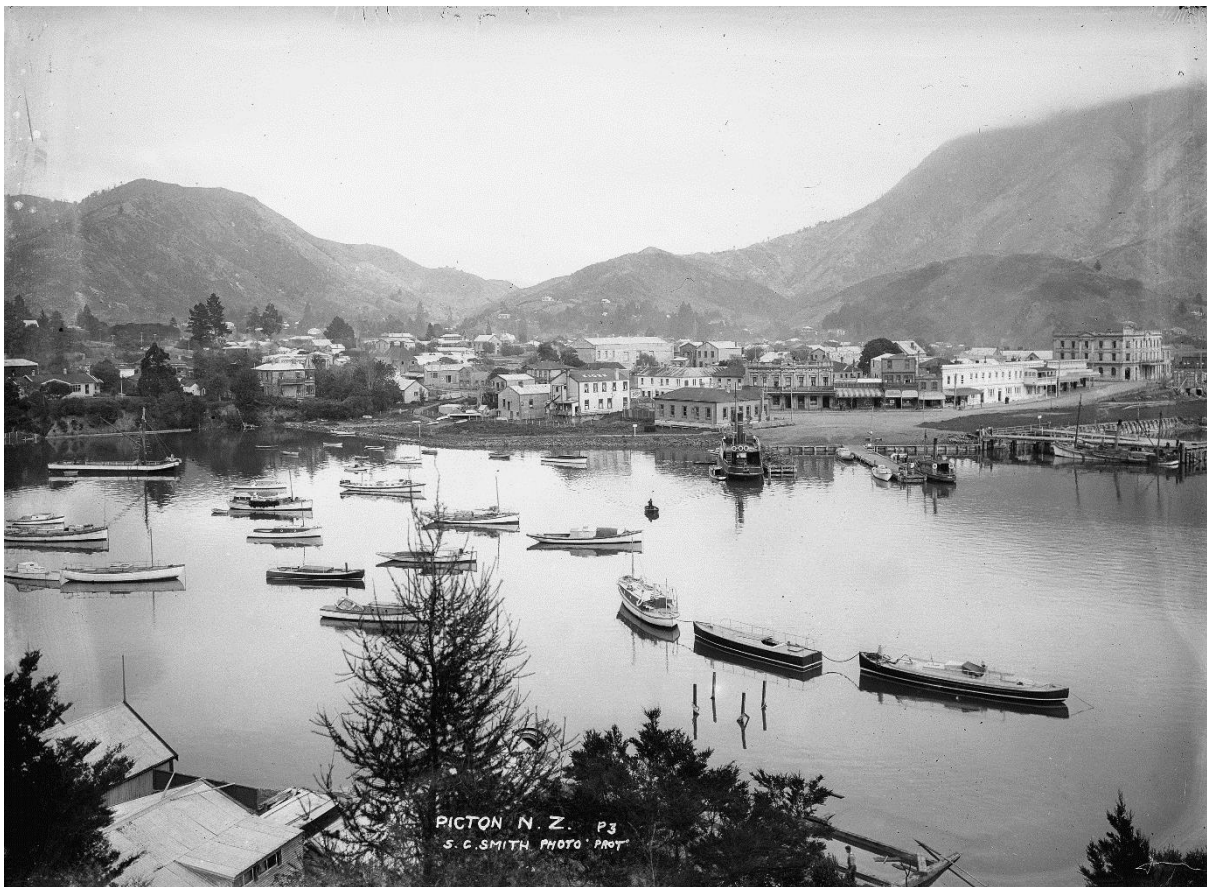
Figure 3. Picton Harbour circa 1920s. (Smith, Sydney Charles, 1888-1972: Photographs of New Zealand. Ref: 1/2-049257-G. Alexander Turnbull Library, Wellington, New Zealand)

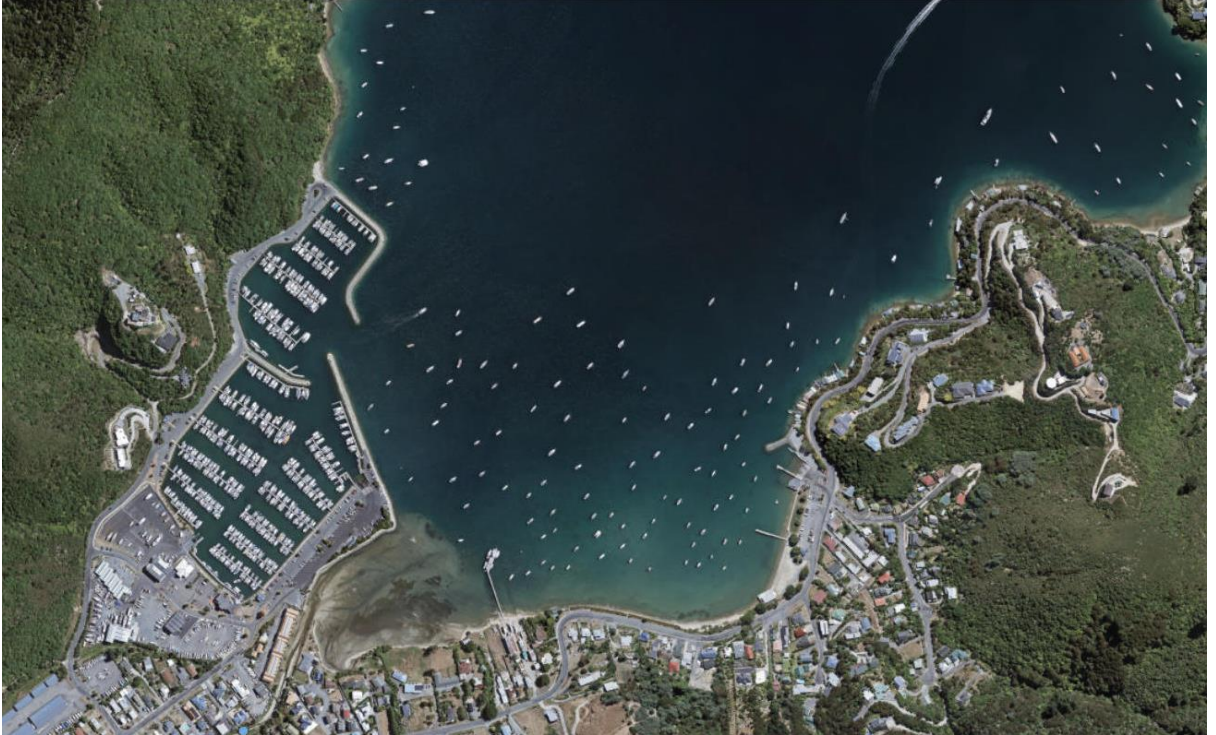
Figure 5. Waikawa Bay. The marina occupies much of the western side of the head of the bay, while small remnant wetlands are apparent on the south-east of the marina. Urban development fringes much of the remainder of the bay. <http://maps.marlborough.govt.nz>

In Waikawa Bay, the western side of the bay is taken up by a marina, while a small area of intertidal sand or mud flats remains on the eastern side (Figure 5). In August 2015 a change to the Marlborough Sounds Resource Management Plan became operative, allowing extension of the Waikawa Marina to the north<sup>9</sup>.

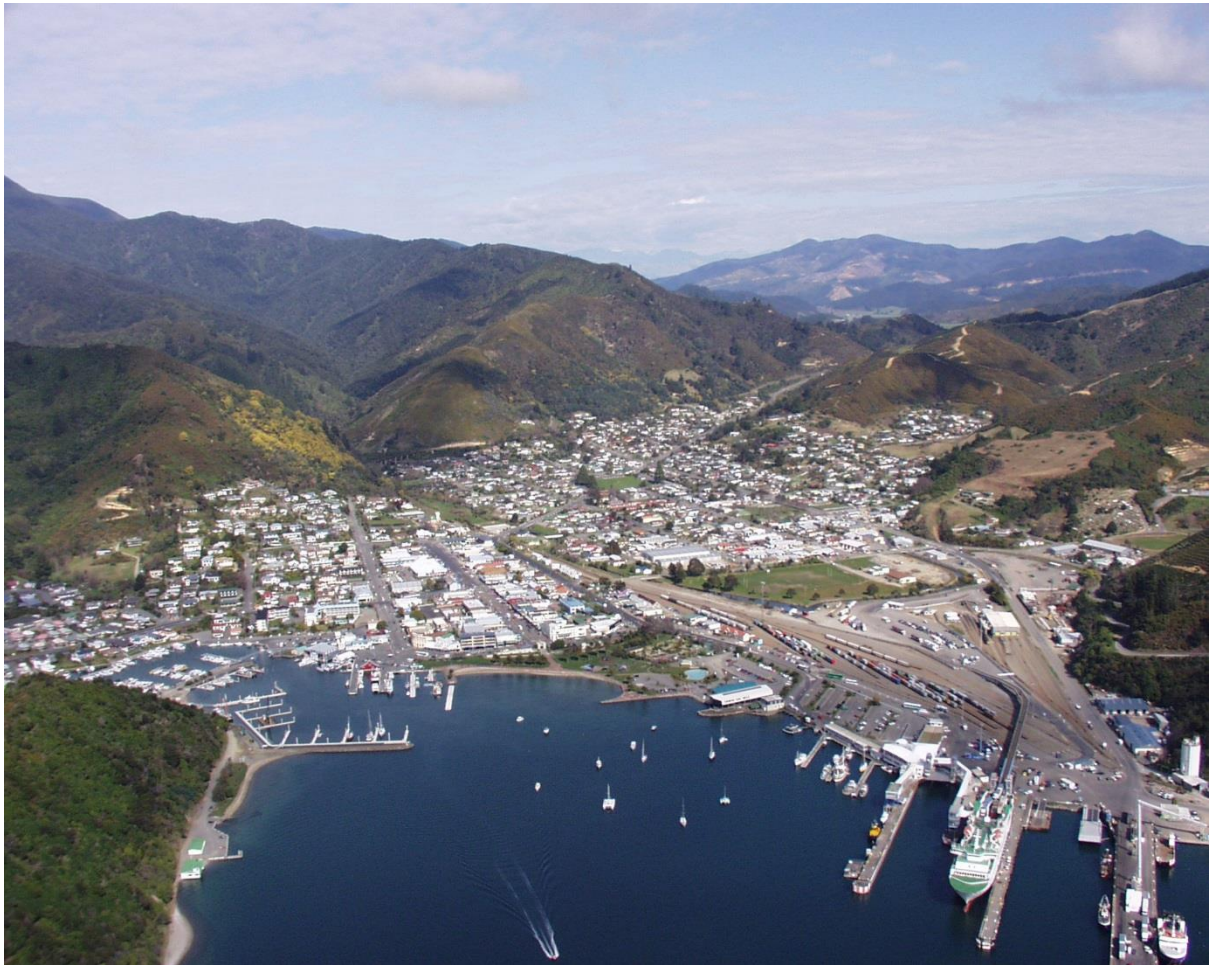
Figure 6. Picton Harbour waterfront, looking south. The Picton marina was built over the Kaiaua Lagoon. Urban development, including wharves, dominates the head of the harbour. Photo: Peter Hamill, MDC, 2002

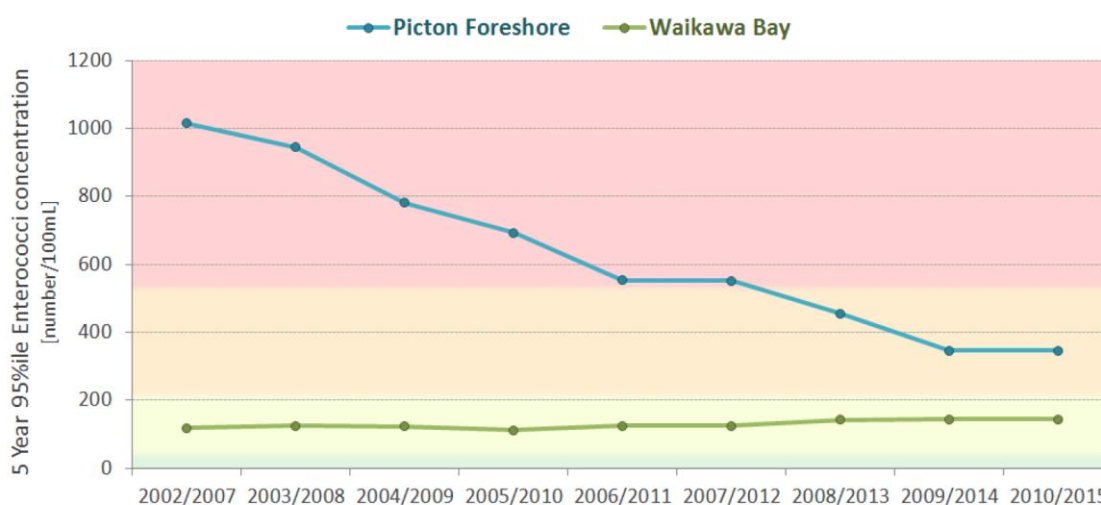
Figure 9. Enterococci levels at Picton foreshore and Waikawa Bay. 95th percentile results integrated over progressive 5-year periods. Shading indicates Unsafe (pink) Increased Risk (yellow) and Safe (green) ranges (Henkel 2015). (Ref Henkel)

Seawater enterococci<sup>27</sup> concentrations over successive 5-year periods show that concentrations at Waikawa have been very steady, and lower than at Picton (Henkel 2015). The concentration at Picton has, nonetheless, been declining steadily, and while in 2012 the 5-year 95<sup>th</sup> percentile was in the 'unsafe' zone, in the past three sampling periods contamination over the preceding 5-year period has placed it in the 'increased risk' zone (Henkel 2015). Most samples are of course much lower than the 95<sup>th</sup> percentile, and those peaks in concentration that do occur (in Picton more so than at Waikawa), are considered to be associated with rainfall.
