# Shoreline Monitoring in Tory Channel and Queen Charlotte Sound

## Summary report November 2013 – November 2016

Report prepared for the Marlborough District Council

June 2017

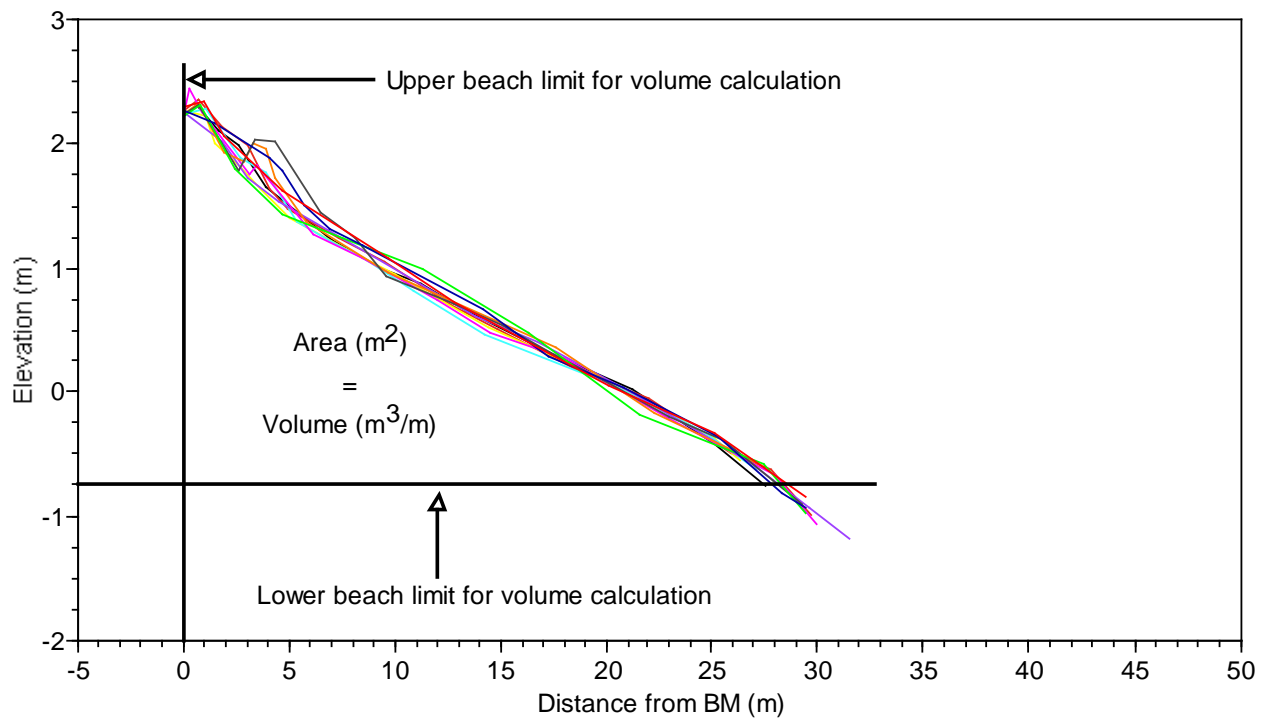
**Figure 3: Volume calculation methodology**

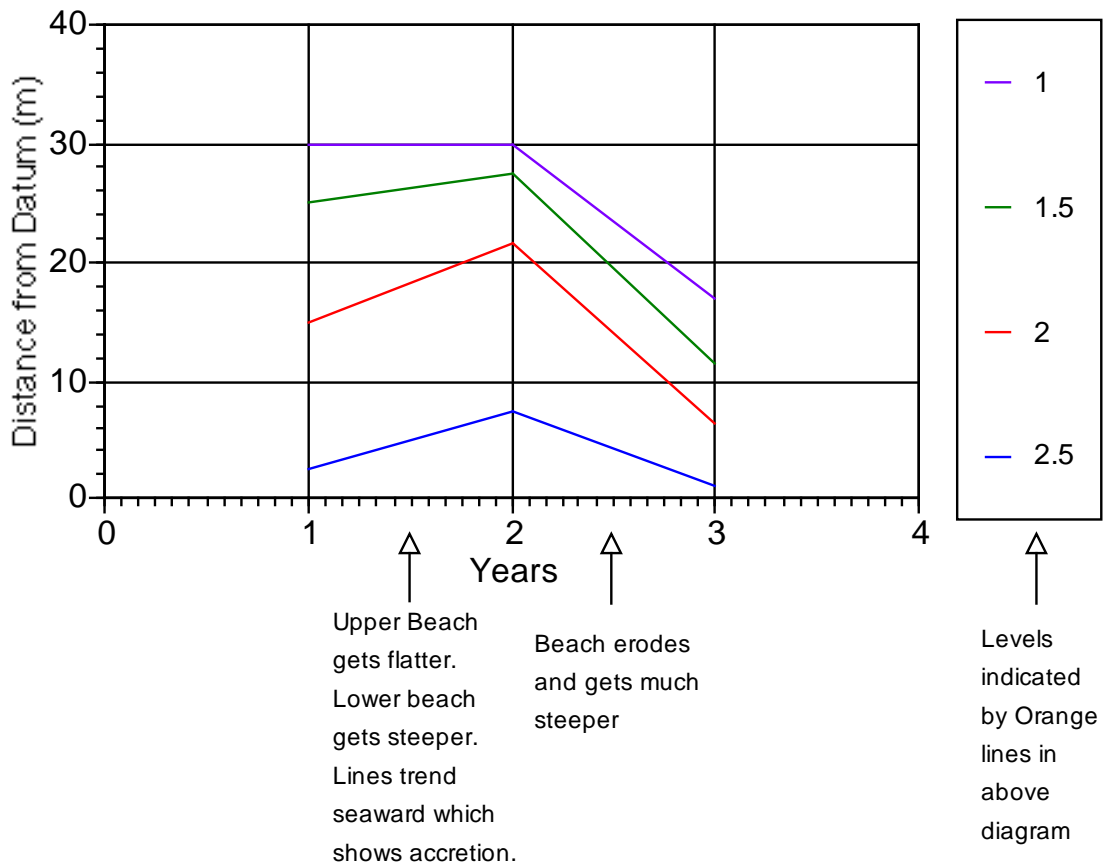
The 'spaghetti' plots of profiles are useful for establishing envelopes of change of the beach shape, but interpretations of changes that have occurred are difficult, due to the clutter of lines that are present. As the data set grows, any useful interpretation based on these plots becomes almost impossible. Excursion distance plots use exactly the same data plotted as a time series, and makes interpretation of beach changes easier. Excursion distance analysis is a method by which three dimensional data sets (distance, height and time) can be illustrated as plots with time on the independent axis. It can be undertaken with either distance or height on the vertical axis, although having distance on the vertical axis is more useful for most purposes. Excursion distances are calculated by determining a set of height values for which calculations will be made. These values are normally equally spaced and in the following figures, are shown in the box on the right hand side of the graph. These numbers are in units of metres above or below the datum (in this case the zero level established by Aysons in the GPS survey in 2013, stated as being Chart Datum Picton). Using linear interpolation, the horizontal distance from the datum is calculated for each of the height values, and these are plotted as a time series with time on the horizontal axis. For each survey this provides a "point contour map" of the profile, and when plotted as a time series, an indication of how levels change through time. The graphs provide a lot of information. If two lines converge, the beach is getting steeper at those contour heights. If two lines diverge, the beach is getting flatter. If the lines trend seaward (increasing values on the distance axis), the beach is accreting. If the lines trend landward, the beach is eroding. Figure 4 attempts to show the methodology of Excursion Distance Analysis.

**Figure 4 : Excursion Distance Analysis Demonstration**

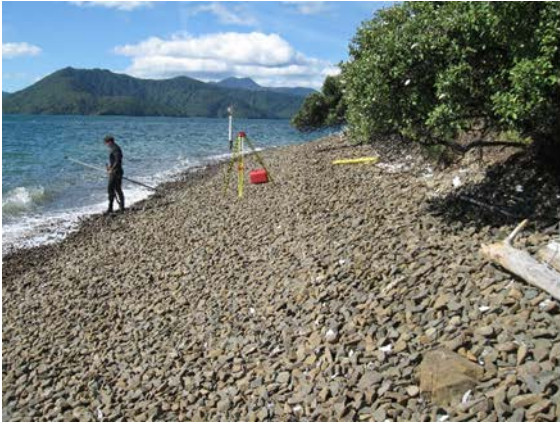
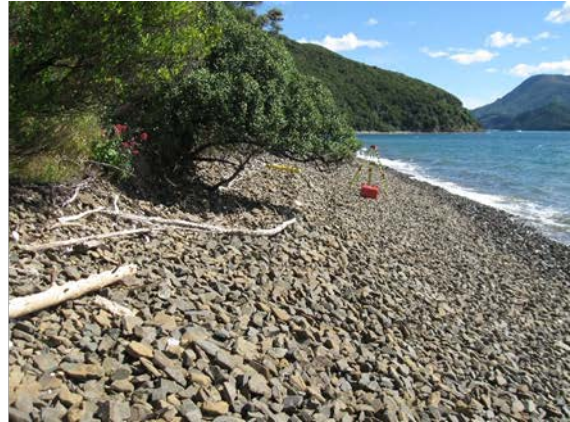
**Profile 2: The Snout at Picton Point**

Since April 1997, the profile landward of about -1m CD has retreated and significantly steepened on the upper beach. The extent of retreat has been in the order of 2-3m horizontally. This is seen particularly by the downward trend and convergence of lines on the EDA plots. The major cause is probably the slow migration of the deep water channel in a shoreward direction. Beach volumes have followed an almost linear trend of loss over the same period, with the loss of over 7m<sup>3</sup>/m. A significant loss of volume between December 2010 and December 2011, was reversed through to November 2013, when the loss trend returned. There have been no apparent changes to sediment composition. The reason for the channel migration is not clear, although the site does receive considerable and regular wave energy.

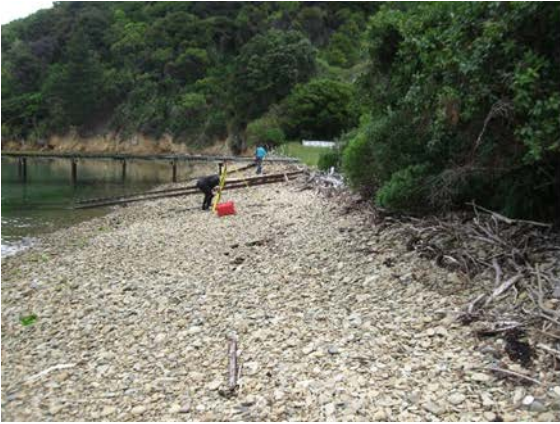
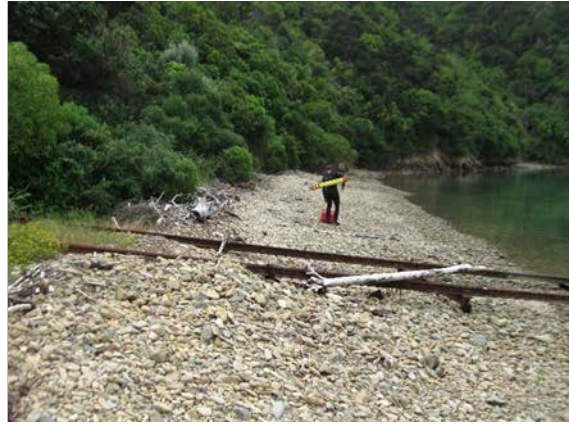
**Profile 4: Ngaionui Bay**

The Ngaionui Bay site is complicated by human modifications to move sediment from the top of the beach which was covering the launching rails and potentially causing water to pond. The most significant removal of sediment was in 2000-2001. The nature of any works and their frequency since 2001 is not known, but between 2001 and 2006 the beach sediment that was removed or reprofiled, returned or was replaced. The interpretation is also complicated by the presence of a landslide at the western end of the beach, with sediment redistribution within the compartment. It was very clear in the early years of the monitoring program that fast ferry operation contributed to significant beach accretion (see the high berm evident on two early surveys on the 'spaghetti' plot), and that wakes and natural waves, coinciding with an increased sediment supply from the slip, contributed to beach building during the time that the fast ferries were operating. This site was the subject of much media and political attention during those years. Since 2006, beach volume has varied little within a  $1.5\text{m}^3/\text{m}$  range.

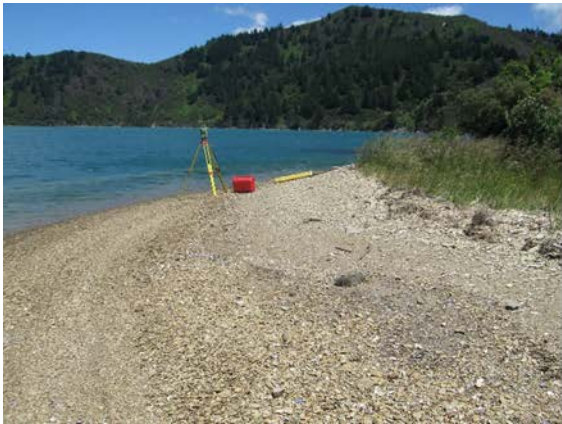
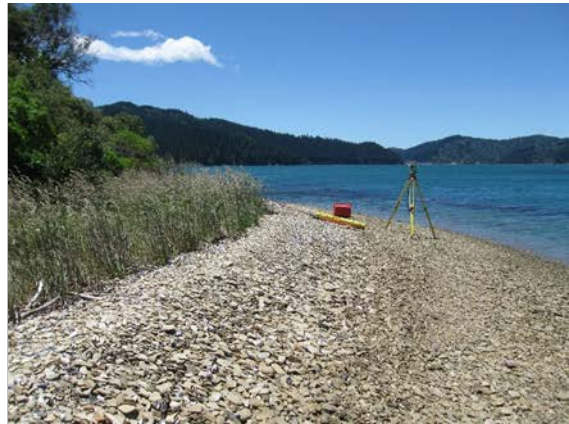
**Profile 7: Moioio Island 1**

There is little doubt that the beach changes taking place on this profile are related in part to ferry operation (evidenced by the very strong seasonal signal when fast ferries were operating seasonally), but they are affected significantly by changes to sediment supply. For example, the accretion event observed on Profile 6 between April 2003 and April 2004 is reflected on Profile 7 between November 2004 and April 2005.

Over the period of surveys, the high tide berm has grown seaward by about 7m, and has become vegetated. Beach volume increased (with seasonal reversals) from 1995 through to 2006, and has been stable since then.

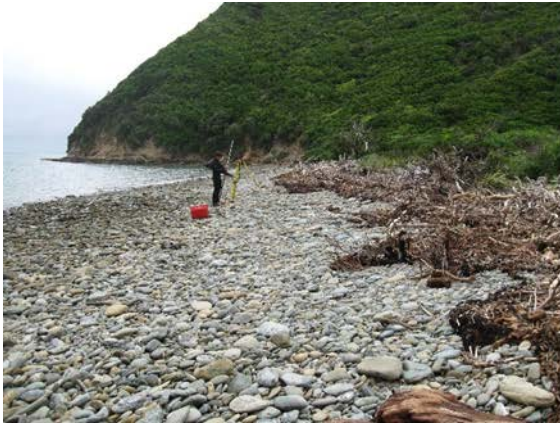
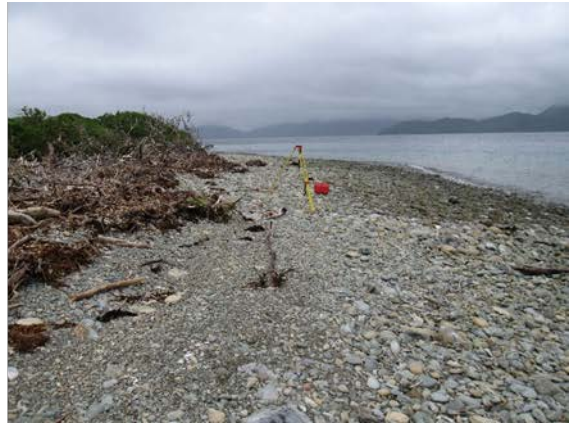
**Profile 11: Long Island**

The Long Island profile is relatively exposed to storm events that cause waves to propagate through the northern entrance to Queen Charlotte Sound. There is considerable variability in the level of the upper beach, with the build-up and removal of a berm, although this has been less evident since about 2000. The level of the middle and lower beach also shows some variability, but with no obvious seasonal trends. There has been a slow trend of profile lowering since 1995 (~0.25m), and the profile is currently in its most depleted state. There has been an overall decrease in sediment volume since 1997, with considerable variability.

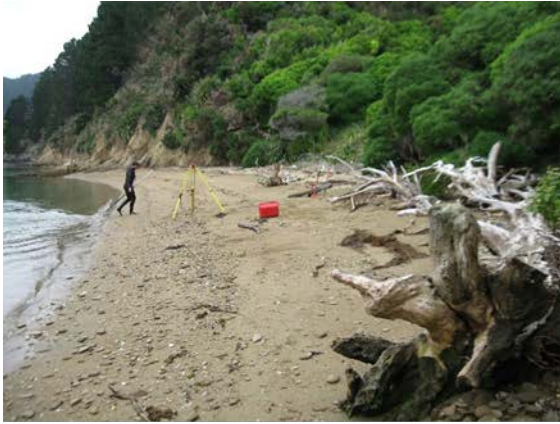
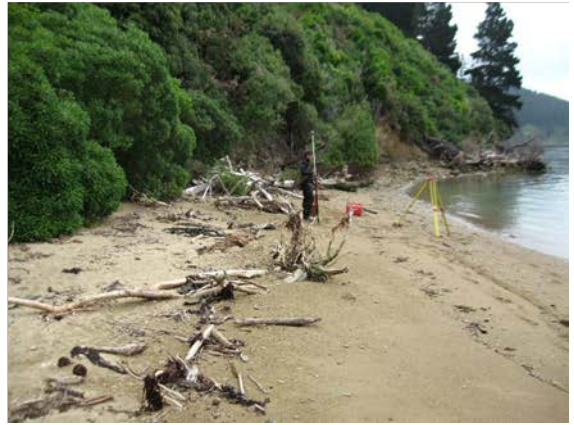
**Profile 13: Slip Beach**

It was earlier believed that the variability in the profile was to a significant extent related to fast ferry operation. However, similar variability in levels and volumes has continued since fast ferry operation ceased. Slip beach has a long fetch into Queen Charlotte Sound to the north, and natural waves may be substantial. However, wave measurements at this site have showed substantial wake events (both fast and conventional) affect this beach that continue for unusually long periods of time.

Because of its unusual exposure, extreme seasonality, unusual wakes and, for the area, fine sediments, this location continues to be of particular interest, although apart from seasonality there is no obvious explanation for the changes observed.

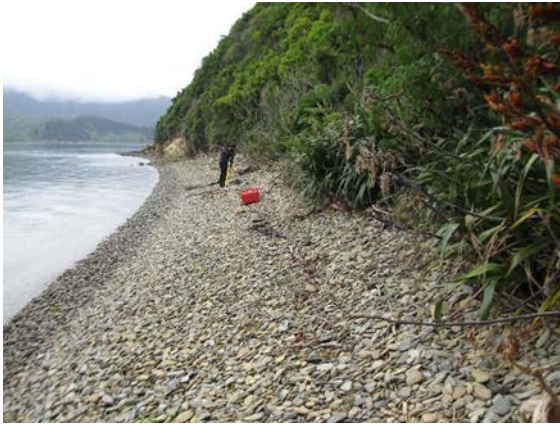
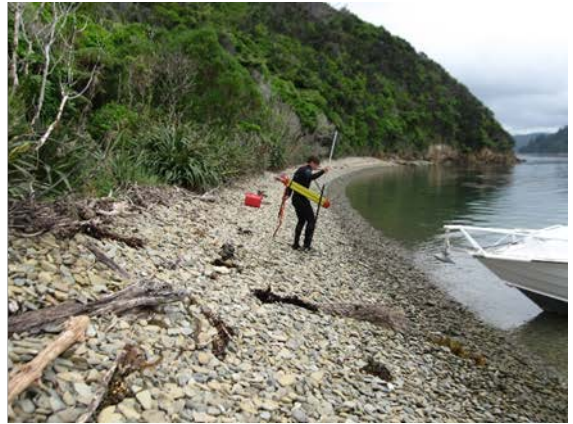
**Profile 14: Ngaionui Point**

Given its proximity to the sailing line of vessels in Tory Channel, the beach at Ngaionui Point probably changed significantly when the fast ferry first started operation, with accretion and berm building. There was a slow trend towards accretion up until about April 2002, and a trend of erosion since that time, reflecting the slow return to pre-fast ferry conditions. The beach is now lower than at the start of surveys, although the first survey did not coincide with the commencement of fast ferry operation, and it is quite possible that there had already been rapid berm building.

Apparent changes at the very lower beach are probably the result of different survey placement. There have been no significant changes in sediments.

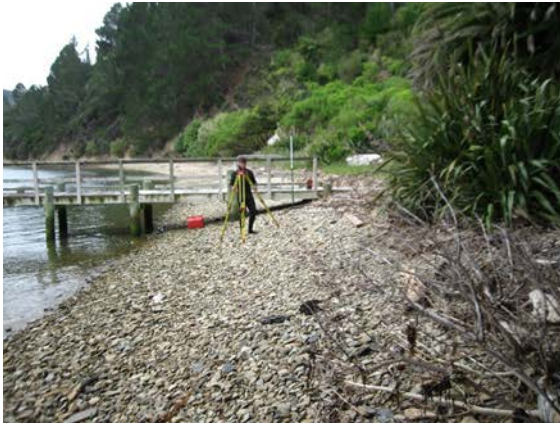
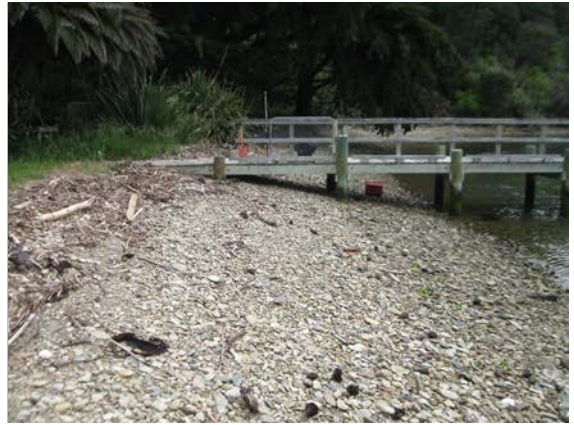
**Profile 15: Te Weka Bay**

Te Weka Bay was the site of much of the 'dramatic' news footage of fast ferry wakes. The fast ferries caused the development of an upper beach berm which has remained generally intact since that time. The middle beach has built a little seawards. In the last 3 years, there has been significant sediment deposited on the lower profile, although a similar feature was evident in about 2005. The source of this sediment is not known. With considerable variability, sediment volume has increased slowly. However, the deposition on the lower profile over the last 3 years has resulted in a substantial increase in sediment volume over that period.

There have been no significant changes in sediment characteristics.
