Shoreline Monitoring in Tory Channel and Queen Charlotte Sound

FINAL REPORT

April 2000 – April 2002

Report prepared for the Marlborough District Council

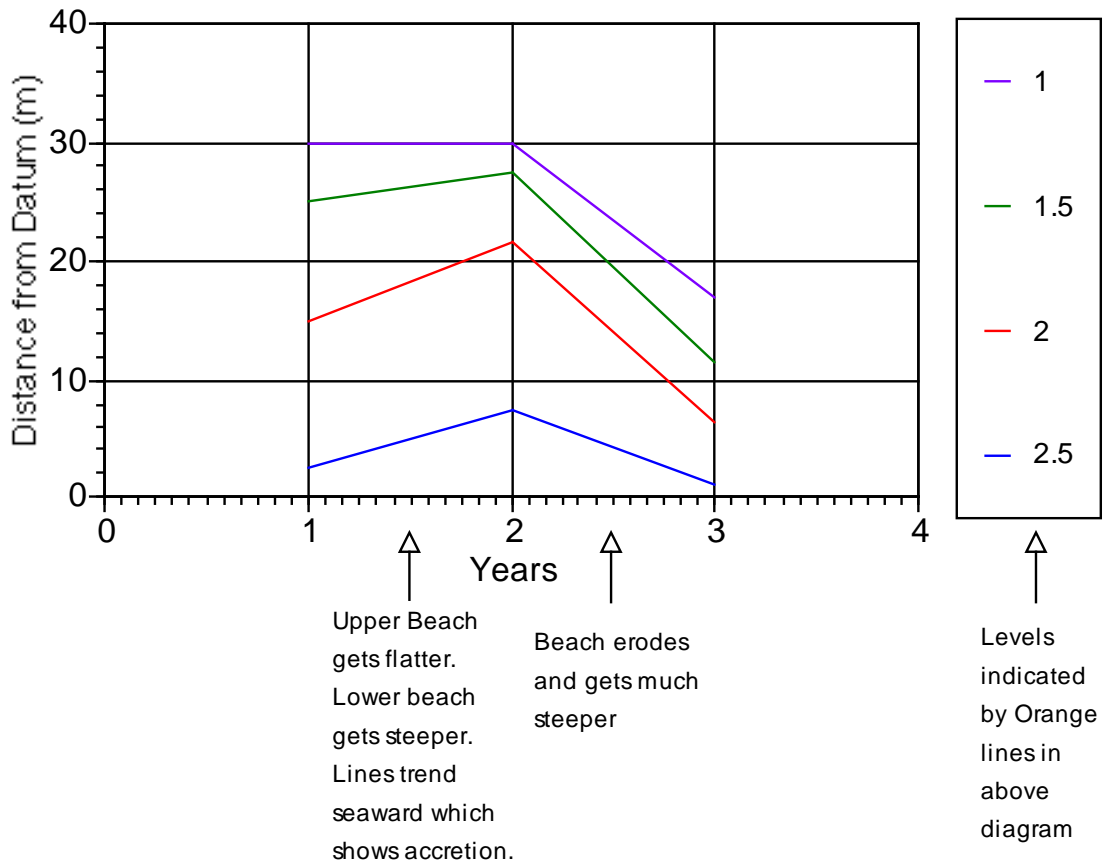
Figure 3 : Excursion Distance Analysis Demonstration

The 'spaghetti' plots of profiles are useful for establishing envelopes of change of the beach shape, but interpretations of changes which have occurred are difficult, due to the clutter of lines which are present. As the data set grows, any useful interpretation based on these plots becomes almost impossible. Excursion distance plots use exactly the same data plotted as a time series, and makes interpretation of beach changes easier. Excursion distance analysis is a method by which a three dimensional data set (distance, height and time) can be illustrated as two dimensional plots. It can be undertaken with either distance or height on the vertical axis, although having distance on the vertical axis is more useful for most purposes. Excursion distances are calculated by determining a set of height values for which calculations will be made. These values are normally equally spaced and for the following figures, are shown in the box on the right hand side of the graph. These numbers are in units of metres above or below the datum (in this case approximate MSL). Using linear interpolation the horizontal distance from the datum is calculated for each of the height values, and these are plotted as a time series with time on the horizontal axis. For each survey this provides a "point contour map" of the profile, and when plotted as a time series, an

indication of how levels change through time. The graphs provide a lot of information. If two lines converge, the beach is getting steeper at those contour heights. If two lines diverge, the beach is getting flatter. If the lines trend seaward (increasing values on the distance axis), the beach is accreting. If the lines trend landward, the beach is eroding. Figure 3 attempts to show the methodology of Excursion Distance Analysis.

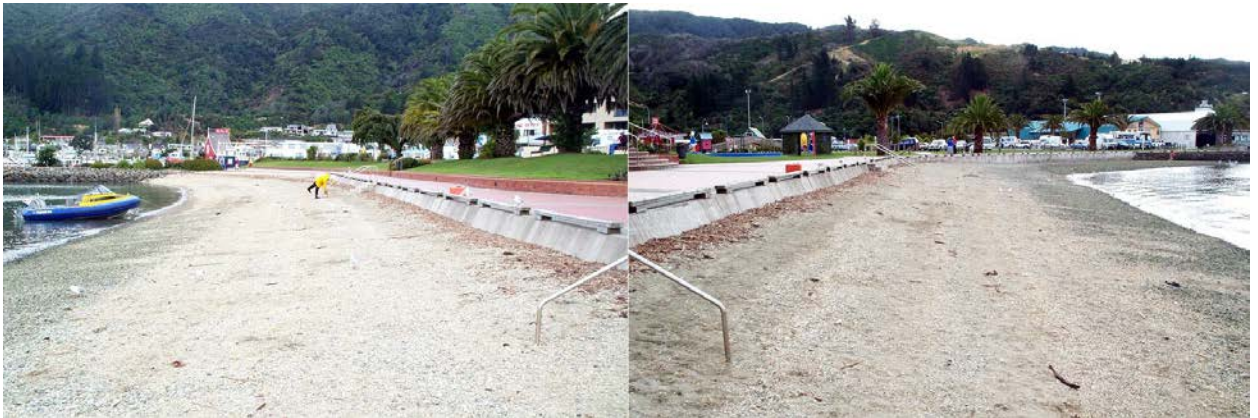
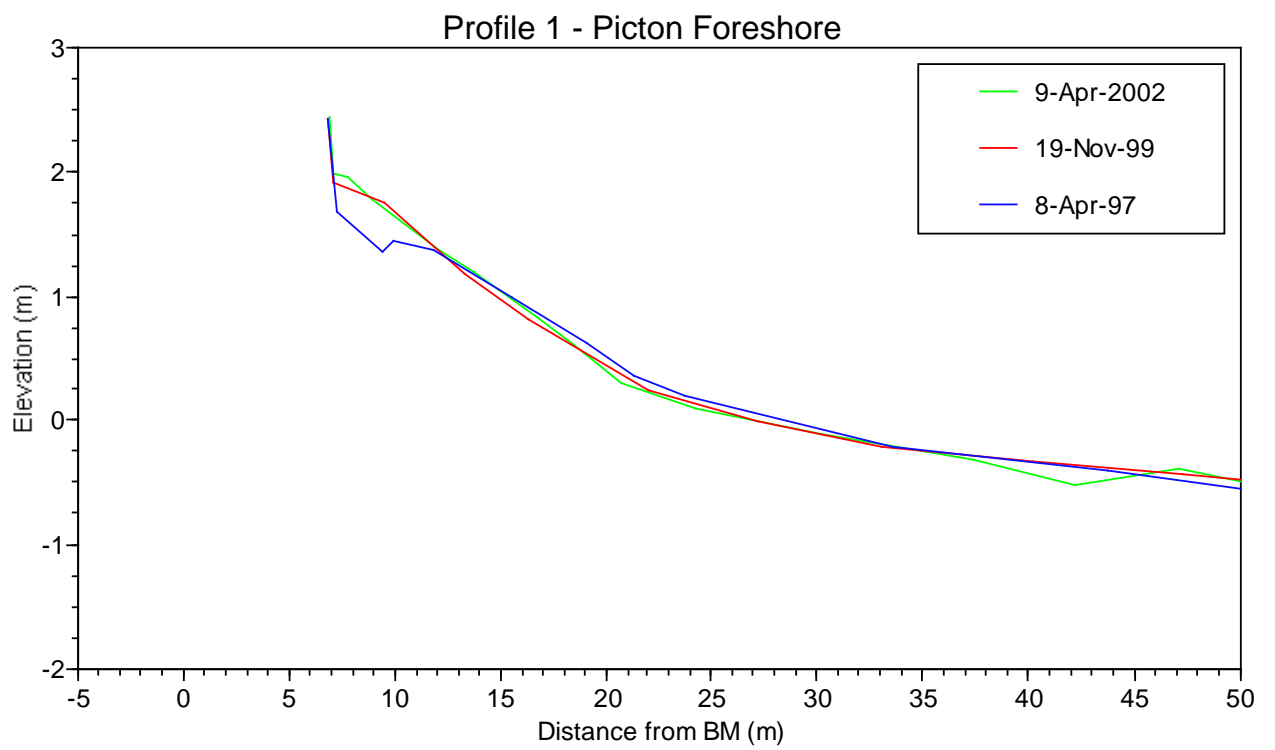
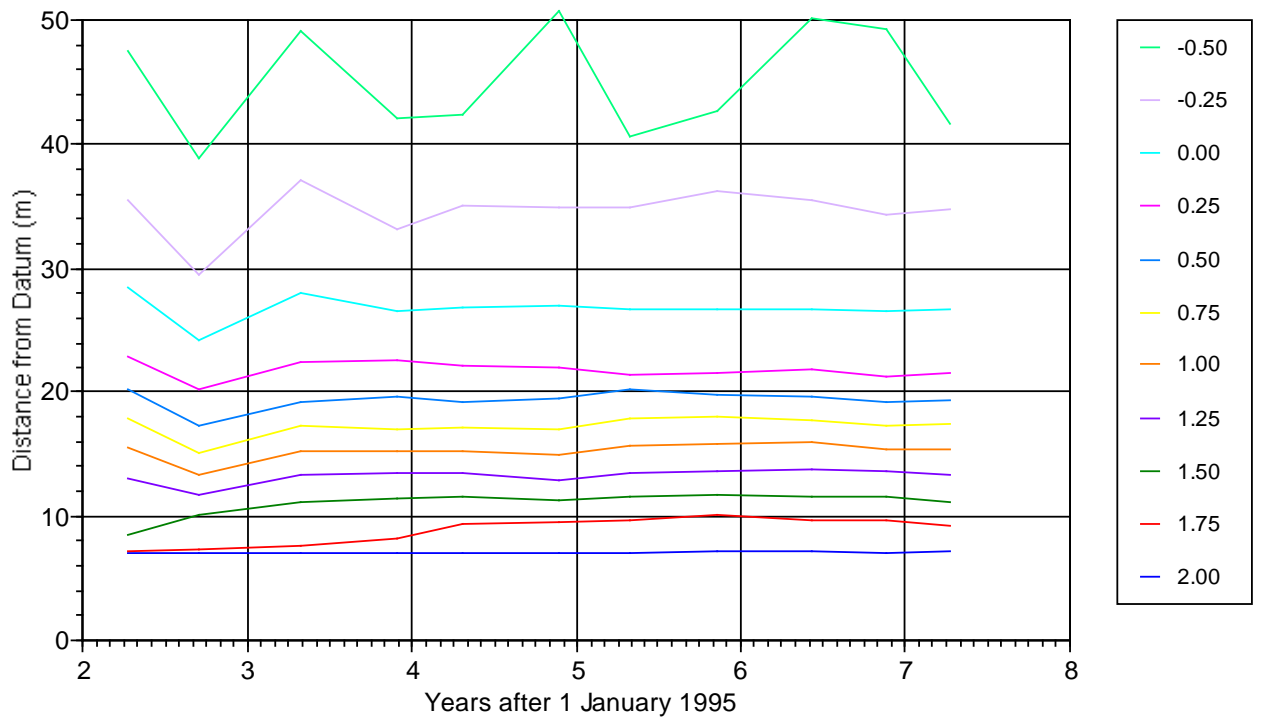
Profile 1 - Picton Foreshore

The Picton Foreshore underwent extensive modification with the improvement of the landward side of the retaining wall in late 1997. Sediments on the beach comprise both natural marine sediments and river sand deposited in a beach nourishment programme.

I do not know if further nourishment has taken place since late 1997 or early 1998. If further nourishment has taken place, then the rate of nourishment is clearly appropriate. If there has been no renourishment then the beach has been very stable since that time. Beach volume has maintained a relatively narrow range since April 1998, between 30.8 m³/m and 32.9 m³/m. There has been no apparent change in sediment characteristics. There is no indication that the seawall has had an adverse effect on beach stability. There is no indication that waves caused by vessel wash in the inner harbour are having an adverse effect on the Picton foreshore beach.

There is no indication that this site is affected by vessel operation, with the beach being relatively stable despite being highly modified. However, I do not have data on the timing and extent of renourishment programmes. If these data are available, they would assist interpretation.

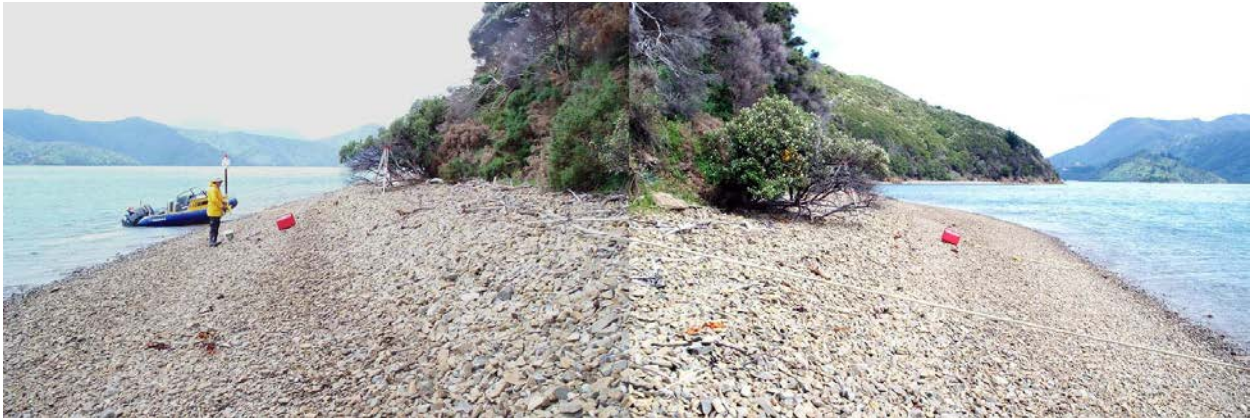
Profile 2 - The Snout at Picton Point

It was concluded at the time of the last major report in December 1999 that Profile 2 had been stable over the survey period. It is now clear that there has been a distinct trend of erosion of the lower beach and accretion of the upper beach, leading to a substantial steepening of the beach profile. This is most clearly illustrated by the EDA plots. The beach profile lines show that the measured beach profile does not reach closure depth, which indicates that the deep water channel is migrating shoreward. There has, however, been some recovery of the lower beach since November 2000 when it was at its most landward position. It is likely that sediment accumulating on the upper beach has come from further down the profile. There has, however, been an overall loss of sediment from 36.4 m³/m in April 1997, to 33.6 m³/m in April 2002. The lowest volume recorded, however, was 31.8 m³/m in November 2000. It may or may not be coincidental that recovery started immediately after the fast ferries were slowed to 18 knots. However, recordings at this site in 1995/6 indicated a very large wave, possibly associated with the fast ferry passing through critical velocity adjacent to this site. There have been no apparent changes in sediment composition over the survey period.

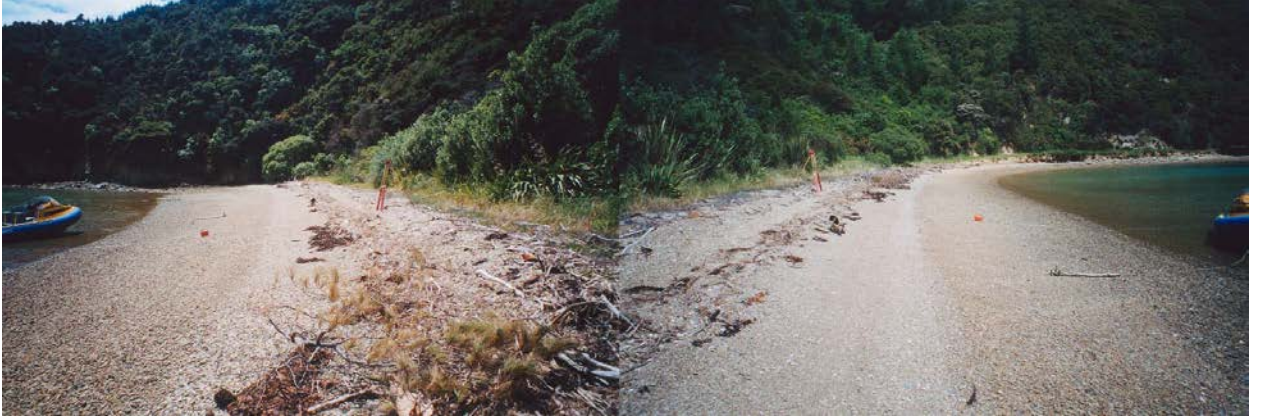
Profile 3 - Double Bay

The upper beach and berm have accreted over the survey period, but the changes in beach level have only been in the order of 20cm. The berm, however, virtually disappeared for a short period in early 2000. There has been a corresponding loss of sediment on the middle beach, in the order of 20cm, leading to a small steepening of the beach face. The profiles clearly reach closure depth. Sediment composition has been stable although bands of sand are either deposited or exposed on the surface on some occasions. Volume data indicate relative stability but with significant fluctuations. There is no indication of a seasonal pattern to the changes.

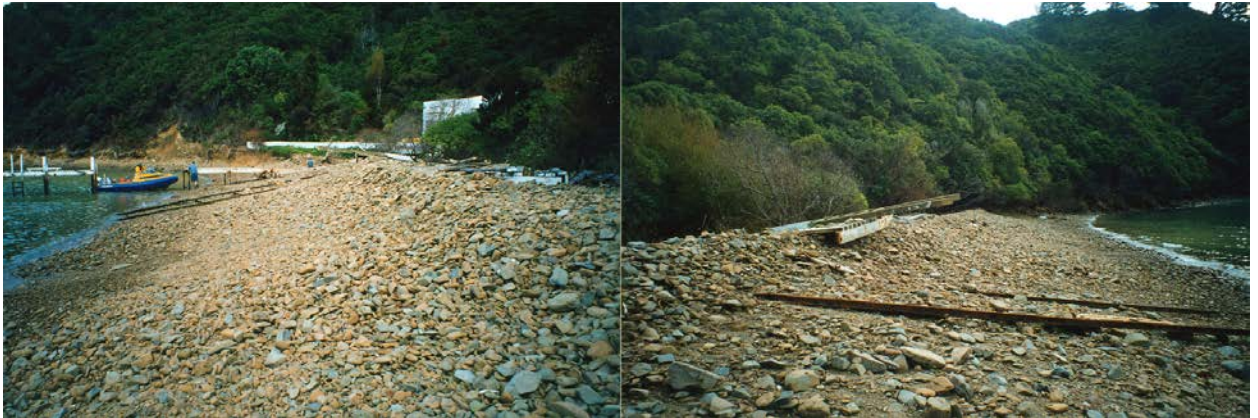
Profile 4 - Ngaionui Bay

Between April 1999 and April 2000 a very substantial berm built at the top of the beach. The upper beach prograded substantially and the middle beach retreated a little. The berm was still in place in November 2000. Between that time and the following survey, substantial beach works took place, removing the berm and much of the sediment on the upper beach. This is clearly evident in the data and in the profile photographs. It is unfortunate that these beach works coincided with the slowing of the fast ferries in December 2000, as this makes interpretation of the changes difficult. The build up of the berm had previously been interpreted as possibly relating to the continuation of the fast ferry service through the winter months, or to the wake characteristics of the ferries operating at that time. There has been an apparent recovery of the upper beach (and consequently the beach volume) since the beach works took place, evident in the last two surveys.

This location has a very distinct change in slope at approximately -0.25m , indicating probable closure depth for this profile.

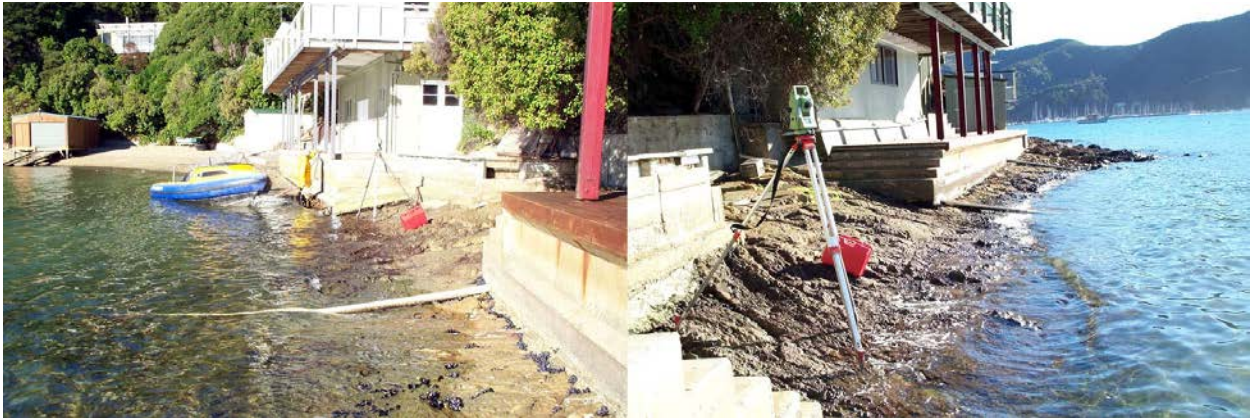
Profile 5 - Blackmore's at Waikawa

There has been a gradual retreat on this profile since surveys began in April 1997. There has at various times been building work in the vicinity of this profile line, and it may be that these events have contributed to the change. At present, the profile appears to be stripped to bedrock, and further loss of sediment is therefore unlikely. There has been no recovery since the fast ferries slowed down in December 2000.

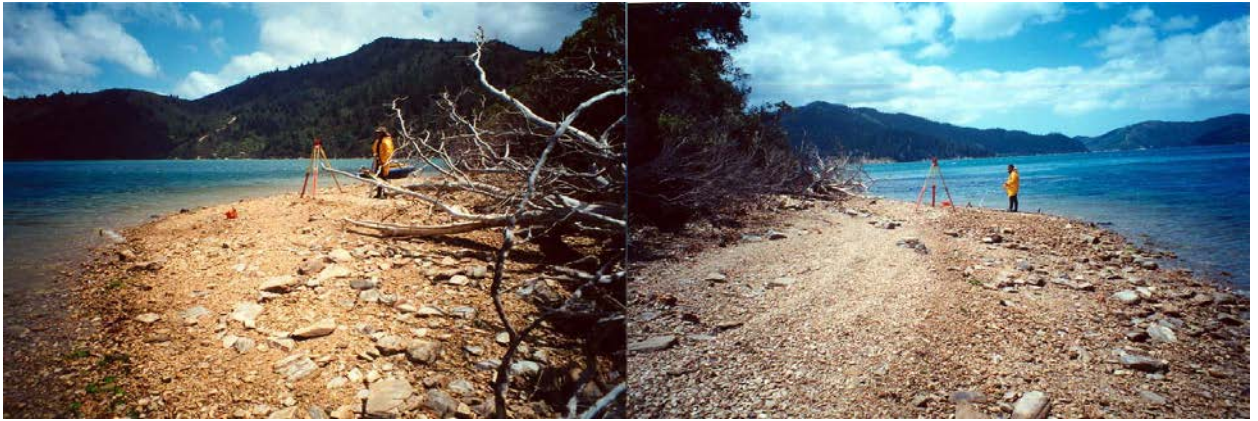
Profile 6 - Moioio Island 2

Moioio Island 2 is at the eastern end of the beach on the island, near the slip that has been of considerable concern to Te Ati Awa. For the first few years the beach profile demonstrated seasonality, with a build up of a berm on the upper beach over the winter months, and its removal over the summer months. The berm did not return during the winter of 1999, and by May 2000, the berm at the very top of the beach was removed. It is possible that the cause of the non-return is the continued operation of fast ferries over this period. However, there was recovery by November 2000, with the upper beach berm and the berm at the very top of the beach both returning. Since November 2000, the upper beach berm has removed, and the beach level at the position of the upper beach berm has fallen to its lowest recorded level.

The lower beach, sloping into the channel has been building out over the entire survey period, possibly being supplemented by material coming from the slip at the end of the island.

Profile 6 shows significant changes through time, and there is some difficulty in interpretation due to apparent contradictions. The pattern during the period of seasonal operation of the fast ferry seemed clear. The upper beach berm built up over the winter, when the fast ferries were not operating, and then was lost during the summer. When the fast ferries ran continuously, the berm did not return. However, the entire upper beach grew significantly during the second half of 2000, contrary to expectations. Since the ferries slowed in December 2000, the level of the upper and middle beach has fallen significantly, along with beach volumes.

It remains likely that this site reacts to changes in ferry operation. However, it is also likely that it reacts to changes in sediment supply from the adjacent slip. Determining the relative effects of the two sets of events is difficult.

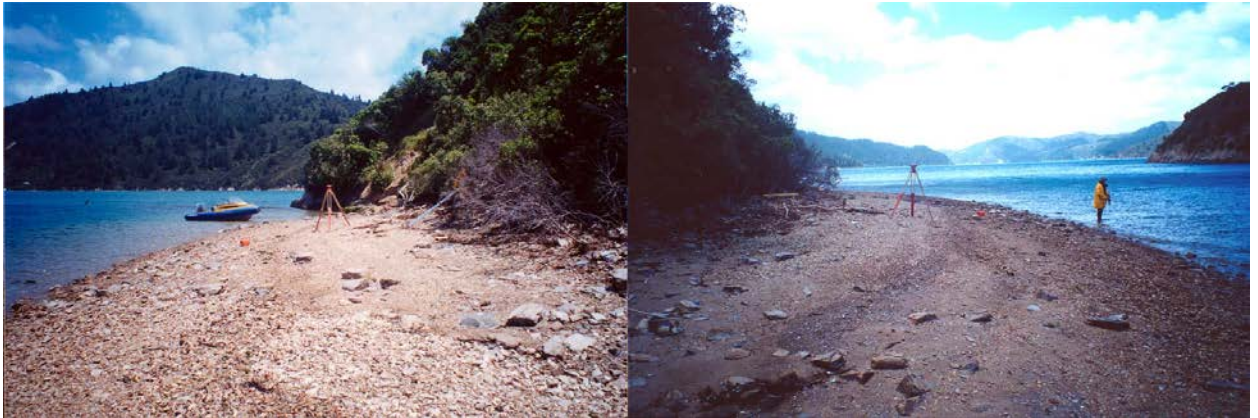
Profile 7 - Moioio Island 1

The Moioio Island 1 profile is to the west of Profile 6. There was remarkable seasonality up to the winter of 1999, with the growth of a berm over winter and its loss over summer, but with the growth of the berm not occurring during the winter of 1999. There has been substantial accretion of the upper beach since May 2000, with a major increase in volume, particularly between May 2000 and April 2001. This probably indicates an increase in sediment supply from the slip. Accretion on the middle and lower beach has continued since surveys began in 1995.

There is little doubt that the beach changes taking place on this profile are caused by the ferry operation regime, but supplemented by changes in sediment supply. In particular, I think it very likely that there was a significant slip event between May and November 2000.

The high level of the beach in 1977 (surveyed by Newton) is interesting, but little significance can be placed on this without further data and assurances regarding data quality.

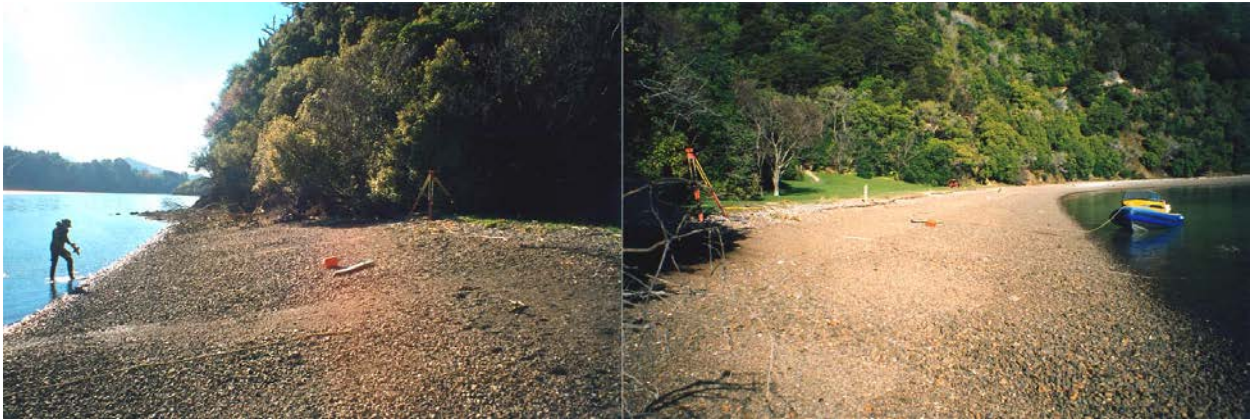
Profile 8 - Bob's Bay

Bob's Bay has demonstrated an almost linear erosion trend since 1995 across the whole beach profile down to the change in slope (and probable closure depth) at about –1 m. Most of the beach has lowered in level by about 0.5m. Volume data shows a loss of approximately 7 m³/m since 1995. This erosion is significant within the context of beaches in this study. The beach slope has stayed relatively constant. There is an indication that surficial sediment has been becoming finer over the survey period.

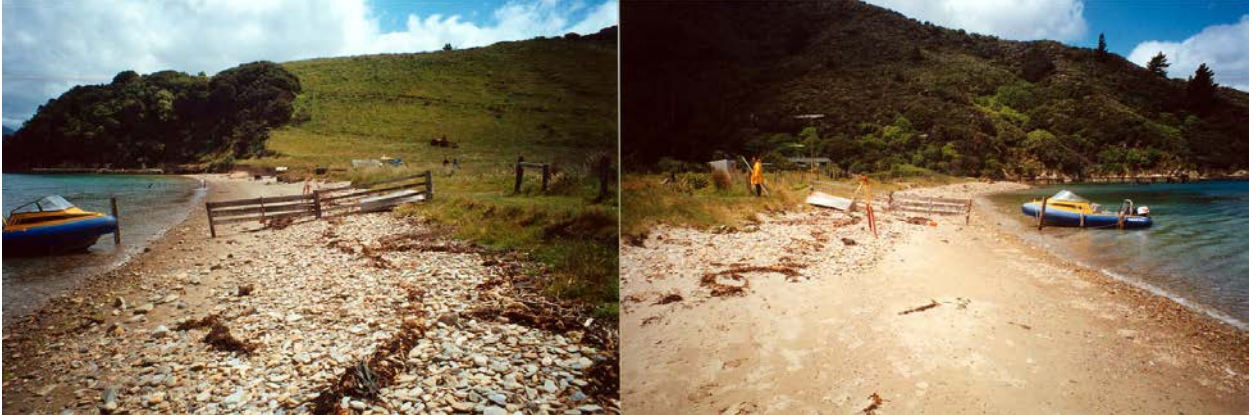
Profile 9 - Te Awaiti Bay

There has been no significant change in the profile of this beach over the survey period. The most remarkable aspect of this beach is the change in surficial sediment characteristics that occurs. This is clearly indicated in the photographs accompanying this report and those in Appendix 2 of the first contract report. The sand forms as a thin veneer, which has little impact on beach sediment volumes. There seems to be a trend of sand deposition over winter and loss over summer, although the trend is not particularly clear. The most significant deposit occurred over winter in 1997.

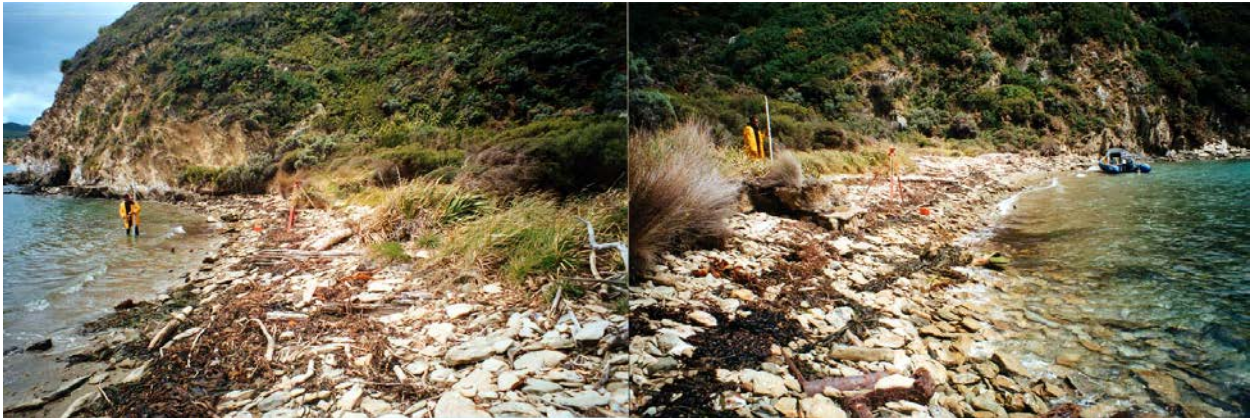
Profile 10 - Tipi Bay

Tipi Bay has shown no significant change since 1997, and this is confirmed by Kirk and Single's longer term record. Because of the relatively coarse nature of the sediments, the placement of the survey staff can have significant impact on the apparent appearance of the profile line. There have been no apparent trends in sediment composition.

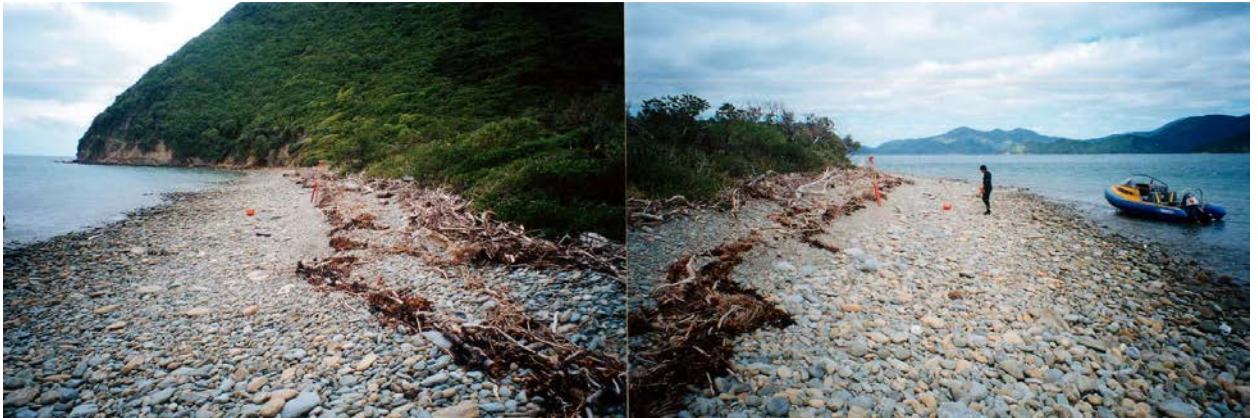
Profile 11 - Long Island

The Long Island profile is relatively exposed to storm events that cause waves to propagate through the northern entrance to Queen Charlotte Sound. There is considerable variability in the level of the upper beach, with the build up and removal of a berm, although this has been less evident over the last 5 surveys. The most significant berm construction took place between April 1998 and November 1998. The level of the middle and lower beach also shows some variability, but with no obvious seasonal trends. There are no significant sedimentary trends.

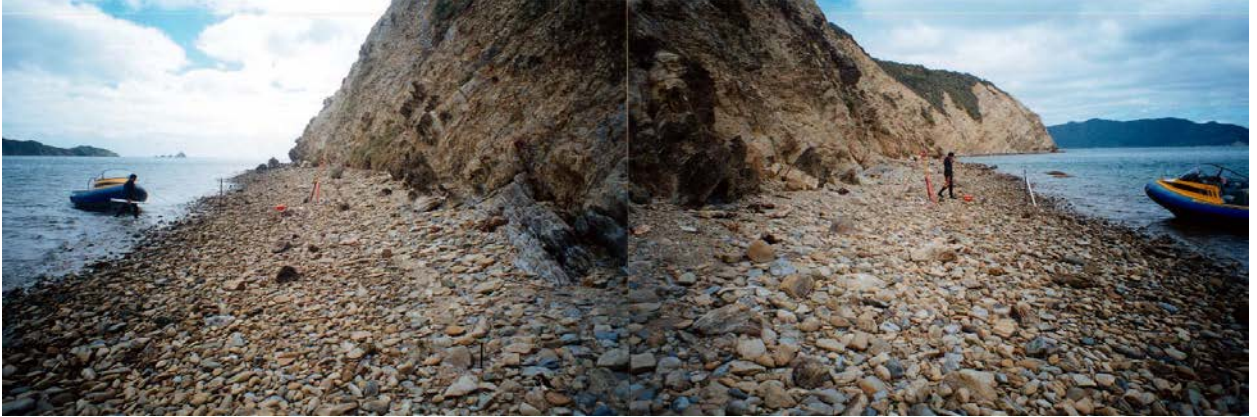
Profile 12 - Clark Point

This profile, with a similar aspect to Profile 11 (Long Island), has shown no significant change in level or sedimentary characteristics since 1997.

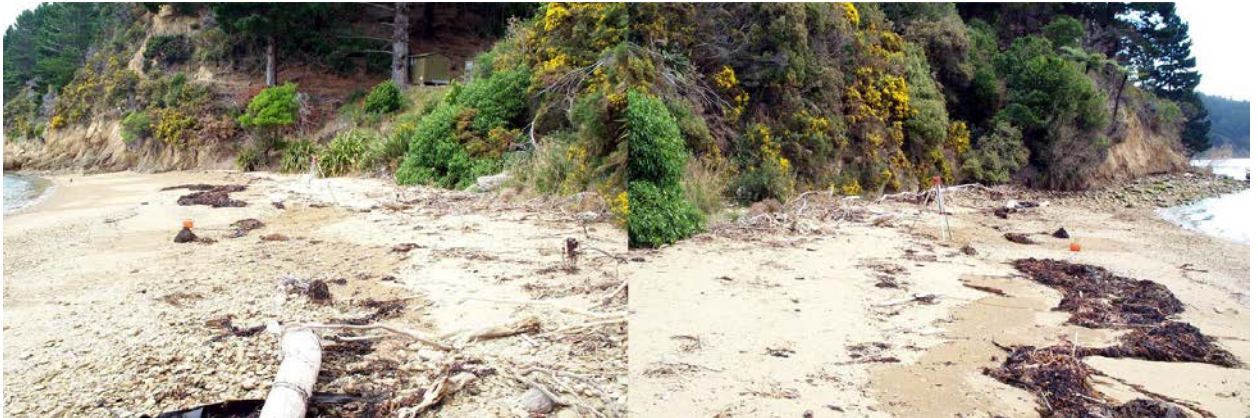
Profile 13 - Slip Beach

Slip Beach demonstrated considerable variability between 1995 and April 1998 when it reached its lowest level. Since that time, and with the single exception of the period between April 1999 and November 1999, there has been a trend of accretion, with about 0.5 m of sediment deposited across the beach profile to closure depth at about – 1.0m. The beach is currently as full as it has been at any time, and the volumes of sediment held in it indicate this.

The 1977 plots derived from Newton's work indicate that at that time Slip Beach was significantly depleted.

The photographs indicate that the dominant sediment type is sand with some small cobbles and pebbles.

There are no obvious relationships between ferry operations and beach change. Slip beach has a considerable fetch into Queen Charlotte Sound to the north, and natural waves may be substantial. However, wave measurements at this site have indicated substantial wake events that continue for unusually long periods of time. Because of its unusual exposure, unusual wakes and, for the area, fine sediments, this location is of particular interest.

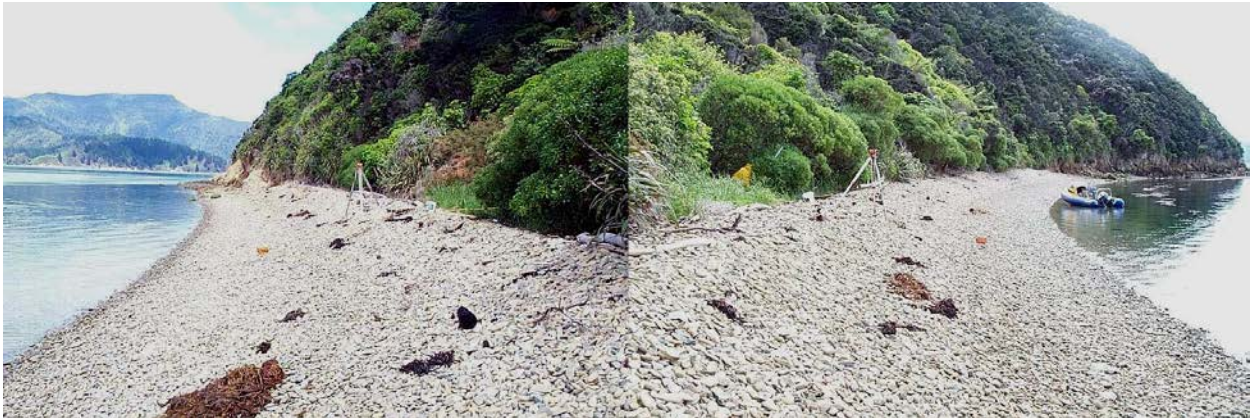
Profile 14 - Ngaionui Point

The beach on Ngaionui Point has shown surprisingly little change, particularly given its proximity to the sailing line of vessels in Tory Channel. It is most likely that significant change occurred when the fast ferry first started operation, and that the beach form has held since that time. There has been a slow trend of accretion since surveys started, perhaps increasing slowly in recent years. A small berm on the middle to upper beach that was recorded in November 1997, caused a small 'bump' in an otherwise consistent pattern of minor change.

Apparent changes at the very lower beach are probably the result of different survey placement. There have been no significant changes in sediments.

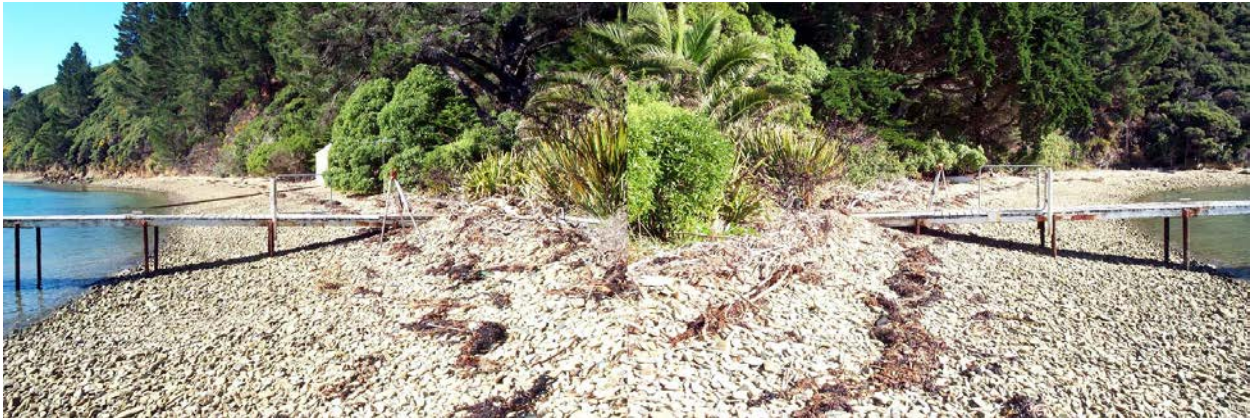
Profile 15 - Te Weka Bay

The Te Weka Bay profile, adjacent to the jetty, has been stable over the short term and long term survey periods, particularly as indicated by the volume data. A small upper beach berm accumulated between November 1999 and April 2000. This berm remains to the present, but has reduced slightly in size. The upper beach is fuller than it was in 1995, and Newton's 1977 data indicates it is now much fuller than it was then. Small changes occur over the middle to lower beach.

There have been no significant sedimentary changes.

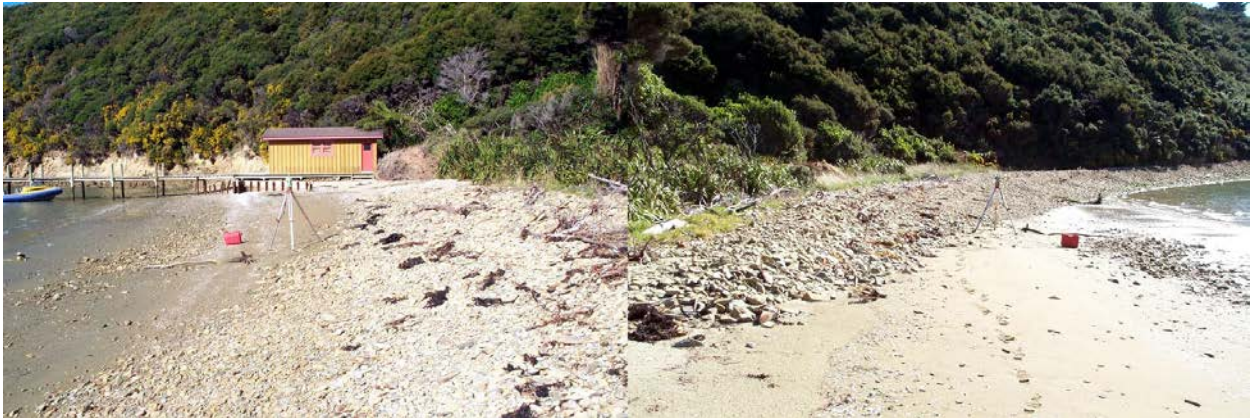
Profile 16 - McMillan's Bay

This profile line is clearly being influenced by longshore transport of gravels from west to east. It may also be that there is transport of sand either onshore or alongshore. It is most likely that the mechanism of accretion is the result of ferry generated wake waves but that an increase in sediment supply has occurred. This is further discussed in relation to Profile 17.

McMillan’s Bay is quite unusual in the context of the Tory Channel, being wide and with a relatively small slope. It has a wide ‘surf’ zone, unlike almost all other shorelines in the area.

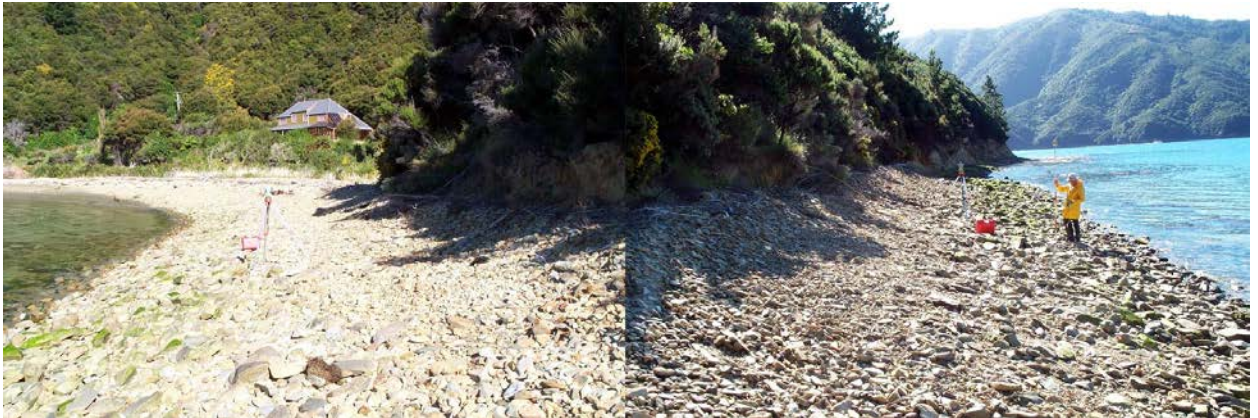
Profile 17 - McMillan's Side

Beach volumes have been increasing, with most of the accumulation on the lower profile.

The reason for the major deposition between November 1999 and May 2000, reflected also on Profile 16, is unknown. However, there must have been a significant increase in sediment supply, perhaps a slip in the vicinity of Arrowsmith Point.

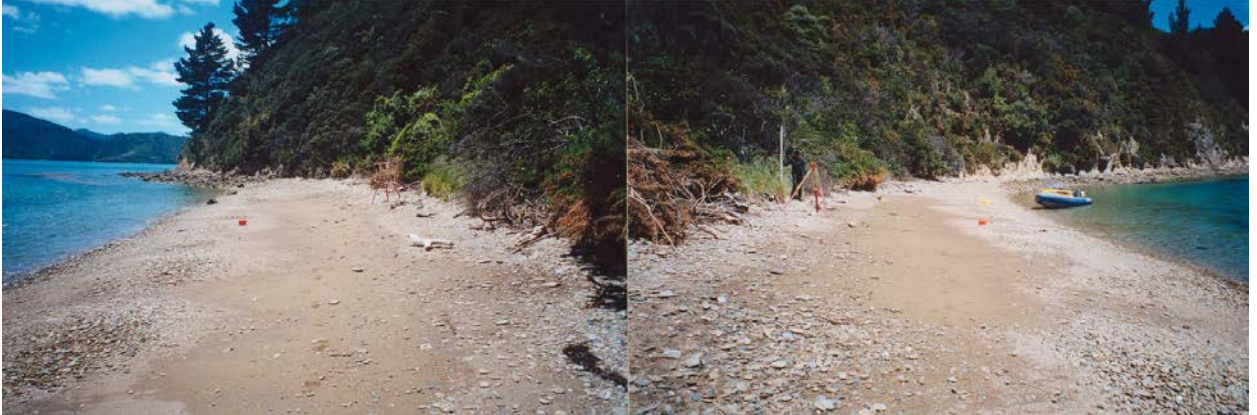
Profile 18 - Dieffenbach West

There is some indication that there is a fining of surficial sediments over the winter months, although this is not particularly clear.

During 2000 a small cottage was built at the northern end of this beach.

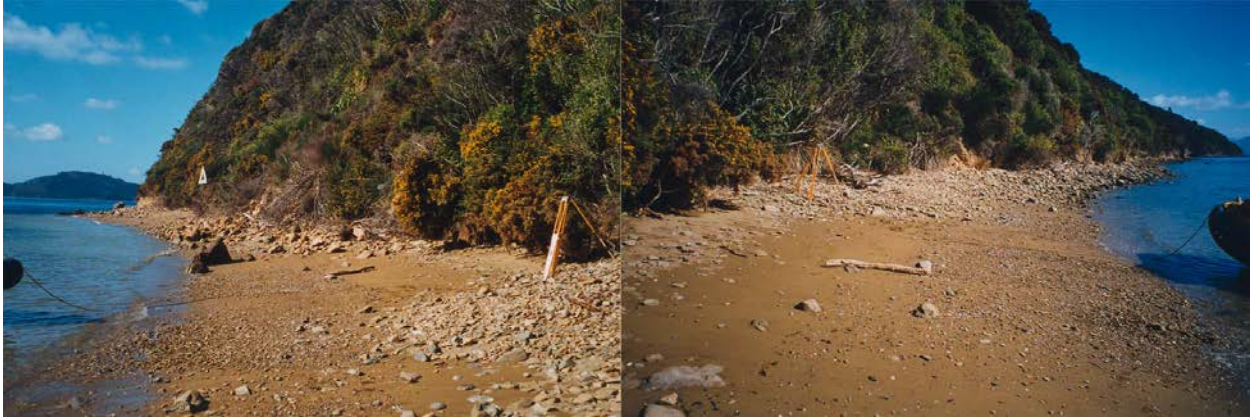
Profile 19 - Curious Monkey

Between April 1997 and April 2000 there was a small gradual accumulation of sand across the entire profile. Since that time there has been stability, or perhaps a small reversal of this trend. However, overall, the beach has been stable.

There have been no notable changes in sediment characteristics.

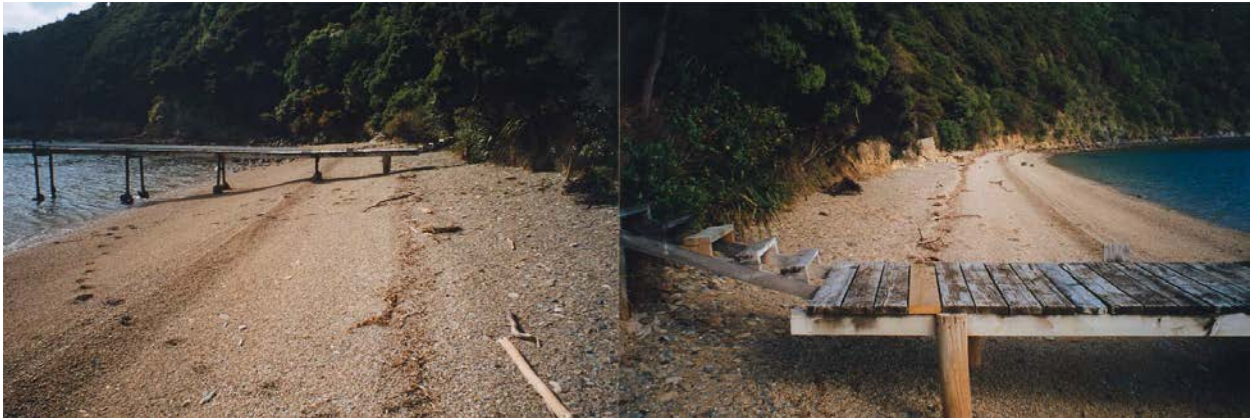
Profile 20 - Patten's Passage

Although there is considerable variability on the upper and middle beach, there has been no trend of erosion or accretion. Small berms build and are removed on the upper beach, with no particular seasonal pattern. Sediments are gravels and sands, and there is frequent banding, but no significant trends are obvious. Volume data indicate considerable stability.

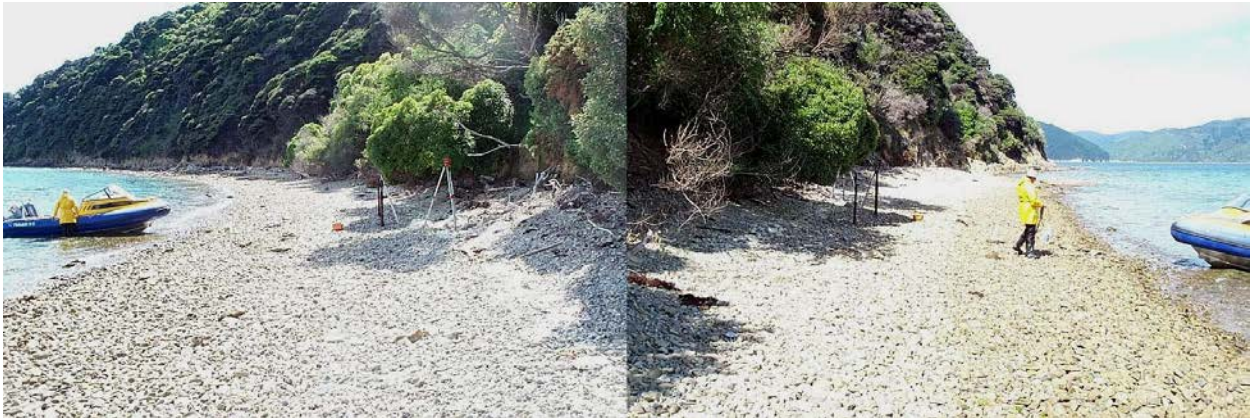
Profile 21 - Blumine Island

Blumine Island has a similar aspect to the Patten's Passage profile. There have only been minor changes (<10cm) across the profile. There is no indication of seasonality, and no indication of sediment characteristic change. Beach volumes have been very stable.
