# Shoreline Monitoring in Tory Channel and Queen Charlotte Sound

FINAL REPORT

November 2002 – May 2006

Report prepared for the Marlborough District Council

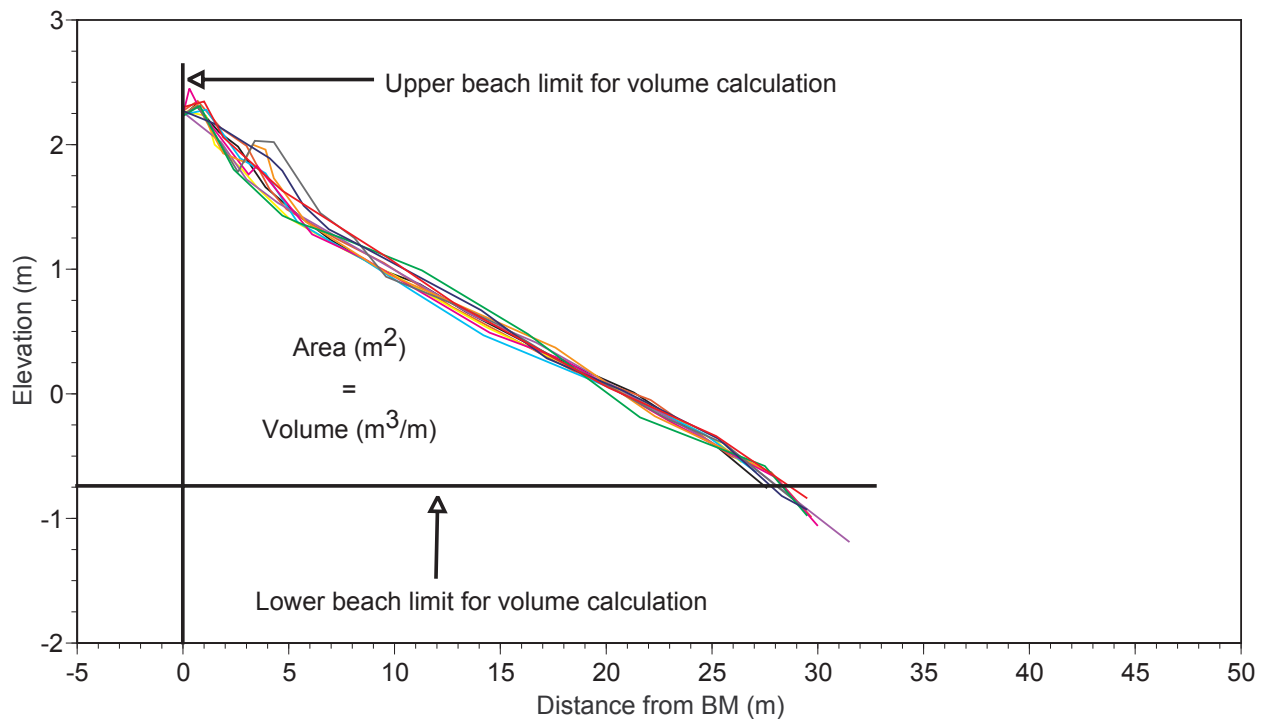
**Figure 3: Volume calculation methodology**

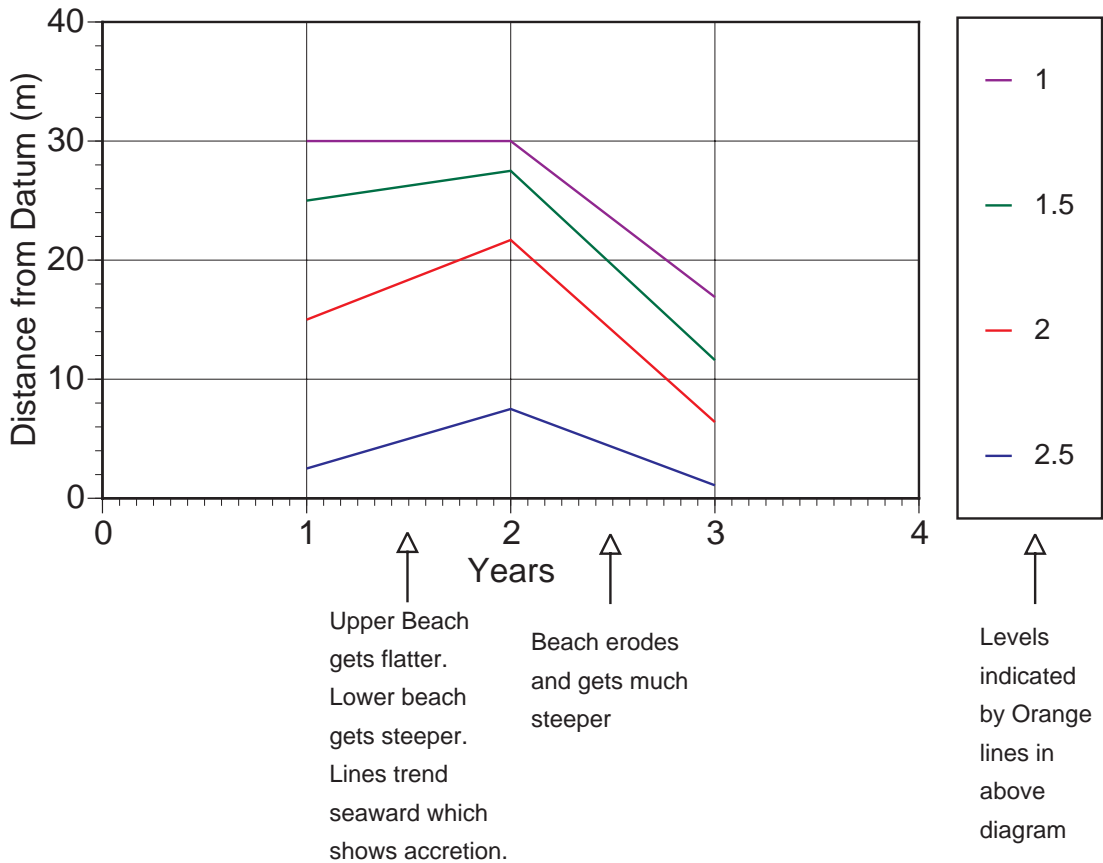
The 'spaghetti' plots of profiles are useful for establishing envelopes of change of the beach shape, but interpretations of changes which have occurred are difficult, due to the clutter of lines that are present. As the data set grows, any useful interpretation based on these plots becomes almost impossible. Excursion distance plots use exactly the same data plotted as a time series, and makes interpretation of beach changes easier. Excursion distance analysis is a method by which three dimensional data sets (distance, height and time) can be illustrated as two dimensional plots. It can be undertaken with either distance or height on the vertical axis, although having distance on the vertical axis is more useful for most purposes. Excursion distances are calculated by determining a set of height values for which calculations will be made. These values are normally equally spaced and in the following figures, are shown in the box on the right hand side of the graph. These numbers are in units of metres above or below the datum (in this case approximate MSL). Using linear interpolation the horizontal distance from the datum is calculated for each of the height values, and these are plotted as a time series with time on the horizontal axis. For each survey this provides a "point contour map" of the profile, and when plotted as a time series, an indication of how levels change through time. The graphs provide a lot of information. If two lines converge, the beach is getting steeper at those contour heights. If two lines diverge, the beach is getting flatter. If the lines trend seaward (increasing values on the distance axis), the beach is accreting. If the lines trend landward, the beach is eroding. Figure 4 attempts to show the methodology of Excursion Distance Analysis.

**Figure 4 : Excursion Distance Analysis Demonstration**

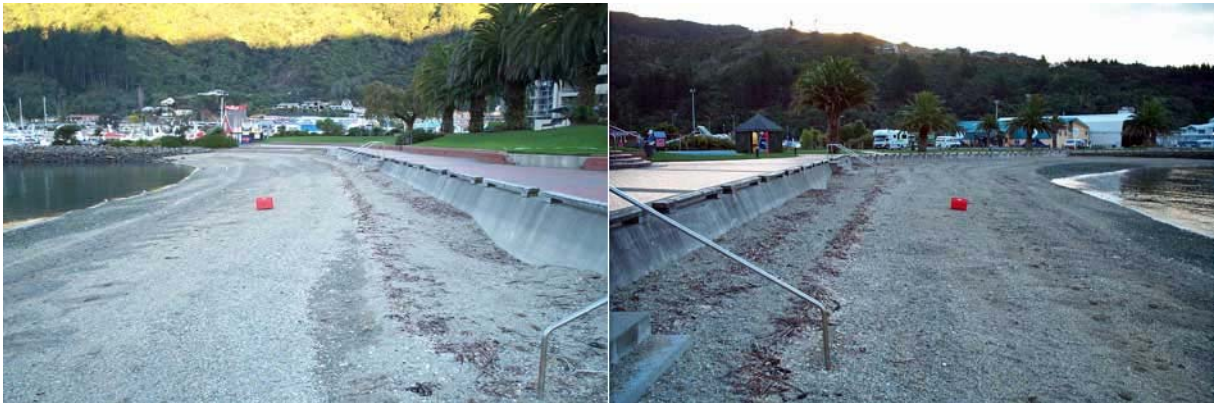
**Profile 1: Picton Foreshore**

The Picton Foreshore underwent extensive modification with the improvement of the landward side of the retaining wall in late 1997. Sediments on the beach comprise both natural marine sediments and river sand deposited in a beach nourishment programme.

I do not know if further nourishment has taken place since late 1997 or early 1998. If further nourishment has taken place, then the rate of nourishment is clearly appropriate. If there has been no renourishment, then the beach has been very stable since that time. Beach volume has maintained a relatively narrow range since April 1998, between 29.1 m<sup>3</sup>/m and 32.9 m<sup>3</sup>/m, although there is an indication that a small amount of sediment may have been lost since November 2004, with volumes since that time being at the lower end of the range. There has been no apparent change in sediment characteristics. There is no indication that the seawall has had an adverse effect on beach stability. There is no indication that waves caused by vessel wash in the inner harbour are having an adverse effect on the Picton foreshore beach.

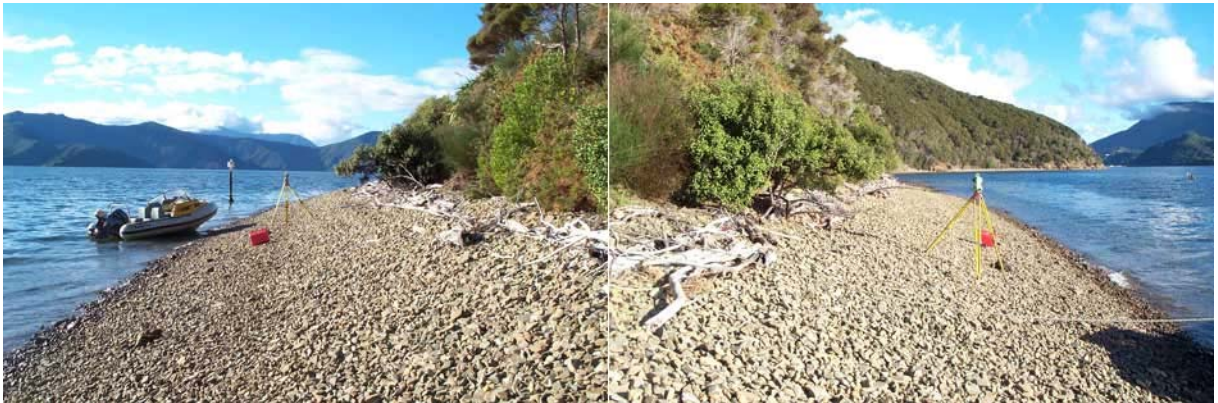
**Profile 2: The Snout at Picton Point**

The trend of erosion of the middle and lower beach and some accretion of the upper beach, reported in the last summary report has continued. This has led to a steepening of the beach profile, clearly evidenced by the convergence of lines in the EDA graph. The beach profile lines show that the measured beach profile does not reach closure depth, which indicates that the deep water channel is migrating shoreward. These changes have been accompanied by a significant loss of sediment volume from 36.4 m<sup>3</sup>/m in April 1997, to 31.9 m<sup>3</sup>/m in May 2006, although similar low volumes have been recorded in November 2000 and in November 2003. There have been no apparent changes in sediment composition over the survey period.

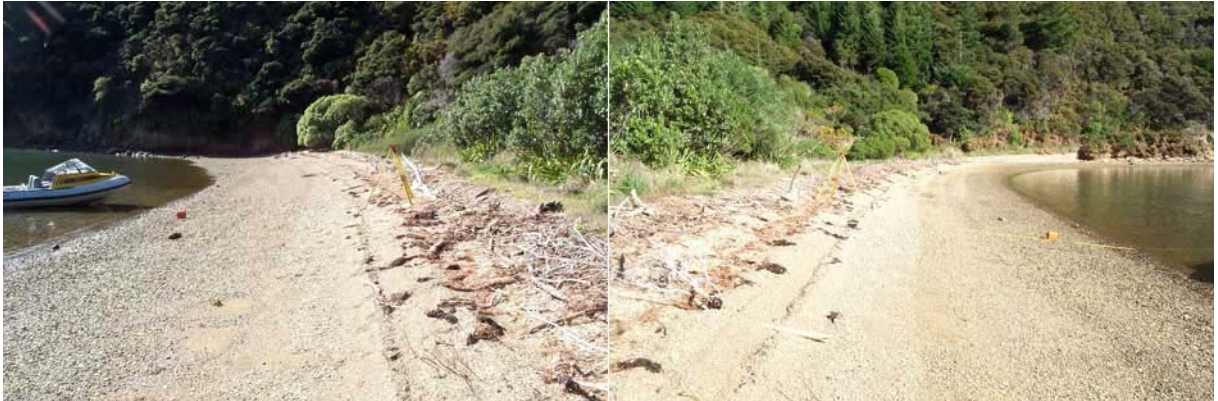
**Profile 3: Double Bay**

The Double Bay beach profile has changed within a very narrow range over the period April 1997 to May 2006. The most recent profile data sits close to the centre of the long-term sweep, with beach volume in 2006 being almost exactly the same as it was in April 1997. There has been a minor steeping of the beach with the construction of a berm and a minor lowering of the mid-beach surface, although this peaked in 2002. The profiles clearly reach closure depth at about -0.5m. There is some indication that the sediments may have become slightly more sandy over the last 10 years.

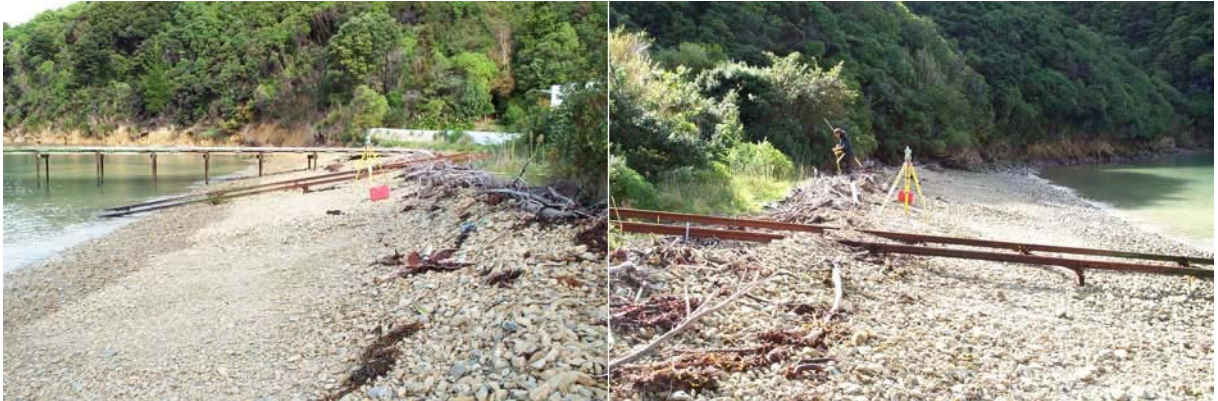
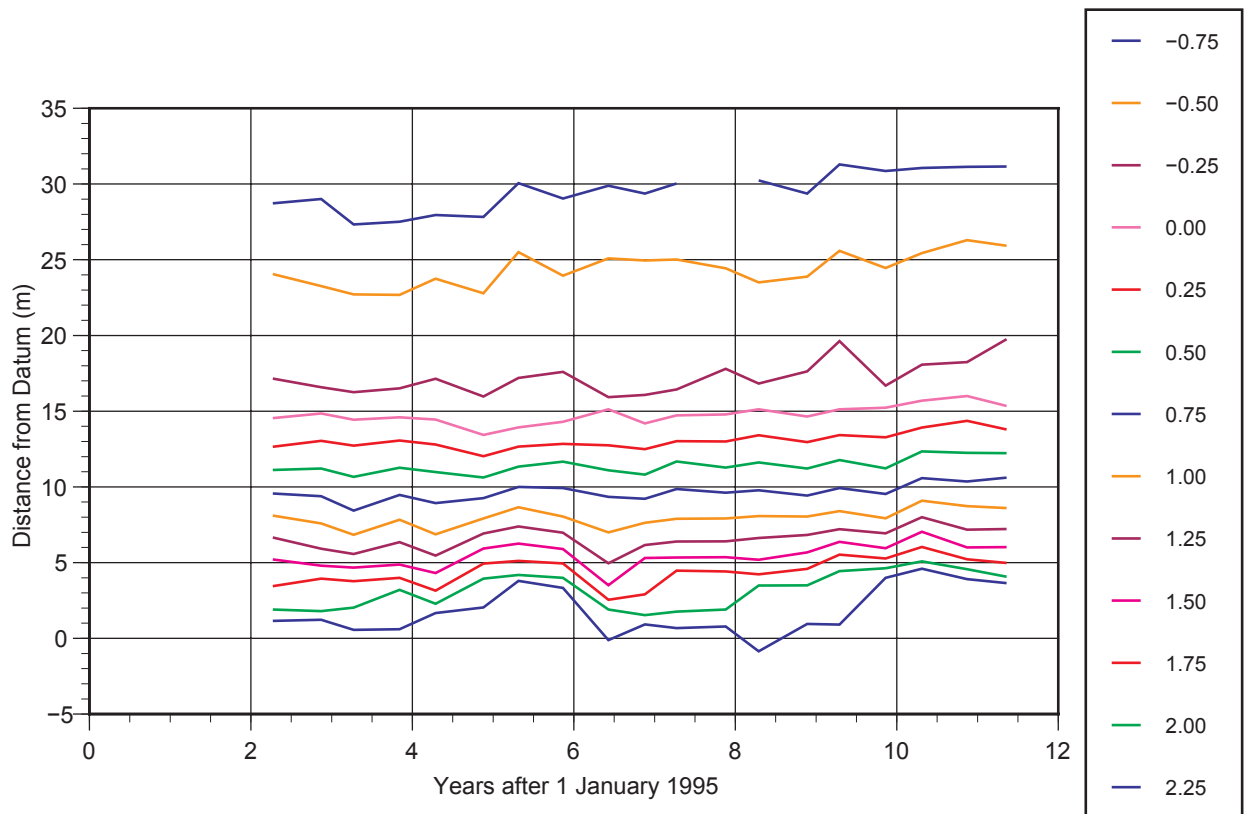
**Profile 4: Ngaionui Bay**

Between April 1999 and April 2000 a substantial berm built at the top of the beach. The upper beach prograded and the middle beach retreated. Between November 2000 and April 2001, beach works removed the berm and much of the sediment on the upper beach. It is unfortunate that these beach works coincided with the slowing of the fast ferries in December 2000. The build up of the berm had previously been interpreted as possibly relating to the continuation of the fast ferry service through the winter months, or to the wake characteristics of the ferries operating at that time. Since the beach works in late 2000 or early 2001 there has been recovery of the beach (and consequently the beach volume) through to the present. Beach volume now exceeds that of November 2000, with 'new' sediment being distributed over the whole profile, rather than in the berm as was the case in November 2000. The surveyors indicated that there may have been further beach works between April 2005 and November 2005, although this is not evident from the data. This profile has a very distinct change in slope at approximately  $-0.25\text{m}$ , previously interpreted as indicating closure depth. However, sediment has built up significantly seawards of this point along with the rest of the profile, indicating this interpretation was not accurate.

It is clear that fast ferry operation contributed to significant accretion of relatively coarse sediments at the top of the beach. After reconstruction, sediment has continued to build, probably indicating that all waves, including conventional vessel wakes cause sediment to accrete at the top of the beach. Interpretation of this site is complicated by two things. Firstly, there have been beach works, including a significant lowering of the upper beach in late 2000 or early 2001, and perhaps at other times. Secondly, prior to surveys commencing, there was a significant landslide at the western end of the beach that contributed significantly to the sediment supply. It is highly likely that much of the accretion can be attributed to that event, as the material is redistributed through the bay. This is likely to account for the accretion of the middle and lower profile, and has provided material for waves to build a high tide berm.

Photographs indicate that the sediments on the upper beach since 2001 considerably finer than those on the surface from 1997-2000, prior to beach works.

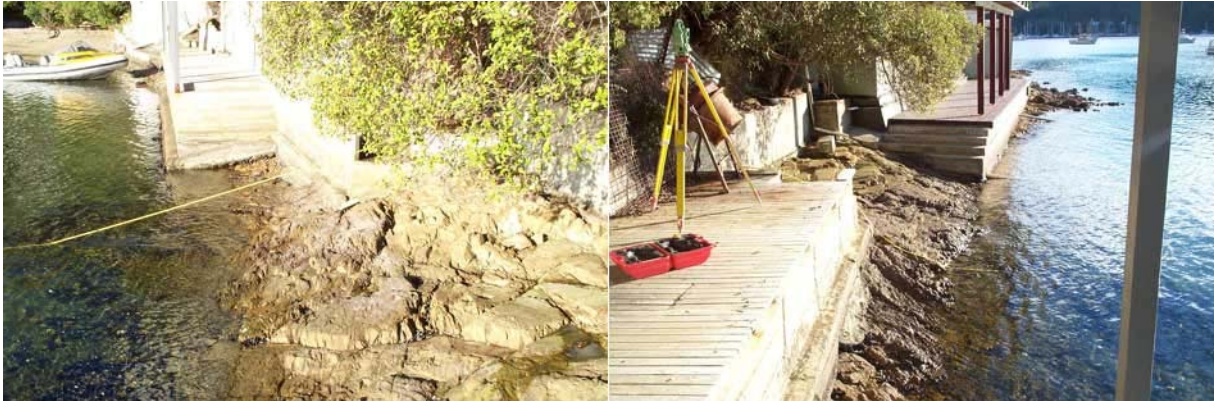
**Profile 5: Blackmore's at Waikawa**

Between April 1999 and November 1999, sand on the small beach started to disappear. By November 2001, the beach had been stripped to bedrock, and it has remained essentially devoid of sediment since that time. Further loss of sediment is therefore not possible. There has been no recovery since the fast ferries slowed down in December 2000. Minor changes in profiles and volumes recorded since that time are likely to be the result of slightly different survey alignments, and possibly minor changes in sediments on the lower profile.

There has, at various times, been building work in the vicinity of this profile line, the most significant of which occurred between November 1997 and April 1998 and it may be that these events have contributed to the change.

Profile 5 (Blackmore's at Waikawa) was established at the request of Council. This site demonstrated erosion, but is now stripped to bedrock, but it is unlikely that the reason for the loss of sand is ever going to be known. As previously noted, I see no good reason for maintaining this site.

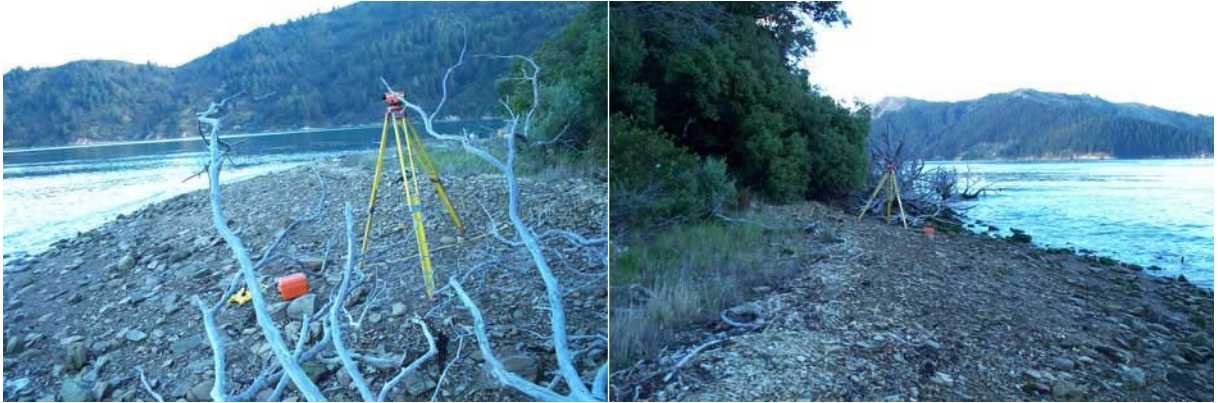
**Profile 6: Moioio Island 2**

Moioio Island 2 is at the eastern end of the beach on the island, near the slip that has been of considerable concern to Te Ati Awa. This profile has a record going back to November 1995 and until 1999 the beach profile demonstrated seasonality, with a build up of a berm on the upper beach over the winter months, and its removal over the summer months, after which time, seasonal patterns have not been evident. Overall however, there has been a trend of accretion, with a significant reversal between November 2000 and April 2002.

Up until 2000 much of the accretion was on the lower beach with the steep slope into the channel accreting. Because of the high angle, this required significant sediment. After that time, the upper beach accreted, with the lower beach remaining relatively stable. Between April 2003 and April 2004 there was a very significant accretion event across the upper and middle profile, with the placement of a new berm. This berm was subsequently modified by being pushed landward, but is still evident.

The most significant effect on this profile has almost certainly been the adjacent slip. Major fluctuations in beach shape and volume, and indeed the general accretion is related to sediment supply from periods of activity and inactivity of the slip. There is no other plausible explanation for the rapid accretion between April 2003 and April 2004.

It was apparent in the early years of the survey that vessel wakes were having a considerable influence on this profile, and this was confirmed by process measurements. However, this was contradicted by events following the slowing of the fast ferries in December 2000, after which the beach eroded for a period of time. It remains likely that this site reacts to changes in ferry operation. However, it is also likely that it reacts to changes in sediment supply from the adjacent slip. Determining the relative effects of the two sets of events is difficult.

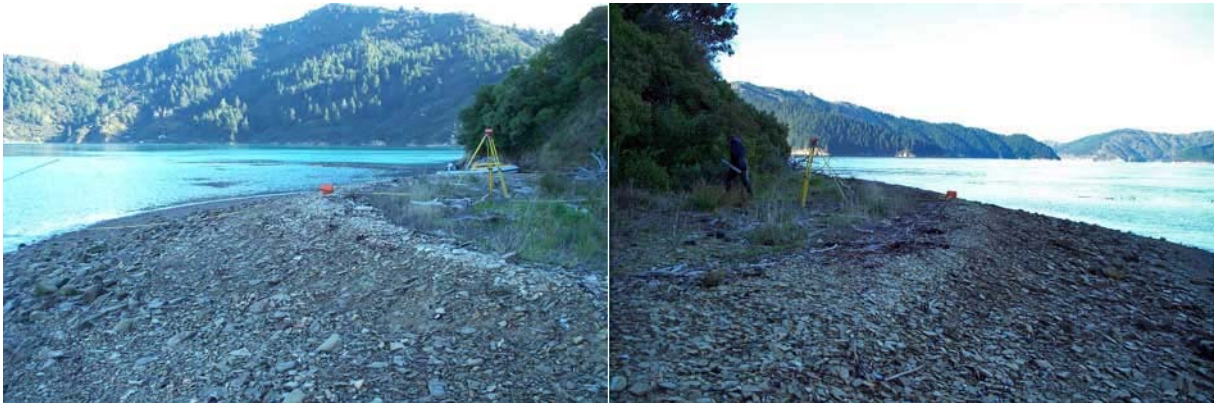
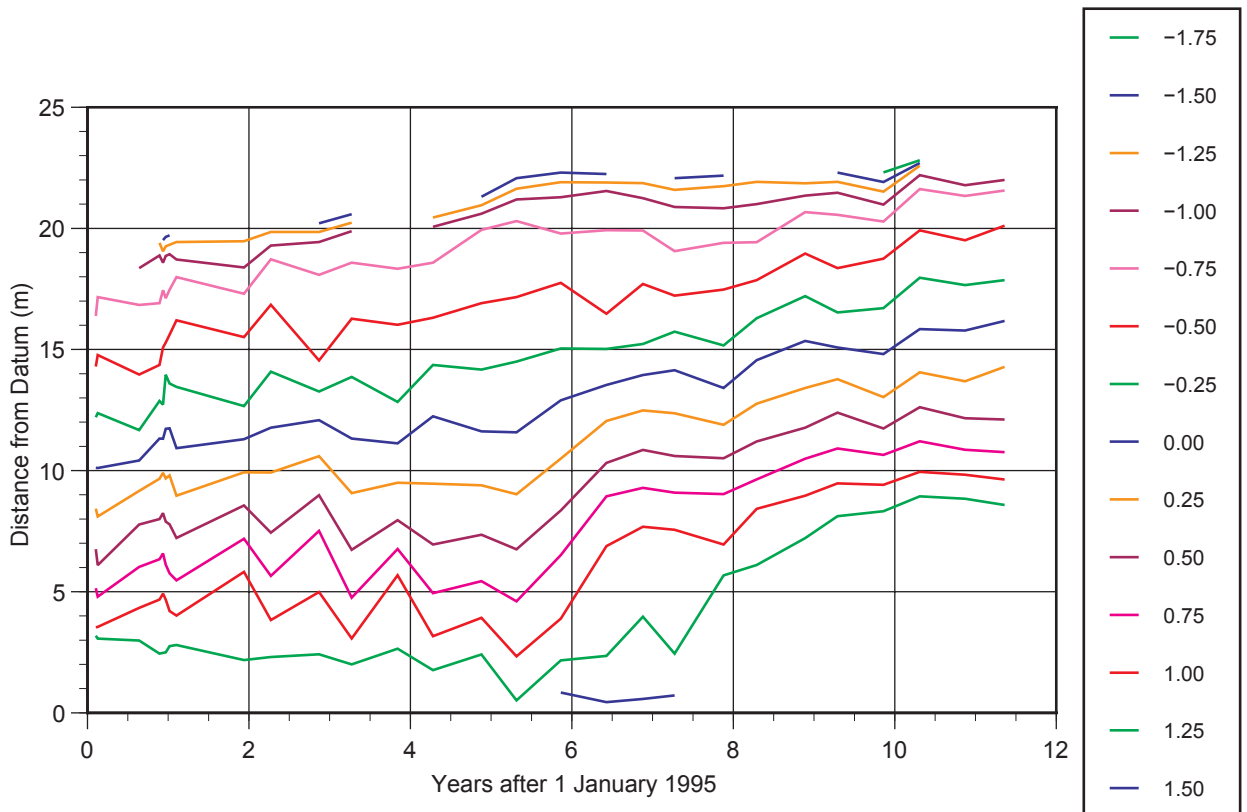
**Profile 7: Moioio Island 1**

The Moioio Island 1 profile is to the west of Profile 6. There was remarkable seasonality up to the winter of 1999,, with the growth of a berm over winter and its loss over summer. Up until the end of 2000, the upper beach was generally stable, with seasonality, and with the lower beach accreting into the channel. Since that time, the whole profile has accreted rapidly with very substantial volume increases. There has been substantial accretion of the upper beach since May 2000, with a major increase in volume, particularly between May 2000 and April 2001. This probably indicates an increase in sediment supply from the slip. Accretion on the middle and lower beach has continued since surveys began in 1995.

There is little doubt that the beach changes taking place on this profile are caused by the ferry operation regime (evidenced by the very strong seasonal signal when fast ferries were operating seasonally), but affected by changes in sediment supply. The accretion event observed on Profile 6 between April 2003 and April 2004 is reflected on Profile 7 between November 2004 and April 2005.

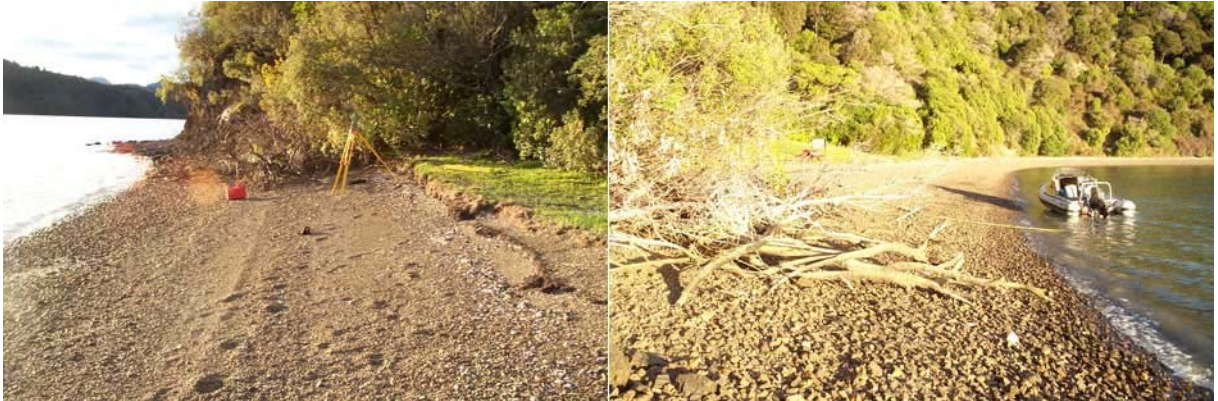
**Profile 8: Bobs Bay**

Bob's Bay has demonstrated an almost linear erosion trend since 1995 across the whole beach profile down to the change in slope (and probable closure depth) at about –1 m. Most of the beach has lowered in level by about 1m. Volume data shows a loss of 14 m<sup>3</sup>/m since 1995. This erosion is very significant within the context of beaches in this study. The beach slope has stayed relatively constant.

The location of this profile is at the northern end of the beach, adjacent to a headland of significance to Te Ati Awa. It may be that the erosion is accompanied by accretion elsewhere in the embayment.

The cause of the erosion is not known. The site is well inside Mabel Island, and all major shipping movements should be at low speed with small wakes. There is also limited fetch, so natural waves should also be small. The mechanism of sediment transport away from the profile line, and where the sediment goes could be investigated if erosion at this particular point becomes of concern.

The Bob's Bay profile has been continuously eroding. Erosion may be caused by all vessel wakes in the high traffic area near Picton (including the many small boats that pass quite close to the shore at this point), but may be entirely natural. Should erosion at this site be of particular concern, another profile towards the southern end of the bay should be established, to determine if the whole beach is eroding or if sediment is being redistributed within the embayment. In the longer term, some process studies could be considered.

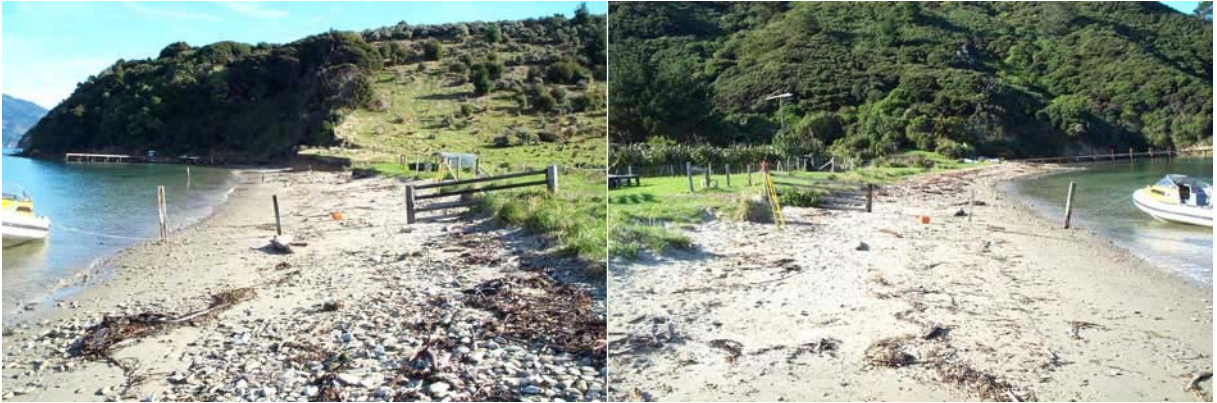
**Profile 9: Te Awaiti Bay**

There has been no significant change in the profile of this beach over the survey period. Over the period November 2003 to November 2005 a lower beach bar developed, but it was not evident in May 2006. Its presence is reflected in a significant increase in beach volume over this period. Minor changes evident in the plots at the top of the profile are the result of slightly different survey pole placement. Until 2003, the most remarkable aspect of this beach was the change in surficial sediment characteristics that occurred. At times the cobbles were covered by a thin veneer of sand making the beach appear to be comprised of sand, and at other times, the cobbles were completely exposed, completely changing the beach character. Since 2003, however, the sand covering has been present continuously.

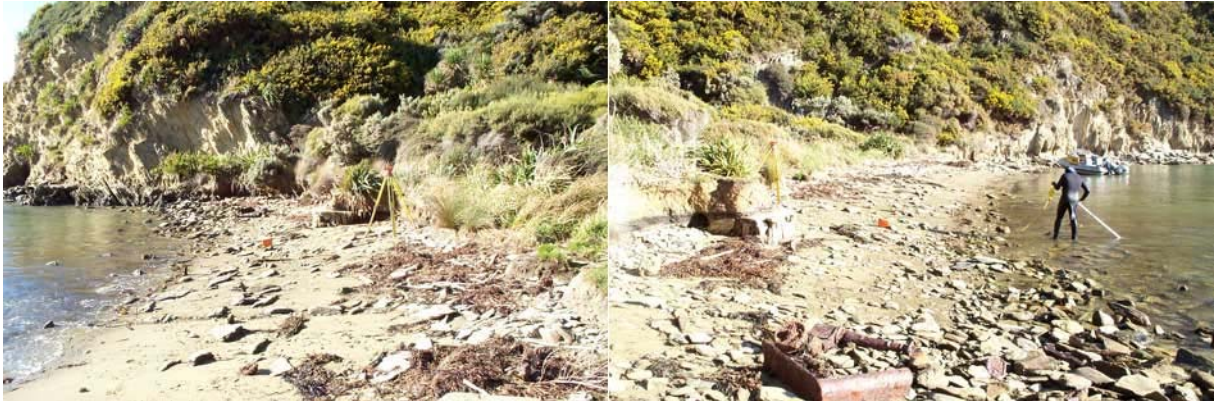
**Profile 10: Tipi Bay**

There has been some retreat of the upper beach scarp (approximately 1m) and a corresponding increase in the level of the middle beach, but the changes have generally been minor. Because of the relatively coarse nature of the sediments, the placement of the survey staff can have significant impact on the apparent appearance of the profile line. The photographs indicate that there has been some sand deposited on the cobble dominated profile in the last 4 years.

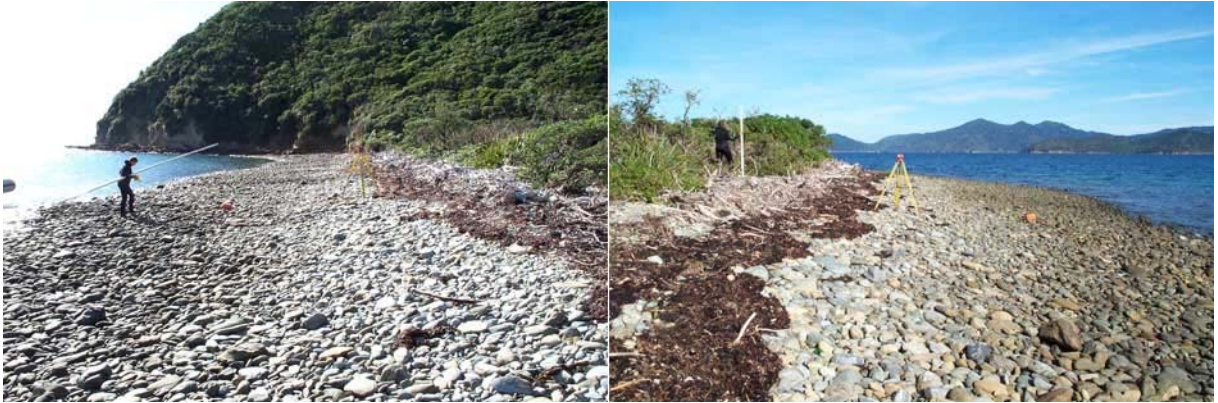
**Profile 11: Long Island**

The Long Island profile is relatively exposed to storm events that cause waves to propagate through the northern entrance to Queen Charlotte Sound. There is considerable variability in the level of the upper beach, with the build up and removal of a berm, although this has been less evident since about 2000. The level of the middle and lower beach also shows some variability, but with no obvious seasonal trends. There has been a small overall decrease in sediment volume over the last 10 years. There are no significant sedimentary trends.

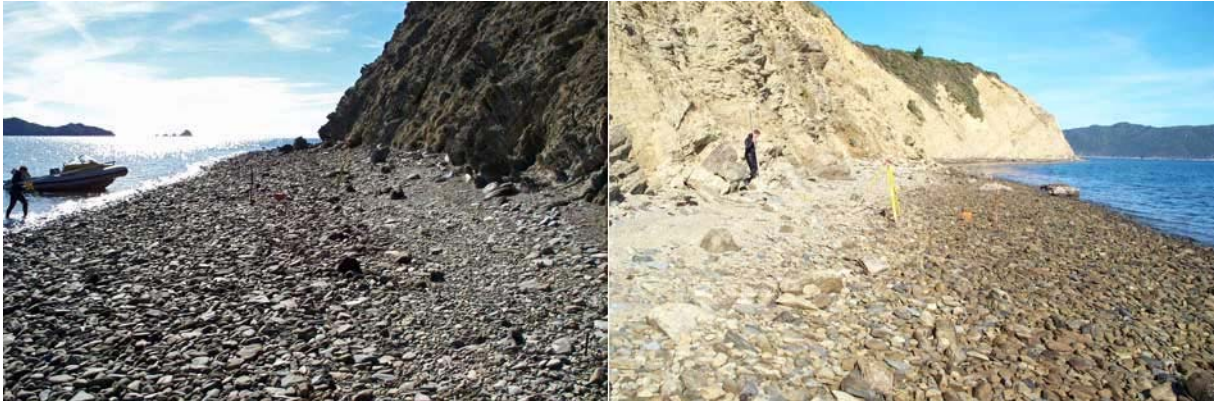
**Profile 12: Clark Point**

This profile, with a similar aspect to Profile 11 (Long Island), has shown no significant change in level, volume or sedimentary characteristics since 1997.

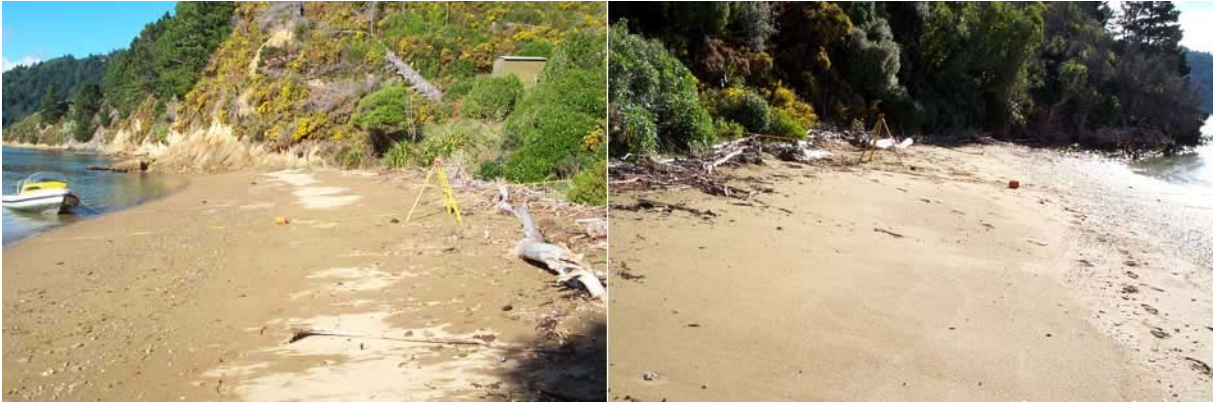
**Profile 13: Slip Beach**

The photographs indicate that the dominant sediment type is sand with some small cobbles and pebbles.

Although no obvious relationships between ferry operations and beach change were able to be determined, it is apparent that the considerable variability in the profile ceased about the same time as fast ferry operations ceased. Slip beach has a considerable fetch into Queen Charlotte Sound to the north, and natural waves may be substantial. However, wave measurements at this site have indicated substantial wake events that continue for unusually long periods of time. Because of its unusual exposure, unusual wakes and, for the area, fine sediments, this location continues to be of particular interest.

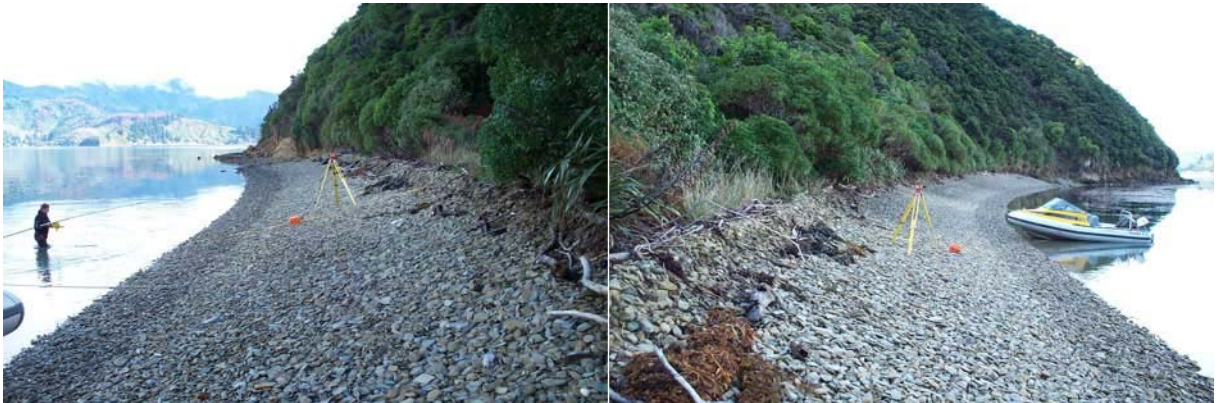
**Profile 14: Ngaionui Point**

The beach on Ngaionui Point has shown surprisingly little change, particularly given its proximity to the sailing line of vessels in Tory Channel. It is most likely that significant change occurred when the fast ferry first started operation, and that the beach form has held since that time. There was a slow trend towards accretion up until about April 2002, and a very slow trend of erosion since that time, perhaps reflecting the start of a return to pre-fast ferry conditions.

Apparent changes at the very lower beach are probably the result of different survey placement. There have been no significant changes in sediments.

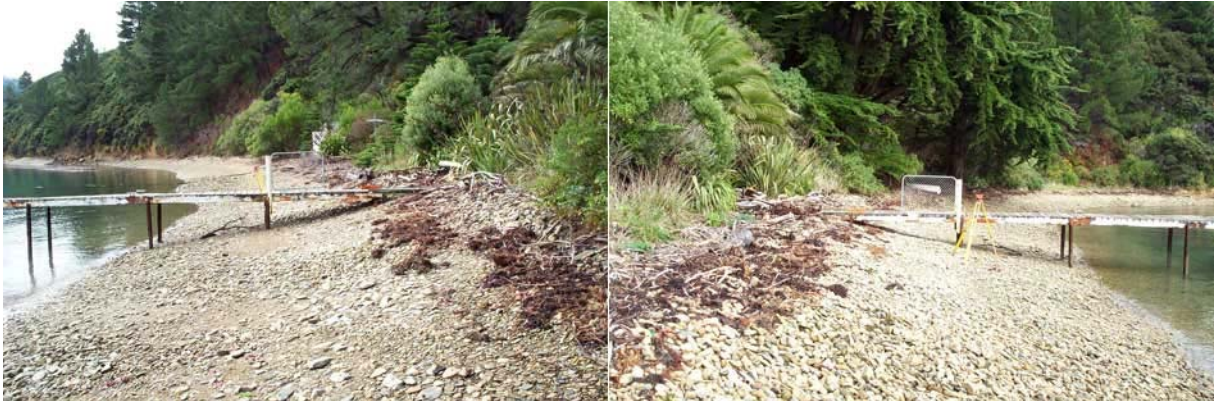
**Profile 15: Te Weka Bay**

The Te Weka Bay profile, adjacent to the jetty, has been generally stable over the survey period, with very slight accretion, particularly on the upper beach. The development of an upper beach berm and the reduction in level of the middle beach during the period of fast ferry operation is evident (reaching a peak in April 2000). The berm has remained generally intact since that time

There have been no significant changes in sediment characteristics.

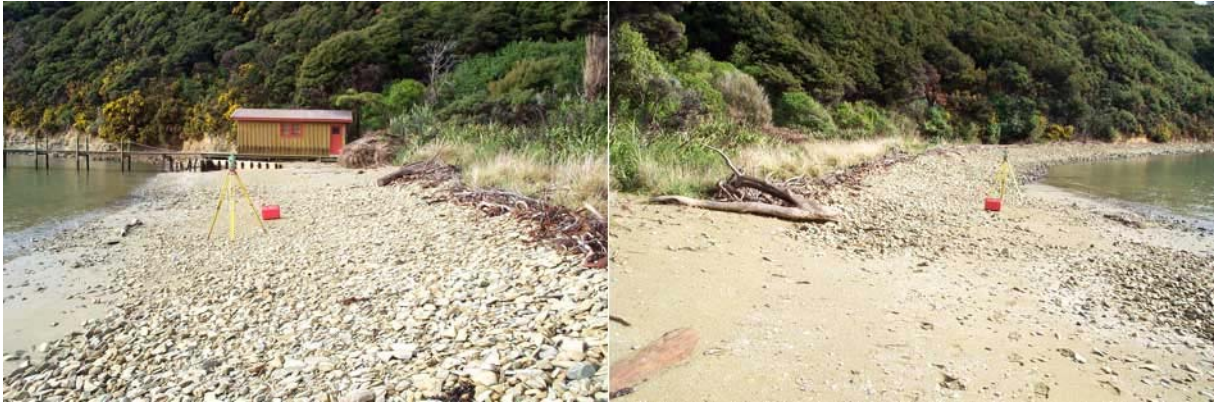
**Profile 16: McMillan's Bay**

This profile line is clearly being influenced by longshore transport of gravels from west to east. It may also be that there is transport of sand either onshore or alongshore. It is most likely that the mechanism of accretion is the result of ferry generated wake waves. The rate of accretion dropped markedly about the time the fast ferry operation ceased, probably the result of a reduced ability of the waves to transport sediment.

McMillan’s Bay is quite unusual in the context of the Tory Channel, being wide and with a relatively small slope. It has a wide ‘surf’ zone, unlike almost all other shorelines in the area.

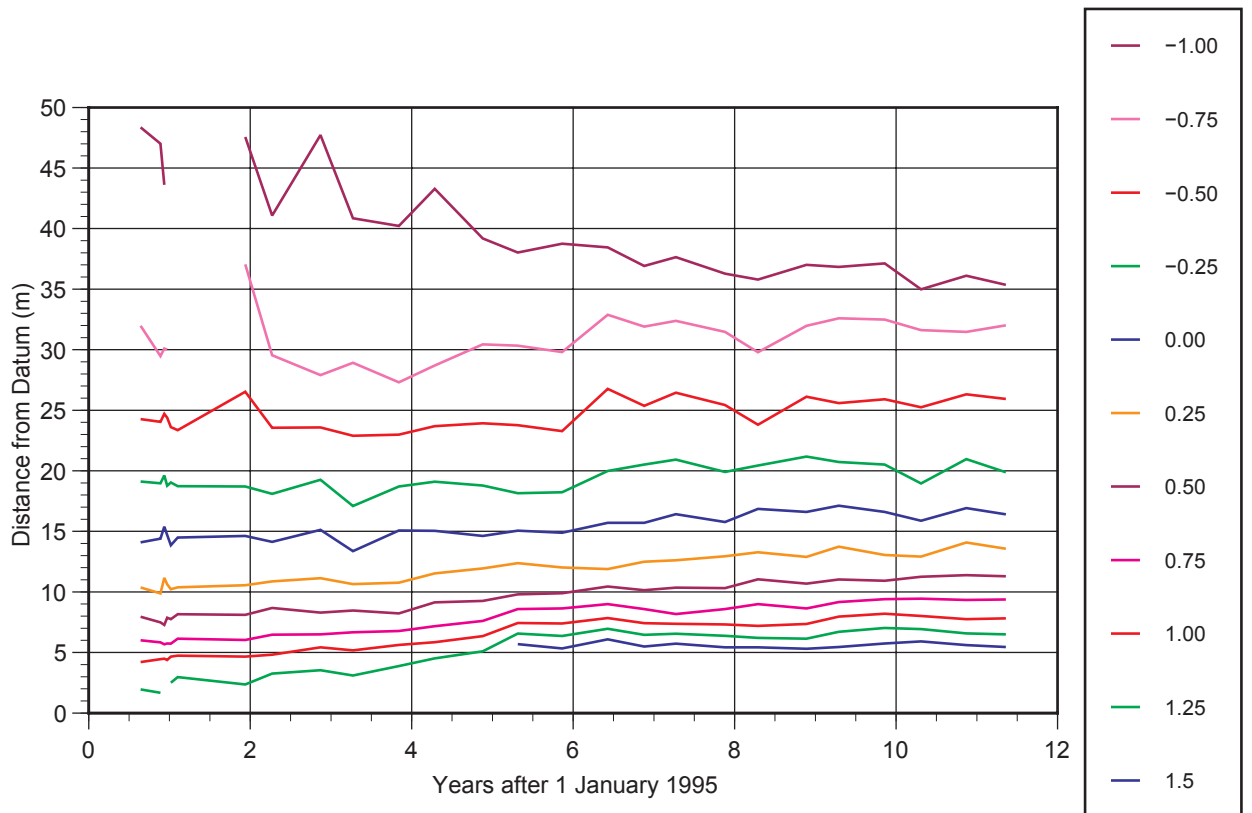
Up until November 1999 there had been a gradual accretion of the upper McMillan’s Bay profile. The accretion was mainly comprised of gravels that were moving along the beach from the direction of Arrowsmith Point, although there had been some rise in the middle beach level, due to deposition of sand. Between November 1999 and May 2000 a major increase in the height of the upper beach berm occurred, with a very large deposit of gravel, again coming from the direction of Arrowsmith Point. This deposit has remained almost unchanged since that time. The middle beach has continued to build with the deposition of sand, although the rate of accretion slowed in 2000. The lower beach has been relatively stable, apparent changes probably being the result of minor differences in survey line.

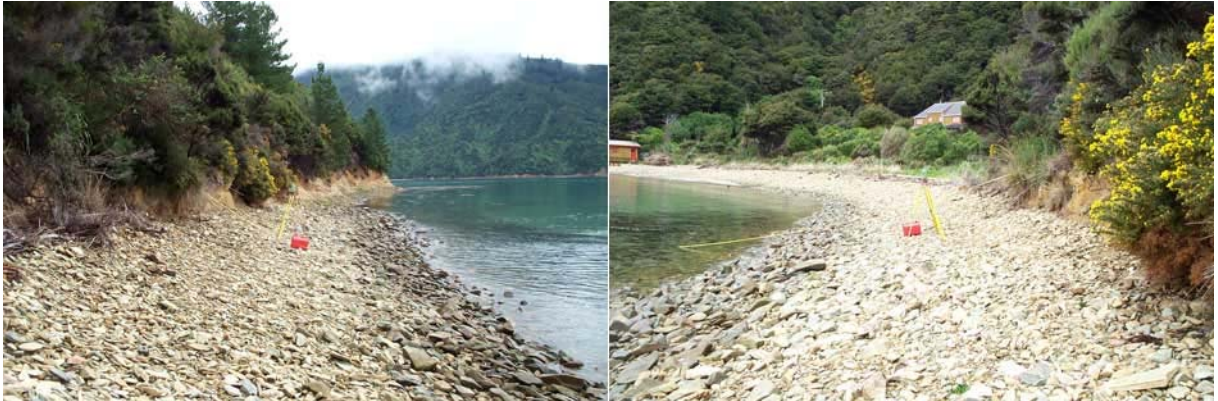
**Profile 17: McMillan's Side**

Beach volumes increased until 2001, with most of the accumulation on the lower profile. Since that time volumes have decreased, with most loss coming from the mid to upper beach. There is no indication of erosion at the upper beach scarp.

The reason for the major deposition between November 1999 and May 2000, reflected also on Profile 16, is unknown. However, there must have been a significant increase in sediment supply, perhaps a slip in the vicinity of Arrowsmith Point. After fast ferry operation ceased in 2000, there was a change from sediment accumulation to sediment loss. This occurred at the same time as a change from sediment accumulation to stability on Profile 16. Changes in this profile reflect changes in vessel operations, but there also appears to be a sediment supply control.

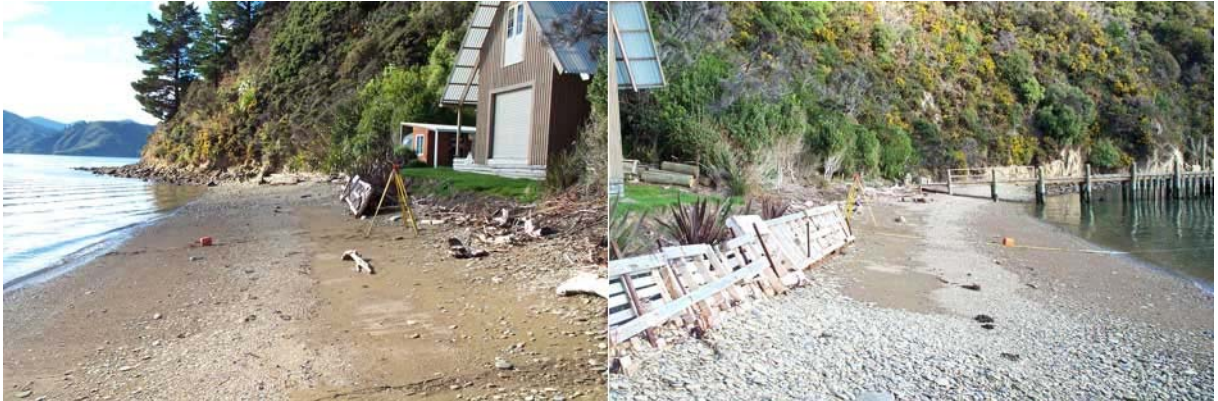
**Profile 18: Dieffenbach West**

There has been no significant change in the profile shape or in sediment volume over the survey period. At time there is more sand on the beach, and it has been more persistent in recent times.

During 2000 a small cottage was built at the northern end of this beach, and in 2003 a boatshed was built and a minimal wooden seawall constructed adjacent to the profile line. The seawall does not appear to be affecting beach processes, but it is also not providing any significant protection to the land.

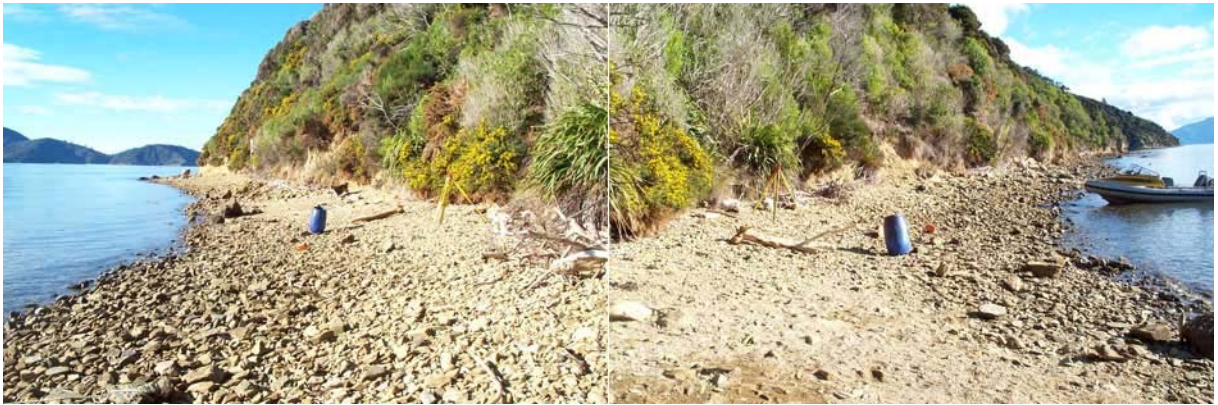
**Profile 19: Curious Monkey**

Overall the beach has been stable since 1997. However, there was slow accretion through to the end of 2000, and slow erosion since that time, the change coinciding with fast ferry operation ceasing. The lower beach, however, has remained at an accreted position.

There have been no notable changes in sediment characteristics.

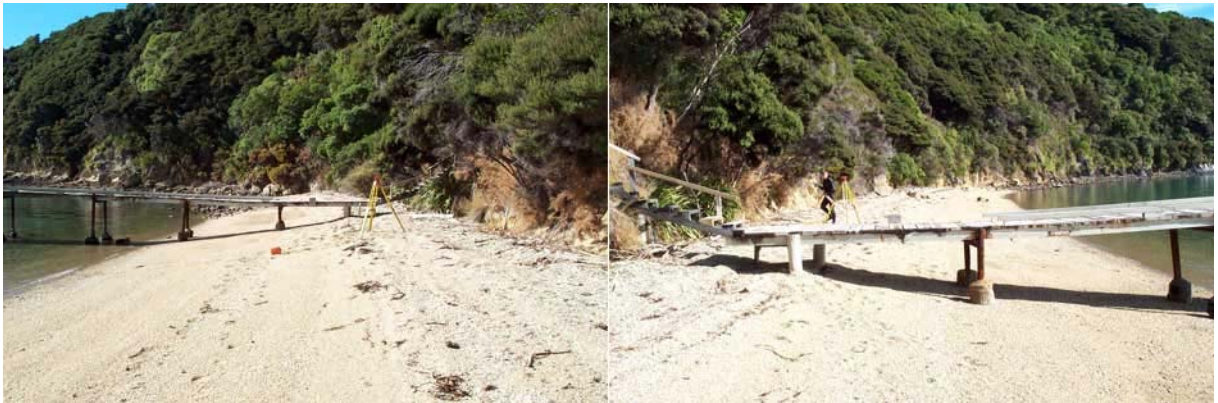
**Profile 20: Patten's Passage**

There is considerable variability on the upper and middle beach, but overall stability, although volume data indicates that there may have been some minor erosion since 2003. Small berms build and are removed on the upper beach, with no particular seasonal pattern. Sediments are gravels and sands, and there is frequent banding, but no significant trends are obvious.

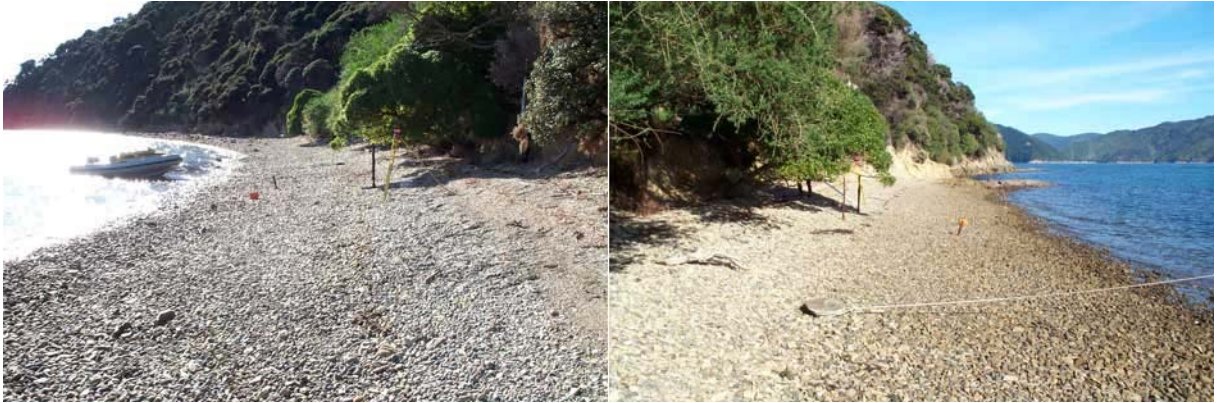
**Profile 21: Blumine Island**

Blumine Island has a similar aspect to the Patten's Passage profile. There have only been minor changes across the profile, although there has been up to 15 cm of level variability at the extreme upper beach. There is no indication of seasonality, and no indication of sediment characteristics changing. Beach volumes have been stable.
