# Shoreline Monitoring in Tory Channel and Queen Charlotte Sound

FINAL REPORT

November 2009 – April (May) 2012

Report prepared for the Marlborough District Council

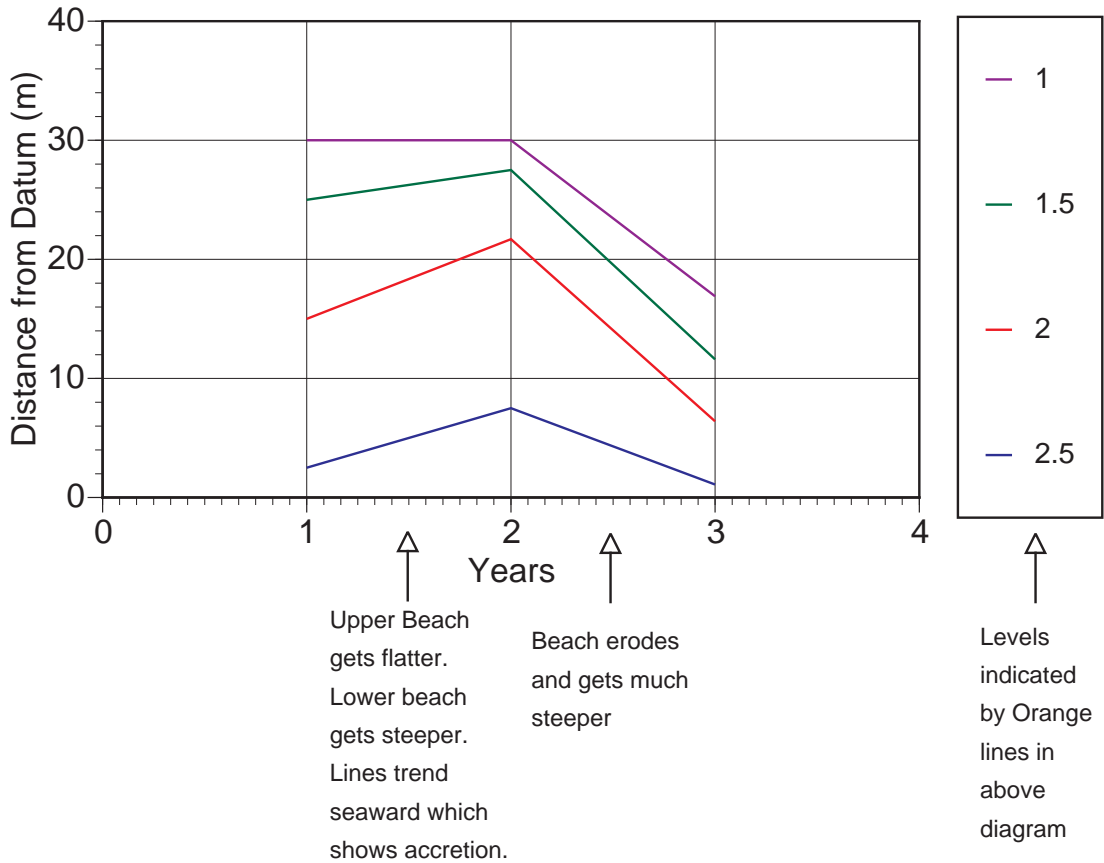
**Figure 4 : Excursion Distance Analysis Demonstration**

The 'spaghetti' plots of profiles are useful for establishing envelopes of change of the beach shape, but interpretations of changes that have occurred are difficult, due to the clutter of lines that are present. As the data set grows, any useful interpretation based on these plots becomes almost impossible. Excursion distance plots use exactly the same data plotted as a time series, and makes interpretation of beach changes easier. Excursion distance analysis is a method by which three dimensional data sets (distance, height and time) can be illustrated as plots with time on the independent axis. It can be undertaken with either distance or height on the vertical axis, although having distance on the vertical axis is more useful for most purposes. Excursion distances are calculated by determining a set of height values for which calculations will be made. These values are normally equally spaced and in the following figures, are shown in the box on the right hand side of the graph. These numbers are in units of metres above or below the datum (in this case approximate MSL). Using linear interpolation, the horizontal distance from the datum is calculated for each of the height values, and these are plotted as a time series with time on the horizontal axis. For each survey this provides a "point contour map" of the profile, and when plotted as a time series, an indication of how levels change through time. The graphs provide a lot of information. If two lines converge, the beach is getting steeper at those contour heights. If two lines diverge, the beach is getting flatter. If the lines trend seaward (increasing values on the distance axis), the beach is accreting. If the lines trend landward, the beach is eroding. Figure 4 attempts to show the methodology of Excursion Distance Analysis.

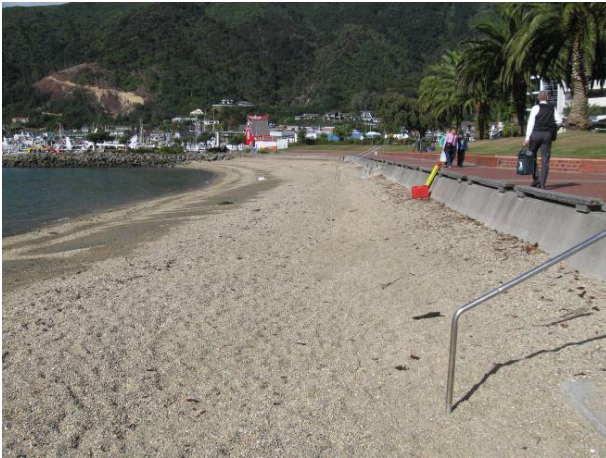
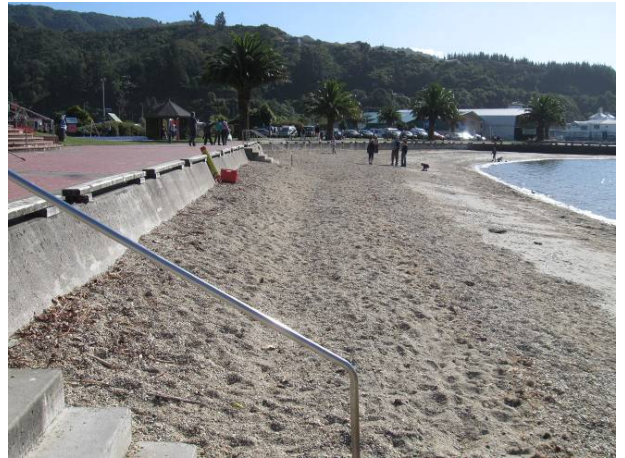
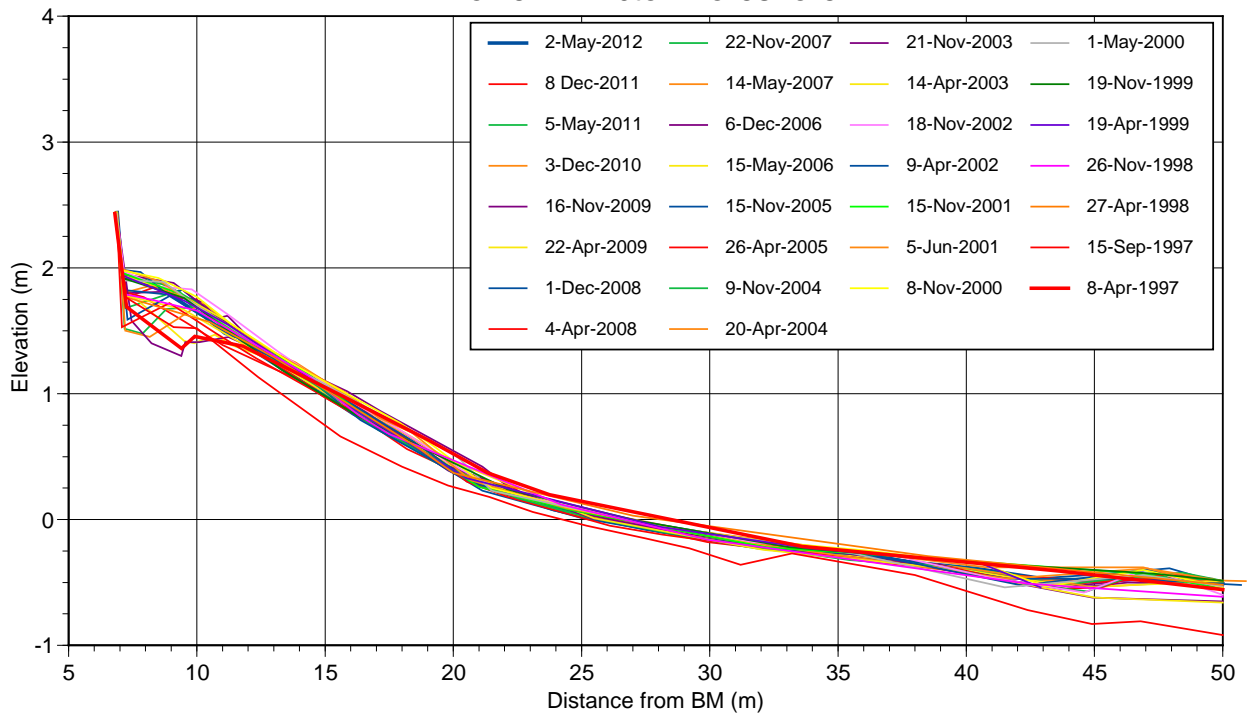
**Profile 1: Picton Foreshore**

The Picton Foreshore underwent extensive modification with the improvement of the landward side of the retaining wall in late 1997. Sediments on the beach comprise both natural marine sediments and river sand deposited in a beach nourishment programme.

I do not know if further nourishment has taken place since late 1997 or early 1998. If further nourishment has taken place, then the rate of nourishment is clearly appropriate. If there has been no renourishment, then the beach has been very stable since that time. Beach volume has maintained a relatively narrow range since April 1998, between 29.1m<sup>3</sup>/m and 32.9m<sup>3</sup>/m. There has been no apparent change in sediment characteristics. There is no indication that the seawall has had an adverse effect on beach stability. There is no indication that waves caused by vessel wash in the inner harbour are having an adverse effect on the Picton foreshore beach.

There is no indication that this site is currently affected by vessel operation, with the beach being relatively stable despite being highly modified. However, I do not have data on the timing and extent of any renourishment programmes.

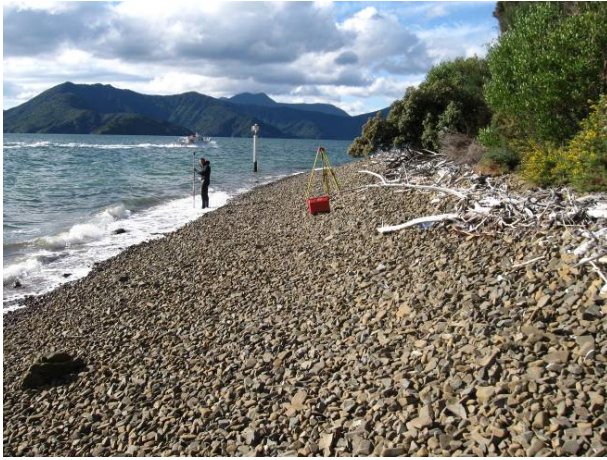
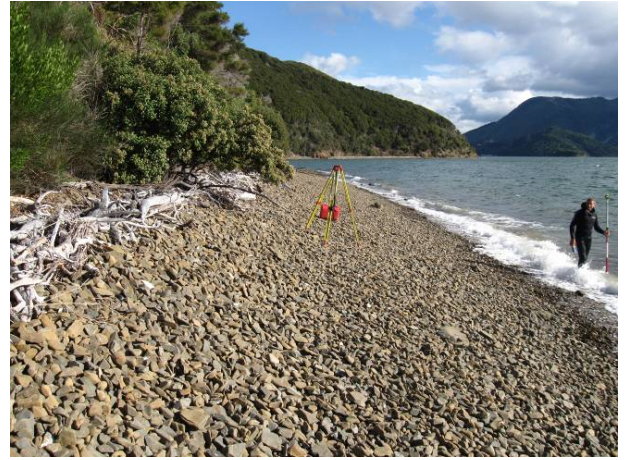
**Profile 2: The Snout at Picton Point**

Since April 1997, the profile has retreated and significantly steeped, seen particularly by the convergence of lines on the EDA plots. The major cause is probably the slow migration of the deepwater channel in a shoreward direction. Beach volumes have followed an almost linear trend of loss over the same period, with the loss of over  $7\text{m}^3/\text{m}$ . There have been no apparent changes to sediment composition. The reason for the channel migration is not clear, although the site does receive considerable wake energy.

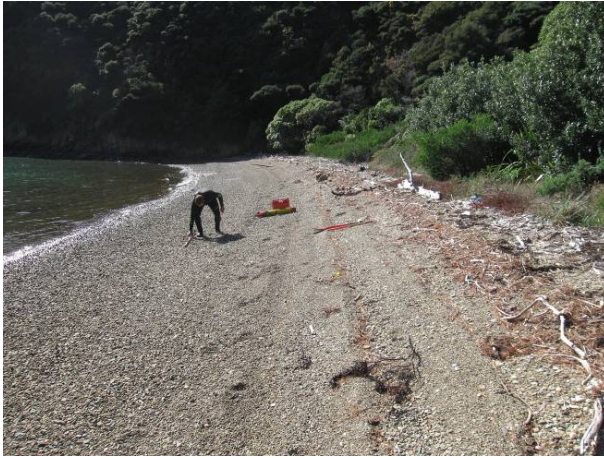
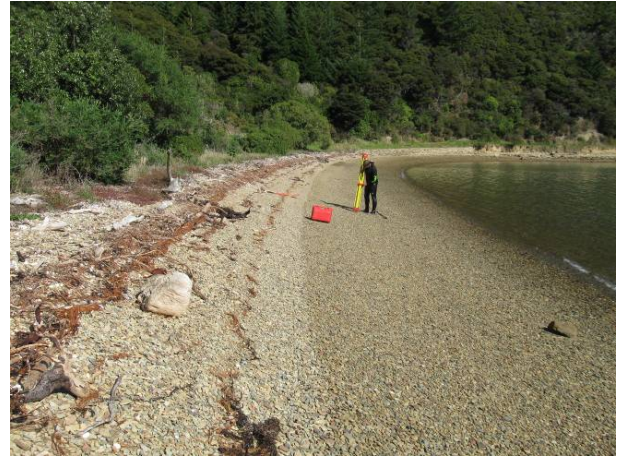
**Profile 3: Double Bay**

The Double Bay beach profile has changed within a very narrow range over the period April 1997 to April 2012. The most recent profile data sits close to the centre of the long-term sweep, with beach volume in 2012 being only 0.2m<sup>3</sup>/m different to April 1997. There has been a minor steeping of the beach with the construction of a berm over the earlier years of the survey and a minor lowering of the mid-beach surface. The profiles clearly reach closure depth at about -0.5m. Sediment characteristics have not changed significantly.

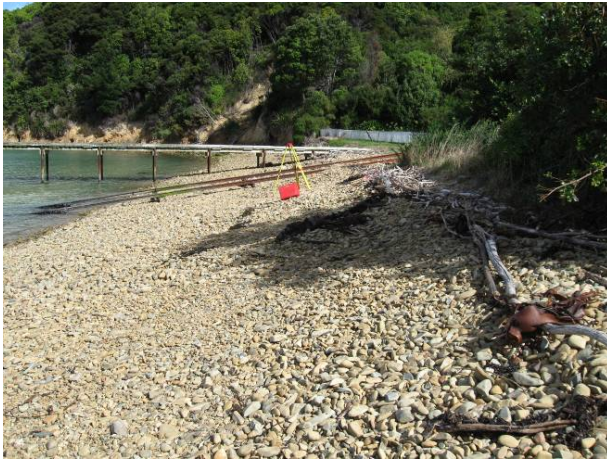
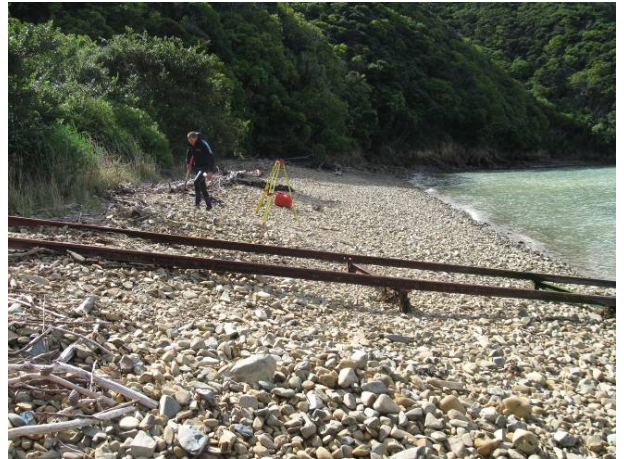
**Profile 4: Ngaionui Bay**

The long-term history of this site has been discussed in previous reports. The site is complicated by relatively frequent human modifications (although the nature of any works and their frequency in recent times is not known). It is also complicated by the presence of a landslide at the western end of the beach, with sediment redistribution within the compartment. It was very clear that fast ferry operation contributed to significant beach accretion, and that all wakes and natural processes, coinciding with a sediment supply from the slip, have all contributed to slow beach building. However, since 2006, the beach has been relatively stable, with minor adjustments to the beach berm. Since 2006, beach volume has varied little within a  $1\text{m}^3/\text{m}$  range.

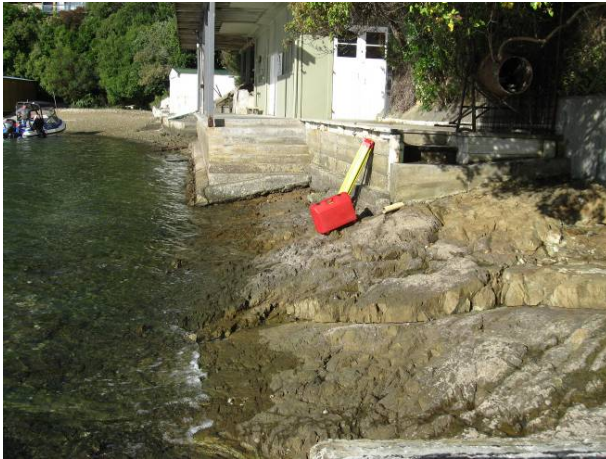
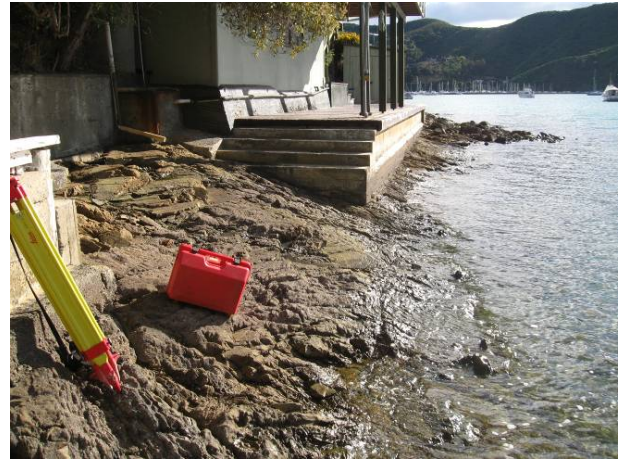
**Profile 5: Blackmore's at Waikawa**

Between April 1999 and November 1999, sand on the small beach started to disappear. By November 2001, the beach had been stripped to bedrock, and it has remained essentially devoid of sediment since that time. Further loss of sediment is therefore not possible. There has been no recovery since the fast ferries slowed down in December 2000. Minor changes in profiles and volumes recorded since that time are likely to be the result of slightly different survey alignments, and possibly minor changes in sediments on the lower profile.

Profile 5 (Blackmore's at Waikawa) was established at the request of Council. This site demonstrated erosion, but has now been stripped to bedrock for a number of years, but it is unlikely that the reason for the loss of sand is ever going to be known. As previously noted, I see no good reason for maintaining this site.

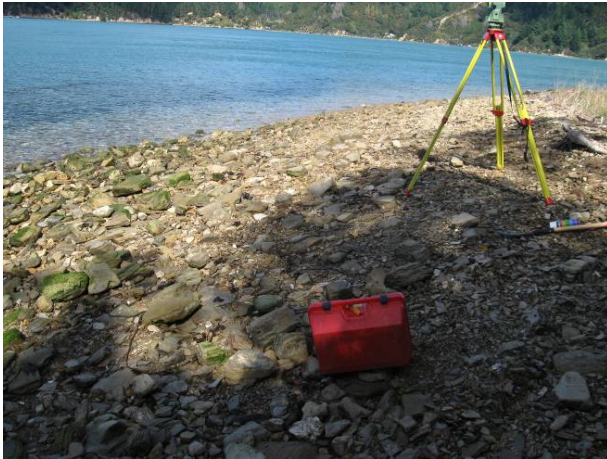
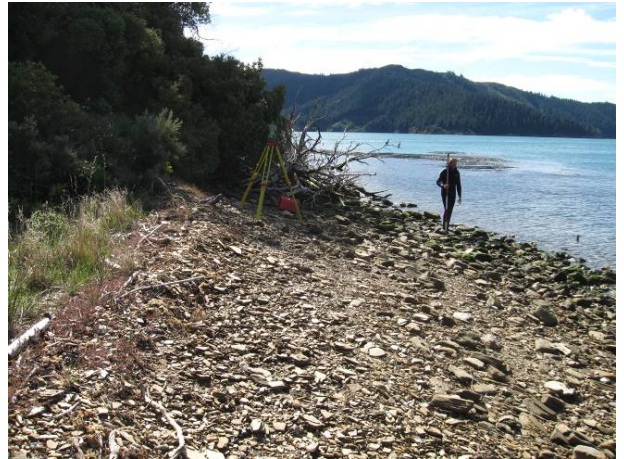
**Profile 6: Moioio Island 2**

Moioio Island 2 is at the eastern end of the beach on the island, near the slip that was of considerable concern to Te Ati Awa at the time the fast ferries were operating. This profile has a record going back to November 1995 and until 1999 the beach profile demonstrated seasonality, with a build up of a berm on the upper beach over the winter months, and its removal over the summer months, after which time, seasonal patterns have not been evident. The beach experienced significant accretion up to 2005, with a significant reversal for a period between November 2000 and April 2002 (coinciding with the slowing of the fast ferries possible affecting sediment mobility from the slip source). Between 2005 and 2009 the beach eroded, particularly on the upper and middle sections. Over the last 3 years, the upper beach has again accreted, probably due to an input of sediment from the slip. A significant berm remains at the top of the profile, and the lower beach continues to extend slowly into the deep water channel.

The most significant effect on this profile has almost certainly been the adjacent slip. Major fluctuations in beach shape and volume, and indeed the general accretion, are almost certainly related to sediment supply from periods of activity and inactivity of the slip.

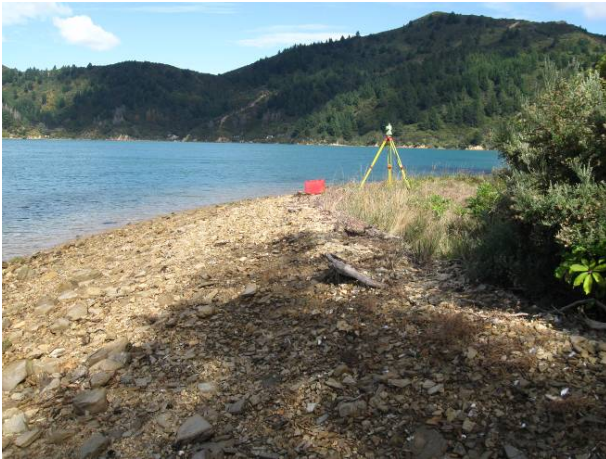
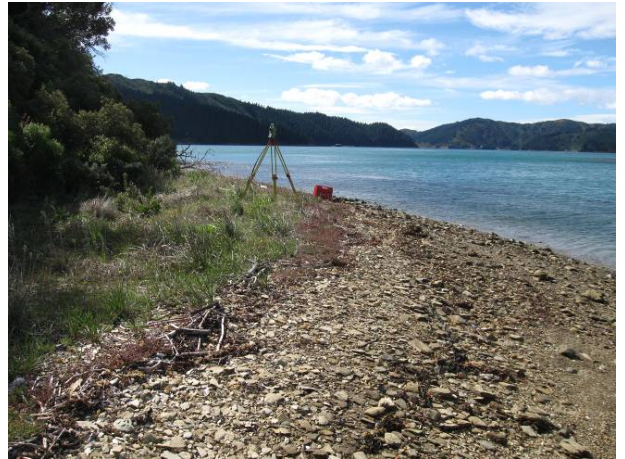
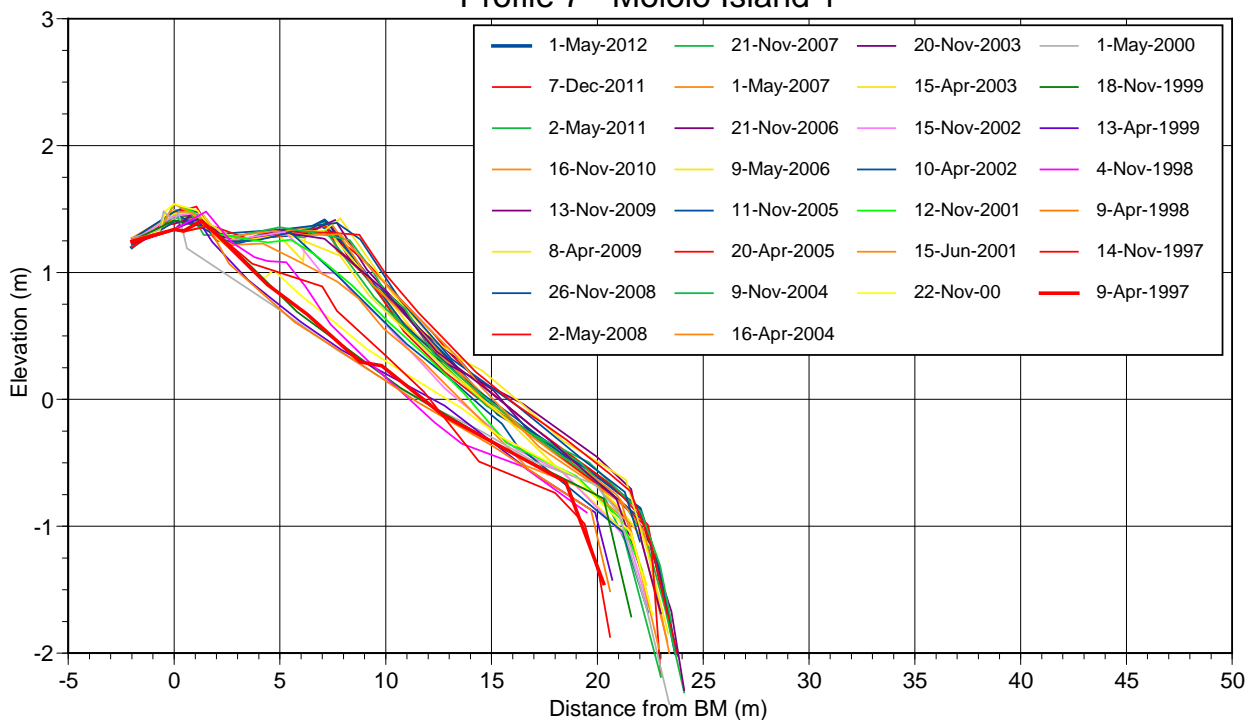
**Profile 7: Moioio Island 1**

The Moioio Island 1 profile is to the west of Profile 6. There was remarkable seasonality up to the winter of 1999, with the growth of a berm over winter and its loss over summer. Up until the end of 2000, the upper beach was generally stable, with seasonality, and with the lower beach accreting into the channel. Up to 2006, like Profile 6, the whole profile accreted rapidly with very substantial volume increases. There was substantial accretion of the upper beach between May 2000 and May 2006, with a major increase in volume, particularly between May 2000 and April 2001. Like Profile 6, there was a reversal in 2006, with a year of significant erosion, although the substantial berm remained. Since 2007 the profile has been relatively stable. This profile is almost certainly reacting principally to sediment supply.

There is little doubt that the beach changes taking place on this profile are related in part to ferry operation (evidenced by the very strong seasonal signal when fast ferries were operating seasonally), but they are affected significantly by changes to sediment supply. For example, the accretion event observed on Profile 6 between April 2003 and April 2004 is reflected on Profile 7 between November 2004 and April 2005.

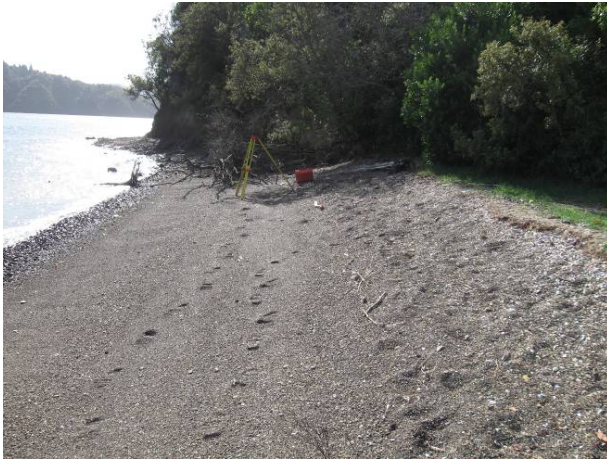
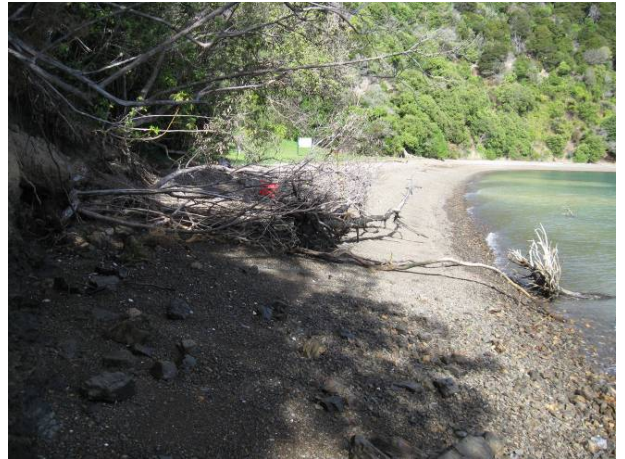
**Profile 8: Bobs Bay**

Bob's Bay has demonstrated an almost linear erosion trend since 1995 across the whole beach profile down to the change in slope (and probable closure depth) at about –1m. Most of the beach has lowered in level by about 1.2m. Volume data shows a volume change of the monitored area from 38.2m<sup>3</sup>/m in 1995 to 16.9m<sup>3</sup>/m since 1995. Because the profile line clearly encompasses the sweep zone, the 55% volume loss accurately reflects the total loss of sand. This erosion is very significant within the context of beaches in this study. The beach slope has stayed relatively constant.

The location of this profile is at the northern end of the beach, adjacent to a headland of significance to Te Ati Awa. It may be that the erosion is accompanied by accretion elsewhere in the embayment.

The cause of the erosion is not known. The site is well inside Mabel Island, and all major shipping movements should be at low speed with small wakes. There is also limited fetch, so natural waves should also be small. The mechanism of sediment transport away from the profile line, and where the sediment goes could be investigated if erosion at this particular point becomes more of concern.

Other sites in Tory Channel and inner Queen Charlotte Sound continue to provide good data. The possible return to pre fast ferry conditions on some profiles is of significant interest. The Bob's Bay profile has been continuously eroding. Erosion may be caused by all vessel wakes in the high traffic area near Picton (including the many small boats that pass quite close to the shore at this point), but may be entirely natural. Should erosion at this site be of particular concern, another profile towards the southern end of the bay should be established, to determine if the whole beach is eroding or if sediment is being redistributed within the embayment. In the longer term, some process studies could be considered.

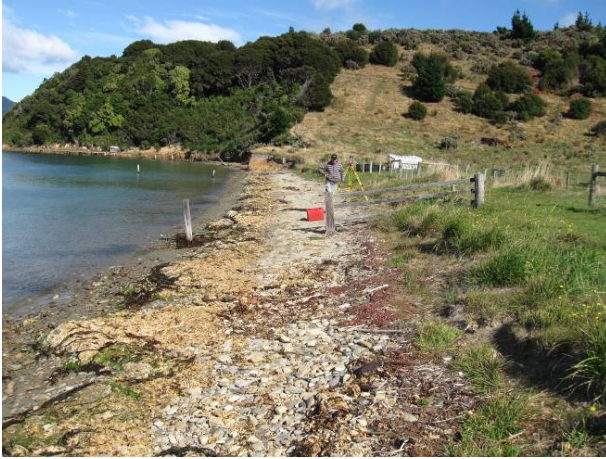
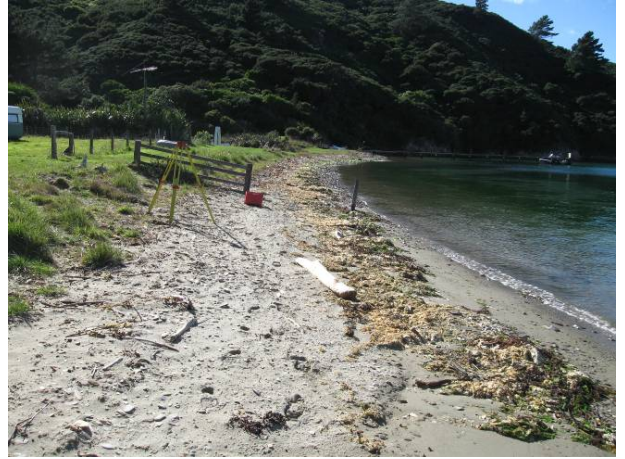
**Profile 9: Te Awaiti Bay**

Despite frequent changes in surficial sediments (more common up to 2003), with the deposition and removal of a small quantity of fine sediment, the beach profile has changed little. Beach volumes were relatively stable up until 2001, but then increased significantly, coinciding with the slowing of the fast ferries. Volumes reduced slightly by 2006 after peaking in 2004, and have remained constant since. Some redistribution of sediment has occurred with deposition at the top of the beach. Photographs indicate that the sediment deposited at the top of the beach may have an aeolian origin.

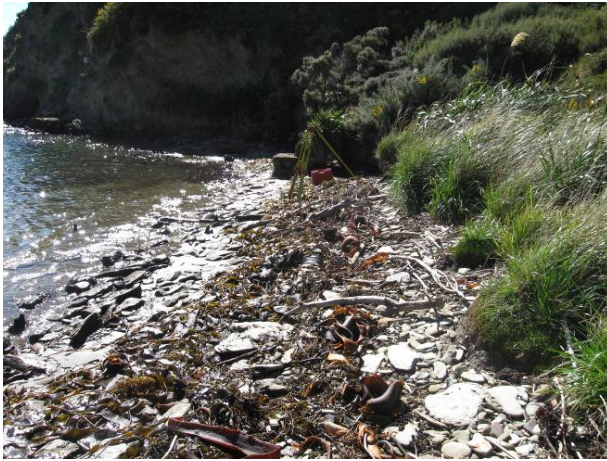
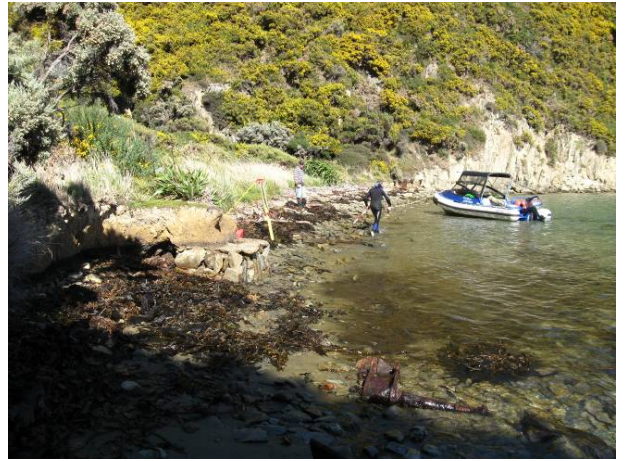
**Profile 10: Tipi Bay**

There has been some retreat of the upper beach scarp (approximately 1m) and a corresponding increase in the level of the middle to lower beach, but the changes have generally been minor. Because of the relatively coarse nature of the sediments, the placement of the survey staff can have significant impact on the apparent appearance of the profile line. Overall, beach volumes have reduced only a little.

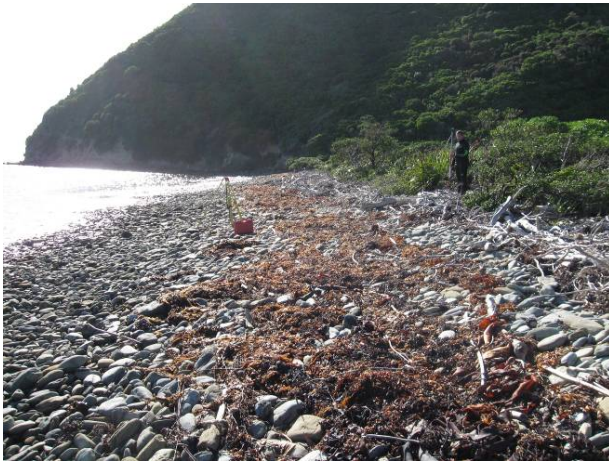
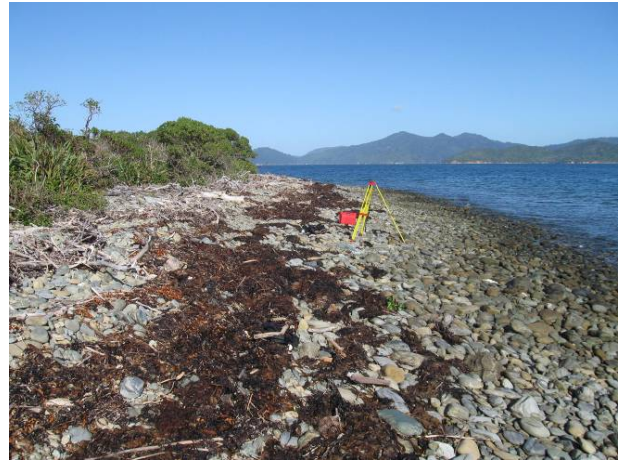
**Profile 11: Long Island**

The Long Island profile is relatively exposed to storm events that cause waves to propagate through the northern entrance to Queen Charlotte Sound. There is considerable variability in the level of the upper beach, with the build up and removal of a berm, although this has been less evident since about 2000. The level of the middle and lower beach also shows some variability, but with no obvious seasonal trends. There has been an overall decrease in sediment volume since 1997, with considerable variability... There are no significant sedimentary trends.

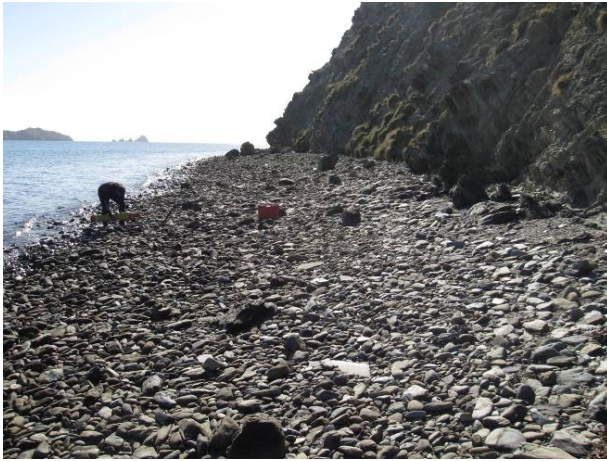
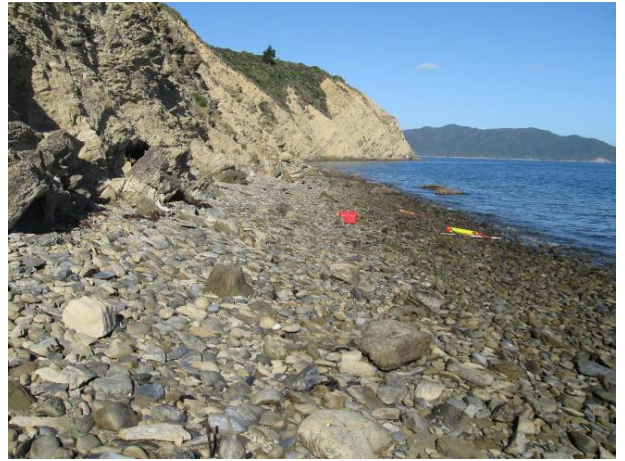
**Profile 12: Clark Point**

This profile, with a similar aspect to Profile 11 (Long Island), has shown no significant change in level, volume or sedimentary characteristics since 1997.

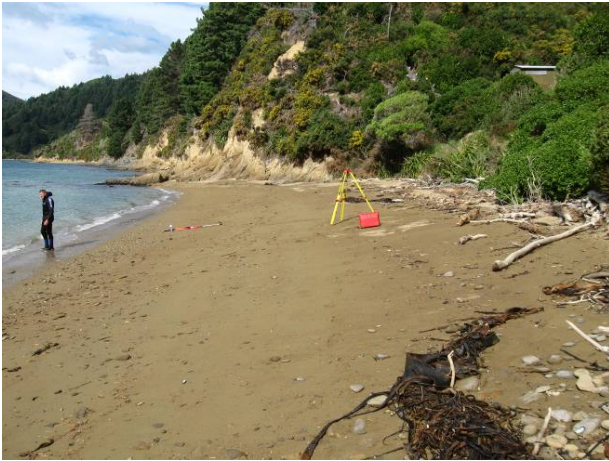
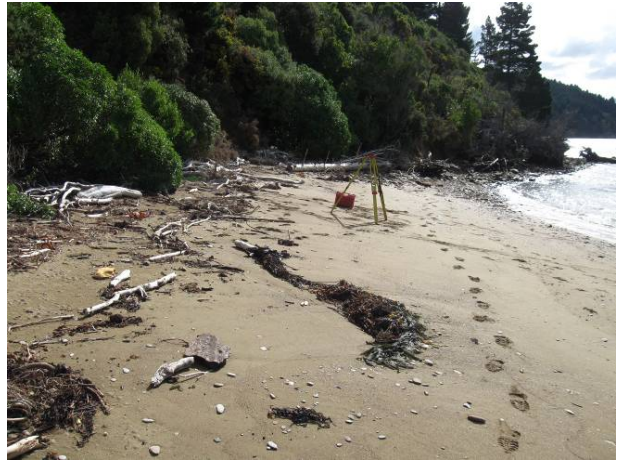
**Profile 13: Slip Beach**

Slip Beach demonstrated considerable variability between 1995 and April 1998 when it reached its lowest level. Up until the end of 2000, there was variability but in the context of accretion. Between 2000 and 2006 there was less variability, but with continued accretion. Since 2006 the beach has been relatively stable from year to year, but with very significant seasonality, with accretion over the summer, and sediment loss over the winter (with occasional years when seasonality is less evident). Overall, however, the beach is in a considerably accreted state compared to the 1997.

The photographs indicate that the dominant sediment type is sand with some small cobbles and pebbles.

Although no obvious relationships between ferry operations and beach change were able to be determined, it is apparent that the considerable variability in the profile ceased about the same time as fast ferry operations ceased. Slip beach has a long fetch into Queen Charlotte Sound to the north, and natural waves may be substantial. However, wave measurements at this site have indicated substantial wake events that continue for unusually long periods of time.

Because of its unusual exposure, extreme seasonality, unusual wakes and, for the area, fine sediments, this location continues to be of particular interest, although apart from seasonality there is no obvious explanation for the changes observed.

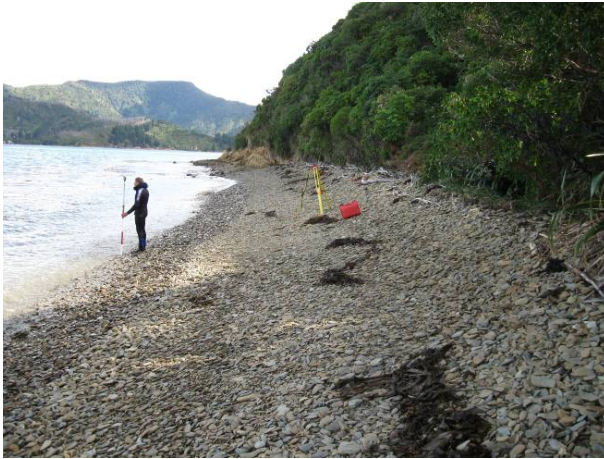
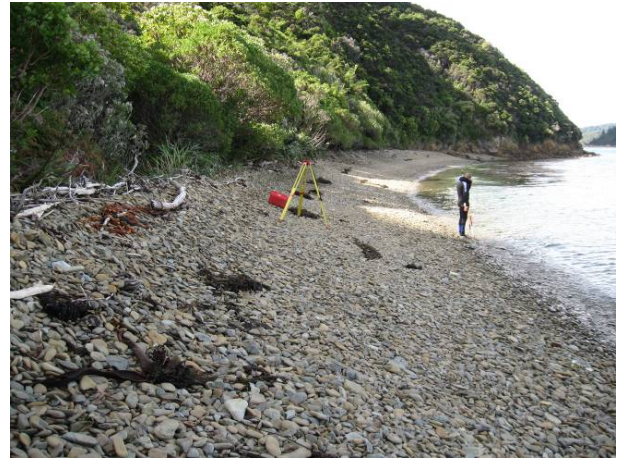
**Profile 14: Ngaionui Point**

Given its proximity to the sailing line of vessels in Tory Channel, the beach at Ngaionui Point probably changed significantly when the fast ferry first started operation, and that the beach form has generally held since that time. There was a slow trend towards accretion up until about April 2002, and a trend of erosion since that time (although this has slowed in the last 3 years), reflecting the return to pre-fast ferry conditions. The beach is now lower than at the start of surveys. However, it is unknown what its status is compared to the situation prior to fast ferry operation.

Apparent changes at the very lower beach are probably the result of different survey placement. There have been no significant changes in sediments.

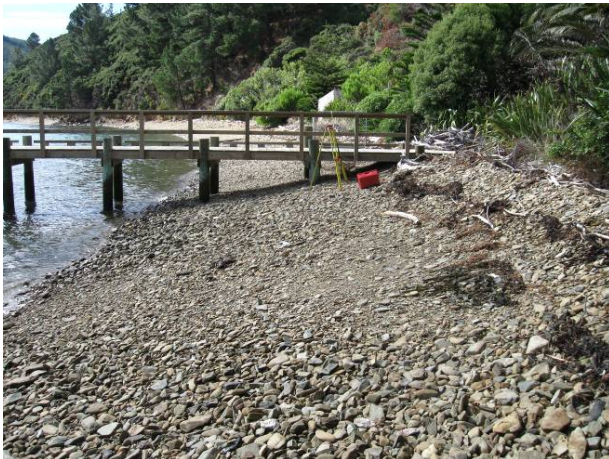
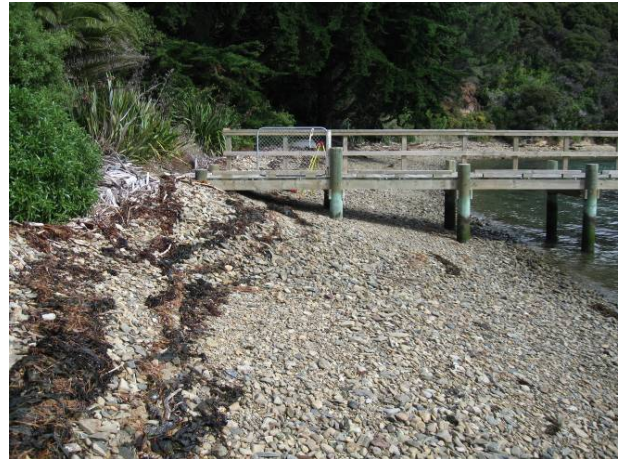
**Profile 15: Te Weka Bay**

The Te Weka Bay profile has changed little since surveys began in 1995. The development of an upper beach berm and the reduction in level of the middle beach during the period of fast ferry operation is evident (reaching a peak in April 2000). The berm has remained generally intact, even building a little, since that time. Beach volumes now equal the 2000 peak.

There have been no significant changes in sediment characteristics.

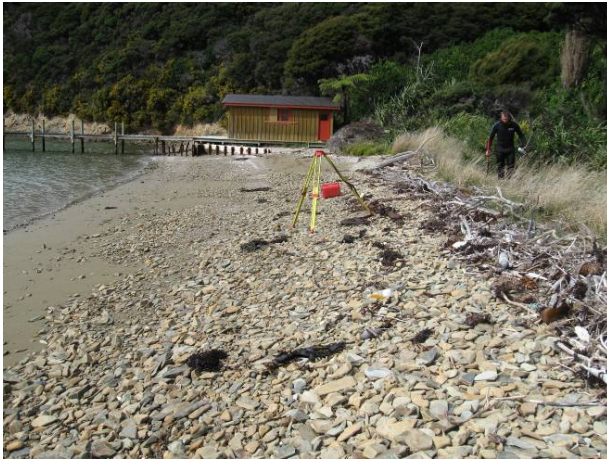
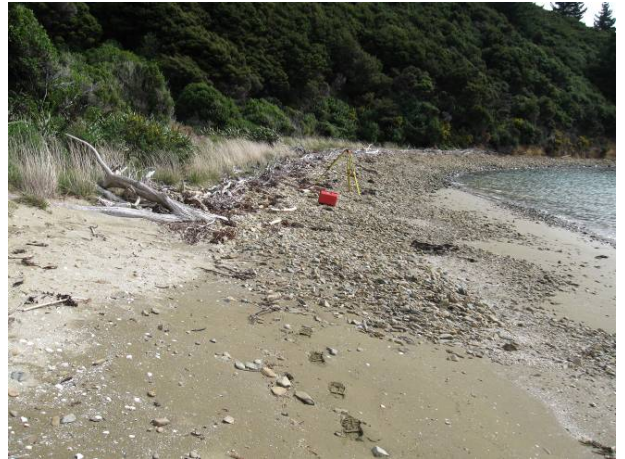
**Profile 16: McMillan's Bay**

This profile line is clearly being influenced by longshore transport of gravels from west to east. It may also be that there is transport of sand either onshore or alongshore. It is most likely that the mechanism of accretion is the result of ferry generated wake waves. The rate of accretion dropped markedly about the time the fast ferry operation ceased, probably the result of a reduced ability of the waves to transport sediment.

McMillan’s Bay is quite unusual in the context of the Tory Channel, being wide and with a relatively small slope. It has a wide ‘surf’ zone, unlike almost all other shorelines in the area.

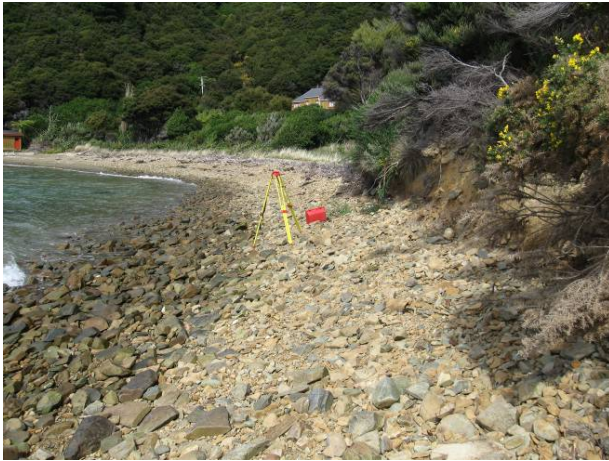
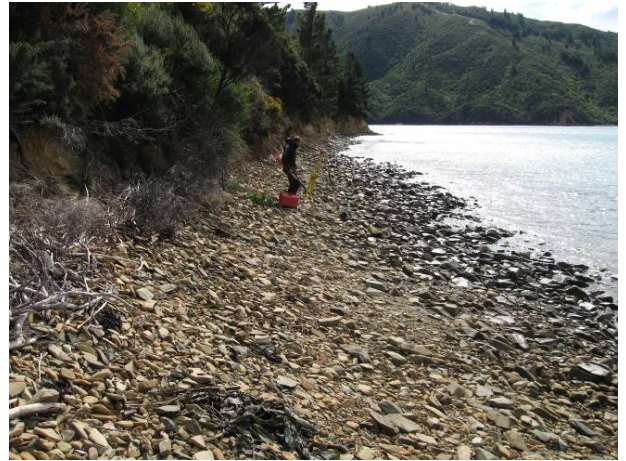
**Profile 17: McMillan's Side**

Beach volumes increased until 2001, with most of the accumulation on the lower profile. Since that time volumes have decreased, with most loss coming from the mid to upper beach. There is no indication of erosion at the upper beach scarp.

The reason for the major deposition between November 1999 and May 2000, reflected also on Profile 16, is unknown. However, there must have been a significant increase in sediment supply, perhaps a slip in the vicinity of Arrowsmith Point. After fast ferry operation ceased in 2000, there was a change from sediment accumulation to sediment loss, which continued through to 2009. This occurred at the same time as a change from sediment accumulation to stability on Profile 16. Since 2009 the profile and sediment volumes have changed little. Changes in this profile reflect changes in vessel operations, but there also appears to be a sediment supply control.

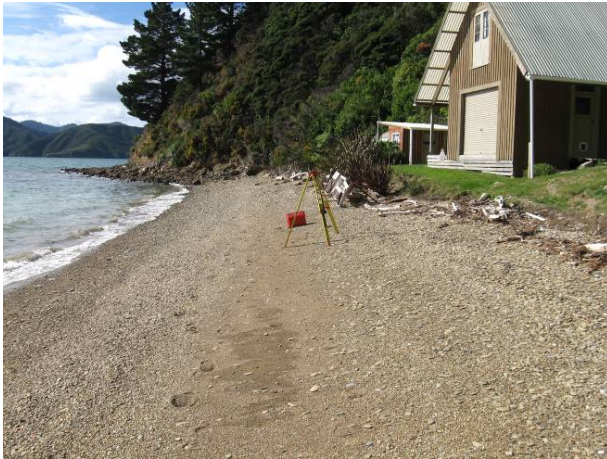
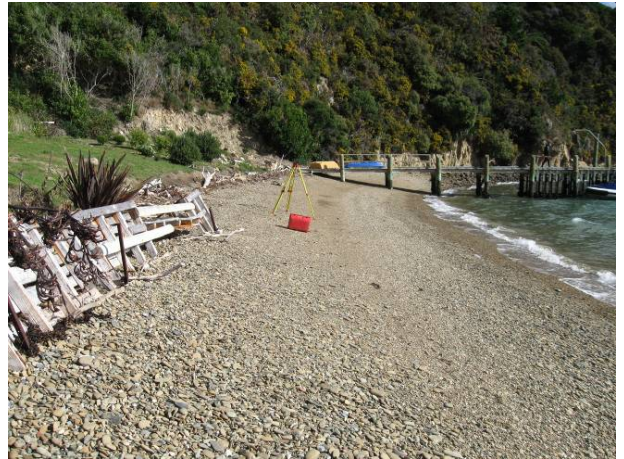
**Profile 18: Dieffenbach West**

There has been no significant change in the profile shape or in sediment volume since 1997. The upper beach scarp has retreated by about 50cm. Levels on the lower beach have increased a little. A thin covering of sand is sometimes present over the coarser beach sediment.

During 2000 a small cottage was built at the northern end of this beach, and in 2003 a boatshed was built and a minimal wooden seawall constructed adjacent to the profile line. The seawall (which has slowly been destroyed) does not appear to be affecting beach processes, but it is also not providing any protection to the land. It has now virtually gone.

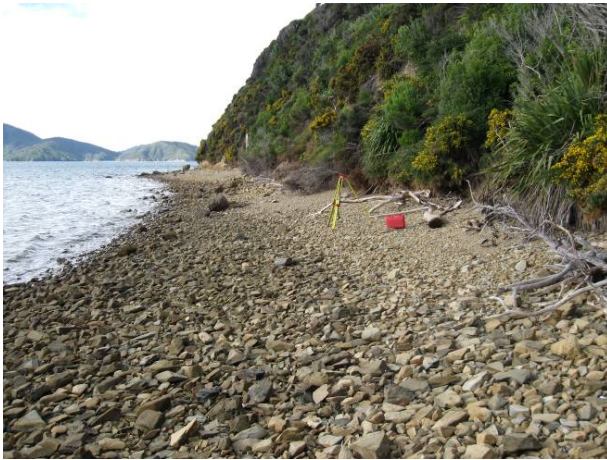
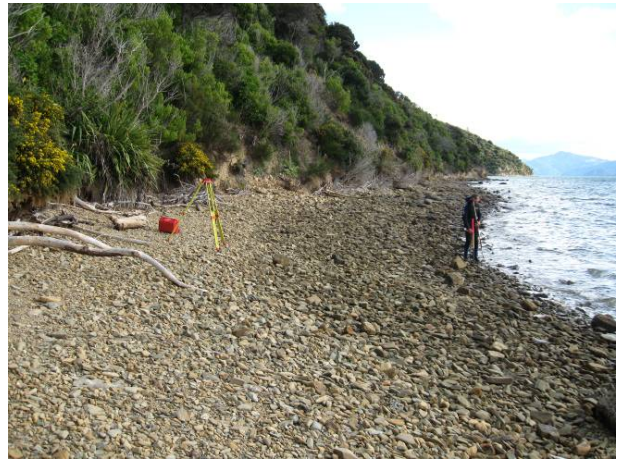
**Profile 19: Curious Monkey**

There was slow accretion over the period of fast ferry operation through to the end of 2000, and slow erosion following the end of fast-ferry operations through to 2007. Since 2007 the beach has been very stable. ,

There have been no notable changes in sediment characteristics.

The Curious Monkey site showed a change from minor accretion to minor erosion coinciding with fast ferry operation ceasing, although overall changes are small, and there has been very little change since 2007. Ngaionui Point, a site very close to the vessel travel line, particularly on the Wellington to Picton journey, shows a change from accretion to erosion in 2002. The erosion trend eased in 2009, perhaps indicating a return to pre-fast ferry conditions.

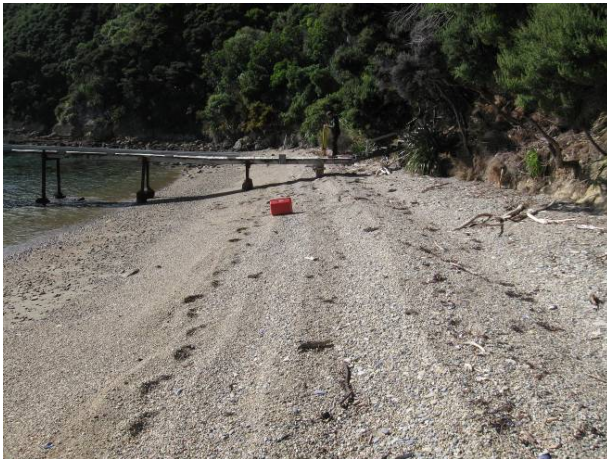
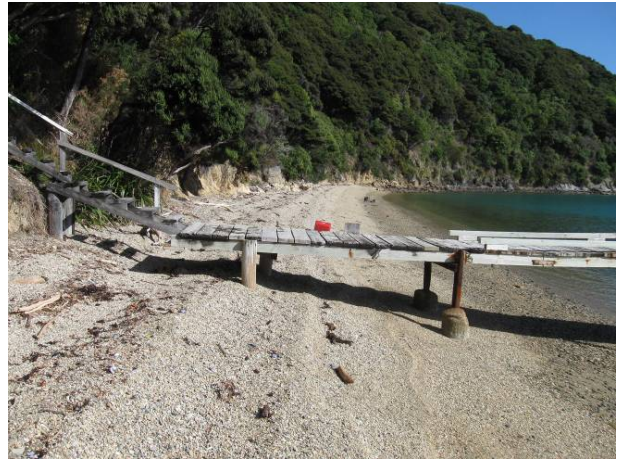
**Profile 20: Patten's Passage**

There is considerable variability on the upper and middle beach, but overall stability, with perhaps an erosion trend in from 2003 to 2009 and an accretion trend since.. Small berms build and are removed on the upper beach, with no particular seasonal pattern. Sediments are gravels and sands, and there is frequent banding, but no significant trends in sediment cover are obvious.

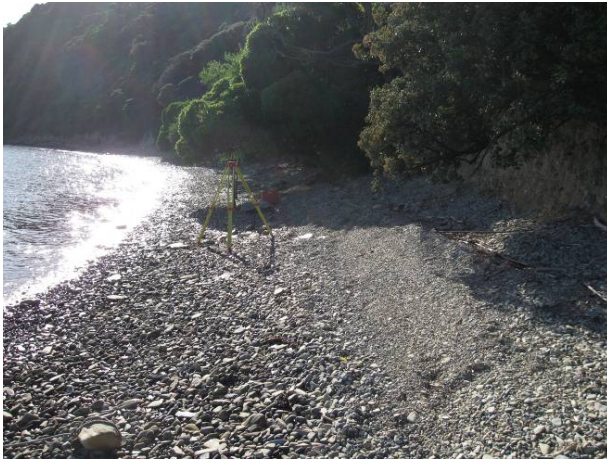
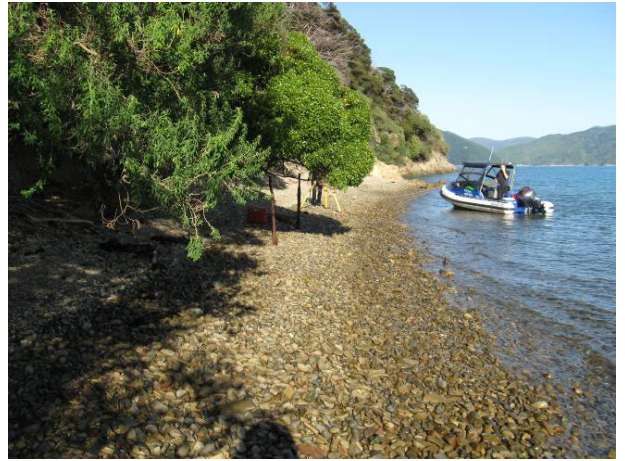
**Profile 21: Blumine Island**

Blumine Island has a similar aspect to the Patten's Passage profile. Up until 2003 changes were generally minor, with no seasonality shown. Since 2003, there has been a slow erosion trend, with some seasonality (and perhaps reversing in the last year). Significant erosion at the beach scarp at the top of the beach was reported by the surveyors in 2009, and the profile line was extended landward to cope with this. There does not appear to have been further significant change at the beach scarp.
