**MARLBOROUGH
DISTRICT COUNCIL**

Soil Properties in the Havelock/ Kaituna and Linkwater Districts

**Technical Report No: 13-002
March 2013**

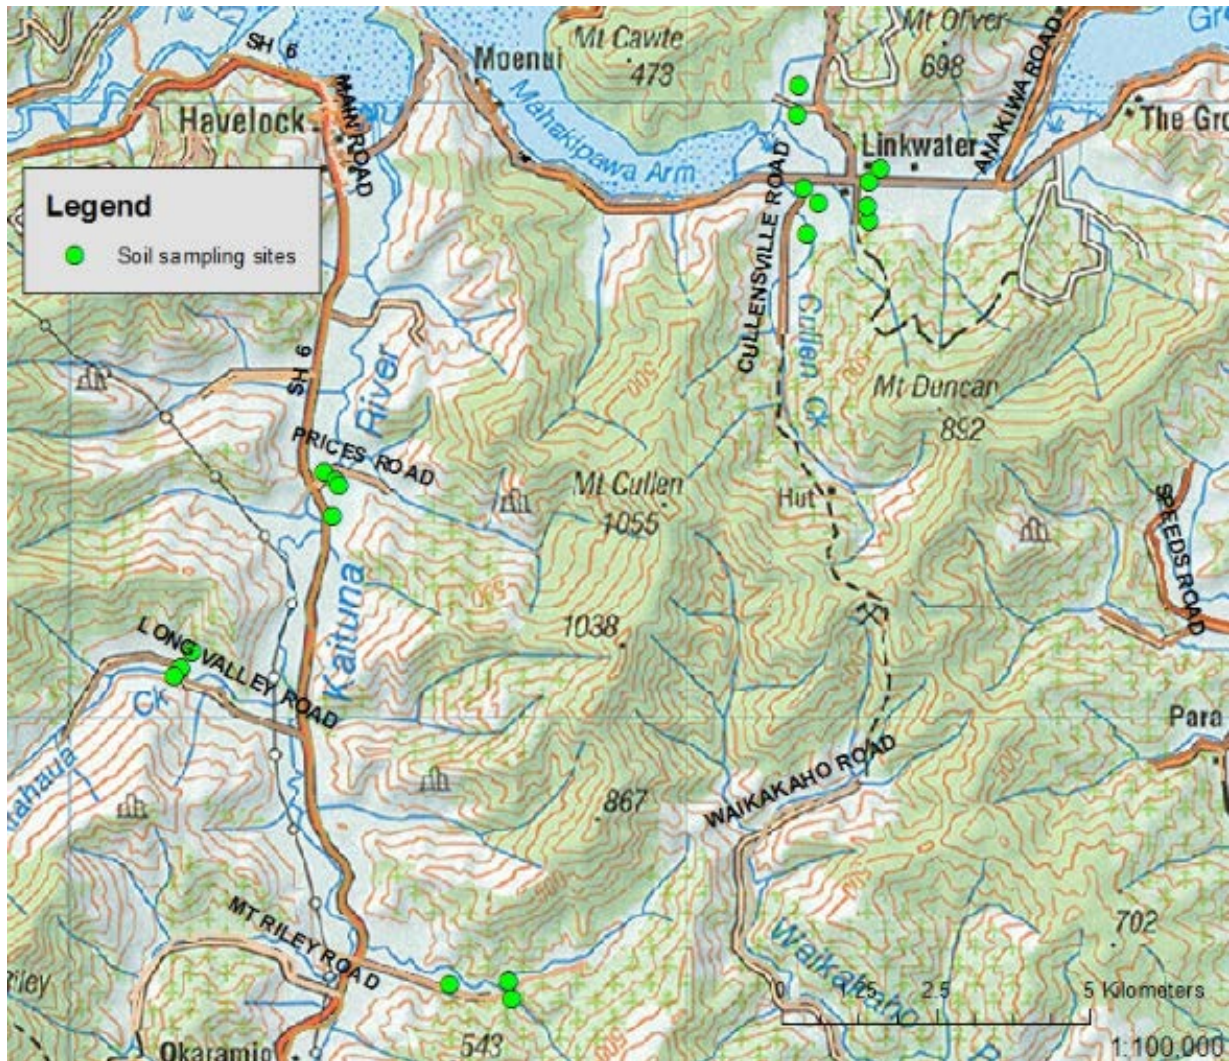
Figure 1. Location of soil sampling sites

A series of soil auger observations were made across a range of sites in the Kaituna/Havelock and Linkwater districts to identify the dominant soil types. Nineteen soil profiles were described and top and subsoils sampled and analysed for a range of soil physical and chemical properties. When specific soils were identified a soil pit was dug to about 1 m depth and a detailed soil profile description was undertaken to confirm the soil type and to note any salient soil features that may affect soil management i.e. rooting depth, mottling, hardpans etc. In addition, details of the site were recorded such as slope, elevation, landform, parent material and soil drainage class. In total 19 soil pits were sampled in the Kaituna/Havelock and Linkwater districts (Figure 1).

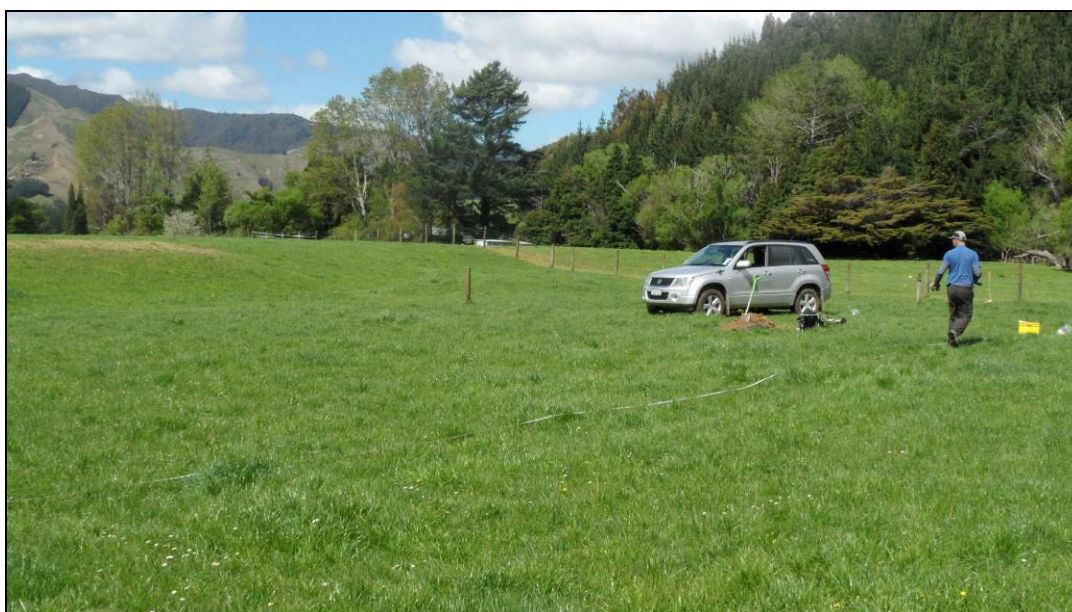
Figure 2. A lower terrace surface on which the Koromiko family of soils occur. The Atahaua stream is located to the right of the photo.

The Koromiko family of soils appears to represent the soils on the lowest land surfaces (described in Bulletin 27 as occurring up to 50 ft above sea level). This topographic unit, as mapped, covers a range of conditions and includes soils on stream and river floodplains and low terraces as well as the toe slopes of some fans (Figure 2).

The Koromiko soils are derived from schistose alluvium. They are classified as a Recent soils in the New Zealand Soil Classification system (Hewitt, 2010). There was some variation in soil profile morphology which reflected that Koromiko soils were sampled on floodplains and low terraces as well as the toe slopes of some fans. Typically topsoil profiles were dark yellowish brown or dark brown, had a moderately developed fine polyhedral structure, weak soil strength and were friable. Subsoil characteristics were quite variable which reflected the fact that some profiles contained buried horizons. Profiles ranged between light olive brown to yellowish brown, had moderately developed coarse block structure and also weakly developed fine polyhedral structure, a weak to slightly firm soil strength and were very friable.

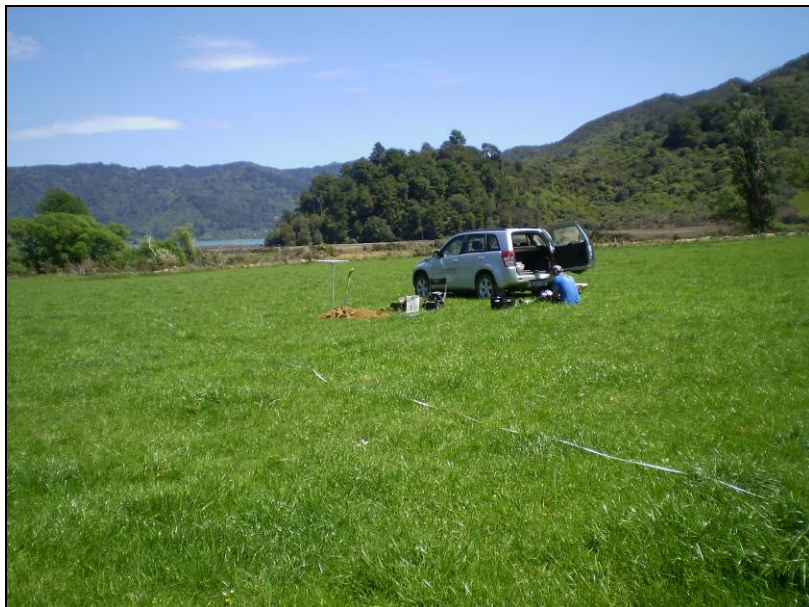
Figure 3. The Manaroa soil located on a low lying fan deposit surface.

Manaroa soils occur on surfaces that are intermediate between the lower floodplains and the more elevated remnant terrace and fan surfaces. They are formed on both alluvial surfaces and fans (Figure 3).

The Manaroa soils are derived from schistose alluvium and colluvium. They are classified as a Brown soil in the New Zealand Soil Classification system (Hewitt, 2010). Typically topsoil profiles were dark yellowish brown, had moderately developed fine polyhedral structure, weak soil strength and were friable. Subsoils were typically yellowish brown to light olive brown deeper in the profile, had a moderately developed fine polyhedral to medium/coarse blocky structure, a weak soil strength and were often firm, sometimes brittle at depth.

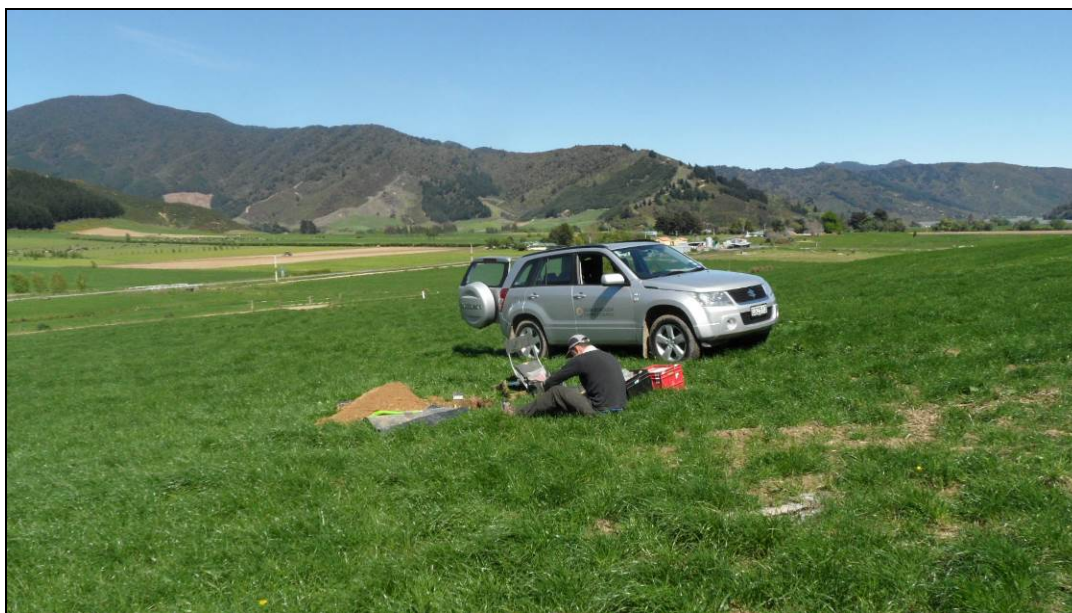
Figure 4. Kaituna soil occurring on a low fan above the valley floor in the Linkwater district.

The Kaituna soils appear to represent the soils on terraces and fans that occur above the valley floors (Figure 4).

The Kaituna soils are derived from schistose colluvium. They are classified as a Brown soil in the New Zealand Soil Classification system (Hewitt, 2010). Typically topsoil profiles were dark yellowish brown, had a strongly developed fine polyhedral structure, a weak soil strength and were friable. Subsoils were typically yellowish brown, had a moderately developed fine polyhedral structure, a weak to very weak soil strength and were very friable.

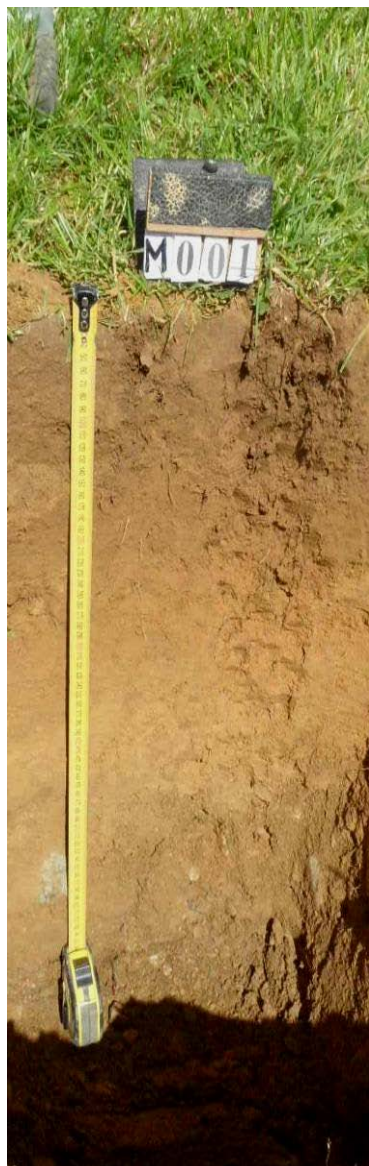
Sample name: Site 1

Soil Name: Manaroa (34c)

Soil drainage: well

Horizon	Depth	Description
A	0-18cm	dark yellowish brown (10YR 4/6) silt loam; 1% medium stones; moderately developed medium polyhedral structure; compact packing; friable; many fine roots
AB	18-25cm	dark yellowish brown and yellowish brown 10YR 4/6+5/8) silt loam; 1% medium stones; moderately developed fine polyhedral
Bw	25-52cm	yellowish brown (10YR 5/8) heavy silt loam; 1% medium stones; moderately developed fine polyhedral and medium blocky structure; weak soil strength, compact packing; very friable; common fine roots
BC	52-64cm	light olive brown (2.5Y 6/4) sandy silt loam; 15% fine and medium stones; weakly developed fine polyhedral structure; weak soil strength; compact packing; very friable; common fine roots
C	64-72cm+	light olive brown to olive brown (2.5Y 5/6-4/4); sand; 45% fine to coarse stones; apedal; loose

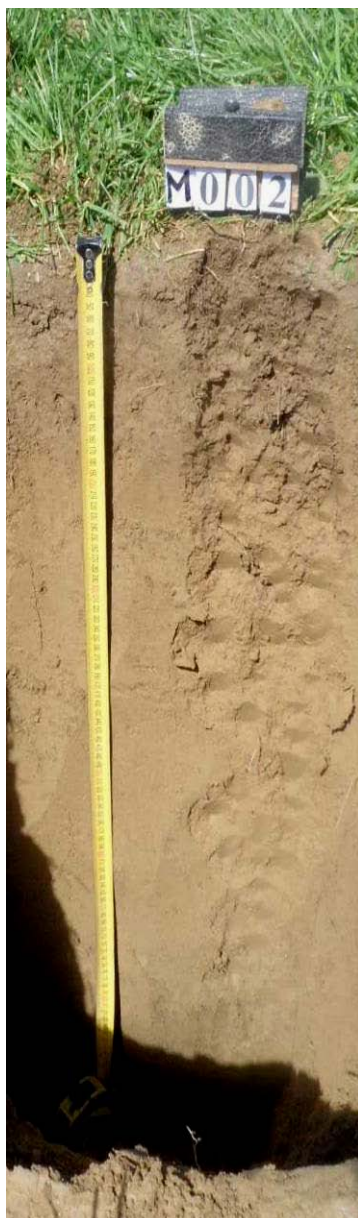
Sample name: Site 2

Soil Name: Koromiko (34e)

Soil drainage: well

Horizon	Depth	Description
A	0-16cm	dark yellowish brown (10YR 4/4) heavy silt loam; moderately developed fine polyhedral structure; weak soil strength; compact packing; friable; many fine roots
AB	16-21cm	dark yellowish brown and light olive brown (10YR 4/4 + 2.5Y /6) heavy silt loam weakly developed fine polyhedral structure weak soil strength; compact packing; friable; many fine roots
BC	21-75cm	light olive brown (2.5Y 6/4) heavy silt loam; weakly developed medium blocky structure; weak soil strength; compact packing; brittle; common fine roots
C	75-100cm	olive brown (2.5Y 4/4) sand; apedal; compact packing

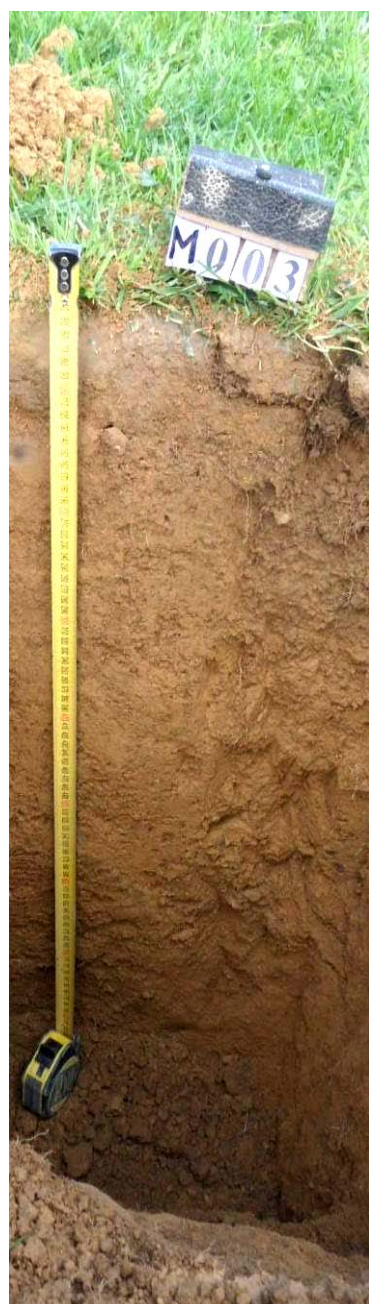
Sample name: Site 3

Soil Name: Kaituna (34a)

Landscape: valley side, truncated fan

Soil drainage: well

Horizon	Depth	Description
A	0-22cm	dark yellowish brown (10YR 4/6) silt loam; 2% fine and medium stones; strongly developed fine polyhedral structure; weak soil strength; compact packing; friable; many fine roots
AB	22-28cm	dark yellowish brown and yellowish brown (10YR 4/6+ 5/6) silt loam; 2% medium stones; moderately developed fine polyhedral structure; weak soil strength, compact packing; very friable; many fine roots
Bw1	28-56cm	yellowish brown (10YR 5/6) silt loam; 5% medium stones; strongly developed fine polyhedral structure; very weak soil strength; compact packing; many fine roots
Bw2	56cm-75cm	yellowish brown (10YR 5/6) silt loam; 7% fine and medium stones; strongly developed fine polyhedral and weak fine blocky structure; weak soil strength; compact packing; common fine roots
BC	75-90 cm+	yellowish brown (10YR 5/8) sandy silt loam; 10% fine and medium stones; weakly developed fine blocky and polyhedral structure; weak soil strength; compact packing; few fine roots

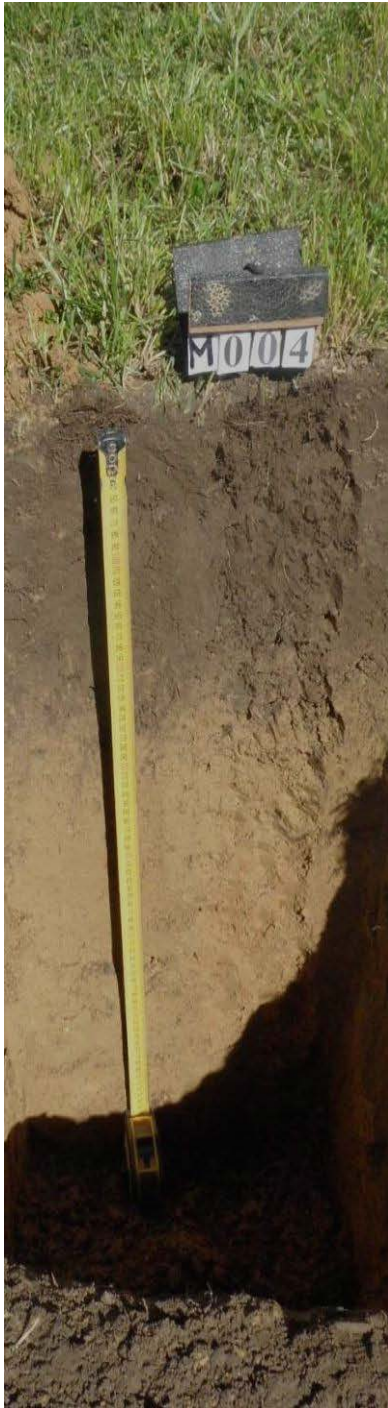
Landscape: narrow side valley with colluvial infilling

Soil drainage: moderately well

Horizon	Depth	Description
A	0-22cm	dark brown (10YR 3/3) heavy silt loam; 1% fine stones; moderately developed fine polyhedral structure; slightly firm soil strength; compact packing; friable; abundant fine roots
AB	22-29cm	dark brown and yellowish brown (10YR 3/3+5/8) clay loam; 1% fine stones; moderately developed fine polyhedral structure; weak soil strength; compact packing; friable; many fine roots
Bw1	29-52cm	yellowish brown to light olive brown (10YR 5/8-2.5YR 5/6) clay loam; 1% fine stones; moderately developed coarse blocky structure; weak soil strength; compact packing; brittle fracture; few fine roots
Bw2	52cm-68cm	yellowish brown to light olive brown (10YR 5/8-2.5YR 5/6) clay loam; 1% fine stones; 5% dark reddish brown (5YR 4/6) and 5% light yellowish brown (2.5Y 6/4) fine distinct mottles; slightly firm soil strength; compact packing; few fine roots
BC	68-85 cm+	Light olive brown to yellowish light yellowish brown (2.5Y 5/4-10YR 5/8) sandy clay loam; 1% fine stones; 5% light yellowish brown (2.5Y 6/4) fine mottles; weakly developed medium blocky structure; slightly firm soil strength; compact packing; brittle fracture; very few fine roots

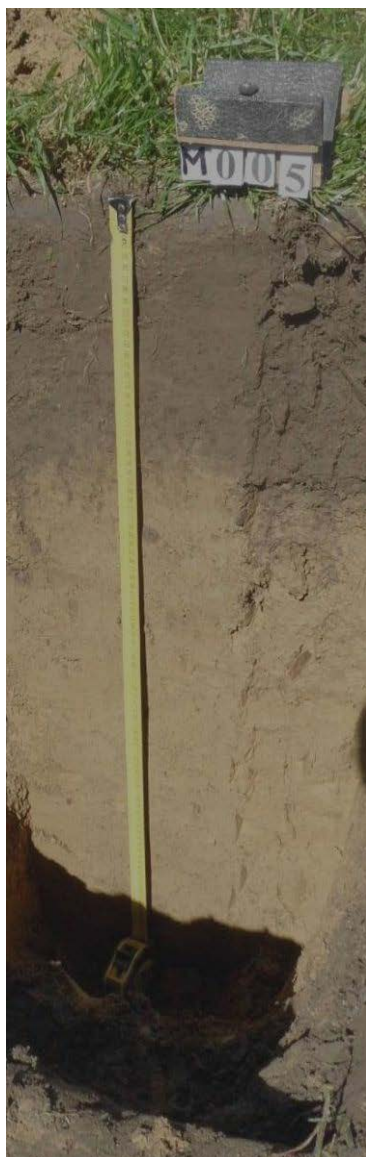
Sample name: Site 5

Landscape: elongated valley, intermittent terrace surface

Soil drainage: moderately well

Horizon	Depth	Description
A	0-22cm	dark brown (10YR 3/3) silt loam; moderately developed fine polyhedral structure; weak soil strength; compact packing; friable; many fine roots
AB	22-28cm	dark brown and light olive brown (10YR 3/3 + 2.5Y 5/6) clay loam; moderately developed fine polyhedral structure; weak soil strength; compact packing; friable; few fine roots
B(g)	28-40cm	light olive brown (2.5Y 5/6) clay loam; 5% reddish brown (5YR 5/8) and 15% pale olive (5Y 6/3) fine distinct mottles; moderately developed coarse blocky structure; weak soil strength; compact packing; brittle failure; few fine roots
bB	40cm-80cm	yellowish brown (10YR 5/6) clay loam; moderately developed fine polyhedral structure; weak soil strength; compact packing; friable; few fine roots
b BC	80-100 cm+	light olive brown (2.5Y 5/6) silt loam; weakly developed fine polyhedral structure; weak soil strength; compact packing; friable

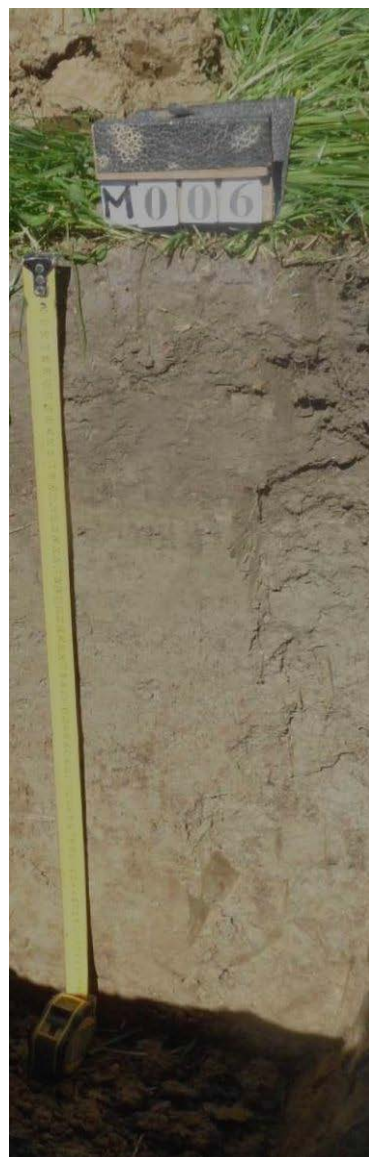
Sample name: Site 6

Landscape: elongated valley, side-valley toe slope

Soil drainage: moderately well

Horizon	Depth	Description
A	0-18cm	dark greyish brown (10YR 4/2) heavy silt loam; 2% yellowish red fine distinct pug mottles; moderately developed fine polyhedral structure; weak soil strength, compact packing; friable; common fine roots
AB	18-23cm	dark greyish brown (10YR 4/2) and olive (5Y 5/4) clay loam; moderately developed medium blocky structure; slightly firm soil strength; compact packing; friable; common fine roots
BC1	23-35cm	olive (5Y 5/4) clay loam; 2% dark reddish brown (5YR 4/2) concretions; moderately developed coarse blocky structure; slightly firm soil strength; compact packing; brittle fracture; few fine roots
BCg	35cm-60cm	olive grey (5Y 4/2) clay loam; 25% yellowish brown (10YR 5/4) and 40% light olive brown (2.5Y 5/4) medium mottles; moderately developed coarse blocky structure; slightly firm soil strength; compact packing; brittle fracture; few fine roots
Cg	60-90 cm+	light olive brown (2.5Y 5/4) heavy clay loam; 35% yellowish brown (10YR 5/4) and 45% olive grey (5Y 5/2) coarse mottles; apedal; firm

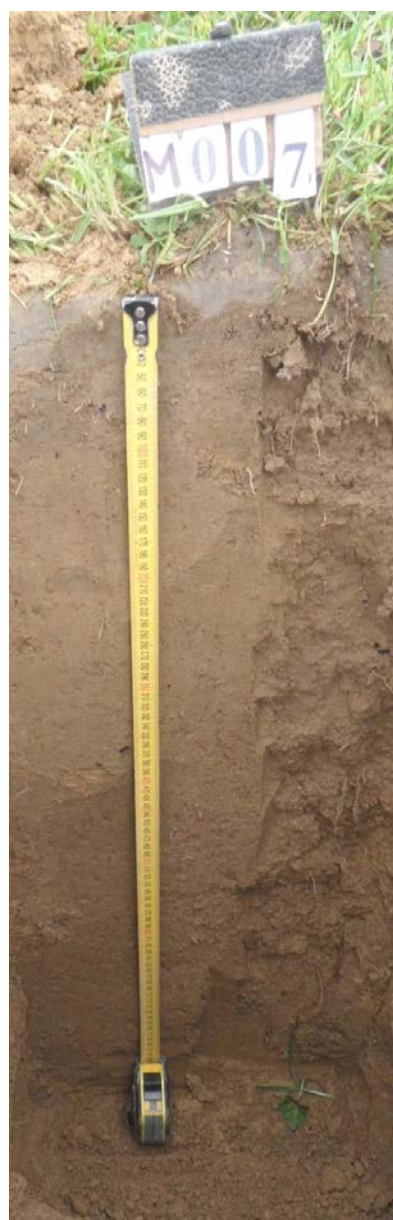
Sample name: Site 7

Landscape: low valley terrace/floodplain

Soil drainage: moderately well

Horizon	Depth	Description
A	0-9cm	brown to dark brown (10YR 4/3) silt loam; 5% yellowish red (5YR 5/6) and 5% dark greyish brown (2.5Y 4/2) fine pug mottles; weakly developed fine polyhedral and medium blocky structure; very weak soil strength; compact packing; friable; common fine roots
AB	9-13cm	brown to dark brown (10YR 4/3) and light olive brown (2.5Y 5/6) fine sandy loam; weakly developed fine polyhedral structure; weak soil strength; compact packing; friable; common fine roots
BC	13-30cm	light olive brown (2.5Y 5/6) fine sandy loam; apedal; few charcoal particles; very weak soil strength; compact packing; few fine and few medium roots
b B	30cm-66cm	yellowish brown (10YR 5/4) fine sandy loam; moderately developed fine polyhedral structure; weak soil strength; compact packing; friable; few fine roots
b BC	66-92 cm+	brownish yellow (10YR 6/6) silt loam; moderately developed fine polyhedral structure; weak soil strength; compact packing; friable

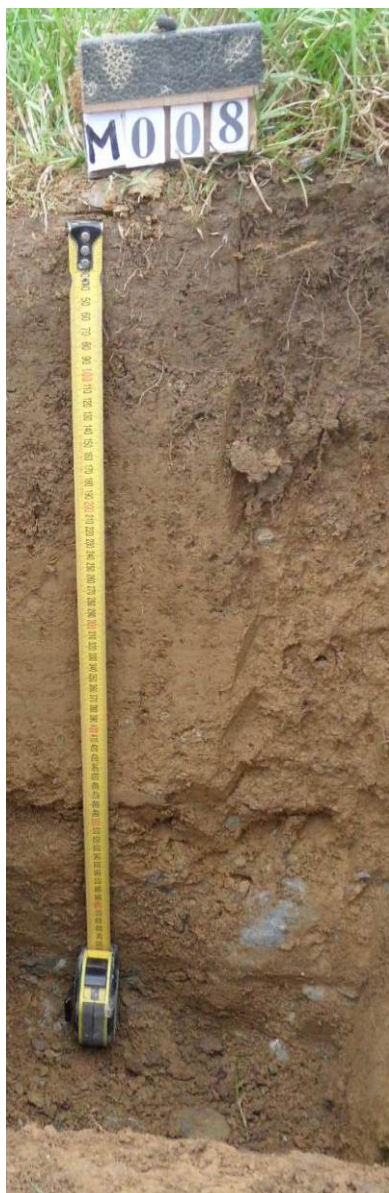
Sample name: Site 8

Landscape: low river terrace/floodplain

Soil drainage: well

Horizon	Depth	Description
A	0-16cm	dark yellowish brown (10YR 4/4) silt loam; 1% medium stones; moderately developed fine polyhedral structure; weak soil strength; compact packing; friable; abundant fine roots
AB	16-24cm	dark yellowish brown (10YR 4/4) and yellowish brown (10YR 5/6) heavy silt loam; 1% medium stones; moderately developed fine polyhedral structure; weak soil strength; compact packing; friable; common fine roots
Bw1	24-48cm	yellowish brown (10YR 5/6) clay loam; 3% medium stones; moderately developed fine polyhedral structure; weak soil strength; compact packing; friable; few fine roots
Bw2	48cm-68cm	yellowish brown (10YR 5/6) clay loam; 25% medium to coarse stones; moderately developed medium polyhedral structure; weak soil strength; compact packing; brittle; few fine roots
BC	68-78 cm+	yellowish brown (10YR 5/8) sandy silt loam; 45% medium to coarse stones; apedal
C	on	light olive brown fine to coarse, loose stony gravel

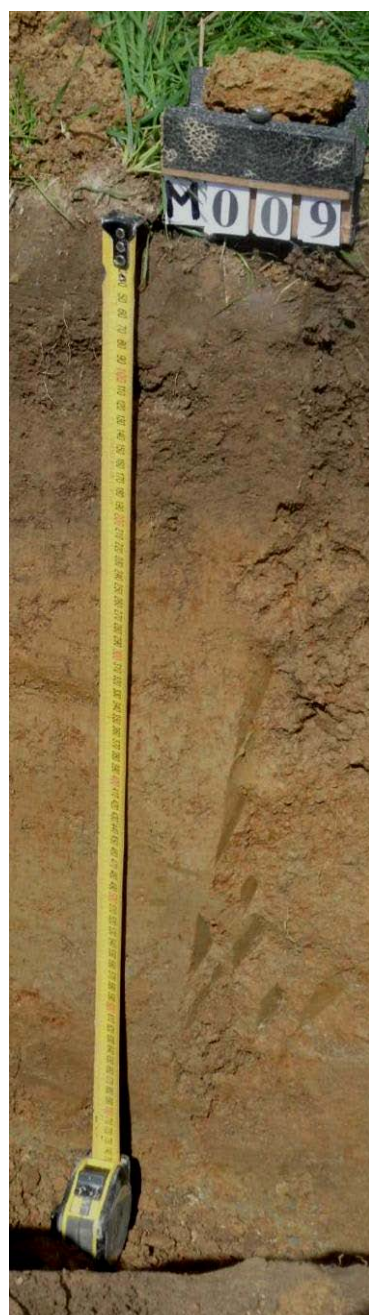
Sample name: Site 9

Landscape: main valley terrace, slightly lower-lying area

Soil drainage: imperfectly

Horizon	Depth	Description
A	0-20cm	brown to dark brown (10YR 4/3) silt loam; moderately developed fine polyhedral structure; slightly firm soil strength; compact packing; friable; many fine roots
Bw(g)1	20-30cm	light olive brown (2.5Y 5/6) clay loam; 7% red (2.5YR 4/8) and 5% pale olive (5Y 6/3) fine distinct mottles; moderately developed fine polyhedral and blocky structure; slightly firm soil strength; ; compact packing; friable; common fine roots
Bw(g)2	30-57cm	light olive brown (2.5Y 5/6) clay loam; 50% light olive brown (2.5Y 5/4) fine diffuse mottles; moderately developed fine polyhedral and medium blocky structure; slightly firm soil strength; compact packing; brittle fracture; few fine roots
Bw(g)3	57cm-72cm	light yellowish brown (2.5Y 6/6) clay to clay loam; 5% fine stones; 25% red (2.5YR 5/6) and 50% olive (5Y 5/3) fine distinct mottles; weakly developed coarse blocky structure; slightly firm soil strength; compact packing; brittle fracture; few fine roots

BC	72-82 cm+	light olive brown (2.5Y 5/4) sandy silt loam; 30% fine to medium stones; 35% red (2.5YR 5/6) medium distinct mottles; apedal

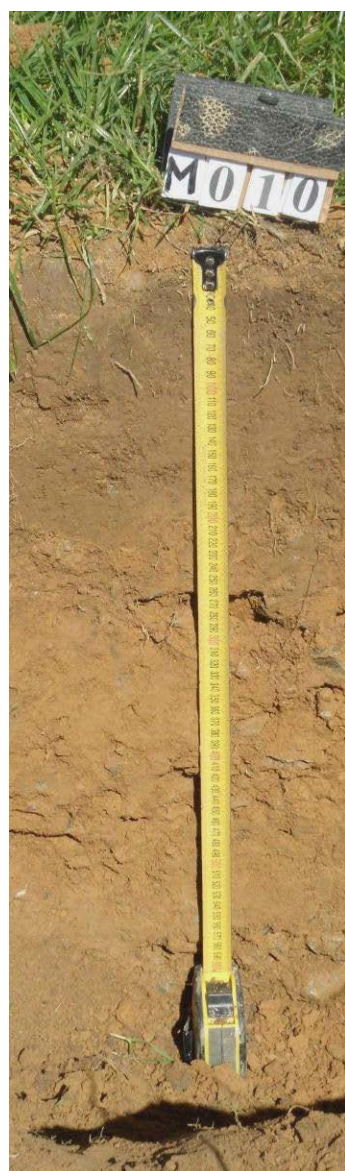
Landscape: main valley terrace

Soil drainage: well

Horizon	Depth	Description
A	0-17cm	dark yellowish brown (10YR 4/4) silt loam; 2% fine and medium stones; moderately developed fine polyhedral structure; weak soil strength; compact packing; friable; abundant fine roots
AB	17-23cm	dark yellowish brown (10YR 4/4) and yellowish brown (10YR 5/8) silt loam; 2% fine and medium stones; strongly developed fine polyhedral structure; weak soil strength; compact packing; friable; common fine roots
Bw1	23-50cm	yellowish brown (10YR 5/8) silt loam; 5% fine to medium stones; strongly developed fine polyhedral structure; weak soil strength; compact packing; friable; common fine roots
Bw2	50cm-64cm	yellowish brown (10YR 5/8) sandy silt loam; 15% fine to medium stones; moderately developed fine polyhedral and coarse blocky structure; weak soil strength; compact packing; friable; few fine roots
BC	64-72 cm+	light olive brown (2.5Y 5/6) loamy sand; 40% fine to medium stones; apedal; loose

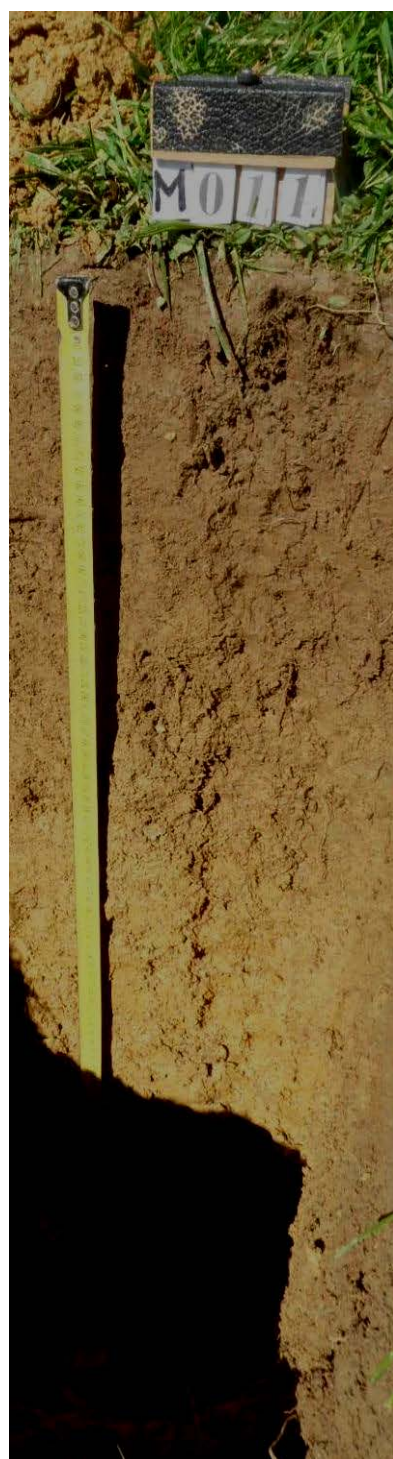
Sample name: Site 11

Landscape: midslope fan

Soil drainage: moderately well

Horizon	Depth	Description
A	0-22cm	dark yellowish brown (10YR 3/6) heavy silt loam; 1% fine stones; moderately developed fine polyhedral structure; weak soil strength; compact packing; friable; common fine roots
AB	22-30cm	dark yellowish brown (10YR 3/6) and yellowish brown (10YR 5/6) silt loam; moderately developed fine polyhedral structure; weak soil strength; compact packing; friable; common fine roots
Bw	30-52cm	yellowish brown (10YR 5/6) silt loam; 5% fine stones; moderately developed medium polyhedral structure; very weak soil strength; compact packing; friable; few fine roots
Bw(g)	52cm-70cm	brownish yellow (10YR 6/8) clay loam; 25% light brownish grey to light olive brown (2.5Y 6/2-6/4) and 20% strong brown (7.5YR 5/8) fine distinct mottles; weakly developed coarse blocky structure; slightly firm soil strength; compact packing; brittle fracture; few fine roots
BC(g)	70-93 cm+	light olive brown (2.5Y 5/4) clay to clay loam; 25% light olive brown (2.5Y 6/2) and 25% yellowish red (5YR 5/8) medium distinct mottles; weakly developed coarse blocky structure; slightly firm soil strength; compact packing; brittle fracture

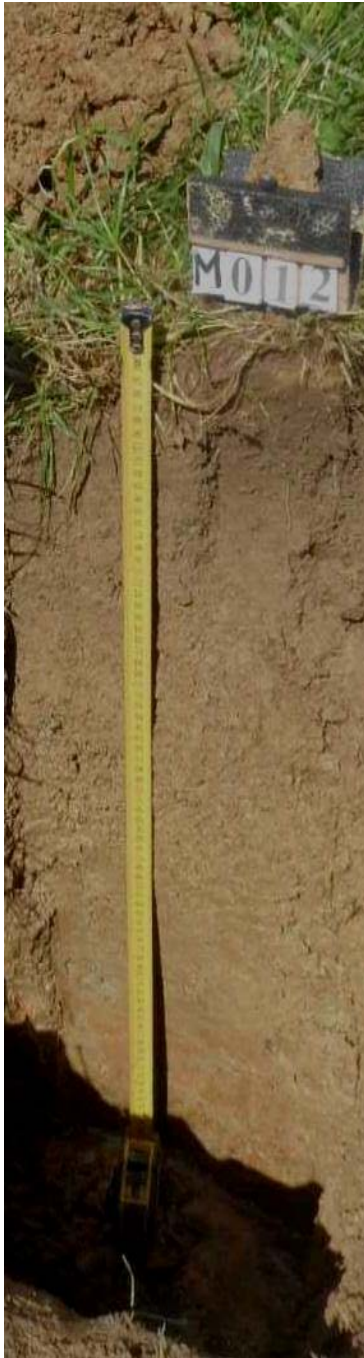
Sample name: Site 12

Soil drainage: moderately well

A	0-16cm	dark yellowish brown (10YR 4/4) silt loam; 2% fine stones; moderately developed fine polyhedral structure; weak soil strength; compact packing; friable; common fine roots
AB	16-20cm	dark yellowish brown (10YR 4/4) and yellowish brown (10YR 5/6) silt loam; 5% fine stones; moderately developed fine polyhedral structure; weak soil strength; compact packing; friable; common fine roots
Bw	20-38cm	yellowish brown (10YR 5/6) silt loam; 7% fine and medium stones; 5% strong brown (7.5YR 5/6) and 5% light olive brown (2.5Y 6/4) fine and medium distinct mottles; moderately developed fine polyhedral structure; weak soil strength; compact packing; very friable; common fine roots
BC	38cm-58cm	yellowish brown to olive brown (10YR 5/6-2.5Y 5/6) heavy silt loam; 5% strong brown (7.5YR 5/8) and 5% light olive brown (2.5Y 5/4) fine and medium mottles; weakly developed coarse blocky structure; slightly firm soil strength; compact packing; brittle fracture;

BCg	58-78 cm+	olive (5Y 5/3, 60%) and reddish brown (5YR 4/4, 40%) distinct medium mottled sandy clay loam; 2% fine stones; moderately developed medium polyhedral structure; slightly firm soil strength; compact packing; brittle fracture

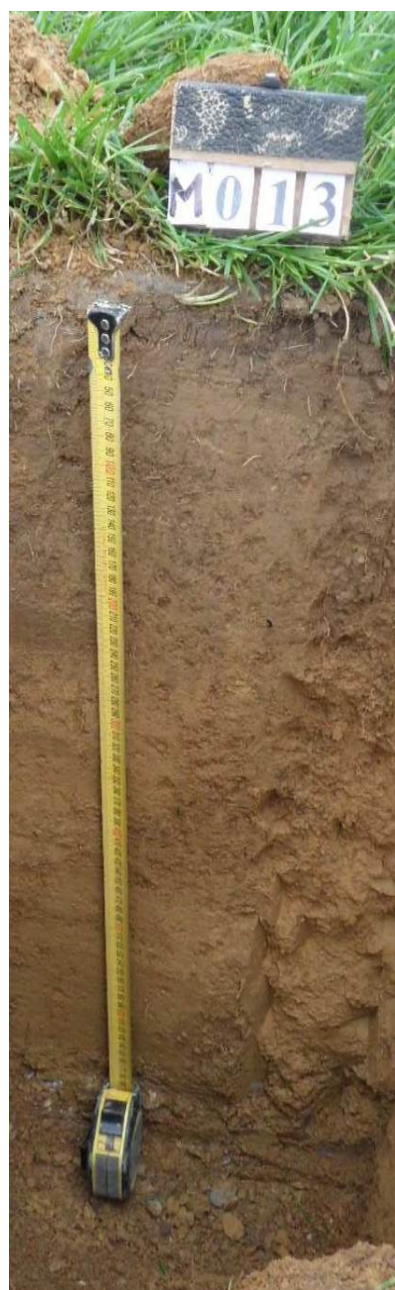
Landscape: valley floor, midslope of fan

Soil drainage: well

Horizon	Depth	Description
A	0-21cm	dark yellowish brown (10YR 4/6) silt loam; 1% fine and medium stones; moderately developed fine and medium polyhedral structure; weak soil strength; compact packing; friable; common fine roots
AB	21-27cm	dark yellowish brown (10YR 4/6) and yellowish brown (10YR 5/8) silt loam; moderately developed fine polyhedral structure; weak soil strength; compact packing; friable; common fine roots
Bw1	27-42cm	yellowish brown (10YR 5/8) heavy silt loam; 1% fine and medium stones; moderately developed fine polyhedral structure; weak soil strength; compact packing; friable; few fine roots
Bw2	42cm-70cm	light olive brown (2.5Y 5/6) heavy silt loam to clay loam; 2% strong brown (7.5YR 5/8) and 2% light yellowish brown (2.5Y 6/4) fine mottles; weakly developed coarse blocky structure; very weak soil strength; compact packing; very friable; few fine roots
BC	70-85 cm+	light olive brown (2.5Y 5/6) sand; 50% fine to coarse stones; apedal; compact

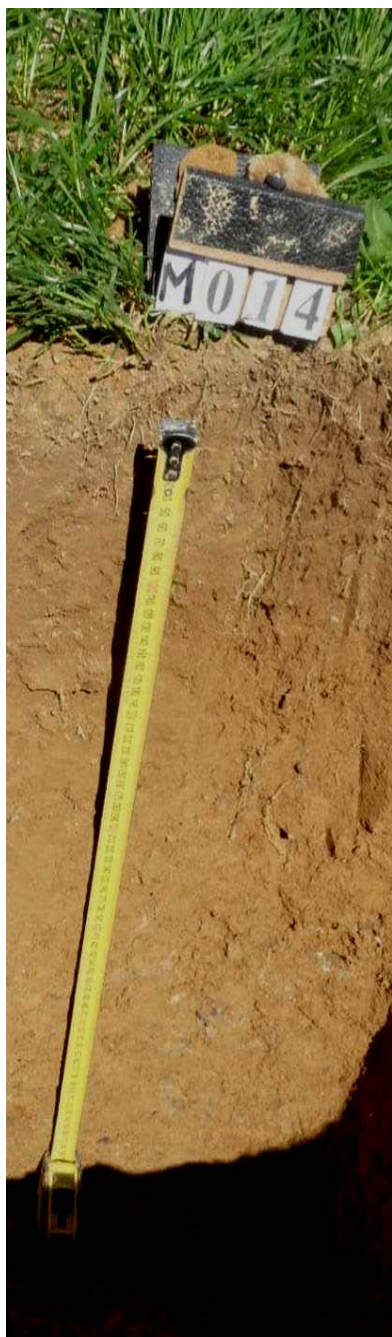
Sample name: Site 14

Soil drainage: well

Horizon	Depth	Description
A	0-18cm	dark yellowish brown (10YR 4/6) clay loam; 3% fine and medium stones; strongly developed fine polyhedral structure; weak soil strength; compact packing; friable; many fine roots
AB	18-23cm	dark yellowish brown (10YR 4/6) and yellowish brown (10YR 5/6) clay loam; 3% fine to medium stones; moderately developed fine polyhedral structure; weak soil strength; compact packing; very friable; common fine roots
Bw1	23-42cm	yellowish brown (10YR 5/6) silt loam; 3% fine to medium stones; moderately developed fine polyhedral structure; weak soil strength; compact packing; very friable; common fine roots
Bw2	42cm-80cm	yellowish brown (10YR 5/6) sandy silt loam; 30% fine to coarse stones; weakly developed fine polyhedral structure; weak soil strength; compact packing; very friable; few fine roots

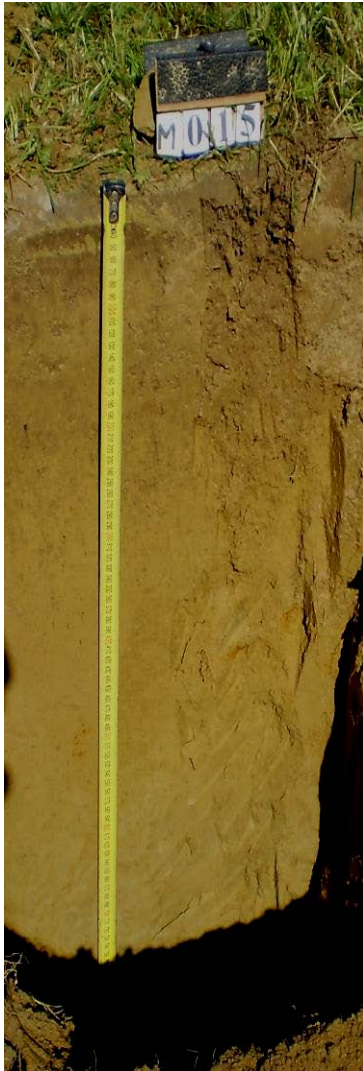
Sample name: Site 15

Soil Name: Manaroa (34c)

Landscape: gently sloping valley floor infilling

Soil drainage: moderately well

Horizon	Depth	Description
A	0-20cm	dark yellowish brown (10YR 4/4) silt to silt loam; moderately developed fine polyhedral structure; weak soil strength; compact packing; friable; common fine roots
AB	20-28cm	dark yellowish brown (10YR 4/4) and yellowish brown (10YR 5/6) silt to silt loam; moderately developed fine polyhedral structure; weak soil strength; compact packing; friable; common fine roots
Bw	28-45cm	yellowish brown (10YR 5/6) silt to silt loam; moderately developed fine polyhedral structure and coarse blocky structure; weak soil strength; compact packing; friable; few fine roots
BC	45cm-67cm	light olive brown (2.5Y 5/6) silt loam to heavy silt loam; 5% pale olive (2.5Y 6/4) fine mottles; weakly developed coarse blocky structure; very weak soils strength; compact packing; very friable; few fine roots
C	67-92cm	dark yellowish brown (10YR 4/6 30%) and pale olive (2.5Y 6/4 60%) mottled heavy silt loam to silt loam; apedal; weak soil strength; compact packing; friable; few fine roots

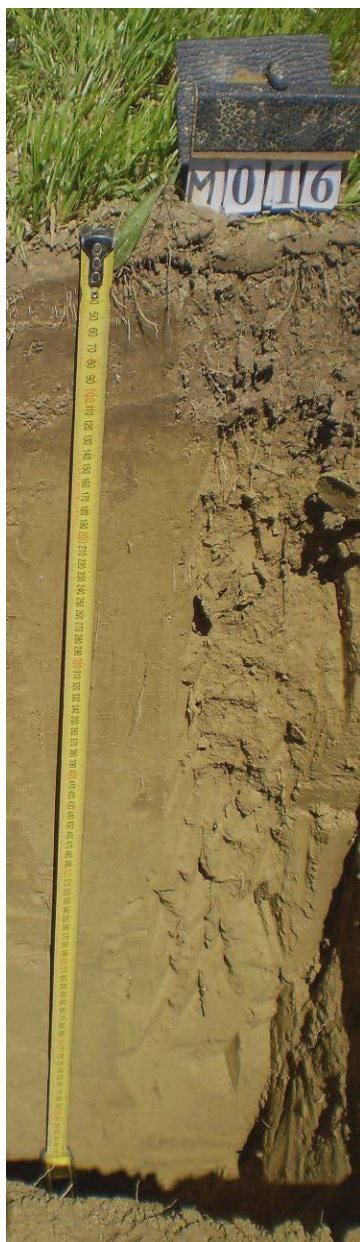
Sample name: Site 16

Soil drainage: well

Horizon	Depth	Description
A	0-16cm	brown to dark brown (10YR 4/3) silt to silt loam; weakly developed fine polyhedral structure; weak soil strength; compact packing; friable; many fine roots
AB	16-22cm	yellowish brown (10YR 5/6) and brown to dark brown (10YR 4/3) silt to silt loam; weakly developed fine polyhedral and coarse blocky structure; weak soil strength; compact packing; friable; many fine roots
Bw	22-40cm	yellowish brown (10YR 5/6) silt to silt loam; weakly develop coarse blocky structure; weak soil strength; compact packing; friable; common fine roots
BC	40cm-60cm	light olive brown (2.5Y 5/6) silt to silt loam; 20% light brownish grey (2.5Y 6/2) to light yellowish brown (2.5Y 6/4) fine distinct mottles; apedal; weak soil strength; compact packing; friable; few fine roots
C	60-100cm	light olive brown (2.5Y 5/6) heavy silt loam; apedal; weak soil strength; compact packing; friable

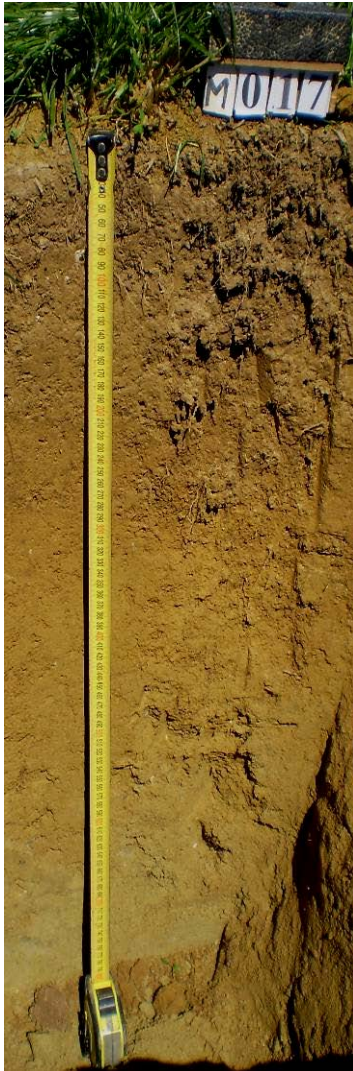
Sample name: Site 17

Soil Name: Kaituna (34a)

Landscape: terrace remnant of once more extensive side valley, Last Glaciation, fan-type infill deposits

Soil drainage: well

Horizon	Depth	Description
A	0-21cm	dark yellowish brown (10YR 4/4) silt loam; 2% fine stones; strongly developed fine polyhedral structure; weak soil strength; compact to loose packing; very friable; abundant fine roots
AB	21-27cm	dark yellowish brown (10YR 4/4) and yellowish brown (10YR 5/6) silt loam; 2% fine stones; strongly developed fine polyhedral structure; weak soil strength; compact packing; very friable; abundant fine roots
Bw1	27-50cm	yellowish brown (10YR 5/6) heavy silt loam; 5% fine stones; moderately developed fine polyhedral structure; very weak soil strength; compact packing; very friable; many fine roots
Bw2	50cm-67cm	yellowish brown (10YR 5/6) to light olive brown (2.5Y 5/6) heavy silt loam; 5% fine stones; weakly developed coarse blocky structure; slightly firm soil strength; compact packing; brittle fracture; common fine roots
BC	67-90cm+	light olive brown (2.5Y 5/4) to light yellowish brown (2.5Y 6/4) silt loam; 5% fine stones; 5% yellowish red (5YR 5/6) faint fine mottles; apedal; slightly firm soil strength; compact packing

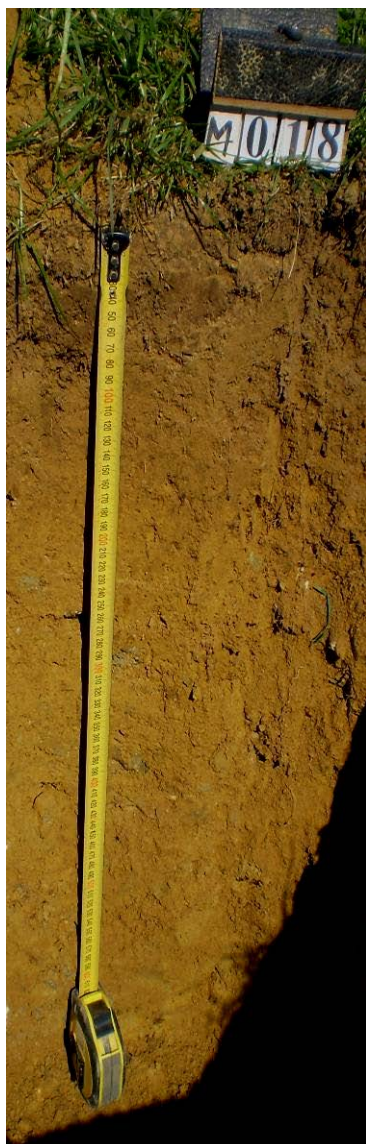
Sample name: Site 18

Landscape: weakly dissected older fan surface

Soil drainage: well

Horizon	Depth	Description
A	0-17cm	dark yellowish brown (10YR 4/6) clay loam; 5% fine and medium stones; strongly developed fine polyhedral structure; weak soil strength; compact packing; friable; abundant fine roots
AB	17-24cm	dark yellowish brown (10YR 4/6) and yellowish brown (10YR 5/8) clay loam; 5% fine and medium stones; strongly developed fine polyhedral structure; weak soil strength; compact packing; friable; abundant fine roots
Bw1	24-42cm	yellowish brown (10YR 5/8) clay loam; 10% fine to coarse stones; strongly developed fine polyhedral structure; weak soil strength; compact packing; very friable; many fine roots
Bw2	42cm-60cm	yellowish brown to brownish yellow (10YR 5/8-6/8) sandy silt loam; 20% fine to coarse stones; moderately developed fine polyhedral structure; weak soil strength; compact packing; friable; common fine roots
BC	60-75cm+	light olive brown (2.5Y 5/6) to olive yellow (2.5Y 6/6) sandy silt loam; 25% fine to coarse stones; weakly developed coarse blocky structure; slightly firm; compact packing; brittle fracture

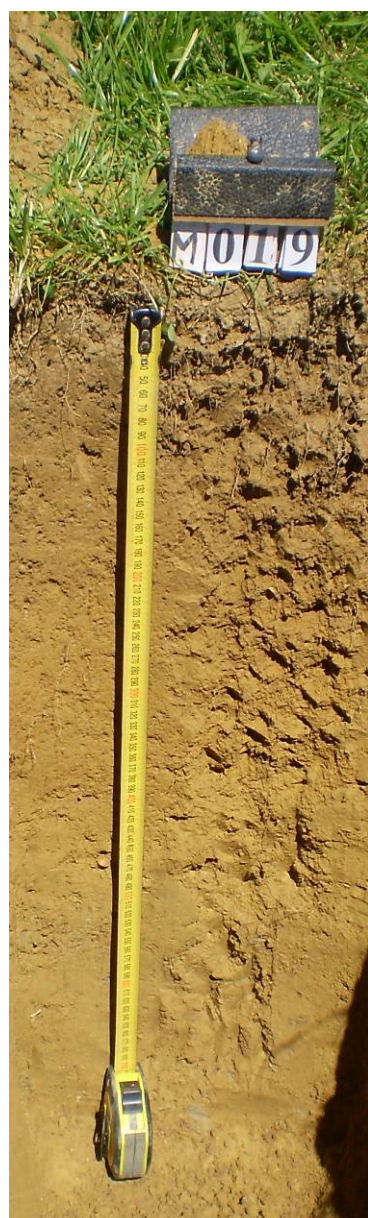
Sample name: Site 19

Landscape: weakly dissected low-lying fan surface

Soil drainage: moderately well

Horizon	Depth	Description
A	0-23cm	dark yellowish brown (10YR 4/4) silt loam; 1% fine stones; moderately developed fine polyhedral structure; weak soil strength; compact packing; friable; abundant fine roots
AB	23-30cm	dark yellowish brown (10YR 4/4) and yellowish brown (10YR 5/6) silt loam; 1% fine and medium stones; moderately developed fine polyhedral structure; weak soil strength; compact packing; friable; abundant fine roots
Bw1	30-48cm	yellowish brown (10YR 5/6) heavy silt loam; 2% fine and medium stones; moderately developed fine polyhedral and coarse blocky structure; slightly firm soil strength; compact packing; brittle fracture; few fine roots
BC	48cm-70cm	light olive brown (2.5Y 5/6) clay loam; 15% fine and medium stones; weakly developed coarse blocky structure; slightly firm soil strength; compact packing; brittle fracture; few fine roots
C	70-80cm+	light olive brown (2.5Y 5/6) clay loam; 25% fine and medium stones; 25% strong brown (7.5YR 5/6) and 25% light yellowish brown (2.5Y 6/4) medium distinct mottles; apedal; dense
