Soil Survey of Part of the Wither Hills - Redwood Hills Area, Marlborough

MDC Technical Report No: 11-004

April 2011

Report Prepared for the Marlborough District Council by:

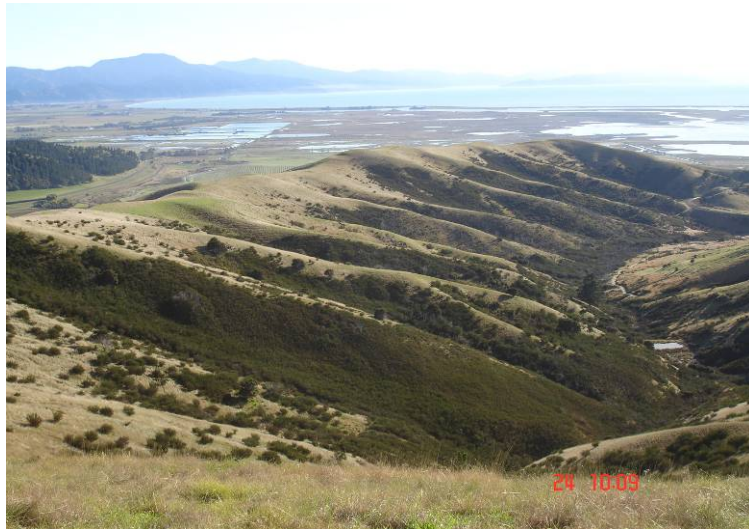
Figure 2. Typical fine-textured dissection pattern of regularly spaced ridges and gullies. The southeast facing side is commonly more steeply sloping than the northeast facing side. The ridges and spurs are easy to moderately sloping but increase in steepness near the valley floor.

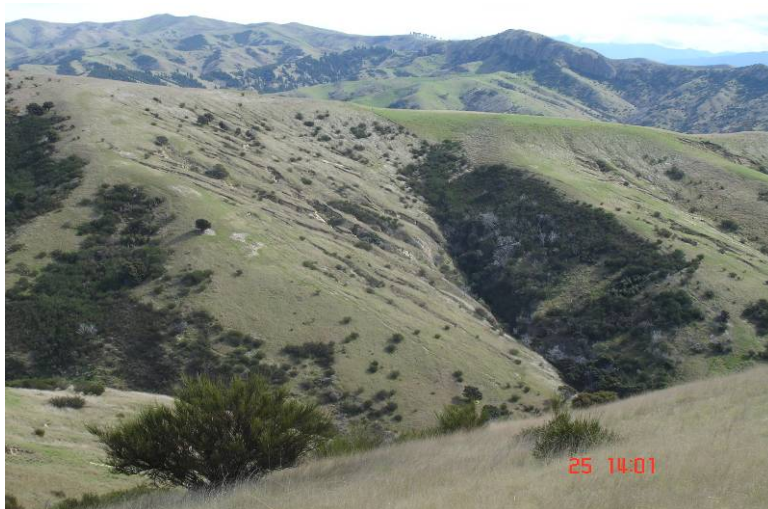
Figure 3. A common pattern of asymmetric gullies with eroded Wither and Vernon soils on one side and Waihopai soils on the other side and on the ridges.

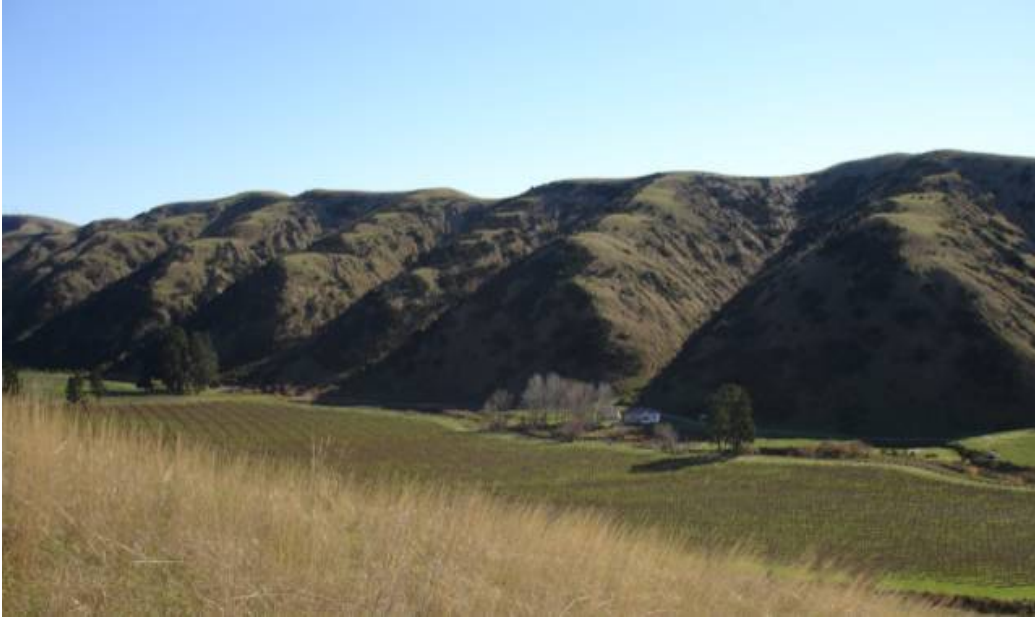
Figure 4. Fine-textured dissection with the ends of the spurs between the gullies over-steepened, either by valley downcutting or possibly by faulting.

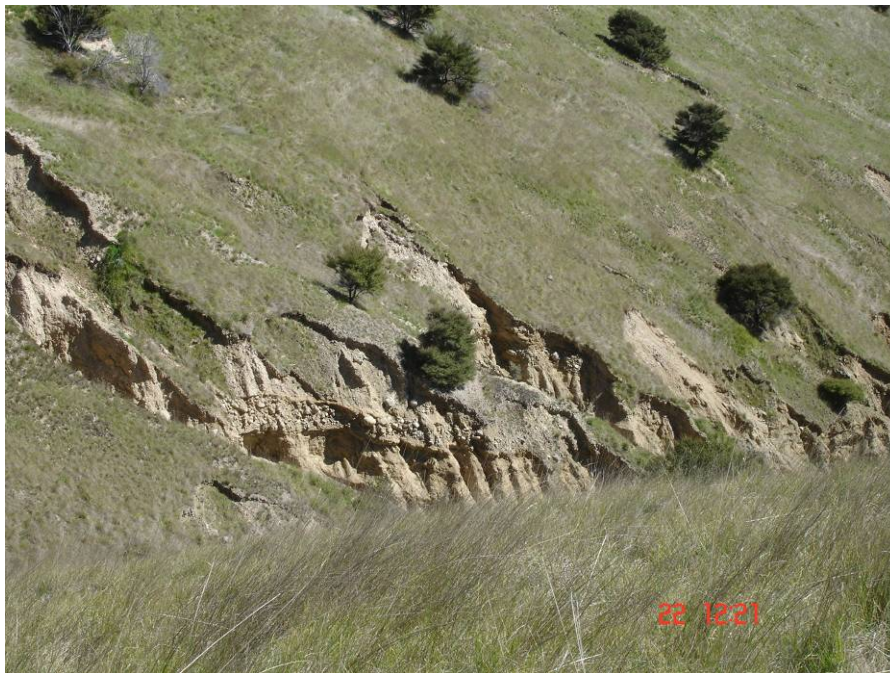
Figure 5. Valley head downcutting in older redeposited gravel materials. The layer of coarse gravels are an indication of earlier active erosion and local scree type aggradation. Waihopai soils are on the steep slopes.

In a few places, the conglomerate is cemented and was found on ridges as hard outcrops. In a number of places towards the heads of the valleys there is deep downcutting in comparatively weakly consolidated gravels and slip erosion is extensive. Occasionally, evidence of significant erosion and re-deposition of gravel within the valley systems was noted (Fig 5).

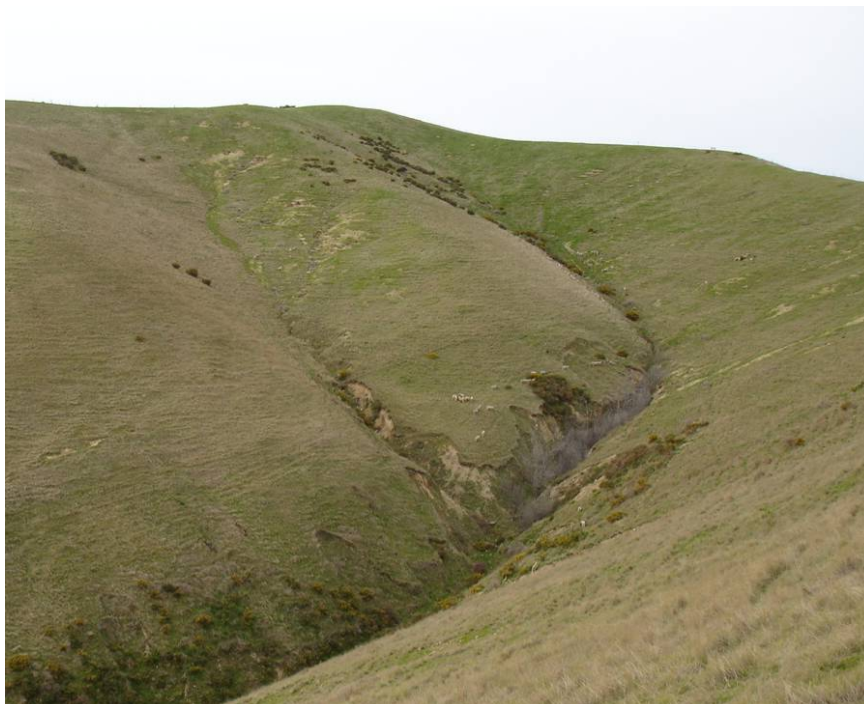
Figure 6. Waihopai hill and stepland soils in a valley head with patches of Vernon soils on the upper eroding slopes. The lower slopes with slip and gully erosion are Waihopai stepland soils on reworked gravels.

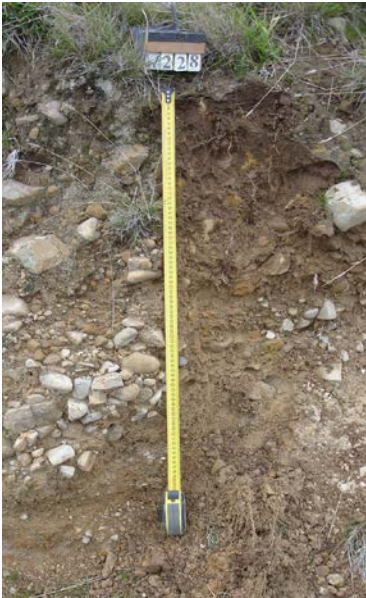
Figure 7. Waihopai hill soil with a brown to dark brown A horizon over yellowish brown B horizon, passing into a BC horizon of brownish yellow *in situ* consolidated gravel.

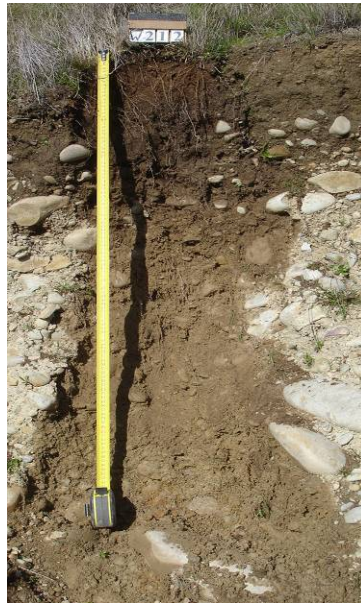
Figure 8. Waihopai hill soil with a thin (25 cm) loess cover and a yellowish brown B Horizon passing into olive brown *in situ* gravel at 100 cm.

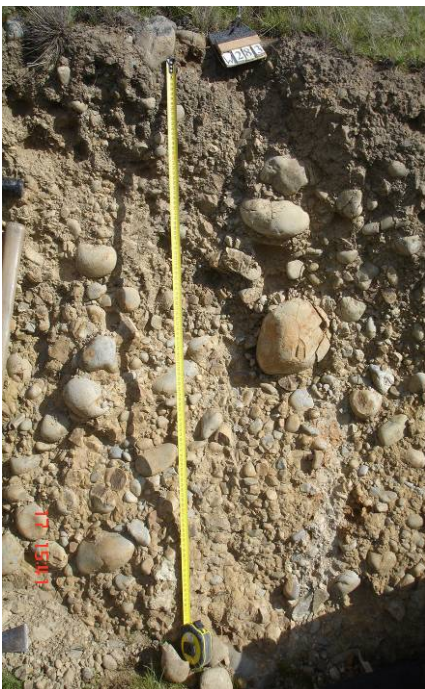
Figure 9. Shallow Waihopai soil on a ridge with *in situ* gravel <25 cm from the surface. Clasts have surface oxide staining with a clayey matrix from earlier weathering.

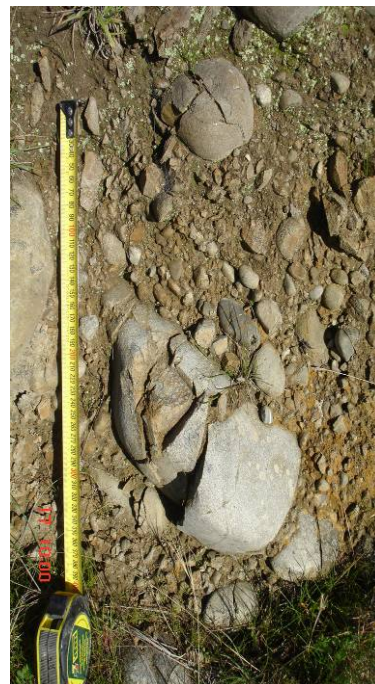
Figure 10. Clasts in the conglomerate are frequently fractured through *in situ* weathering processes.

In exposed sections, clasts may have a thin iron oxide coating while some fractured greywacke clasts have iron oxide coatings along the fracture faces. These weathering features are probably in part relict and may relate to earlier weathering conditions.

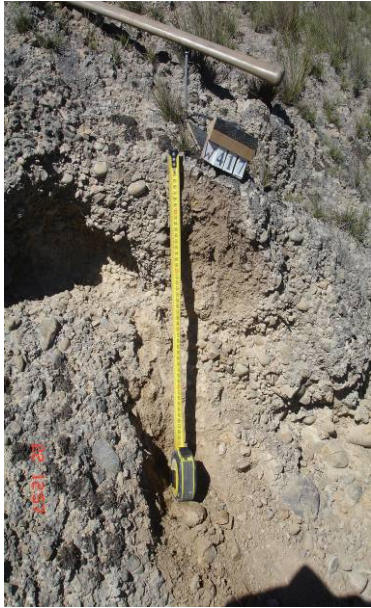
Figure 11. Waihopai steepland soil formed from consolidated and partly cemented conglomerate.

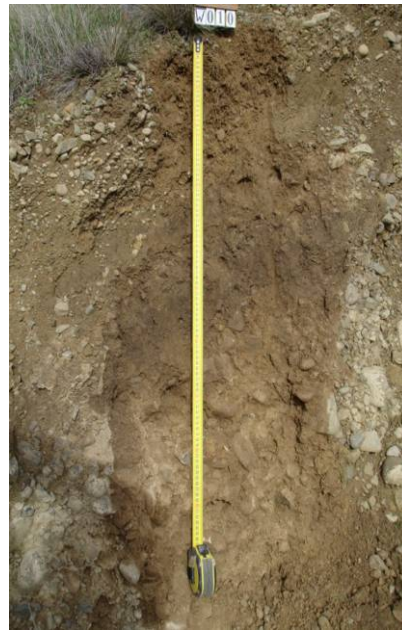
Figure 12. Waihopai steepland soil formed from re-worked material in weakly consolidated gravel. A paleosol with a distinct buried A horizon is present below 30 cm.

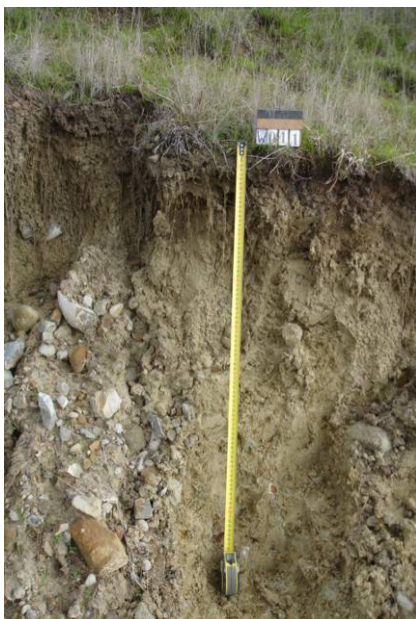
Figure 13. Waihopai hill soil on a lower slope from mixed reworked materials.

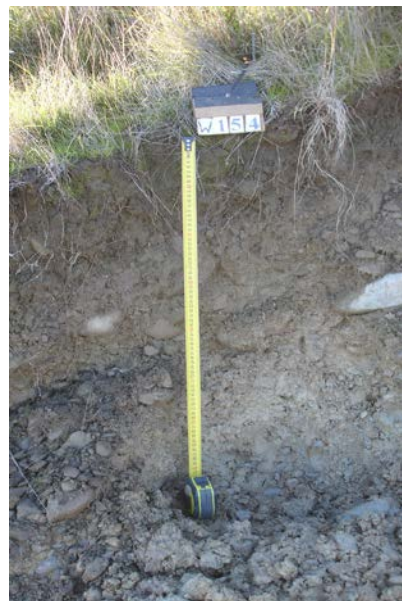
Figure 14. Waihopai hill soil on a lower slope with subsoil grey colours indicating drainage impedance. Reworked material lies over *in situ* firm saturated gravel on which a slip has occurred.

On some lower slopes, concentrations of runoff waters gives rise to soils with grey subsoil colours and reducing conditions, at times with a weak iron pan that forms a shear plane, along which shallow slipping may occur.
