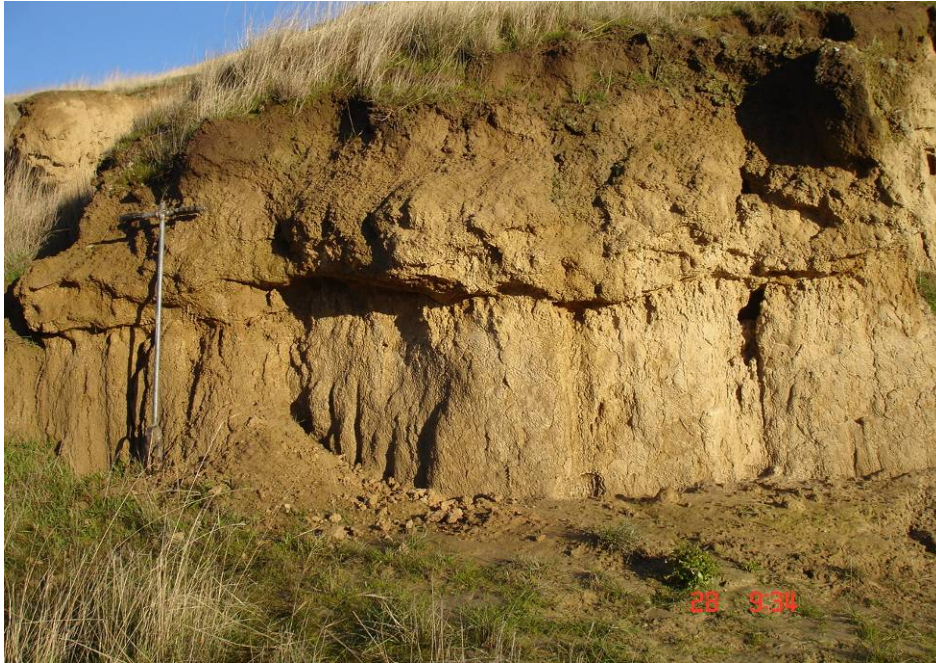
Figure 36. At this site, water in the saturated soil was flowing down-slope on the top of the pan and trickling down the face of the section, causing dispersion of the clay loam material beneath and undercutting the pan. The dispersed soil is being deposited as structureless caked material at the front of the section as headward erosion continues.

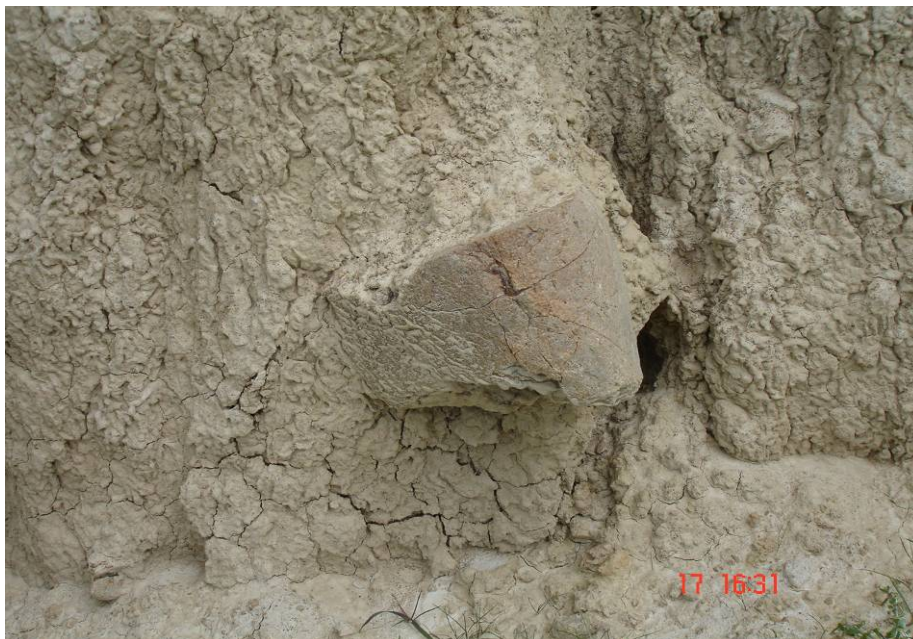
Figure 37. A small solitary boulder within the dispersible silty clay soil material below the fragic horizon. The orientation of the long axis down slope suggests that it has slid rather than being transported amongst a mass of other material, which suggests that solifluction (sliding of thawed material on a firm or frozen surface) may have been the mechanism of transport. The fracturing in the clast has come later as part of soil weathering and may have been facilitated by high salt concentrations present in the soil during the earlier cold and dry conditions.

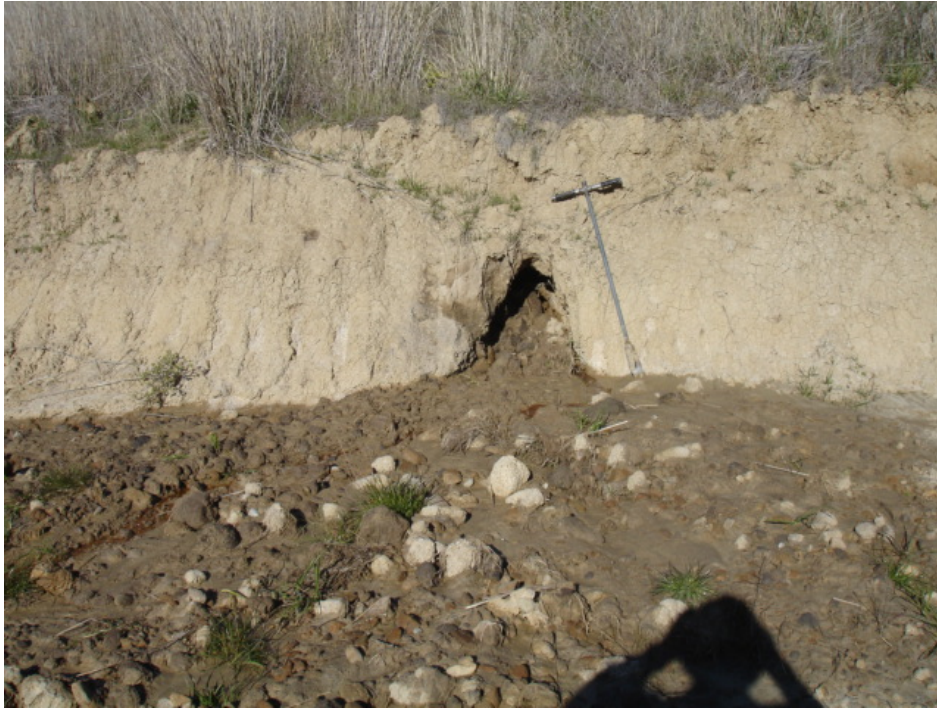
Figure 38. A piping channel on a lower slope with outflow water-transported debris (colluvium) deposited during heavy winter rains.

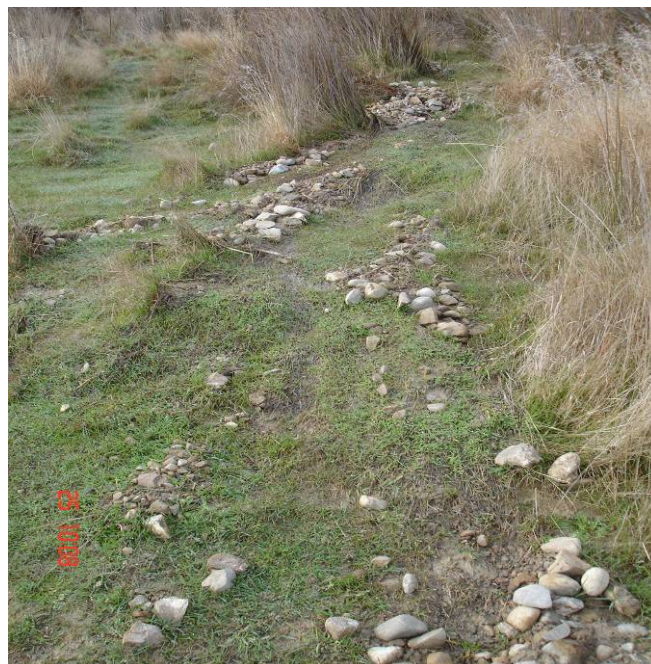
Figure 39. Recently deposited coarse material (colluvium) deposited mid slope, and transported by water from a small up-slope outlet pipe.

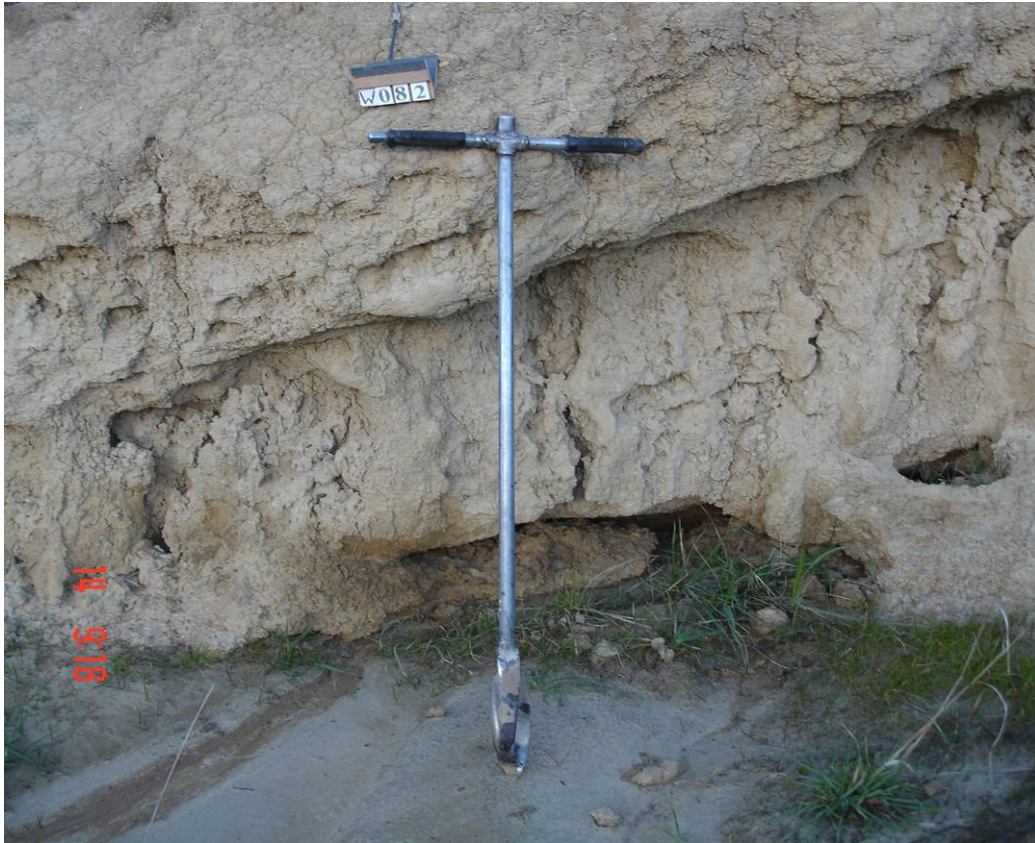
Figure 40. Silt deposited at a piping outlet as a result of soil dispersion. The fragic horizon has multiple layers.

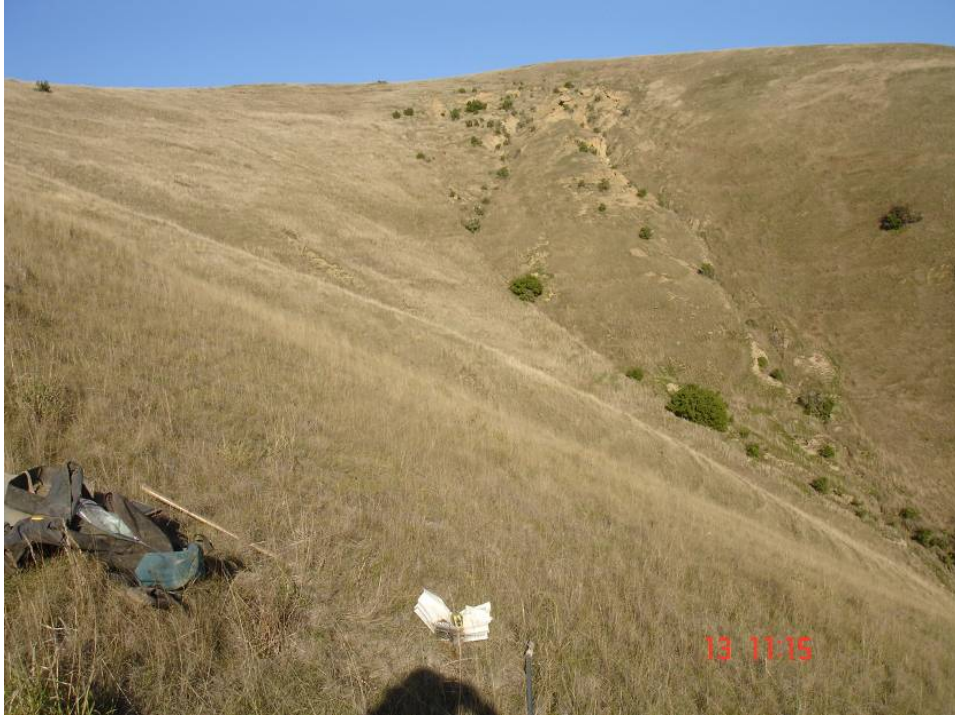
Figure 41. Vernon hill soils with shallow gully erosion occupying a typical gully head position. Waihopai hill and steepland soils are on adjacent surfaces.

Vernon soils were mapped over approximately 30% of the surveyed area. They occur over a range of slopes from strongly rolling through to steep and more especially on the lower surfaces of the valleys and gullies, as well as on gully and valley head surfaces (Figs. 41-43). Vernon soils are transitional grading into Waihopai soils, often within a few metres, where loess becomes thinner (Fig. 15) and into Wither soils where loess increases in thickness and the stone content becomes negligible.

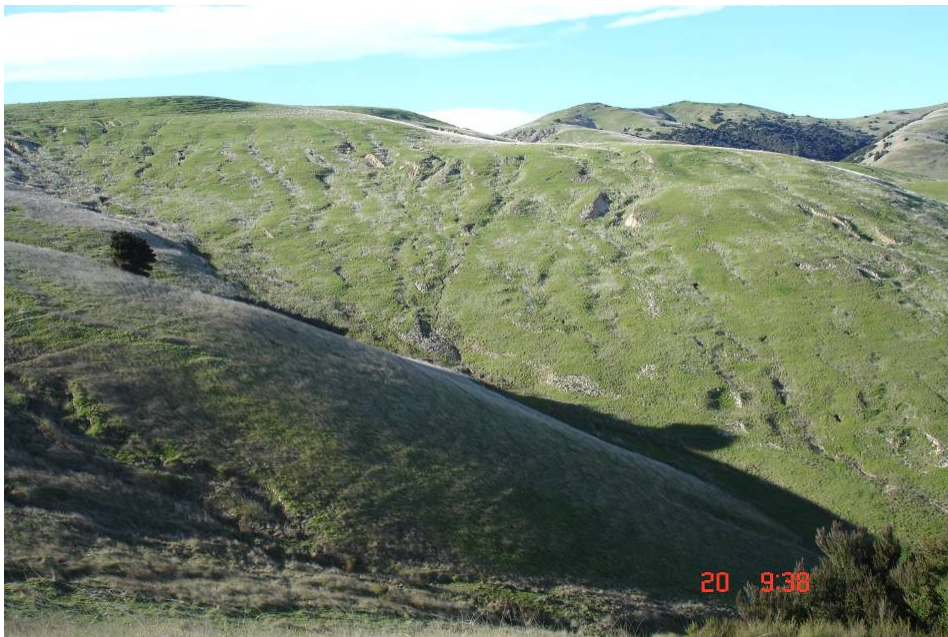
Figure 42. Vernon/Wither soils with shallow gully erosion on the hill slopes below a ridge crest. Waihopai hill soils are on the spur and ridge slopes in the foreground.

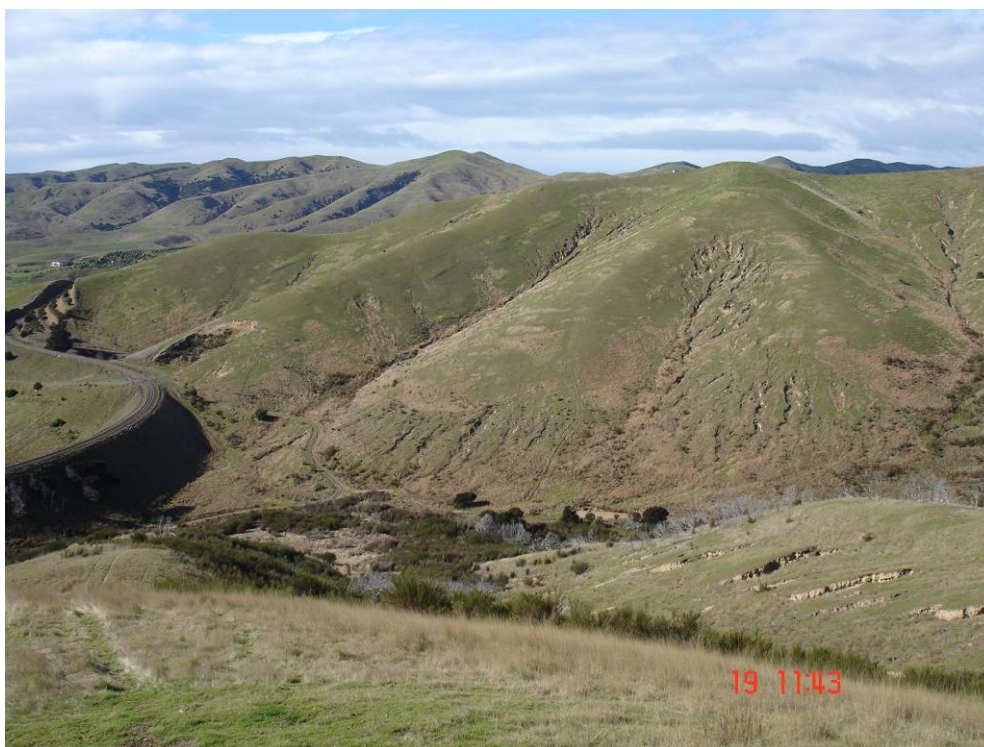
Figure 43. Vernon hill soils are on the lower slopes on the opposite side of the valley (marked by the shallow gullying) where loess and coarse materials have accumulated and Waihopai hill soils are on the spur crests. Wither hill soils are on the slopes on the right foreground and Waihopai hill soils on the immediate foreground slopes.
