**MARLBOROUGH
DISTRICT COUNCIL**

Surface Water Quality Monitoring Report, 2016

**Technical Report No: 16-006
October 2016**

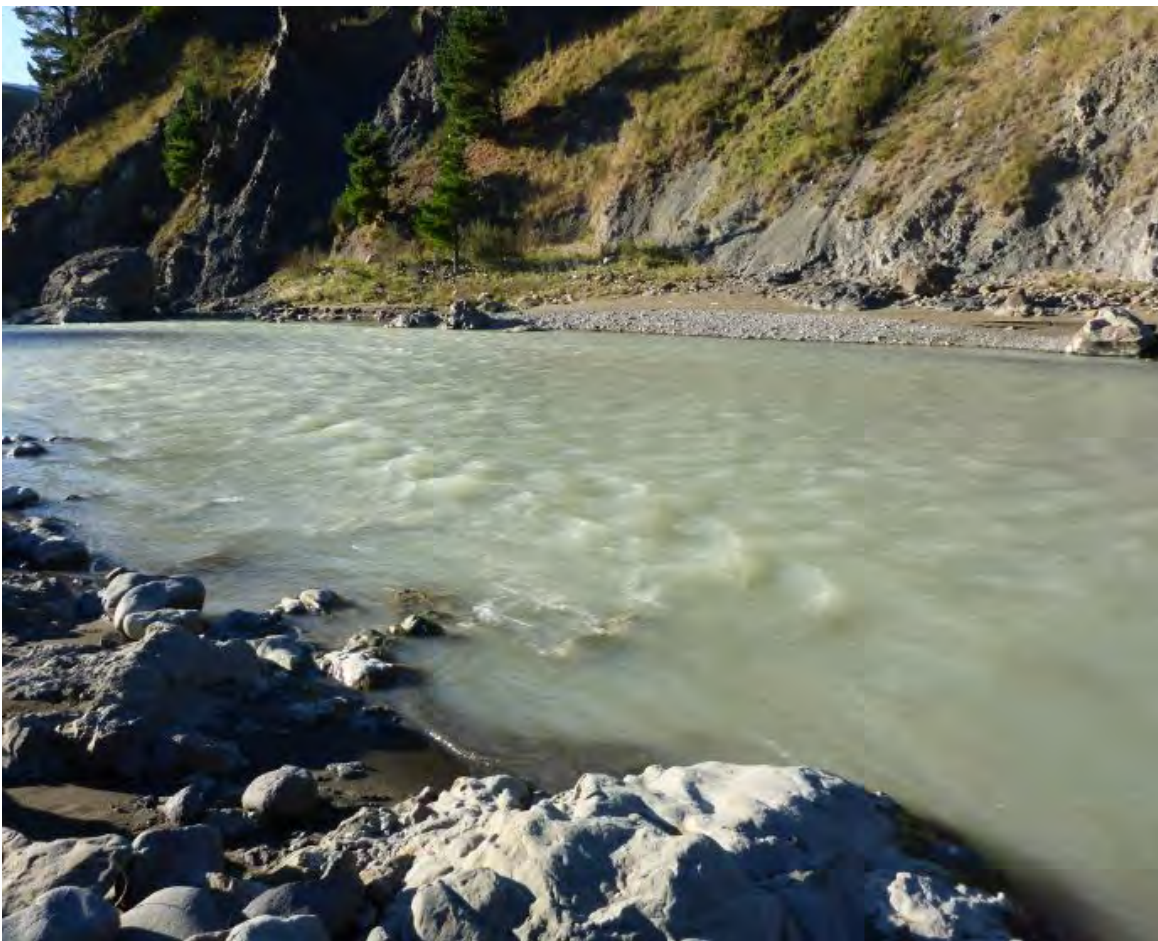
Figure 26: Typical turbid appearance of the Awatere River at the mid Awatere monitoring site.

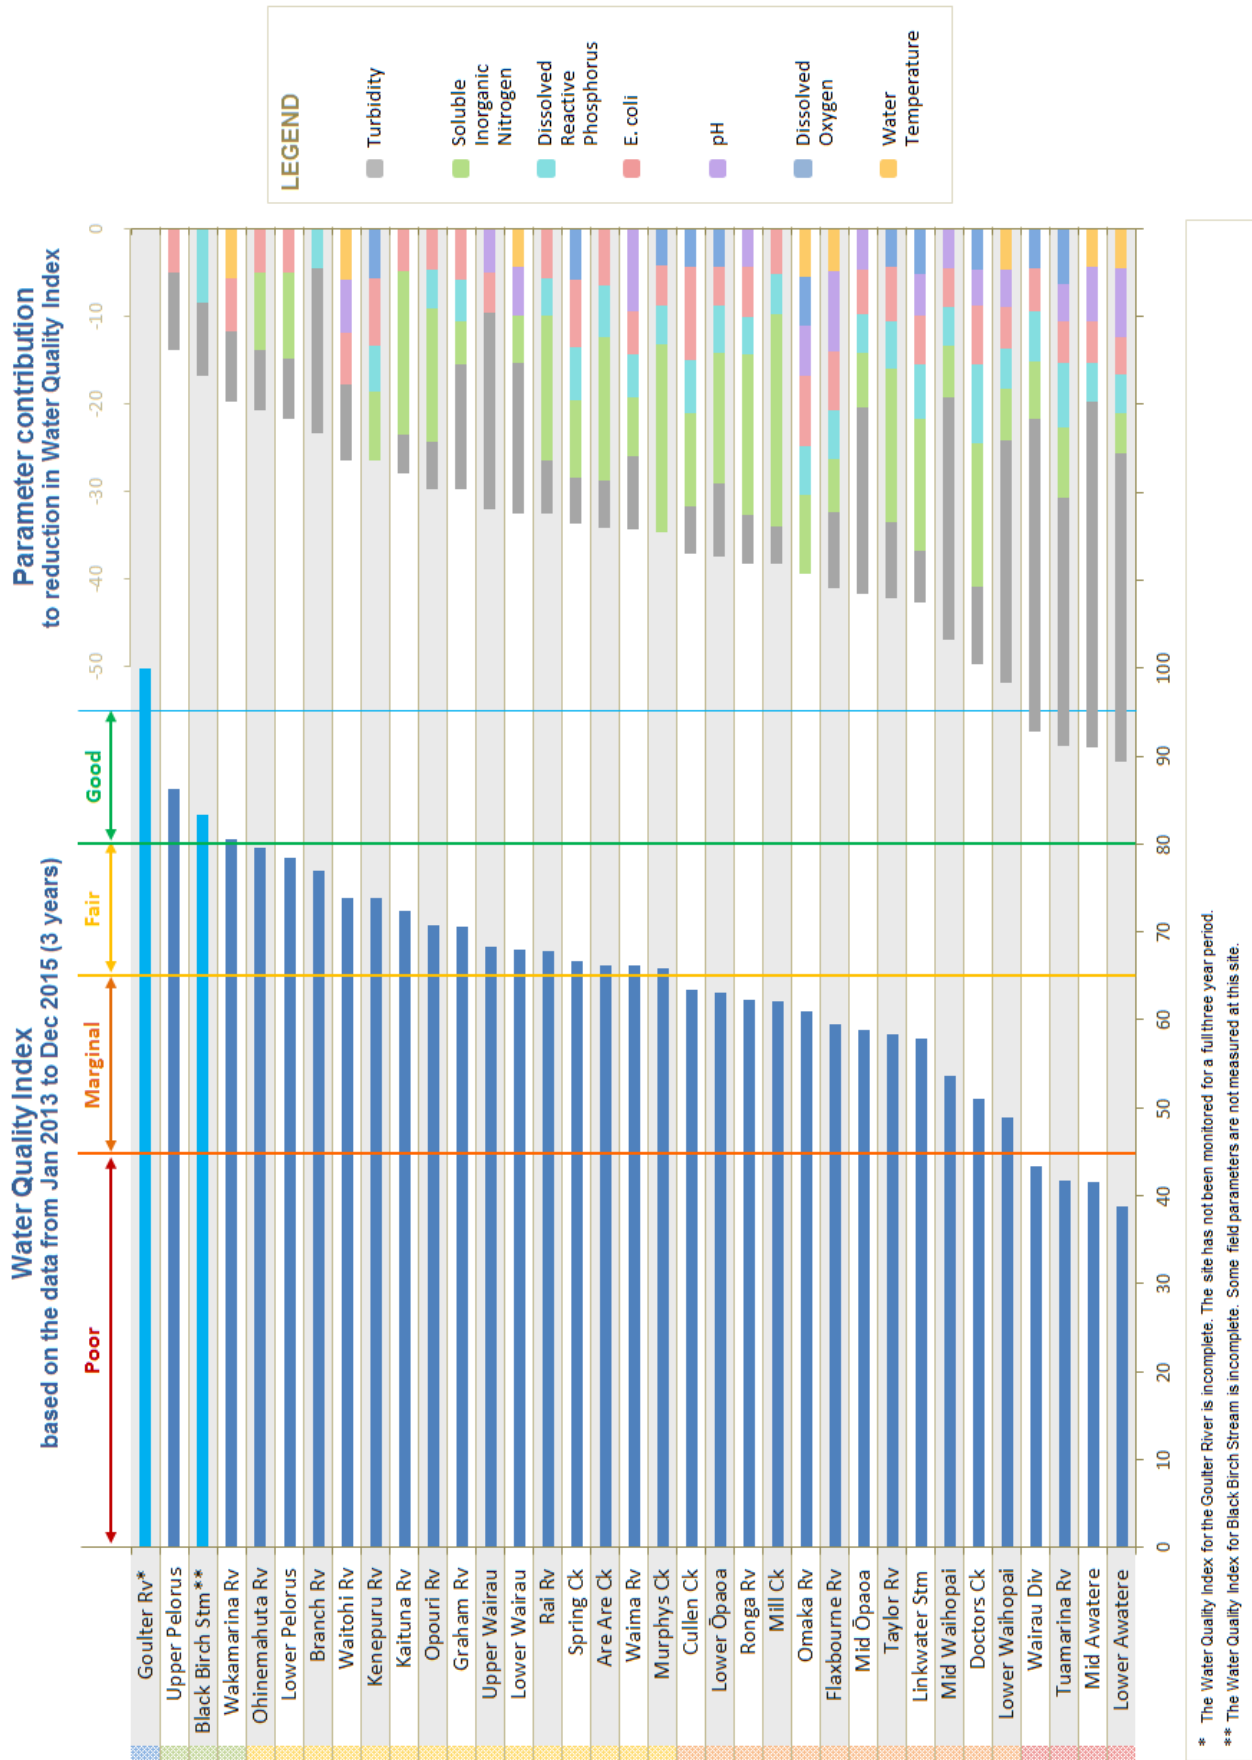
Figure 27: Water Quality Indices and Parameter contributions to the reduction in the Water Quality Indices for the three years from 2013 to 2015 for all sites monitored.

There are three sites with water quality in the 'good' category, the Upper Te Hoiere/Pelorus River, Black Birch Stream and the Wakamarina River (Figure 27). All three waterways have more than 80% of the catchment remaining in native vegetation. However, a large proportion of native vegetation is not a guarantee for good water quality. The Waitohi, Branch, Graham and Upper Wairau Rivers, all have had less than 15% of their catchments converted from native vegetation, but have Water Quality Indices in the fair category. In the Waitohi River the influence of urban development is the main cause for the degradation in water quality. For the other rivers mentioned, turbidity is the parameter causing the most significant reduction of the Indices. The Water Quality Index for the Upper Wairau River had been in the good category in the past, but has declined considerably in recent years. Analysis in an earlier report showed that the increase of turbidity is a result of higher flows during sampling [15]. A similar phenomenon was also identified for the Branch River.
